# **A Summary of Reconnaissance of the Clinton, MO Elks Lodge Building Collapse on June 26, 2006**

Dr. Hai S. Lew  
Dr. Long T. Phan

National Institute of Standards and Technology  
*William A. Jeffrey, Director*

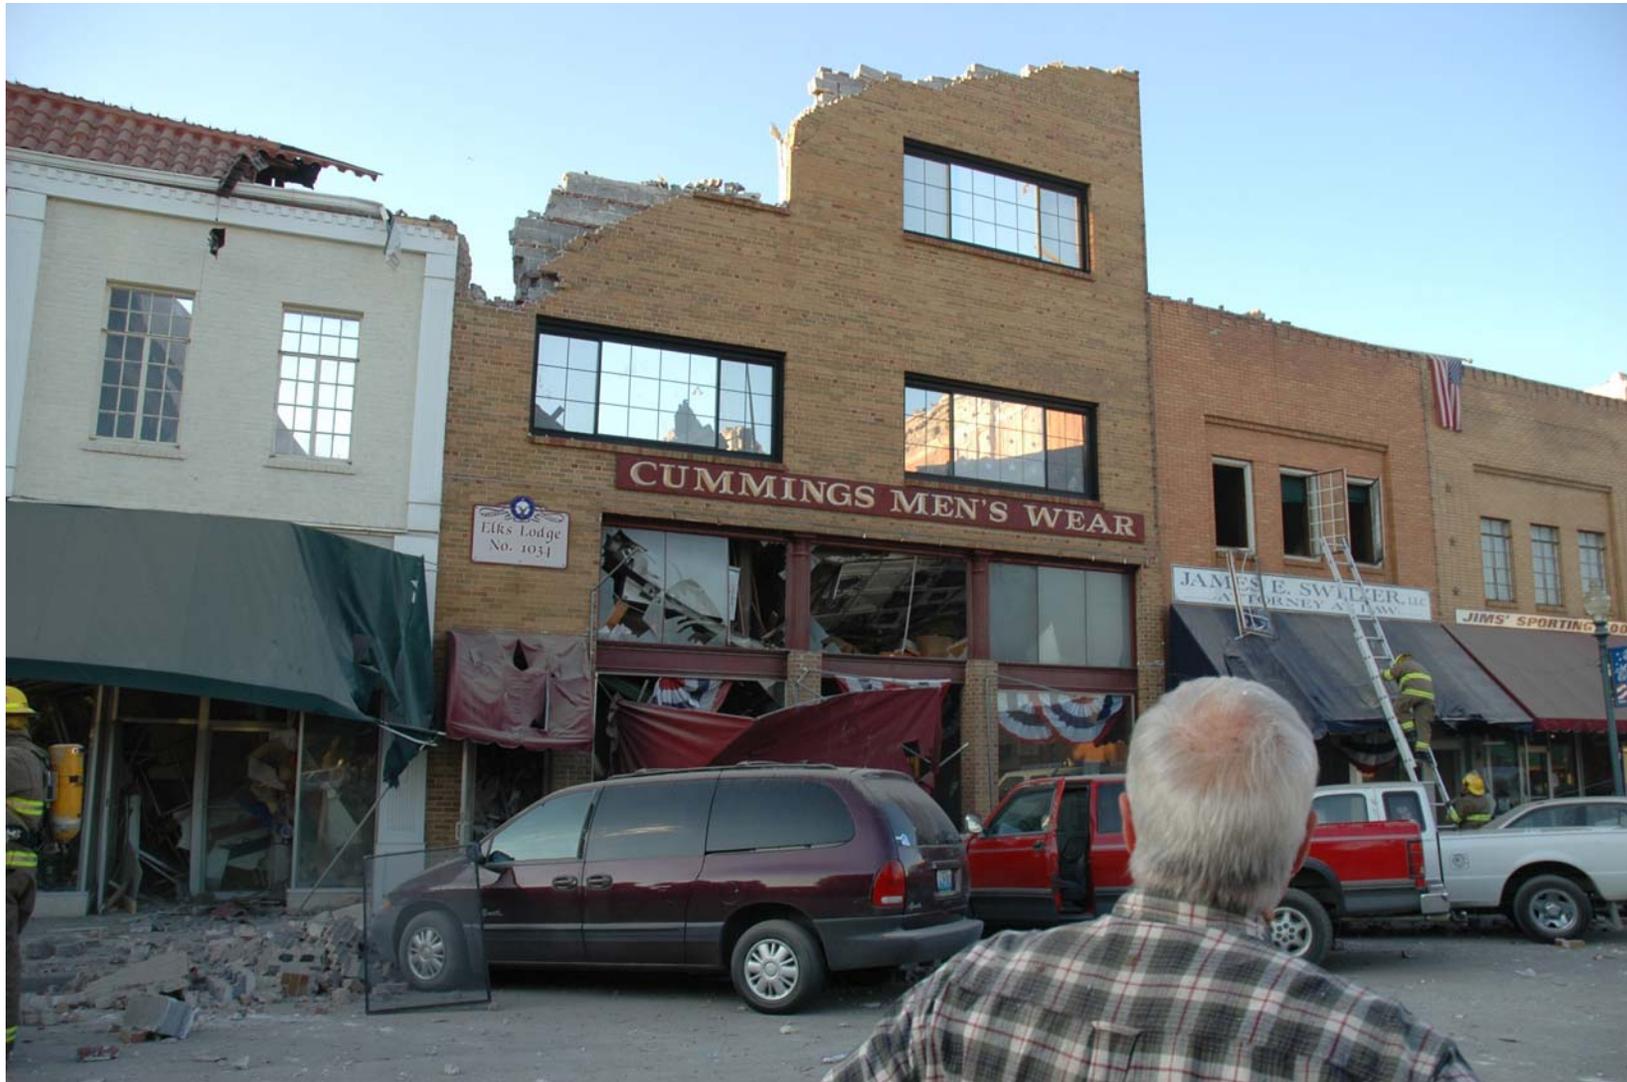
Photograph 1. Front of the Elks Lodge building immediately after the collapse (Photo courtesy of Robert Easton, Director, Henry County Emergency Management Agency, Clinton, MO.)

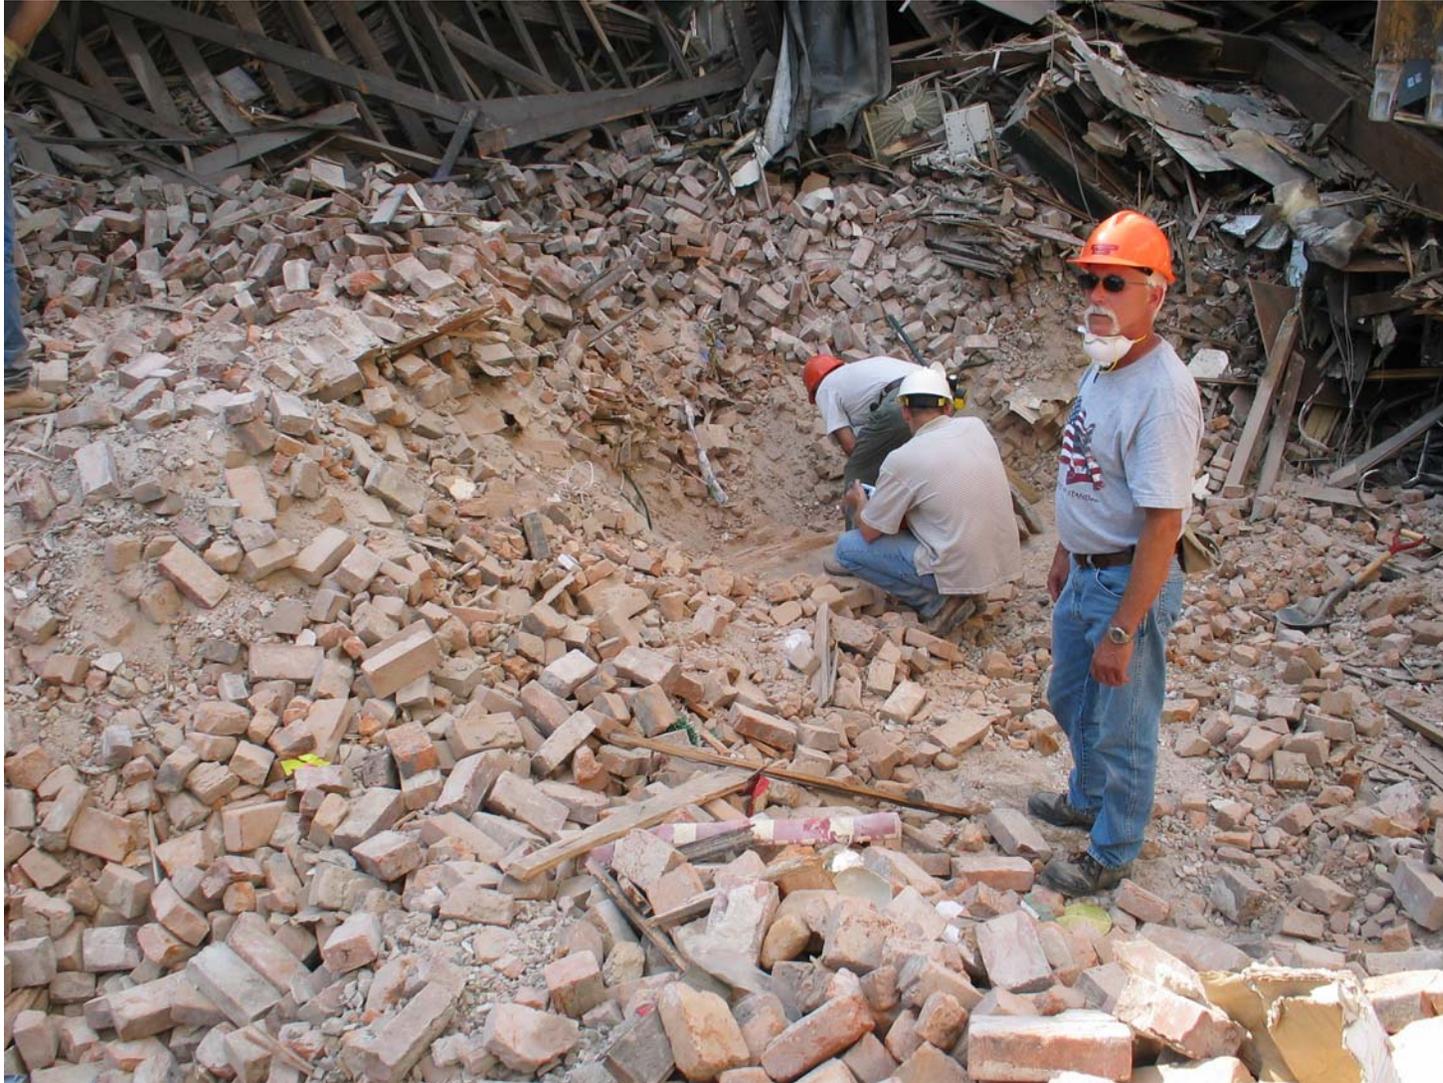
- Photographs taken after removal of the floor debris showed that (1) a large portion of the west wall had disintegrated into individual loose bricks (see photograph 2), (2) many bricks either cracked or broke into smaller pieces, and (3) the lower portion of the west brick wall was wet due to exposure to moisture which would have caused deterioration of the lime-based mortar joints (see photographs 3 and 4). These observations indicate that the west wall was not acting as a single-wall unit at the time of collapse. Rather, it was likely that the deterioration of the mortar joints led to the floor joist loads being carried by individual bricks that were in direct contact with the floor joists. This possibly led to failure of individual bricks (which cracked and broke into smaller pieces) and of the entire west wall progressively. The failure of the west wall resulted in loss of the support for the floors, which ultimately led to the collapse of the entire Elks Lodge building.

Photograph 2. Remnants of the west wall showing individual bricks, broken and pulverized (Note: no wall segments remained. Photo courtesy of Tim Gardner, Executive General Adjuster, Regional Manager, NHI General Adjusters)

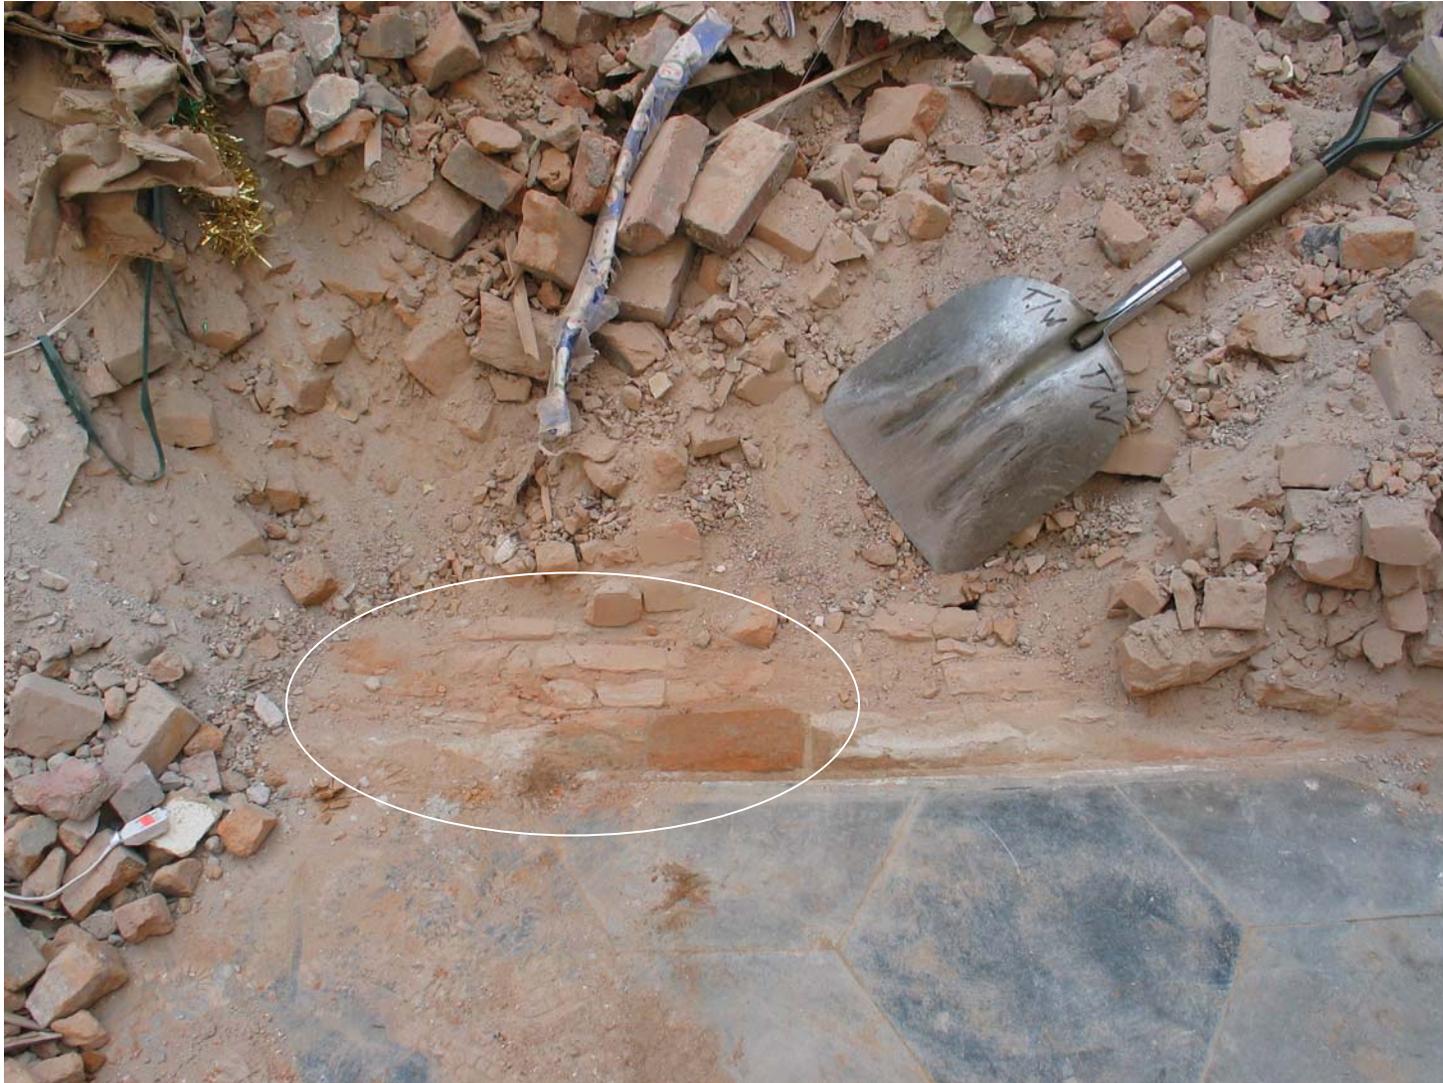
- During the reconnaissance, it was noted that the lime-based mortar of the west wall had signs of extensive deterioration (crumbled easily by rubbing between two fingers and did not appear to have any cohesive strength).

Photograph 3. Base of the west wall with signs of wetness and cracks (Photo courtesy of Tim Gardner, Executive General Adjuster, Regional Manager, NHI General Adjusters)

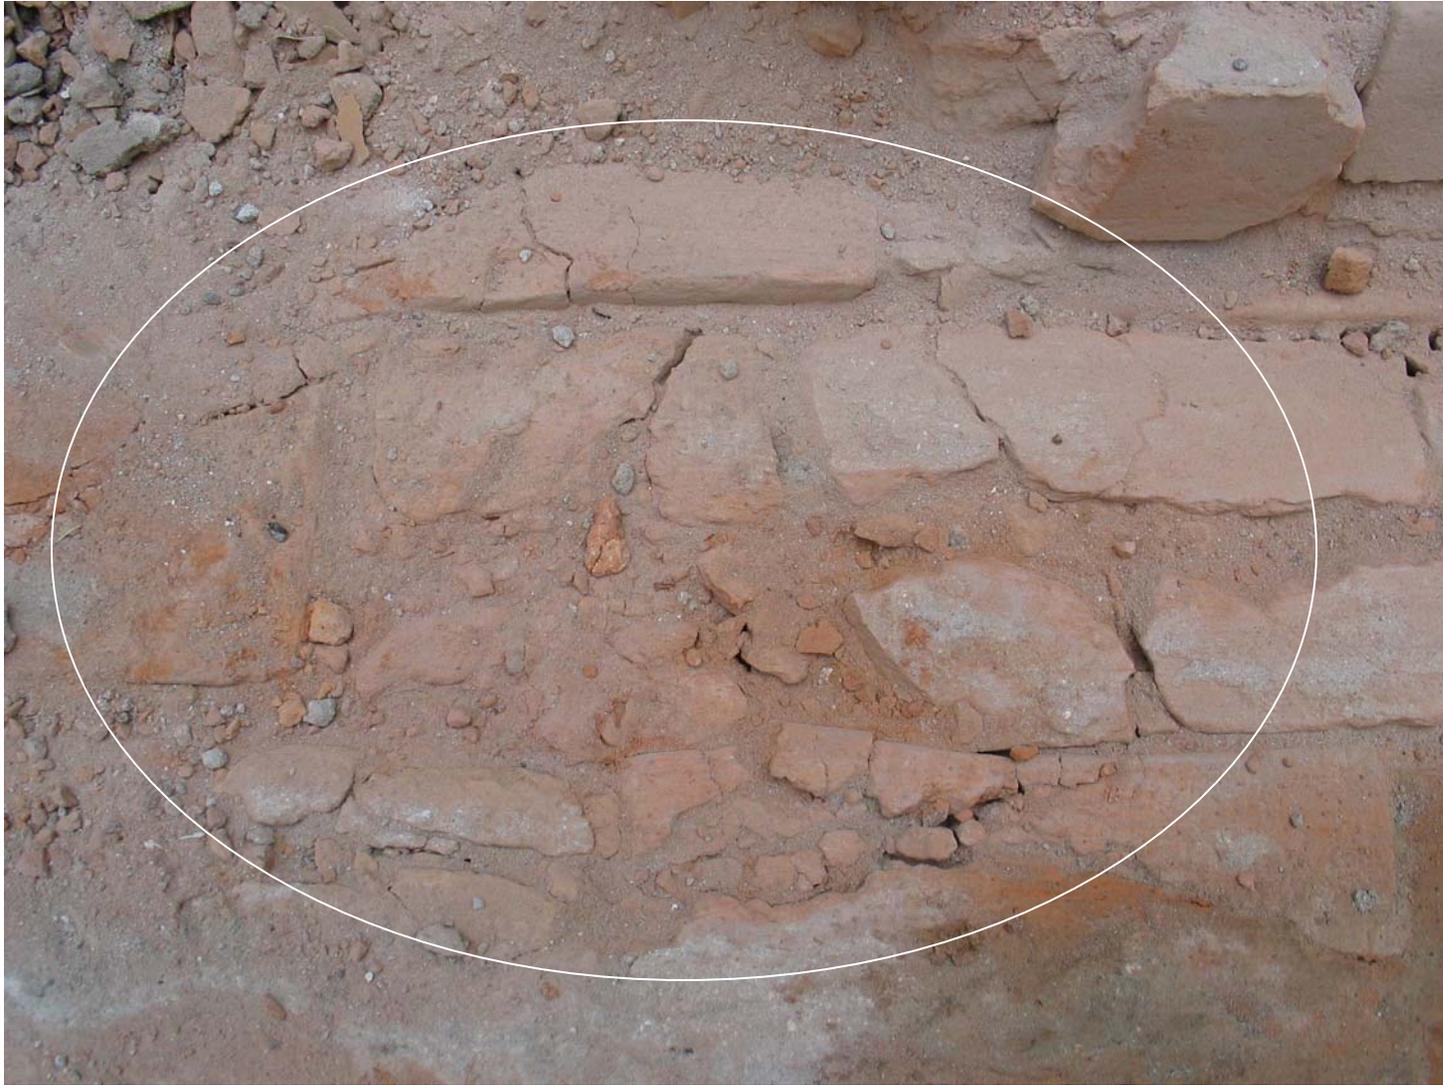
Photograph 4. Close up view of the base of the west wall showing cracked and wet bricks (Photo courtesy of Tim Gardner, Executive General Adjuster, Regional Manager, NHI General Adjusters)
