**NISTIR 7661**

# **Final Report on the Collapse of the Dallas Cowboys Indoor Practice Facility, May 2, 2009**

John L. Gross  
Joseph A. Main  
Long T. Phan  
Fahim H. Sadek  
Stephen A. Cauffman  
*Building and Fire Research Laboratory  
National Institute of Standards and Technology*

January 2010

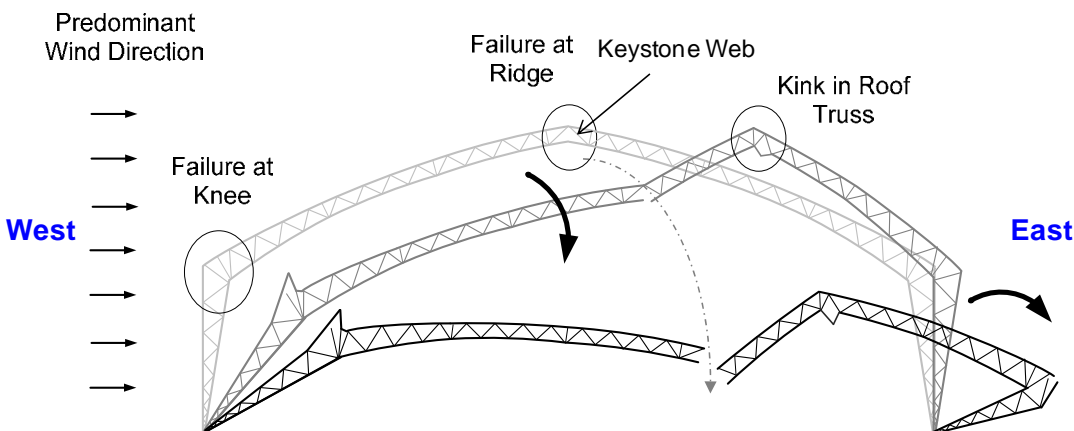
Based upon the observations made during the field reconnaissance and the results of the analysis in which the demand-capacity ratios were ranked in descending order to identify a sequence of member failures, NIST identified the likely collapse sequence for the structure as follows (see Figure ES-2):

1. Buckling of the inner chord in the straight section of the roof on the east side, resulting in formation of a kink in the frame at this location
2. Failures at the east and west knees, allowing the frame to sway eastward (in the direction of the wind)
3. Compressive failure of the east keystone web, leading to tensile fracture of the inner and outer keystone chords at the ridge
4. Spread of individual frame failures in similar patterns, through load redistribution and loss of lateral bracing, resulting in total collapse of the practice facility

**Figure ES-2 Pattern of overall collapse of the north portion of the structure**

**NIST recommends that fabric-covered steel frame structures be evaluated to ensure the adequate performance of the structural framing system under design wind loads. Of particular concern are (1) the use of the fabric covering to provide lateral bracing for structural frames, (2) determination of the appropriate enclosure classification in the calculation of internal pressures for design wind loads, and (3) the ability of the structural system, including the lateral bracing, to maintain overall structural integrity.**

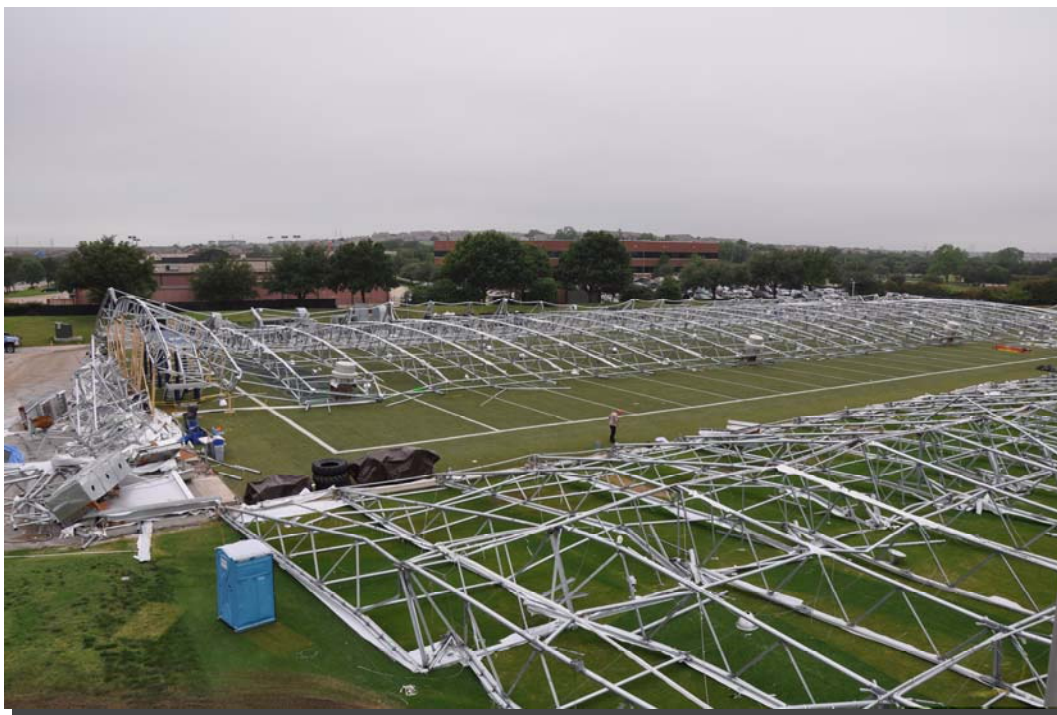
**Figure 1–7 Overall view of collapsed structure after fabric had been removed  
(Photo credit: NIST)**

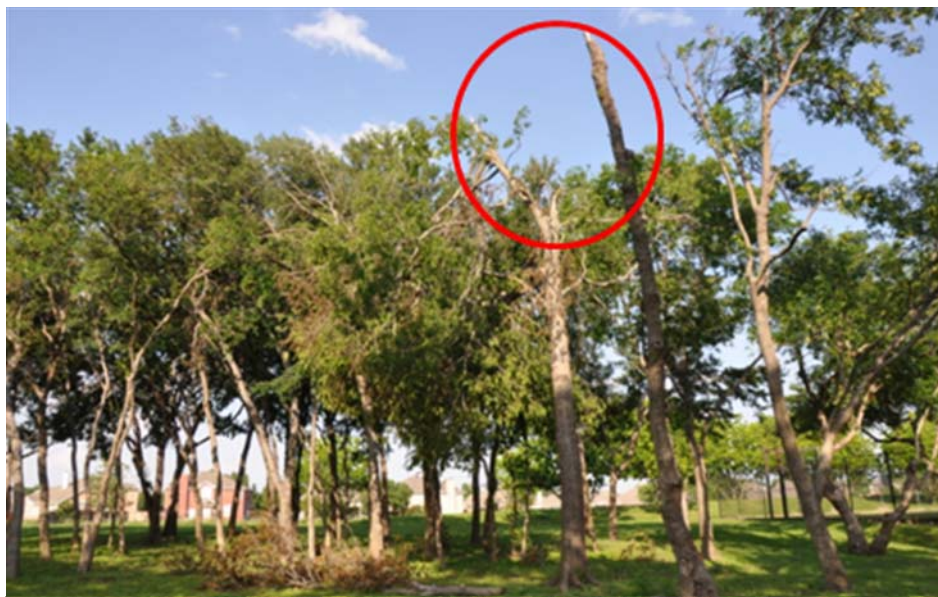
**Figure 2–1 Wind damage to tree limbs east of the collapsed structure  
(Photo credit: NIST)**

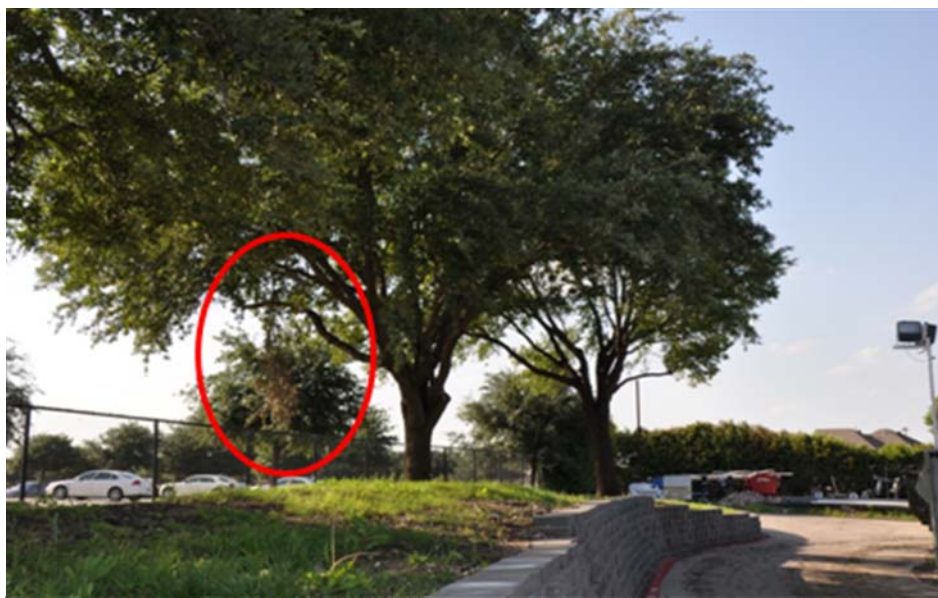
**Figure 2–2 Wind damage to tree limb west of the collapsed structure  
(Photo credit: NIST)**

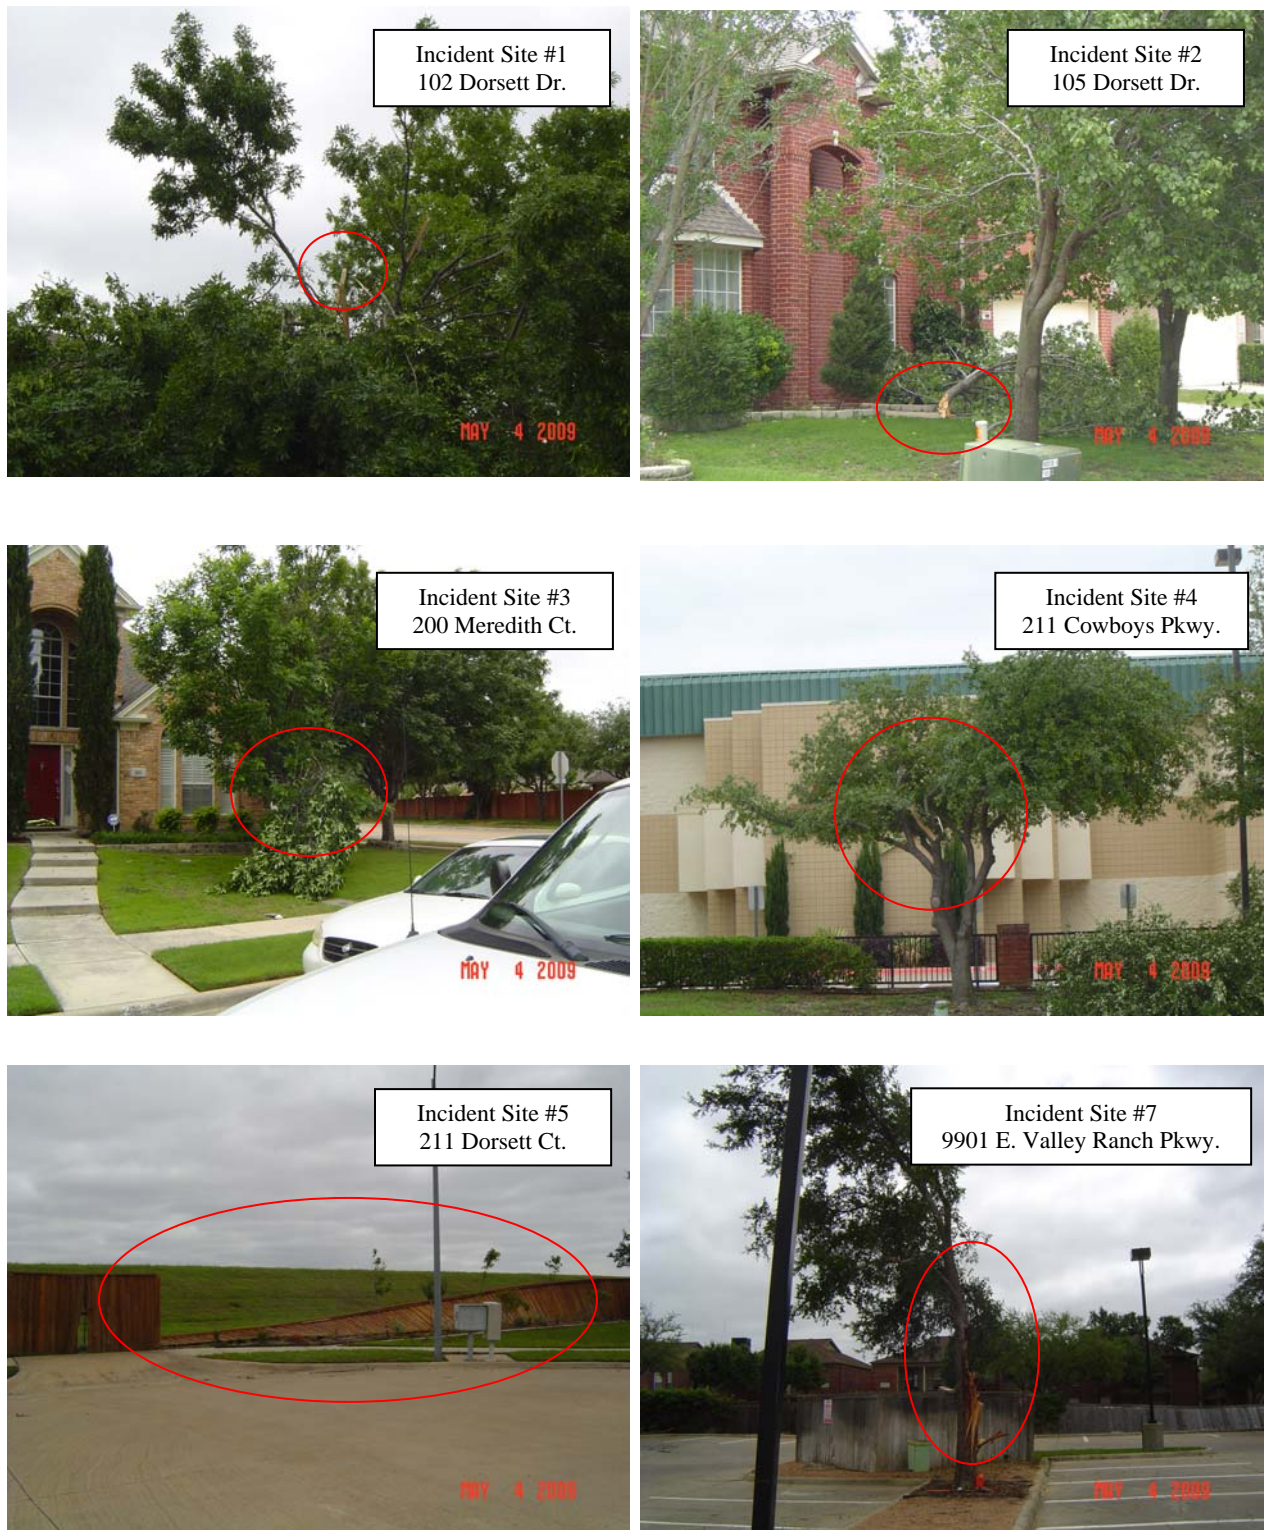
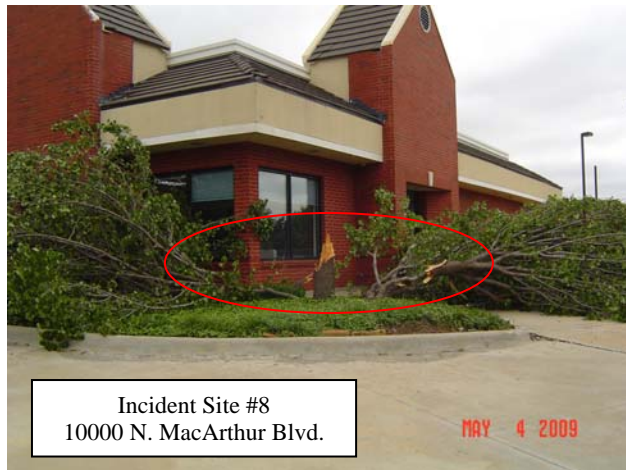
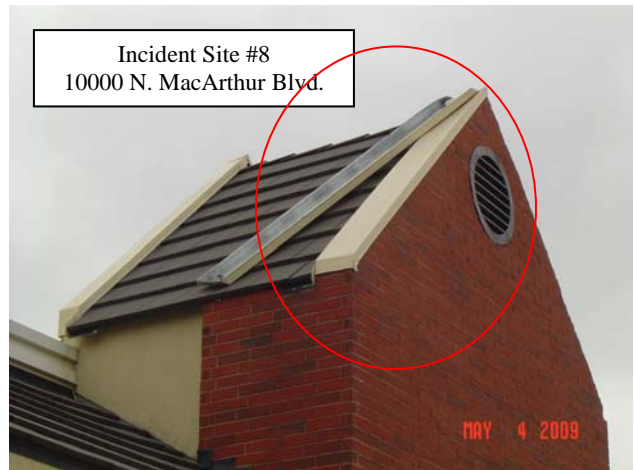
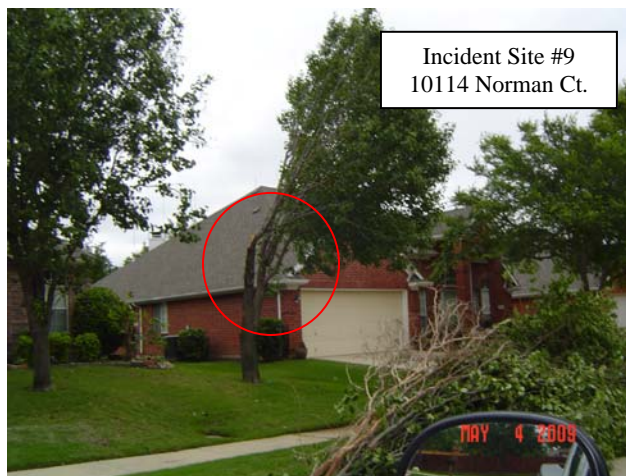
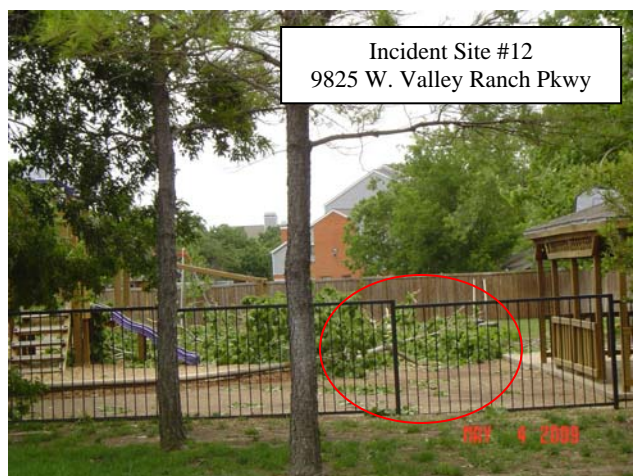
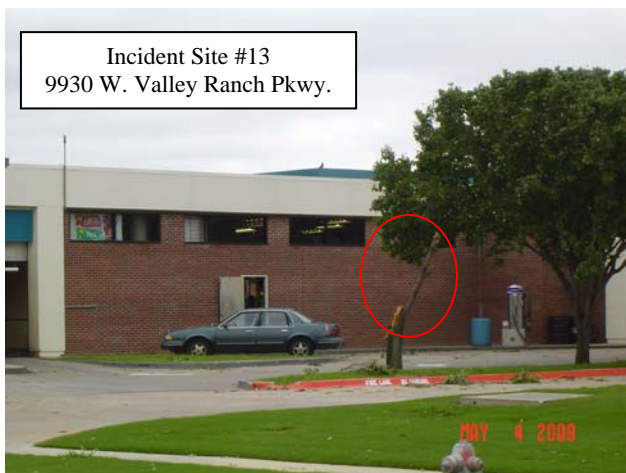
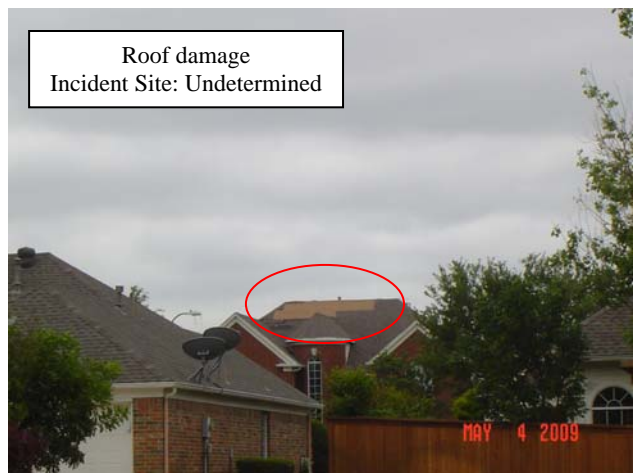
- No structural damage to residential or commercial structures in areas surrounding the practice facility
- Damage to surrounding neighborhoods limited mostly to broken tree limbs, with a few missing roof shingles at one house, and damaged flashing at another (see Figure 2–4)
- A general west-to-east pattern of damage to trees at locations on both east and west sides of the collapsed structure

**Figure 2–4 Wind damage to neighborhoods surrounding the practice facility**  
(Photo credit: City of Irving, Texas – used with permission)

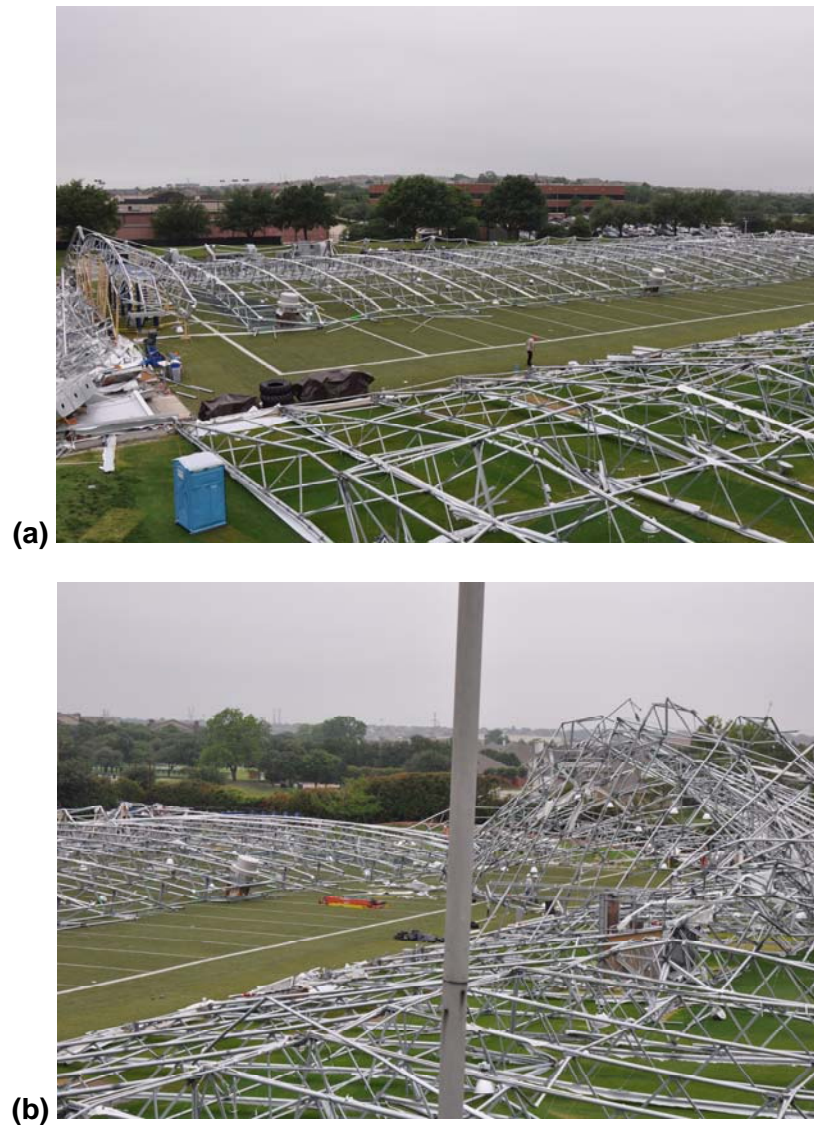
The wind direction on May 2, 2009, was predominantly from the west (see Chapter 2), and the collapse of the entire practice facility was toward the east. The pattern of collapse differed between the south and the north ends of the structure, as shown in Figure 3–4.

**Figure 3–4 View of (a) southern and (b) northern portions of the collapsed structure  
(Photo credit: NIST)**

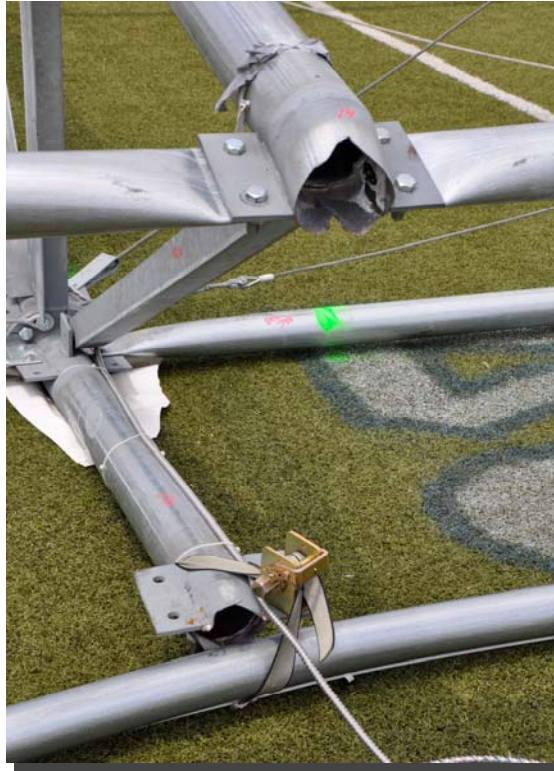
**Figure 3–7 Fracture of inner and outer chords at the keystone**  
(Photo credit: NIST)

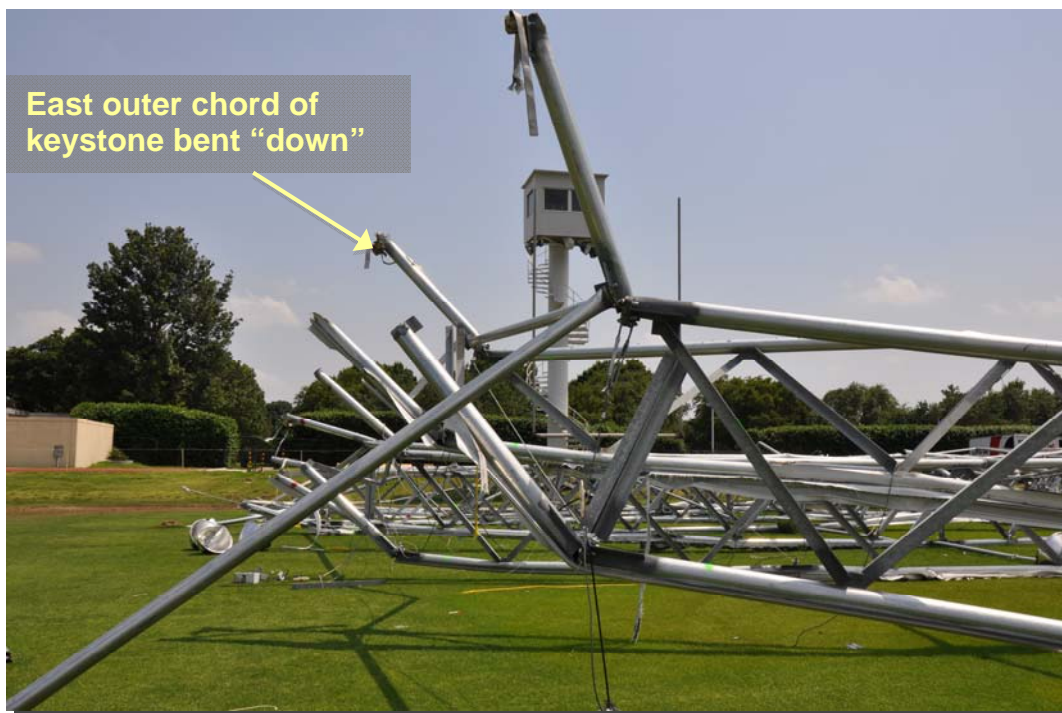
**Figure 3–8 Keystone chords bent down (note roof is upside down)**  
(Photo credit: NIST)

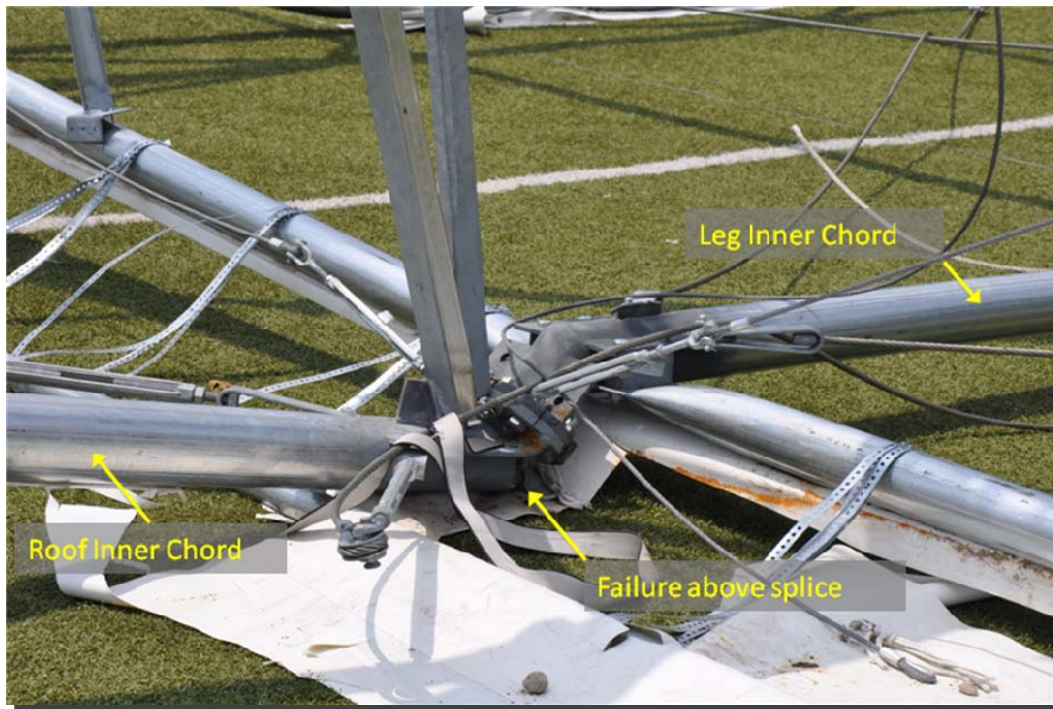
**Figure 3–9 Failure of inner chord near the splice at the west knees  
(Photo credit: NIST)**

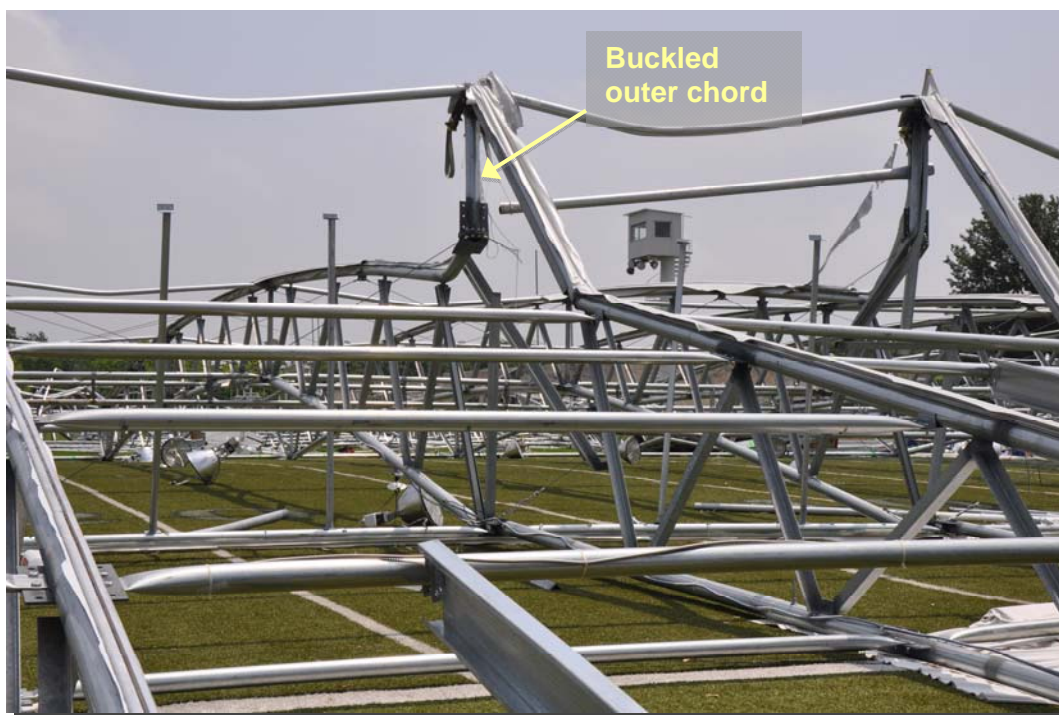
**Figure 3–10 Failure of both outer leg chord and eaves chord  
(Photo credit: NIST)**

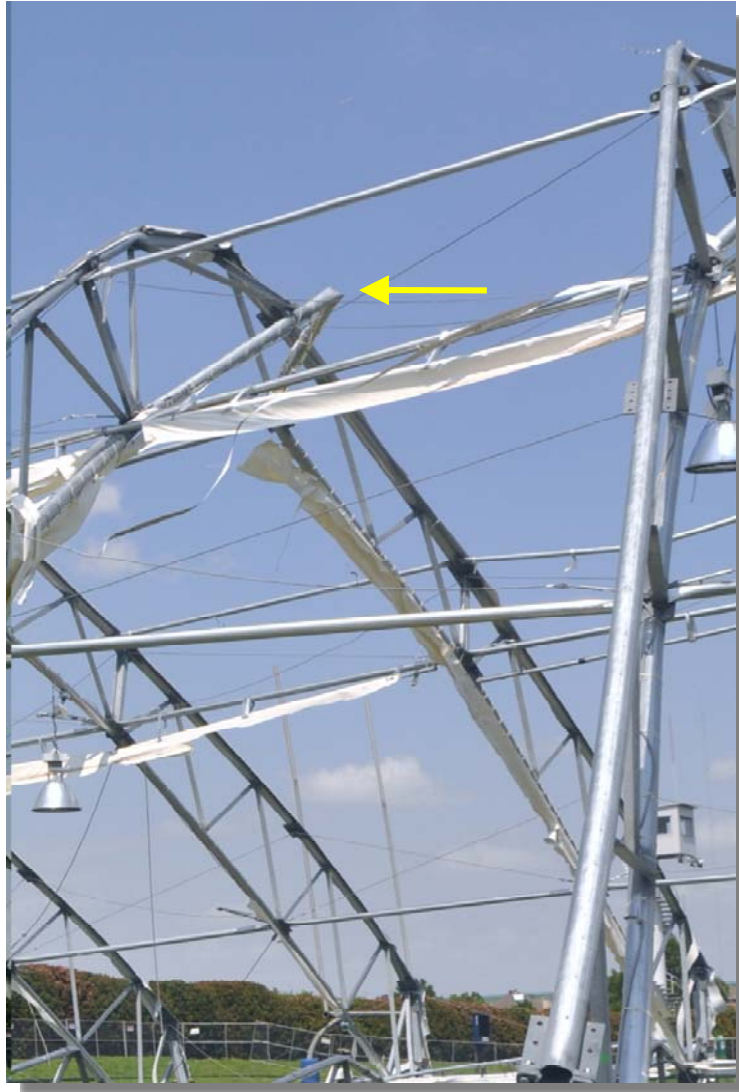
**Figure 3–11 Out-of-plane buckling of inner chord in north portion of collapsed structure  
(Photo credit: NIST)**

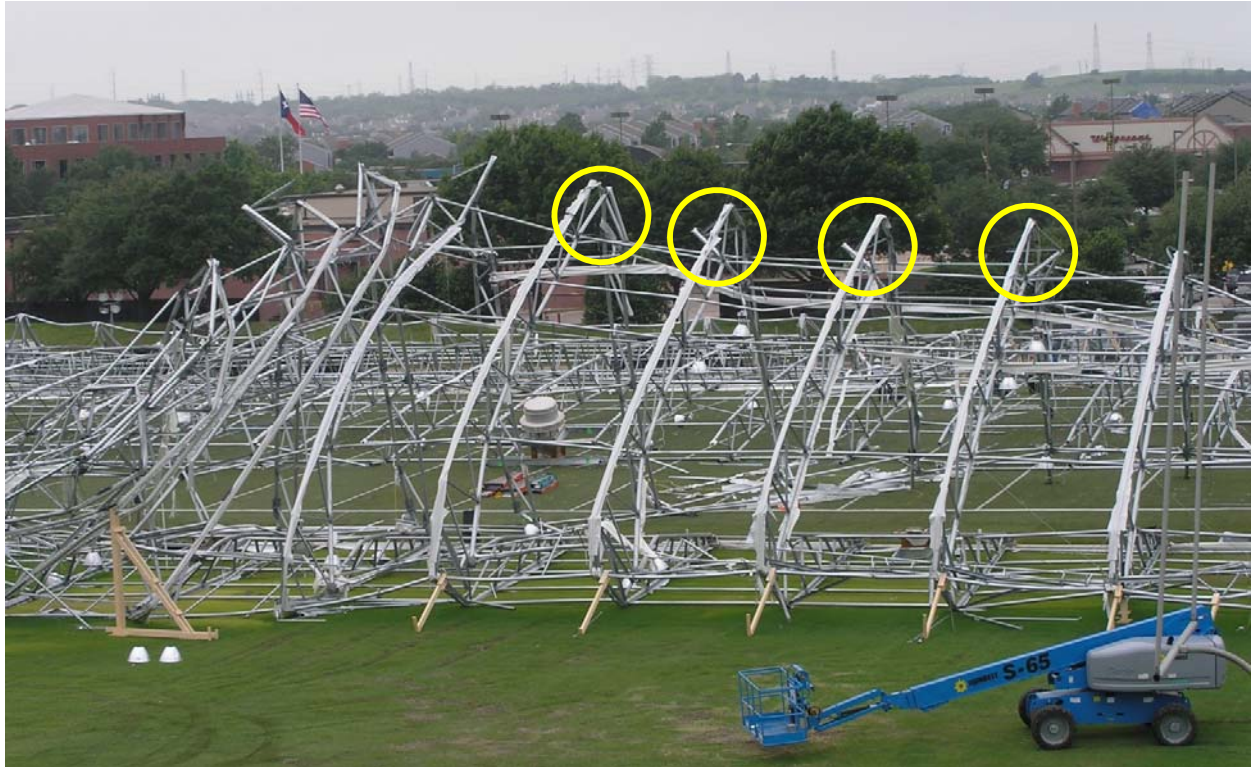
**Figure 3–12 Out-of-plane buckling of inner chords in north portion of collapsed structure**  
(Photo credit: NIST)

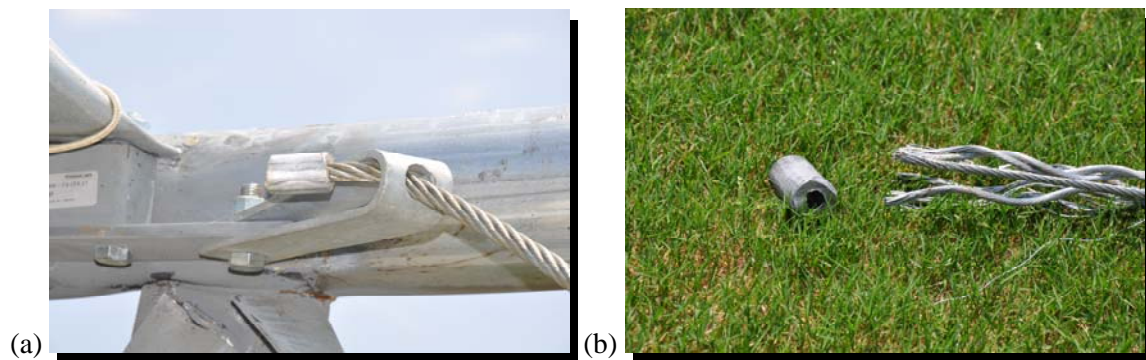
**Figure 3–13 Failure of bracing cable connections: (a) intact, (b) failed**  
(Photo credit: NIST)

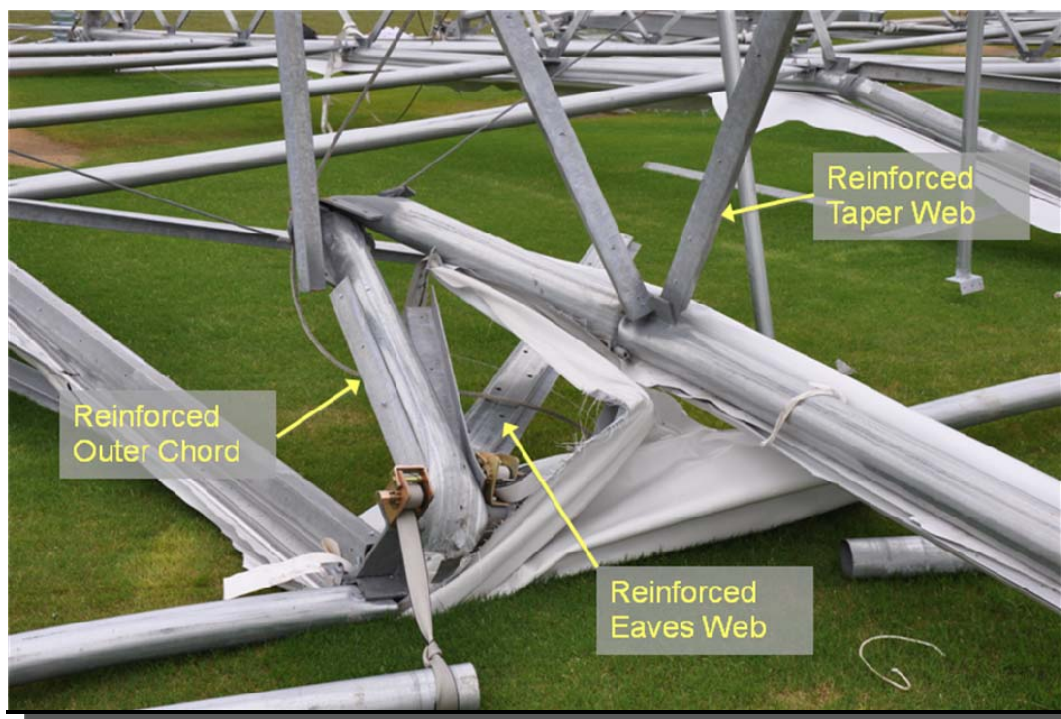
The structural frames supporting the fabric cover were designed and constructed in 2003. In 2008, the frames were reinforced by adding structural angles to selected chord members, rectangular structural tubes to the web members at the knees, and square structural tubes to two webs in the taper section. Figure 4–10 shows the locations of the reinforcement. All three reinforcing schemes can be seen in the photograph of one of the collapsed knees shown in Figure 4–11. Note that in many cases, the reinforcing detached from the original member during the collapse of the facility due to the failure of the screws used to attach the reinforcing.

**Figure 4–11 Collapsed structure showing reinforcement added in the knee region  
(Photo credit: NIST)**
