# Technical Study of the Sofa Super Store Fire - South Carolina, June 18, 2007

# **Technical Study of the Sofa Super Store Fire - South Carolina, June 18, 2007**

*Fire Research Division  
Engineering Laboratory  
National Institute of Standards and Technology*

October 2010

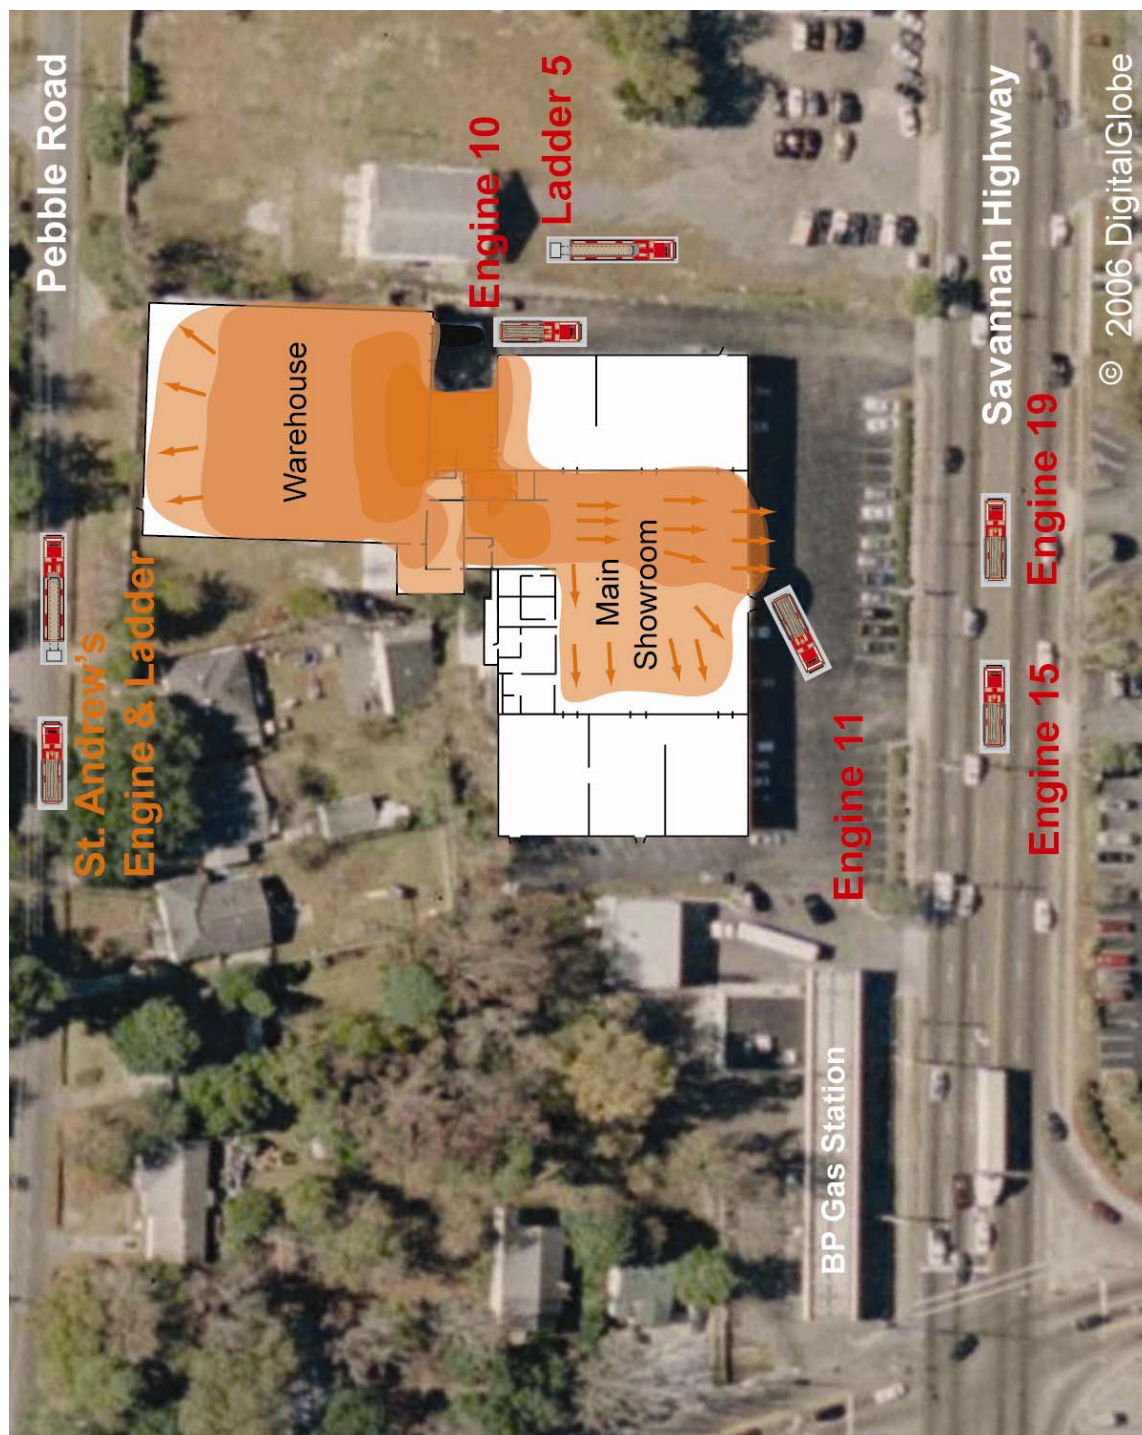
Figure 2-9. Fire spreading to east side of main showroom. This occurred by about 7:37 p.m. Background image used with permission of DigitalGlobe. Enhancements by NIST.

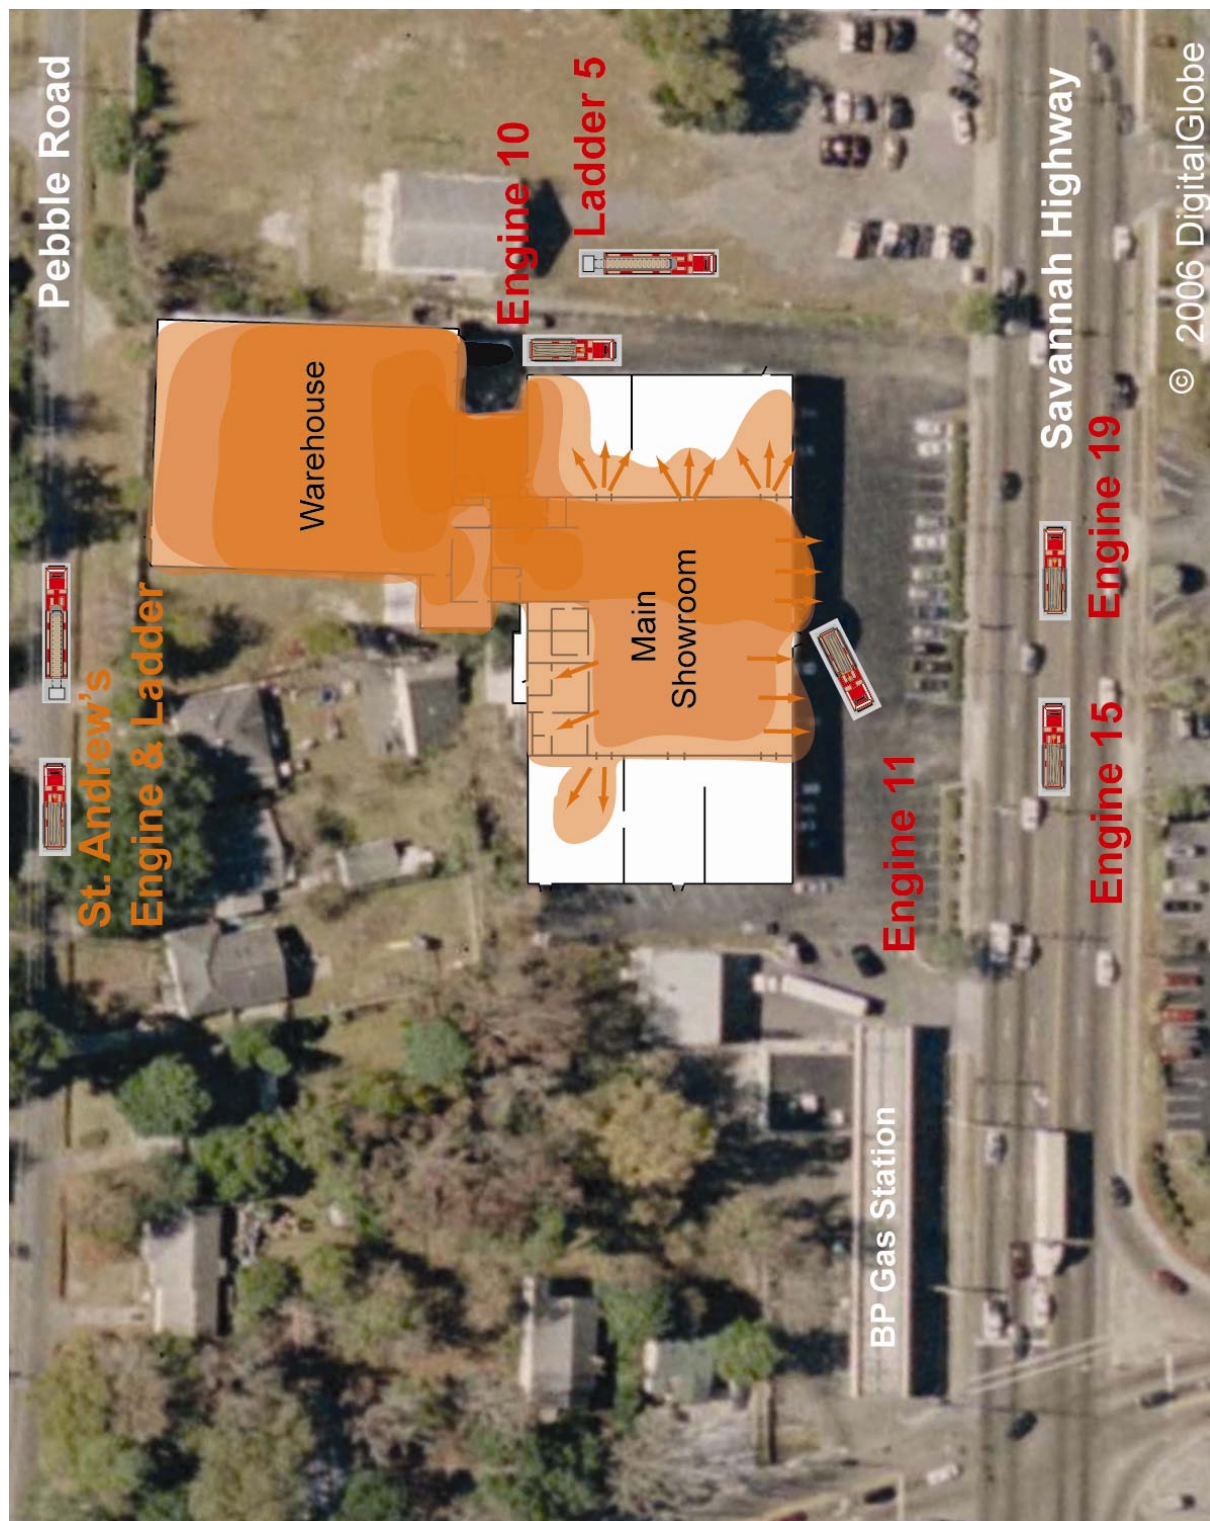
Figure 2-10. Fire spreading to west showroom and the rear of east showroom. This occurred by about 7:38 p.m. Background image used with permission of DigitalGlobe. Enhancements by NIST.

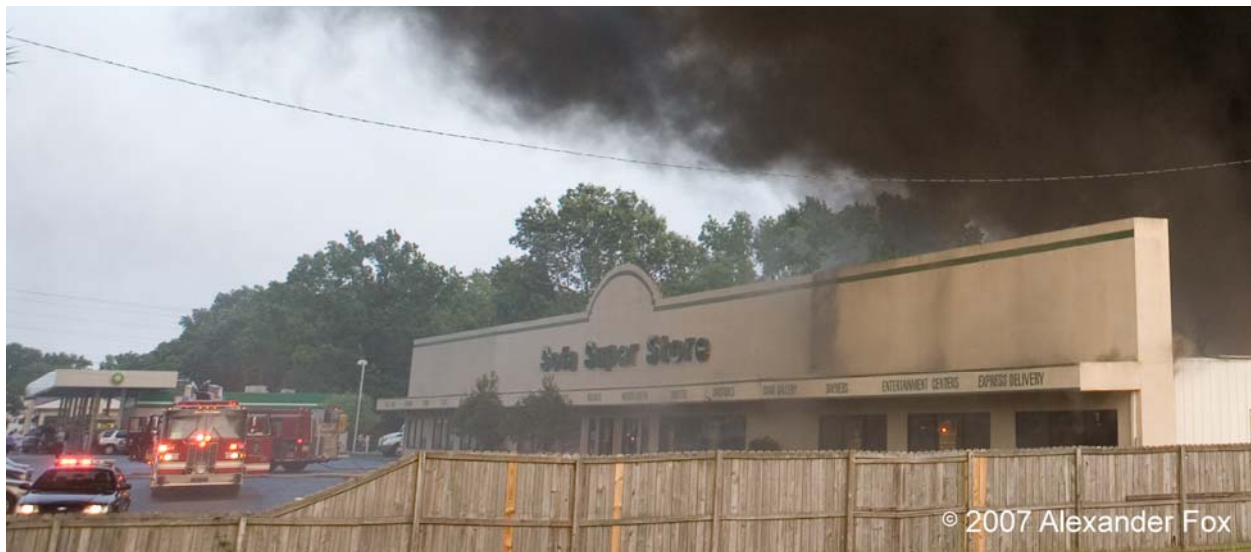
**Figure 3-5. Engine 11 and Ladder 5 positioned in front of store. Smoke plume from loading dock fire visible. Photo used with permission of Alexander Fox.**

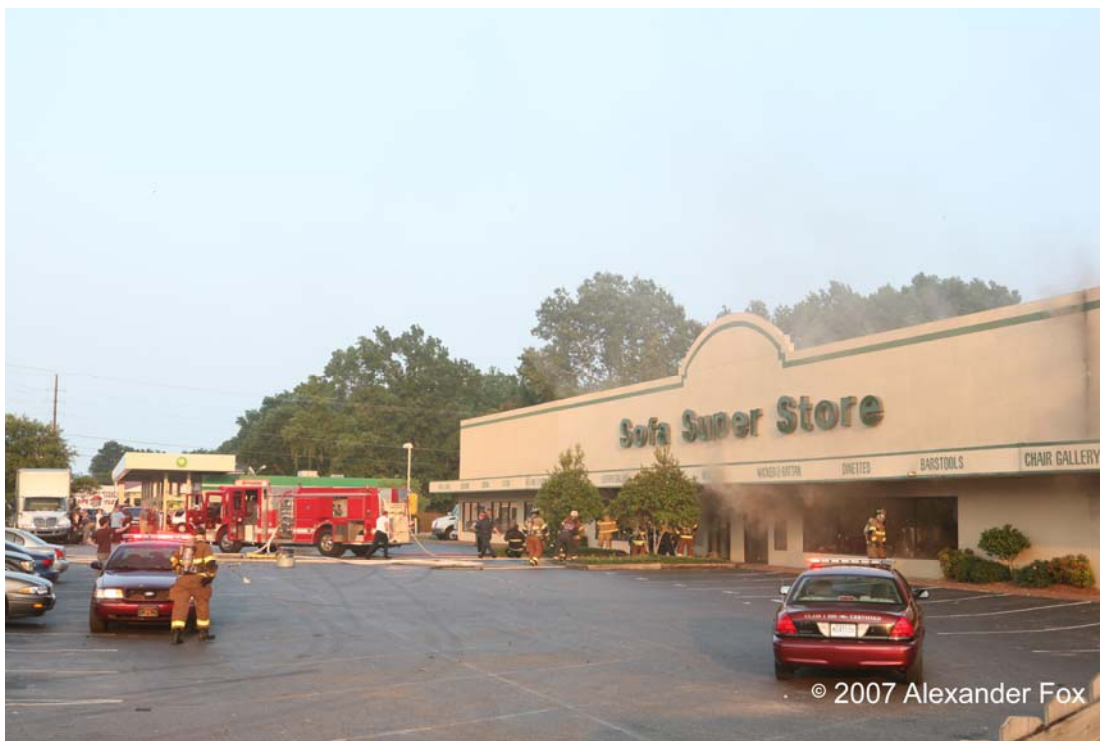
**Figure 3-7. Light brown smoke began to flow out of broken front windows. Photo taken at approximately 7:35 p.m. Photo used with permission of Alexander Fox.**

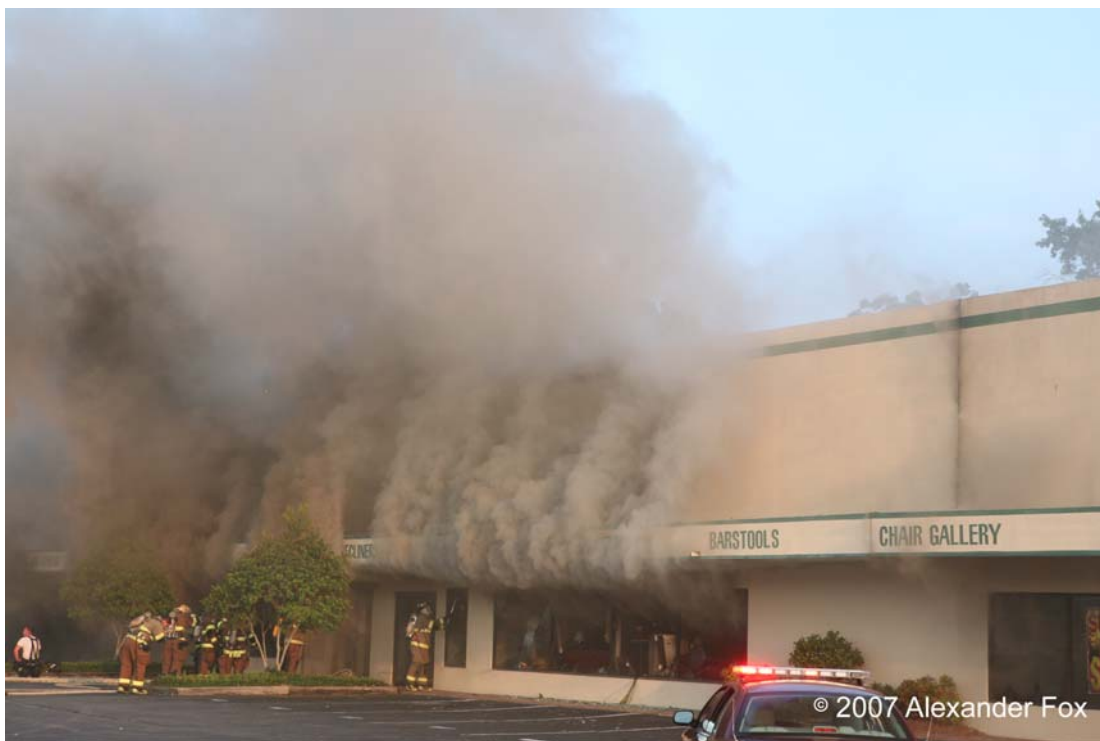
**Figure 3-8. Additional smoke moved out of broken windows. Photo taken at approximately 7:36 p.m. Photo used with permission of Alexander Fox.**

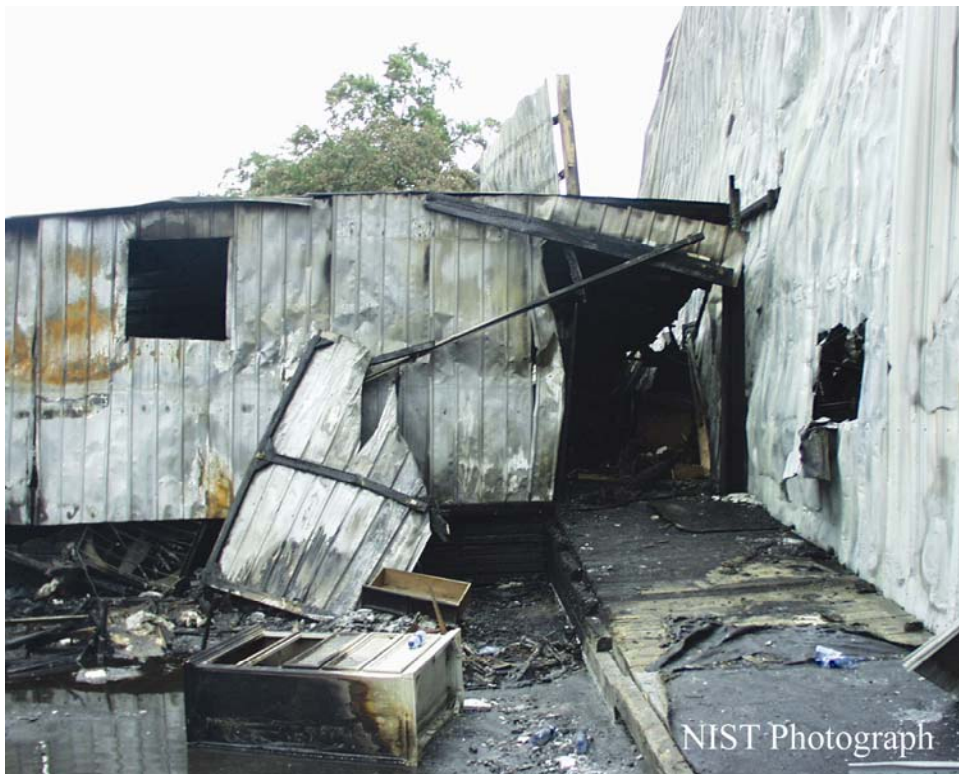
**Figure 4-7. Photograph showing the outside of the loading dock. This was identified as the area of fire origin.**
