NIST Technical Note 1426

***The Fujita Tornado Intensity Scale: A Critique
Based on Observations of the Jarrell
Tornado of May 27, 1997***

Long T. Phan and Emil Simiu

July 1998

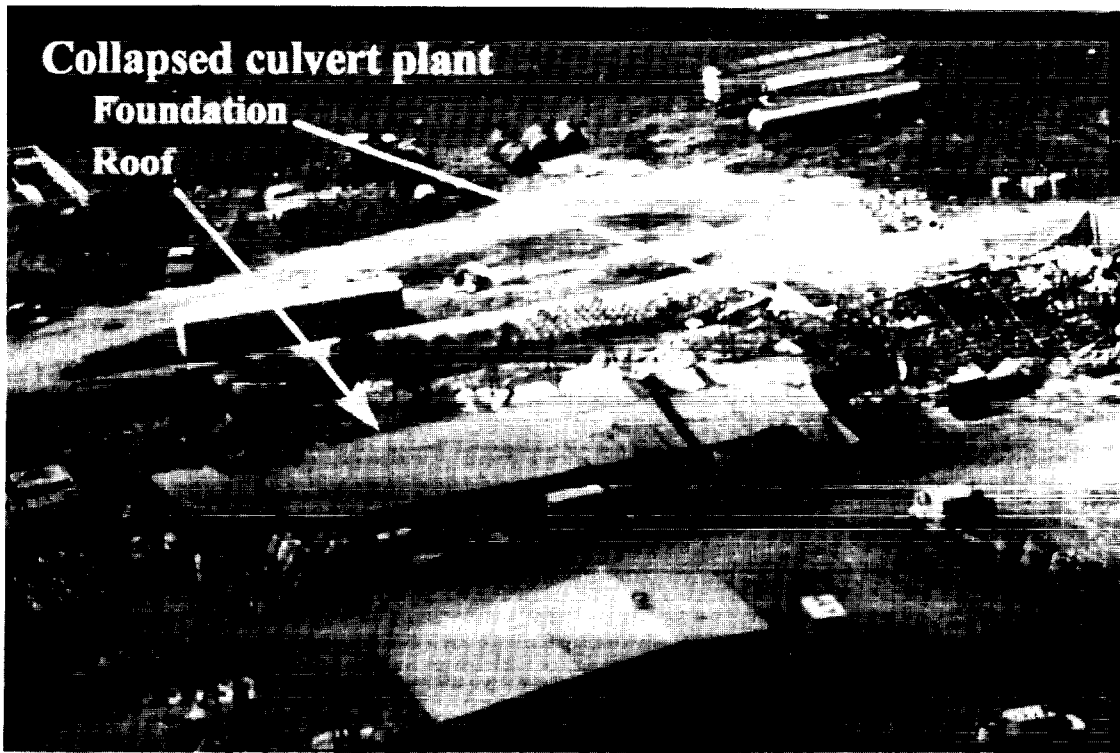
The next structural damage along the tornado path occurred at the corner of CR 305 and CR 307 in Williamson County, where a culvert plant collapsed (figs. 6 to 8). The plant was of light steel frame construction with non-reinforced masonry and steel tube columns supporting steel pipe, gable roof trusses. The steel tube columns were cast into a concrete mat foundation on grade. The roofing, supported by wood purlins, consisted of corrugated sheet metal. An identical plant approximately 15 m (50 ft) away from the collapsed culvert plant, and other surrounding structures, suffered only minimal damage (fig. 8). A mobile home used as an office was hit by a conventional “two by four” timber member 1.2 m (4 ft) long, but the missile did not penetrate into the home. A mobile home located about 150 m (500 ft) north-northwest of the plant had only minor damage. Its occupants fled to a house that was in the center of the damage path, where they were reportedly killed.

Figure 6. Aerial view of collapsed culvert plant.

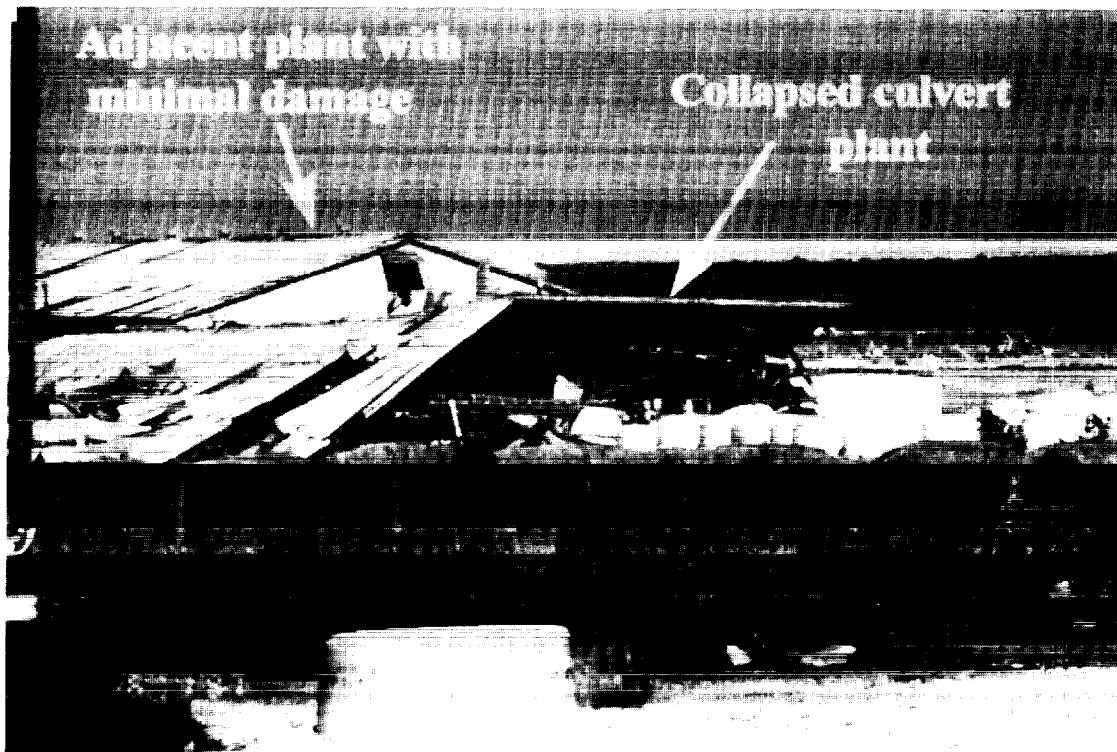
Figure 7. Ground view of collapsed culvert plant.

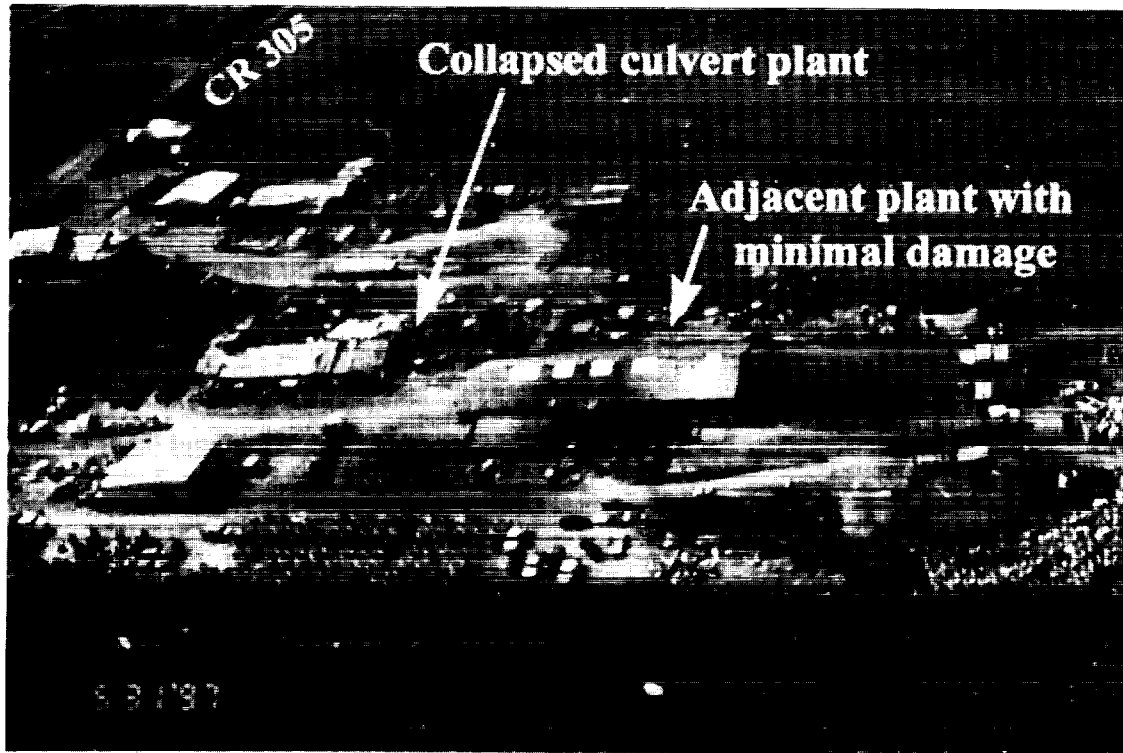
Figure 8. Aerial view of entire culvert plant complex.

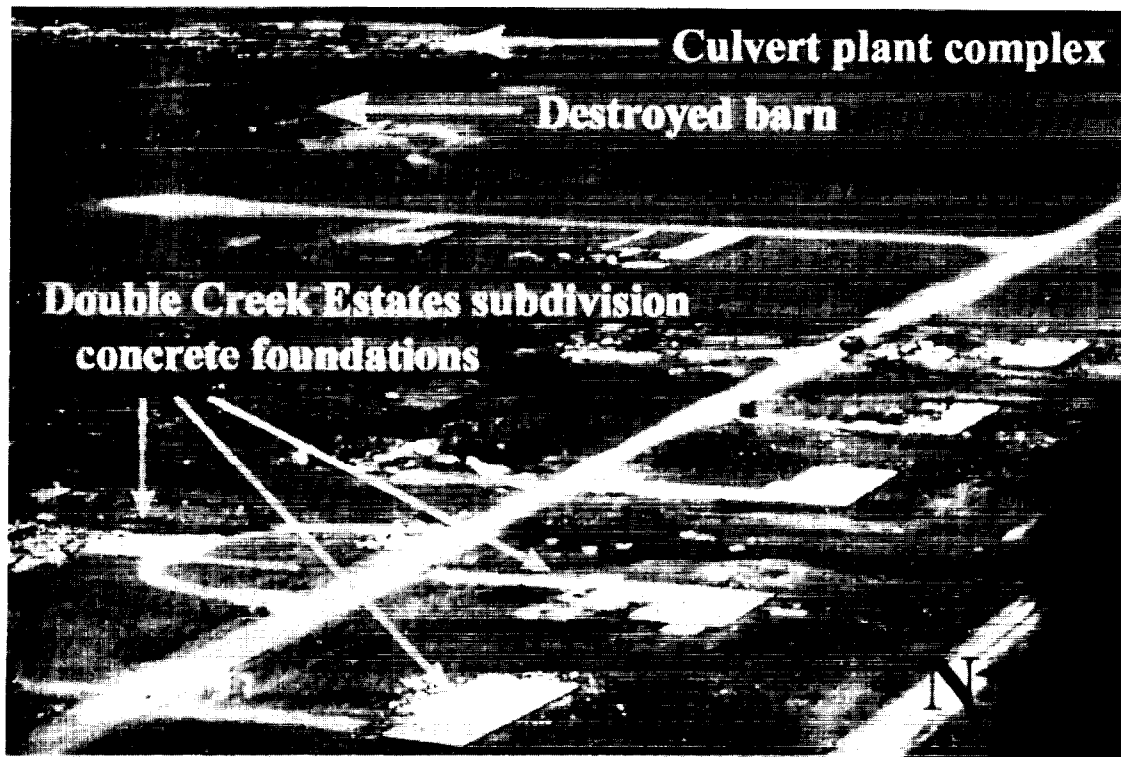
Figure 10 shows a portion of the Double Creek Estates subdivision after the tornado passage. The structures in the subdivision consisted mainly of single-family residences built over the last 15 years or so, of the typical slab-on-grade construction type. Owing to the presence of limestone bedrock close to the surface, most houses had no basements or underground shelters. The houses, which consisted mainly of wood frame construction, were completely swept off the concrete foundations. The debris of the houses was so small and scattered that it was difficult to spot them from the air.

Figure 10. Aerial view of portion of the Double Creek Estates subdivision.

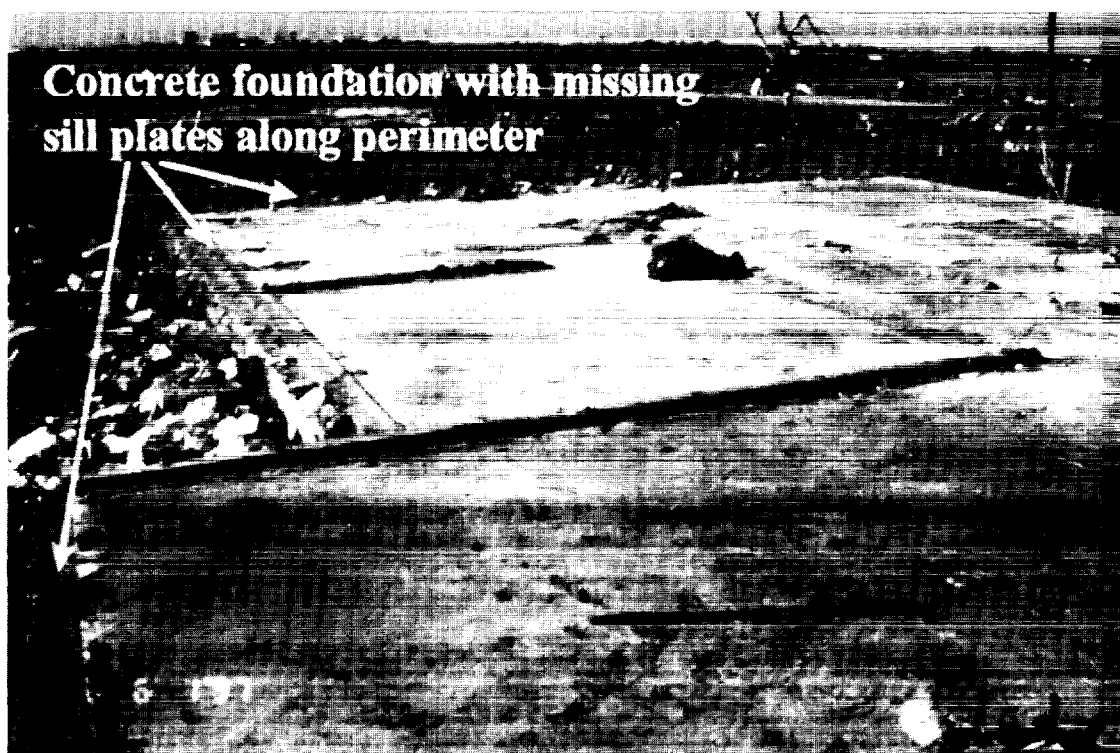
Inspections of the concrete slab-on-grade foundations performed during the ground surveys revealed that, in many cases, even the sill plates that connected the wood frames to the concrete foundations were blown away (see fig. 11). This suggests that the connections between the sill plates and the foundations were not as strong as those between the sill plate and the wood frames. Random, close examination of a few concrete foundations suggested that the houses in this subdivision may not have been well built. For some houses, there was evidence that the sill plates had been connected to the foundations by nails. Figure 12 shows a nail that remained in the foundation, but pulled through the sill plate. Figure 13 shows examples where the nails, which appeared to have been spaced 0.9 m (3 ft) apart, pulled out of the foundation. There was no evidence of anchor bolts or steel straps used at the few random foundations where close inspections were performed. We note

that the Council of American Building Officials (CABO) One and Two-Family Dwelling Code (1995) requires that sill plates of exterior walls for wood-frame construction be anchored to the concrete foundation by 13 mm-diameter (1/2-inch) anchor bolts not more than 1.83 m apart and less than 0.31 m from corners. We also note that Williamson County has not adopted a building code, even though Jarrell had been hit by a tornado on May 17, 1987.

Figure 11. Close-up view of a typical slab-on-grade foundation of houses in the Double Creek Estates subdivision. Only one sill plate remains connected to the concrete foundation.

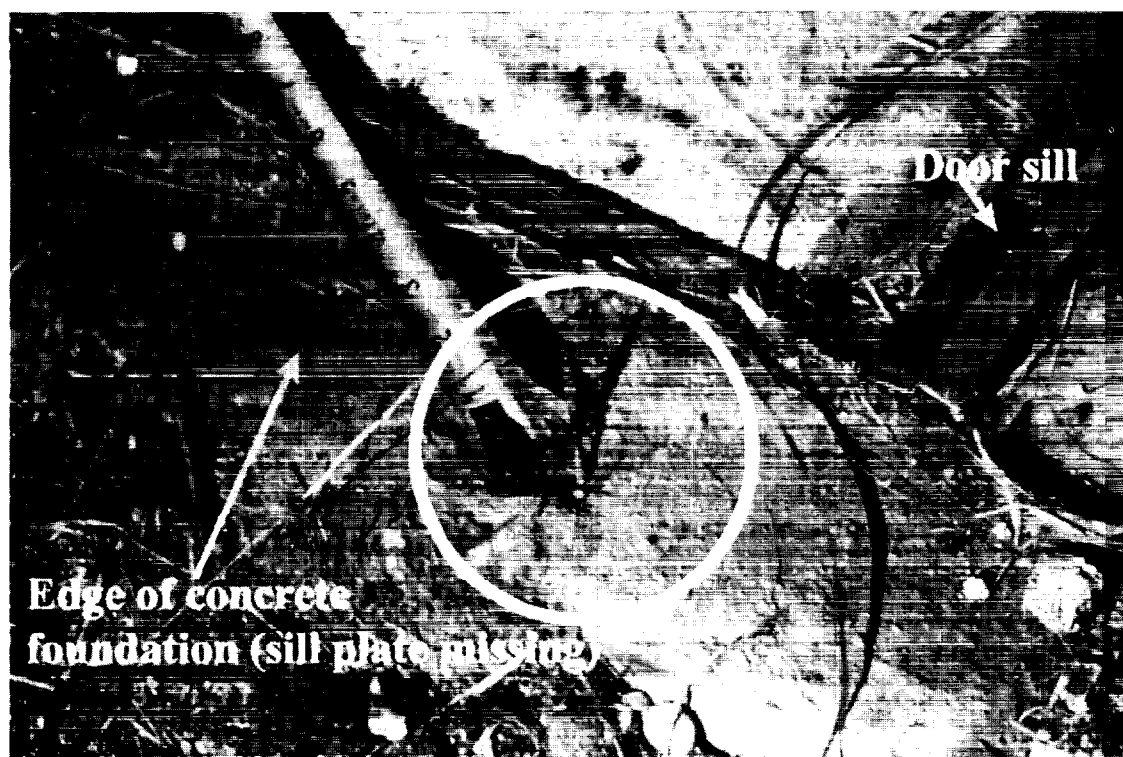
Figure 12. Evidence of nail that was used for connecting sill plate to concrete foundation.

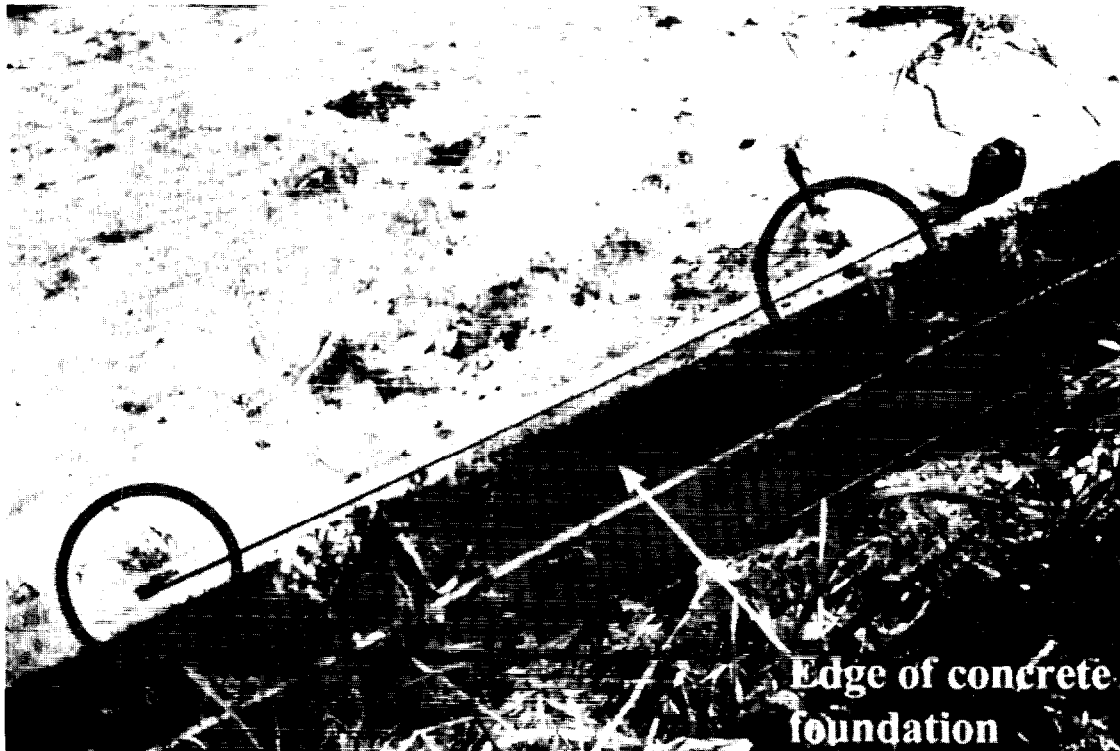
Figure 13. Evidence of pullout of nails used to fasten sill plates to concrete foundation.

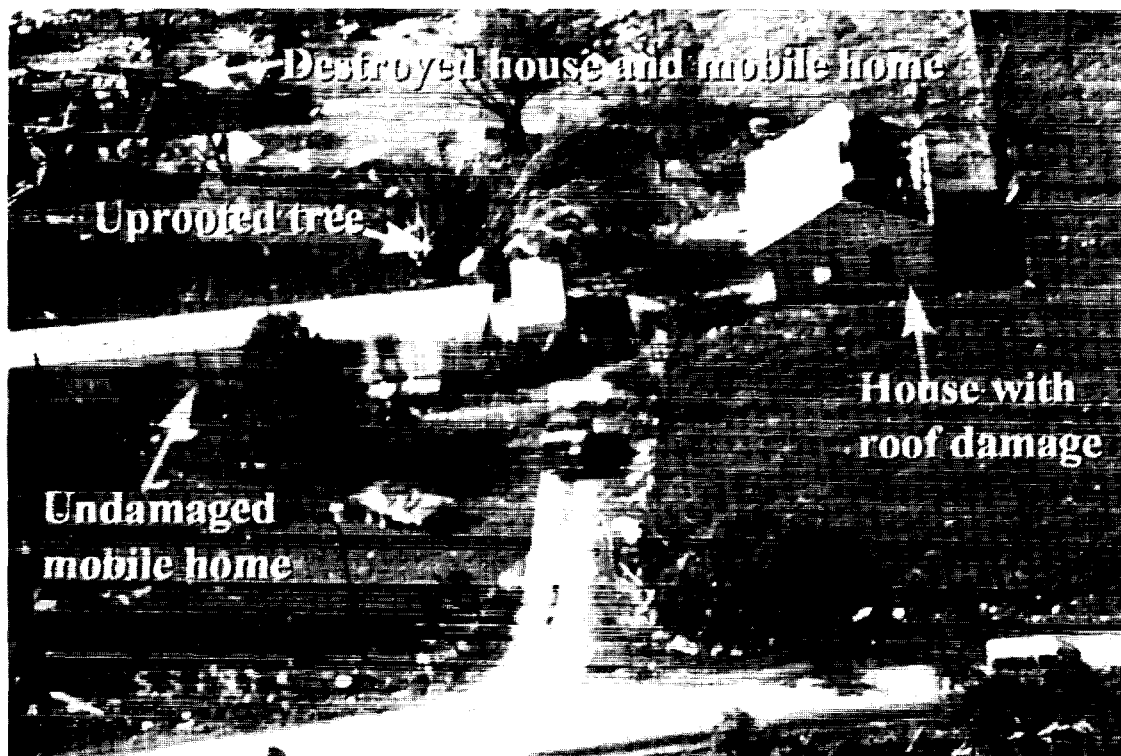
The path of destruction narrowed as the tornado moved to the outlying areas of the Double Creek Estates subdivision. Here the destruction became random. Figure 14 shows a mobile home that sustained only minor damage, while a short distance away a large tree was uprooted and another house lost half of its roof. The tornado then moved across CR 309 and ended in a heavily wooded area southwest of Jarrell.

Figure 14. Structural damage near the end of the path of the Jarrel tornado.
