Investigation of Wind Damage in the Metropolitan Washington, D.C. Area, April 3-4, 1975

F. Y. Yokel, C. W. Yancey,
L. E. Cattaneo, and R. D. Marshall

Center for Building Technology
Institute for Applied Technology
National Bureau of Standards
Washington, D.C. 20234

Issued May 1976

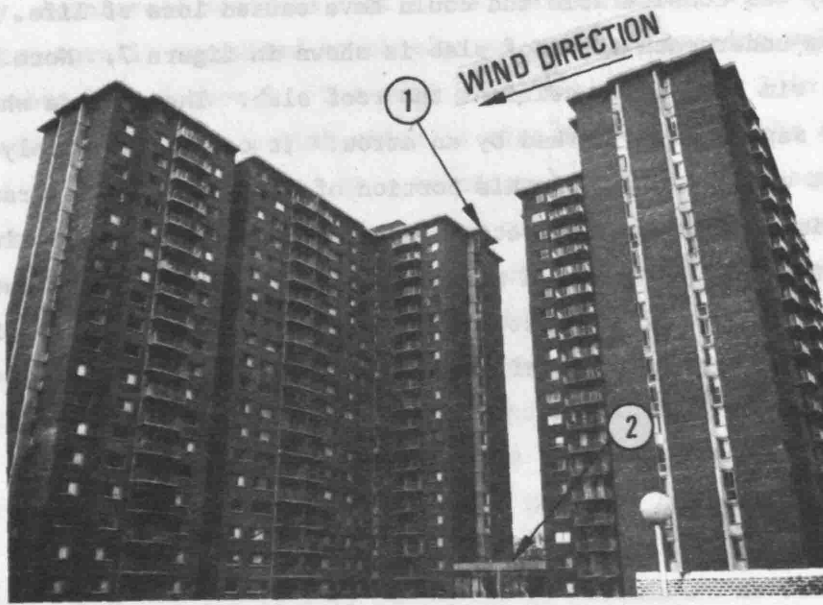
Figure 2 shows the rear elevation of a 19 story apartment building complex. The prevailing wind direction is shown by the arrow at the top of the figure. In this building a masonry wall fell from the location marked 1 into a lobby (location 2) destroying the roof of the lobby. Some of the debris from the wall and the lobby roof resting on the floor of the lobby is shown in figure 3. Figure 4 shows the wall failure in more detail and figure 5 shows an elevation of a similar wall in the opposite wing of the twin buildings which did not fail. The buildings are reinforced concrete structures.

Figure 2 - Damaged areas of high-rise apartment building. Looking south.

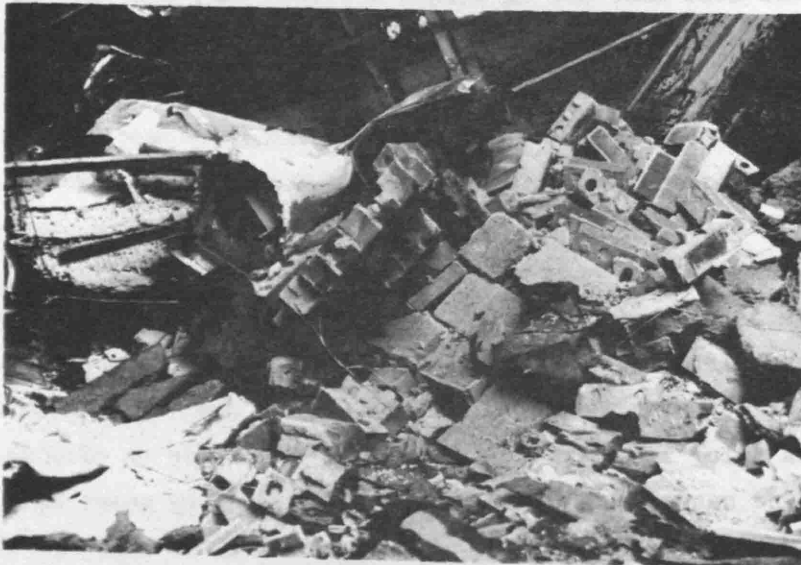
Figure 3 - Partial view of the debris on the floor of the lobby.

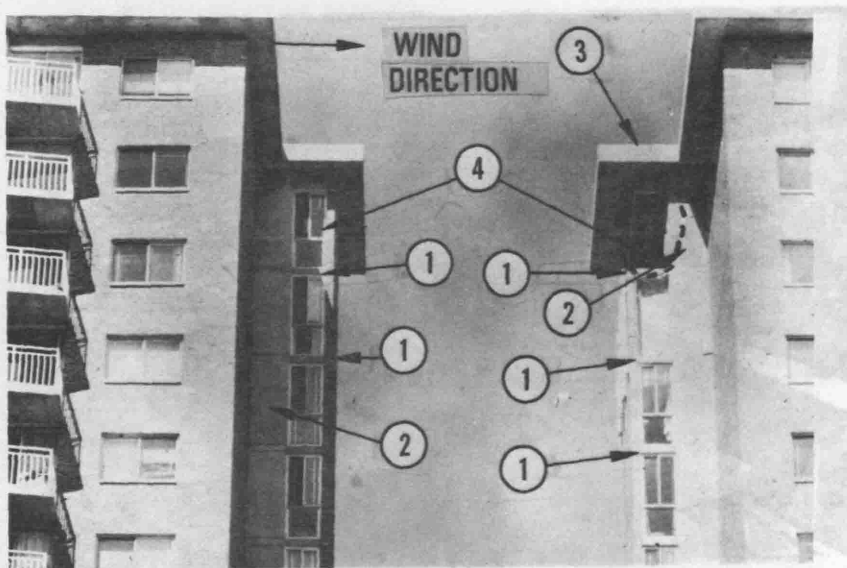
Typically, reinforced concrete flat slabs, marked number 1 in figure 4, are structurally supported by reinforced concrete bearing walls marked number 2 in figure 4. The roof slab, marked number 3 in figure 4 is a reinforced concrete slab which is also supported by the concrete walls and is further stiffened by a reinforced concrete rim beam, marked number 1 in figure 5. The masonry walls are nonstructural curtain walls consisting of one wythe of brick backed up by one wythe of nominally 4 in (10 cm) thick concrete block. Ties between the brick wythe and the concrete block wythe are provided by truss-type horizontal joint reinforcement. There is no vertical reinforcement and the field inspection showed no evidence that reinforcement ties were provided between the masonry wall and the roof or between the masonry wall and the floor slabs. Based on the visual inspection and on occupant accounts the failure mechanism is envisioned as follows: First the window, marked number 4 in figure 4 (see the encircled area on the right hand building) broke inward under the wind pressure, the local wind direction being substantially different from the prevailing direction. Subsequently, outward pressure acted on all the interior surfaces of the room (the opposite window in the same room did not break) and the accelerated flow between the buildings probably resulted in very low pressures acting on the exterior of the wall. In addition to this outward pressure, the roof was quite likely subject to upward pressure on the overhanging part and to suction on the top. The combination of these pressures together with the probable absence of ties between the wall and the roof caused the masonry wall to fail as a cantilever along the top of the floor slab of the uppermost story. Figure 6 shows a portion of the failure surface. It should be noted that the failure surface (near the edge of the floor slab) is clean and smooth with no substantial remnants of the mortar joint above it. This is taken as an indication that the bond between the mortar joint of the concrete block wythe and the floor slab was probably weak. Thus at this cross section, effective moment resistance was provided only by one 3-1/2 in (8.9 cm) wide brick wythe. There was not enough moment resistance available to prevent the wall from failing as a cantilever beam. The weight of the wall section that fell on

Figure 4 - Structural details of the twin buildings. Looking north.

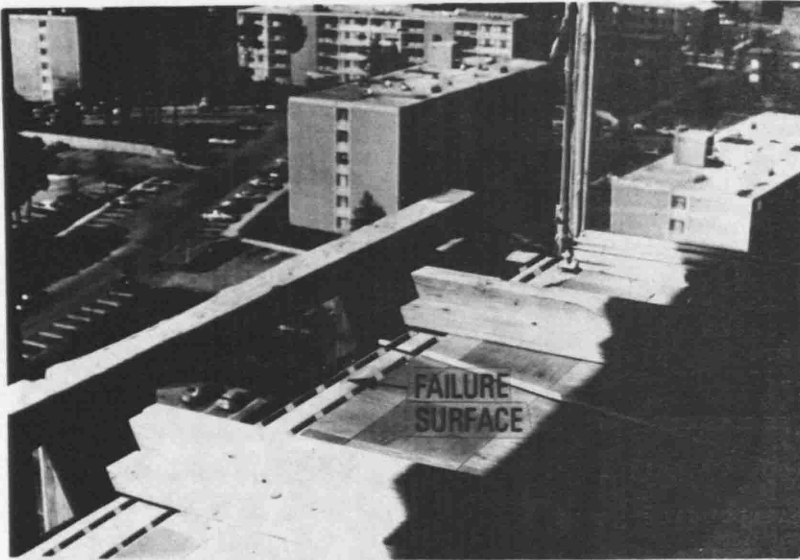
Figure 6 - Failure surface (between dashed lines) on top of floor slab.

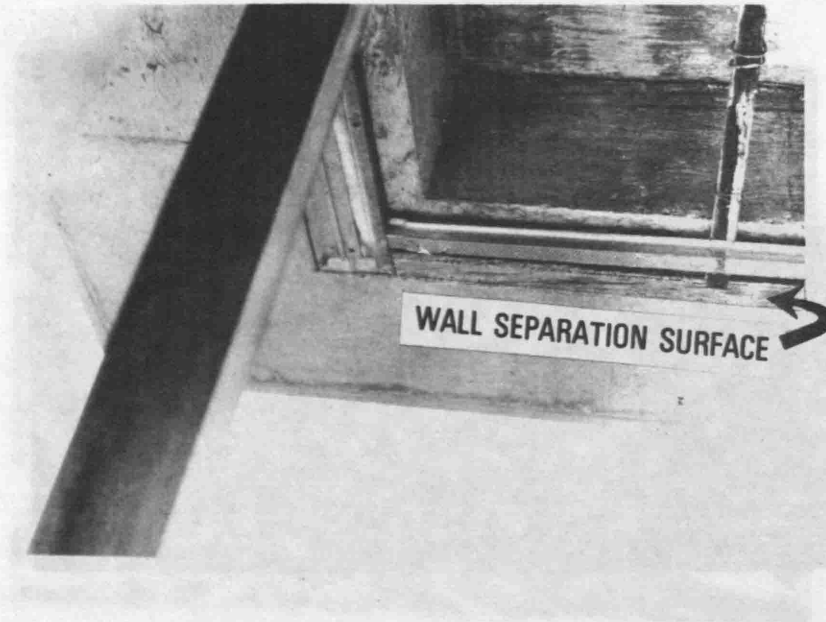
the lobby was considerable and could have caused loss of life. A view from underneath the roof slab is shown in figure 7. Note the concrete rim beam which stiffens the roof slab. The surface where the wall separated is marked by an arrow. It can be reasonably assumed that most of the weight of this portion of the roof slab is transferred by the rim beam to the concrete columns and therefore only a minor part of this weight rests on the masonry wall. Thus no substantial frictional force would resist the outward movement of the top of the masonry wall. Other views of the failure are provided in figures 8 and 9.

Figure 7 - Surface of separation between rim beam and top of wall. Looking at underside of roof slab.

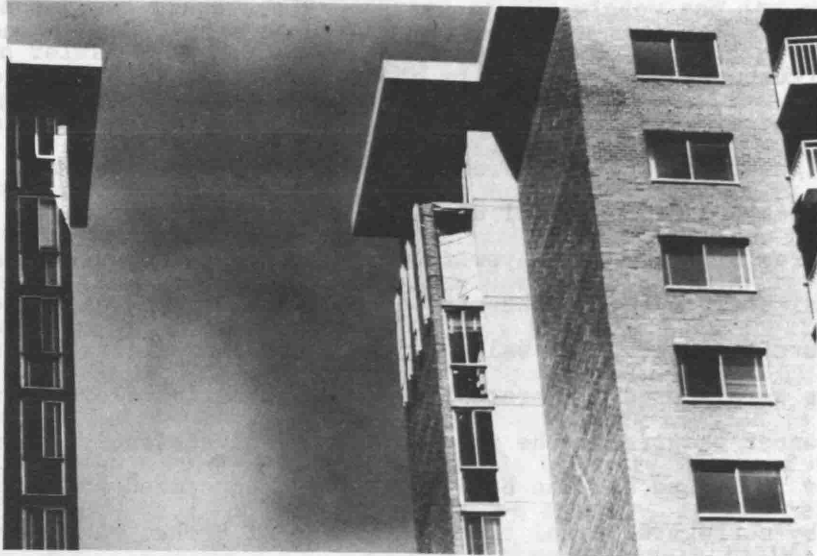
Figure 8 - View of upper-story damage. Looking north.

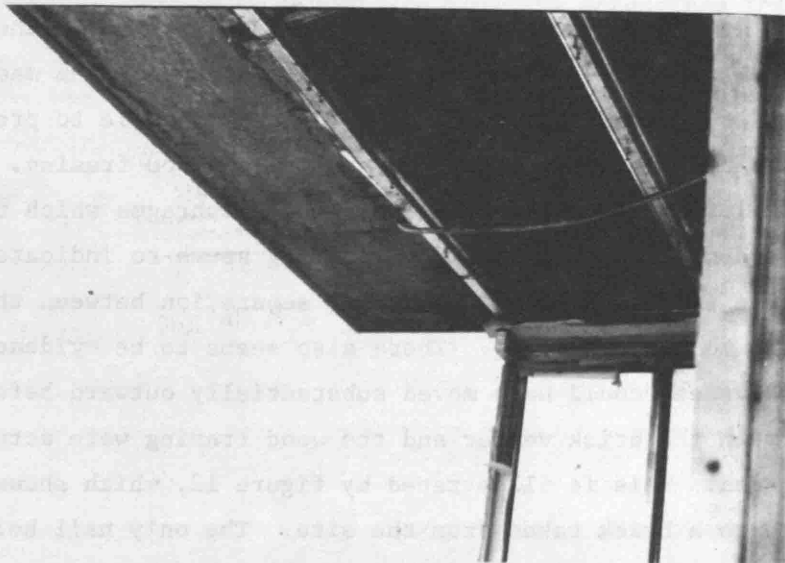
Figure 9 - Closeup of roof slab in damaged area. Looking north.

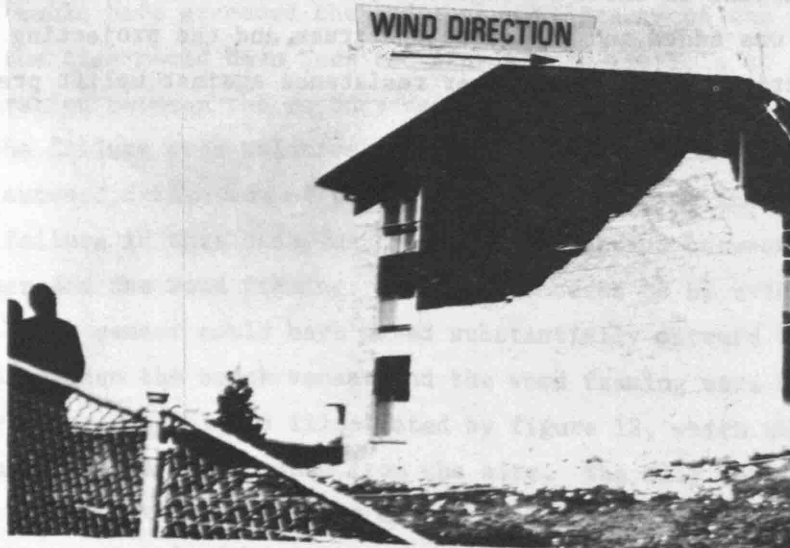
Figure 11 - Damaged brick veneer endwall in a 3-story building.
Looking north.

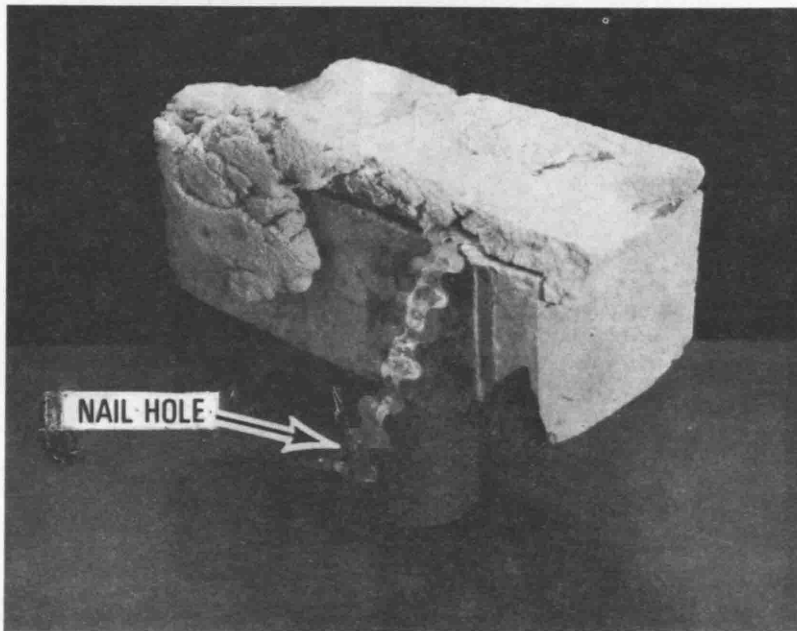
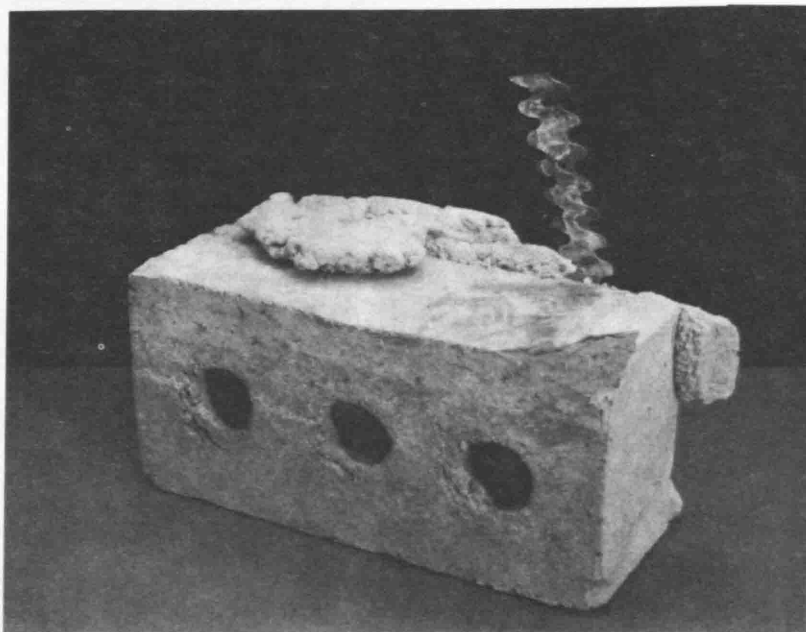
Figure 12 - Two views of a brick and connected tie taken from the endwall debris.

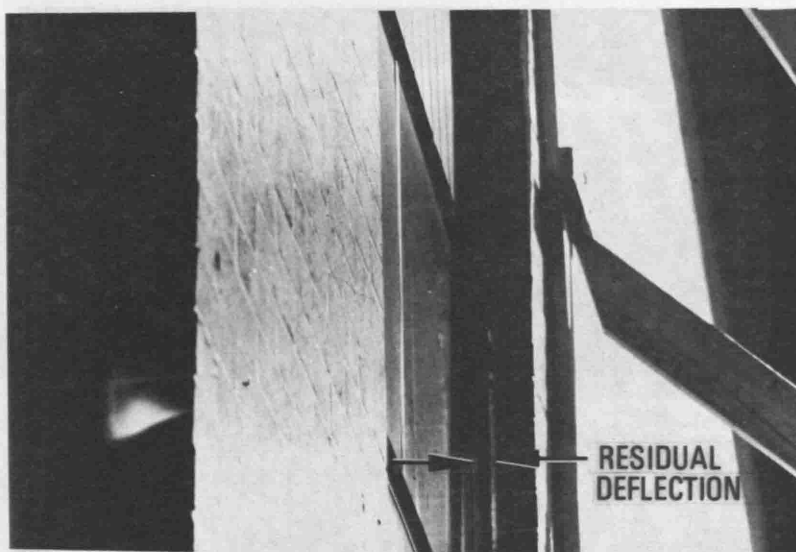
The wind direction, which was parallel to the wall, probably caused suction to act on the brick veneer. Two possible failure mechanism are envisioned: 1. the outward deflection of the gable wall could have exceeded the deflection tolerance of the masonry veneer; 2. the ties could have been too weak or too flexible to prevent a separation between the masonry veneer and the wood framing. The location of the failure area relative to the floor diaphragms which restrain the outward deflection of the wood framing seems to indicate that the failure in this case was caused by separation between the masonry veneer and the wood framing. There also seems to be evidence that the brick veneer could have moved substantially outward before the ties between the brick veneer and the wood framing were actually structurally engaged. This is illustrated by figure 12, which shows a tie connected to a brick taken from the site. The only nail hole in that tie through which a nail was driven is shown by the arrow. The distance of this nail hole from the back face of the brick indicates that the brick could have moved outward substantially before the tie was tight enough to be structurally engaged. Figure 13 shows one of two endwalls which was braced because it was flexing excessively. A total failure

Figure 13 - A brick veneer endwall braced because of excessive flexing.

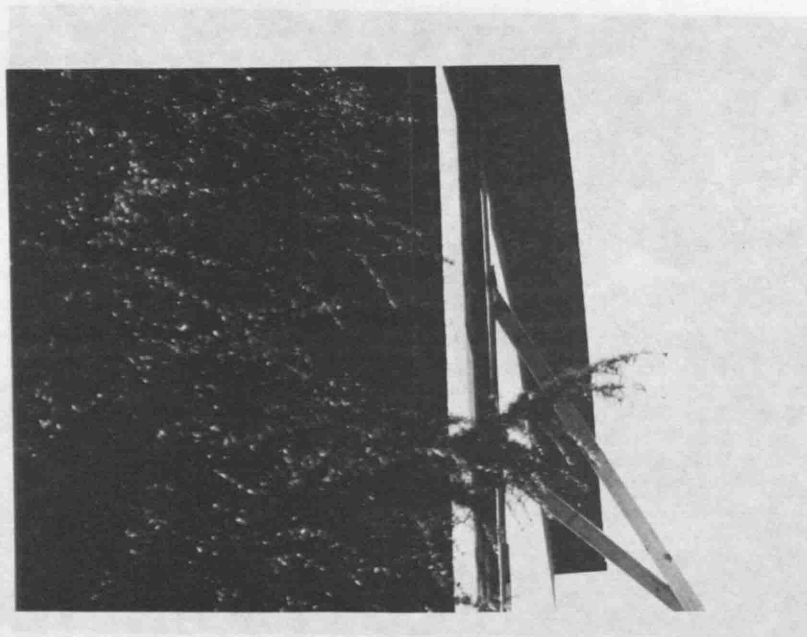
Figure 14 - A second endwall braced because of excessive flexing.

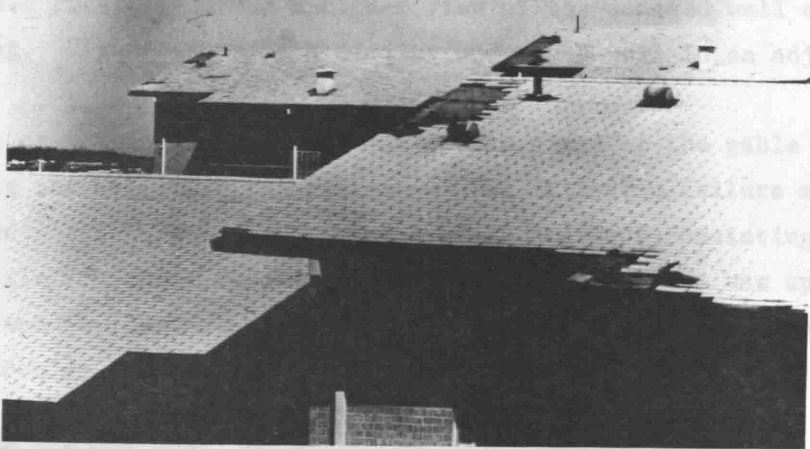
Some of the roof damage in the same apartment complex is shown in figure 15. It occurred mostly near the windward edges of the roofs. It should be noted that not only were roof shingles ripped out, but also, in some instances, the supporting plywood sheets failed. Failure of the plywood sheets tended to occur at the overhanging parts of the roofs. Figure 16 shows a damaged roof under repair. The original projecting purlins which faced the direction of the wind were ripped out and had to be replaced. A measure taken to strengthen the new projecting purlins is shown in figure 17; the timber cleat identified by the arrow was added and nailed to the truss and the projecting purlin respectively. In this manner resistance against uplift pressure was provided.

Figure 15 - Typical roof damage occurring along the windward edges. Looking north.

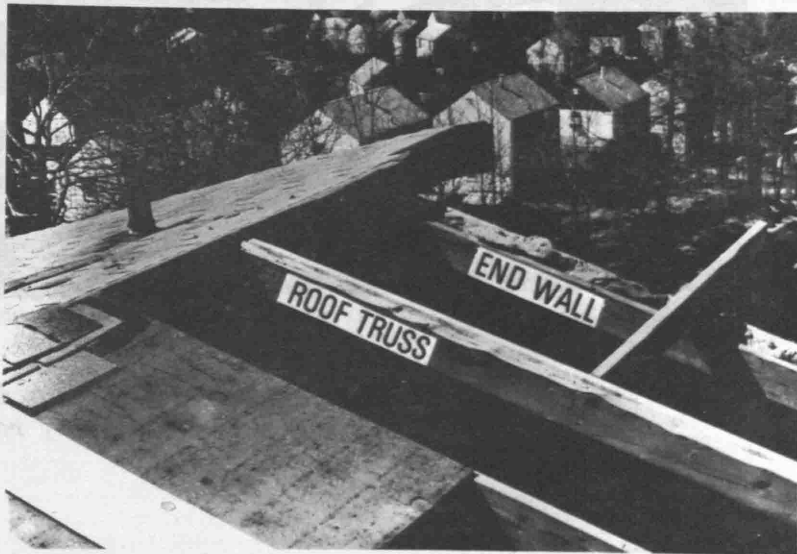
Figure 16 - Partial view of a damaged roof under repair.

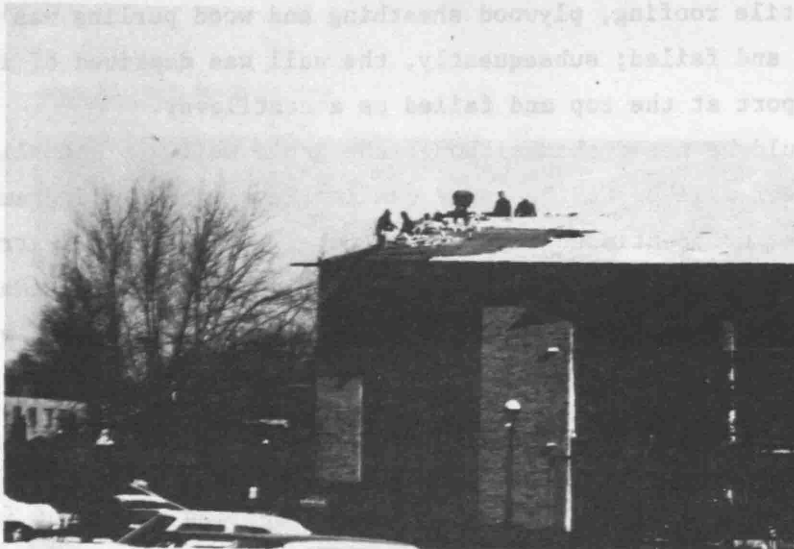
Figure 18 - Partial view of a damaged roof overhanging a gable wall. Looking northwest.

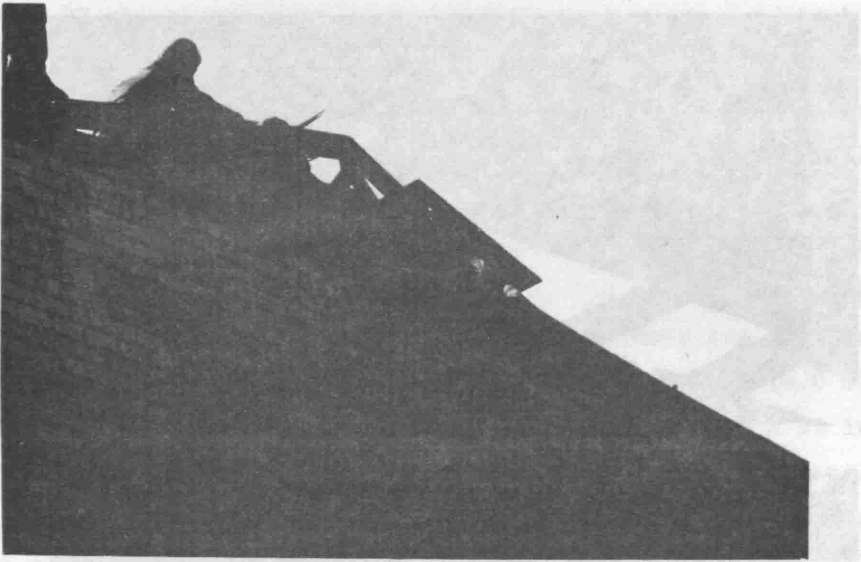
In this case the wind acted normal to the plane of the gable wall, pushing the wall into the building. The following failure mechanism is envisioned: First, the overhanging part of the roof consisting of asphalt tile roofing, plywood sheathing and wood purlins was uplifted by the wind and failed; subsequently, the wall was deprived of its lateral support at the top and failed as a cantilever.

Figure 19 - A damaged brick veneer gable wall and roof overhang under repair.

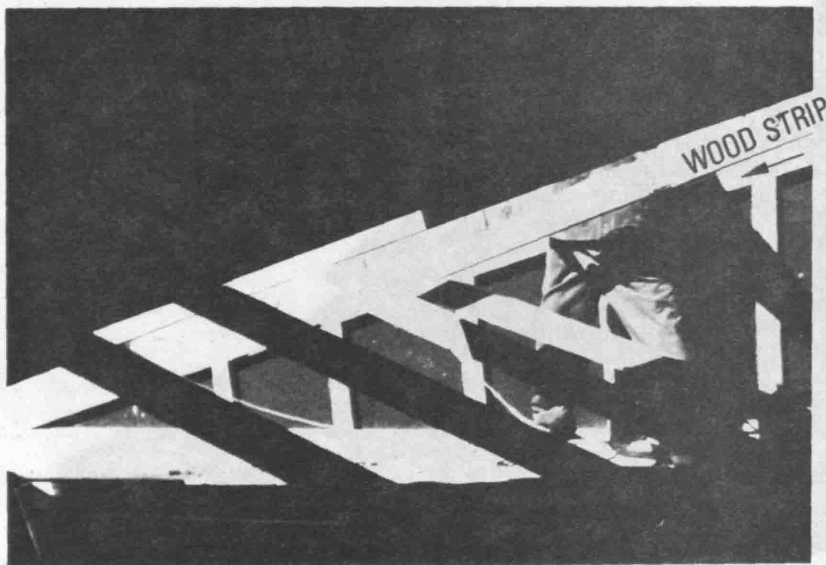
Figure 21 - Details along the back side of the damaged gable wall. Looking west.

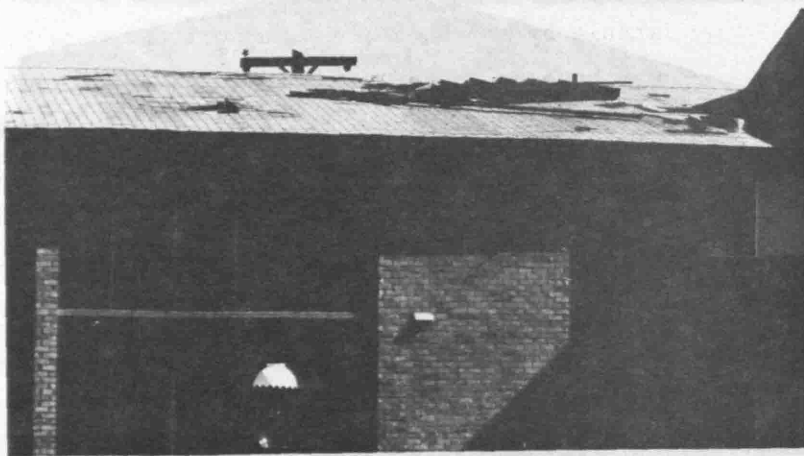
It should be noted that although the gable wall was actually a brick veneer wall up to the upper ceiling level, the wood frame structure was not continued beyond that level. Rather, wood strips were nailed to a fiberboard sheathing which was backed up against the brick veneer. This detail is shown in figure 21. Purlins were then nailed to these wood strips which are shown by the arrow. Lateral support for the top of the cantilevering brick wall was provided by these purlins which were framed into the first roof truss (following the gable wall) and by the plywood sheathing resting on top of these purlins. When the purlins and the plywood sheathing were lifted up by the wind, the brick wall lost its lateral support and was subsequently pushed in. The cantilevering roof section was completely broken off and came to rest on the roof of the building as shown in figure 22.

Figure 22 - View of a portion of the damaged overhanging roof.

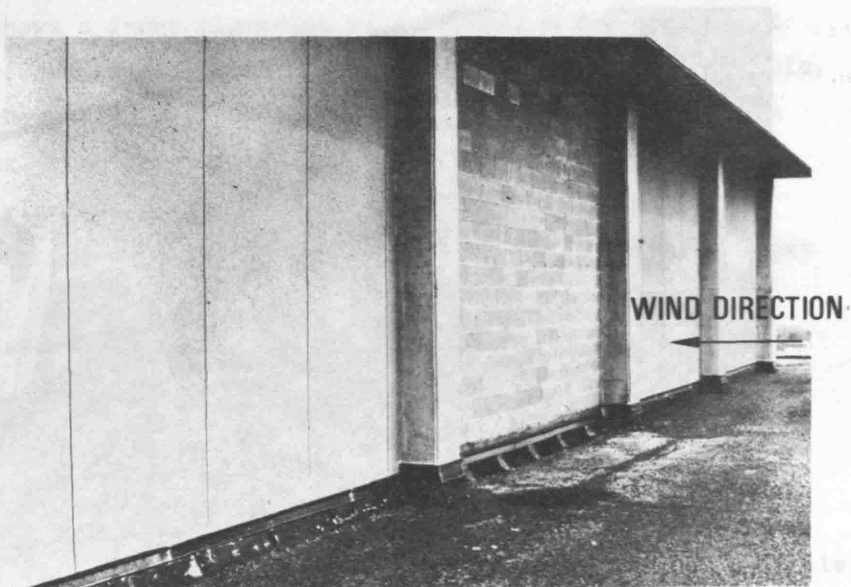
Figure 23 shows part of a 13 ft (4.0 m) high penthouse which is built on top of a 12-story office building. The office building has a flat roof and the penthouse, which houses mechanical equipment, is located about 15 ft (4.6 m) from the edge of the flat roof. The structure of the penthouse consists of a concrete frame with infill masonry walls. As can be seen in figure 23, most of the masonry walls are covered by decorative stucco. Typically, the infill wall is 8 in (20.3 cm) thick hollow concrete block. The columns are 30 in x 22 in (76.2 cm x 55.9 cm) and the masonry panels are 13 ft (4.0 m) wide. The roof overhang shown in the figure projects from a 12 in (30.5 cm) deep beam which rests on top of the concrete block panels, thus making the panels infill panels inside a concrete frame. There is also a concrete beam along the bottom of the masonry panels. The prevailing wind direction was normal to the plane of the wall and the loads acted inward as shown by the arrow in figure 23. The effect of the wind was to cause a violent dynamic response of the masonry infill walls. Eyewitnesses reported that "the wall was wavering visibly in an inward and outward fashion, apparently pivoting about its bottom." It is difficult to interpret this statement exactly but evidently the wall was flexing in and out with an amplitude large enough to be clearly distinguishable by an observer. Inadequate restraint at the top of the wall may have contributed to the large deflections. The flexing of the wall did not lead to a failure, although there is substantial evidence of local distress. Figure 24 shows a view of the bottom of the wall at the interior of the penthouse. Note the crack between the bottom course of the masonry and the concrete beam at the bottom of the wall. Figure 25 shows a similar crack between the top of the masonry wall and the top concrete beam. The picture was taken in the interior of the penthouse in a part which is not covered by a roof (the cooling tower area). Figure 26 shows bracing which was installed in the interior of the penthouse during the storm in order to stabilize the infill panels. The building was evacuated during the storm because of fear that collapse of infill walls might

Figure 23 - Exterior view of the damaged masonry walls of a mechanical equipment penthouse. Looking south.

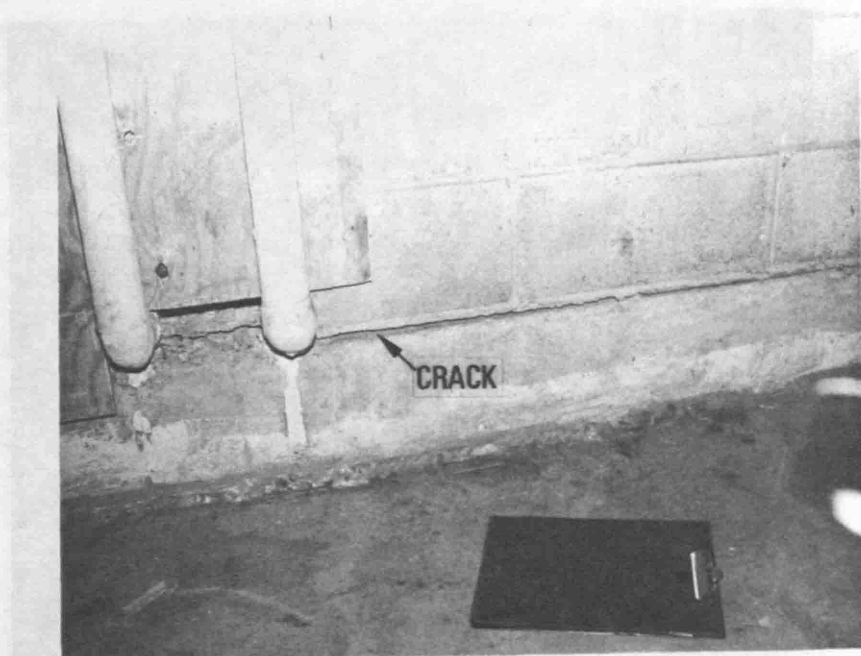
Figure 24 - View of the bottom of a damaged wall at the interior of the penthouse.

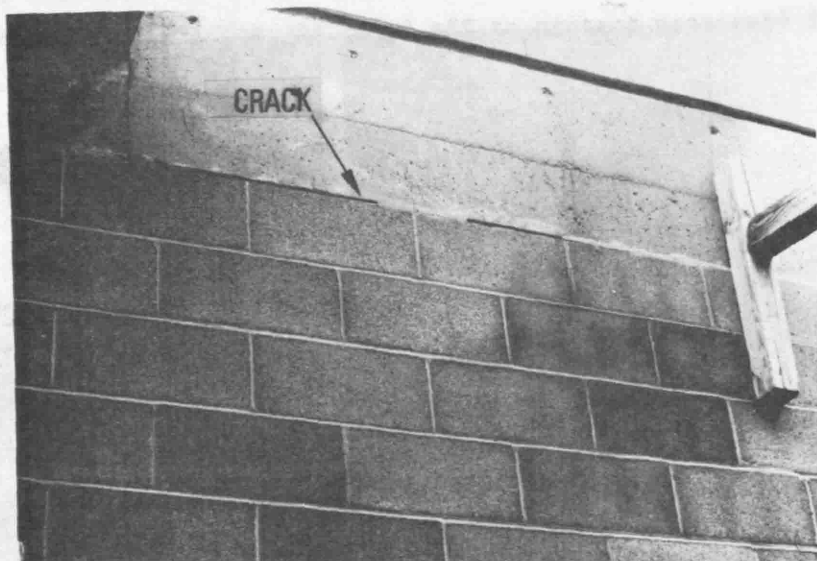
Figure 25 - Mortar crack between top of masonry wall and bottom of concrete beam.

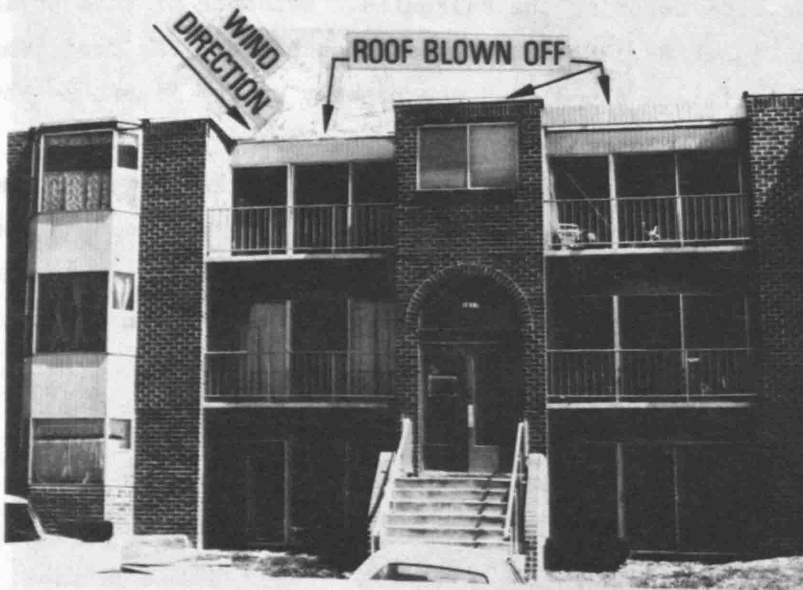
Figure 28 - Front elevation of a building which sustained roof damage. Looking east.

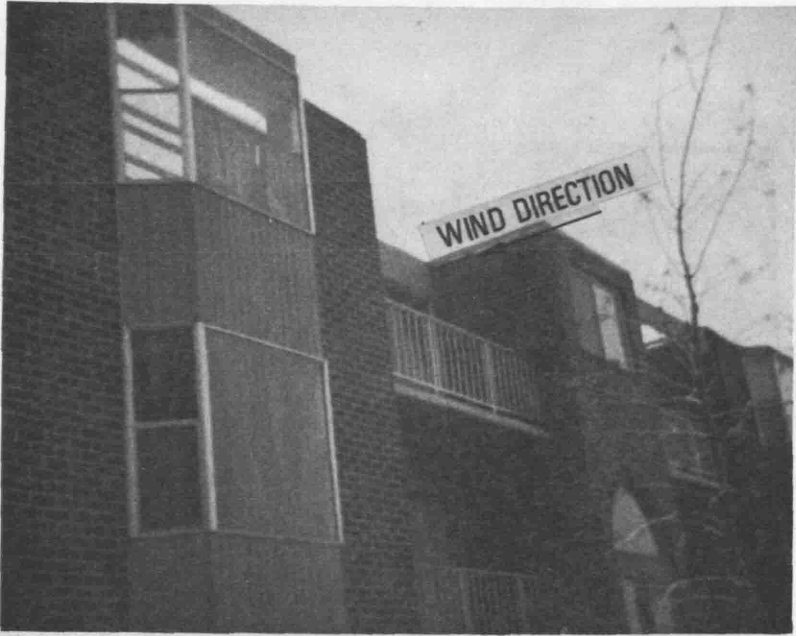
Figure 29 - Closeup view of damage showing loss of roof over living unit and balcony.

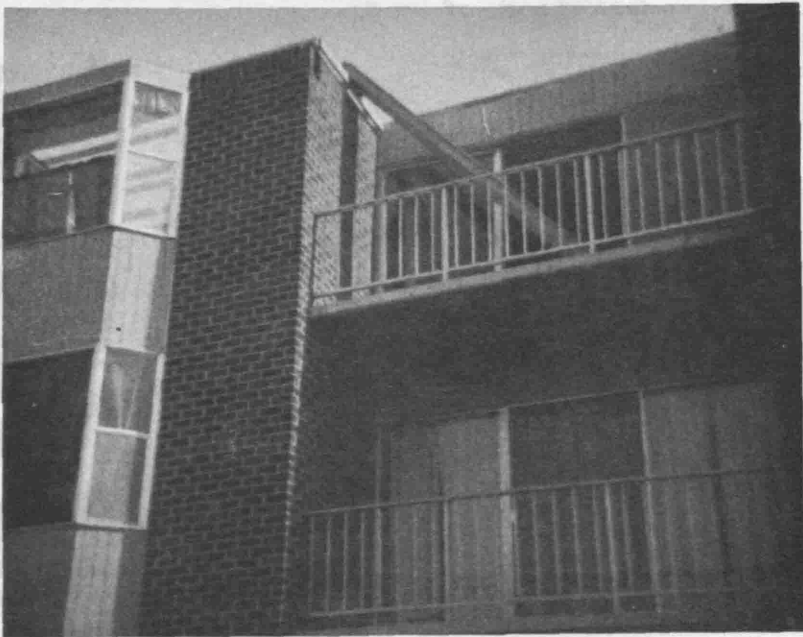
Figure 30 - Closeup view of damage above third-story balcony.

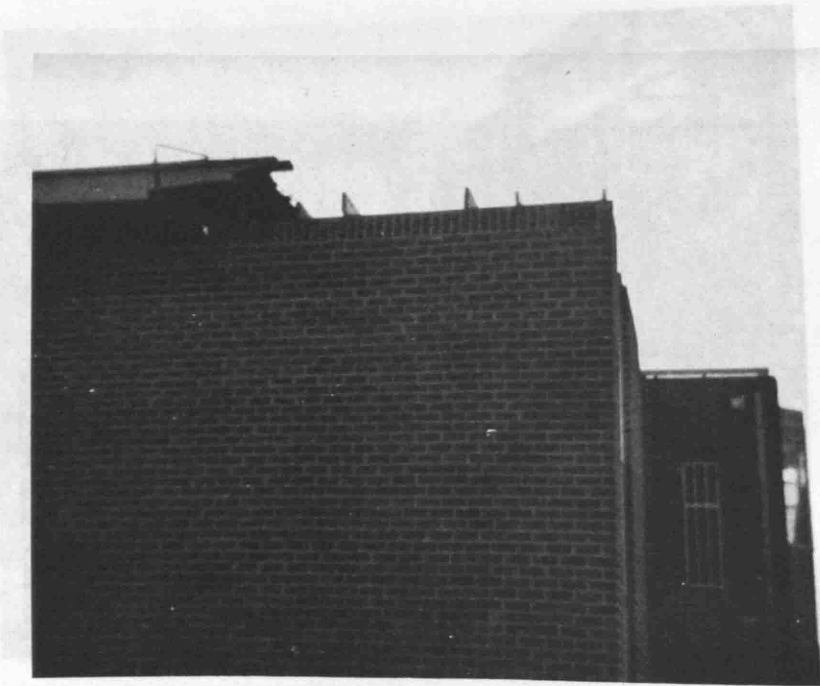
Figure 31 - Side view of damaged building showing partial destruction of roof.

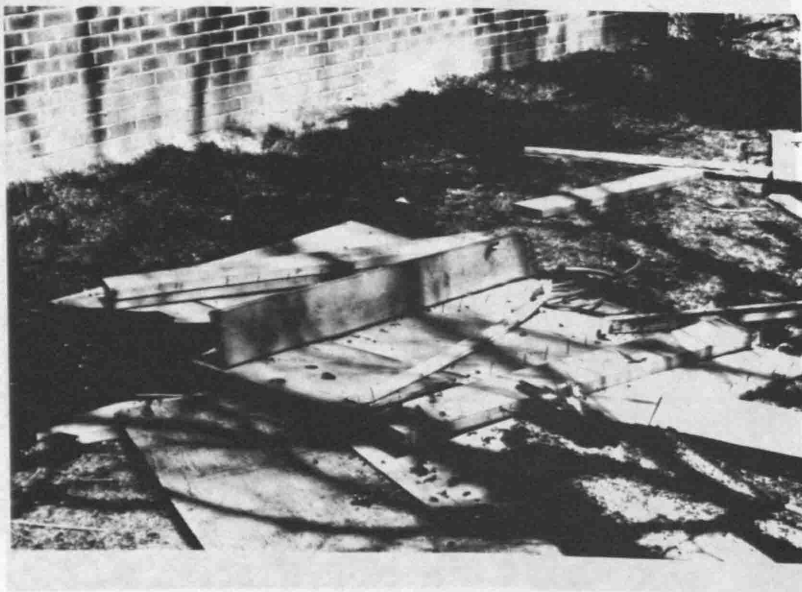
Figure 32 - Ground-level view of some wood framing and sheathing from a damaged roof.

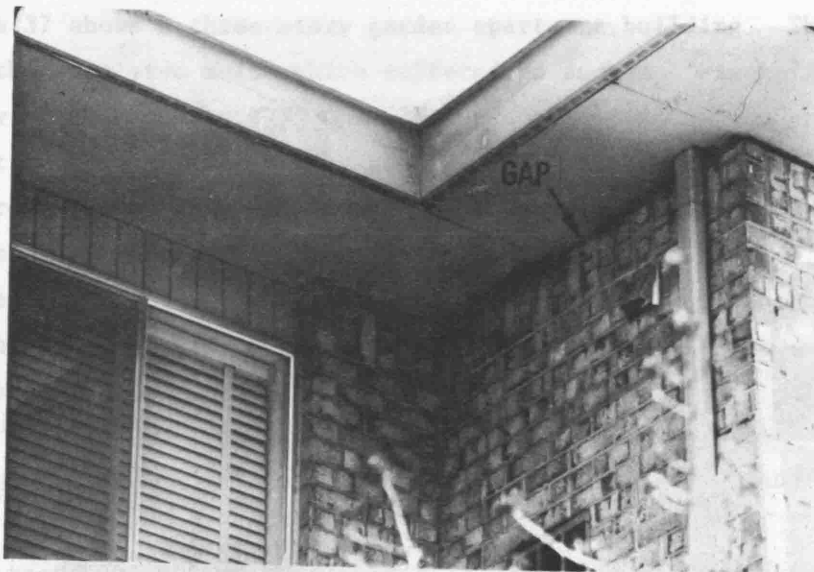
Figure 33 - Residual separation between soffit and masonry wall caused by uplift on roof overhang.

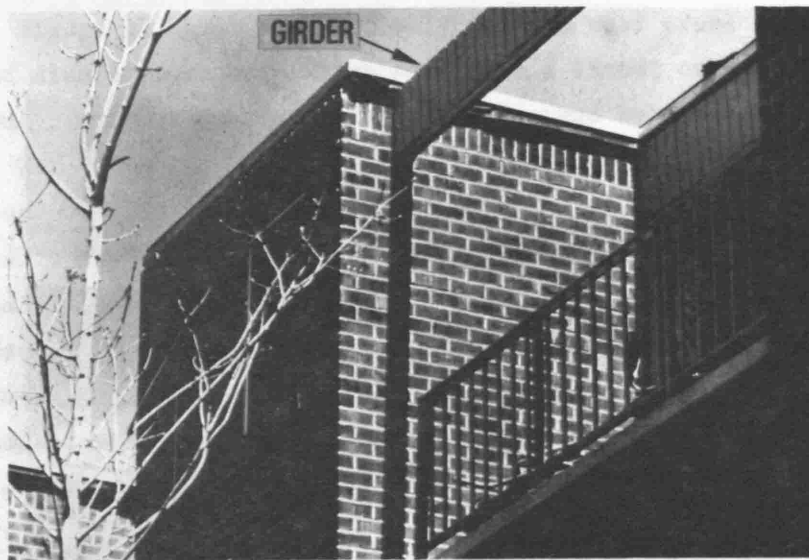
Figure 34 - Girder which supported portion of roof that covered balcony.

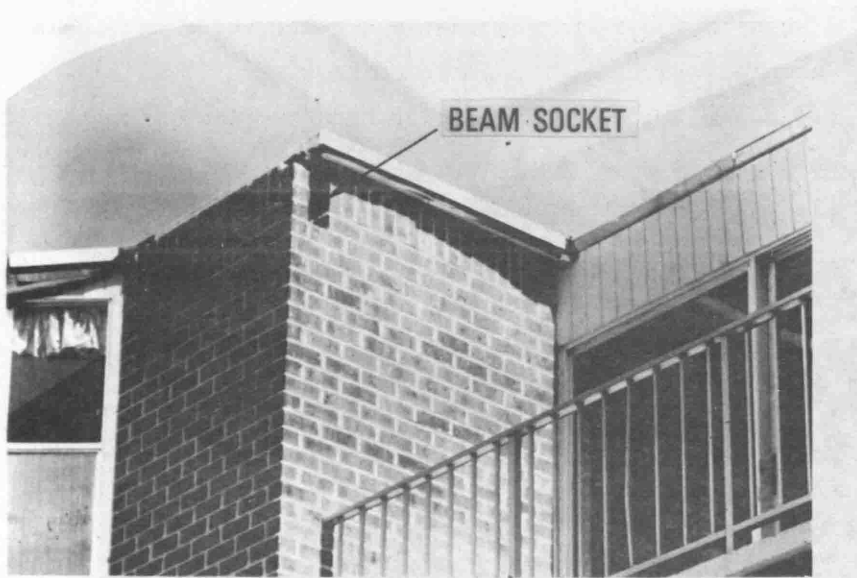
Figure 35 - A balcony above which the roof and supporting girder were removed.

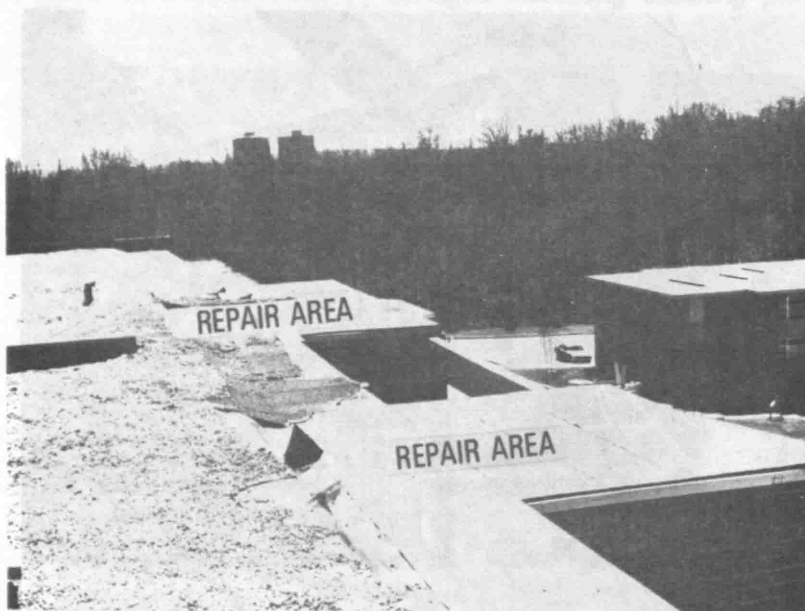
Figure 36 - Overall view of roof under repair.

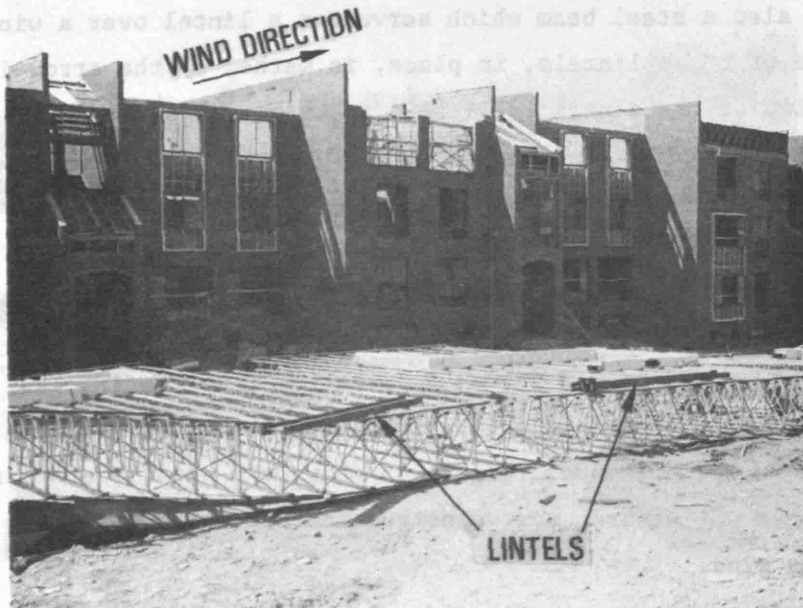
Figure 38 - Front elevation of several buildings under construction from which the roofs were lifted and dropped on the ground.

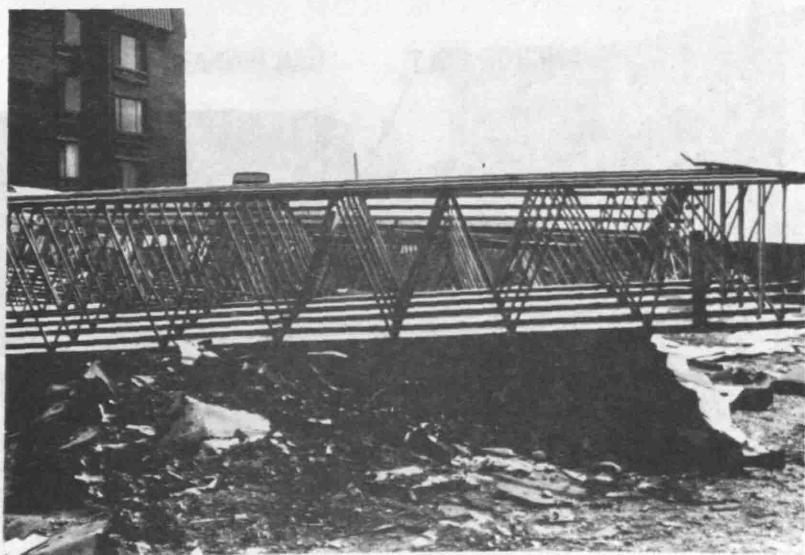
Figure 40 - Side elevation of the roof assemblies lifted up and deposited on the ground.

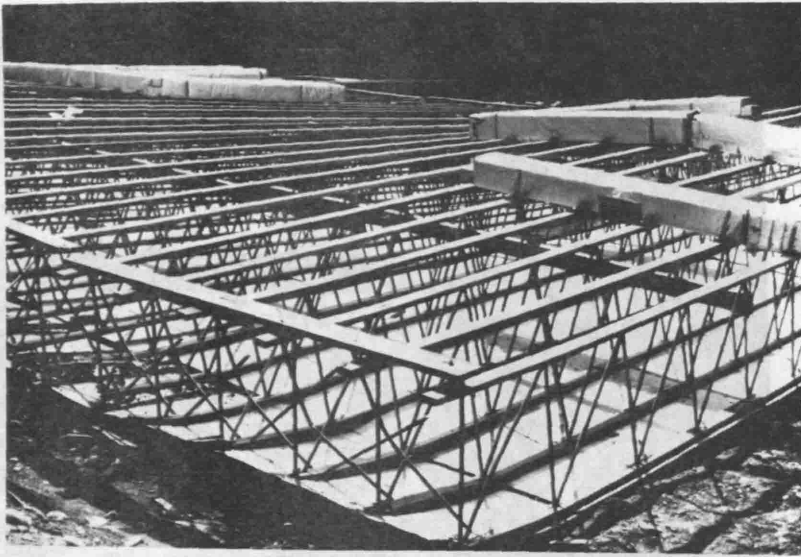
Figure 41 - Closeup view of overturned roof assemblies.

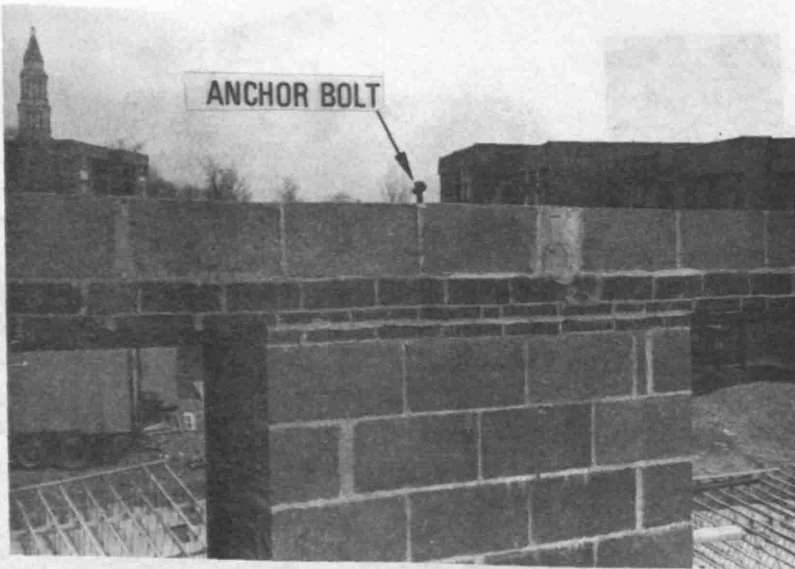
Figure 42 - A front masonry wall with projecting bolt for anchoring the roof assembly.

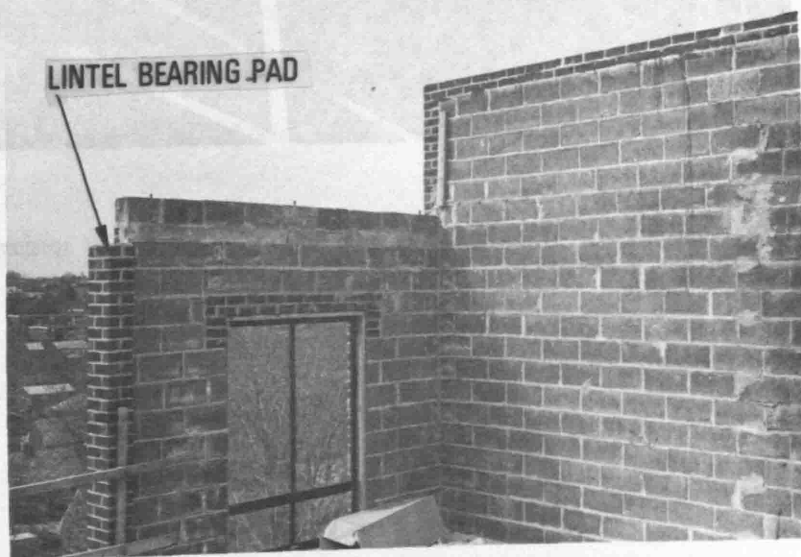
Figure 44 - Elevation of a rear wall from which the roof assembly and lintel beam have been removed. Looking northwest.

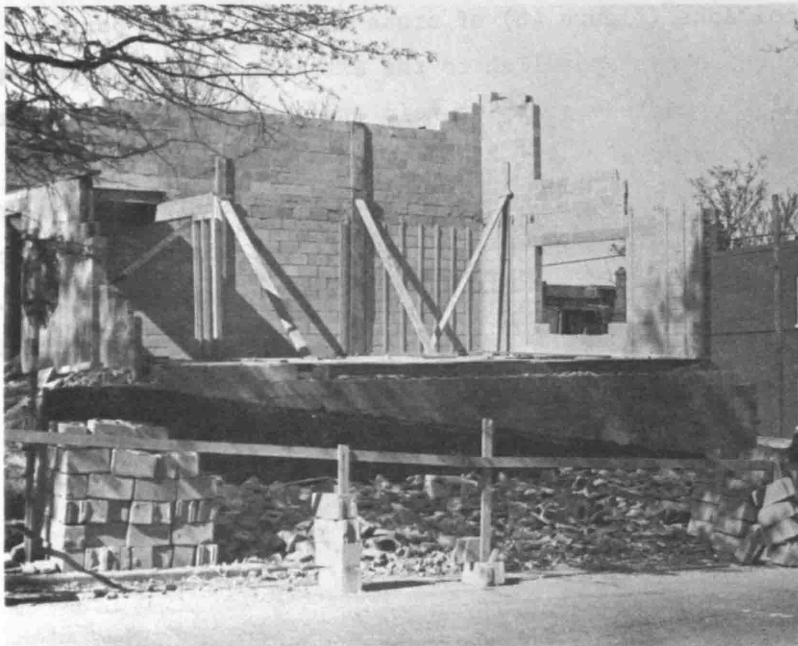
Figure 46 shows the end unit of a four-unit concrete masonry row house under construction. The exterior side wall of this unit collapsed and fell into the street causing two fatalities. (See the debris in the foreground of the photograph). Figures 47 and 48 are other views of the same structure taken from another street at right angles to the one into which the wall collapsed. The direction of the prevailing wind is shown by the arrow in figure 47. Note the partial collapse (figure 48) of cross-walls in other portions of the structure which were parallel to the exterior wall that collapsed. Details of the pulled-out joint reinforcement in one of the damaged cross-walls is shown in figure 49. The construction was 8 in (20 cm) unreinforced hollow concrete block with joint reinforcement. The incident illustrates the vulnerability of masonry walls in the construction stage before they are fully braced at their tops.

Figure 46 - End living unit of a four-unit masonry row house complex damaged during construction.

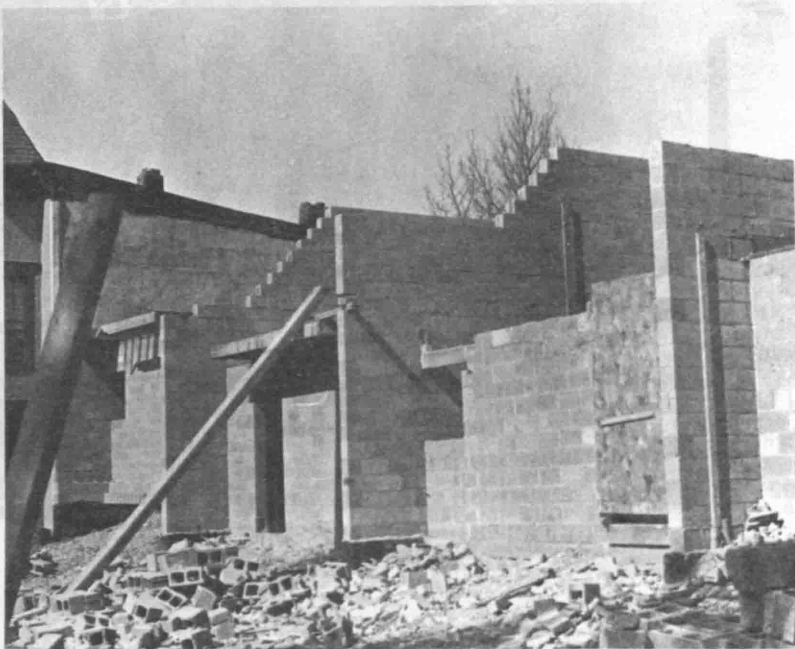
Figure 48 - Closeup front elevation of damaged masonry structures.

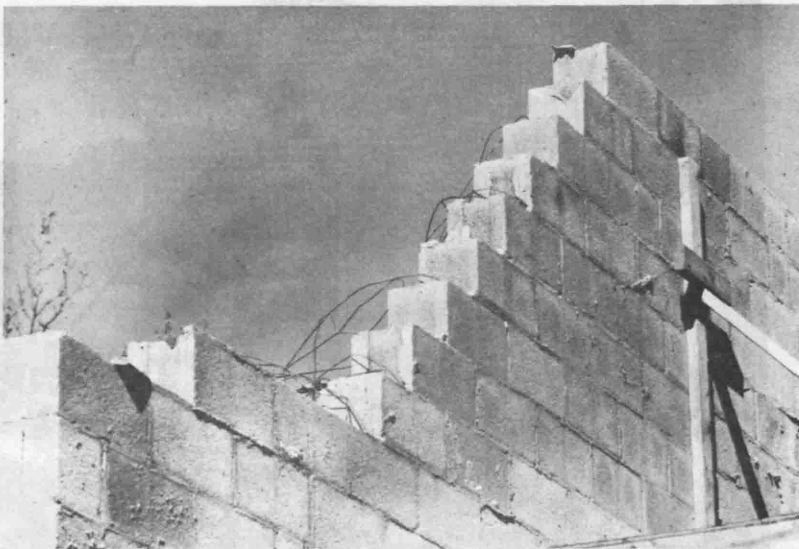
Figure 49 - Details of pulled-out joint reinforcement in a damaged cross wall.

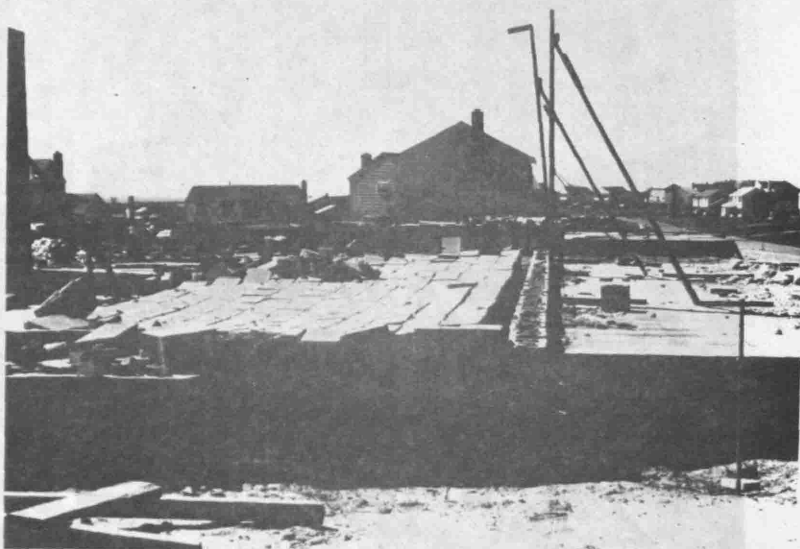
Another instance of masonry wall failure during construction is shown in figures 50 and 51. These walls were braced prior to the storm.

Figure 50 - Masonry wall failure during construction.

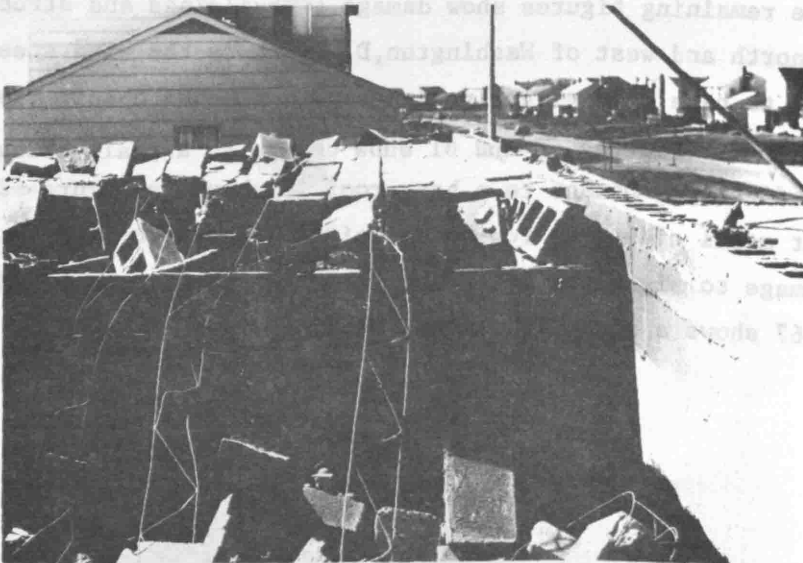
Figure 51 - Closeup view of collapsed wall showing horizontal joint reinforcement.
