Investigation of Wind Damage in the Metropolitan Washington, D.C. Area, April 3-4, 1975

F. Y. Yokel, C. W. Yancey,
L. E. Cattaneo, and R. D. Marshall

Center for Building Technology
Institute for Applied Technology
National Bureau of Standards
Washington, D.C. 20234

Issued May 1976

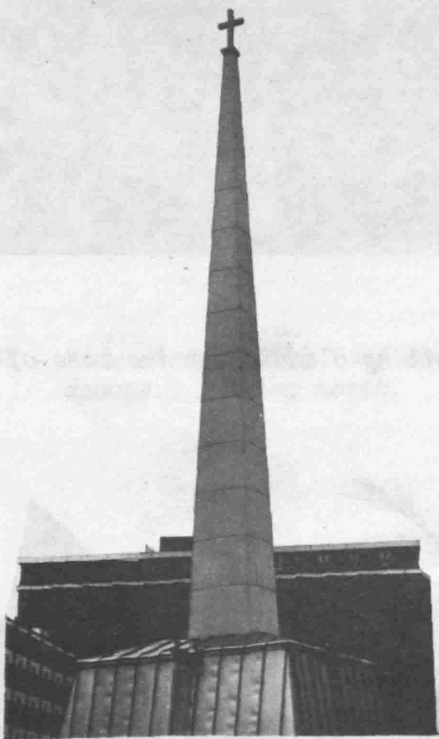
Figure 52 shows an approximately 40 ft (12.2 m) high church steeple which was observed to sway considerably. Figure 53 is a picture of the ceiling at the base of the church steeple. Note the damage that was caused to the cladding by the movement of the steeple. The brittle gypsum ceiling spalled as a result of the movement of the steel truss members.

Figure 52 - Elevation of a church steeple affected by wind.

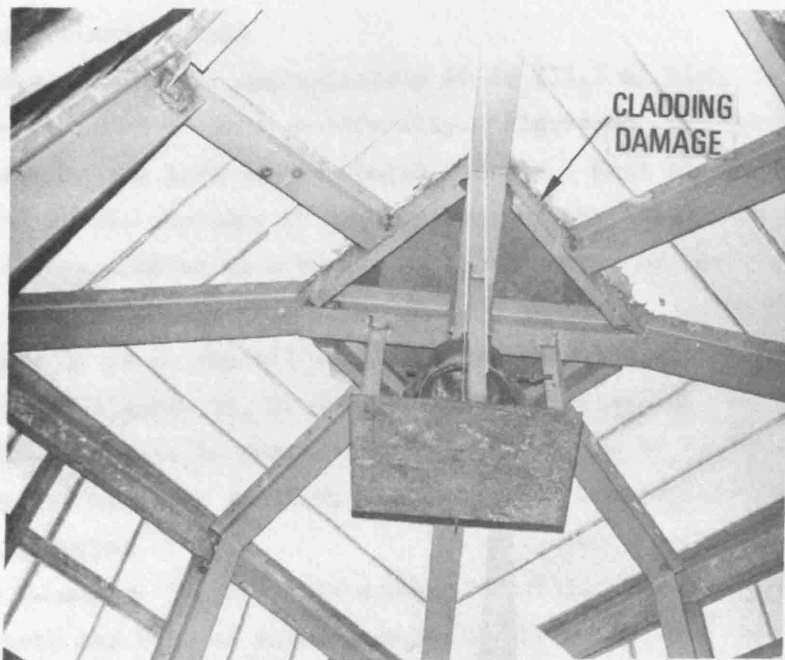
Figure 53 - Damaged ceiling cladding at the base of church steeple.

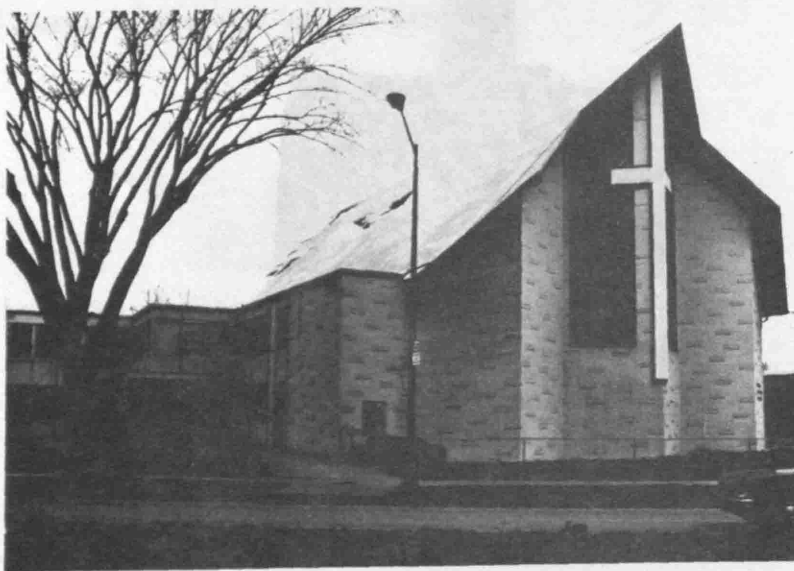
Figure 54 - Overall view of a church which suffered roof damage. Looking west.

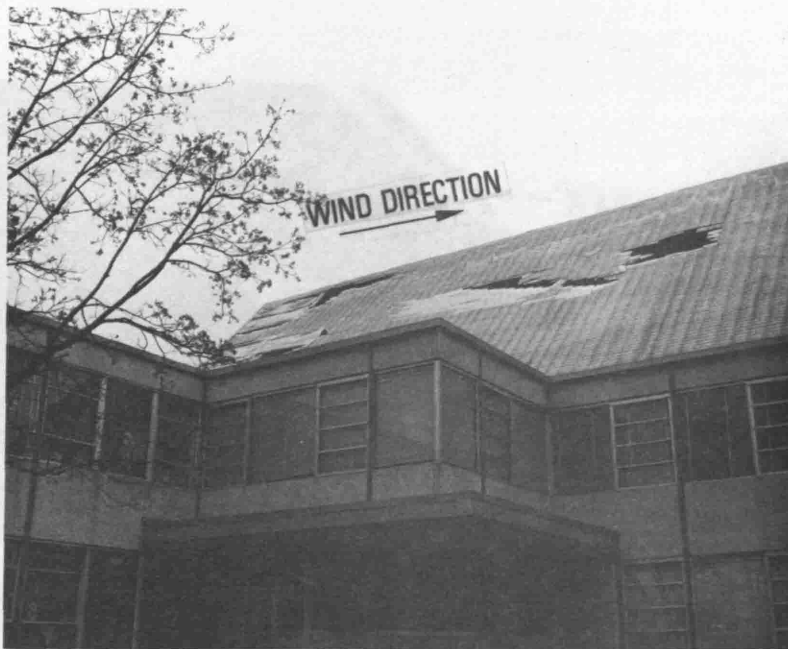
Figure 55 - View along church roof showing extent of roof damage. Looking north.

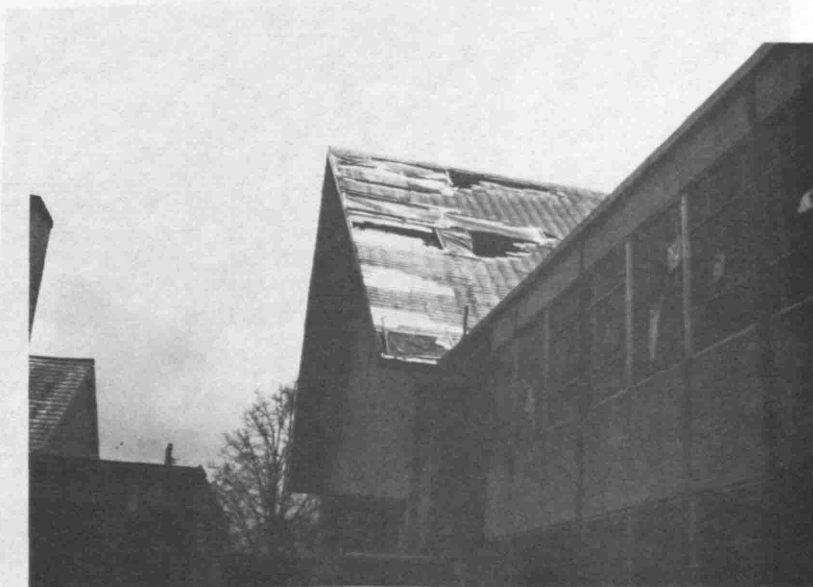
Figure 56 - Roof damage at rear (west side) of church.

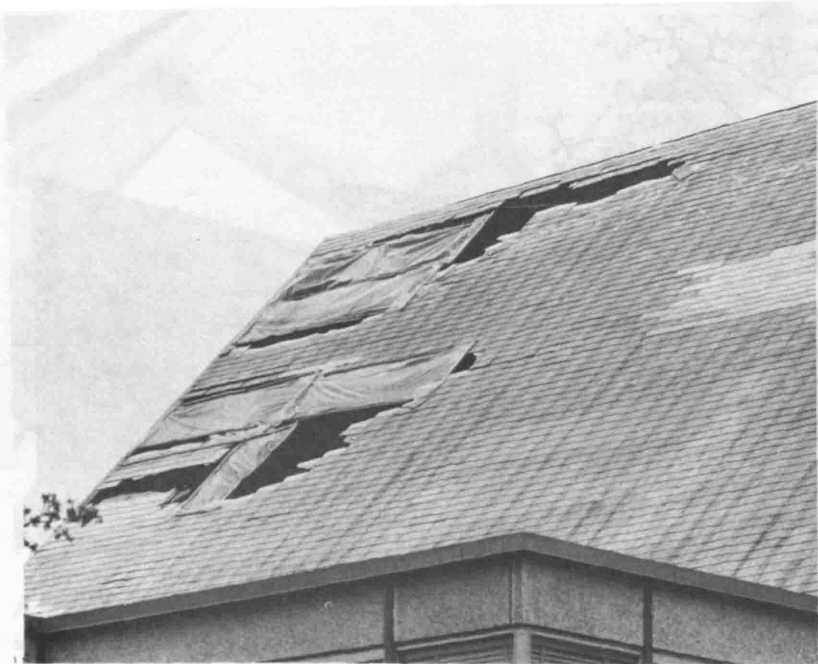
Figure 57 - Closeup view of roof damage at rear of church.

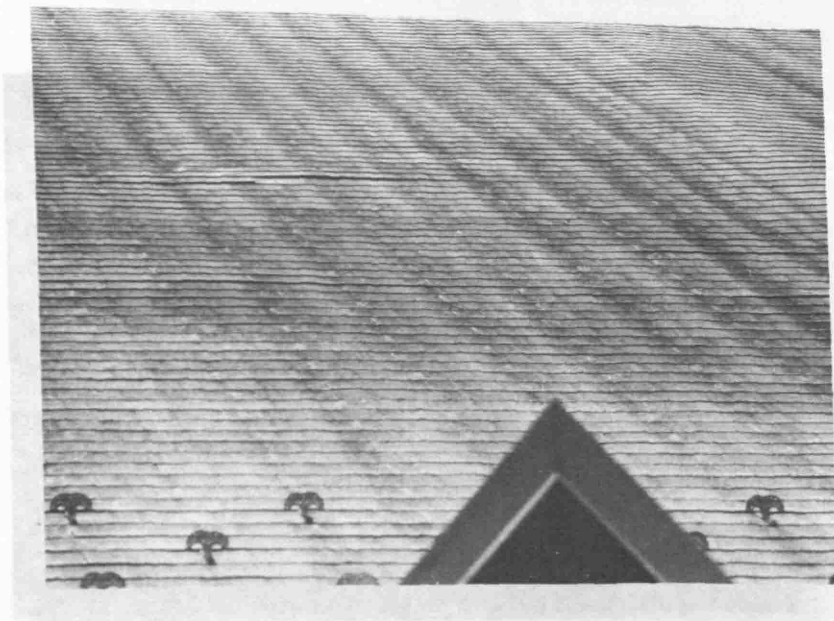
Figure 58 - Uplift of asbestos roof shingles along north side of church.

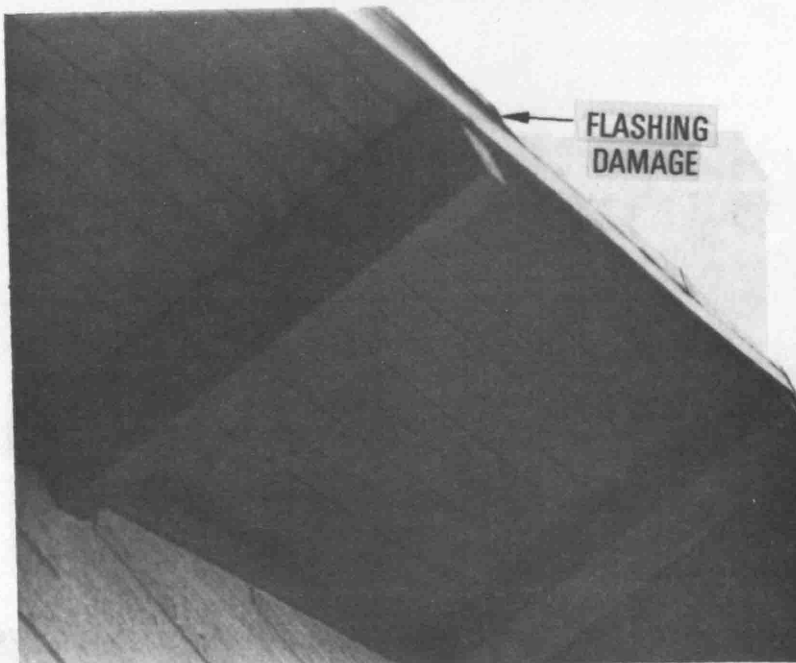
Figure 59 - Damage to roof flashing on gable overhang.

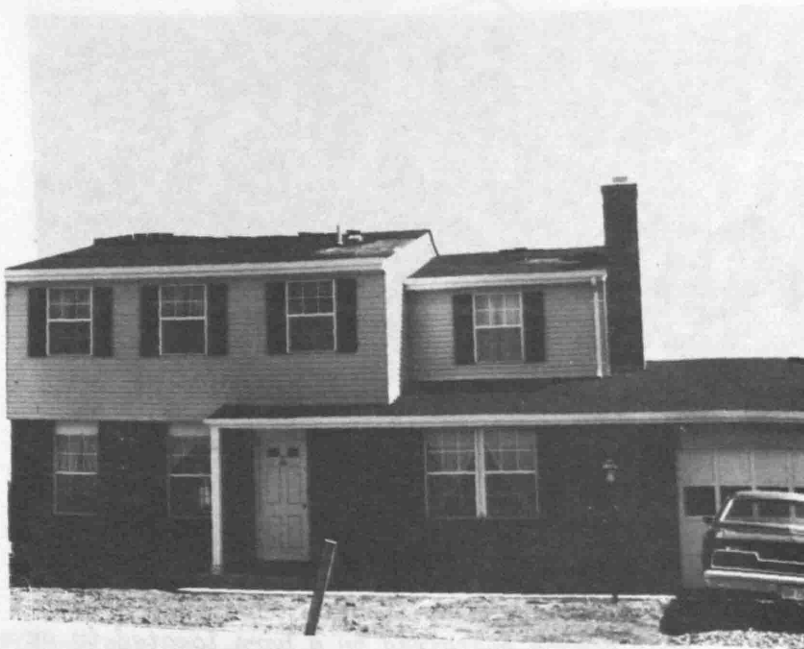
Figure 60 - Damage to asphalt shingle roof located in a new subdivision.

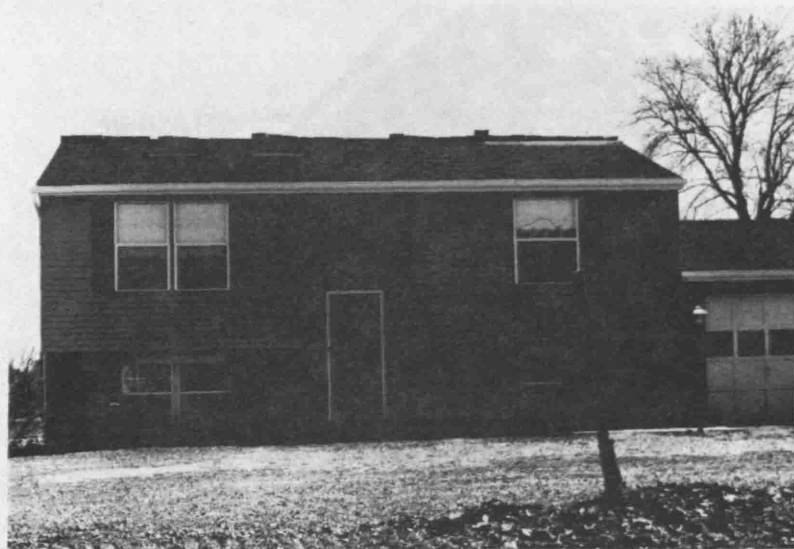
Figure 61 - Uplift of asphalt shingles along ridge and over other roof areas.

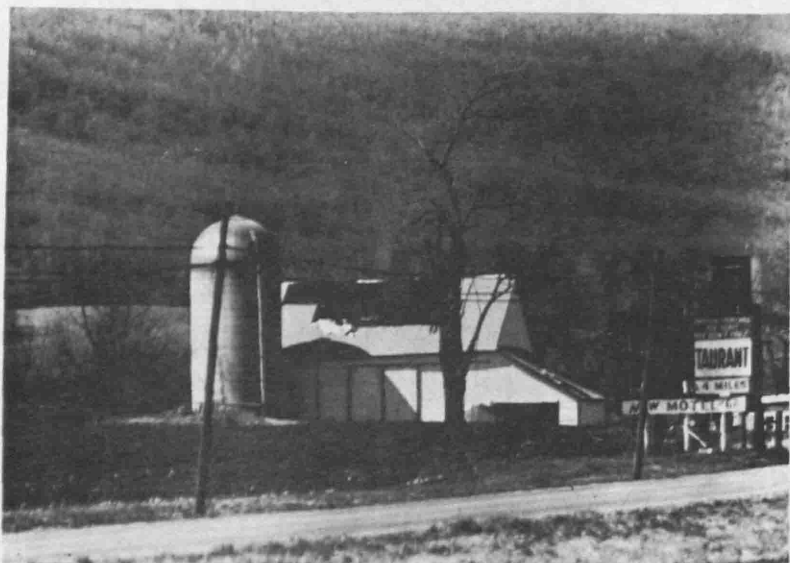
Figure 62 - Roof damage sustained by a barn located in an open area.

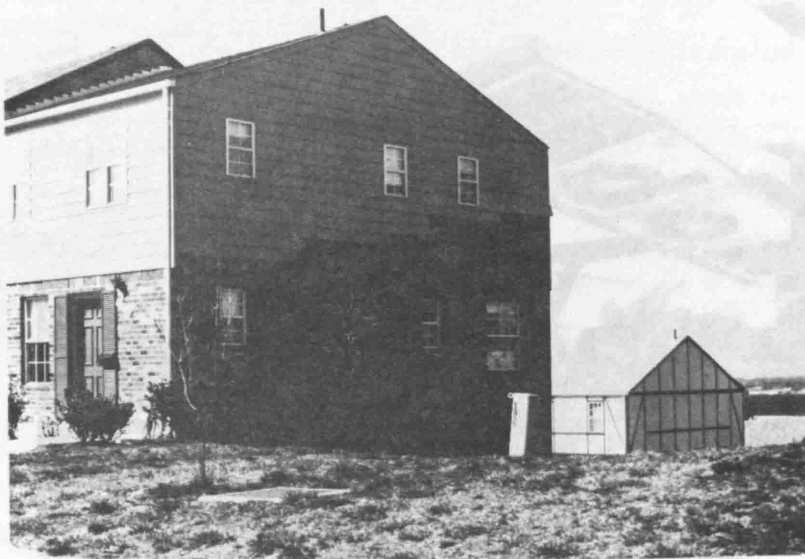
Figure 63 - Damaged sheet metal siding on an end townhouse unit.

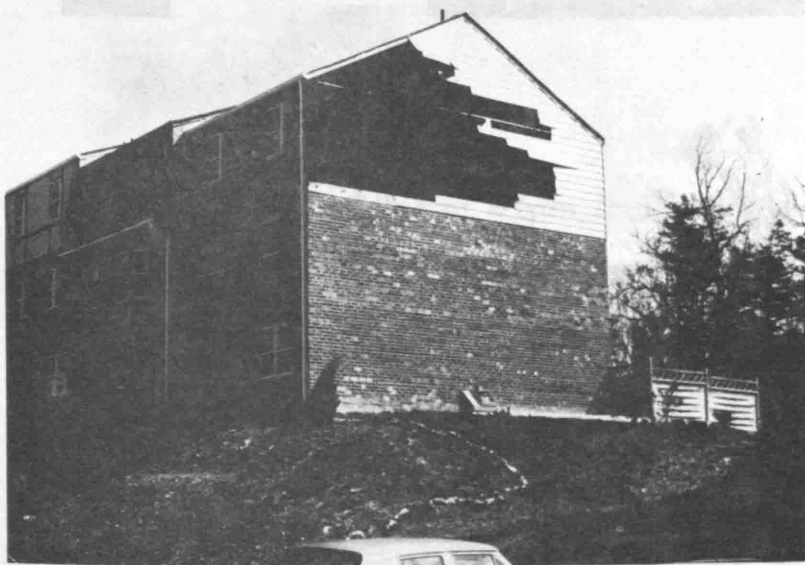
Figure 64 - Damaged sheet metal siding on a townhouse unit.

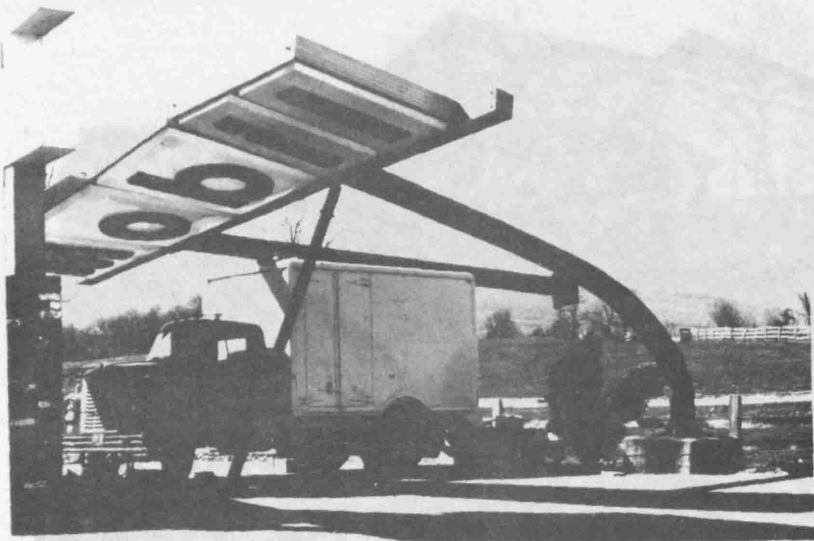
Figure 65 - Overturning failure of a service station sign.

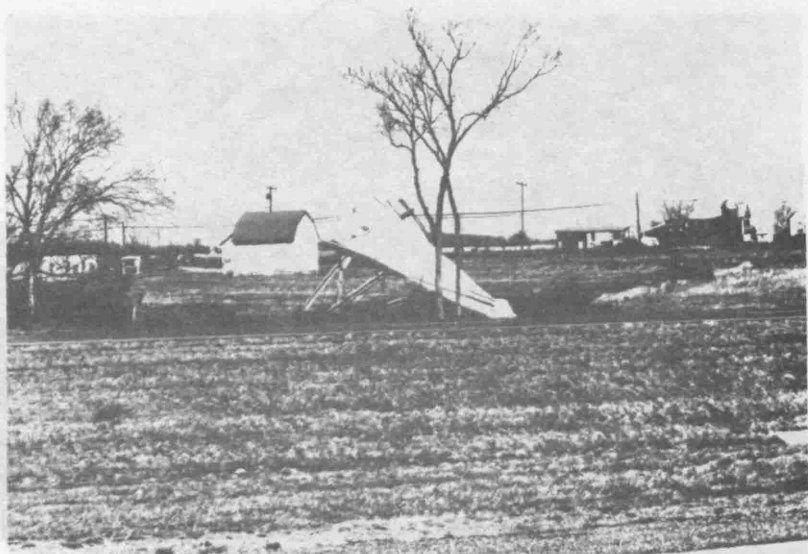
Figure 66 - Overturning failure of a roadside billboard.

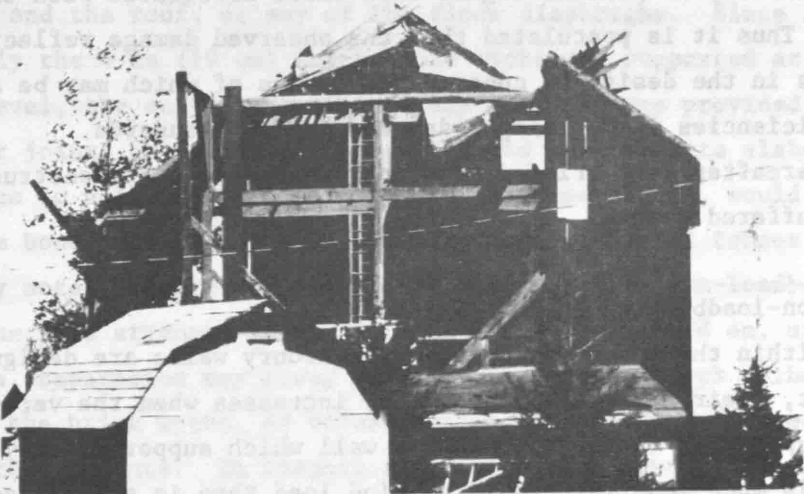
Figure 67 - Partial collapse of a barn located in rural area.
