TECHNICAL NOTE 569

Hurricane Camille - August 1969

A Survey of Structural Damage
Along the Mississippi Gulf Coast

Robert D. Dikkers, Richard D. Marshall
and H.C.S. Thom

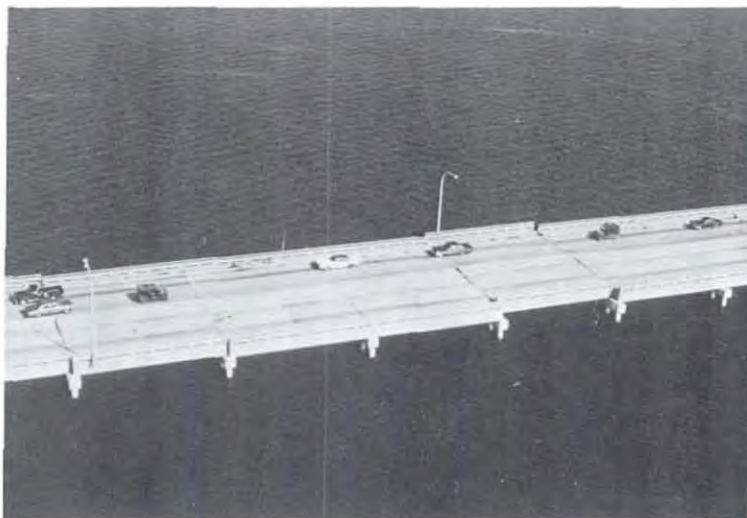
As indicated in figure 3, maximum wind speeds and surge heights in the Biloxi area were approximately 105 mph and 18 ft respectively. Precast concrete deck slabs of the Biloxi Bay Bridge (fig. 6) were moved longitudinally on their pile bents by surge-borne waves. Some slabs were displaced as much as 3 to 4 ft and considerable debris was lodged in the bridge railing. The ground floor of the Buena Vista Motel (fig. 7) was completely gutted by waves and extensive wind damage to the roofing was observed. Note the proximity of the structure to the water.

Figure 6. Biloxi Bay Bridge, Biloxi, Mississippi.

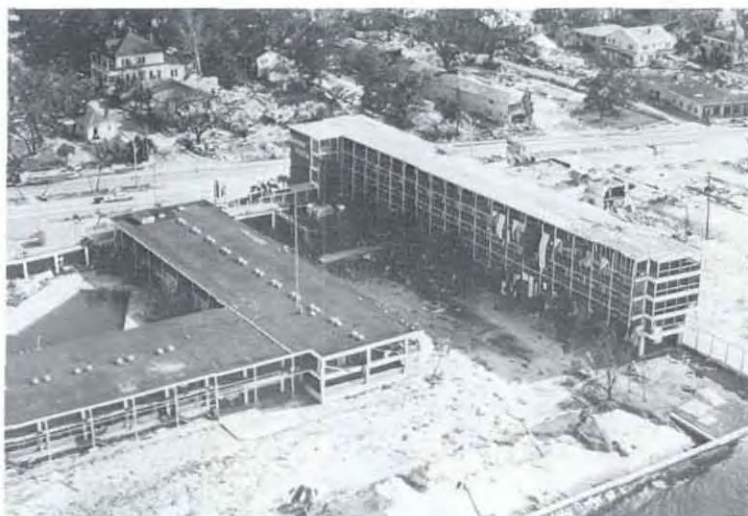
Structures on slightly higher ground fared much better even though their ground floors and basements were flooded (fig. 8). Generally, surge damage was limited to those areas within two blocks of the beach.

Figure 8. Coastal area, Biloxi, Mississippi.

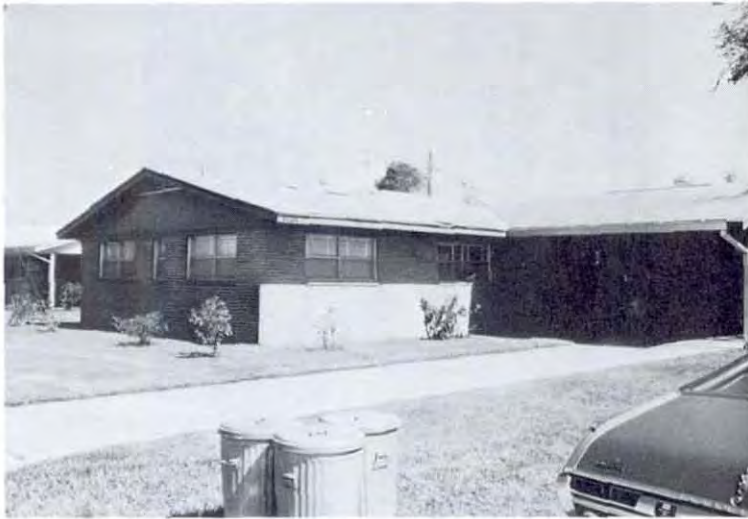
Keesler Air Force Base - Damage to buildings was limited to loss of cladding and roofing with some flooding occurring in housing developments located along the back bay. The chapel shown in figure 9 suffered the most serious damage with the loss of copper roofing and subsequent water damage to the interior furnishings. Single-family dwellings with wind-resistant shingles exhibited very little damage (fig. 10).

Figure 10. Single-family residence, Keesler Air Force Base.

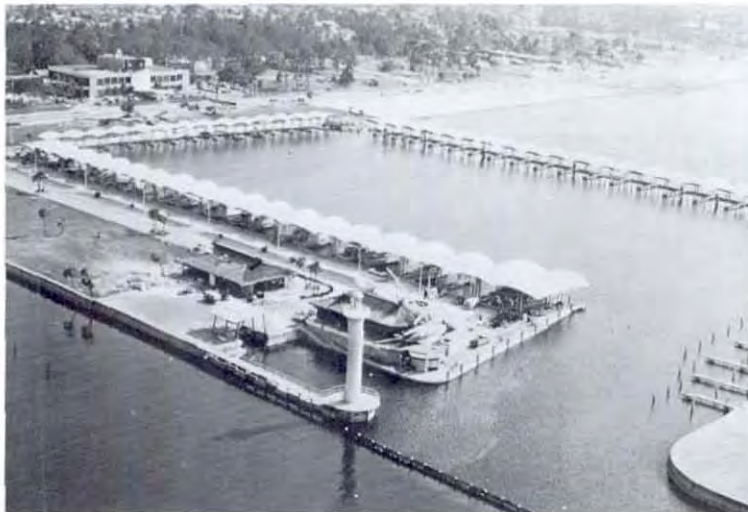
Broadwater Beach Marina - This marina (fig. 11) near Biloxi consists of reinforced concrete columns and double-T roof members over the boat slips. Although some of the roof members were damaged (fig. 12), the overall performance of the structure was very good considering that it was completely inundated by the storm surge. Surge height in this area (approximately half way between Biloxi and Gulfport) was about 20 ft.

Figure 11. Broadwater Beach Marina between Biloxi and Gulfport, Mississippi.

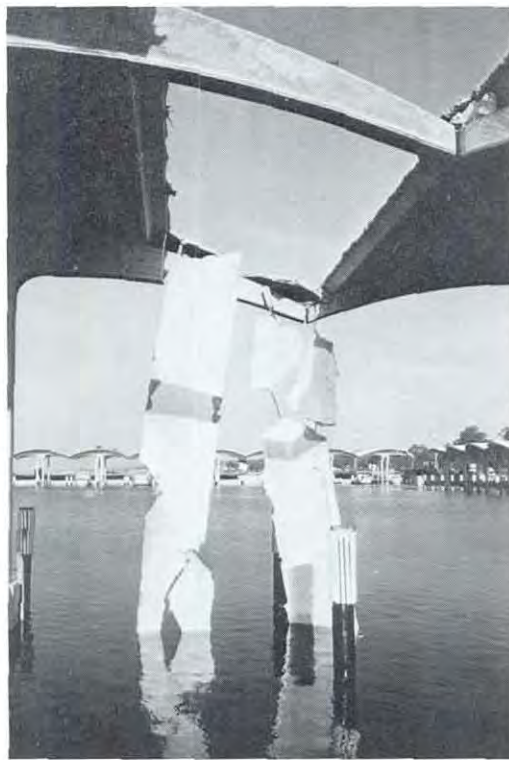
Figure 12. Close-up view of damage to Broadwater Beach Marina.

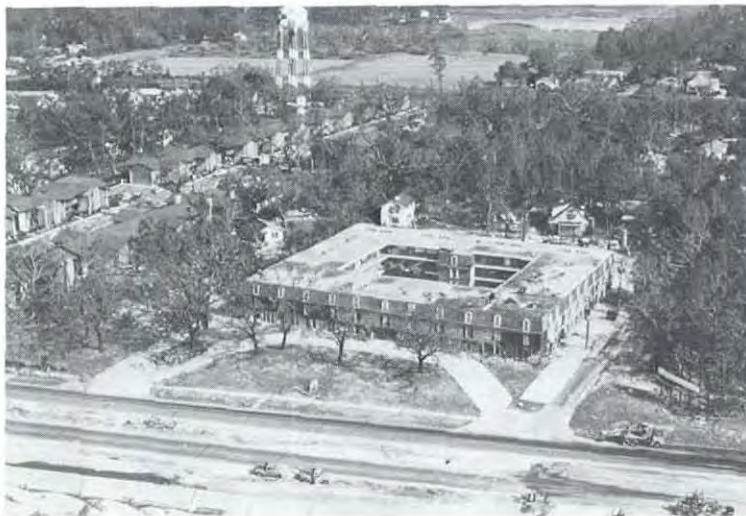
The building shown in figure 13 suffered heavy damage due to wave action and wind. Note the damage to roofing near the windward corner of the building. This type of damage is typical of flat-roofed structures investigated by the team. Although the seawall generally suffered light damage, considerable erosion was observed behind the wall and under the adjacent pavement slabs of U.S. 90 as indicated in figure 14.

Figure 13. Residential area between Biloxi and Gulfport, Mississippi.

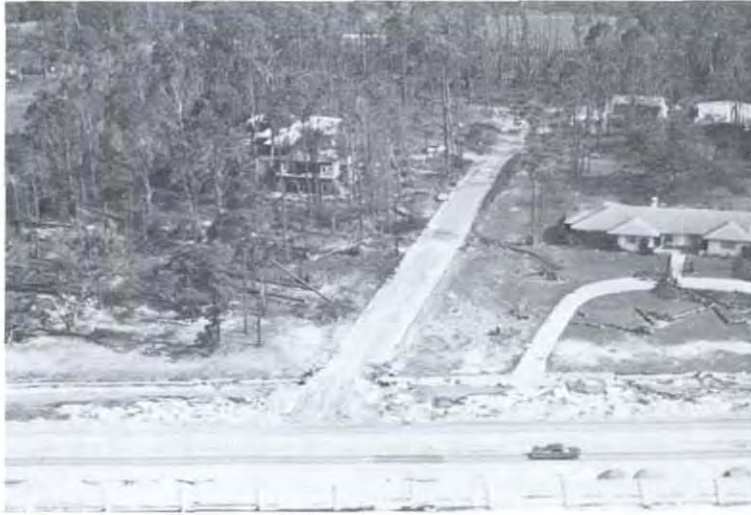
Figure 14. Seawall along U.S. Highway 90.

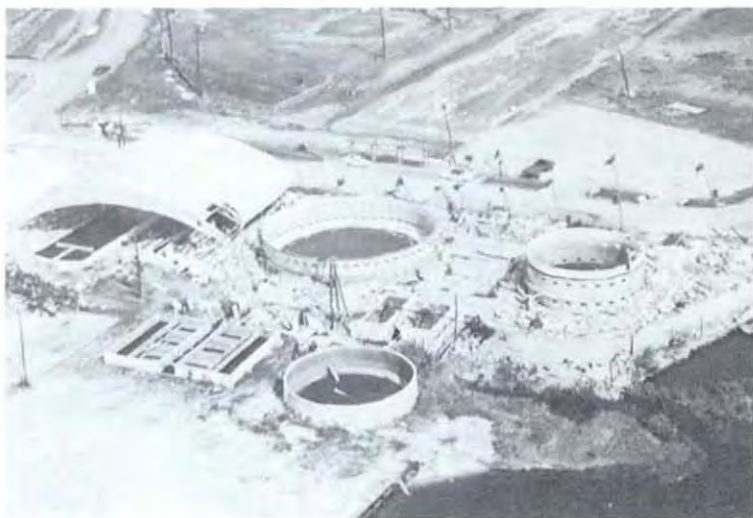
20-ft storm surge. One group of buildings in this area comprised the Marine Life Aquarium (fig. 16). The large steel-arched building at the left provided shelter for a display tank and a concrete seating area. Detailed description of the damage to these structures has been reported by another survey team [10].

Figure 16. Marine Life Aquarium, Gulfport.

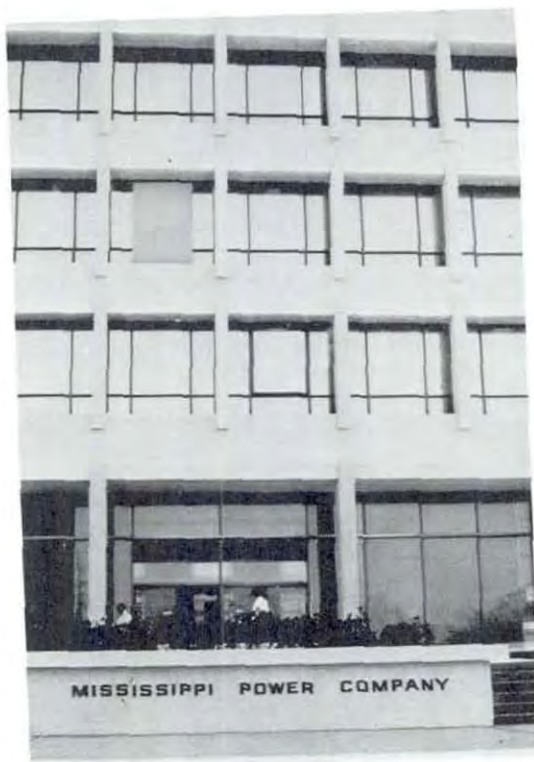
through seventh floors (fig. 20) [11]. The large first-floor windows were protected from flying or floating debris by a wire fabric screen which was erected just prior to the storm. The windows consist of one-inch thick panels of insulating reflective glass set in bronze anodized aluminum framing with neoprene gaskets. The neoprene gaskets provide a resilient mounting for the glass and prevented metal-to-glass contact and minimized breakage. After the storm, it was reported that, out of more than 500 windows, a total of 13 lights had to be replaced [11].

Figure 20. Close-up view of Mississippi Power Company building.

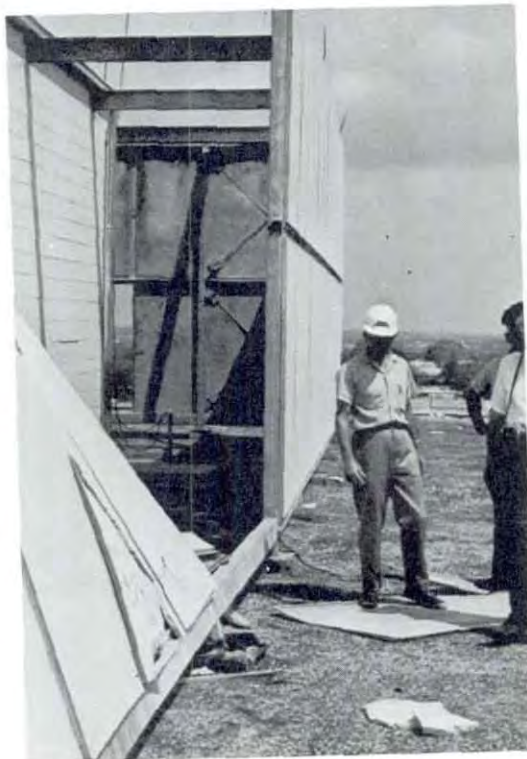
In addition to the window damage, some minor damage occurred to one side of the roof enclosure surrounding the air-conditioning cooling tower (fig. 21). The structure for the enclosure consisted of rectangular structural steel tubing and 2-in thick concrete panels which were reinforced with expanded metal lath.

Figure 21. Enclosure structure on roof of Mississippi Power Company building, Gulfport, Mississippi.

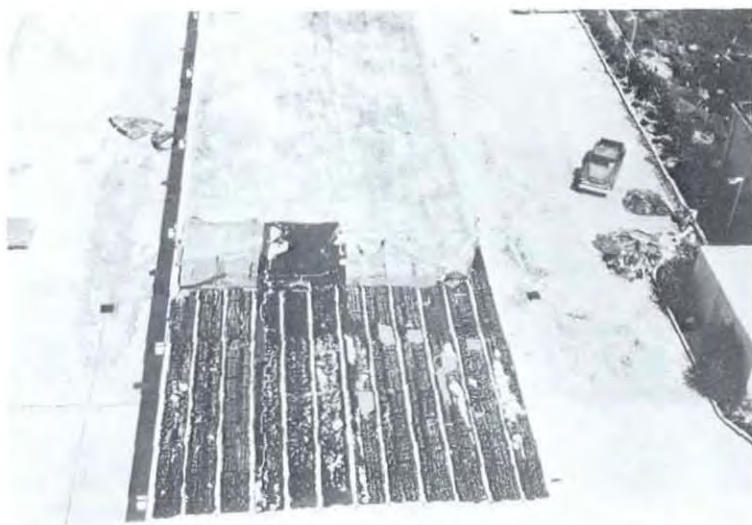
Figures 22 through 24 indicate the general level of damage in the area surrounding the Mississippi Power Company. The prefabricated metal building in figure 22 again points up the importance of local wind effects when designing roof elements. The random distribution of damage shown in figure 23 is typical of the entire area covered by the survey. Failures of roofing are usually progressive as is indicated in figure 24. Gravel from this built-up roof contributed considerably to the flying debris.

Figure 24. Roofing damage on building adjacent to north side of Mississippi Power Company building.

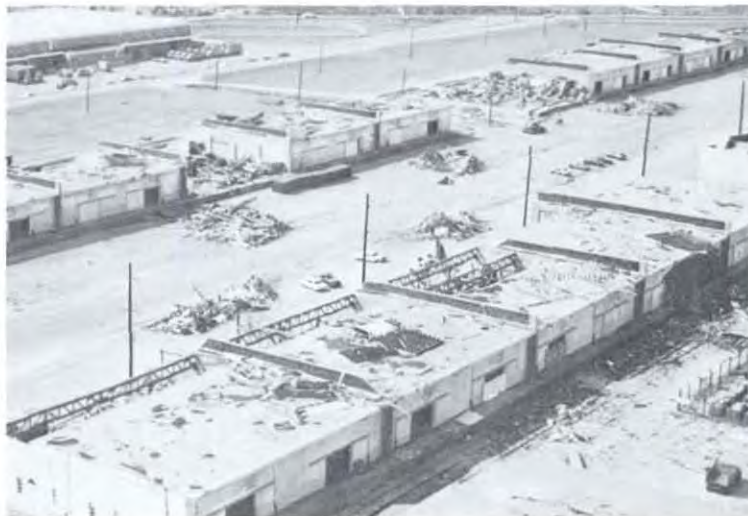
Figure 29. Damaged warehouses, U.S. Naval Construction Battalion Center, Gulfport, Mississippi.

An aerial view of the damaged warehouses is shown in figure 29. These wood-frame buildings were built during World War II and were still in daily use. The major damage to these structures occurred on the windward side. As shown in figure 29, the warehouse units were constructed with brick fire walls between each section. The roofs were supported by timber trusses and the front and back walls were of wood-frame construction. Close-up views illustrating the collapsed wood-frame walls, damaged brick fire walls and dislodged roof trusses are shown in figures 30 and 31.

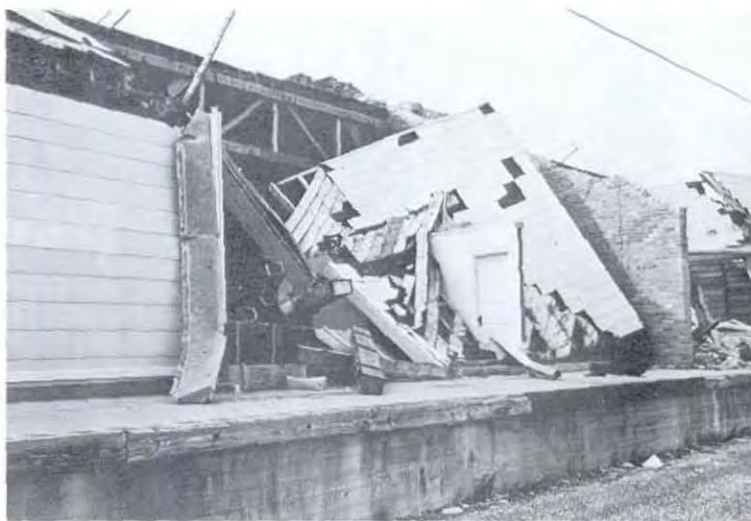
Figure 30. Close-up view of damaged warehouse shown in figure 29.

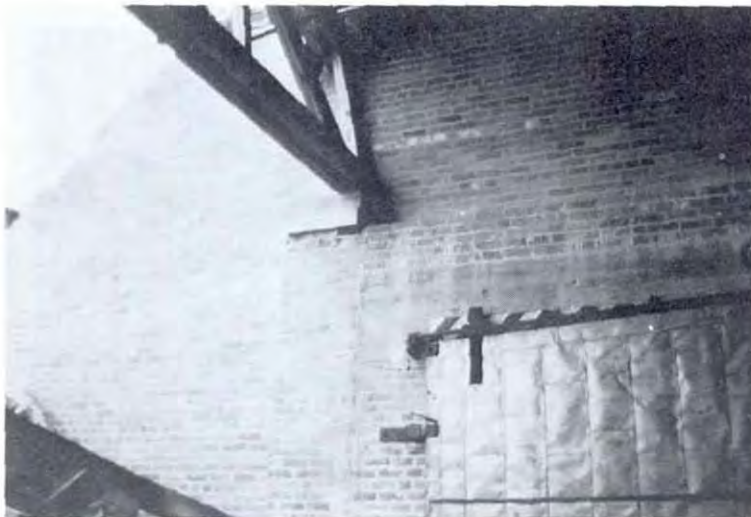
Figure 31. Damaged warehouse roof and fire wall, U.S. Naval C. B. Center, Gulfport, Mississippi.

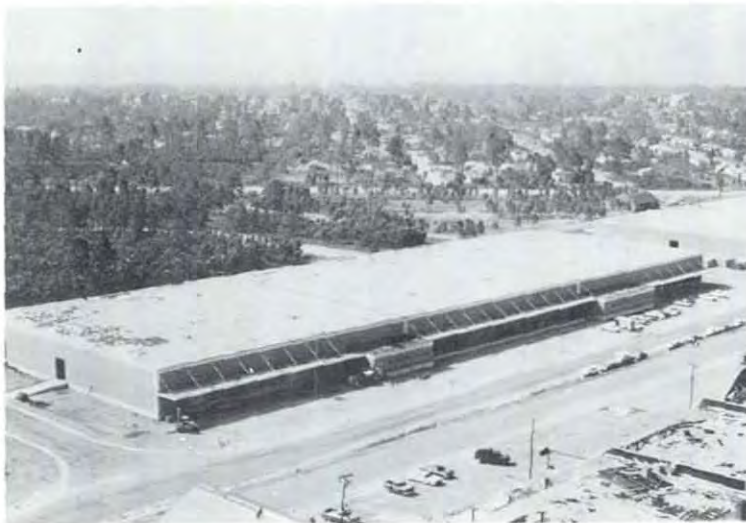
Comparatively minor damage was suffered by three reinforced concrete-masonry warehouses (fig. 32) which were built during or since 1950. These warehouses were located near the older wood-frame warehouses (see upper left of fig. 29). As shown in figure 33, these structures lost some 2-ft wide by 8-ft long precast concrete roof panels along the perimeter of the roof. It was observed that all roof panels were securely anchored at interior points by steel clips but no anchorage was provided for the perimeter panels, the location where peak uplift usually occurs. Prior to the passage of Hurricane Camille, it was reported to the NBS survey team that hundreds of civilian dependents left their homes to take refuge in these concrete-masonry warehouses.

Figure 32. Reinforced concrete and masonry warehouse, U.S. Naval C. B. Center, Gulfport.

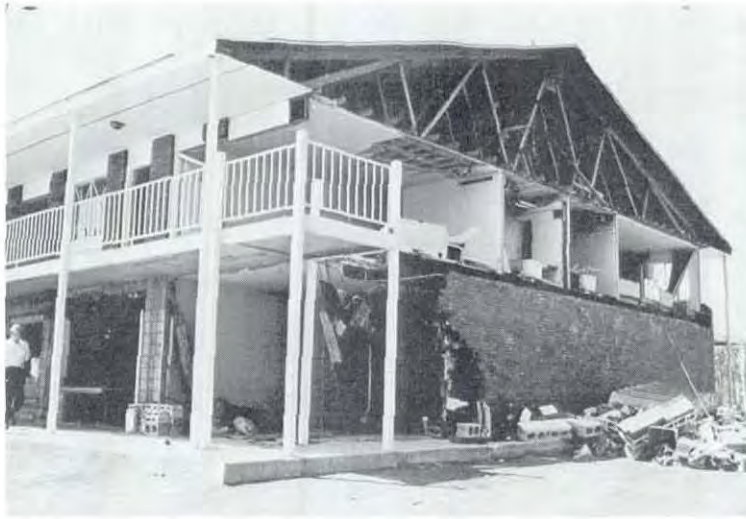
the restaurant area (fig. 49) experienced extensive water damage. On the east end of the main building, the top-story portion of a masonry wall had collapsed (fig. 50). An inspection of this brick and block wall indicated it contained some vertical reinforcement; however, the block cells containing this reinforcement did not contain any grout or concrete (fig. 51).

Figure 50. Damaged masonry wall on east end of main building, Ramada Inn.

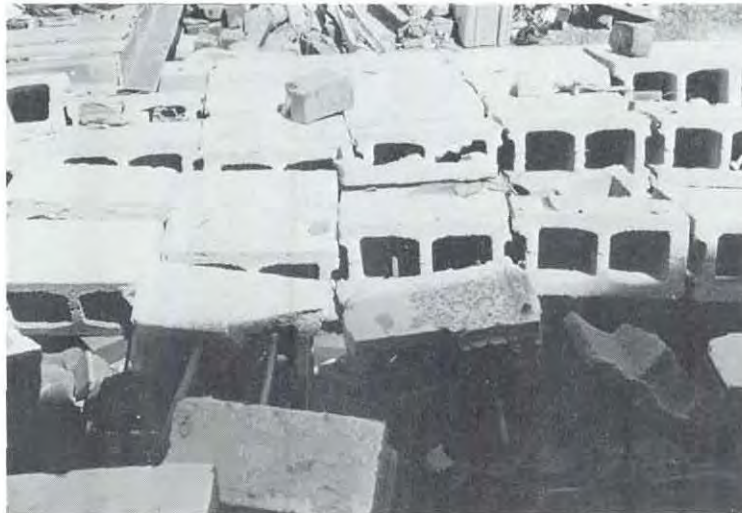
Figure 51. Damaged masonry wall, Ramada Inn; block cells containing vertical reinforcement were not grouted.

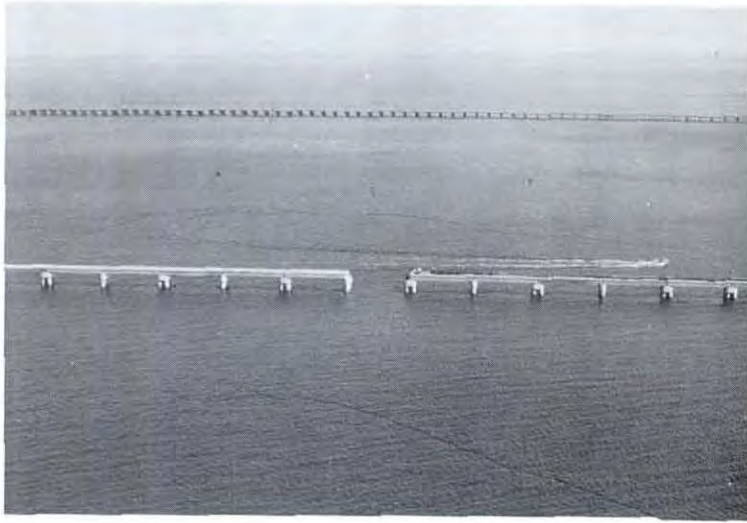
The L & N Railway Bridge over St. Louis Bay is shown in figure 62. Rails, ties and ballast were swept from the deck by surge-borne waves. The missing span was not carried away in the storm but was severely damaged and required replacement. The bridge carrying U.S. Route 90 (shown in background) suffered damage very similar to that of the Biloxi Bay Bridge. A displaced deck slab is shown in figure 63.

Figure 62. L & N Railway Bridge, Bay St. Louis. (Damaged span removed).

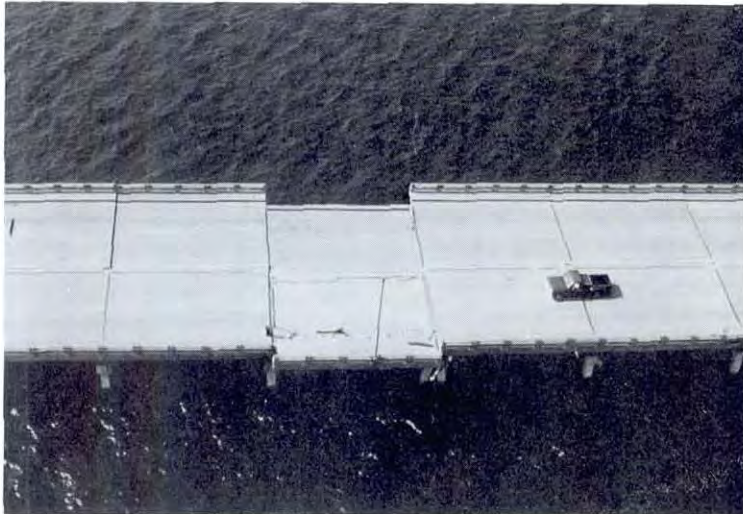
Figure 63. Bay St. Louis Bridge, U.S. Highway 90.

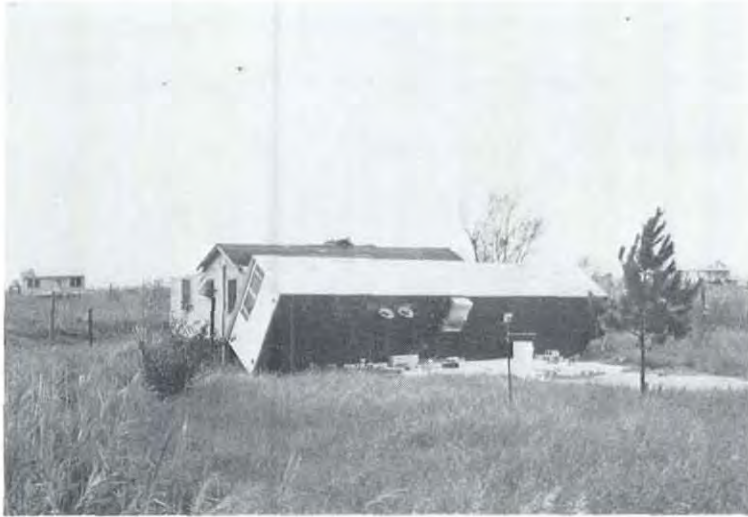
One of the many mobile homes which were overturned is shown in figure 72. This particular mobile home was located in Louisiana on U.S. Route 90 just west of Pearlington, Mississippi.

Figure 72. Damaged mobile home, U.S. Highway 90 near Pearlinton, Mississippi.

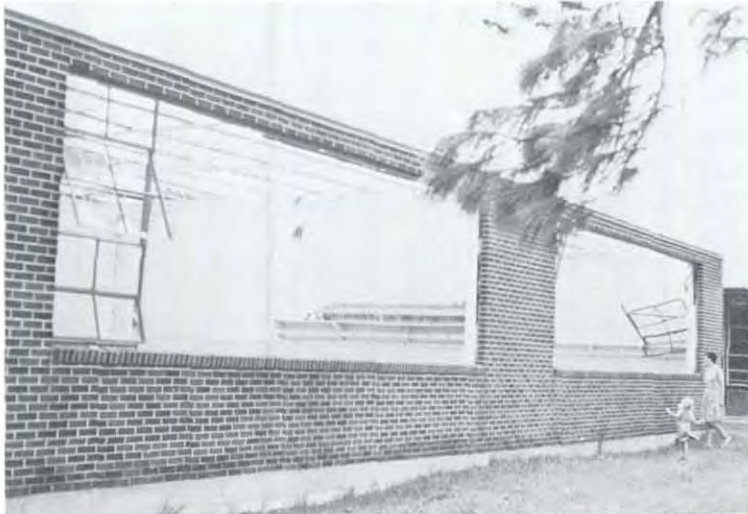
North Central High School is located on County Road 603 about 15 miles north of Waveland, Mississippi. The main school buildings are constructed with brick and block walls and a steel joist roof system. As shown in figure 73, the roof covering and insulation were stripped from the buildings and the windows were badly damaged. This exterior damage also resulted in extensive rain damage to the interior and contents of the buildings.

Figure 73. North Central High School between Waveland and Poplarville, Mississippi.
