NIST Response to the World Trade Center Disaster

World Trade Center Investigation Status

June 22, 2004

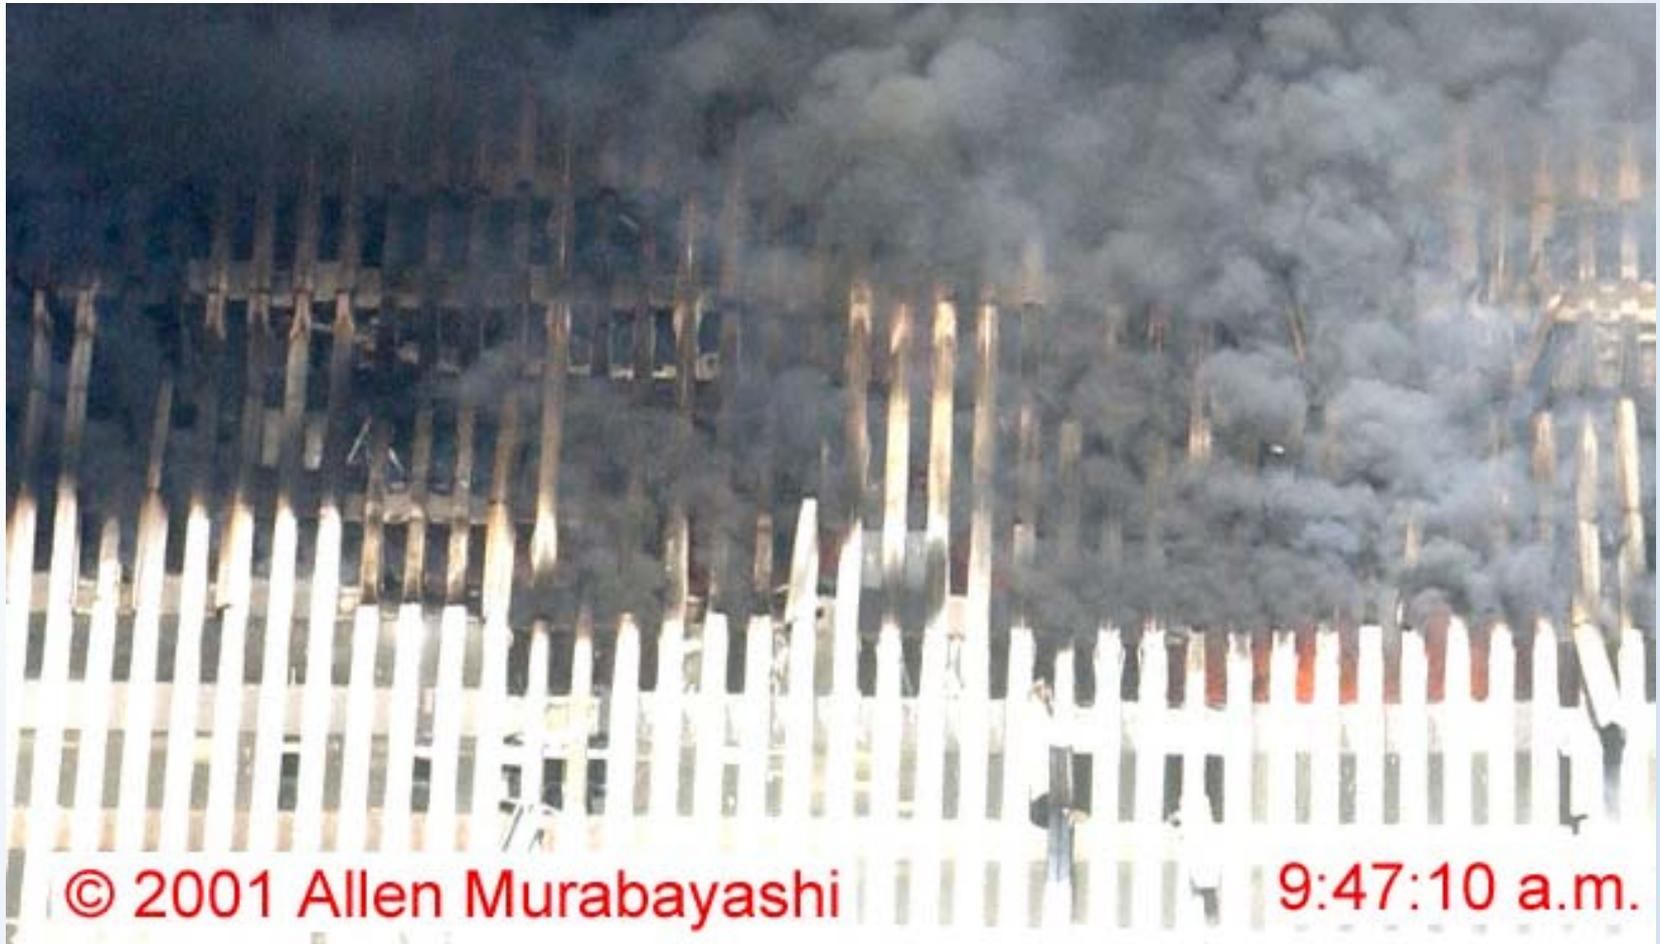
9:47:10 a.m.

East Face of the South Tower. Image shows what appear to be a floor slab from the 83rd floor hanging across window opening over a large fraction of the 82nd floor.

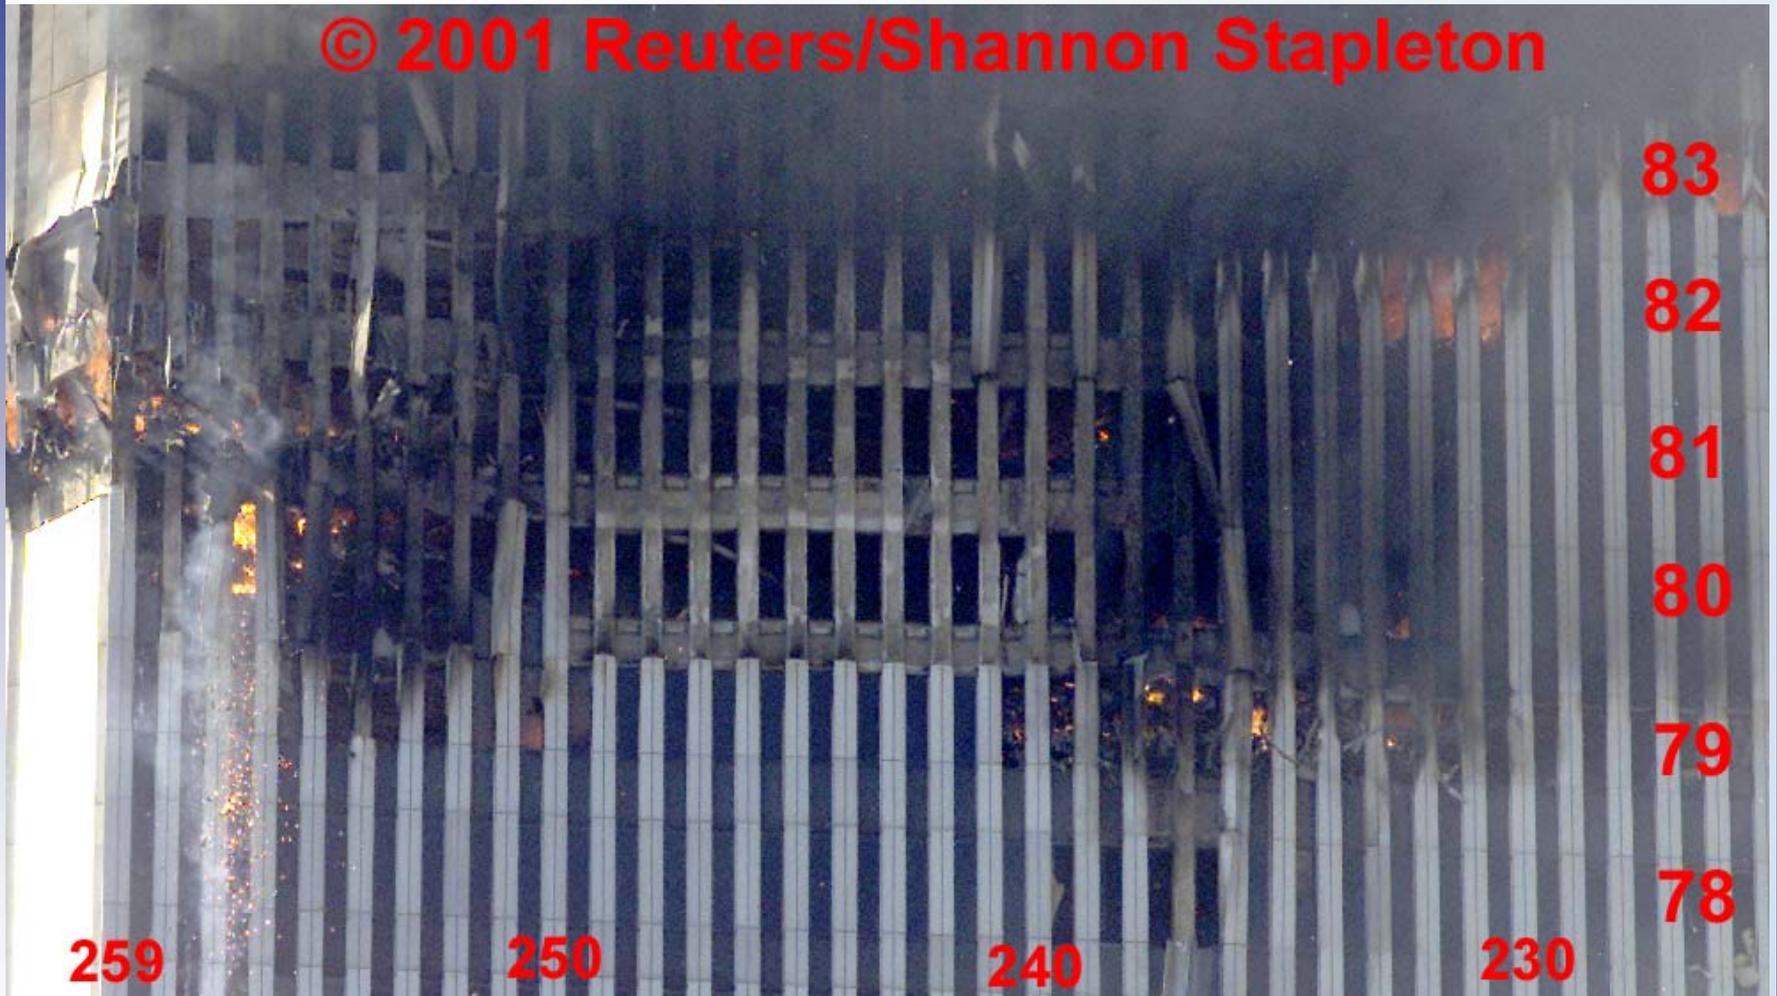
North Face of the South Tower. Image shows what appear to be portions of several floor slabs hanging across window openings on Floors 80, 81, and 82

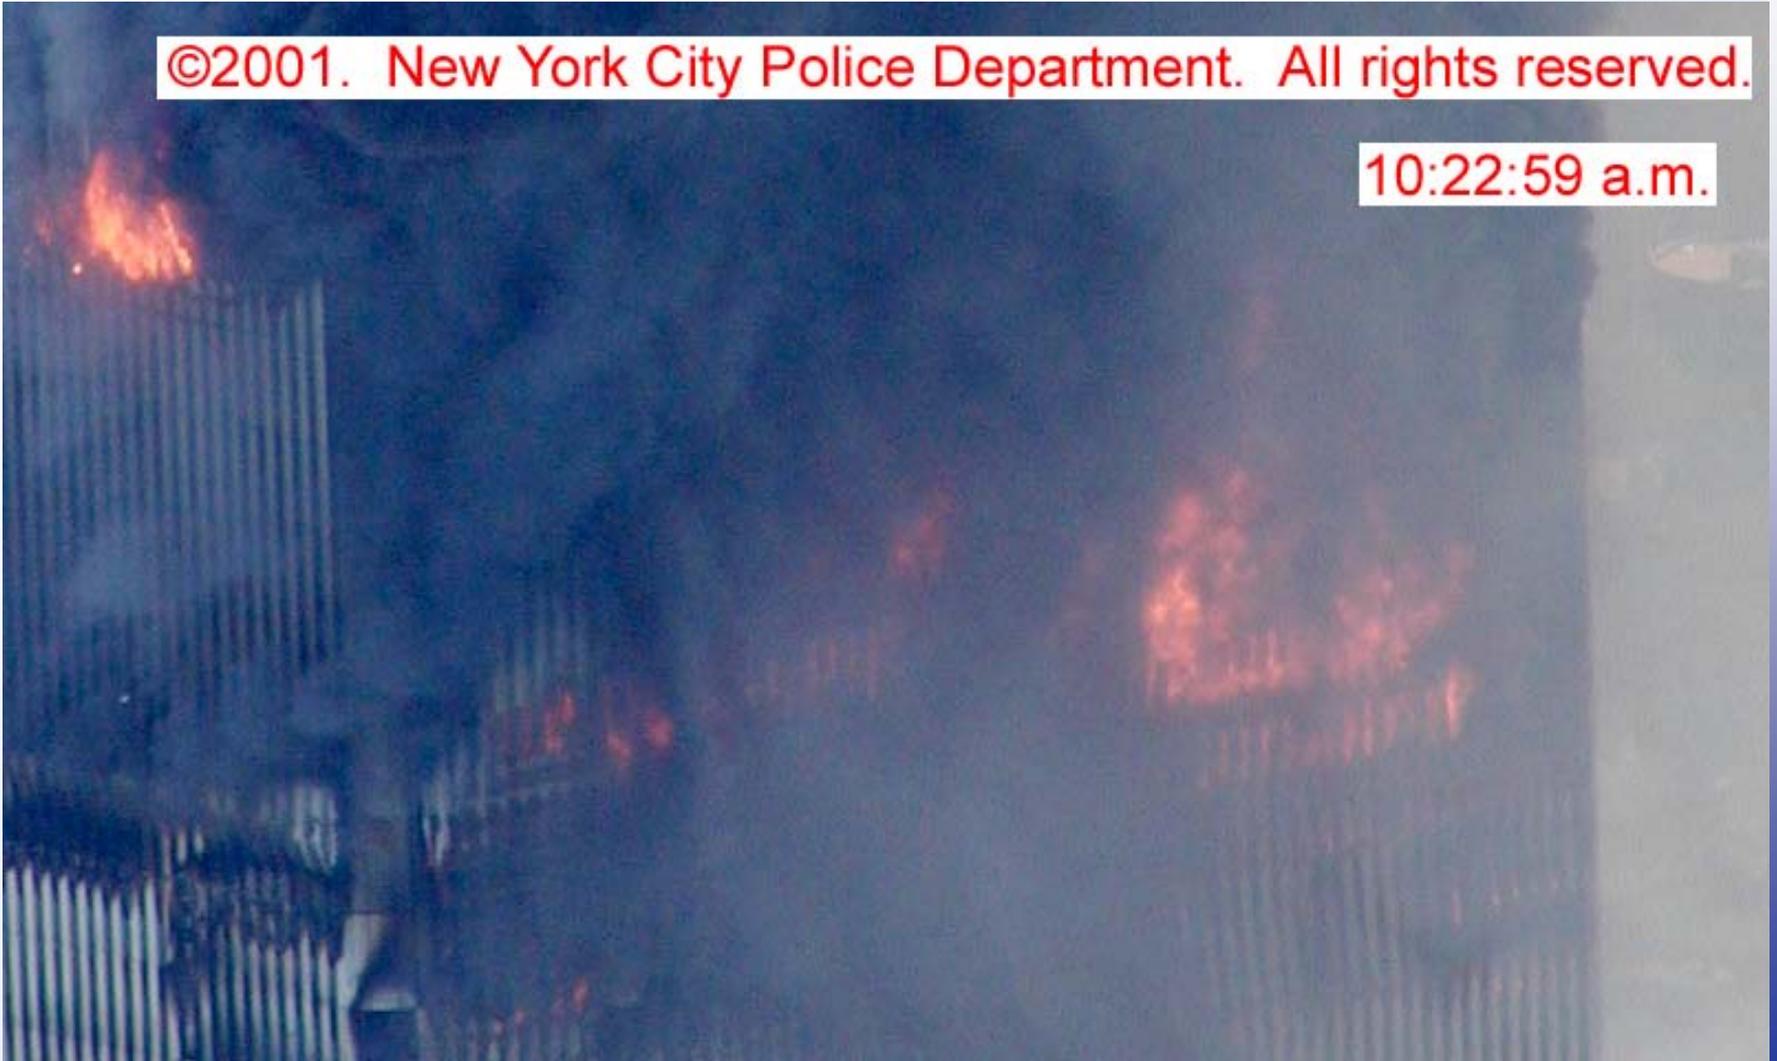
10:22:59 a.m.

Inward Bowing of Perimeter Columns Some Minutes Prior to Collapse: WTC 1 South Face

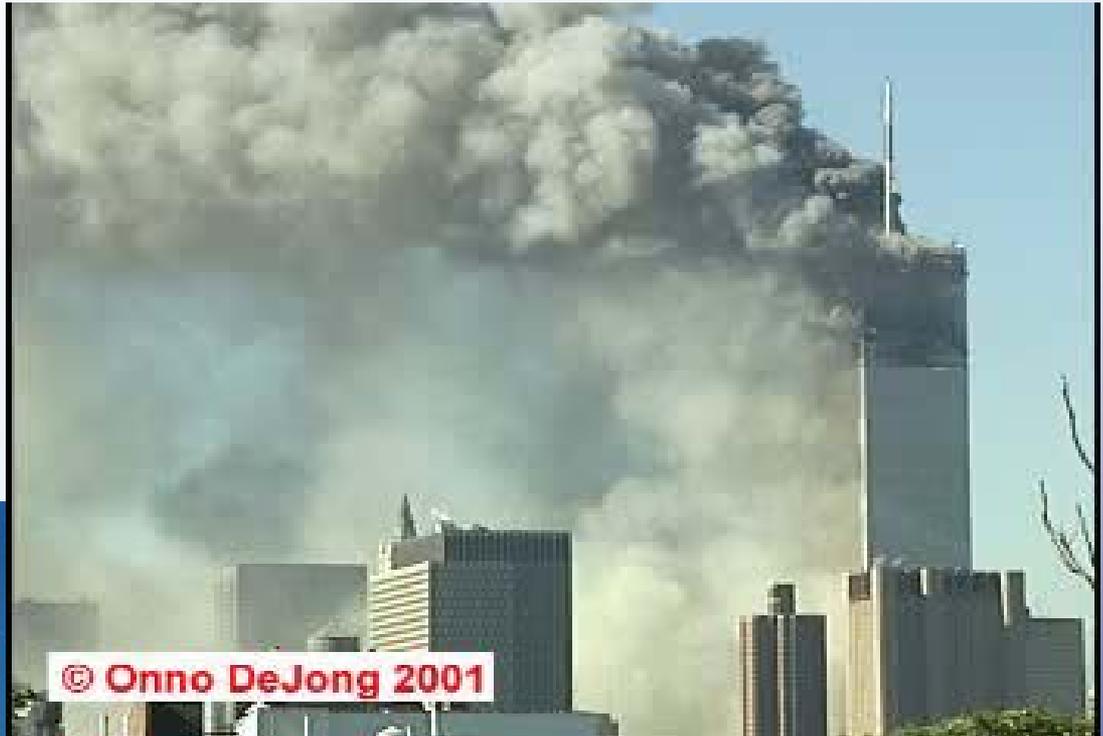
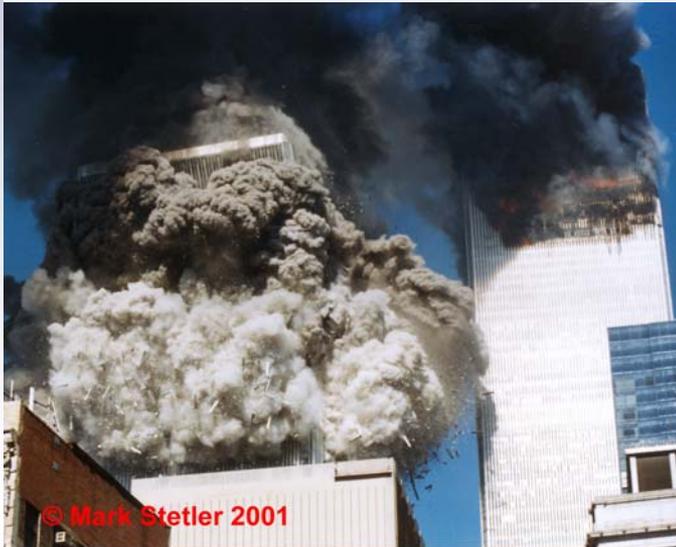
Initiation of global collapse was first observed by the tilting of building sections above the impact regions of both WTC towers.

WTC 1 tilted to the south; WTC 2 tilted to the east and south and twisted in a counterclockwise motion

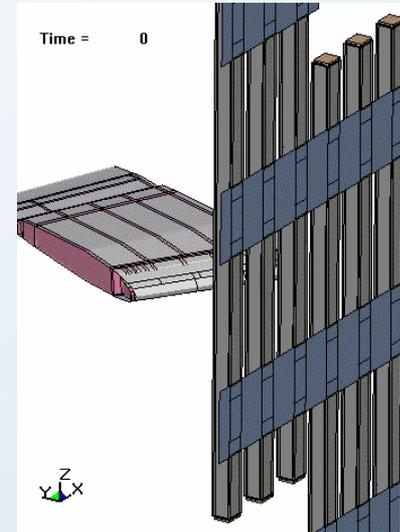
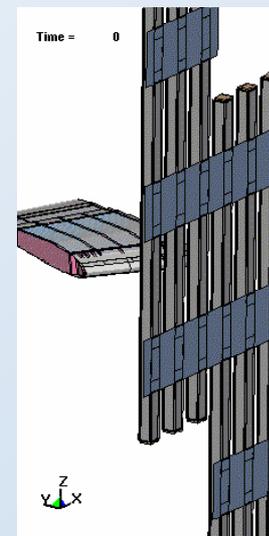
- The impact of the exterior wall by an empty wing segment produces significant damage to the perimeter columns, not necessarily complete failure.
- The impact of a fuel-filled wing section results in extensive damage to the exterior wall panel, including complete failure of the perimeter columns.

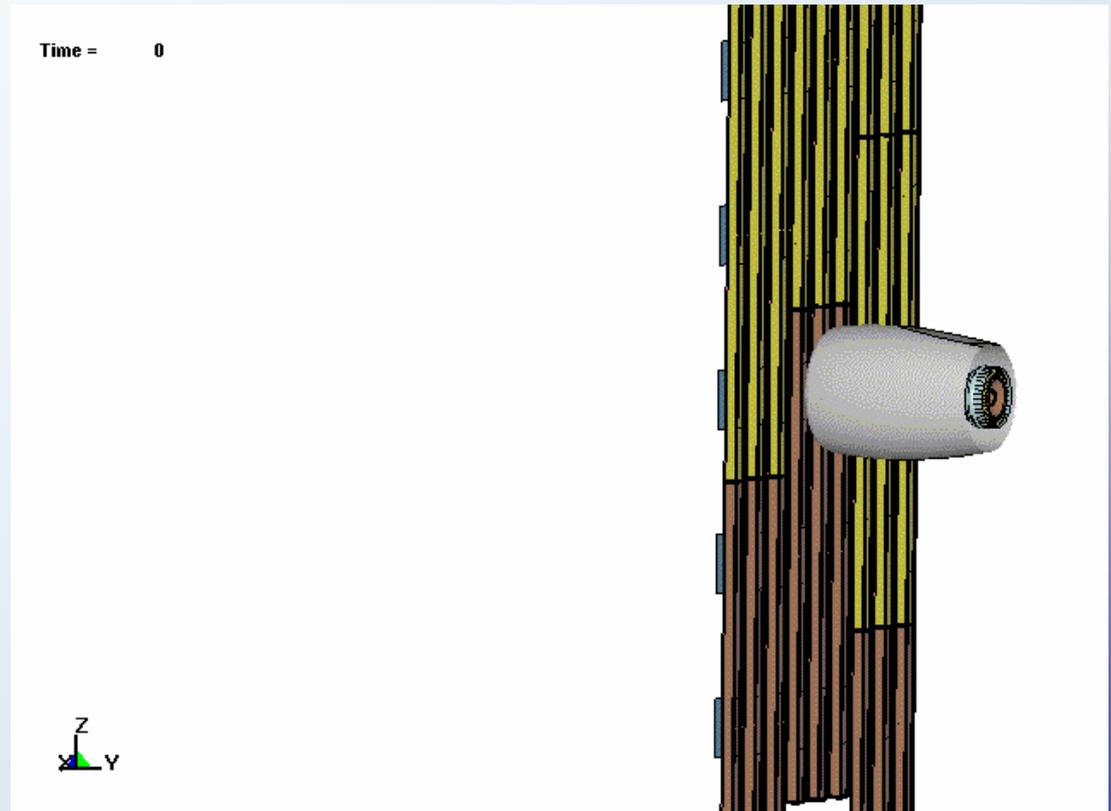
- ❑ Engine impact against an exterior wall panel results in a penetration of the exterior wall and failure of impacted perimeter columns.
- ❑ The residual velocity and mass of the engine after penetration is sufficient to fail a core column in the event of a direct impact

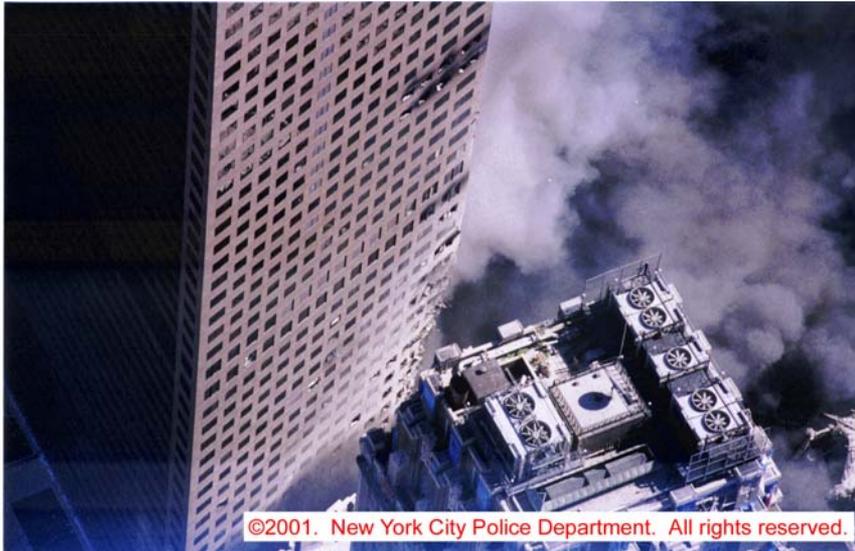
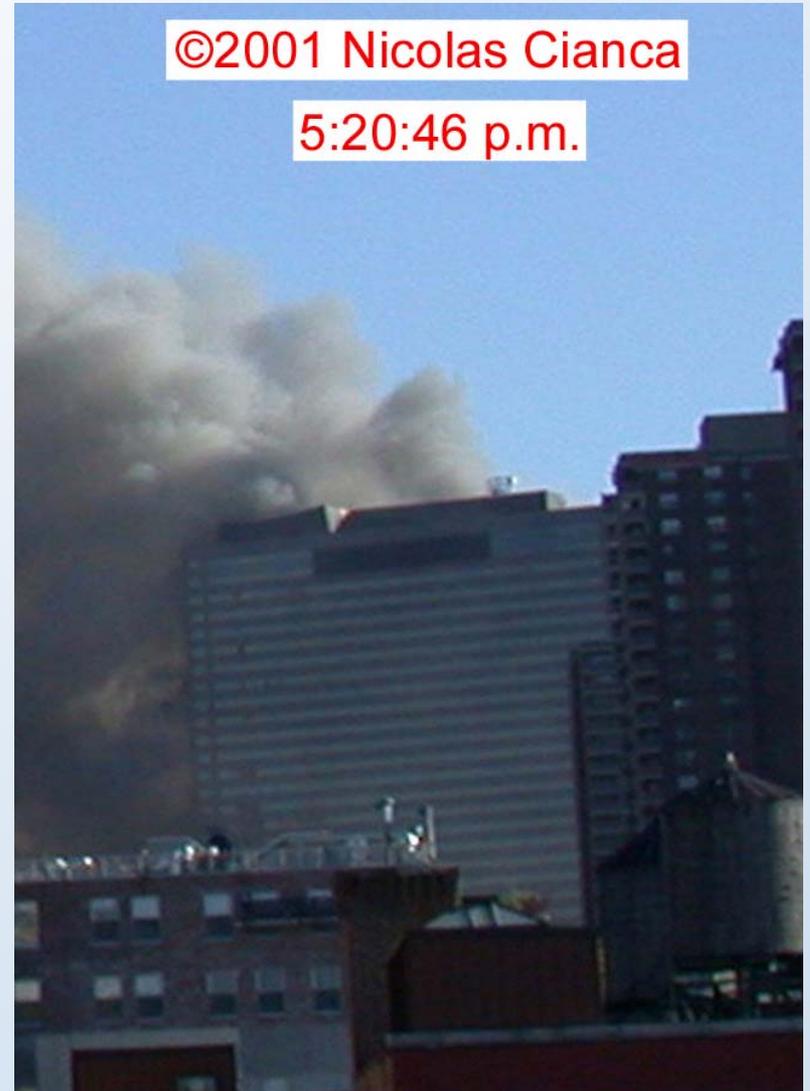
5:20:46 p.m.

- ❑ *The first exterior sign of structural failure in WTC 7 was the sinking of the east penthouse roof structure into the building.*
- ❑ *Witnesses reported structural damage to WTC 7 on its south face and southwest corner from WTC 1 debris.*

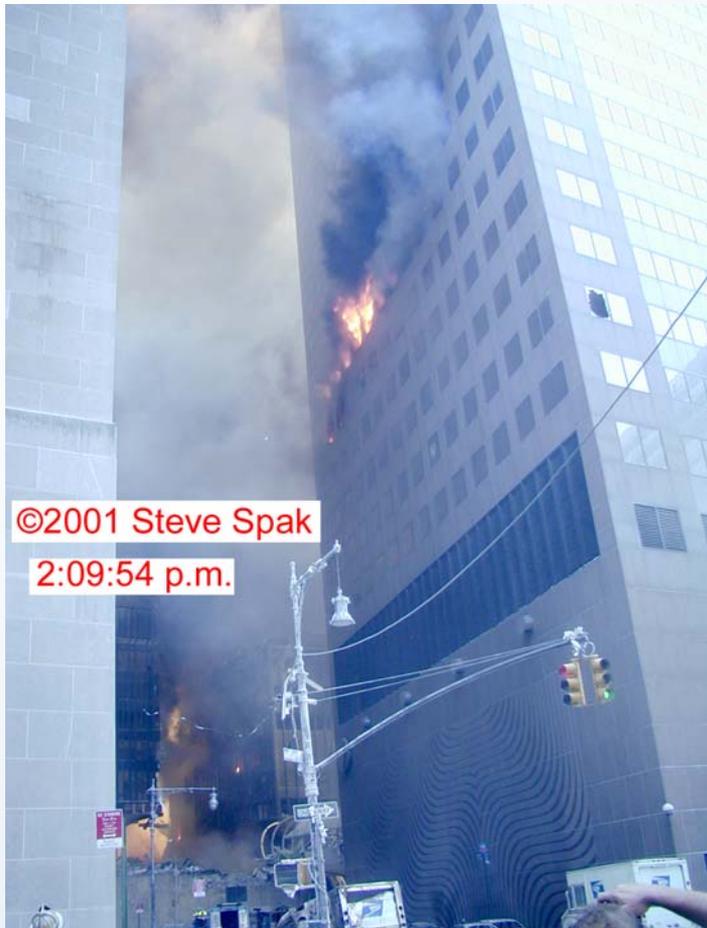
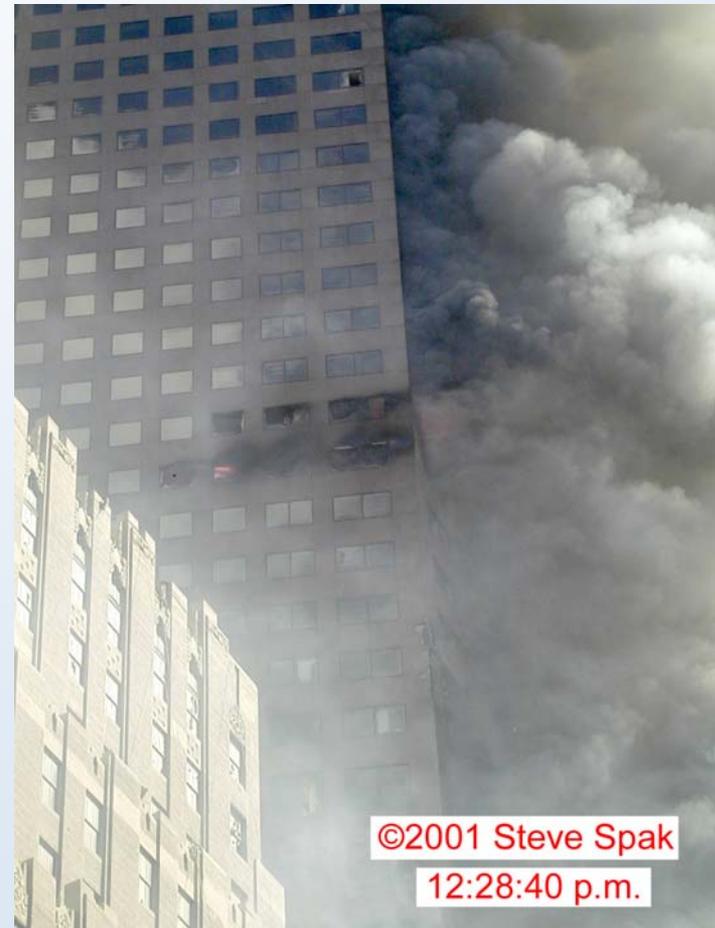
Fires in WTC 7—which began soon after WTC 1 collapsed—were observed on Floors 7, 8, 9, and 11 near the middle about half an hour before collapse; Floor 12 was burned out by this time. Fires were also seen on Floors 12, 13, 22, 29, and 30 at various times during the day.

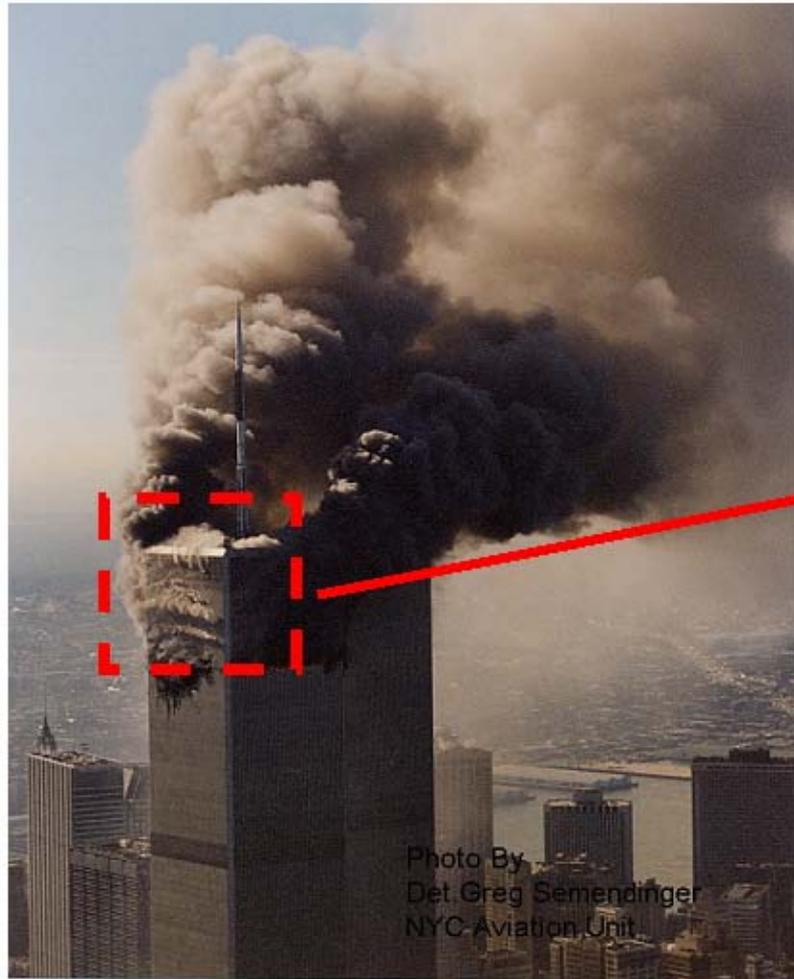
- Analysis indicates that **HVAC (heating, ventilation, and air-conditioning) ductwork was a major path for vertical smoke spread in the buildings.**
- Analysis indicates that **stair pressurization systems would have provided minimal resistance to the passage of smoke in WTC 1 and WTC 2 had they been installed on September 11, 2001.**

North Face – WTC 1
Smoke Exits NW Interior
Ventilation Zone Supply Inlet
