NIST Response to the World Trade Center Disaster

World Trade Center Investigation Status

October 19, 2004

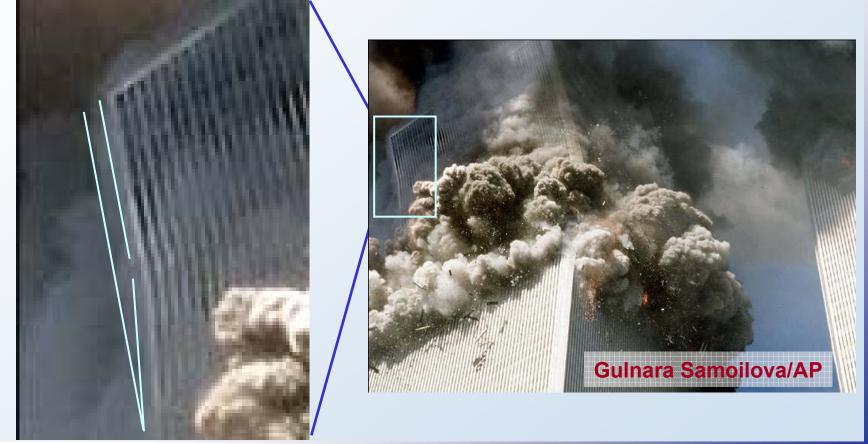
Kink Observed at 106th Floor of WTC 2

Likely associated with inward pulling by hat truss or rigid structure provided by beam-framed upper floors due to core column impact/fire damage.

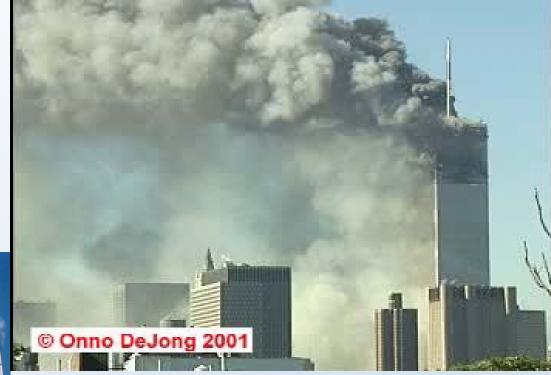
Tilting of Building Sections

Initiation of global collapse was first observed by the tilting of building sections above the impact regions of both WTC towers.

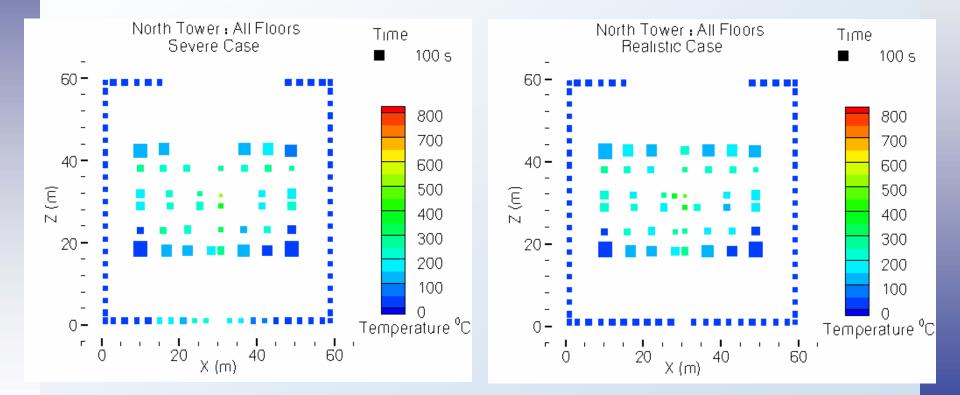
Severe Case

Realistic Case

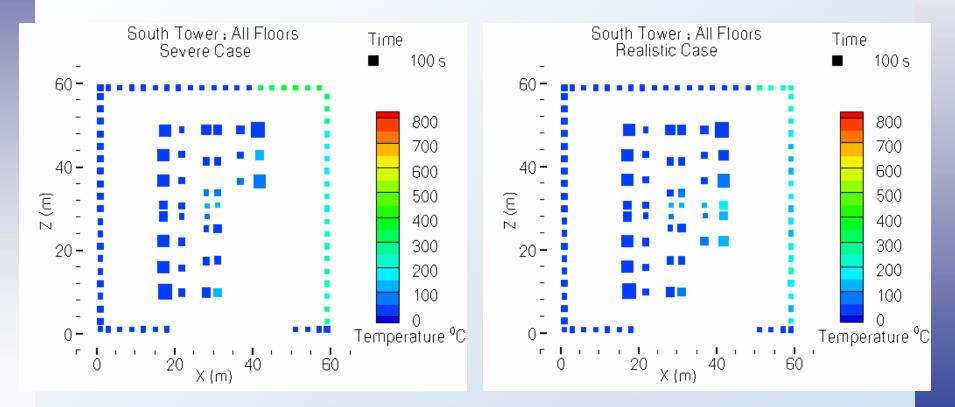
Results of Thermal Analysis for WTC 2

Severe Case

Realistic Case

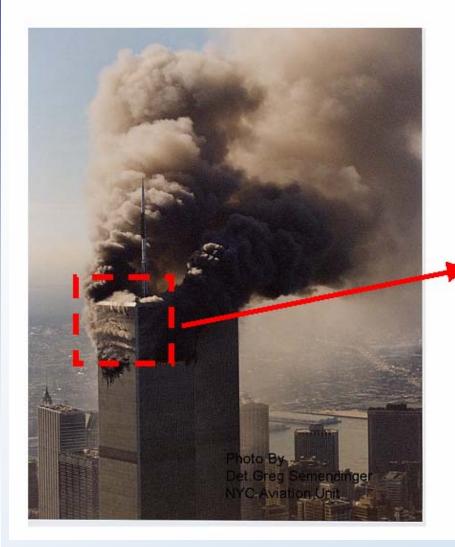
Example of Vertical Smoke Spread

- Analysis indicates that the disruption of the HVAC (heating, ventilation, and air-conditioning) system, particularly the aircraft impact rupture of large return air shafts and related ductwork created a major path for vertical smoke spread in the buildings.

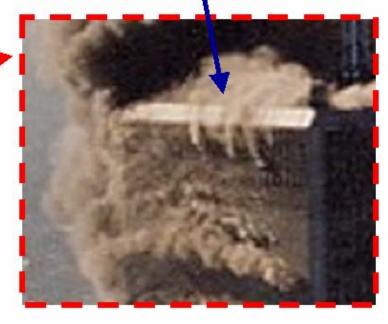
North Face – WTC 1

Smoke Exits NW Interior Ventilation Zone Supply Inlet
