December 10, 2013
NCST Advisory
Committee Meeting

Technical Investigation of the May 22, 2011, Tornado in Joplin, MO

Performance of Buildings, Designated Safe Areas and Lifelines

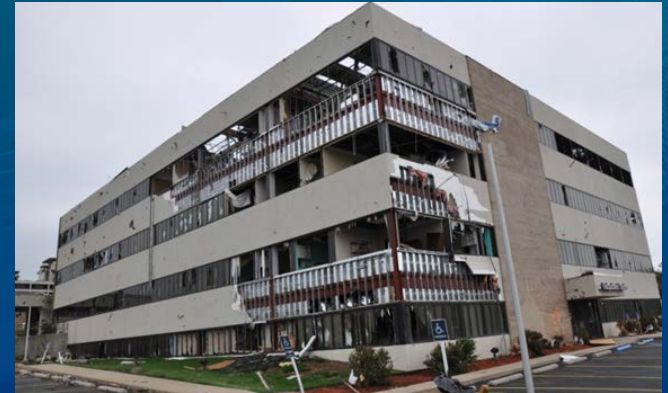
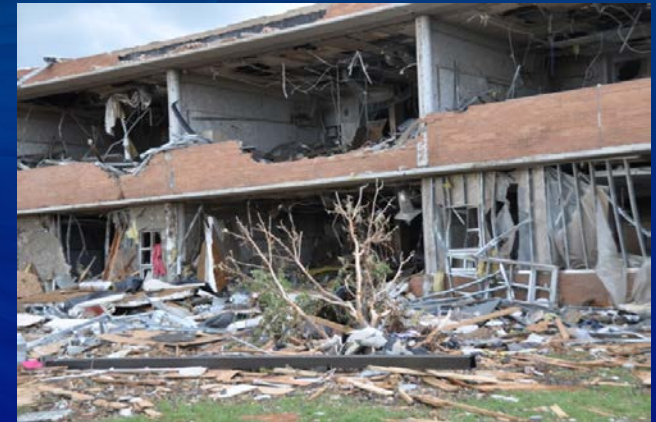
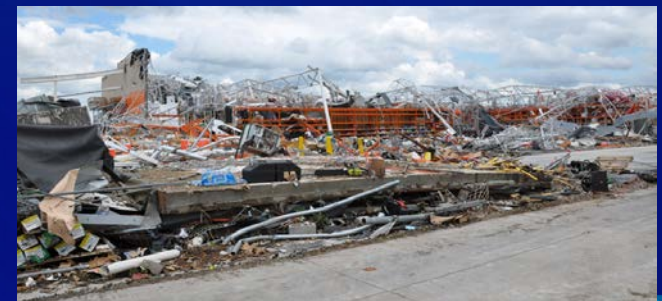
- F10: Engineered buildings that:
 - Had redundant lateral load capacity or that did not depend on roof bracing (steel and concrete moment frames) withstood the tornado without collapse.
 - Had reinforced concrete or composite concrete-steel roof also withstood the tornado without collapse.
 - Relied on bracing from a less robust roof system (such as box-type system (BTS) buildings with light steel roof decks) were prone to structural collapse.

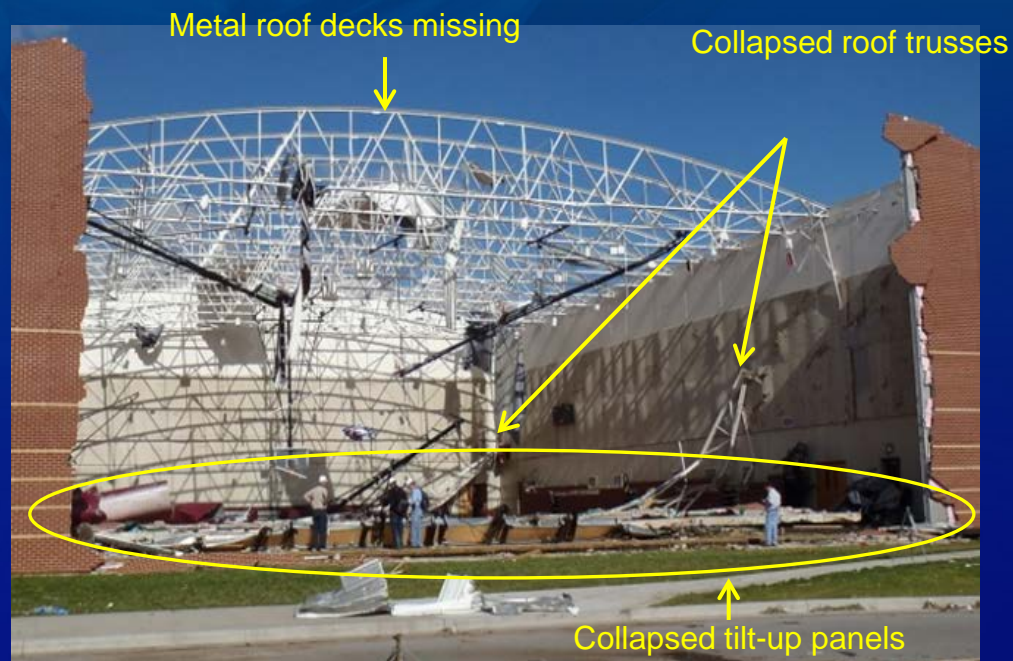
- **F11:** Collapses of BTS buildings typically began with failure of the roof system due to wind uplift (failure of roof *deck-to-joist* or *joist-to-wall* connections), which led to the loss of lateral bracing for perimeter walls, causing them to collapse by rotation at the base due to lateral load.

Available design information showed that the roof connections of these buildings were adequate for code-level design wind pressures, making it unlikely that these buildings could have failed in wind speeds under 115–120 mph, which are the current code-level design wind speeds.

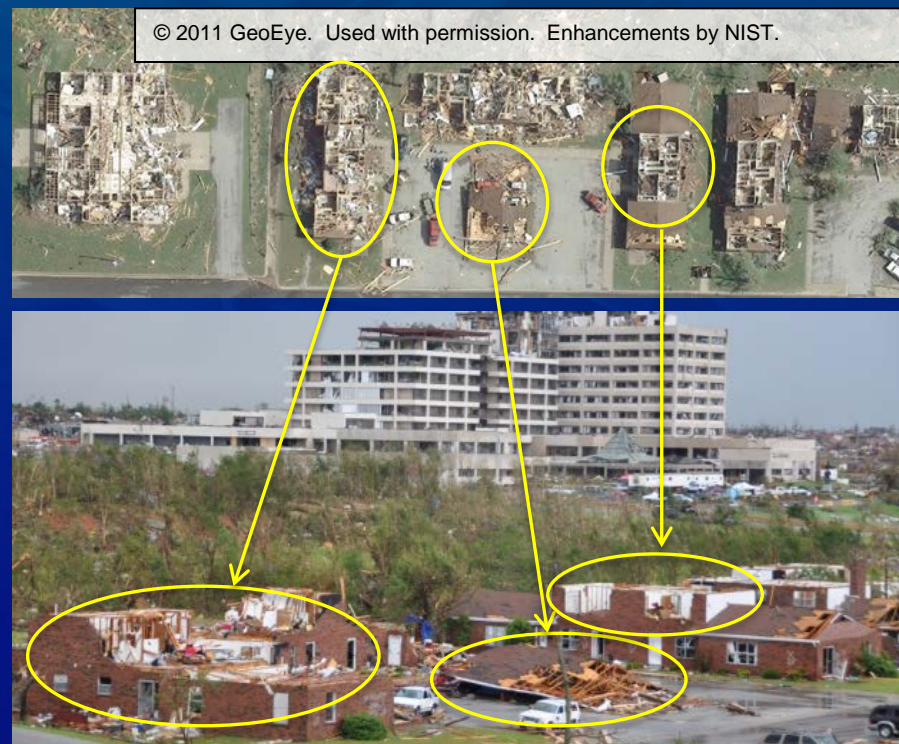
- **F14:** Failures of residential wood-frame buildings predominantly involved failure of the connections between structural components (roof from walls and walls from foundation). This indicates lack of robustness in the connections and in the continuity of the vertical load path from roof to foundation.
- **F15:** Better structural performance in one of the NIST-surveyed multi-family residential buildings can be attributed to use of robust hurricane connectors, typically only required for residential wood-frame buildings in hurricane-prone regions.

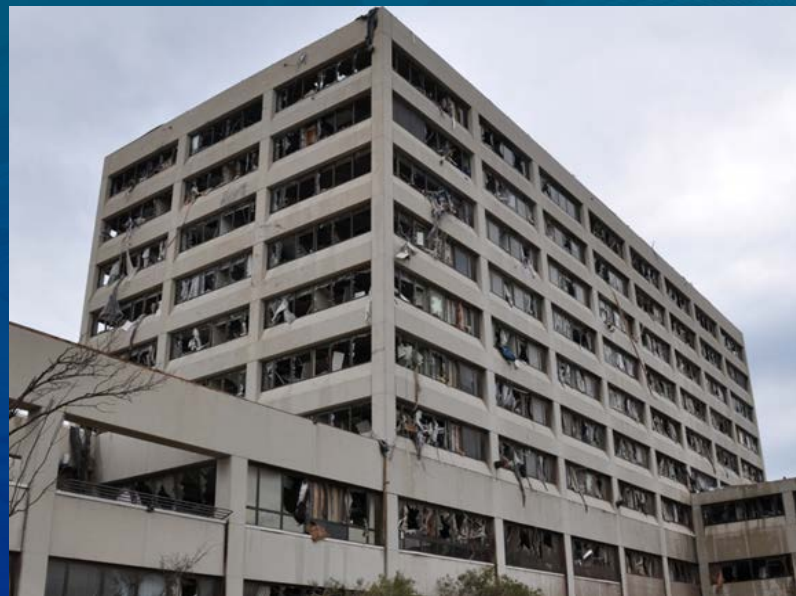
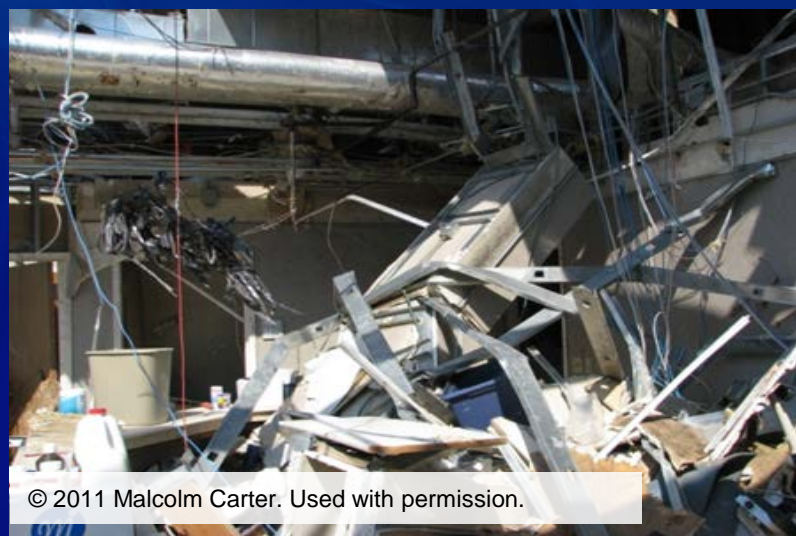
- **F16:** All NIST–surveyed engineered buildings that did not collapse, as well as engineered buildings that collapsed, sustained significant damage to the envelopes and interiors due to the combination of wind pressure, impacts by wind–borne debris, and water intrusion.
- **F17:** The failure of building envelopes at SJRMC, which led to loss of protection and subsequent extensive damage to building interiors, was the primary cause for the complete loss of functionality of this critical facility despite the robust structural system that withstood the tornado without structural collapse.

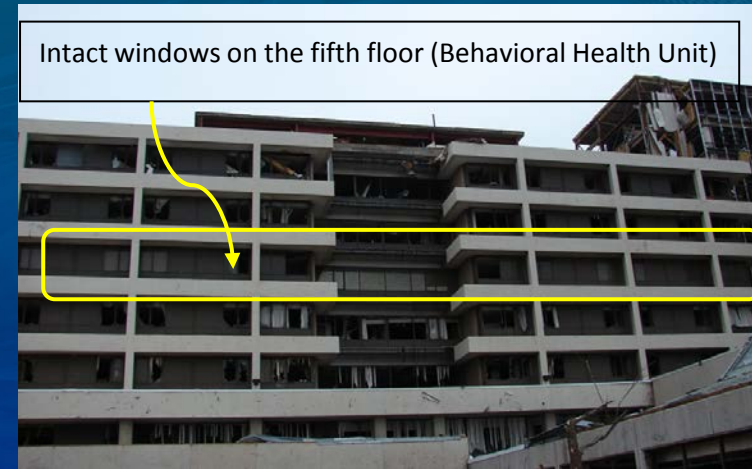
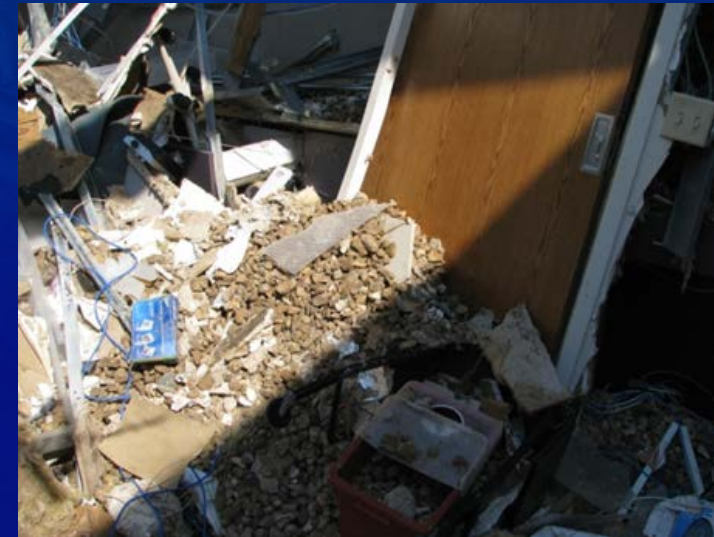
- **F18:** The majority of the impact-resistant windows on the fifth floor (Behavioral Health Unit) of the West Tower of SJRMC remained intact, whereas most regular dual-pane insulated windows at SJRMC were broken when exposed to the same tornado hazards.
- **F19:** While there was no direct evidence that roof aggregate contributed to any injuries or fatalities in Joplin, there was evidence that roof aggregates contributed to envelope damage in SJRMC buildings and surrounding structures, thus adding to the tornado debris hazard and the potential for injuries or fatalities.

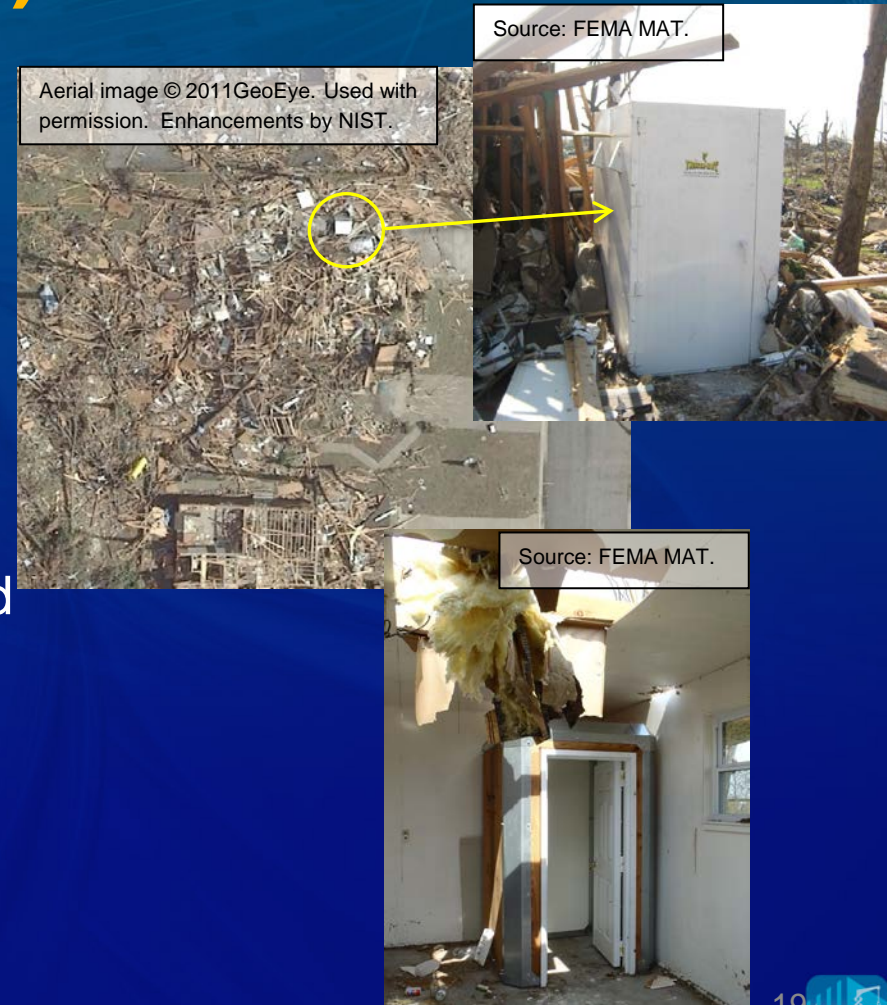
- **F22:** Currently there are optional model code provisions for the design of specially purposed shelters, but such shelters are not required.
- **F23:** Based on a few instances observed in this tornado, in-home shelters did perform well and provided life–safety protection to the home occupants. NIST found no statistics on how many of the 7,411 damaged residential structures had in-home tornado shelters.
