Collapse of the Dallas Cowboys Indoor Practice Facility, May 2, 2009

**Building and Fire Research Laboratory
National Institute of Standards and Technology**

January 2010

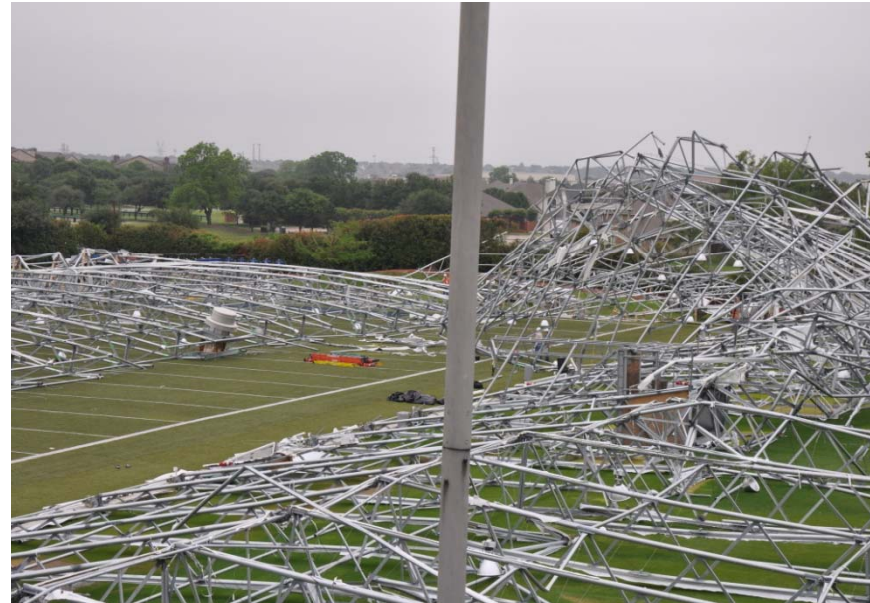
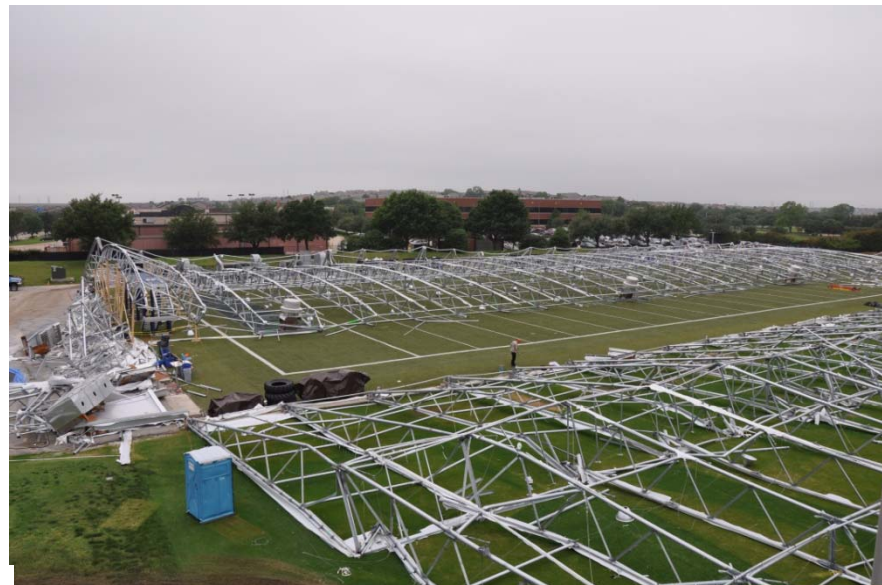
- Dallas Cowboys practice facility collapsed May 2, 2009 during a severe thunderstorm.
- Approximately 70 persons were in the facility at time of collapse.
- Twelve persons were injured, one seriously.
- Reason for collapse was not known.
- Unique opportunity to obtain valuable insight and data on: (1) performance of a full-scale structure during a wind event, and (2) adequacy of building codes, standards, and practices
- Many structures of this type are currently in use, including: sports facilities, industrial and agricultural facilities, casinos, storage facilities, military installations, aircraft hangers, etc.

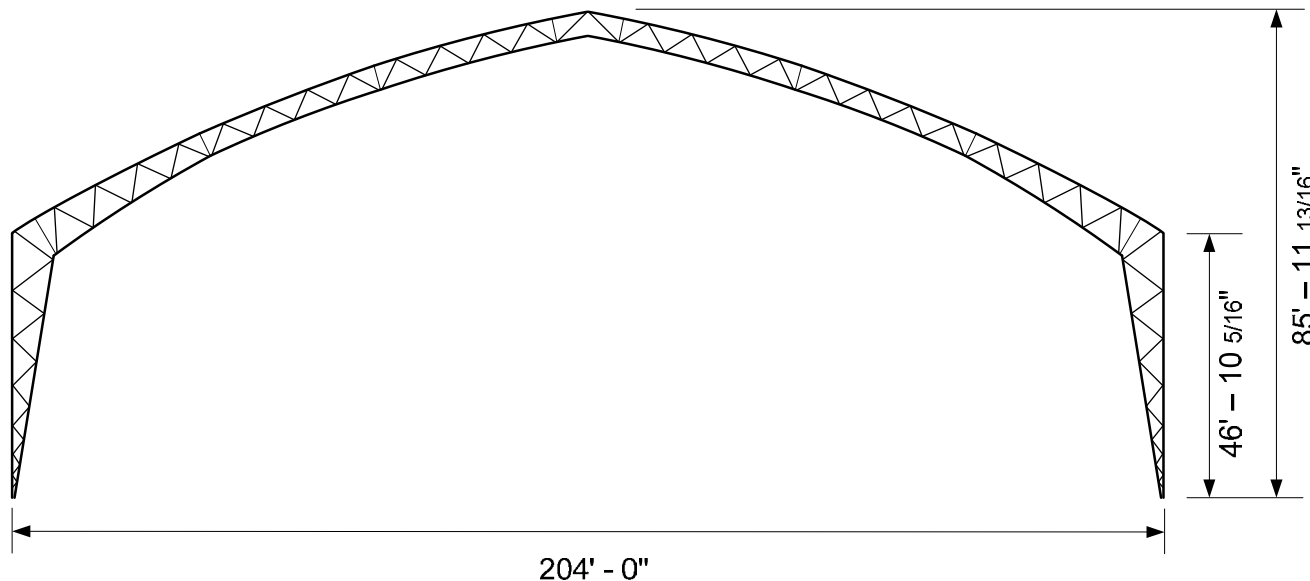
Dallas Cowboys Practice Facility

- Gable-roof, steel frame structure with tensioned fabric covering
- 204 ft x 406 ft in plan
- 86 ft high at ridge
- Designed and constructed in 2003
- Upgraded in 2008 (new roof and reinforcement added to some members)

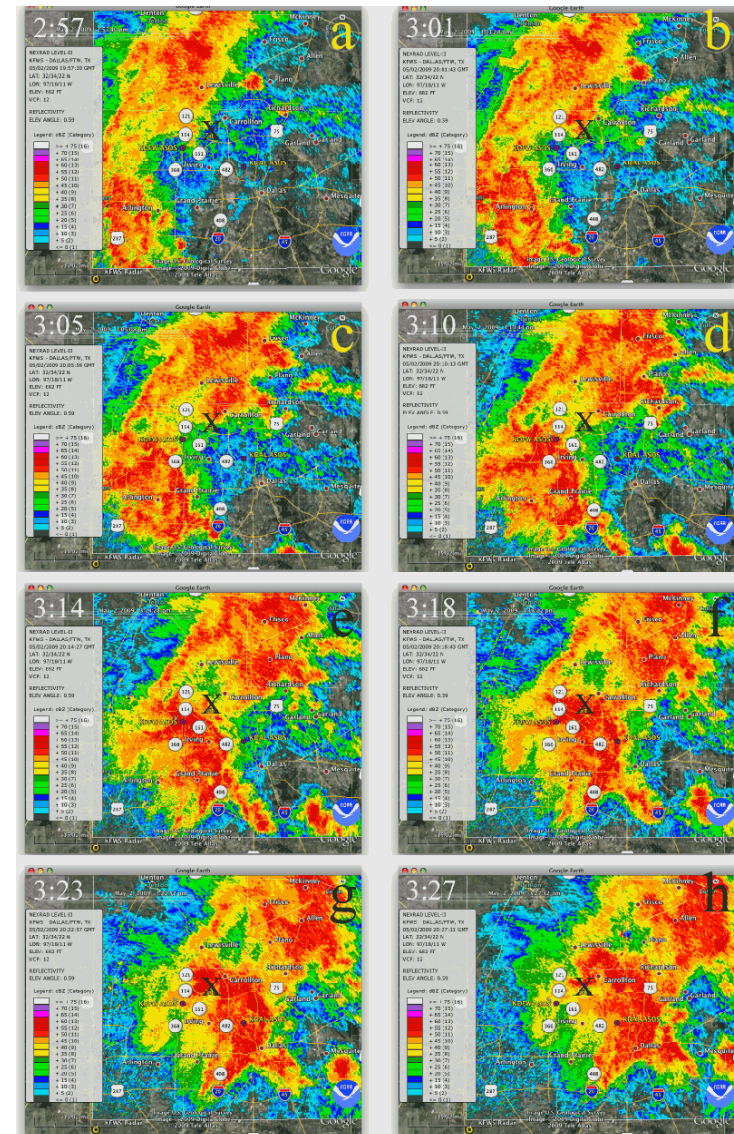
Wind Environment on May 2, 2009

- Obtained and reviewed data from:
 - May 2, 2009 Public Information Statement (NWS)
 - Survey of wind damage to trees on Dallas Cowboys Complex (NIST)
 - Observations of wind damage in neighboring areas (City of Irving)
 - Automated Surface Observing System data (NOAA)
 - Terminal Doppler Weather Radar data (NOAA)
- NIST worked with NOAA's National Severe Storms Laboratory to estimate the wind conditions at time of collapse
- **Summary:**
 - Wind was predominantly westerly
 - Maximum wind speed gusts at time of collapse were estimated to be 55 mph to 65 mph
 - The stagnation point (center of microburst) was located about 1 mile southwest of collapse site at time of collapse.

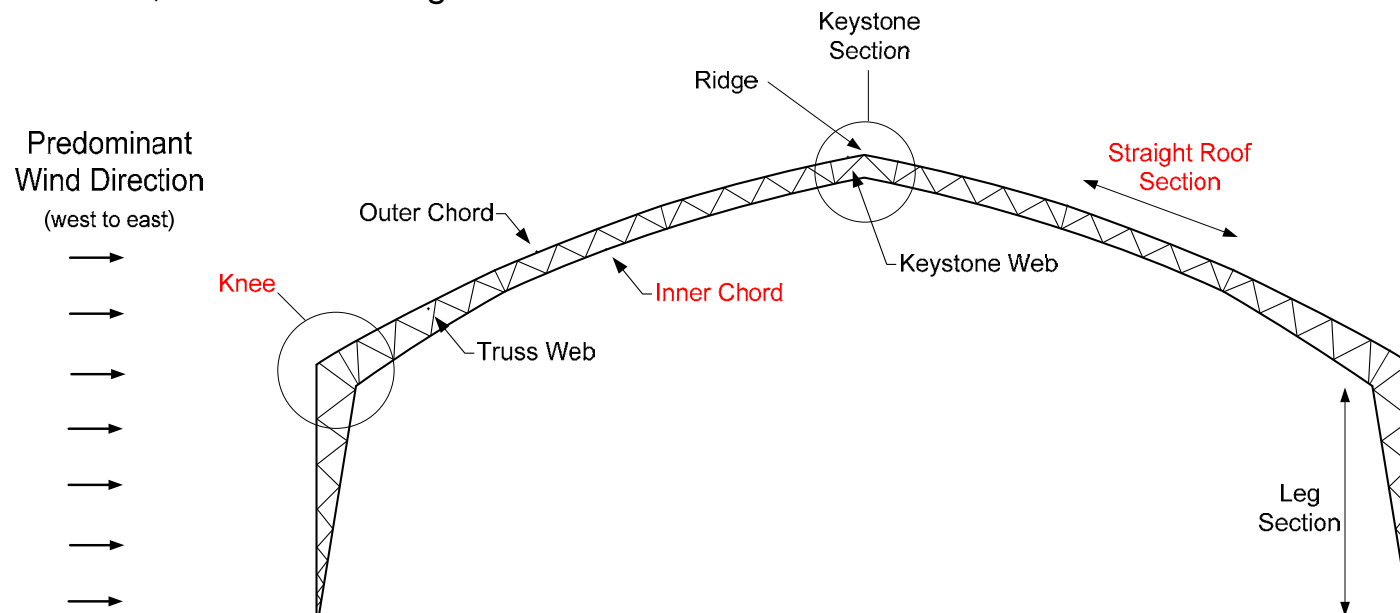
- **Wind speed at time and location of collapse** (55 mph to 65 mph) was **well below the 90 mph design wind speed** specified by the ASCE 7-98 and ASCE 7-05 Standards for that location.
- At wind loads corresponding to the 90 mph design wind speed, **demands significantly exceeded capacities** (design demand-capacity ratio as high as 6.0), especially for frame members around the knees and in the straight sections of the roof.
- At wind loads corresponding to 60 mph wind speed normal to the ridge (consistent with the wind environment on May 2, 2009), **demands exceeded capacities** (nominal unfactored demand-capacity ratio as high as 2.0), especially for inner chord members on the east (leeward) side of the frame, both in the straight section of the roof and around the knee.

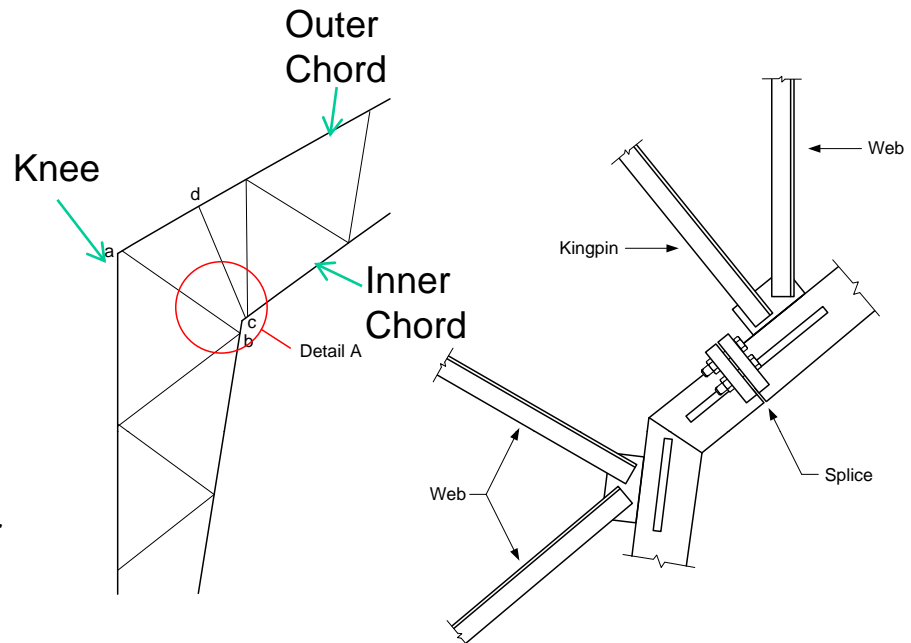
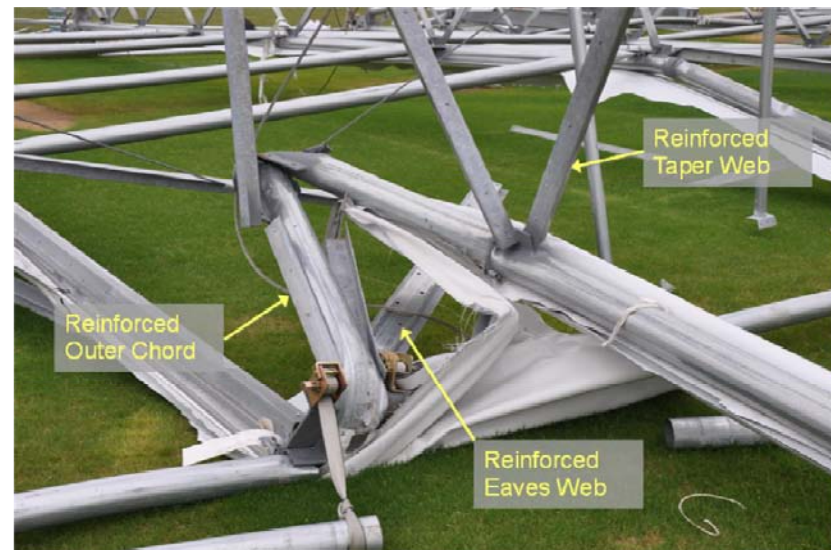
- Wind loads used for both the original 2003 design and the 2008 upgrade differed from wind loads calculated based on the provisions of both the ASCE 7-98 and ASCE 7-05 Standards, producing significantly lower design demands **by a factor of up to 3.9**.
- Frame member capacities reported in the original 2003 design were considerably larger than the capacities calculated by NIST based on the AISC specifications **by a factor of up to 3.0**.
- Details of joints, particularly at the knees of the frames, produced large bending moments and shear forces in the chords of the frame that were not considered in the design (increasing demand-capacity ratios **by a factor of up to 2.3**).
- Reinforcements added in 2008 had a minimal effect as they affected only the compressive capacity of selected members; the most critical members were not reinforced.

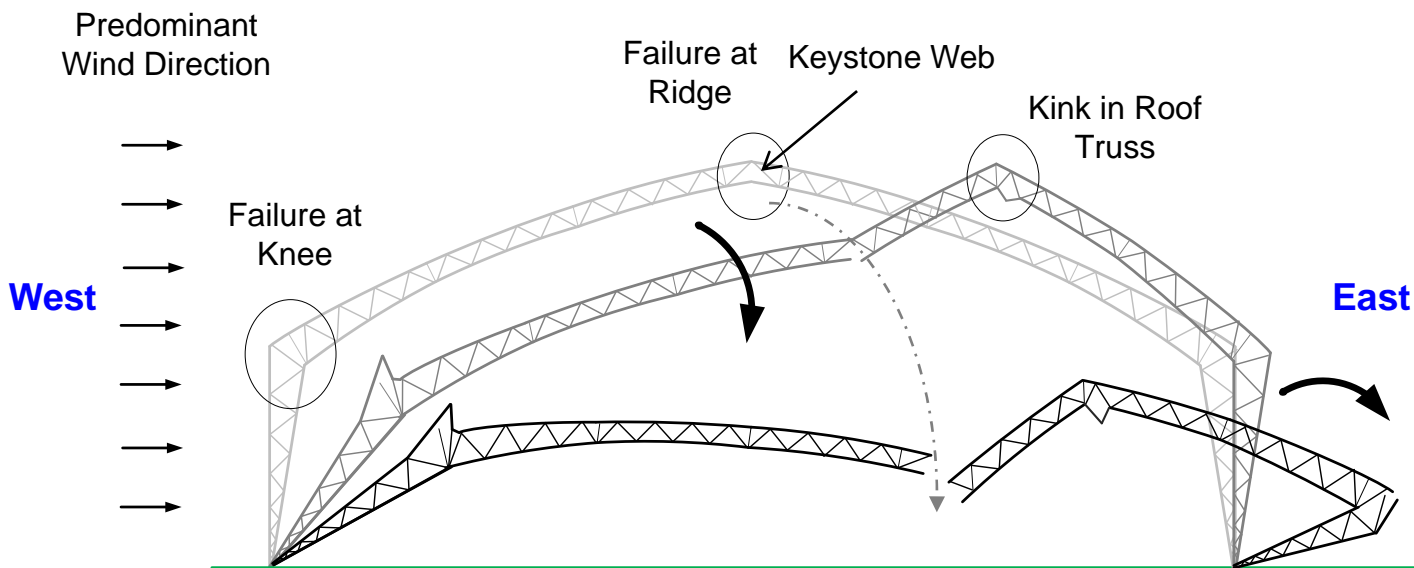
- Buckling of the inner chord in the straight section of the roof on the east side resulted in formation of a kink in the frame at this location (see photographs on next slide)
- Failures at the east and west knees allowed the frame to sway eastward (in the direction of the wind)
- Compressive failure of the east keystone web led to tensile fracture of the inner and outer keystone chords at the ridge
- Spread of individual frame failures in similar patterns, through load redistribution and loss of lateral bracing, resulted in total collapse of the practice facility

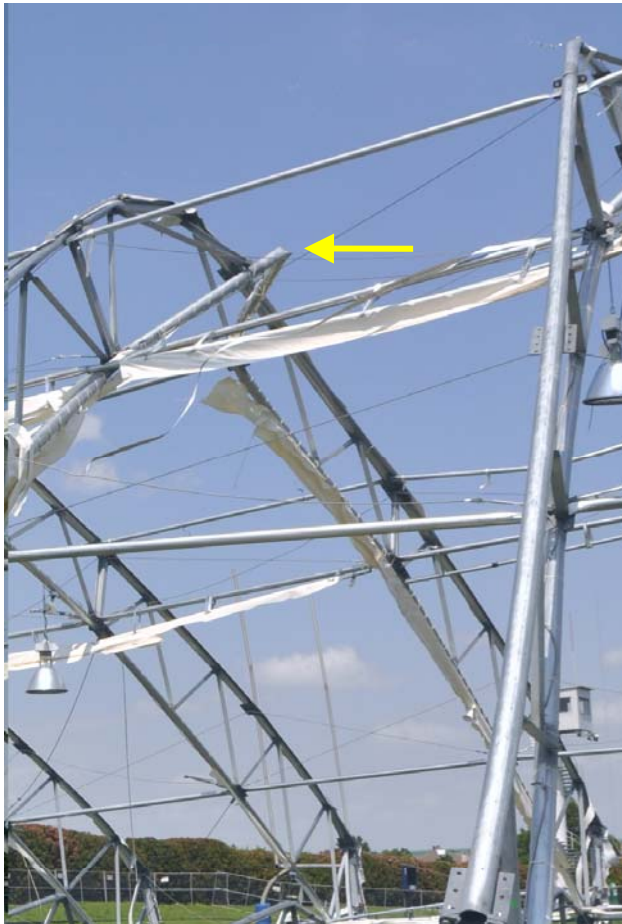
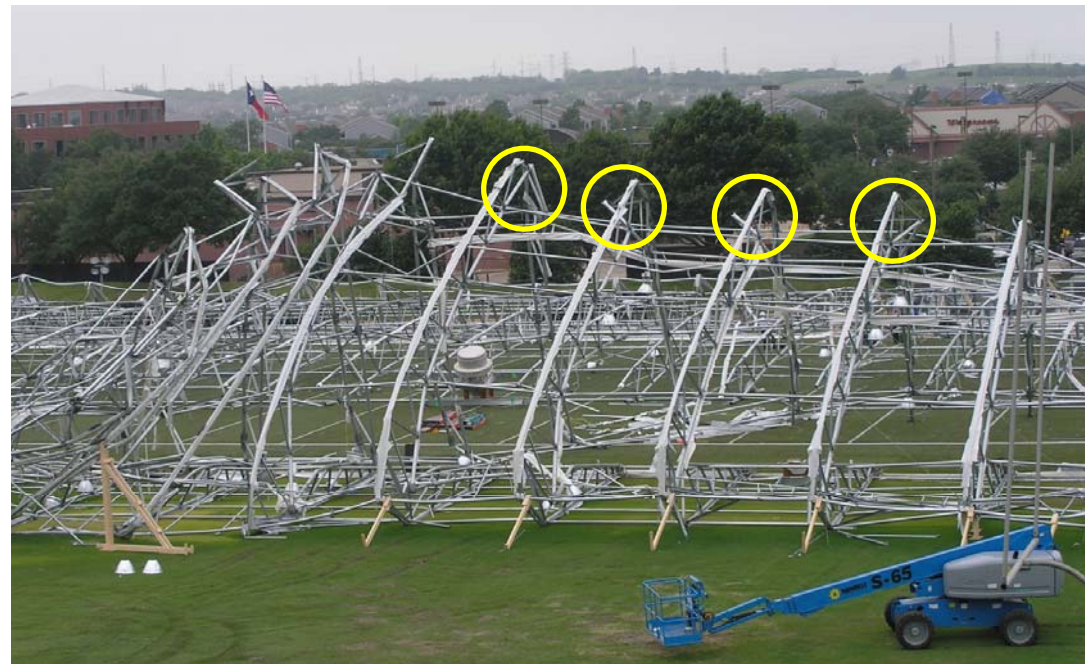
Likely Collapse Initiation Buckling of inner chords in straight sections of the roof on the east side

- **NIST recommends that fabric-covered frame structures be evaluated to ensure the adequate performance of the structural framing system under design wind loads. Of particular concern are (1) the use of the fabric covering to provide lateral bracing for structural frames, (2) determination of the appropriate enclosure classification in the calculation of internal pressures for design wind loads, and (3) the ability of the structural system, including the lateral bracing, to maintain overall structural integrity.**
