**U.S. Federal Building and Fire Safety Investigation  
of the  
World Trade Center Disaster**

**4<sup>th</sup> Annual Congress on  
Infrastructure Security for the Built Environment**

**October 19, 2005**

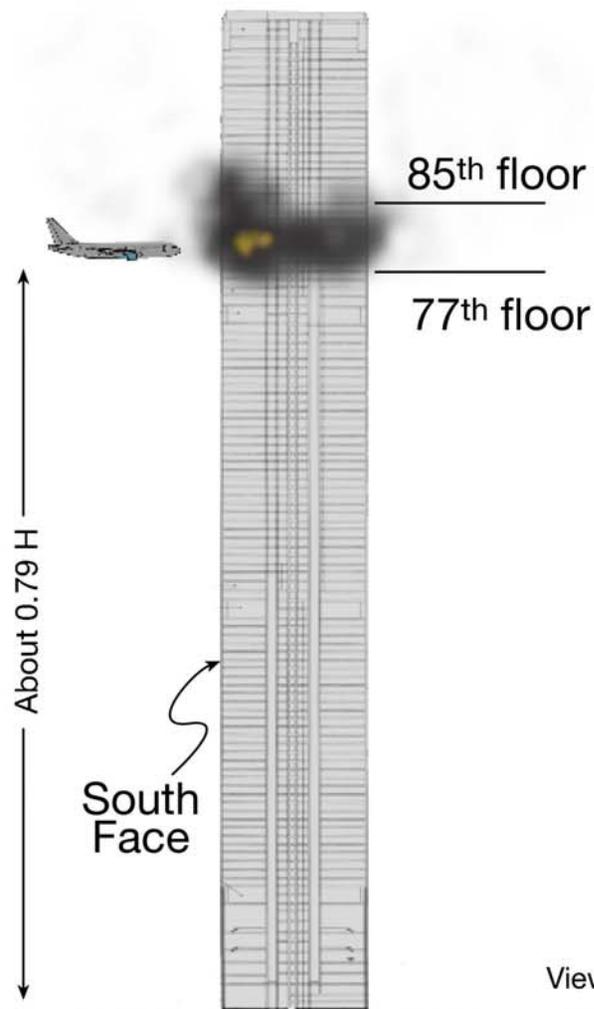
**WTC 2:** Hit at 9:02:59 a.m.  
Collapsed after 56 minutes

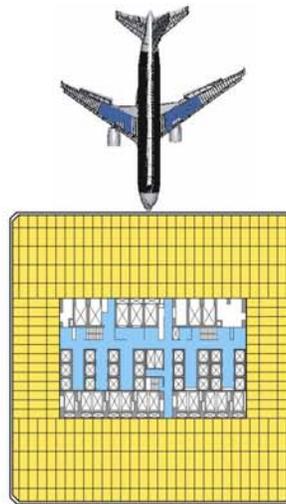
WTC 1

**Point of impact:**  
Close to the center  
and nearly normal  
to the building

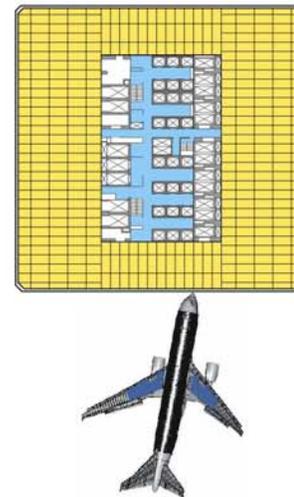
WTC 2

**Point of impact:**  
Close to the corner  
and with an angle

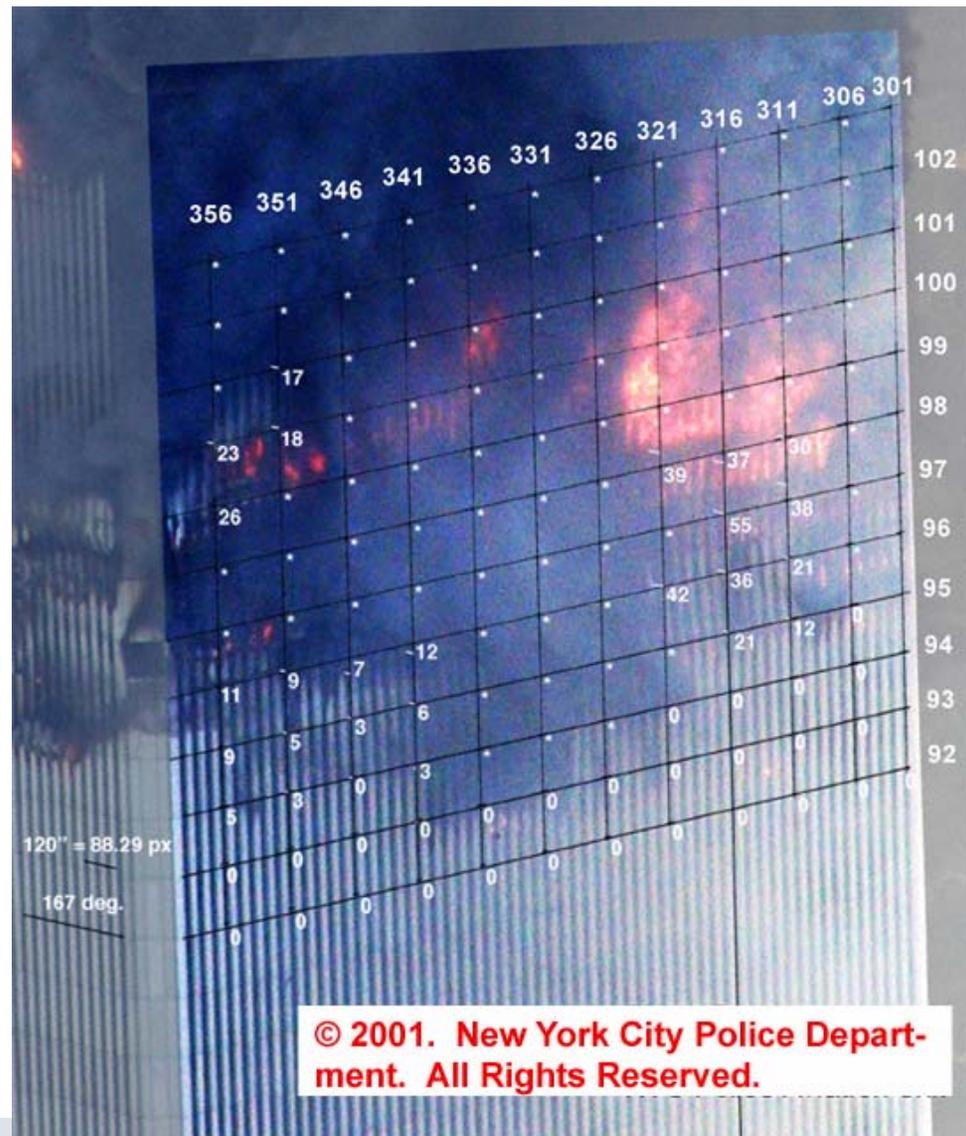
# South Face of WTC1

- Time: 10:22 AM
- Measurements of inward bowing (inches)
- **Maximum = 55 inches**  
(uncertainty ~ +/- 6 inches)

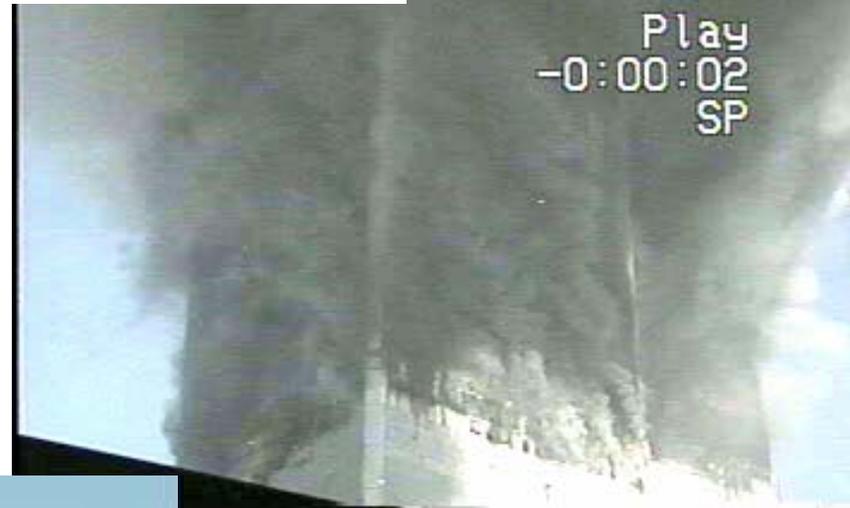
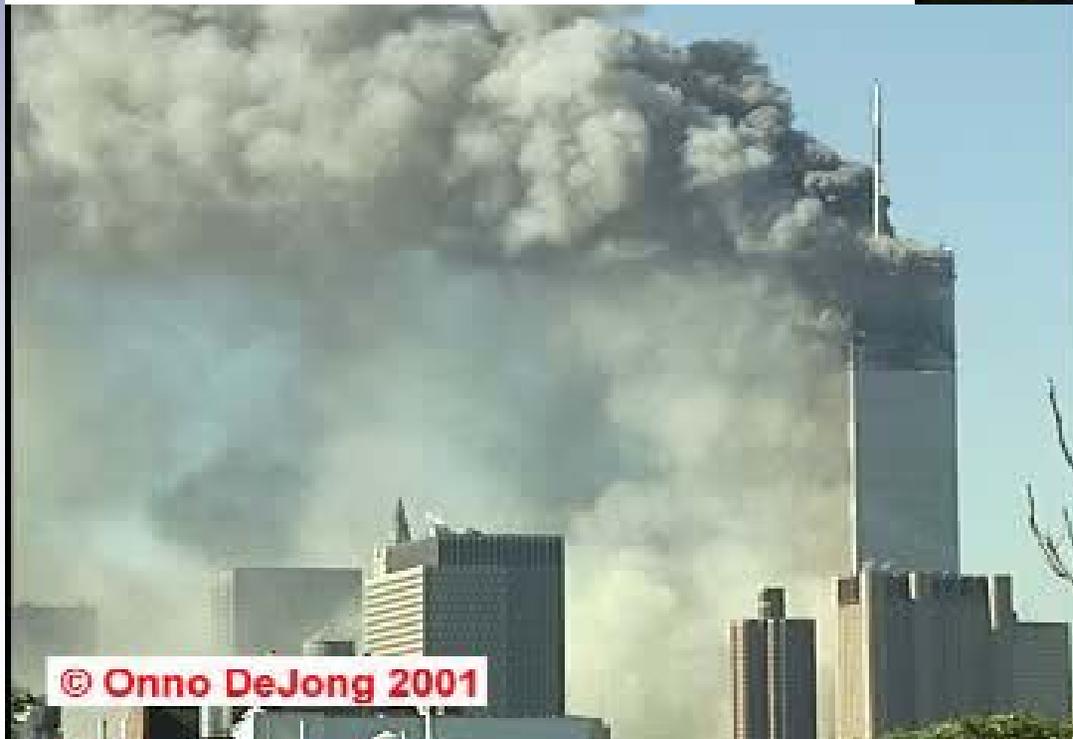
# Tilting of Building Sections

WTC 1 tilted to the south; WTC 2 tilted to the east and south.

*Initiation of global collapse was first observed by the tilting of building sections above the impact regions of both WTC towers.*

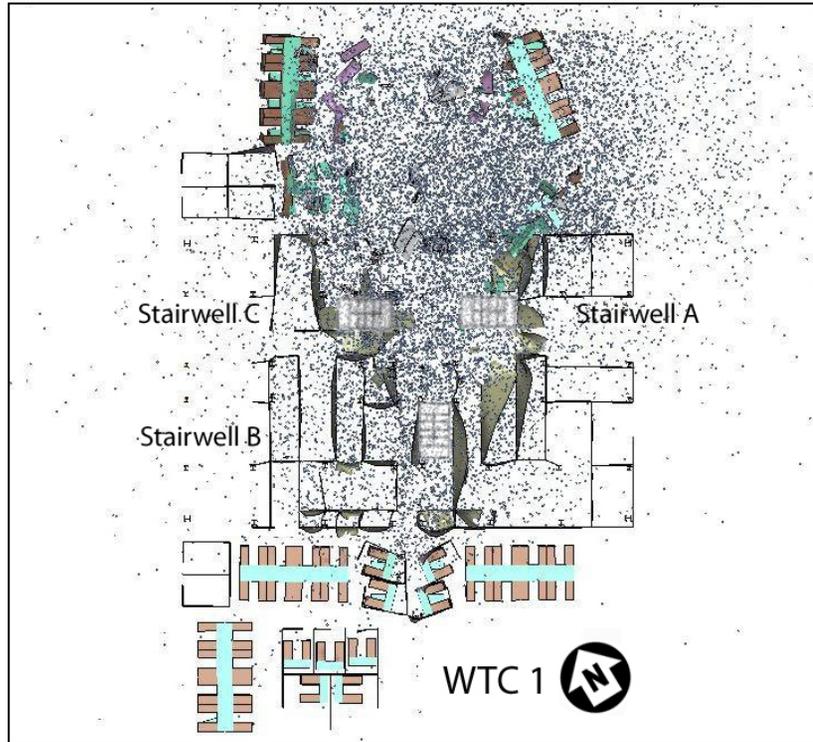
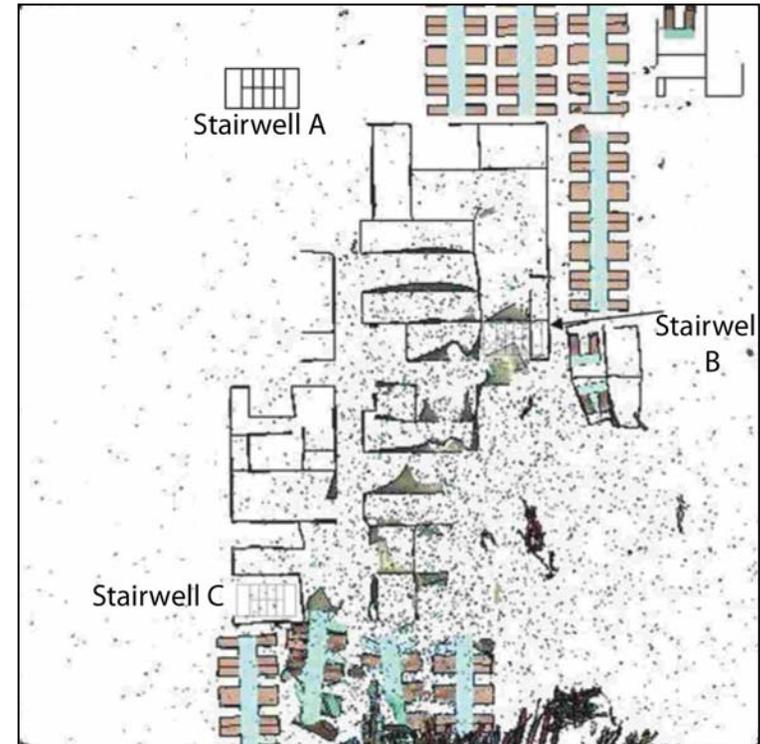
# Condition of Stairwells

- The stairwells, with partition wall enclosures that provided a 2 h fire-rating but little structural integrity, were damaged in the region of the aircraft impacted floors.
- **One of the stairwells in WTC 2 (Stairwell A on the Northwest side) was passable in the region of aircraft impact for some period of time after WTC 2 was attacked.**
- All three stairwells in WTC 1 and the two other stairwells in WTC 2 were rendered impassable in the region of aircraft impact.
