NIST Ionizing Radiation Safety Committee Initial Report of Plutonium Contamination at NIST Boulder

July 30, 2008

IRSC Initial Report of Plutonium Contamination at NIST Boulder

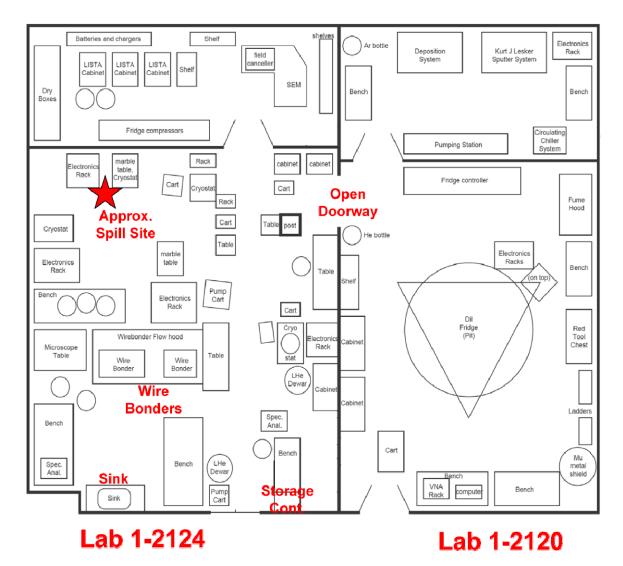
Figure 3. Plan view of the lab where the spill occurred and the connected labs that were isolated due to the incident.

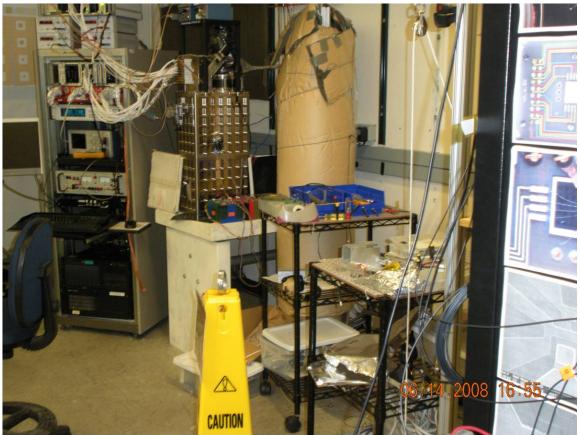
Figure A1. Laboratory 2124 showing the contaminated detector area. The detector is the rectangular device on the white bench in the left-center of the picture. The control computer is located in the electronics rack shown in the left side of the picture. The source position is located between the detector and the electronics rack and is not visible in this photograph.

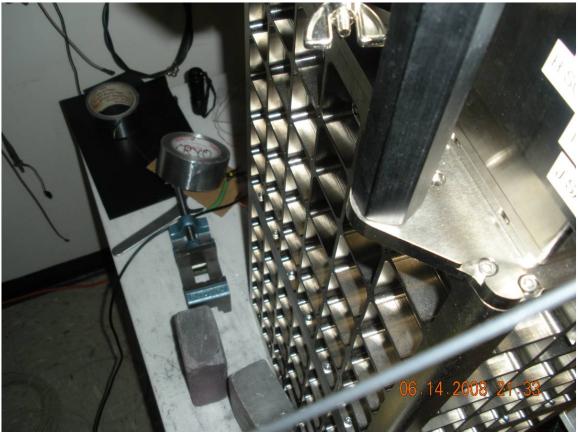
Figure A2 The source position in front of detector. This area is located between the detector and the electronics rack. Shown are the lead bricks and the vice used to position the source.

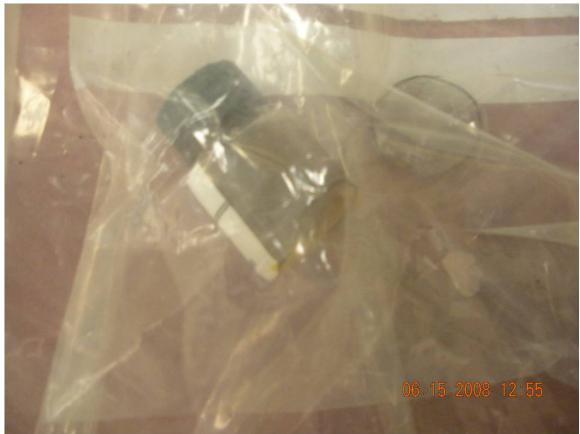
- The most probable direct cause of the spill event is striking the glass bottle containing powdered plutonium sulfate tetrahydrate, which had been removed from all other secondary protection and containment, against a fixed obstacle during the experiment;

Figure A3 Broken CRM 138 source bottle (shown inside multiple plastic bags). The broken bottom of the bottle is visible in the upper right hand corner.

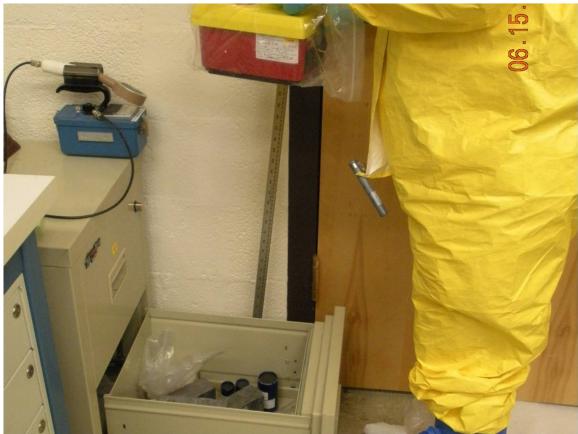
Figure A4. Fire-proof, radioactive source storage cabinet (shown during entry to the contaminated lab). Other glass-bottled source and lead bricks can be seen in the drawer.
