CRACK EVOLUTION IN Cu/LOW-K STACKS AND CRACK STOP EVALUATION USING IN-SITU MICRO-DCB IN A NANO-XCT TOOL

Kristina Kutukova, Jürgen Gluch, Yvonne Standke, Ehrenfried Zschech

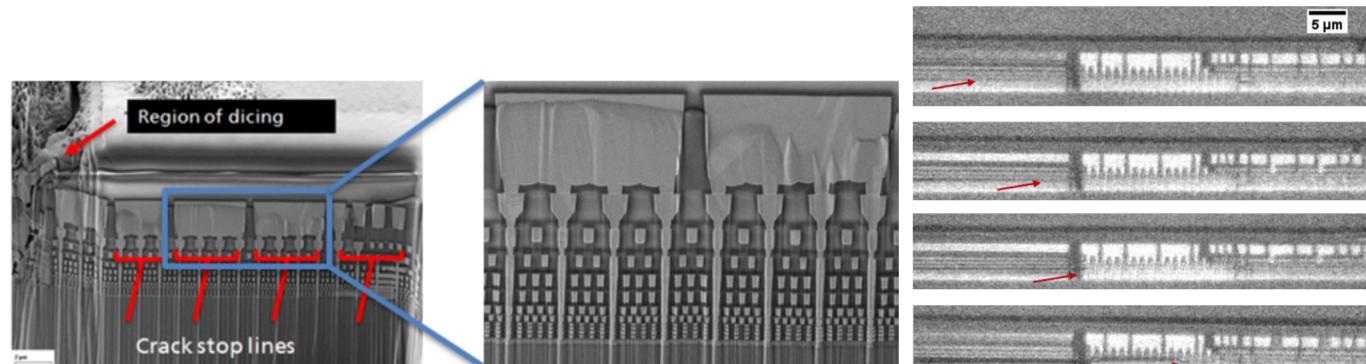
Figure 1
Left) SEM cross-section images with crack-stop structures of an Intel processor with 12 Cu metallization layers. Right) Series of the virtual cross-sections based on nano-XCT, revealing the crack propagation at the Cu/low-k crack-stop structure.

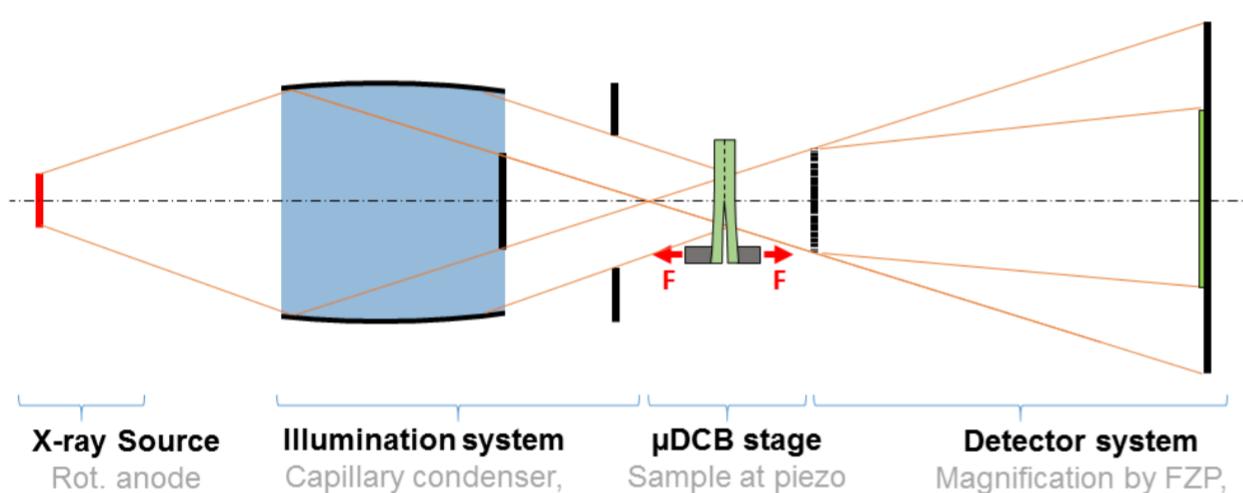
Figure 2
Scheme of μ DCB stage inside nano-XCT.

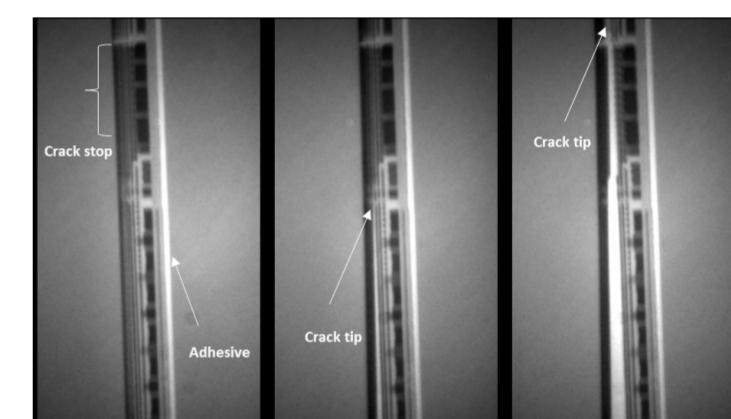
Figure 4
Series of radiographs during μ DCB test represent the crack propagation into crack-stop structure.

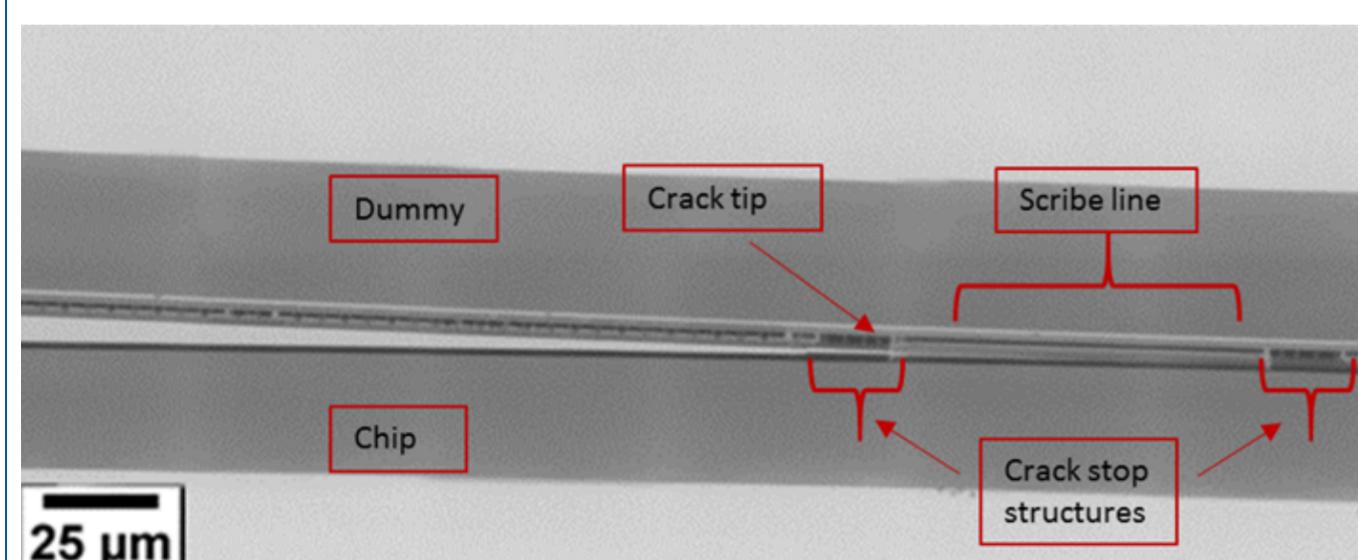
Figure 5
Stitched radiograph of a μ DCB sample under load. The crack penetrates the crack-stop structure from chip side. The image is rotated clockwise by 90°.

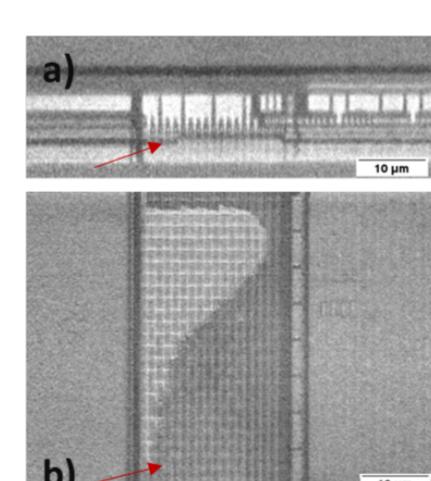
Figure 6
Virtual cross-sections based on nano-XCT:
a) Vertical view: delamination between metallization layers (crack path)
b) Horizontal view: delaminated area (dark) within the metallization layer (here M8).

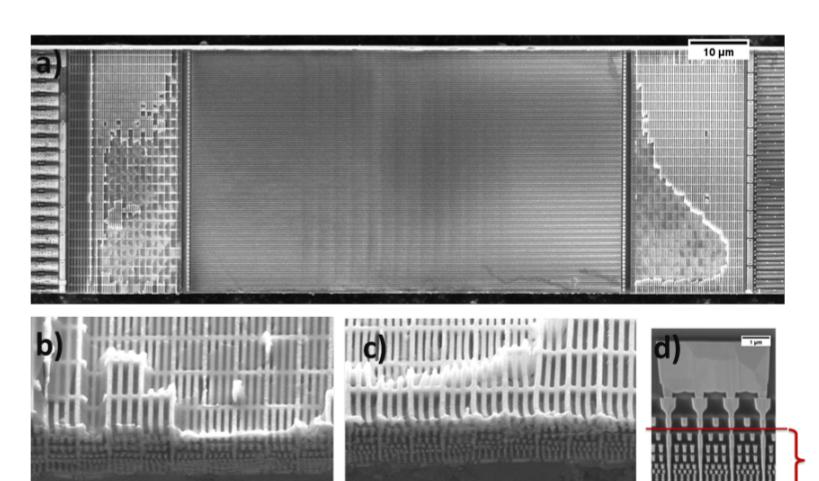
Figure 7
SEM images:
a) Overview of the crack surface with two fractured crack-stop structures and at higher magnification.
b) and c) Comparison of the number of the damaged layers with non-damaged structure.
