# NIST Building 101

## Historic Structure Report and Condition Assessment

Final Submission  
March 15, 2020

**John Milner Associates Preservation**

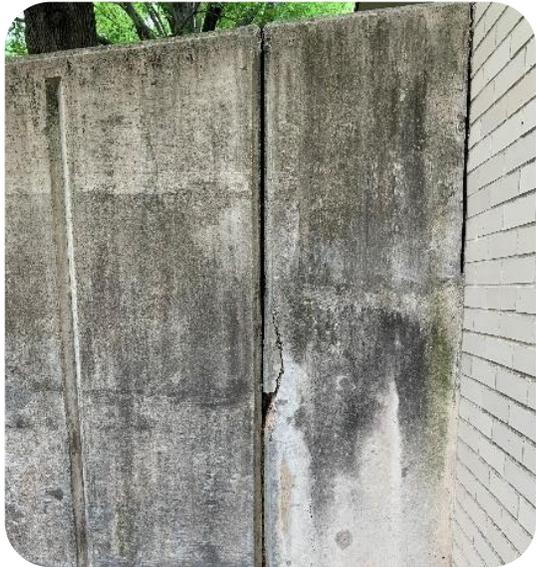
Priority: High			
Concrete Retaining Walls	Vertical expansion joint has hardened. Minor concrete spalling around joint.	<p>Replace old expansion joint material with new backer rod and sealant for soft joint (approximately 10FT).</p> <p>Remove delaminated concrete and patch (approximately 5SF). If rebar is visible after removing spalled concrete, expose it by removing at least 3/4 inches of concrete around bar and check for corrosion.</p> <p>If corrosion is present, the condition should be further investigated by an engineer. Otherwise patch with appropriate concrete patching material</p>

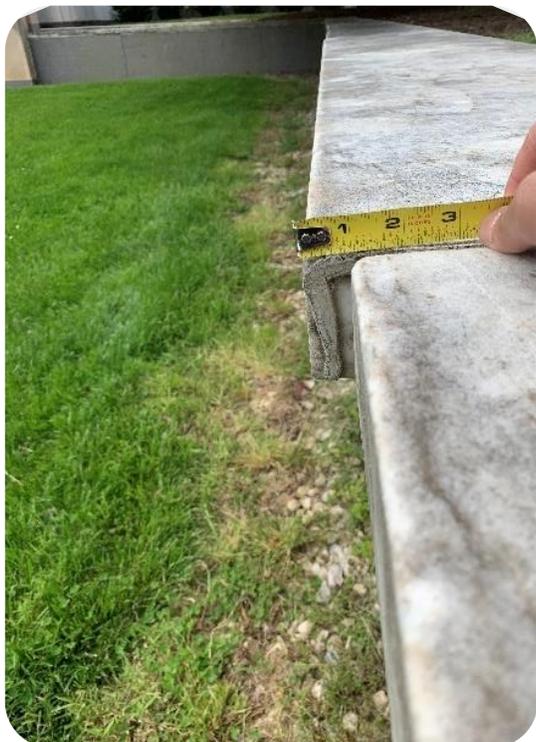
Priority: Medium			
Stone Retaining Walls	Many sections along retaining wall have displaced. Per 2017 water leak survey, drainage behind wall seems to be clogged, causing excess hydrostatic pressure. Also, wall footing is underdesigned for overturning.	Per recommendation on 2017 water leaks survey report, existing wall should be removed and replaced with a footing below it. We also recommend a new drainage system and new grading behind the wall. Retain original stone coping and panels.

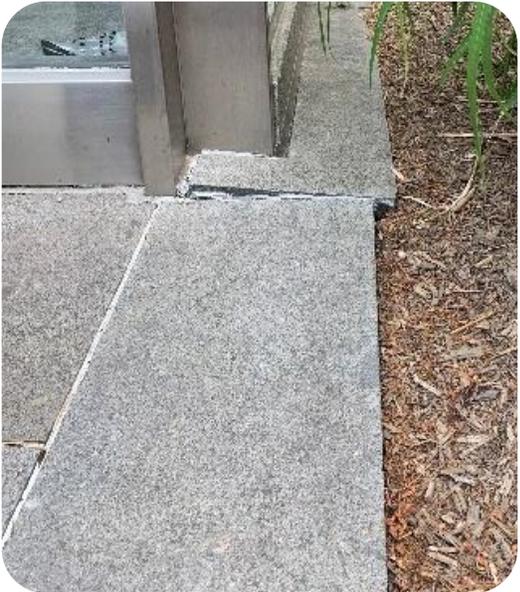
Entrance Terraces - Pavers			
ELEMENT	CONDITION	RECOMMENDATION	PHOTO
Pavers	Granite paver displaced due to soil erosion.	Remove stone, regrade and compact soil, and reset stone.

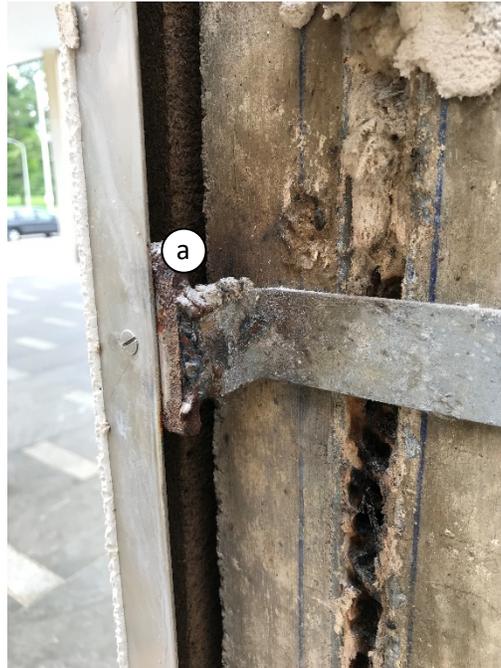
Photo 7 – a. Metal connection plate corroded.

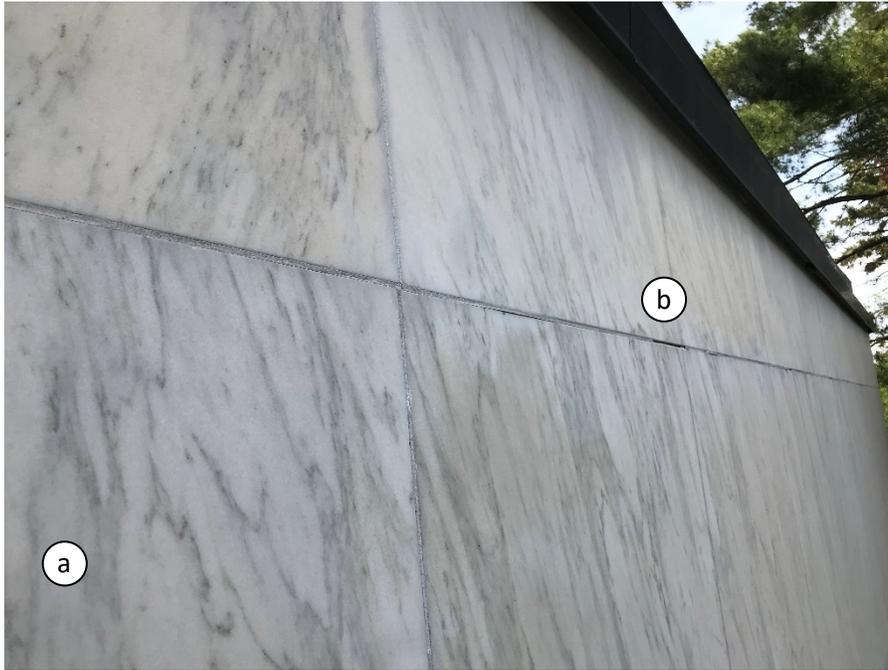
Photo 9 – a. Typical Exterior Panels. b. Missing Mortar.

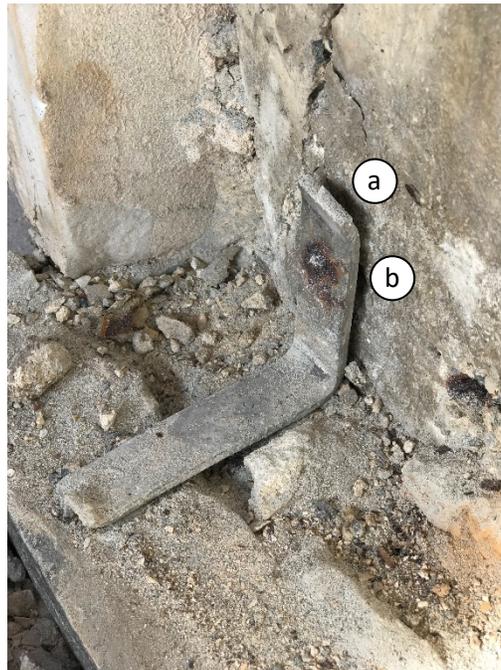
Photo 19 – a. Masonry anchor to Granite Base. b. Anchor pulled loose from concrete.

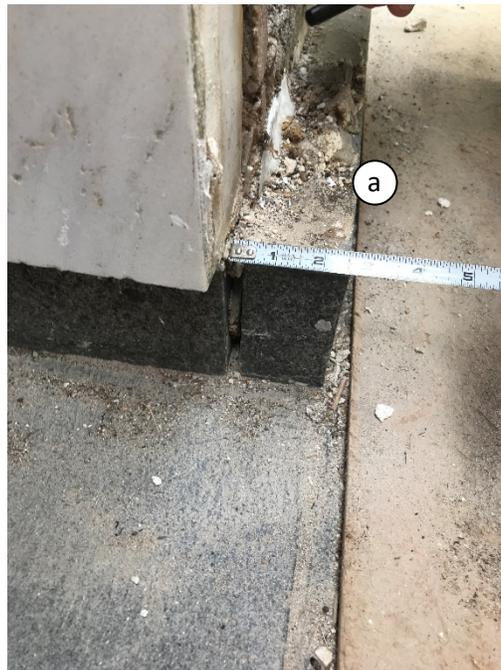
Photo 20 – a. Granite Base moved out.

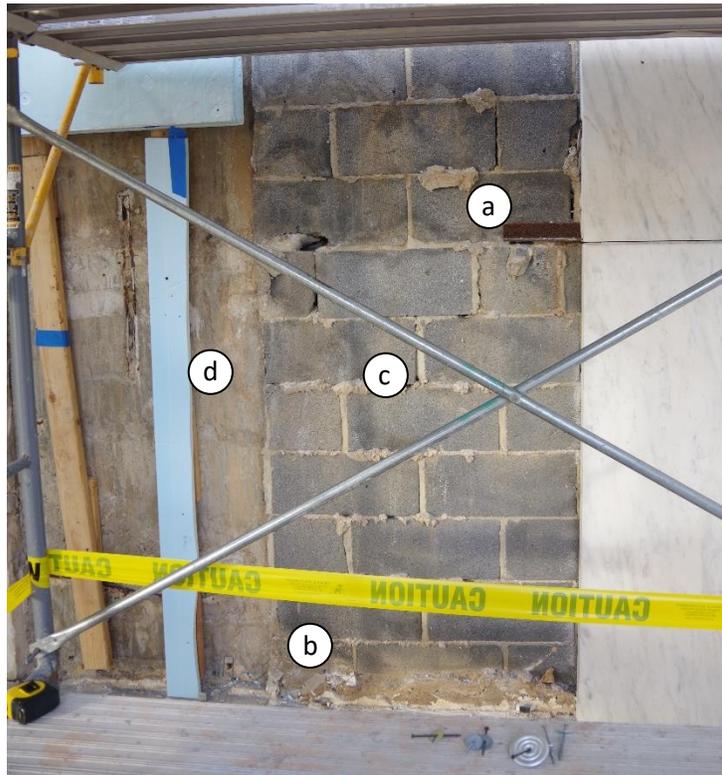
Photo 3 – Bottom of removal area - a. Corroded support angle. b. Base of cavity full of debris. c. CMU backup wall. d. Adjacent concrete column

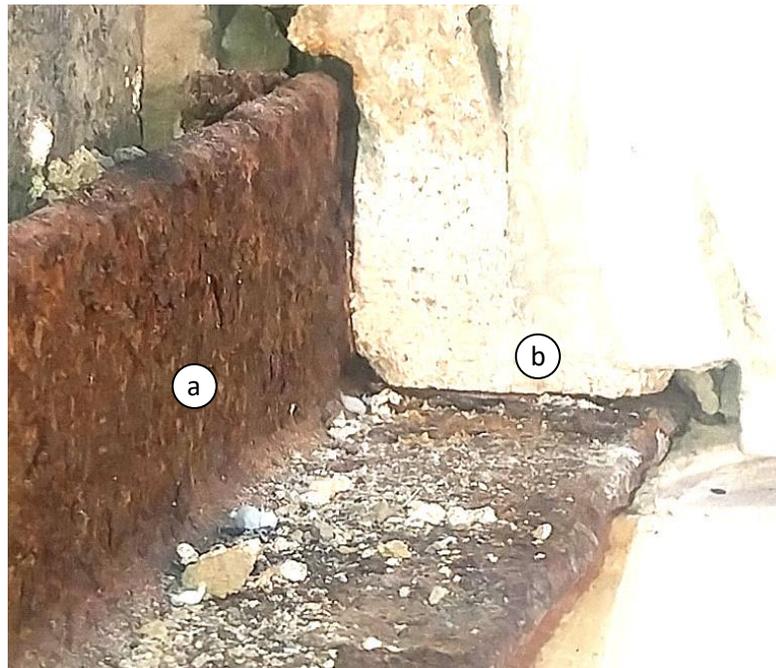
Photo 4 – a. Corroded support angle continuing into joint at adjacent stones. b. Rust jacking visible under adjacent stone.

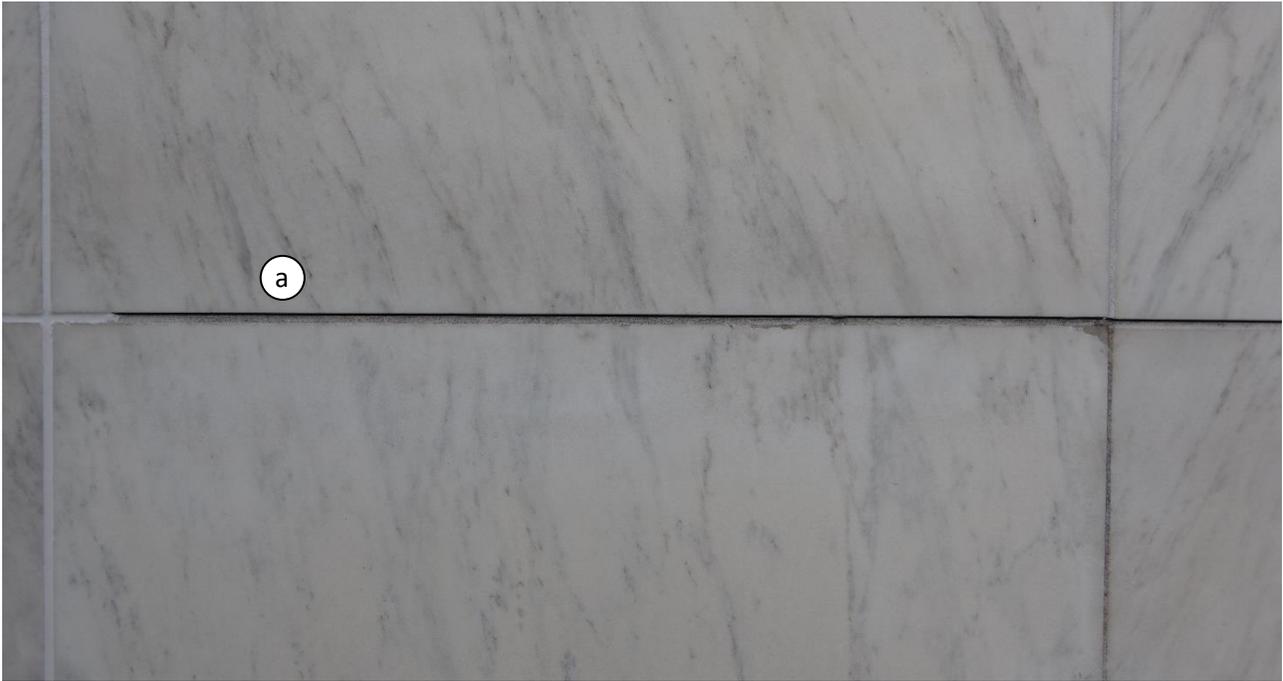
Photo 5 – a. Joint at continuation of corroded steel support over “1962” stone.

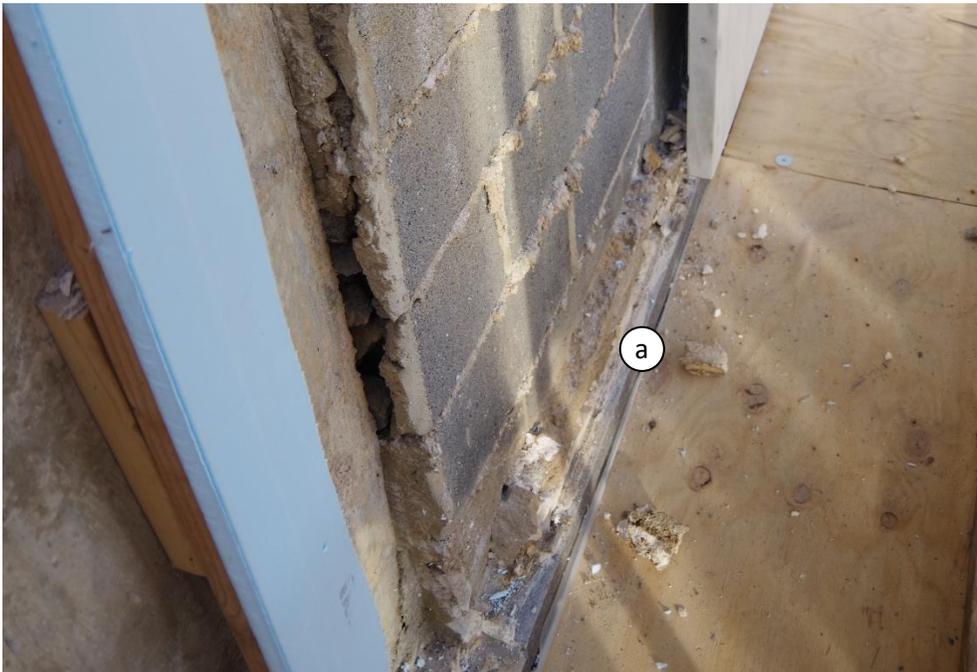
Photo 6 – a. Base of wall cavity full of old debris.

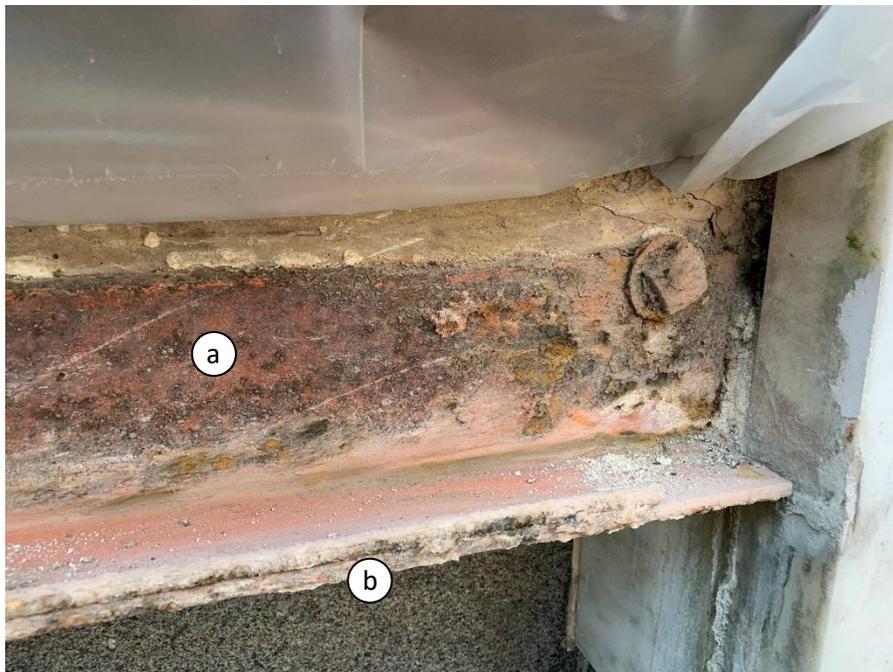
Photo 8 – a. Closeup of steel angle. Note general moderate corrosion on top and vertical face. b. Welded rod for stone lateral restraint.

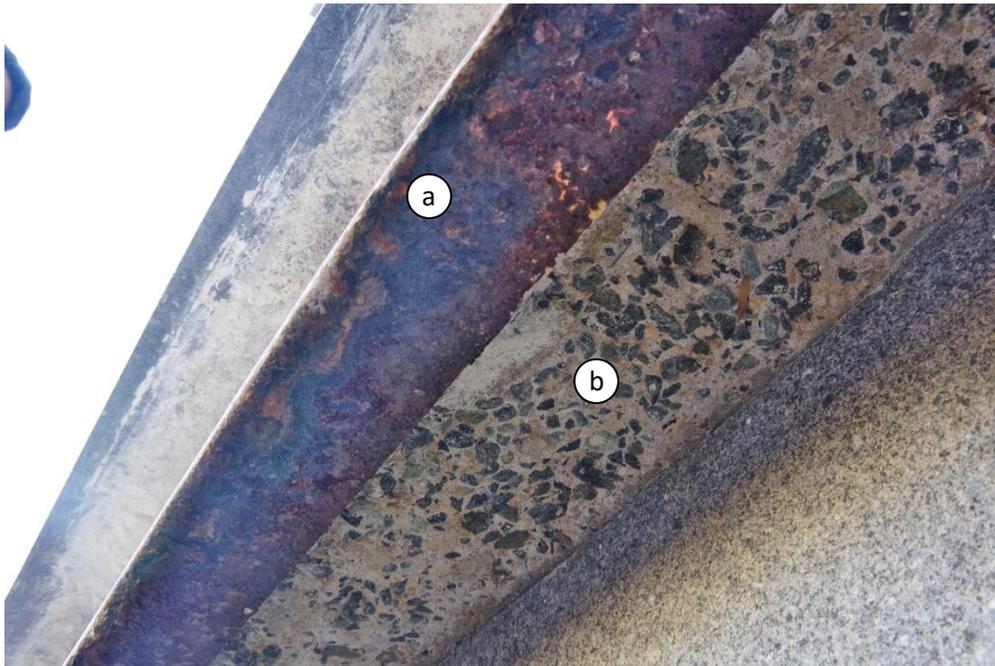
Photo 9 – a. Underside of steel support angle. Note more severe corrosion. b. Underside of concrete lip with water staining.

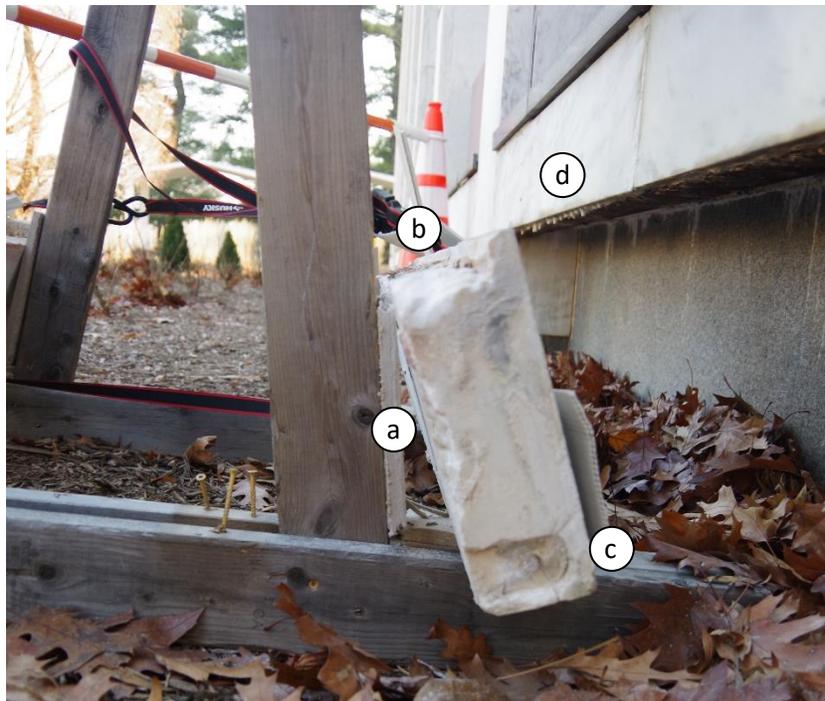
Photo 10 – a. Removed stone (stored upside down from in-place orientation). b. Bottom of stone carved to receive steel rod restraint. c. Side of stone carved to receive metal tie (remnant of pin still in stone). d. Note stalactites on stone in place beyond indicating water flow.

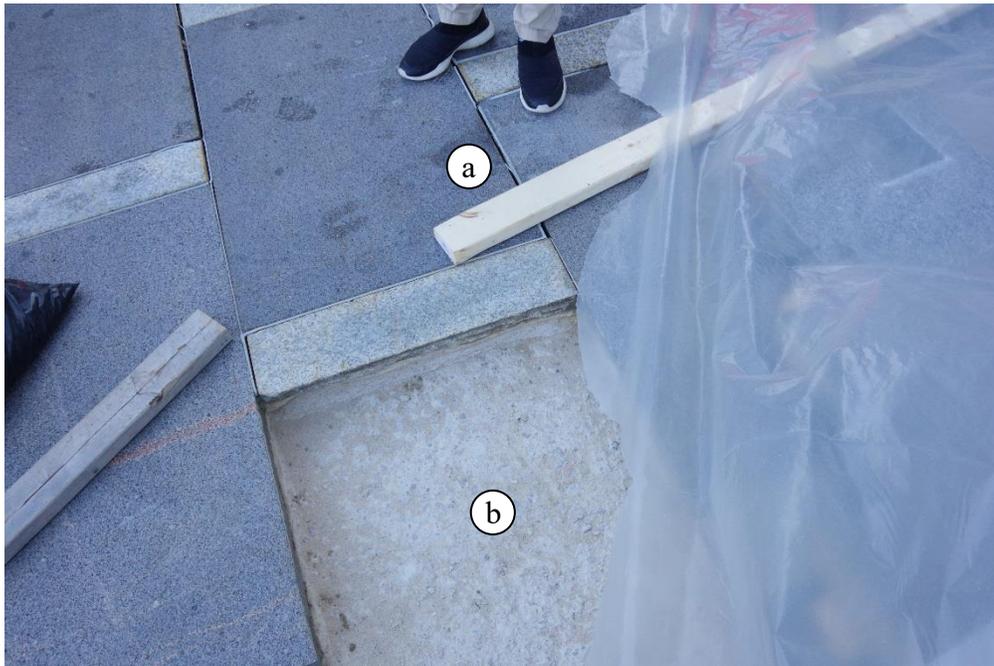
Photo 13 – Removed pavers. a. Note open joints at failed sealant. b. Concrete base slab.

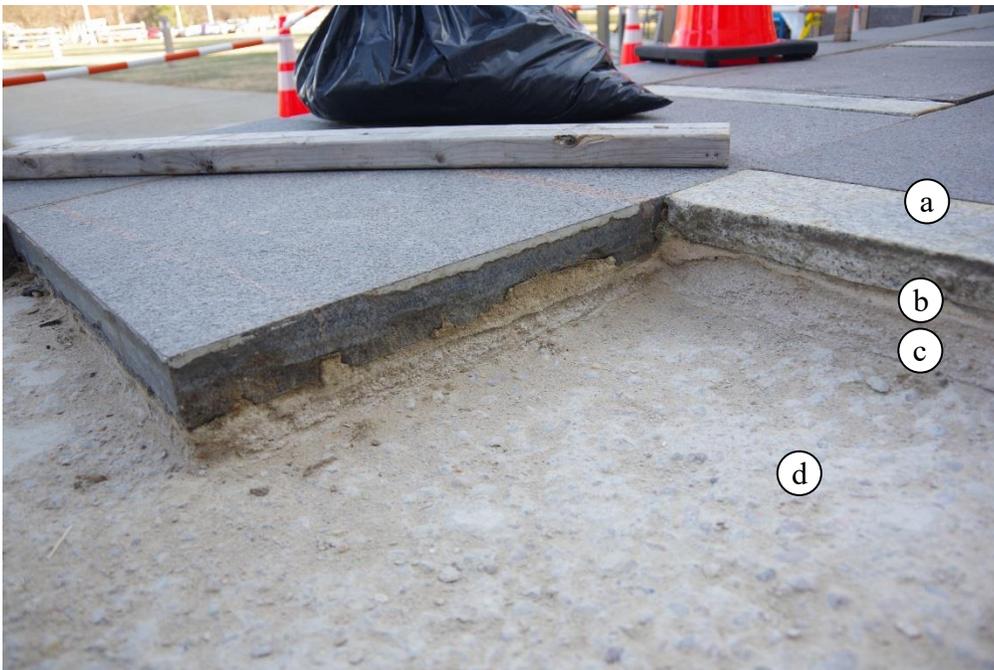
Photo 14 – North entrance plaza overview. a. Granite Paver. b. Top layer of setting bed. c. Bottom layer of setting bed d. Concrete slab, note deteriorated finish on slab.

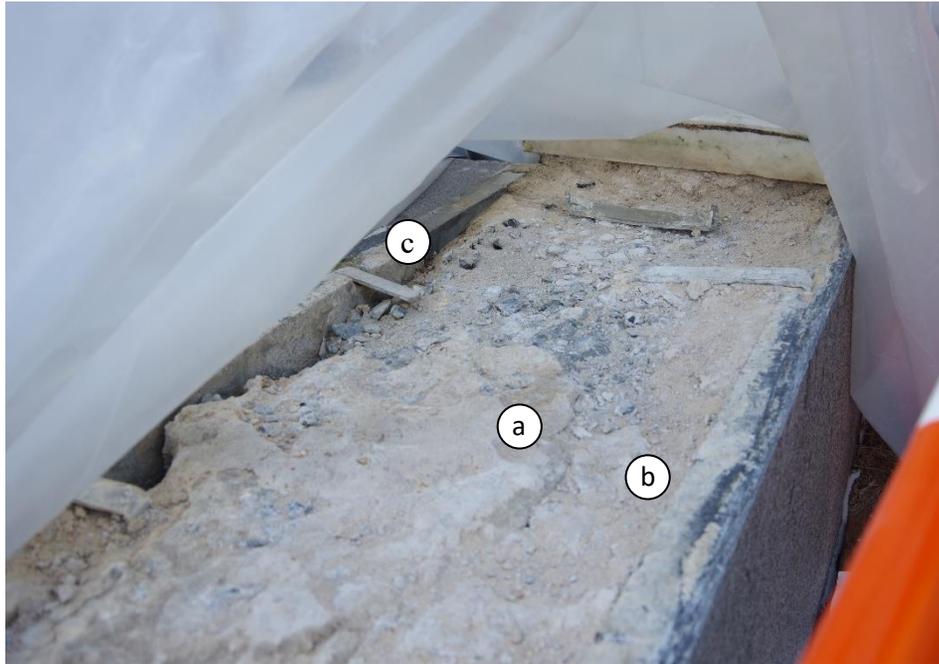
Photo 17 – Top of cheek wall. a. Top of concrete wall deteriorated, but no exposed or corroded reinforcing steel. b. Cavity at side walls fully grouted. c. Stainless steel straps in top of wall not well anchored due to deteriorated concrete.

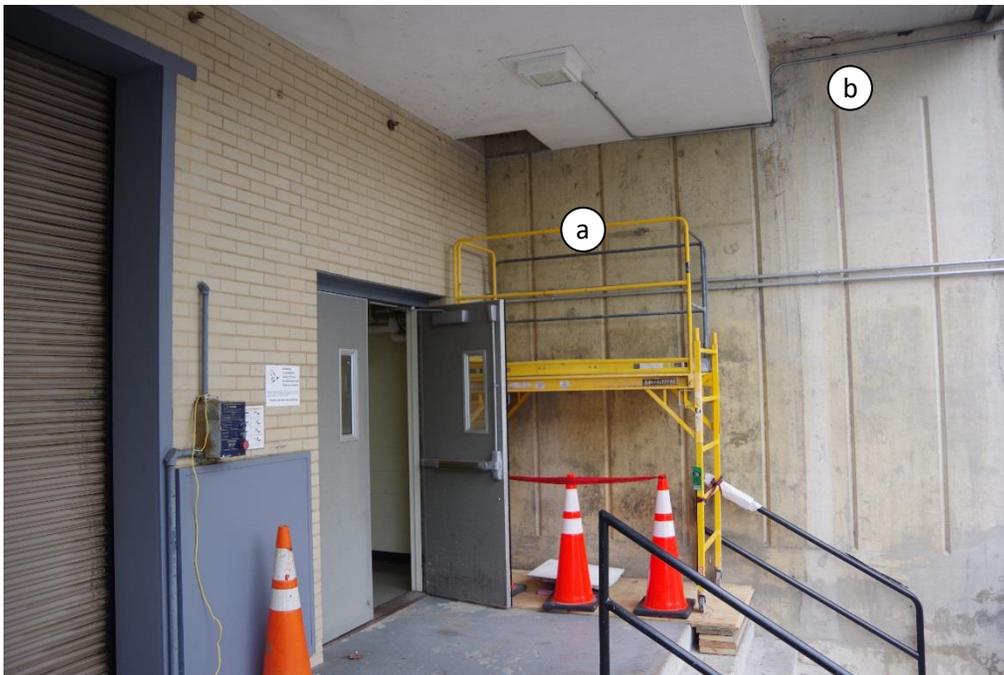
Photo 18 – a. Loading dock investigation area. b. Visible spall adjacent to area covered by soffit.
