Two stand alone systems were installed in Tepoztlan, Morelos in 1990. The first system was designed with 16 modules (16S x 1P) for lighting applications with **Arco Solar M75** modules. The second system has a 1S x 8P configuration for pumping application with **Arco Solar M55** modules. The objective of this analysis is to establish a dependence between degradation effects and climate conditions in the north part of Morelos.

Site of installation	Tepoztlan Morelos, Mex 18° 54' N, 99° 01' W 1706 meters above sea level
Climate condition	Maritime temperate climates, Cwb (Köppen classification)
Manufacturer name:	Arco Solar Inc M55 & M75
Name plate data:	M55 Pmax= 55 W, Isc= 3.35 A, Voc= 21.7 V, Imax= 3.13 A, Vmax= 17.6 V. M75 Pmax= 50 W, Isc= 3.35 A, Voc= 19.8 V, Imax= 3.11 A, Vmax= 17.6 V.
Years exposed in Mexico	25 years

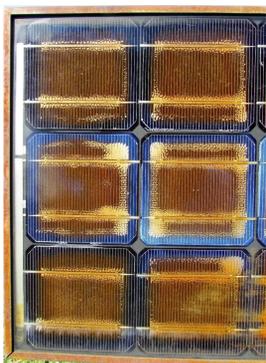
Arco Solar M55 module:

- ✓ Dark discoloration at cell center
- ✓ Delamination between Semiconductor /Encapsulant near the busbars and edges.
- ✓ Oxidation in the frame
- ✓ Crack cells

- The power degradation rate is approximately 2 % per year for the worst module.
- Power degradation is due Isc drop and series resistance increases.
- Although it can not be obtain  $R_s$  increases rate, it can be suggest the increase due the IV curve shape.
- Severe corrosion was found in all the M55 modules.

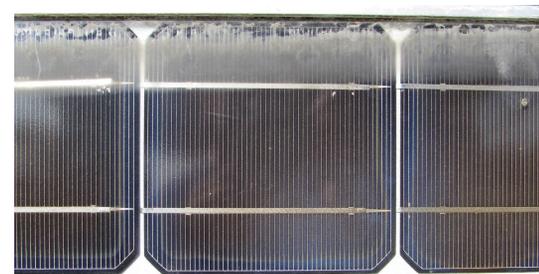
Arco Solar M75 module:

- ✓ Light discoloration at the cell center
- ✓ Soiled near the frame.
- ✓ Crack cells

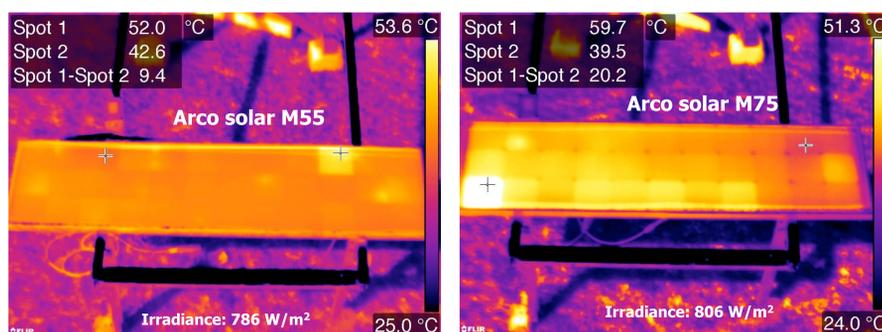
### Infrared Images:

Thermal non-uniformity was found in both models. Multiple hot spots were detected near the positive junction box in Arco Solar M55 and near the negative junction box in Arco Solar M75.

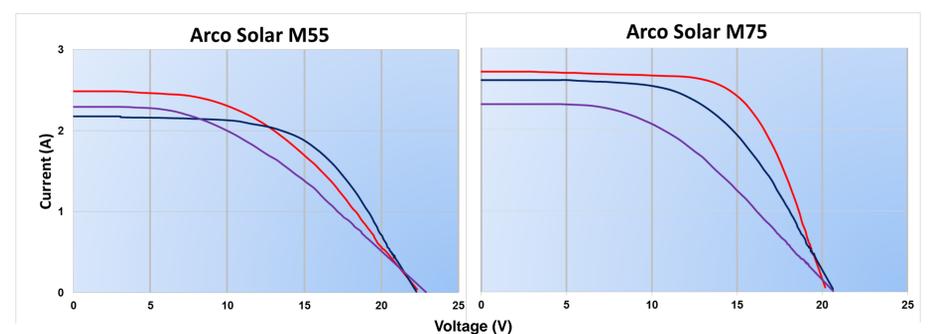
Test Condition	M55					M75				
	Voc (V)	Isc (A)	Vmp (V)	Imp (A)	Pm (W)	Voc (V)	Isc (A)	Vmp (V)	Imp (A)	Pm (W)
Rated @ STC	21.7	3.35	17.60	3.13	55.00	19.80	3.35	15.9	3.11	50
Measured @ STC *	22.9	2.31	13.19	1.64	21.64	20.64	2.31	11.69	1.86	21.74
Measured vs Rated	-1.2	1.04	4.41	1.49	33.56	-0.84	1.04	4.21	1.25	28.26
Measured vs Rated (%)	-5.53	31.04	25.06	47.60	60.65	-4.24	31.04	26.48	40.19	56.52
Annual degradation Rate (%)	-0.22	1.24	1.00	1.90	2.43	-0.17	1.24	1.06	1.60	2.26

Electrical series resistance is calculated using outdoor IV curve; for M55 model it was obtained a value for  $R_s$  of 5.74  $\Omega$ , and 4.57 for M75 module. Since there was no control module, only the values of  $R_s$  are presented
