National Institute of Standards and Technology General Purpose Laboratories

Historic Structures Report | 100% Submission Condition Assessment

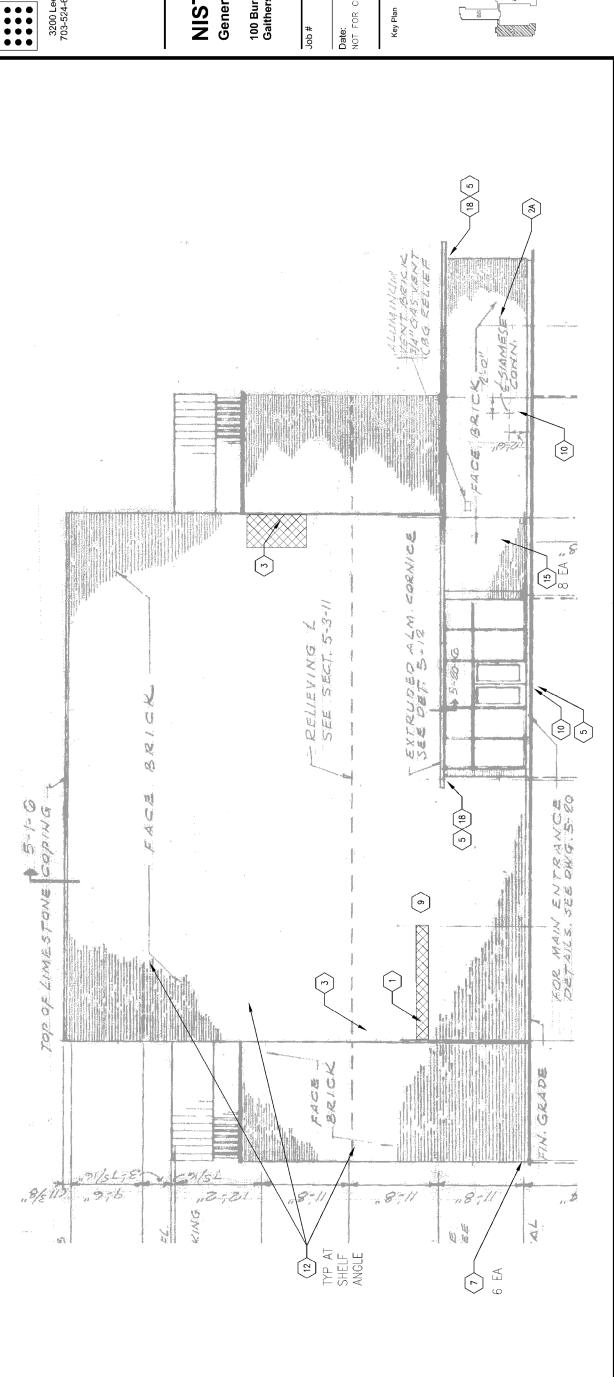
VERTICAL CRACKS. REPLACE

REPAIR WALL AT BROKEN BRICKS.

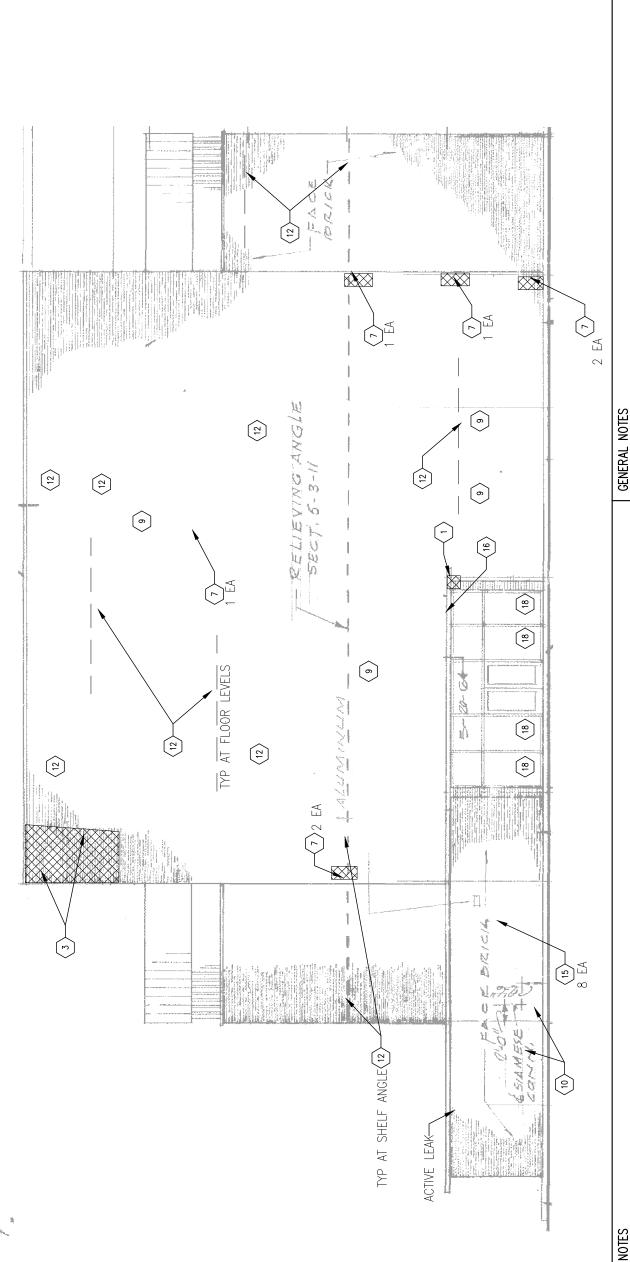
- REPLACE UP TO THREE WARPED/BOWING STOPS AT BOTTOM RAIL OF CURTAIN WALL AT CONNECTORS. REPLACE WEATHERSTRIPPING AND CASKETS AT WINDOWS AND CURTAIN WALLS 100%. REPLACE STOREFRONT ALUMINUM BASE, TYP.
- REPLACE EXIERIOR SEALANT JOINTS 100% INCLUDING AT ALL OPENINGS, CURTAIN WALLS, AND SHELF ANGLES. G.
 - 5% OF BRICK ELEVATIONS. ΞĖ
- REPAIR TOPPING SLAB AT CONNECTOR ENTRANCE LANDINGS, TYP. REPLACE PARGING AT BASE OF WALLS 100%
- REDESIGN JOINT COVER AT TOP OF WINDOW CURTAIN WALLS TO PREVENT STAINING
- INVESTIGATE JOINT AT FLOOR PLATE RELIEVING ANGLE WITH A PROBE TO EXPOSE THE ANGLE AND BRICK DETAILING. CORRECT FOR CONCRETE BEAM SHRINKAGE.
- REPLACE SOLAR FILM ON WINDOWS AT ALL GPL.
- Granite pavers at entrances exhibit erosion, rust staining, previous repairs at railing. Clean and Repair granite.

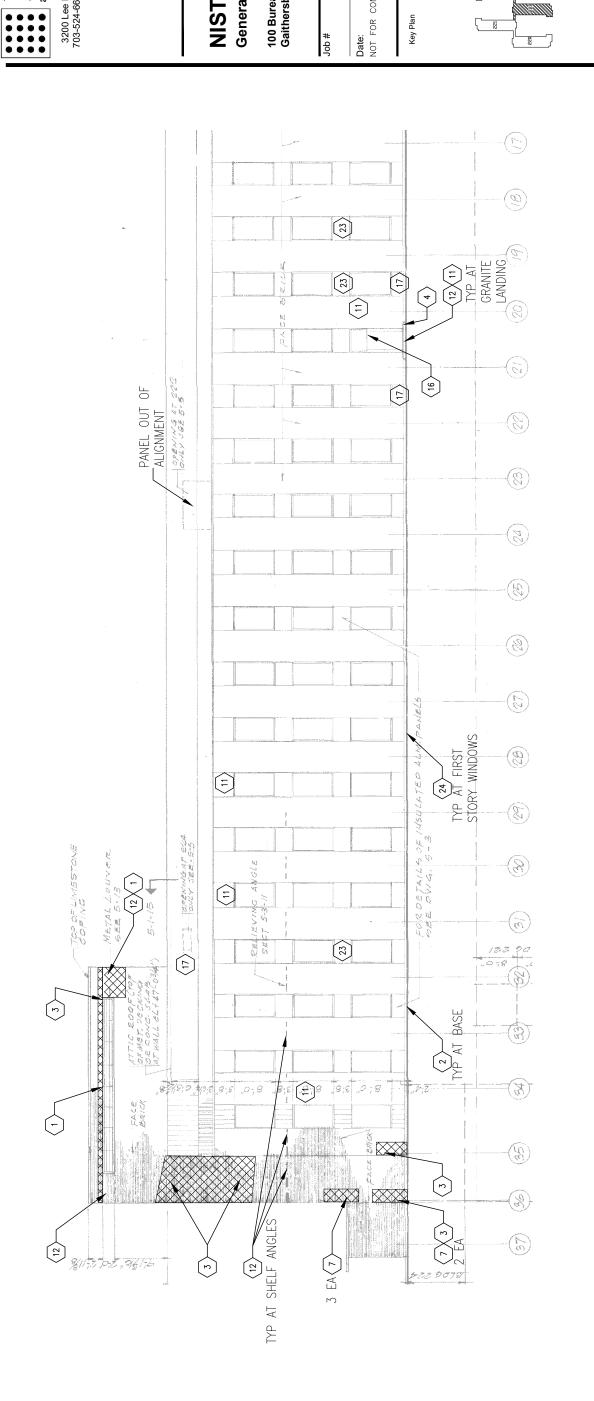
A113

VERTICAL CRACKS. REPLACE REPAIR WALL AT BROKEN BRICKS.

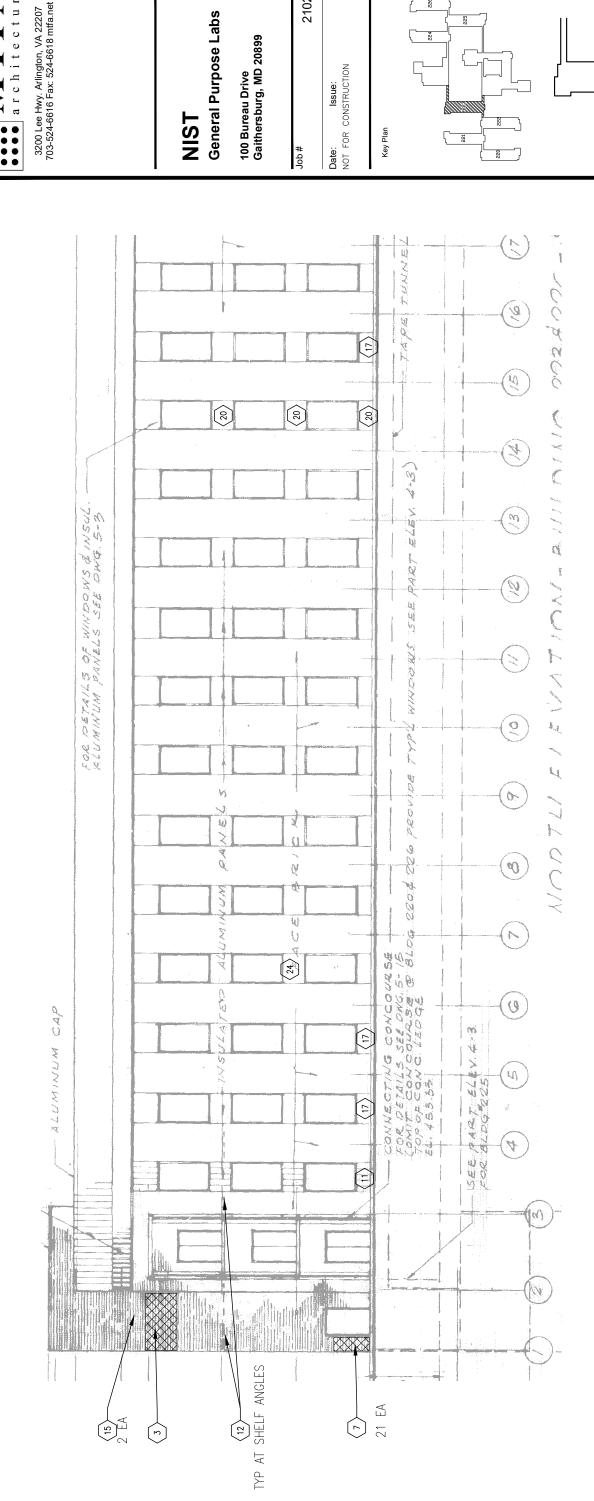
- 5% OF BRICK ELEVATIONS.
- REPAIR TOPPING SLAB AT CONNECTOR ENTRANCE LANDINGS, TYP. REPLACE PARGING AT BASE OF WALLS 100%.
- REDESIGN JOINT COVER AT TOP OF WINDOW CURTAIN WALLS TO PREVENT STAINING.
- INVESTIGATE JOINT AT FLOOR PLATE RELIEVING ANGLE WITH A PROBE TO EXPOSE THE ANGLE AND BRICK DETAILING. CORRECT FOR CONCRETE BEAM SHRINKAGE.
- REPLACE SOLAR FILM ON WINDOWS AT ALL GPL.
- GRANITE PAVERS AT ENTRANCES EXHIBIT EROSION, RUST STAINING, PREVIOUS REPAIRS AT RAILING. CLEAN AND REPAIR GRANITE.

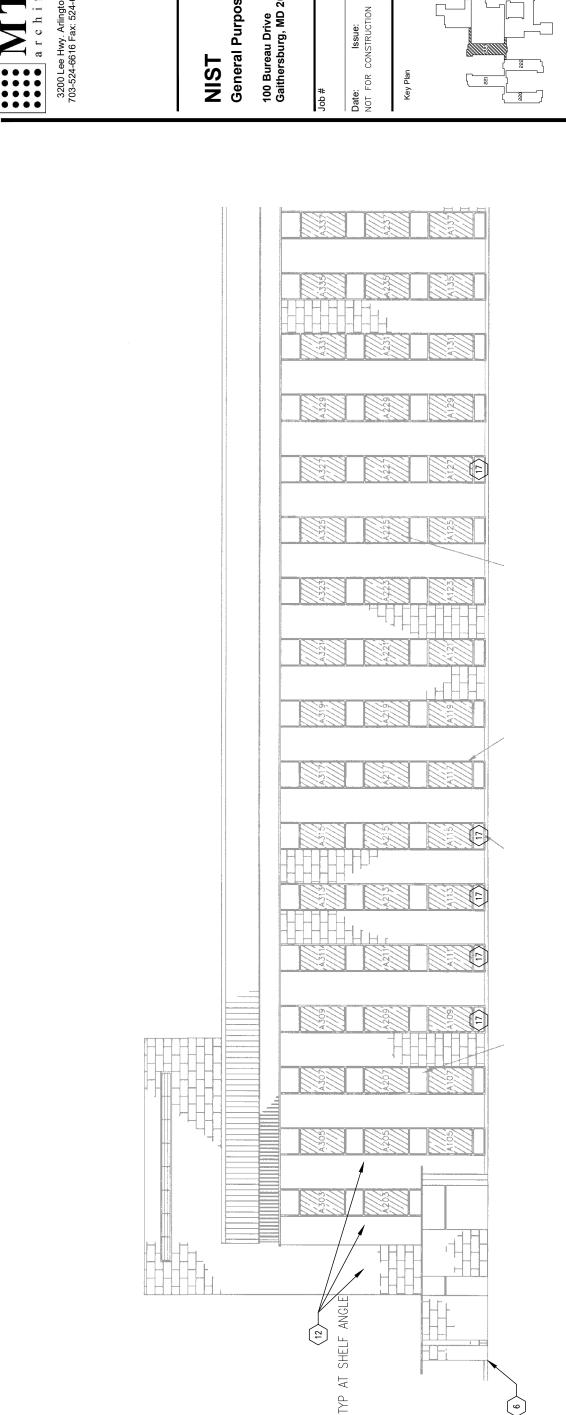
REPAIR WALL AT BROKEN BRICKS. 1 WHERE HATCHED, REPOINT OPEN JOINTS 100%

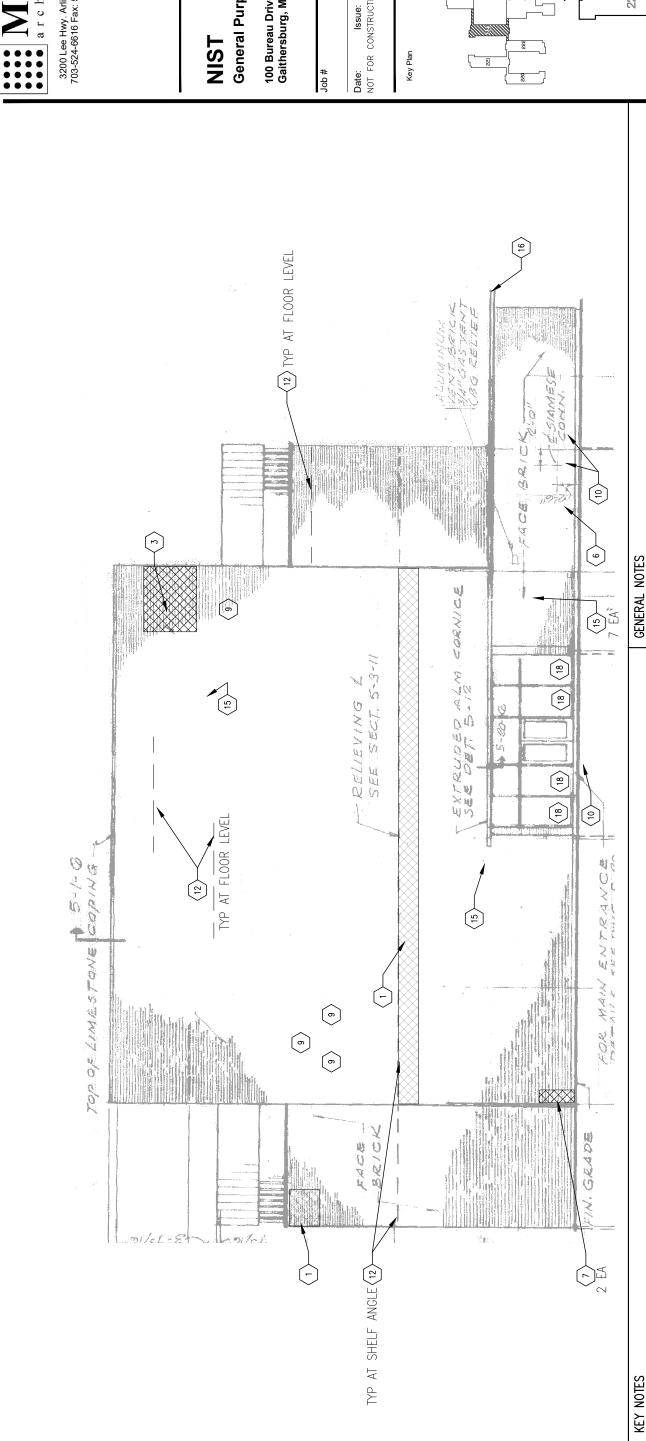
A125

DENTED ALUMINUM. NO REPAIR.

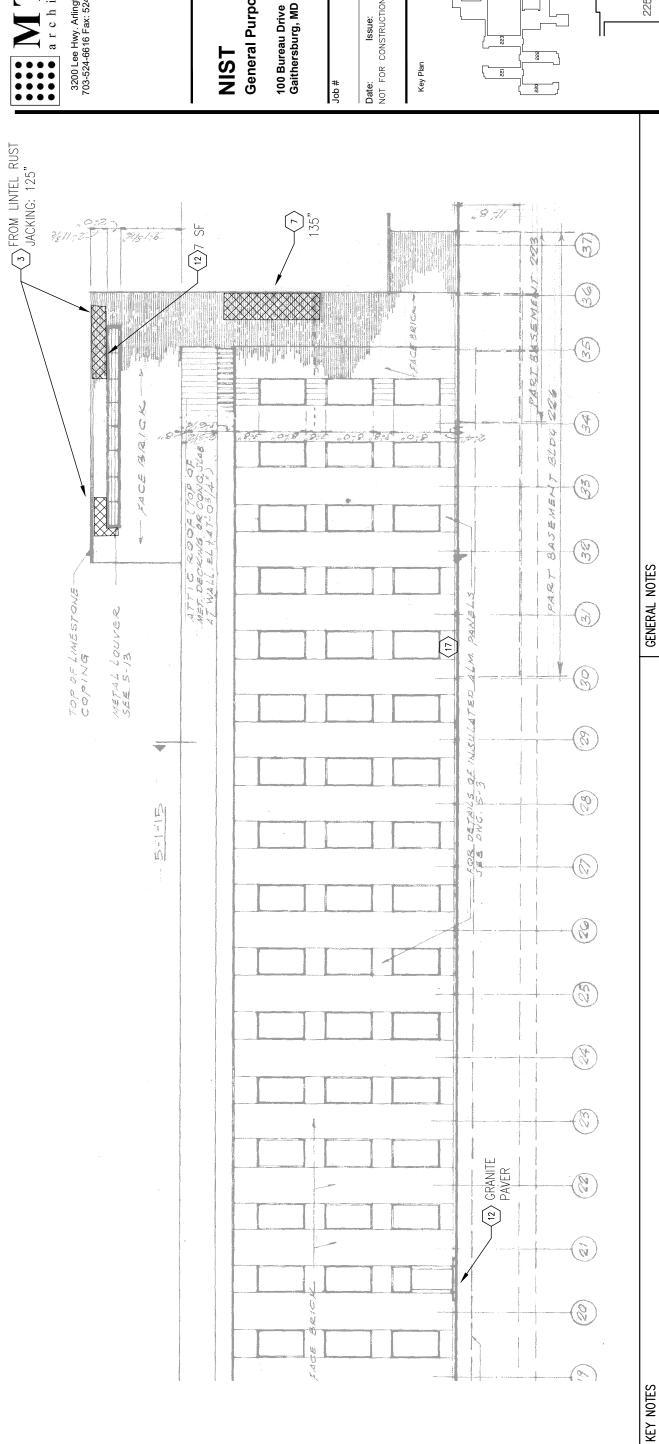
DENTED ALUMINUM. NO REPAIR.
