Solder Bump Coupon Testing of Backsheets for Simplified Comprehensive Evaluation

Michael Kempe, Trevor Lockman, and Joshua Morse
2019 NIST/UL Workshop on Photovoltaic Materials Durability
NIST, Gaithersburg, MD 20899

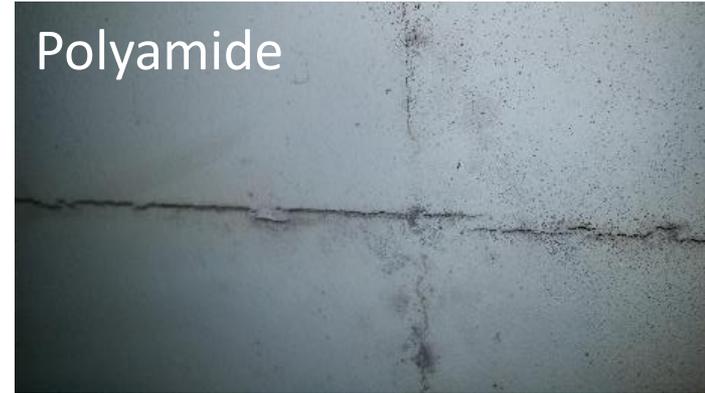
Module Deployed in New Delhi for 4 y (Courtesy of Liang Ji).

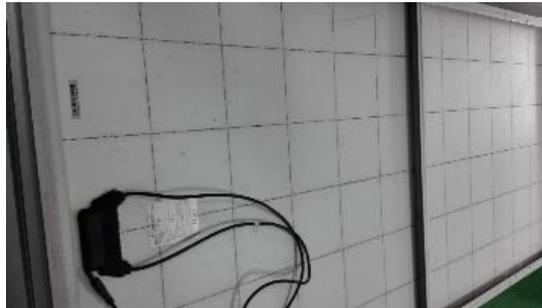
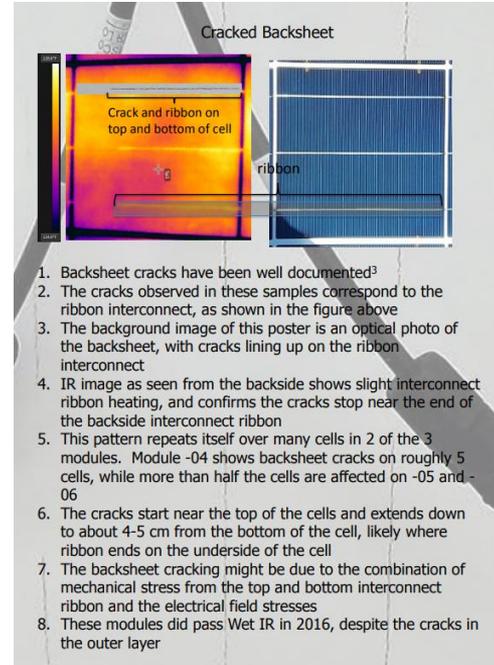
Cracks
between cells
on module
deployed in
Rome for 4 y.

Cracks are large and associated
with module topology.

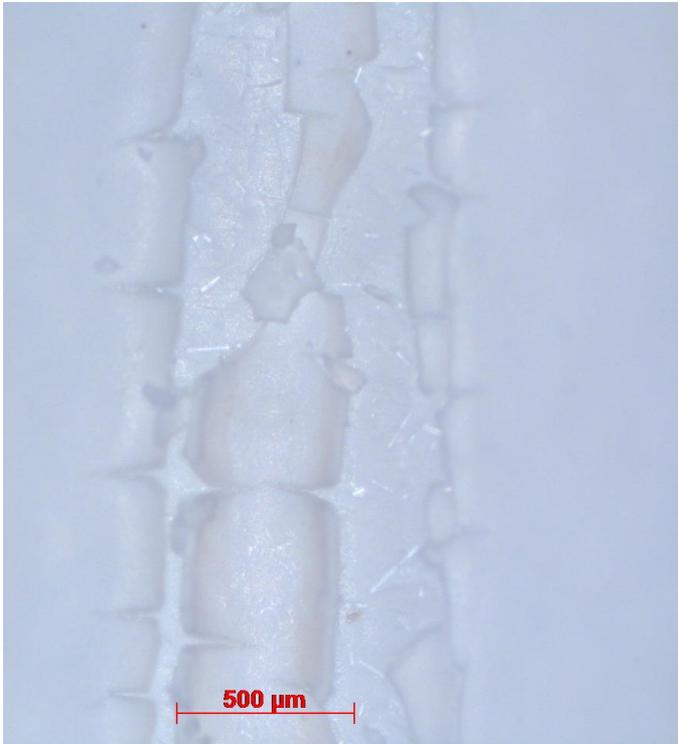
Trench

PA only cracked in the outer layer with just UV/heat/humidity

Photos from 2500 h exposure of UV with air-side exposure.
Even after 4000 h the cracks were only in the outer PA layer.

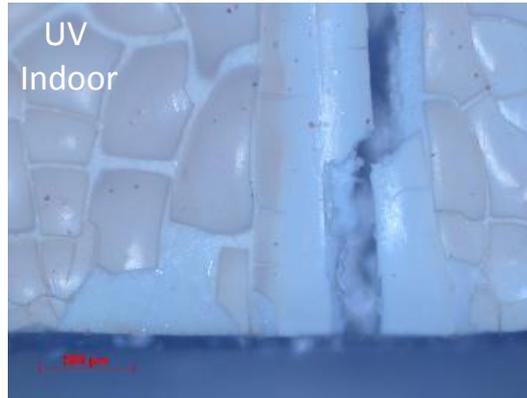
Cell-Side
Exposure

4000 h UV
& 200 TC

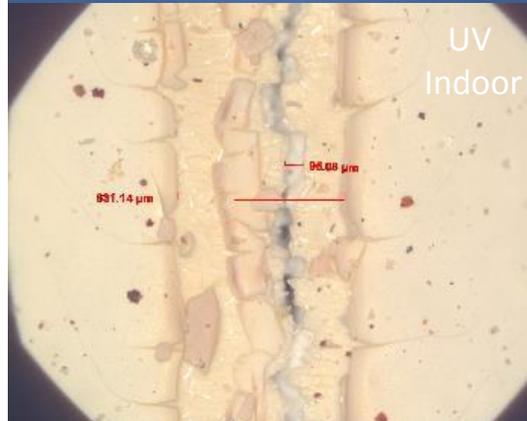
Air-Side
Exposure

4000 h UV
& 400 TC

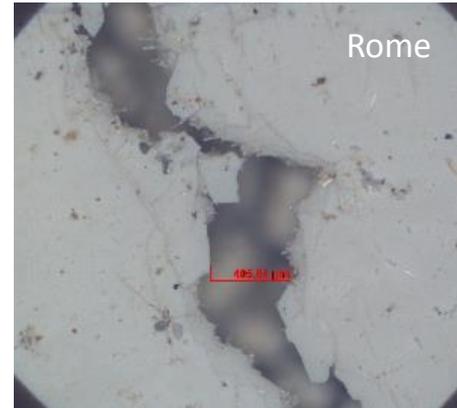
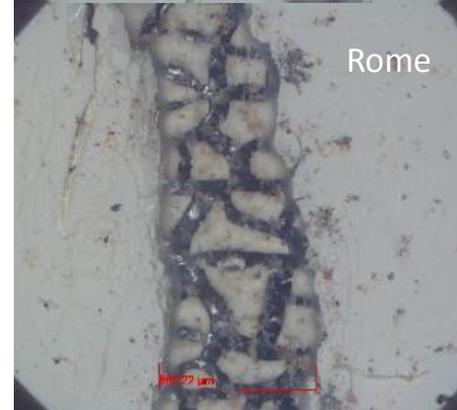
5 y Field Exposure, Rome, Italy

Polyamide Failure in the chamber is similar to outdoor

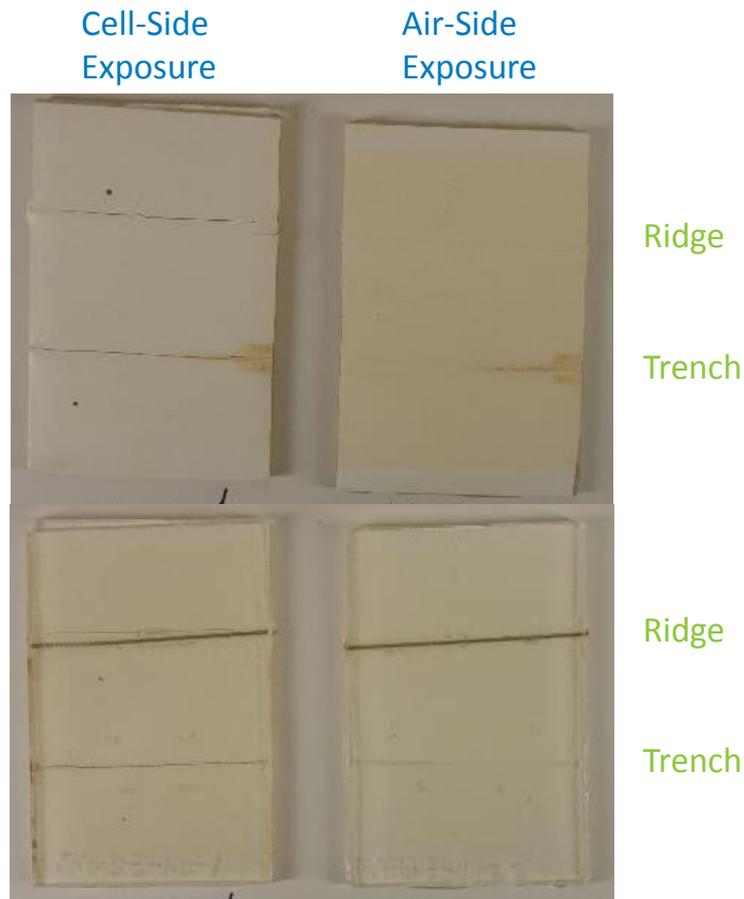
Larger cracks are seen with exposure from the cells side through UV filter EVA. The air-exposed side has more discoloration but much smaller cracks.

Cracks appear best where the inside surface of the backsheet is curved and in tension.

Either the inner polyamide surface is not stabilized the same as the outer surface, or there is a specific interaction with EVA.

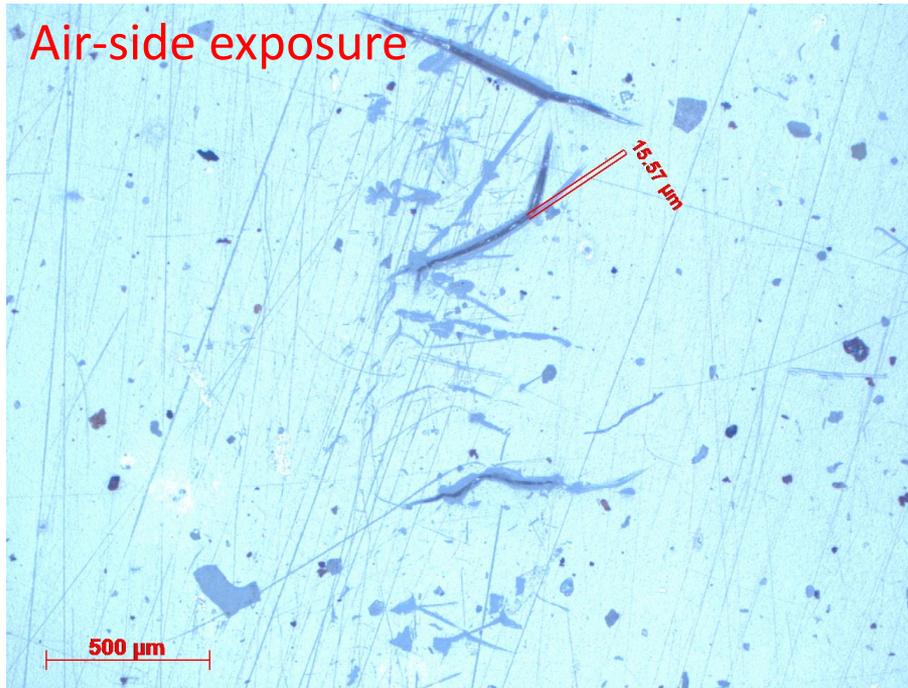
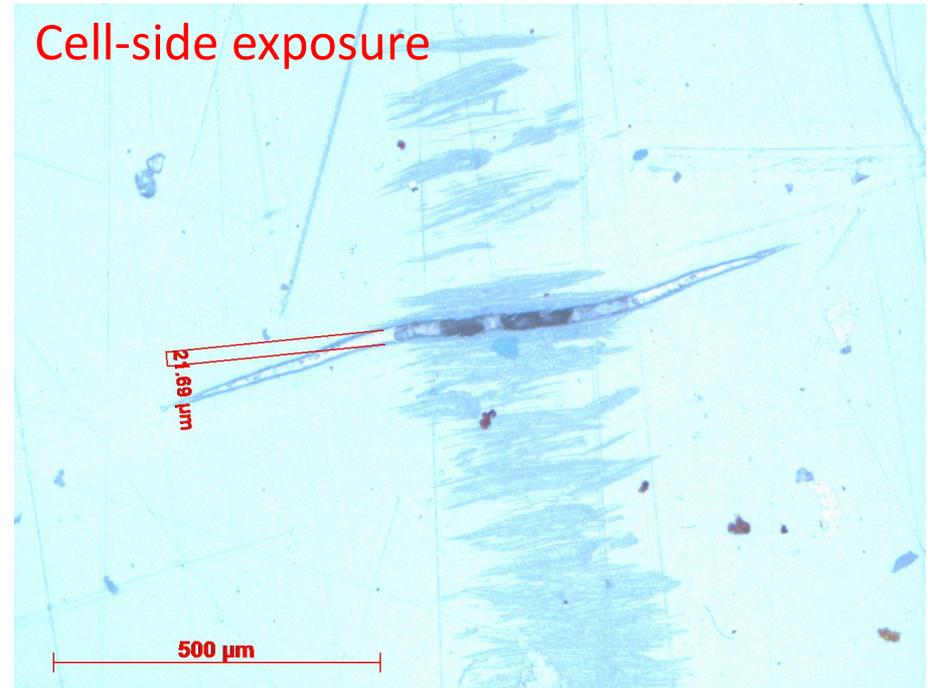
PVDF, Ridge area, after 4000 h UV and 200 TC.

Some PVDF-based backsheets are known to fail in the field. PVDFs have a very high preference for failure with cracks in the MD which runs counter to the typical condition of extra residual strain in the MD which should favor cracks in the TD. One possible explanation for this is their unique crystalline structure.

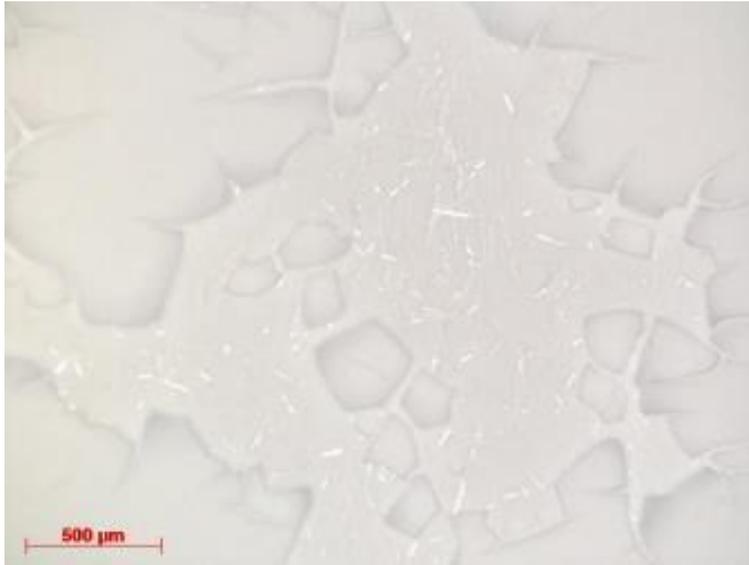
1500 h Exposure, only surface PA film removed,
No cracks

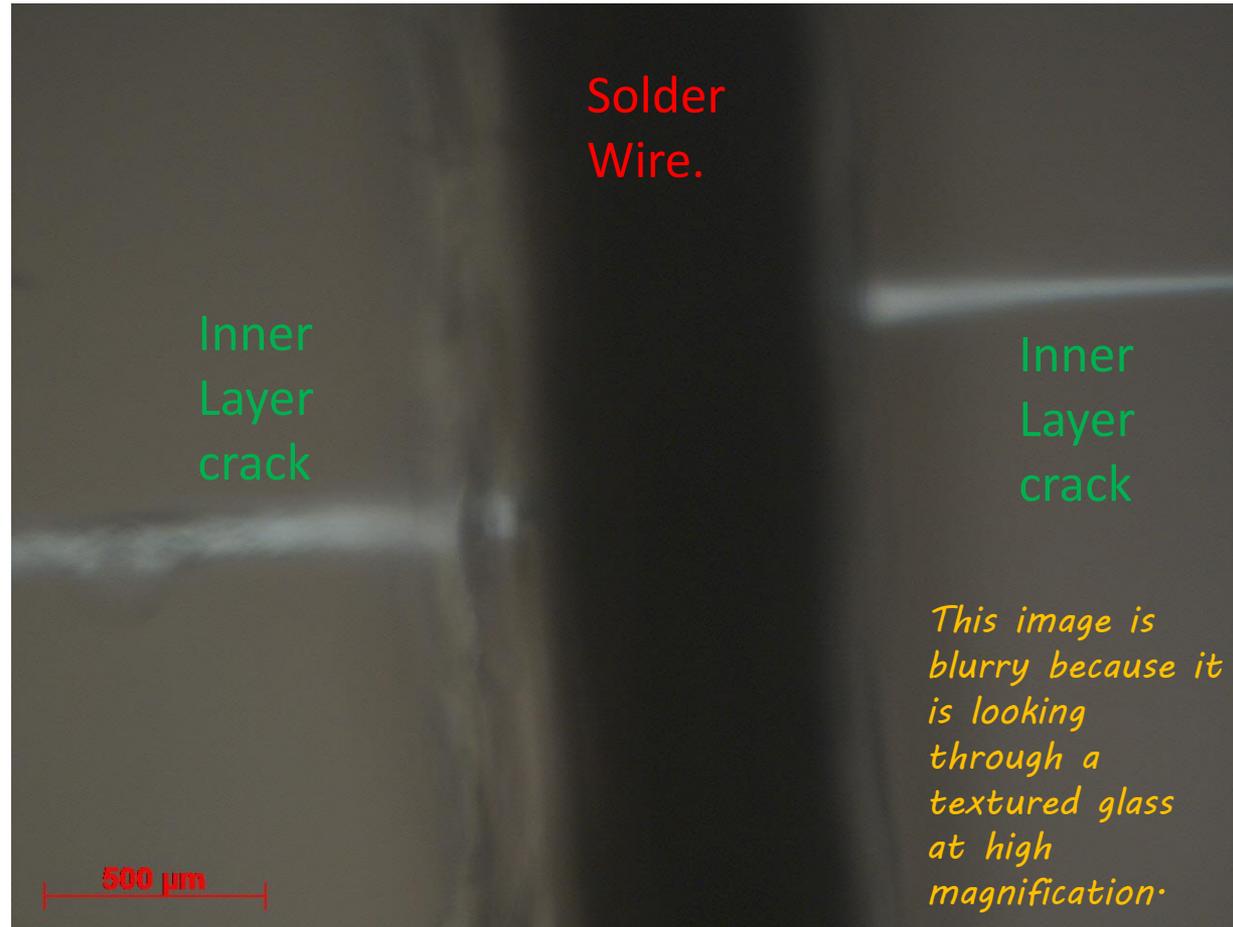
PPE film 4000 h Exposure UV with spray. This demonstrates the ability of this test to also crack an inner layer.

Backlit looking from Glass side where a solder wire under a ridge is visible along with inner layer cracks.

Cell-Side exposure using UV blocking EVA.

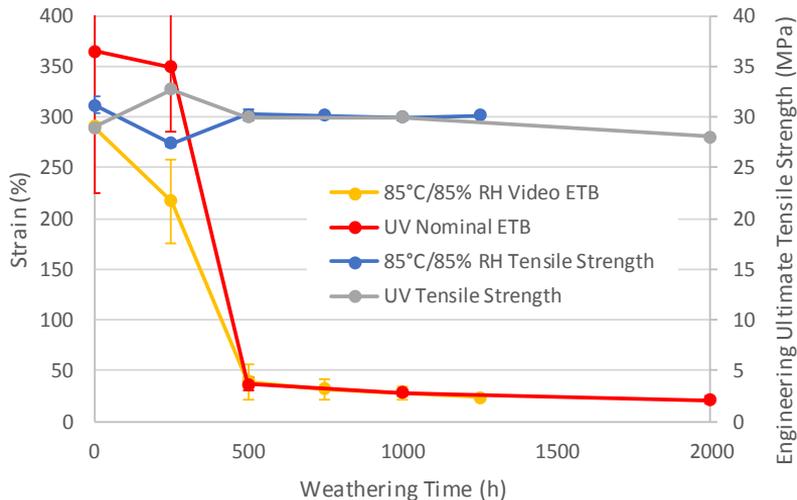
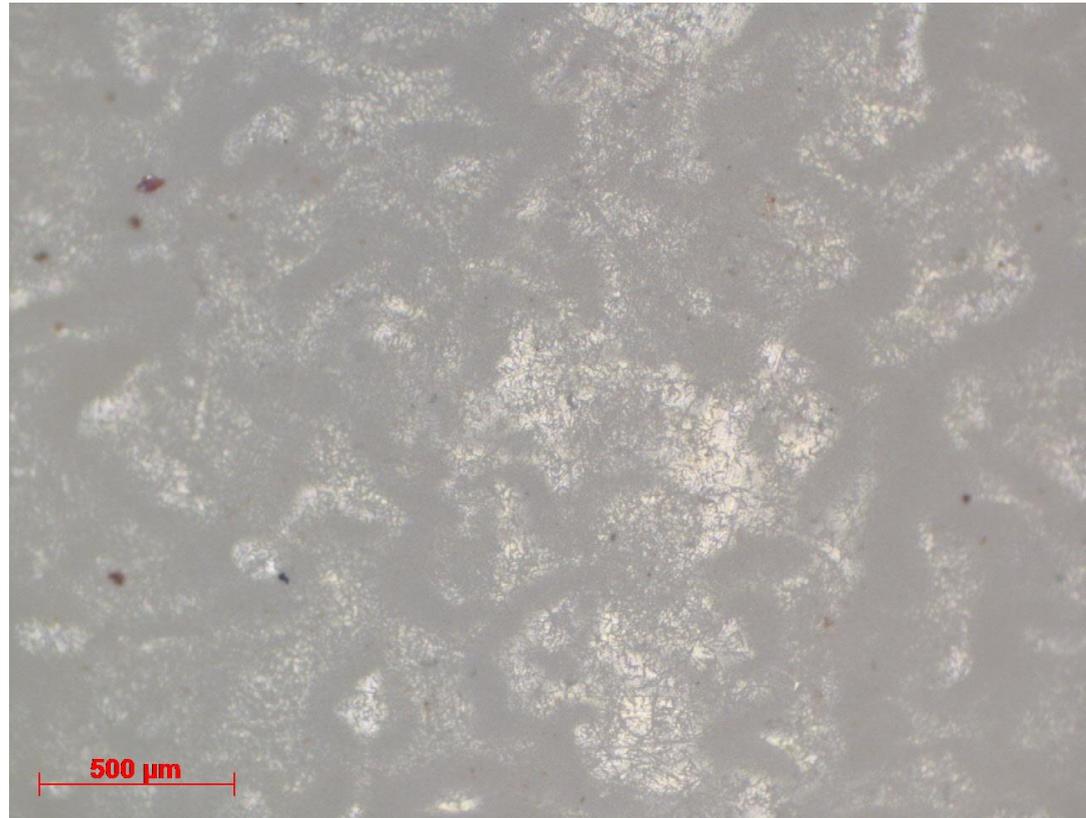
- Damp heat is not sufficient to cause cracking quickly, **UV light seems to be needed for cracks all the way through the PA backsheet** in an amount of time representative of outdoor exposure.

PA, Ridge Area after 2500 h Damp Heat and 500 TC.

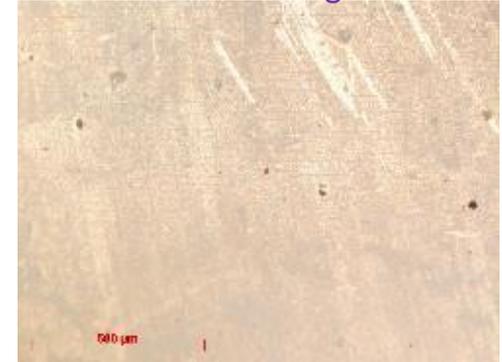
PPE after 4000 h UV
and 600 TC. Ridge

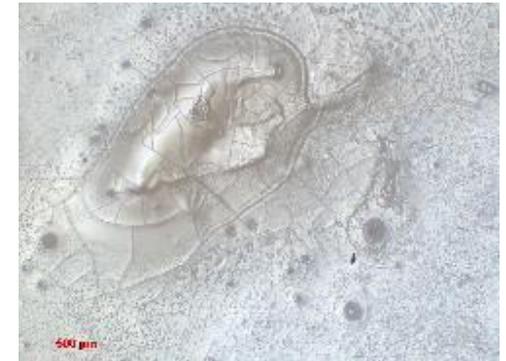
PO/PA/PP/E after
4000 h UV and 400 TC

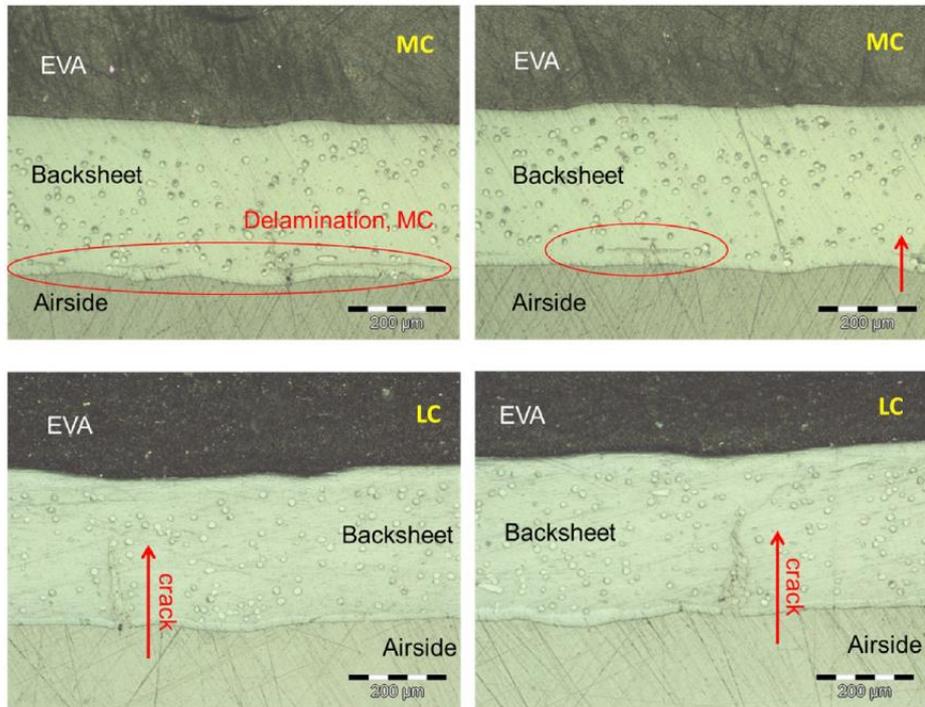
Module with Dispersed Microcracks or Longitudinal Cracks over Tabbing

UV light was seen to affect the side in which cracks were initiated. For cracks between cells, UV light is a key driving stress. Similarly saw EVA enhancement of cracks.

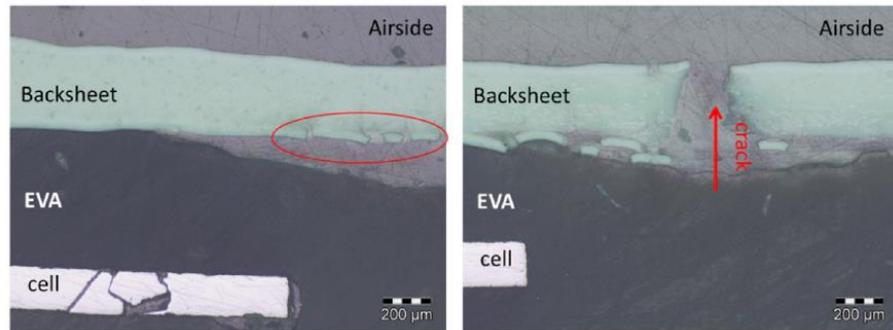
Module with Cracks between Cells
