# Survey of Mechanical Durability of PV Backsheets

Michael D. Kempe<sup>1</sup>, David C. Miller<sup>1</sup>, Allen Zielnik<sup>2</sup>, Daniel Montiel-Chicharro<sup>3</sup>,  
Jiang Zhu<sup>3</sup>, Ralph Gottschalg<sup>3</sup>

Atlas/NIST November 5, 2017

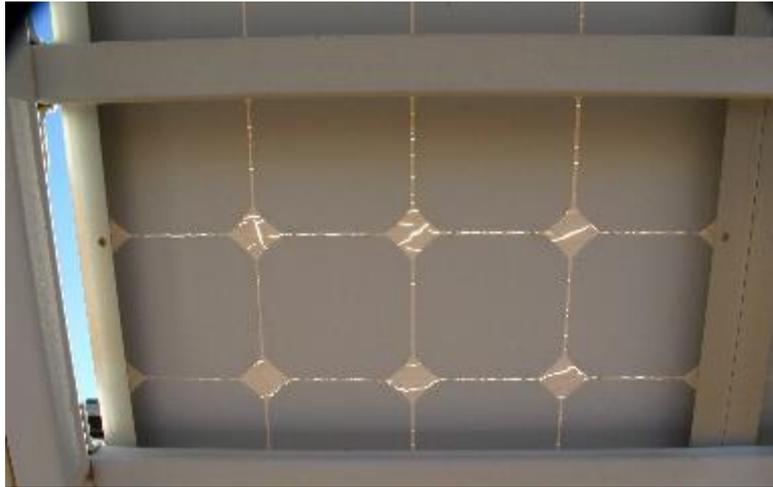
TPE backsheet in conjunction with non-UV absorbing EVA. APS star facility.

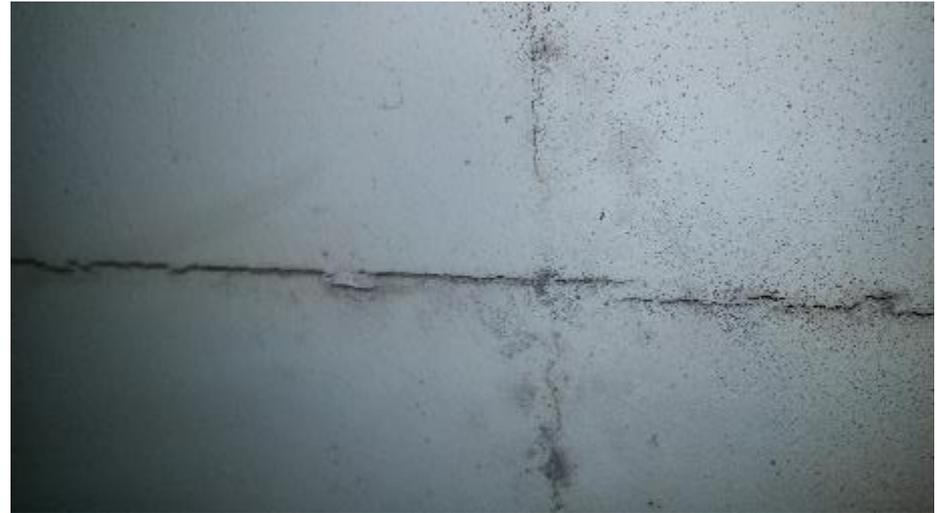
An example of a polyamide backsheet cracking between cells. Other examples show cracks along tabbing. Cracks can appear after as little as 4 to 5 years.

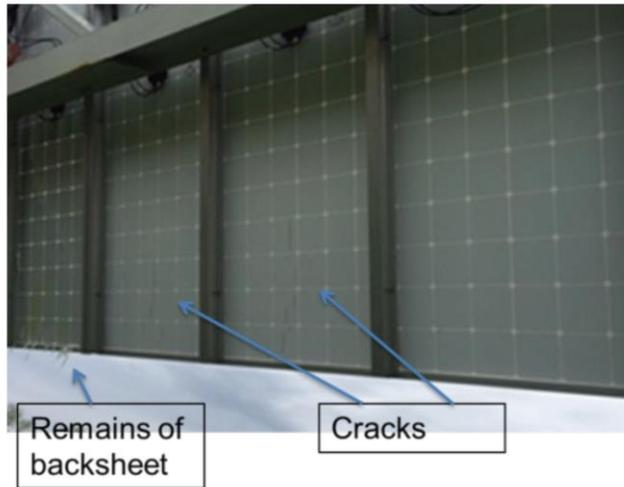
Single-sided PVDF backsheet with cracks in the machine direction preferentially along busbar ribbons.

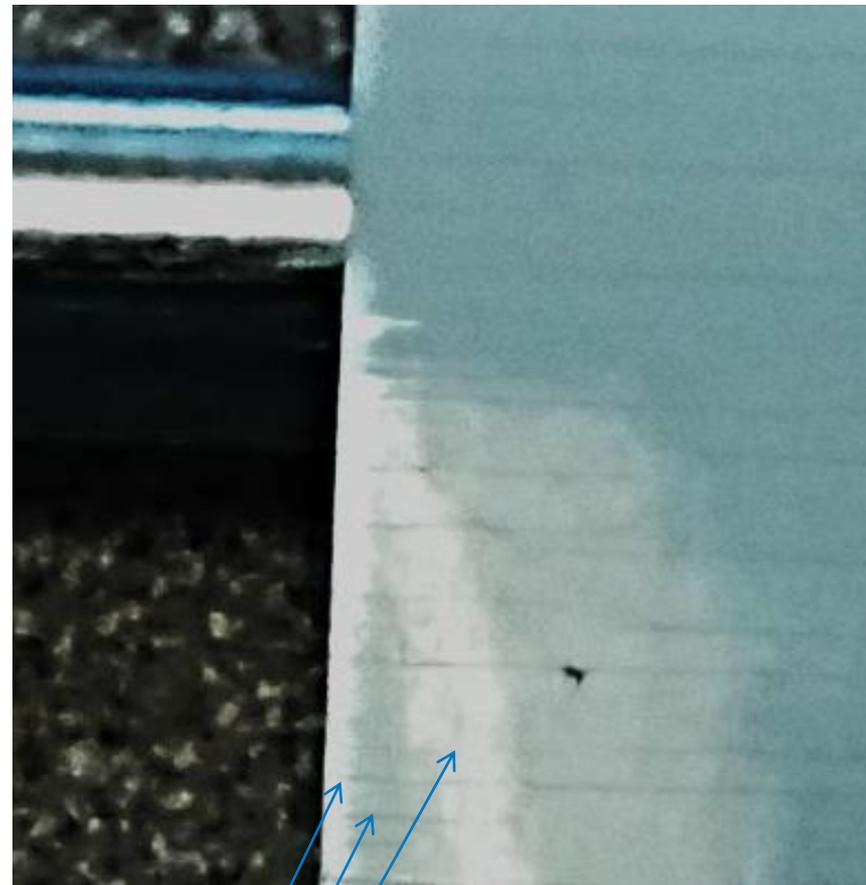
Cracks in transverse direction on cell-side after 750 h.

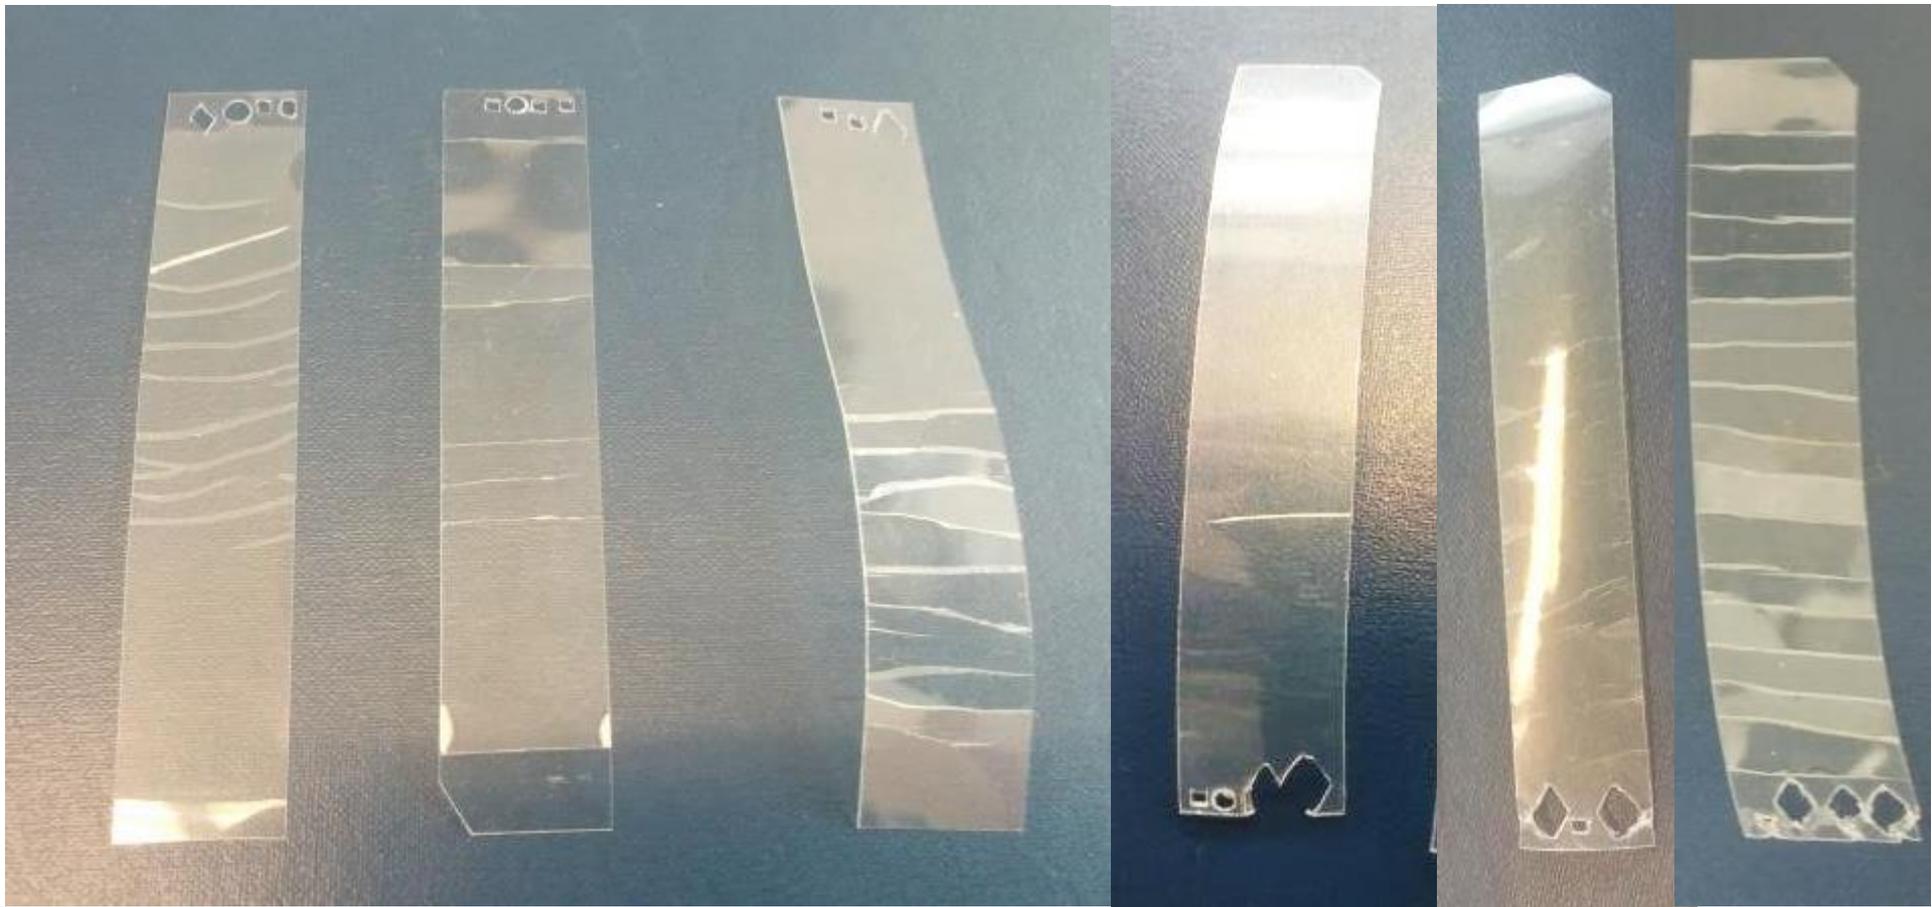
- This is a significant concern for bifacial modules

#38 UV-PET 250 h    #37 Unstabilized PET 250 h    #22 Unstabilized PET 250 h    #35 FPE 500 h    #23 P/P/E 500 h    #53 FPF 750 h

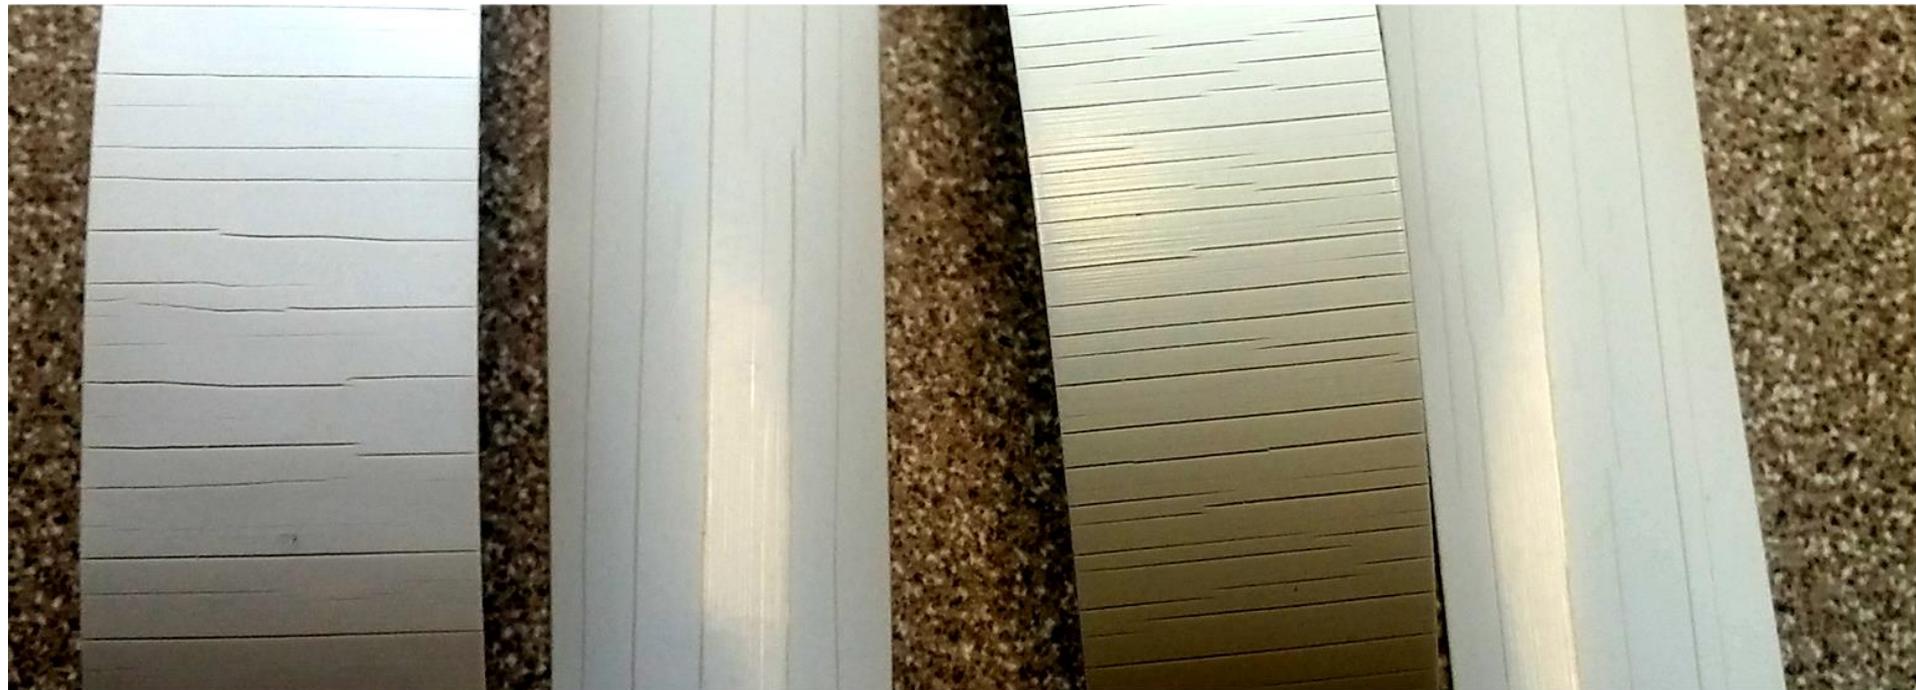
- Cracks usually dominate in the transverse direction but never in the machine direction.
- Residual strain significantly affects cracking.

Cell-Side of Material #1, PVF/PET/Low-VA EVA, 750 h exposure

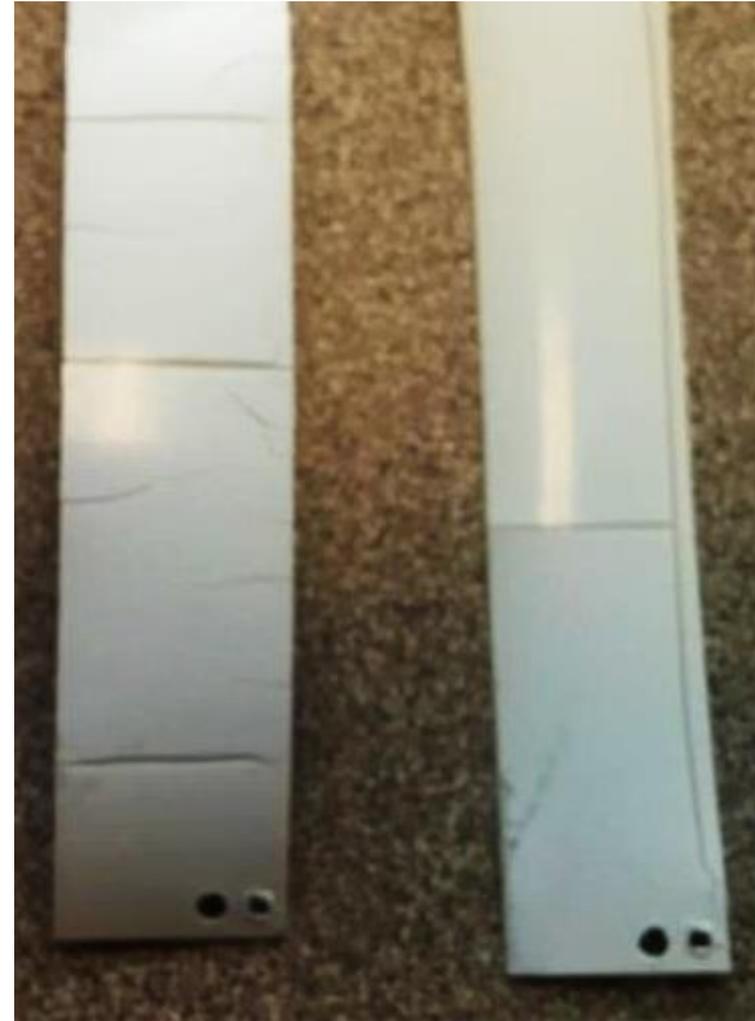
#3 PVF/PET/E, 0.31 mm thick

After 750 h of exposure

- The “E” layer experienced a very large amount of shrinkage.
- In other experiments, even when laminated to an EVA layer, this shrinkage still occurred.
- This is a thermally activated degradation.

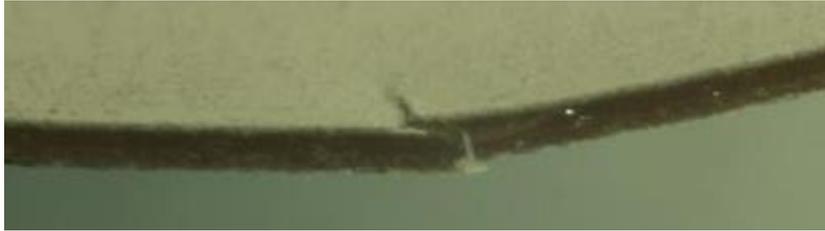
Material #16 PVF/PET/PVF after 2750 h

- View from the edge of three samples with PET failure.
- Cracking only seen in the fluoropolymer where the PET cracked.
- Delamination occurred on both sides of the PET in one material.
- No instances of an opaque surface PET layer failure were seen.

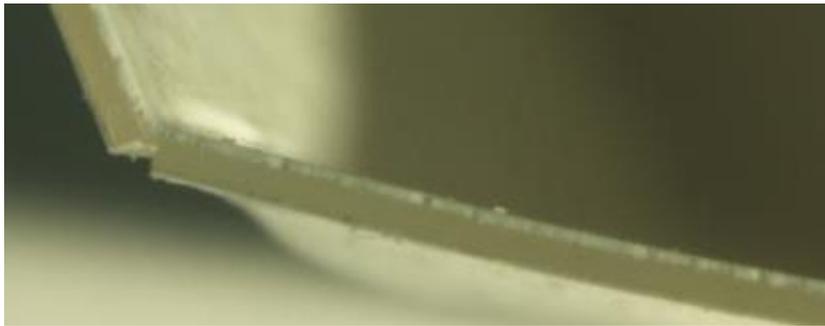
Material #26 PET/PET/"E" after 1500 h

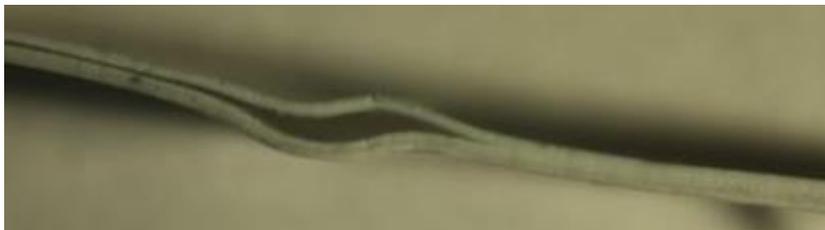
Material #33 PET/PET/"E" failed after 1750 h

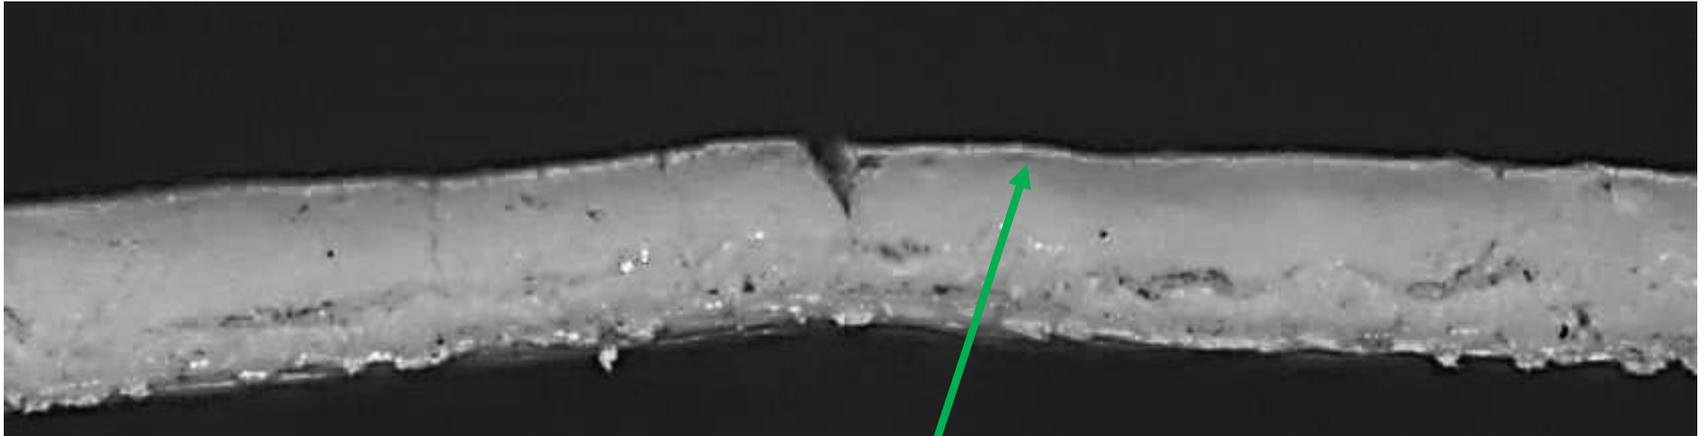
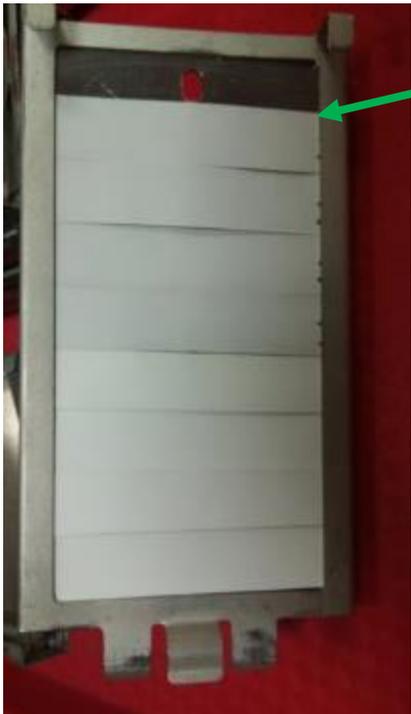
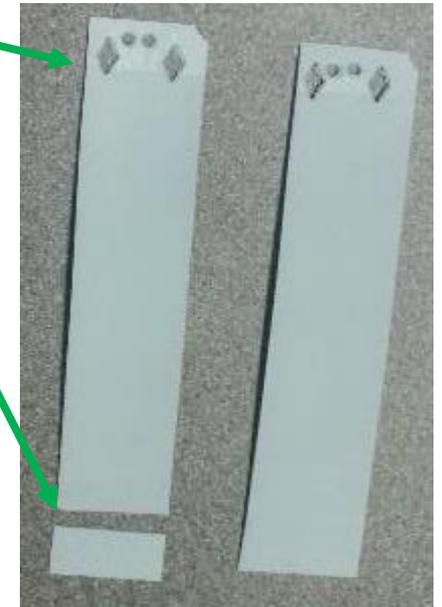
Edge of shaded area

- The area under the metal holder would be hotter because of greater light absorption.
- The ends had a significantly higher modulus and retained the glossy surface appearance. This region occupied a well defined boundary both visibly and physically.
- When bent, the stress concentration at this boundary sometimes caused cracking after 3000 h of exposure.
- This implies that the embrittlement of this material is likely to be very highly thermally activated.

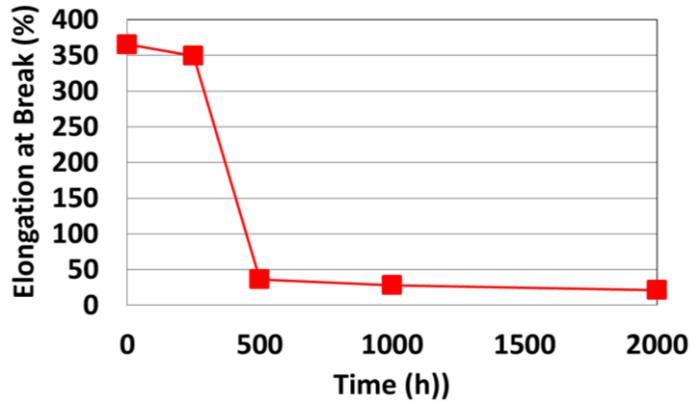
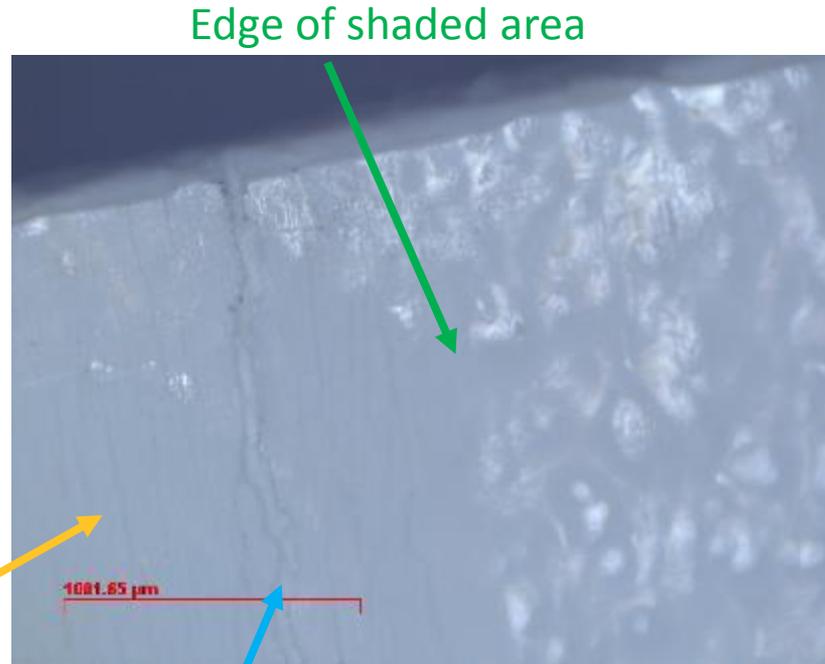
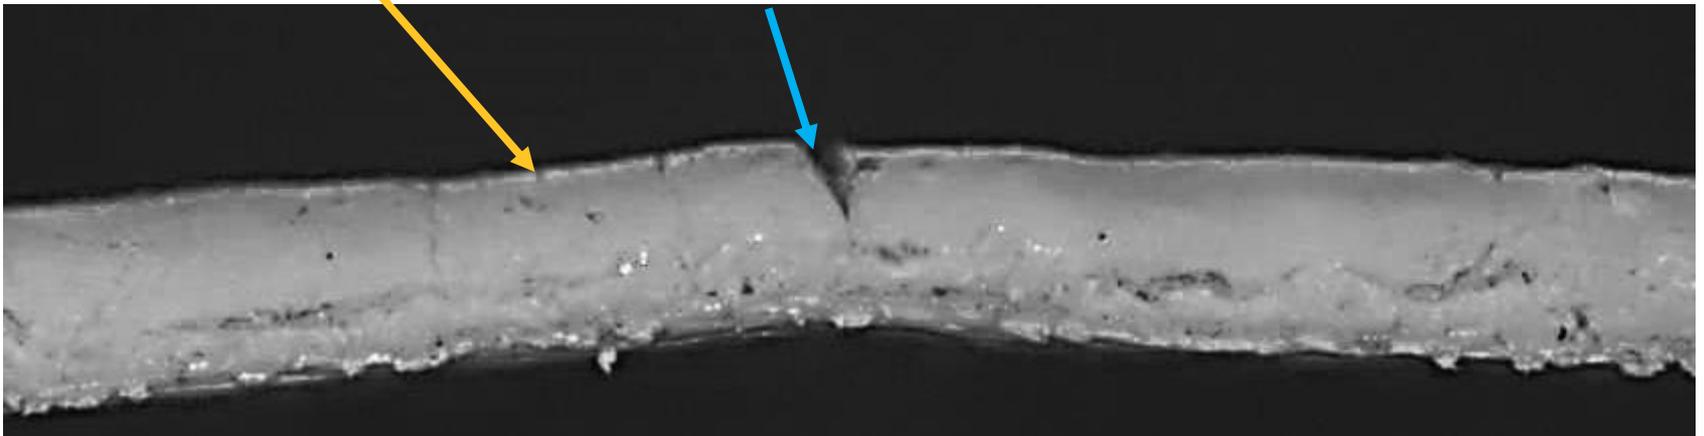
Bulk properties Failed Quickly

UV light alone will not produce cracks that penetrate the whole backsheet.
