Durability of Packaging Material in Globally Fielded PV Modules

Jared Tracy
Dec 2019

DuPont global field reliability program

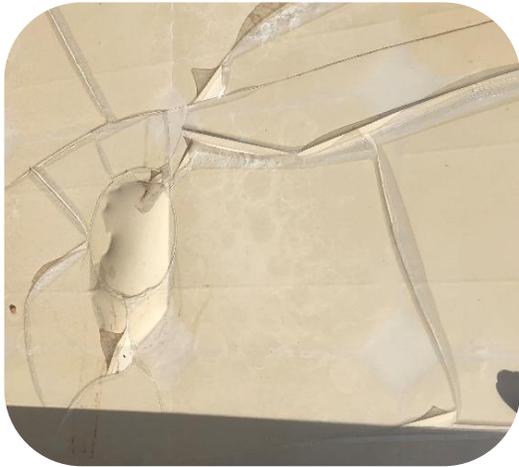
16 years, Arizona high desert

Outer layer (air side) cracking

Cracks expose interior layers/encapsulant to moisture and UV light

- PET core layer often not stabilized, may crack
- direct moisture pathway facilitates interface delamination

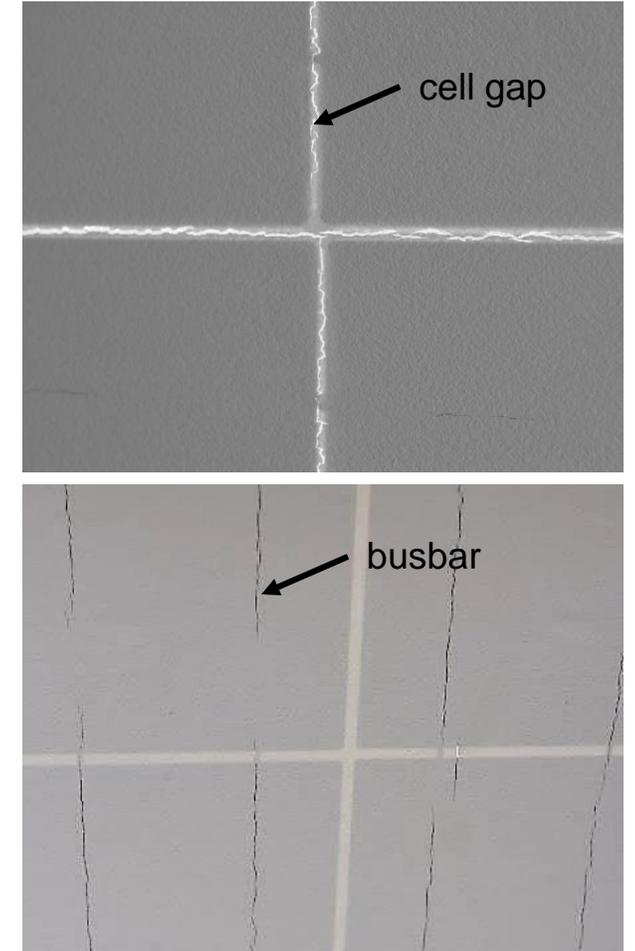
Through-cracks along tabbing ribbons and cell gaps, 6 years, Sonoran Desert

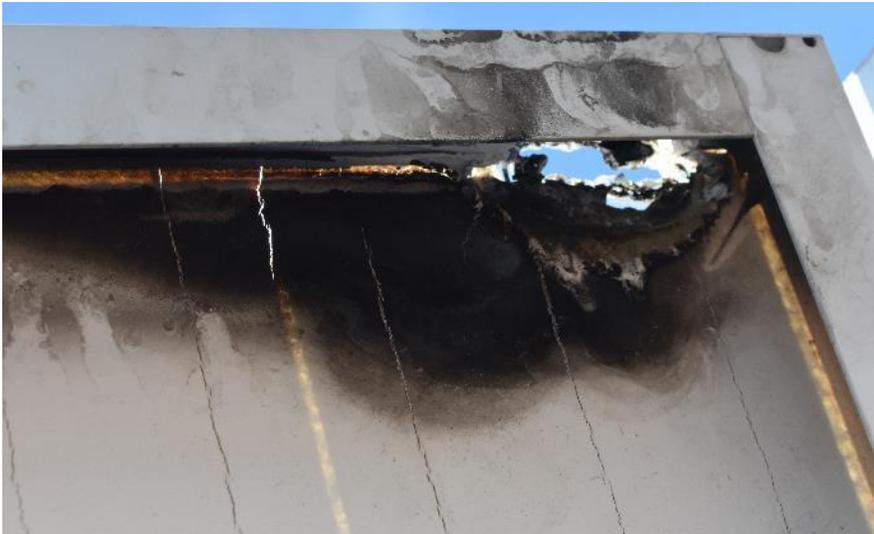
7 years, Sonoran Desert, USA

- prevalent along busbar ribbons, but extends to cell gaps and other regions with continued weathering
- corrosion, shorts, and arcing lead to localized melting/scorning and potentially full module fires
- reported inverter tripping and ground faults

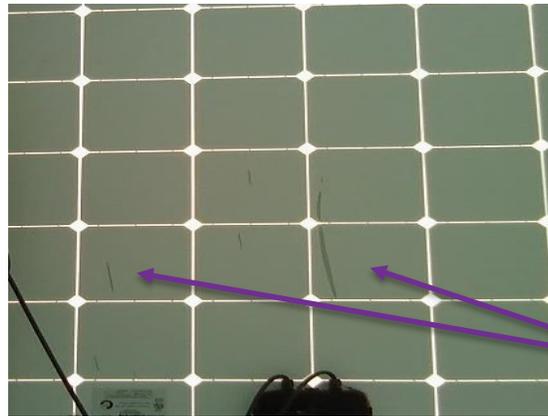
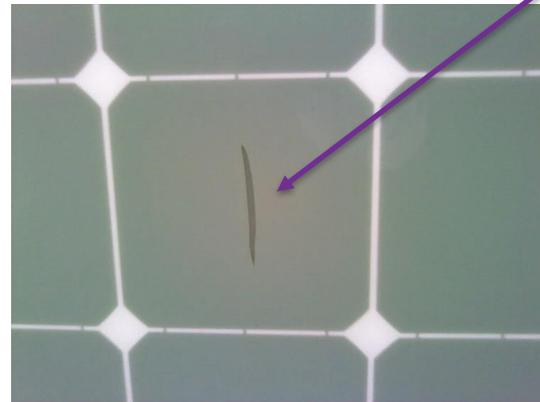
Initial inspection: 4 yrs, Canada

- 10% of modules exhibit cracking

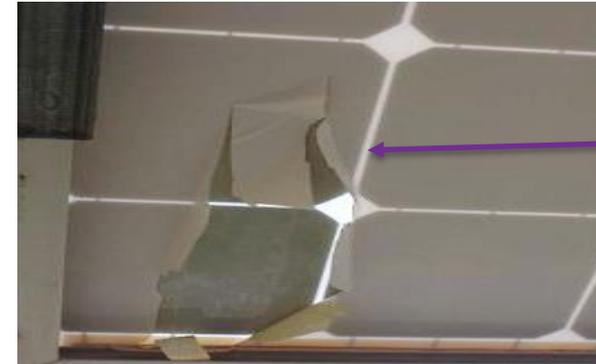
2 yrs →

Cracks evolving into delamination

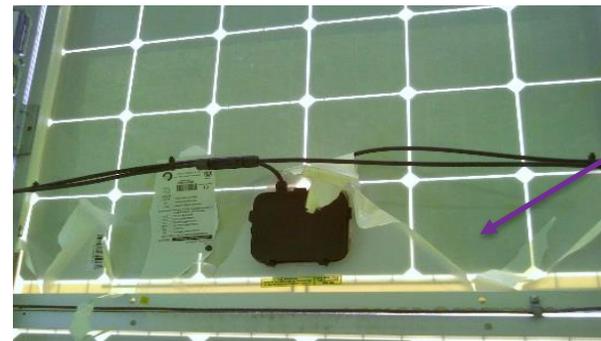
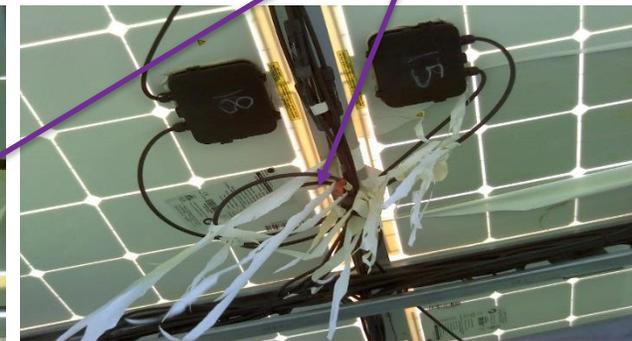
Remains of backsheet outer layer

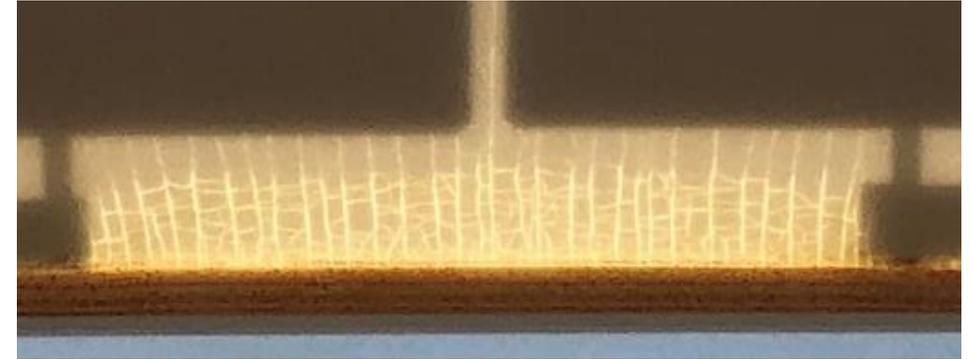
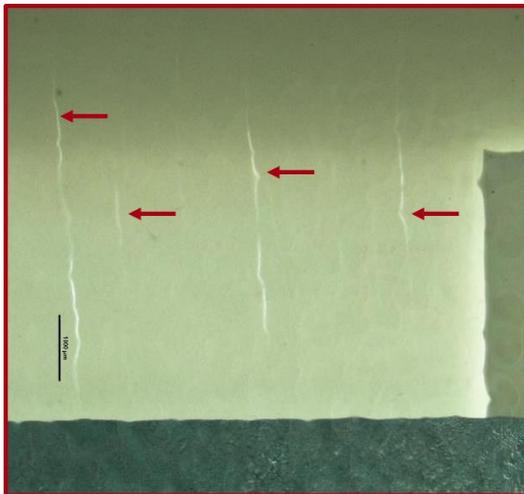
7 years, Sonoran Desert, Arizona

- Inner (tie) layer often an EVA (low VA content)/polyolefin material
 - usually encountered in backsheets composed of FEVE or PET-based outer layers
- Not always readily visible by eye; may require backlit illumination
- Often originate at/near busbar: corrosion can be visual cue

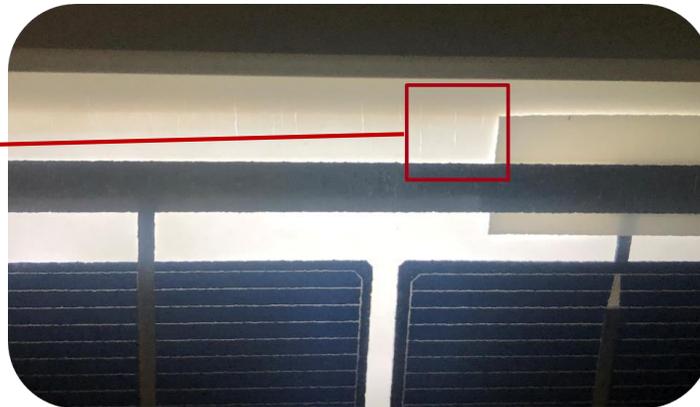
Cracking under backlit illumination,
7 years, Arizona high-desert

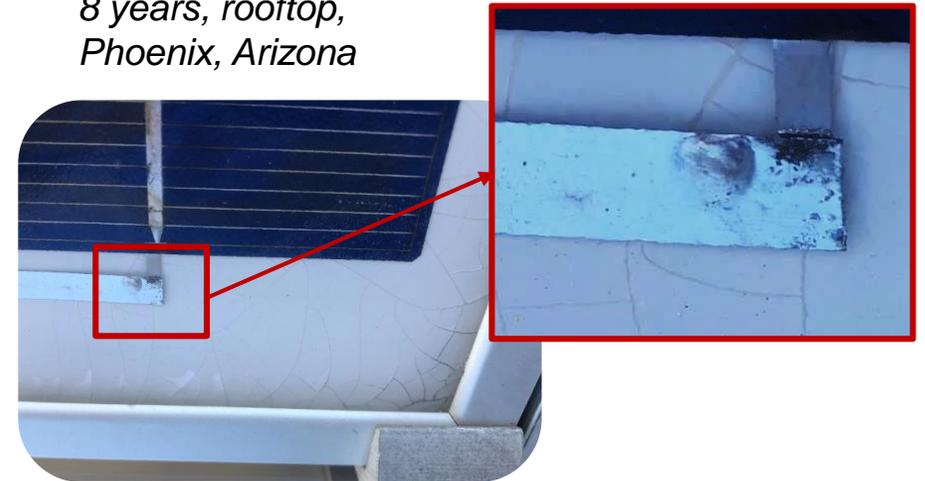
8 years, rooftop,
Phoenix, Arizona

- facilitate moisture ingress, often leading to busbar corrosion
- exposure of module interiors to moisture may lead to shorting, inverter trips, power loss, module fires
- correlation between power loss and inner layer cracking

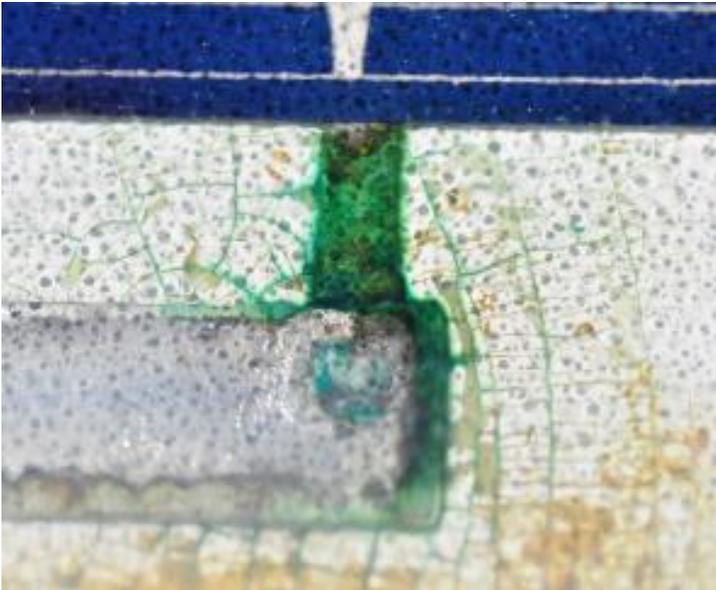
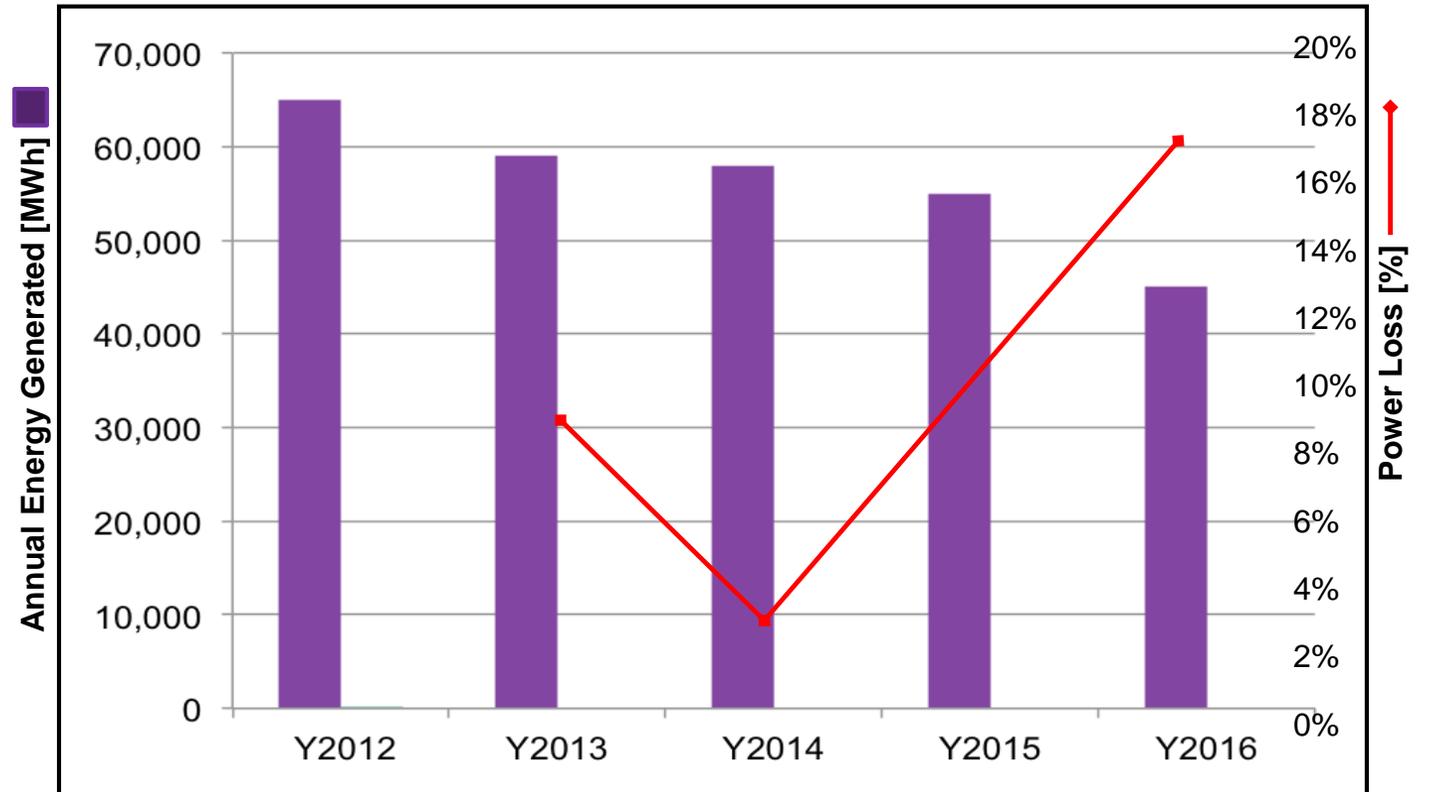
Corrosion of busbar/tabling ribbon

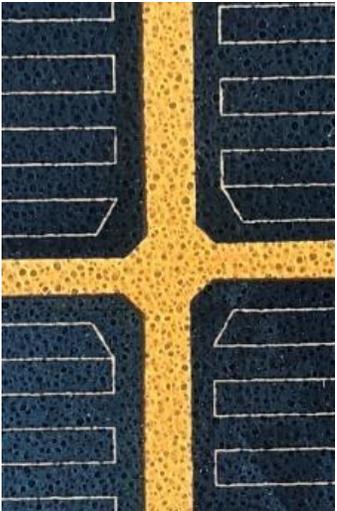
6 years, SW USA

Inner layer yellowing

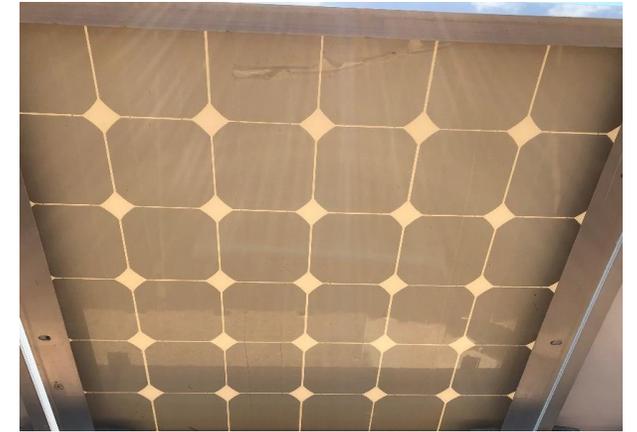
Outer layer yellowing

PET, 16 years, Arizona high desert

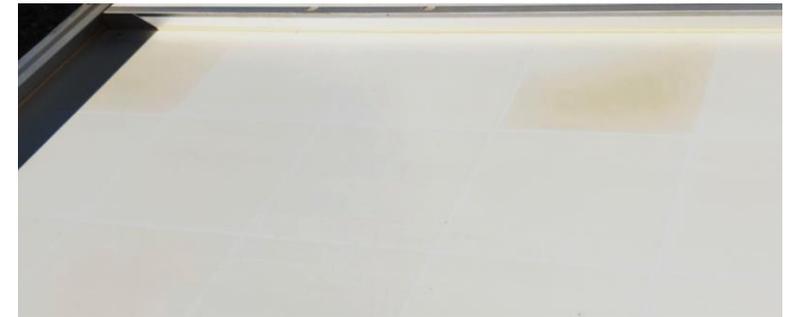
PVDF, 6 years, Sonoran Desert

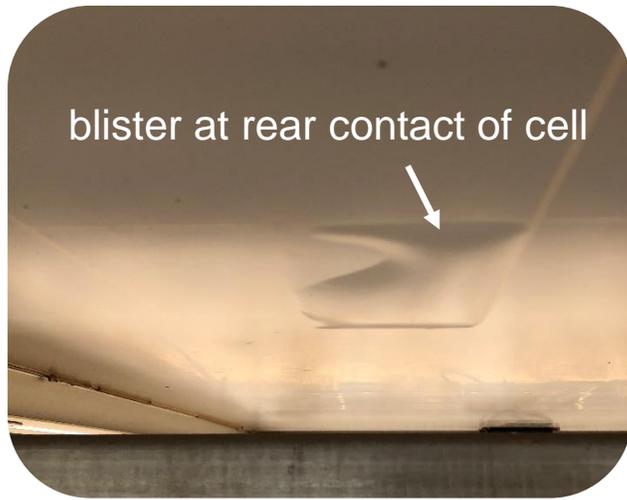
6 years, Sonoran Desert, Arizona

Interface delamination/blistering

- Observed at interfaces within backsheet laminates or at encapsulant interface
- If accompanying cracking, delamination will expose PET core to environmental stressors
- Can provide pathway for shorts to ground, potential module fires

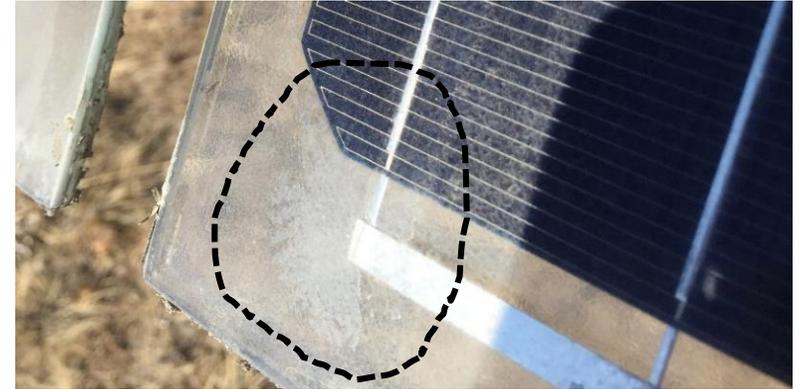
Dual glass module, 1.5 years, NW China

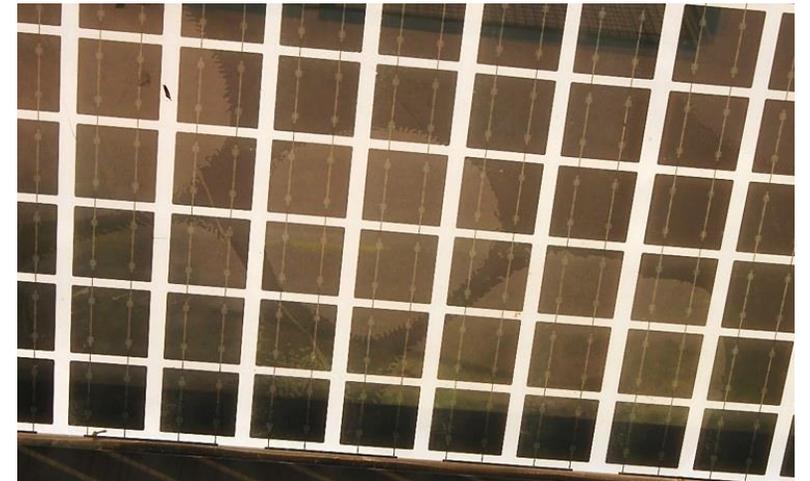
Dual glass module, 10 years, Arizona

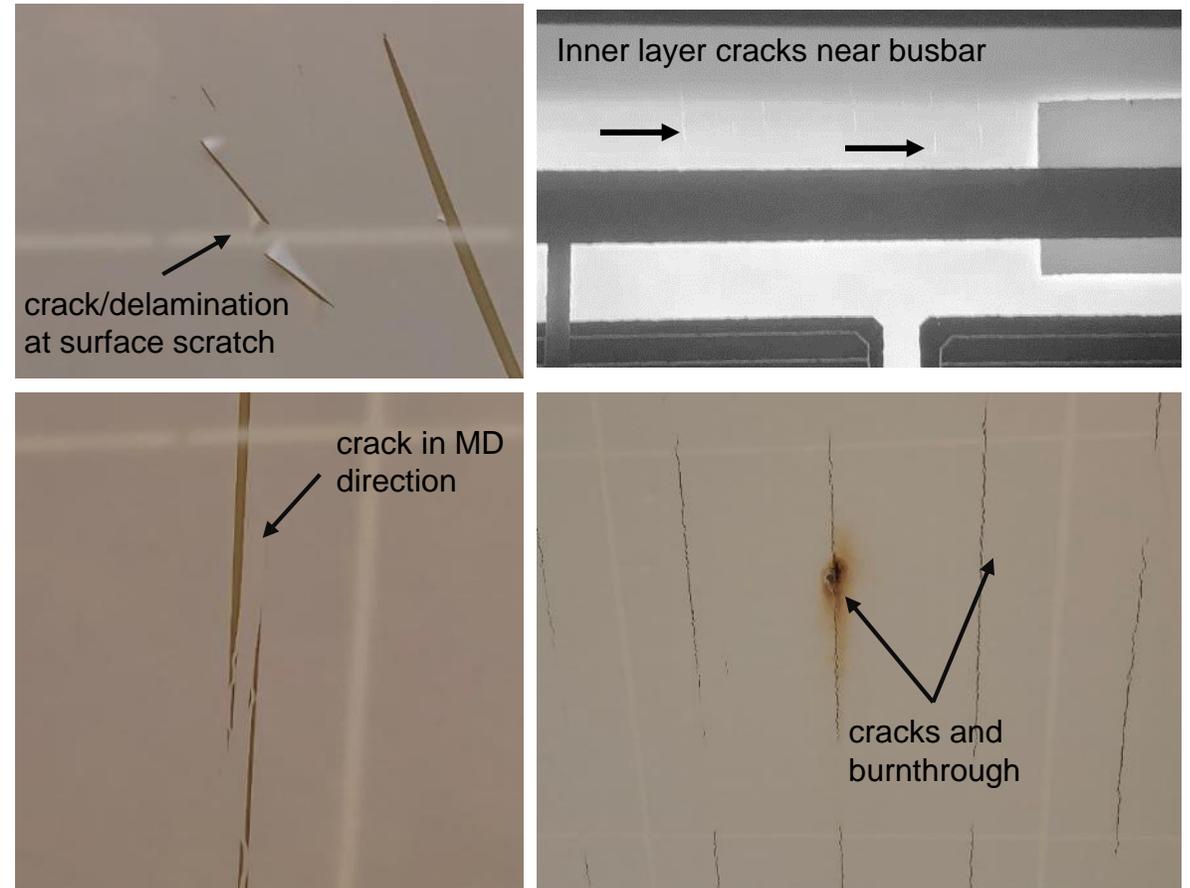
12 MW field in Arizona, USA, 7 years old

PA (6 MW), PET (3 MW), PVDF (1.5 MW), PVF (1.5 MW)

Significant defects observed in PA, PET, and PVDF

- 100% of PA backsheet exhibited cracking along busbar ribbons, with several instances of burn-through
- 100% of PVDF backsheet exhibited outer layer cracking, leading to outer layer delamination
- Inner layer cracking in 100% PET-based backsheets, with ~5% severe busbar corrosion
- No defects in PVF

ALL MODULES REPLACED

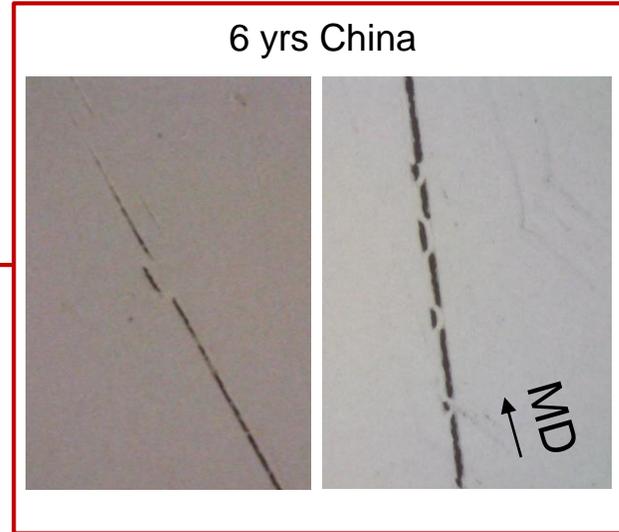
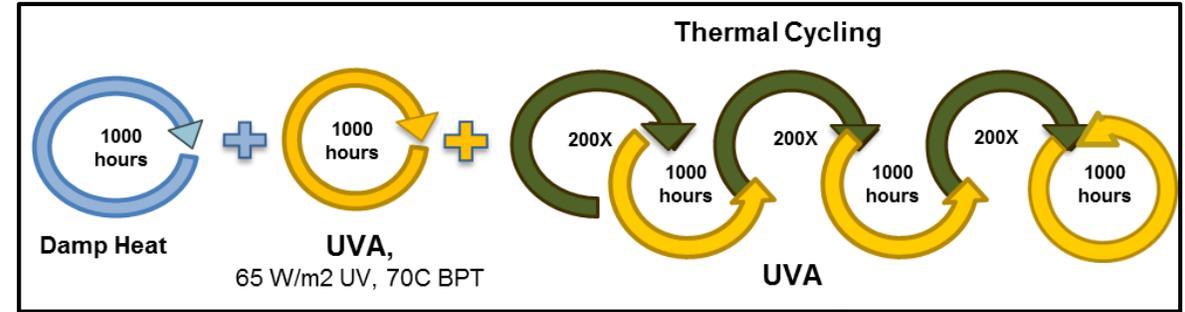
Field

cracking along tabbing ribbon of single layer PVDF

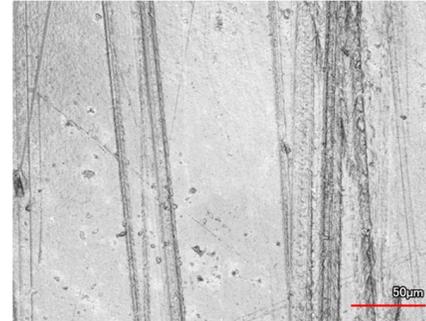
Arizona (laser confocal)

Cracking in tri-layer PVDF

- generally propagate in MD direction or along surface scratches/scuffs
- nucleation and extension observed when thermally cycled
- outermost neat layer exhibits brittle morphology

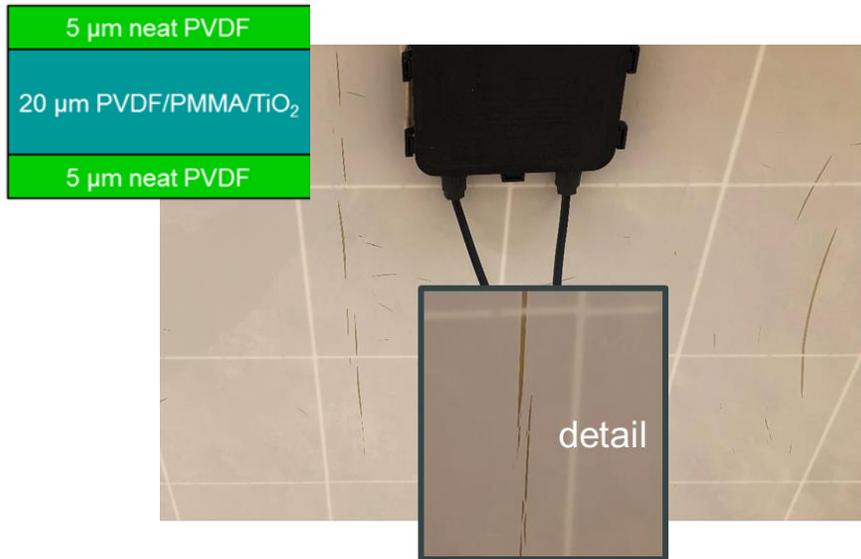
Scratches in neat PVDF layer of globally fielded modules

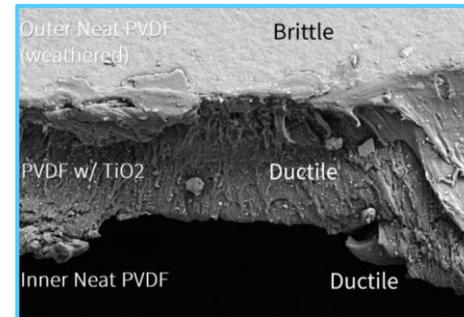
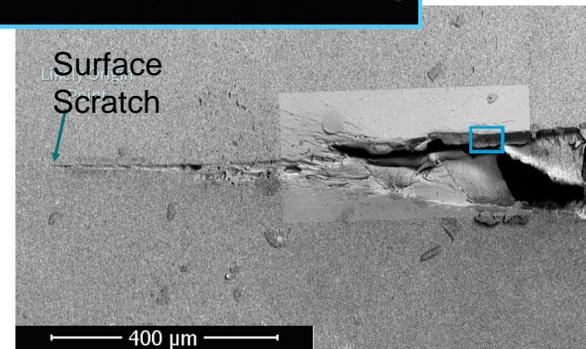
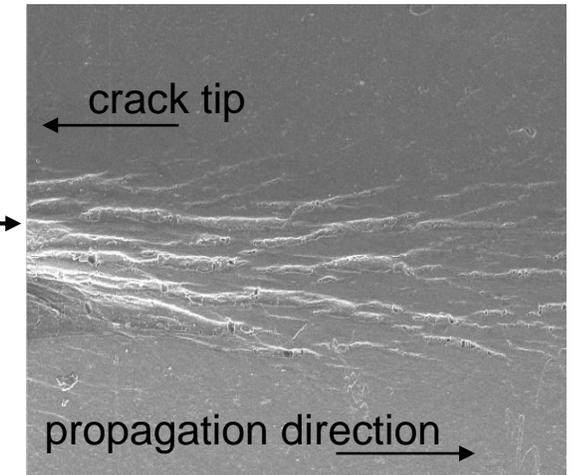
Outer layer crack in tri-layer PVDF after 7 yrs in Arizona

Crack bifurcation of neat outer layer in plastic zone of crack (7 yrs Arizona)

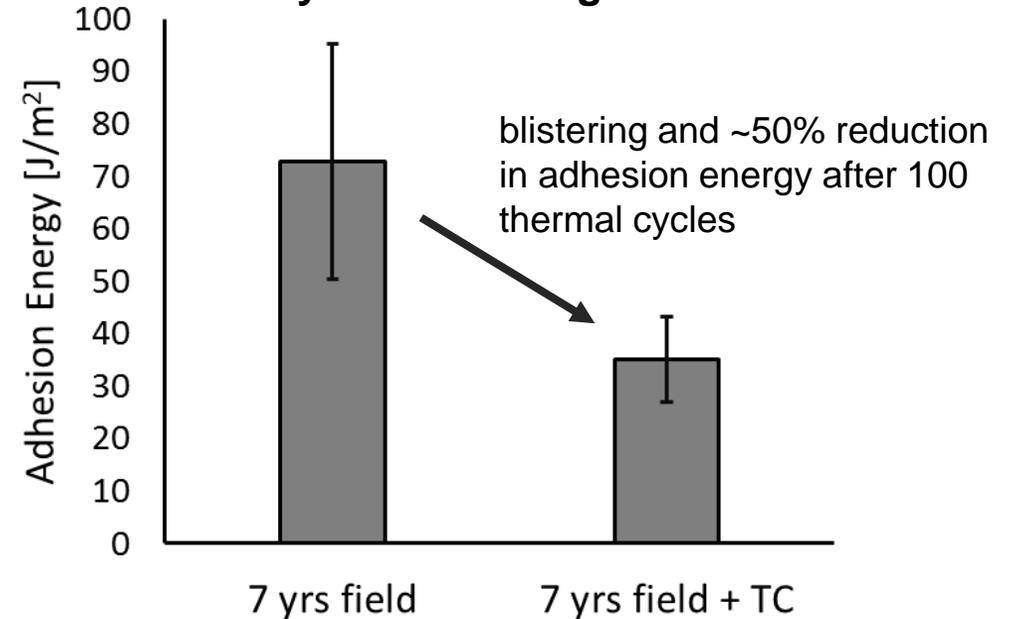
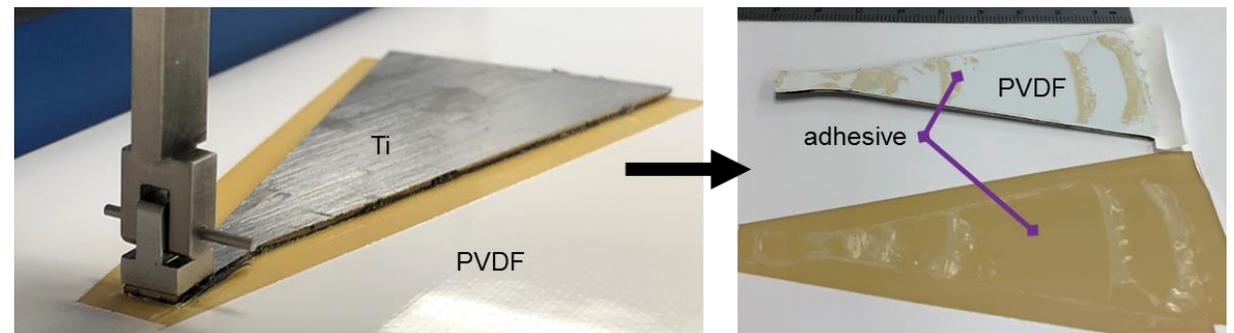
7 yrs Arizona high desert

- PVDF, 7 yrs, Arizona: $70 J/m^2$
- further reduction following 100 thermal cycles

delamination at PVDF/adhesive (polyester isophthalate) interface
