Technical Investigation of the May 22, 2011, Tornado in Joplin, MO

December 10, 2012
NCST Advisory
Committee Meeting

Structural Response

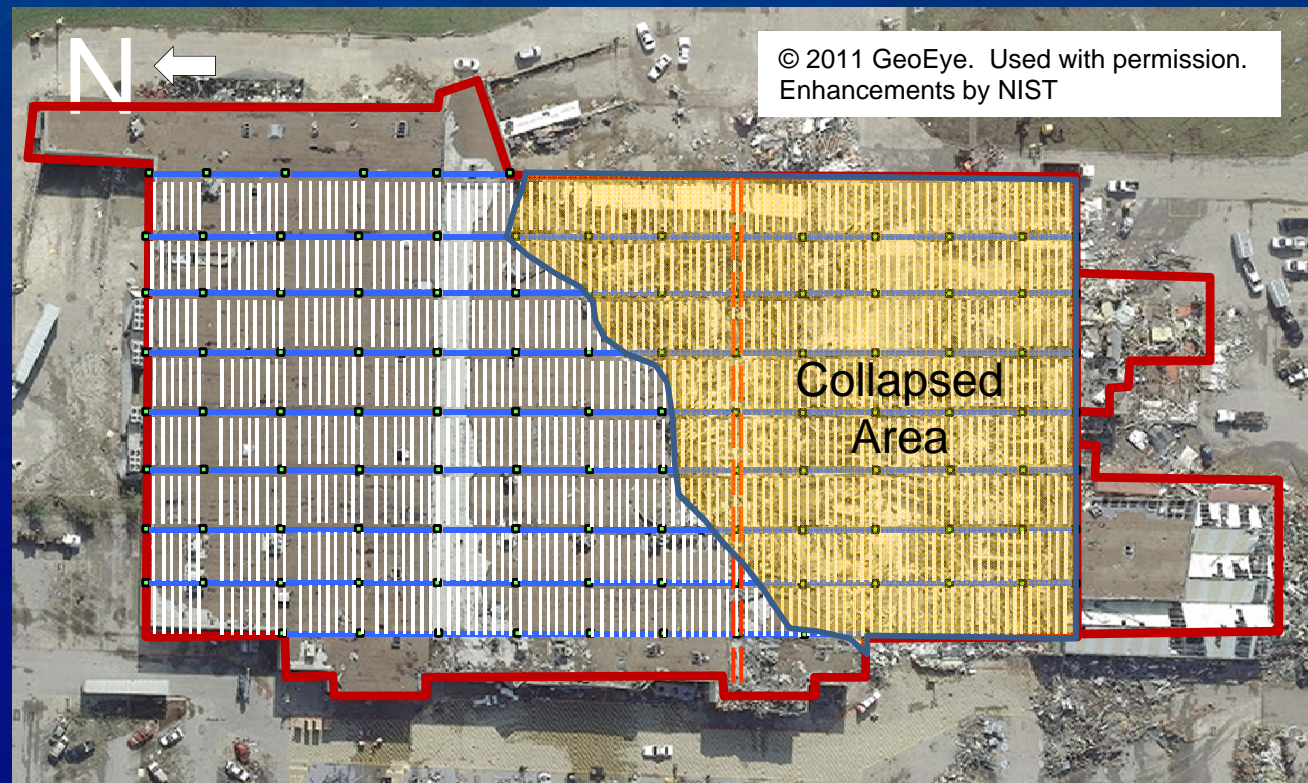
- **Series of individual plane frames:** Gravity Loads (*Open Web Joist Girders* simply supported by *Steel Tube Columns*)
- **Perimeter walls:** Gravity and Lateral Loads (*Reinforced CMU*)
- **Roof system:** Diaphragm providing lateral bracing for walls (*Open Web Bar Joists and Wide Rib Steel Deck*)

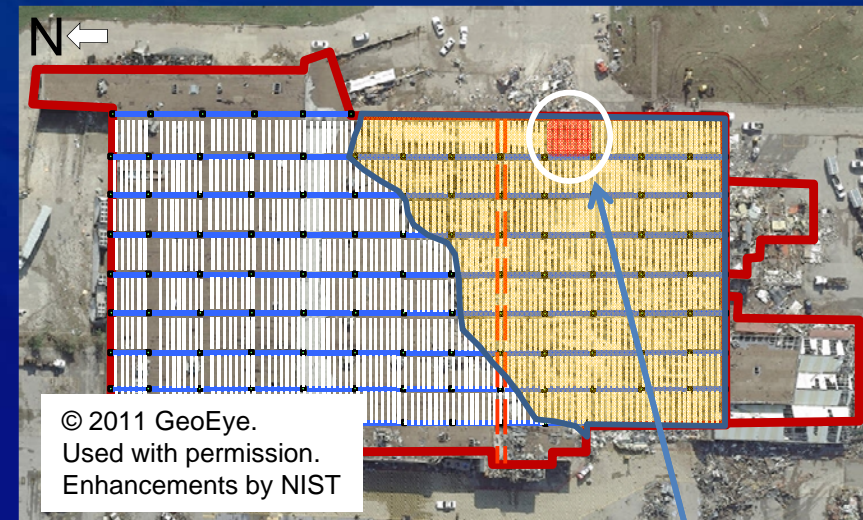
Refuge area with exterior fire exit door

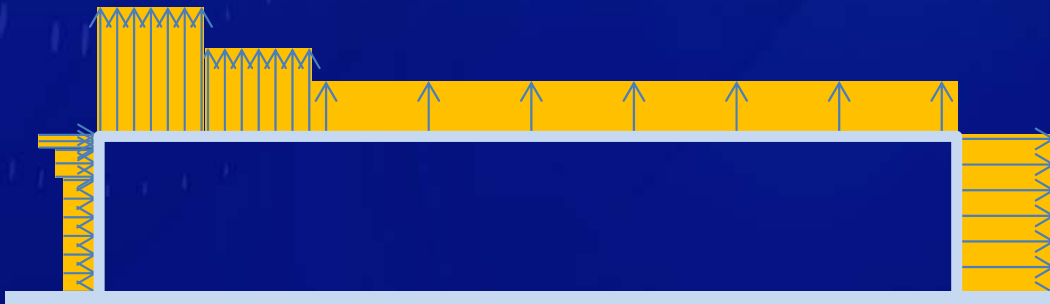
- Loss of roof decks
- Loss of roof joists
- Most joist girders remained in place, albeit damaged (bent upward)
- All interior columns remained in place
- Sections of perimeter walls collapsed inward

Roof Decks and Joists missing

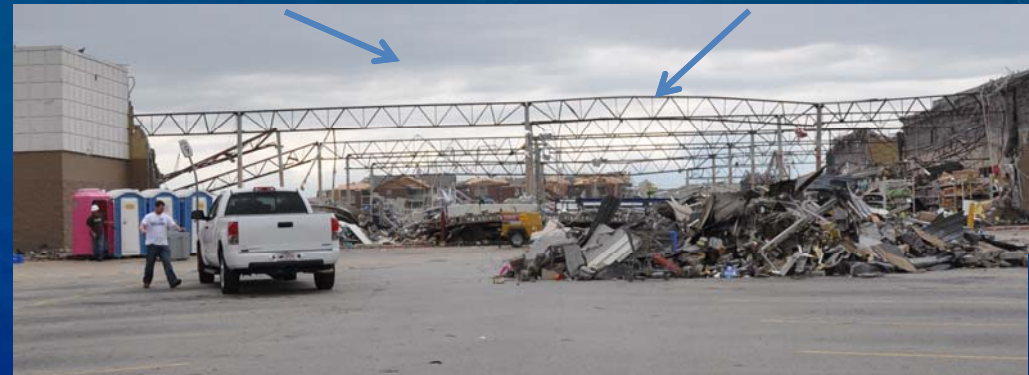
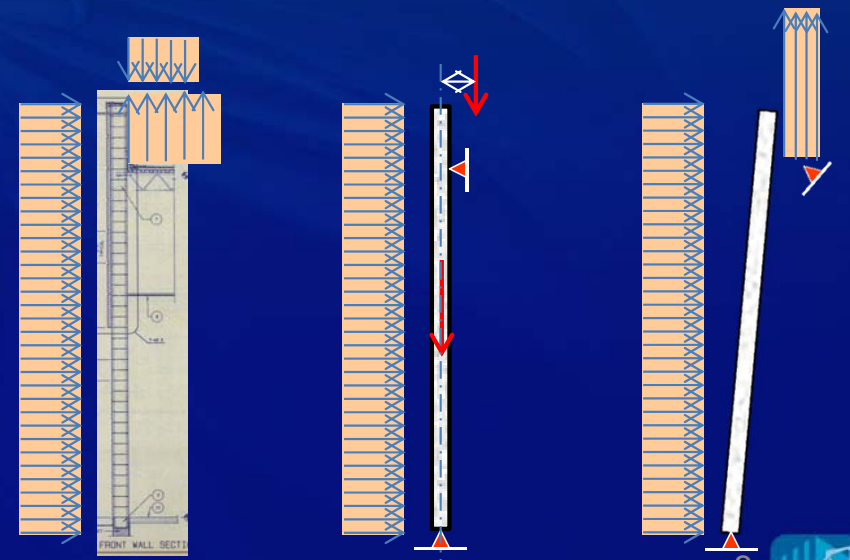
Joist Girders bent upward

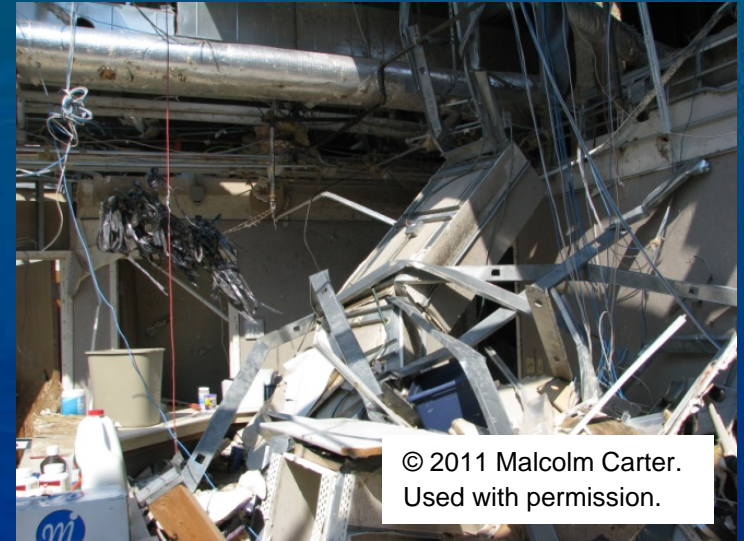
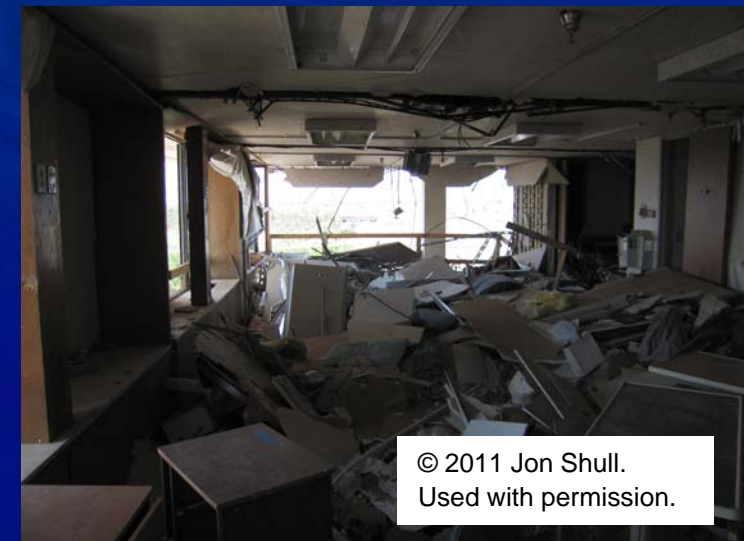
- Critical facility (hospital) provided collapse prevention, but not life safety or continuity of operation due to
 - **Damage to roof envelope**
 - water intrusion
 - Loss of aggregate roof ballast contributed to window damage
 - **Damage to wall envelope**
 - Wind, debris and water intrusion
 - Significant damage to building interior and systems
 - **Loss of power**
 - Loss of line power and backup power
 - Damage to electrical system
 - **Loss of vertical transport**
 - Damage to penthouse housing elevator equipment and to elevator shaft
 - Loss of power

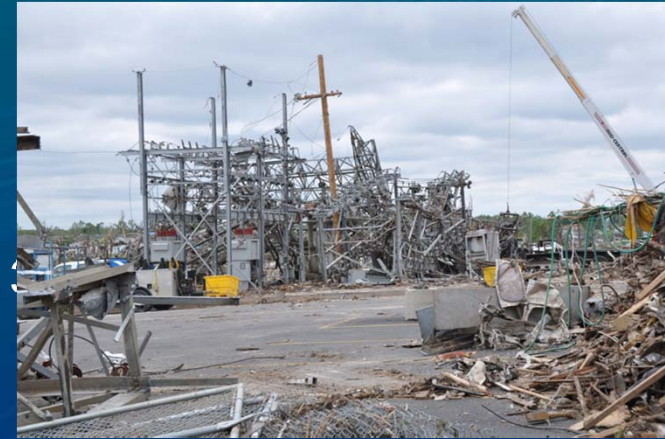
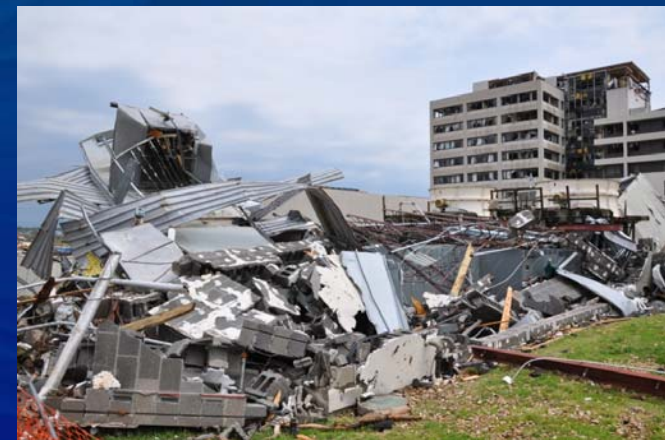
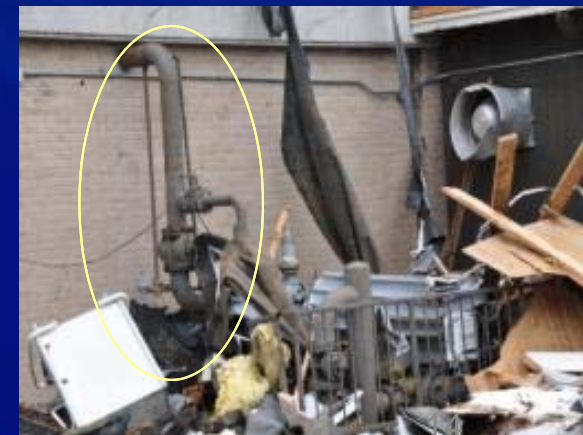
- **Power** (Source: Empire District Electric)
 - 1 substation destroyed (supporting steel frame collapsed), damaged. 20,000 without power
 - Approx. 3,900 poles damaged; 100 miles of line downed; circuits off
 - 10 transmission lines out of service; 135 transmission structures affected; 30 fiber lines cut
- **Loss of emergency backup power** (Source: SJRMC)
- **High Pressure Gas Valve** (Source: SJRMC)
 - Major leak adjacent to area used to triage tornado victims
 - Not shut off for some time
- **Water** (Source: Joplin Fire Department)
 - Numerous small leaks due to broken pipes in buildings
 - Unable to use fire hydrants in some areas due to low pressure
- **Water Treatment Plant** (Source: Mo. Amer. Water Eng.)
 - Unreinforced brick storage building (1898) collapsed
 - Plant remained operational on back-up power
