NIST Response to the World Trade Center Disaster

**Federal Building and Fire Safety Investigation
of
the World Trade Center Disaster**

November 19, 2008

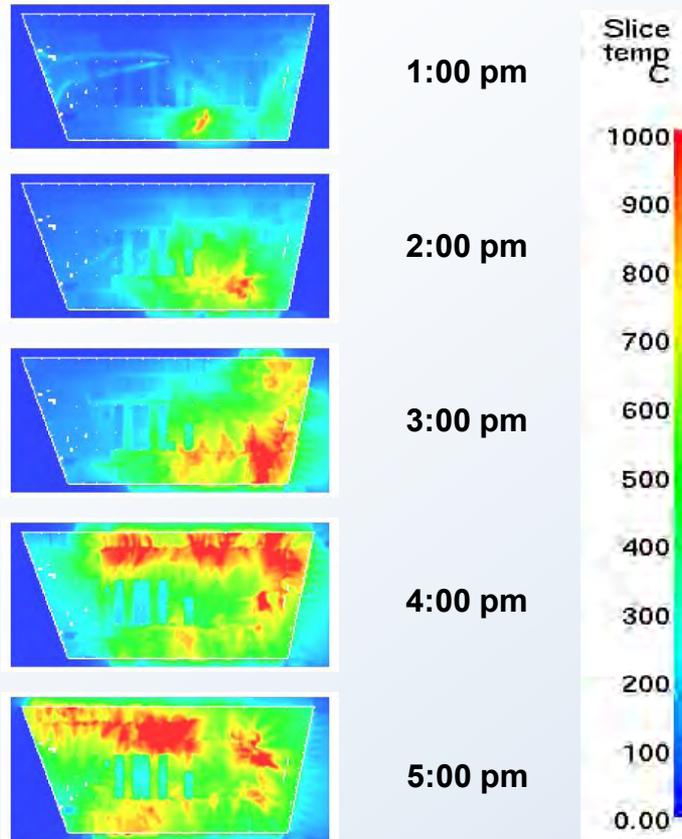
Progression of fires on Floor 12

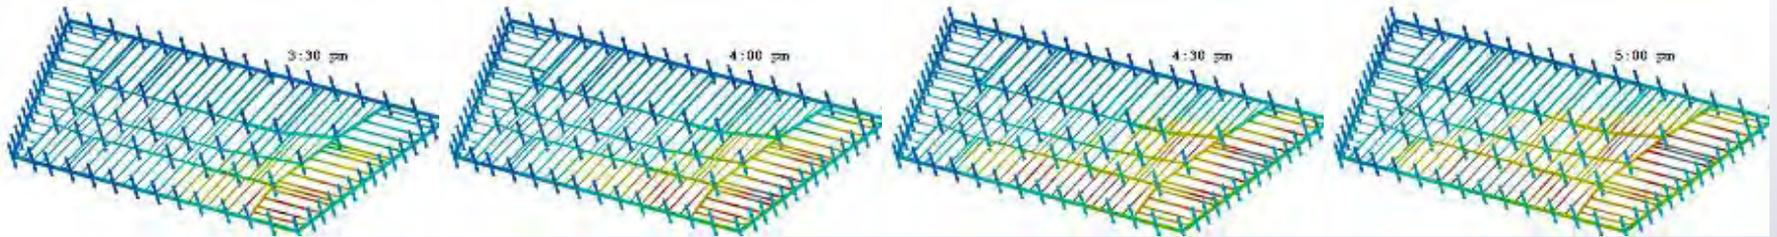
Temperature distribution ($^{\circ}\text{C}$) on the floor beams of Floor 13.

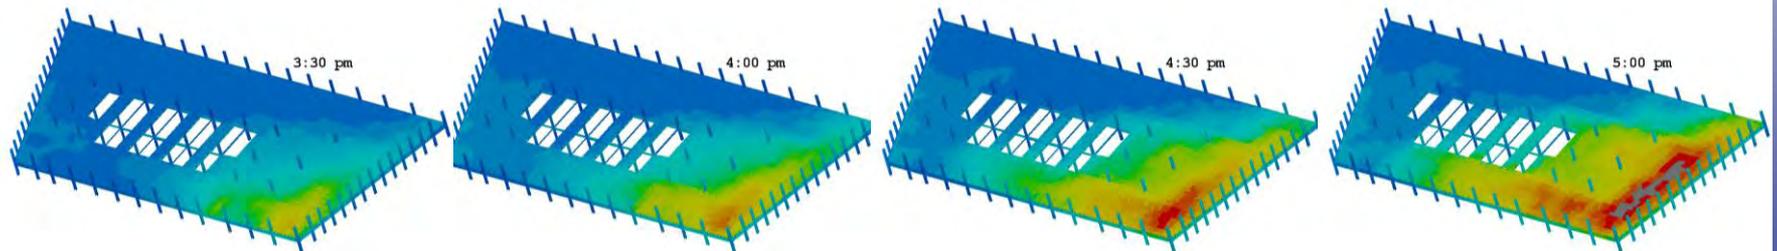
Temperature distribution ($^{\circ}\text{C}$) in the top layer of the floor slabs of Floor 12.

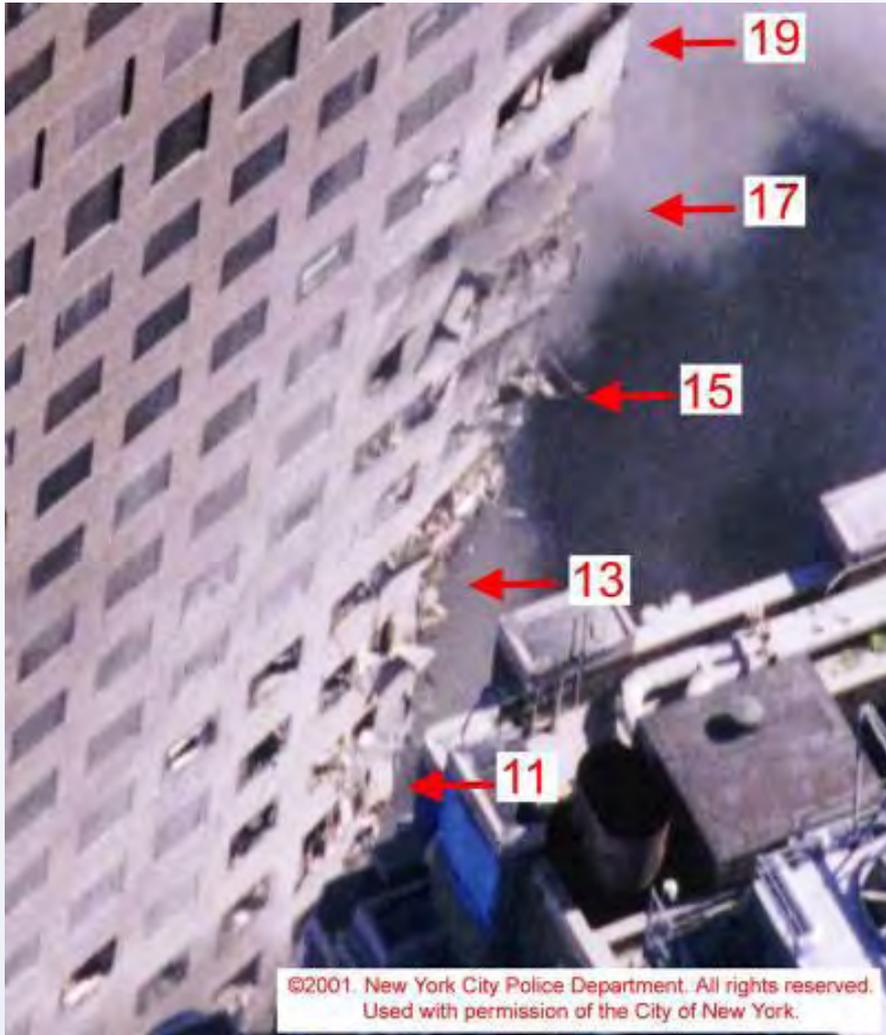
- Collapse of the WTC Towers.
 - Collapse of WTC 2 did not cause any structural damage or start any fires in WTC 7.
 - Collapse of WTC 1 damaged seven exterior columns on the lower floors of the south and west faces and initiated fires on 10 floors between Floors 7 and 30.
- Aerial photograph shot $14 \text{ s} \pm 0.5 \text{ s}$ after WTC 1 began to collapse.
- Arrows mark arcs formed by debris that seemed to be ejected outwards from the debris cloud

- Enlargement of a photograph showing part of the west face of WTC 7.
- Arrows and floor numbers have been added for the corresponding rows of windows.

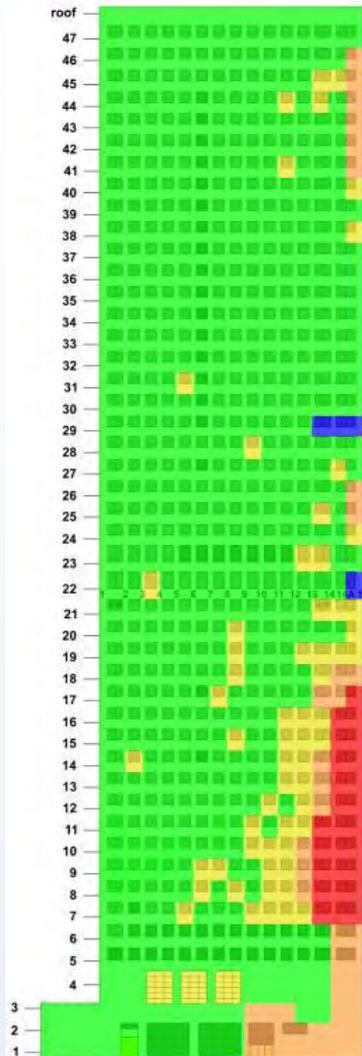
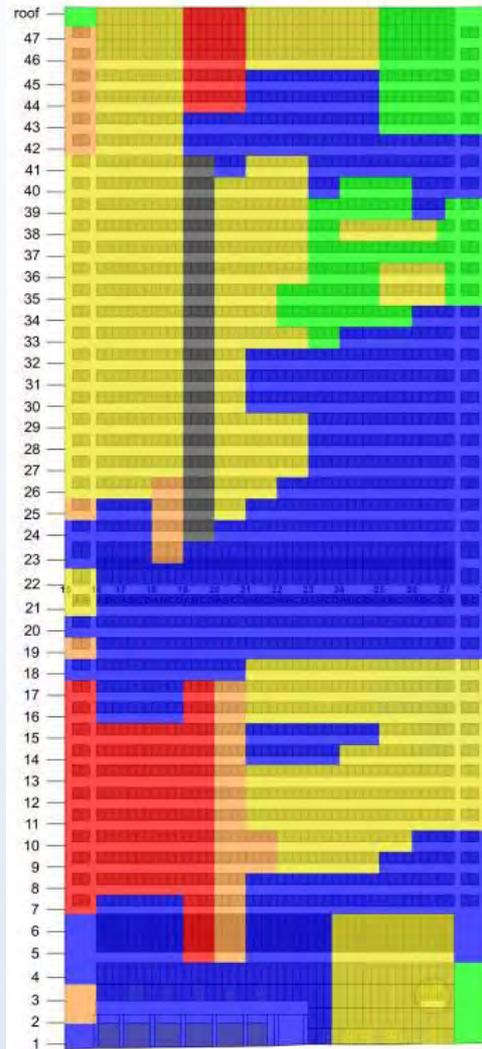
green (■) - no visible damage

yellow (■) – window glass broken

orange (■) – granite and underlying truss damage

red (■) – damage to exterior structural steel

blue (■) – not visible due to smoke, dust, and intervening buildings.

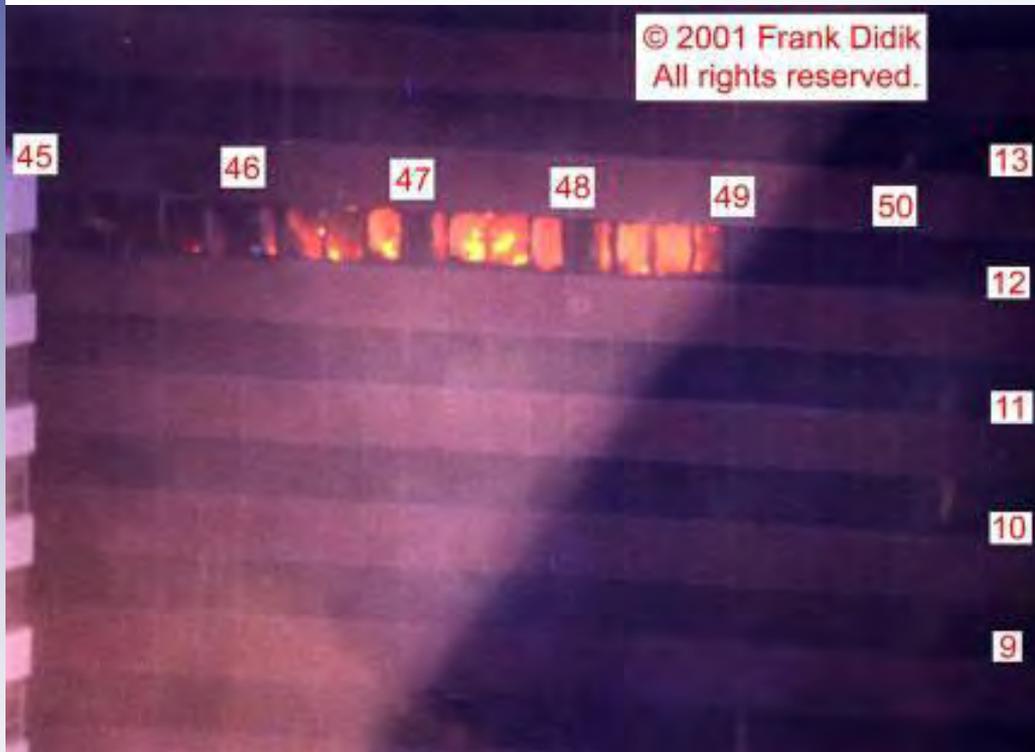
- Cropped photograph of north face of WTC 7 taken between 3:11:15 p.m. and 3:16:51 p.m.

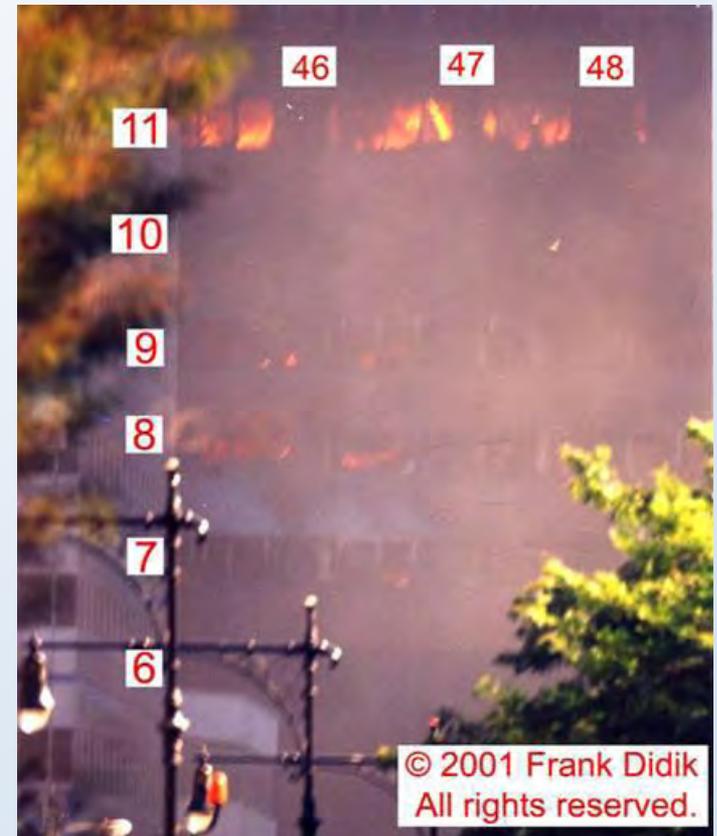
- Cropped photograph showing part of north face of WTC 7 at 4:39 p.m. \pm 120 s.

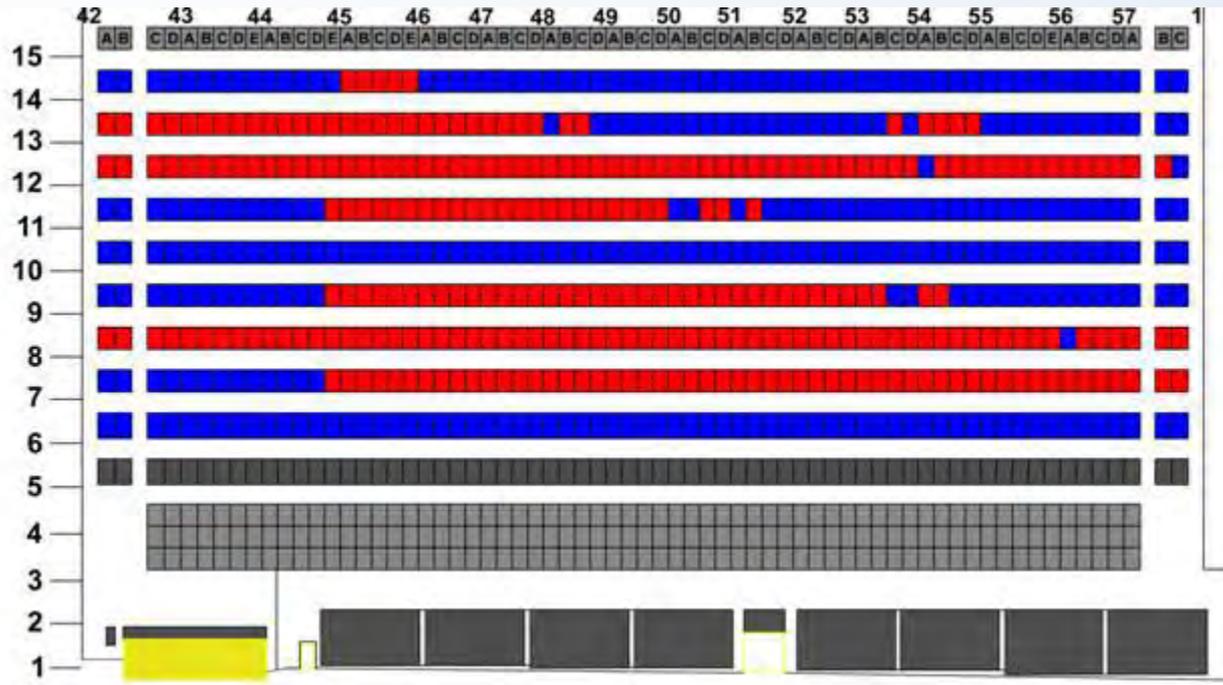
- Façade map showing where windows were broken and/or fire was observed during the period when fire first appeared shortly before 3:00 p.m. until the building collapsed at 5:20:52 p.m.
- Red represents windows where the glass was broken out and/or fire was observed through the window. The remaining windows are colored blue indicating that no direct evidence was observed for fires at these locations.

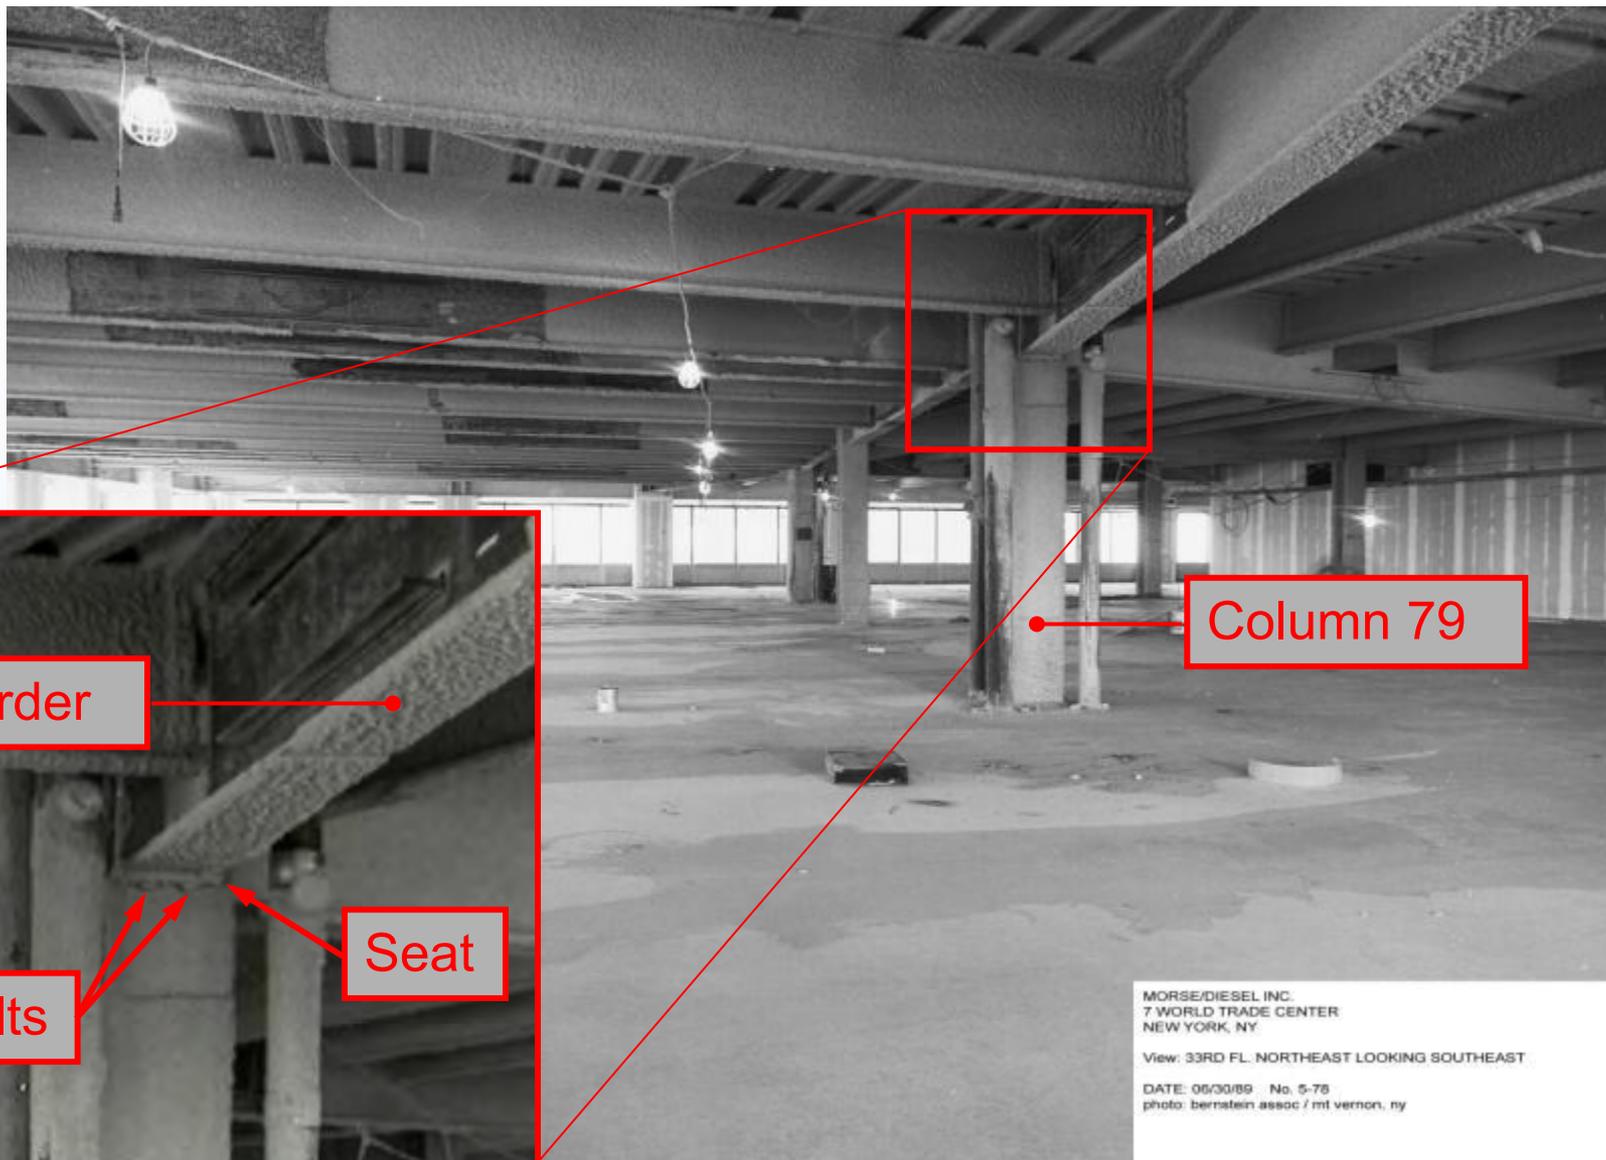
North East Floor System Near Column 79

- Initial Local Failure for Collapse Initiation.
 - Fire-induced thermal expansion of the floor system surrounding Column 79 led to collapse of Floor 13 that triggered a cascade of floor failures.
 - This, in turn, led to loss of lateral support to Column 79 over nine stories, resulting in the buckling failure of Column 79.

Girder was pushed laterally by thermal expansion of floor beams, due to one-sided framing and lack of shear studs.

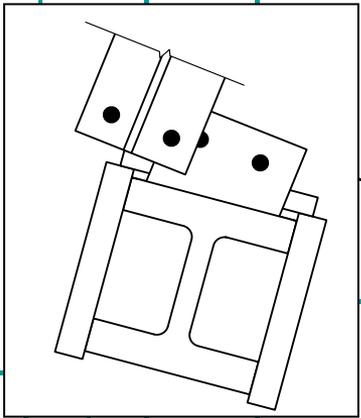
Forces from thermal expansion failed the connection at Column 79, then pushed the girder off the seat.

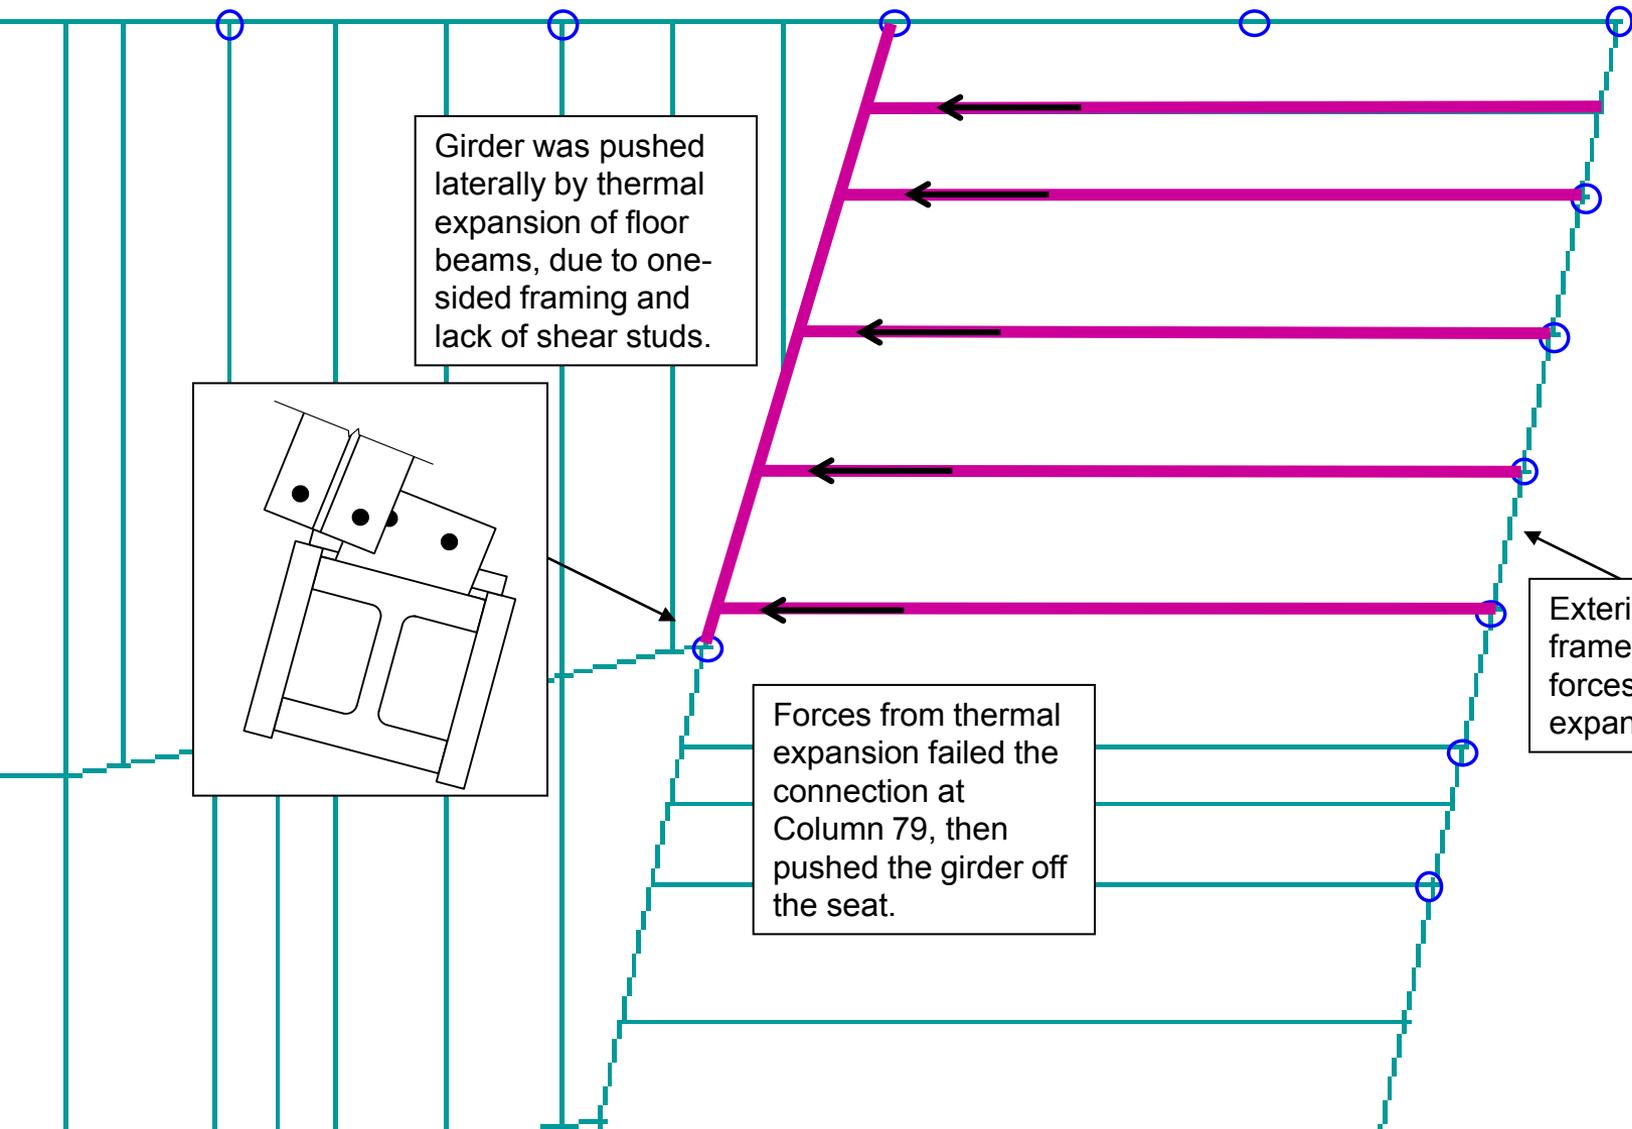
Exterior moment frame resisted forces from thermal expansion.

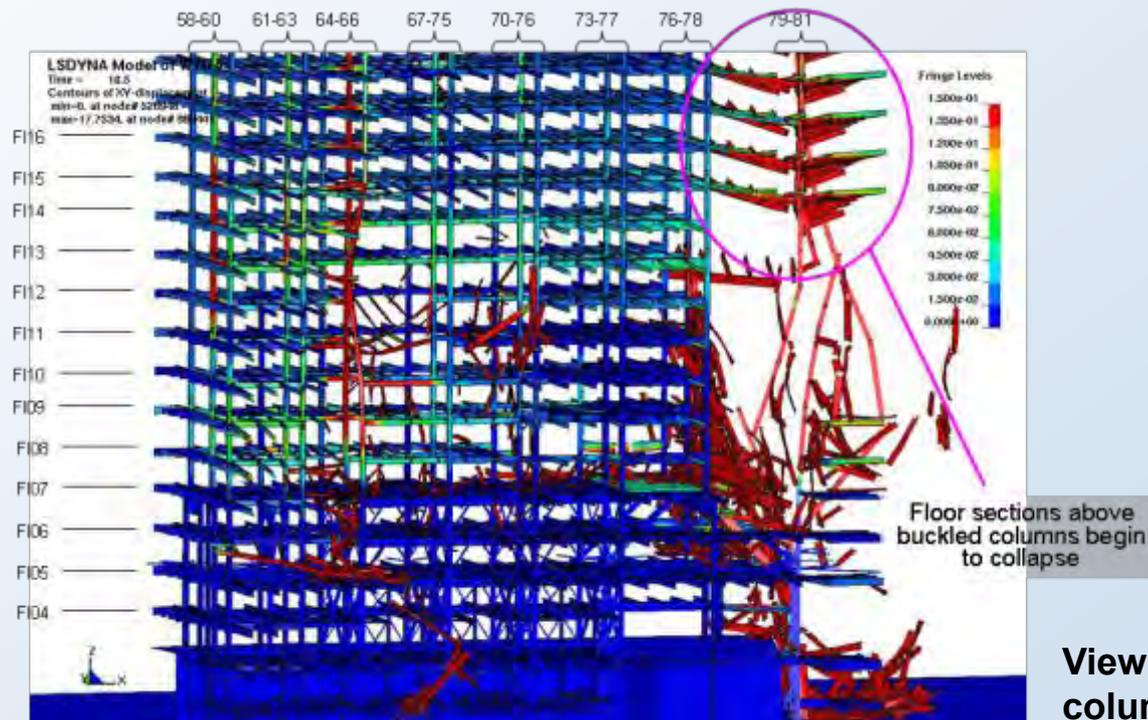
- Buckling of Column 79 (the collapse initiation event) triggered a vertical progression of floor system failures to the east penthouse and subsequent cascading failure of the adjacent interior columns on the east side of the building (i.e., Columns 80 and 81).
- Vertical progression of floor system failures spread to include the entire east region all the way to the top of the building.

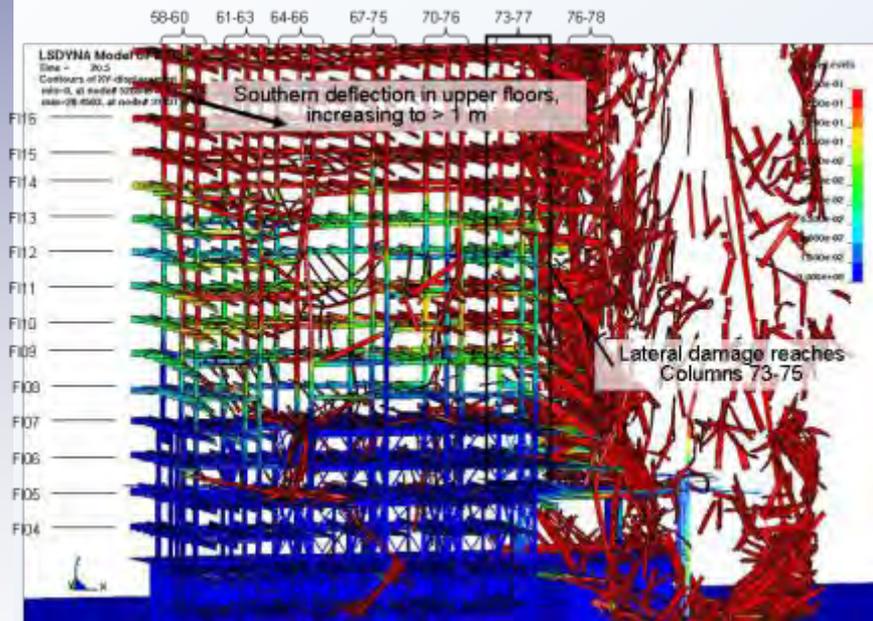
- The interior columns buckled in succession from east to west in the lower floors due to
 - loss of lateral support from floor system failures
 - forces exerted by falling debris
 - load redistributed from other buckled columns.

Failure progresses to the third line of interior columns from the east at 4.5 s following collapse initiation.

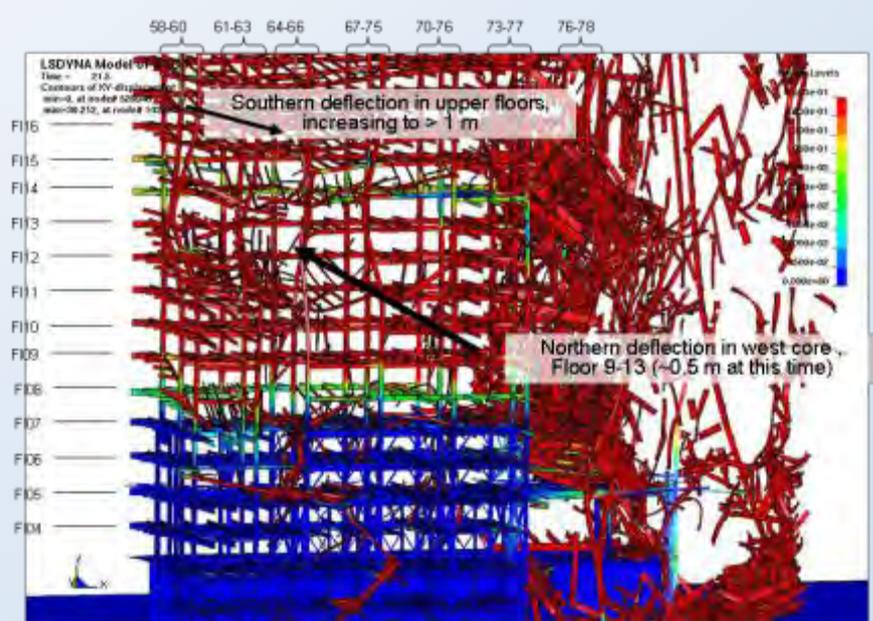
Buckling of all interior columns at 6.5 s following collapse initiation.

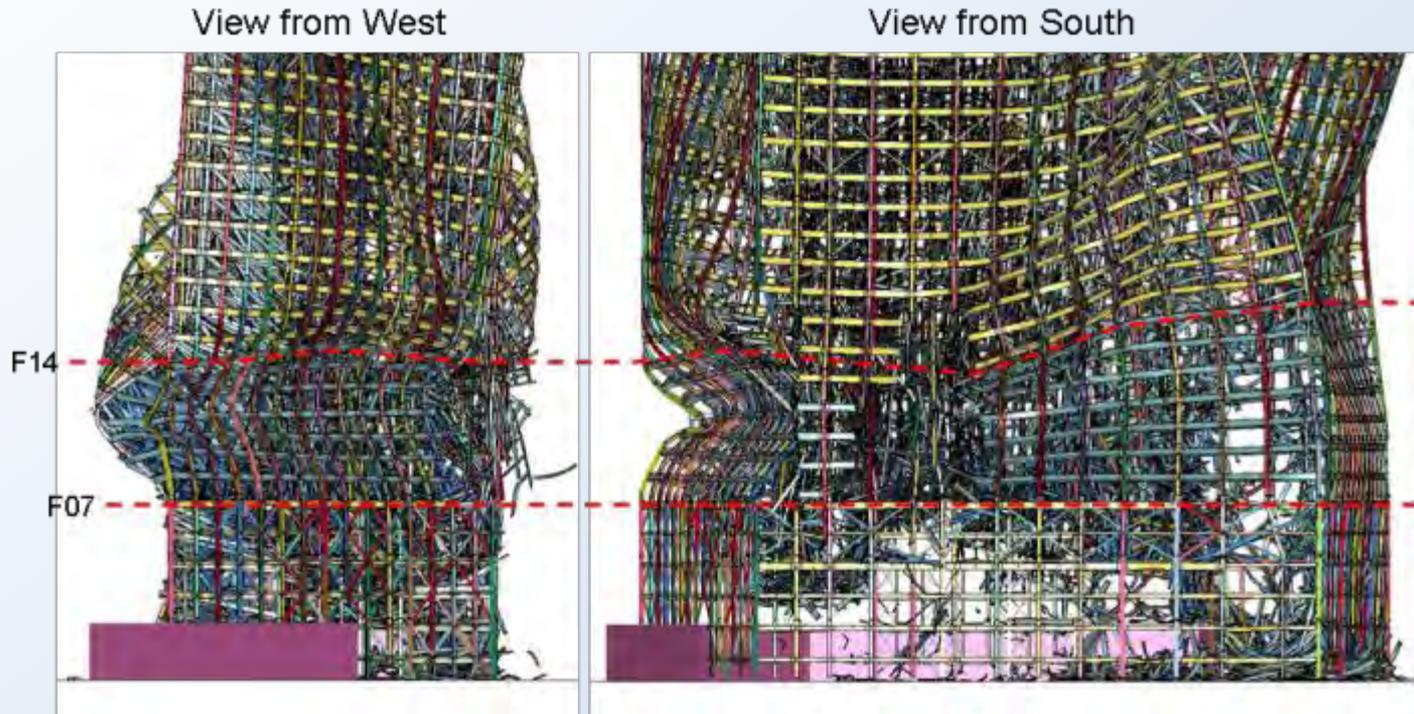
- The exterior columns buckled at the lower floors (between Floors 7 and 14) due to load redistribution to the exterior columns from the downward movement of the building core.
- The entire building above the buckled-column region then moved downward in a single unit, as observed, completing the global collapse sequence.

Buckling of lower exterior columns.

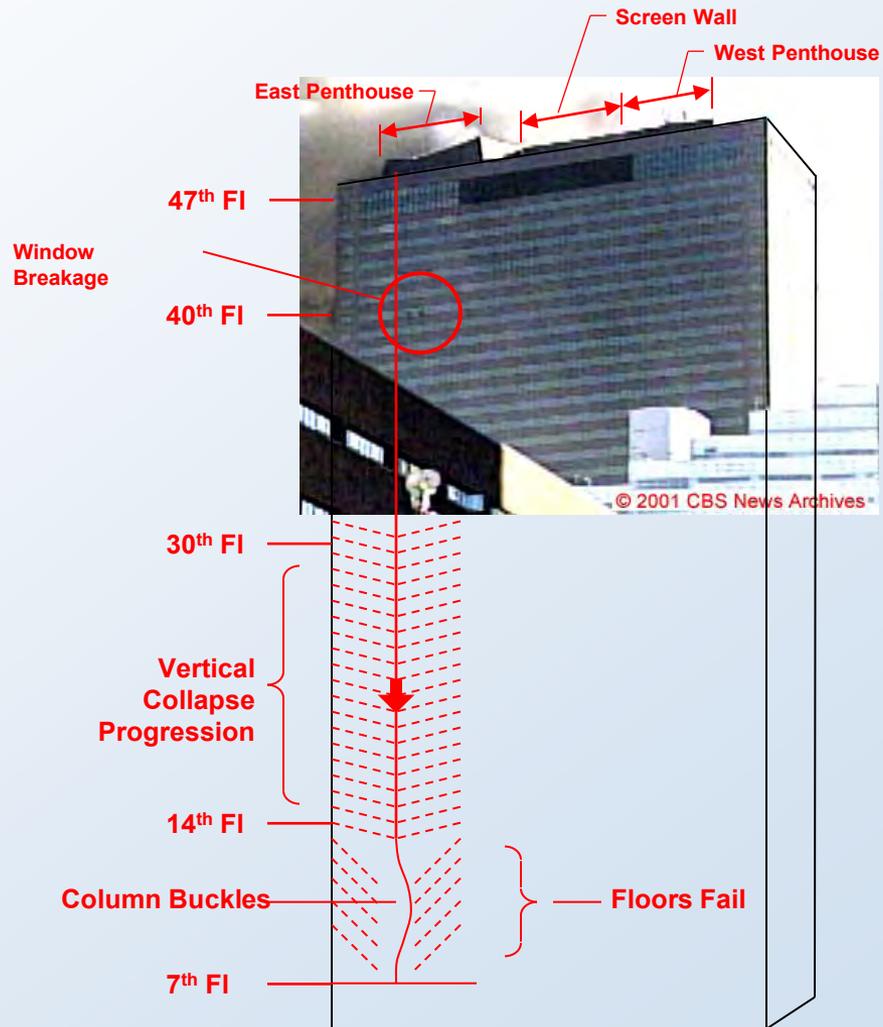
Collapse Initiation Observations

- ❑ East Penthouse Kinks
- ❑ Windows break on East Side of North Face

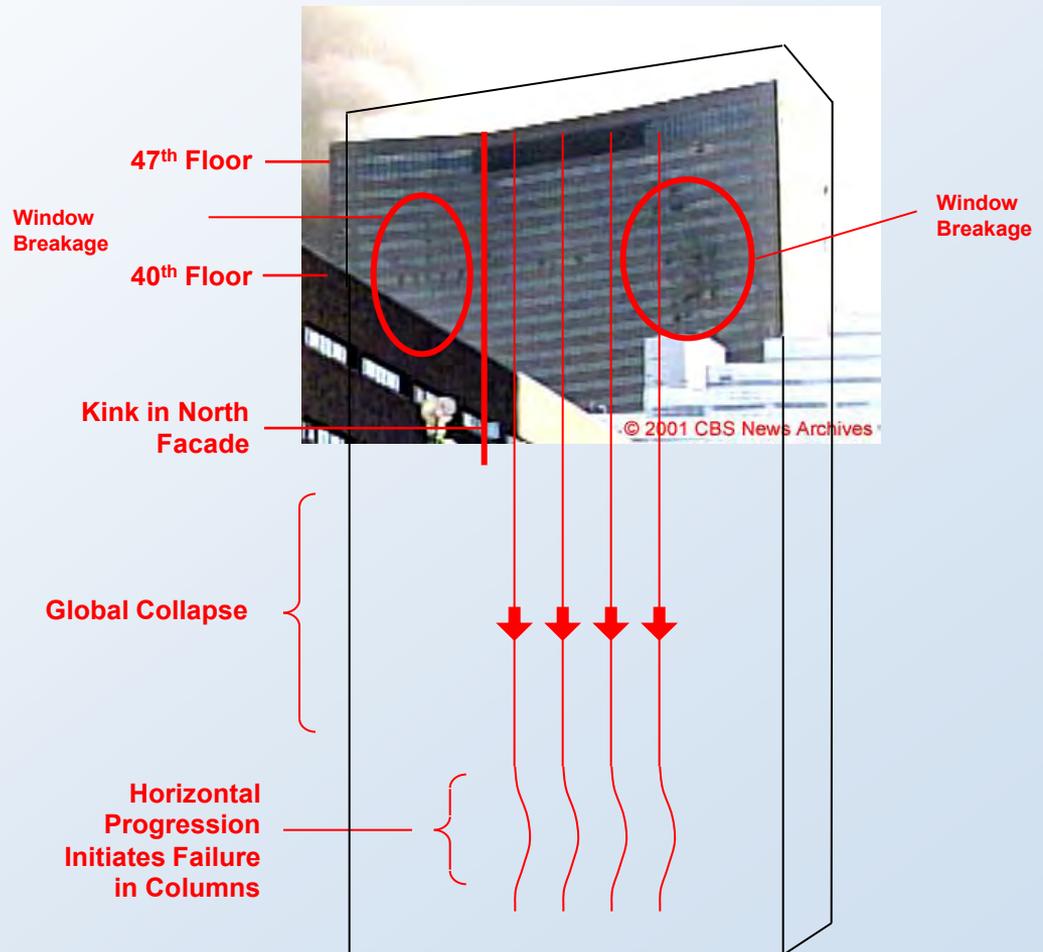
Global Collapse Observations

- ❑ Screenwall and West Penthouse Sink
- ❑ North Façade Kinks at Edge of Core
- ❑ Windows break on West Side of North Face

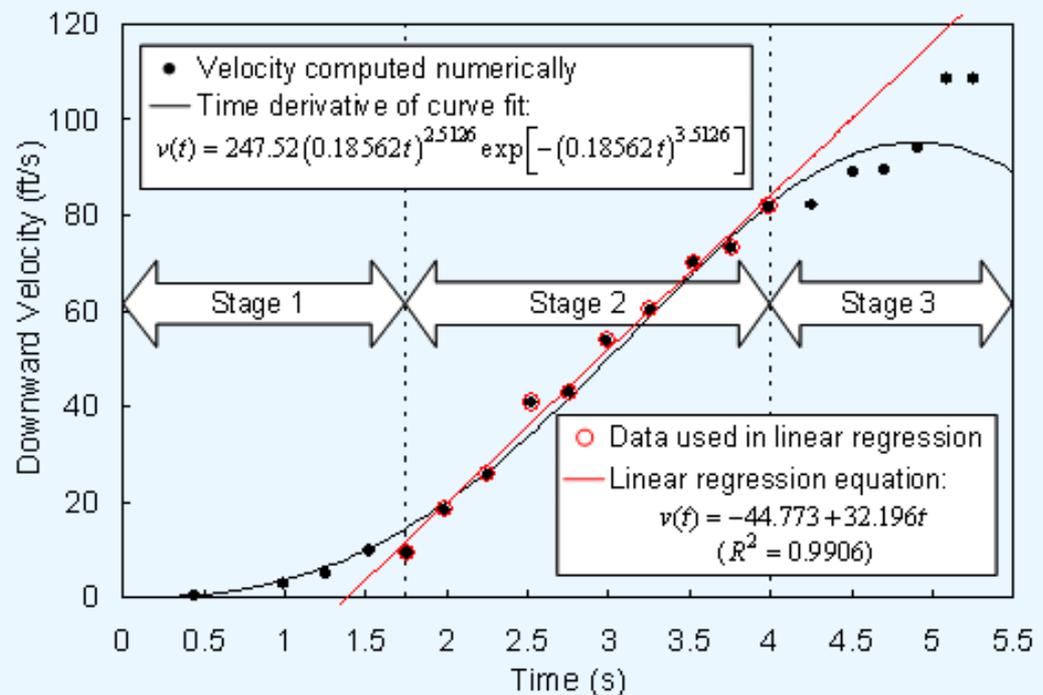
❑ A detailed analysis of the descent of the north face found 3 stages:

- A slow descent at less than gravitational acceleration, corresponding to column buckling
- A free fall descent at gravitational acceleration over approximately 8 stories
- A decreasing acceleration, as the north face encountered resistance from the structure below.
