NIST Response to the World Trade Center Disaster

**Federal Building and Fire Safety Investigation
of
the World Trade Center Disaster**

August 26, 2008

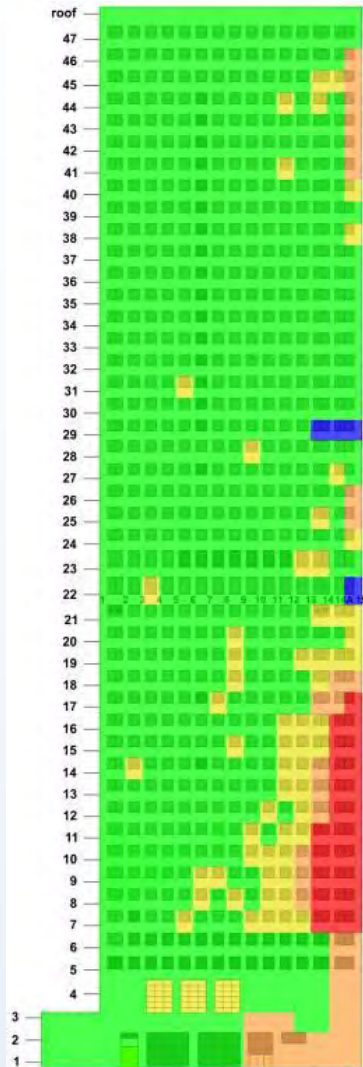
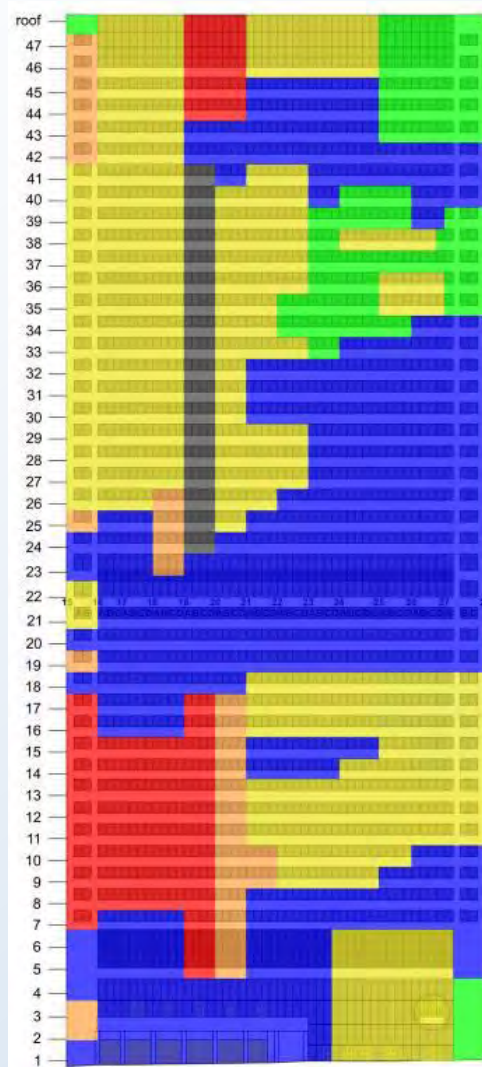
West Face

South Face

green (■) - no visible damage

yellow (■) – window glass broken

orange (■) – granite and underlying truss damage

red (■) – damage to exterior structural steel

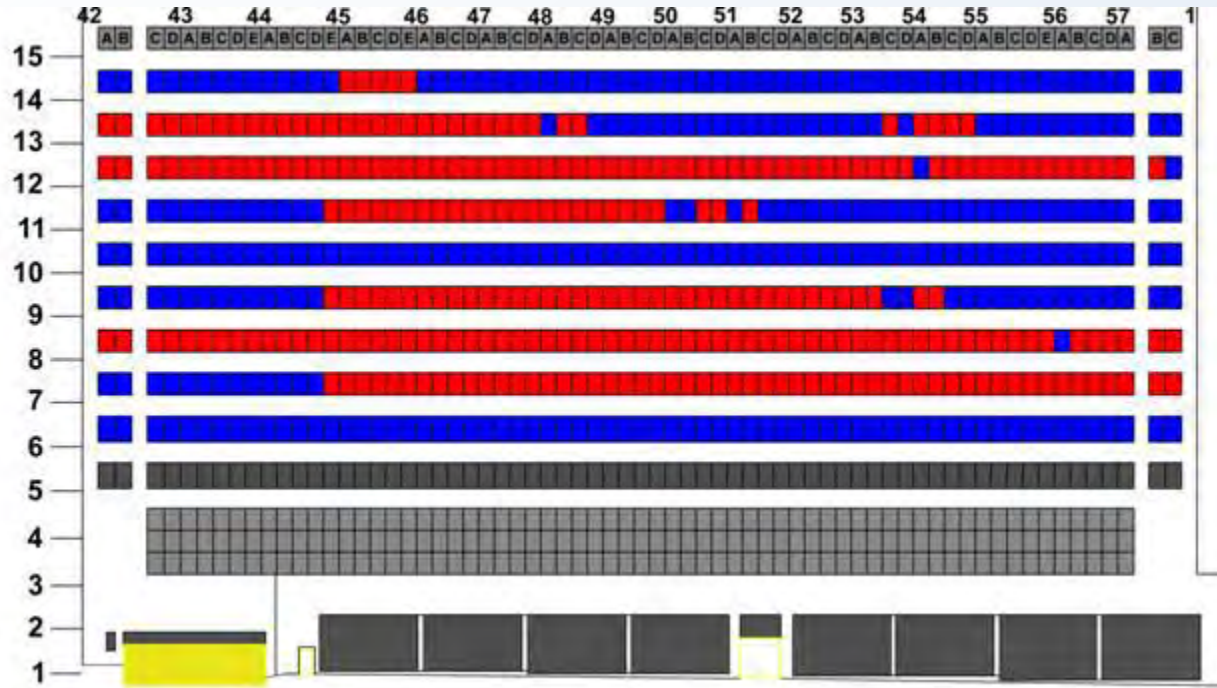
Summary of Fires on North Façade of WTC 7

- Façade map showing where windows were broken and/or fire was observed during the period when fire first appeared shortly before 3:00 p.m. until the building collapsed at 5:20:52 p.m.
- Red represents windows where the glass was broken out and/or fire was observed through the window. Blue indicates that no direct evidence was observed for fires at these locations.

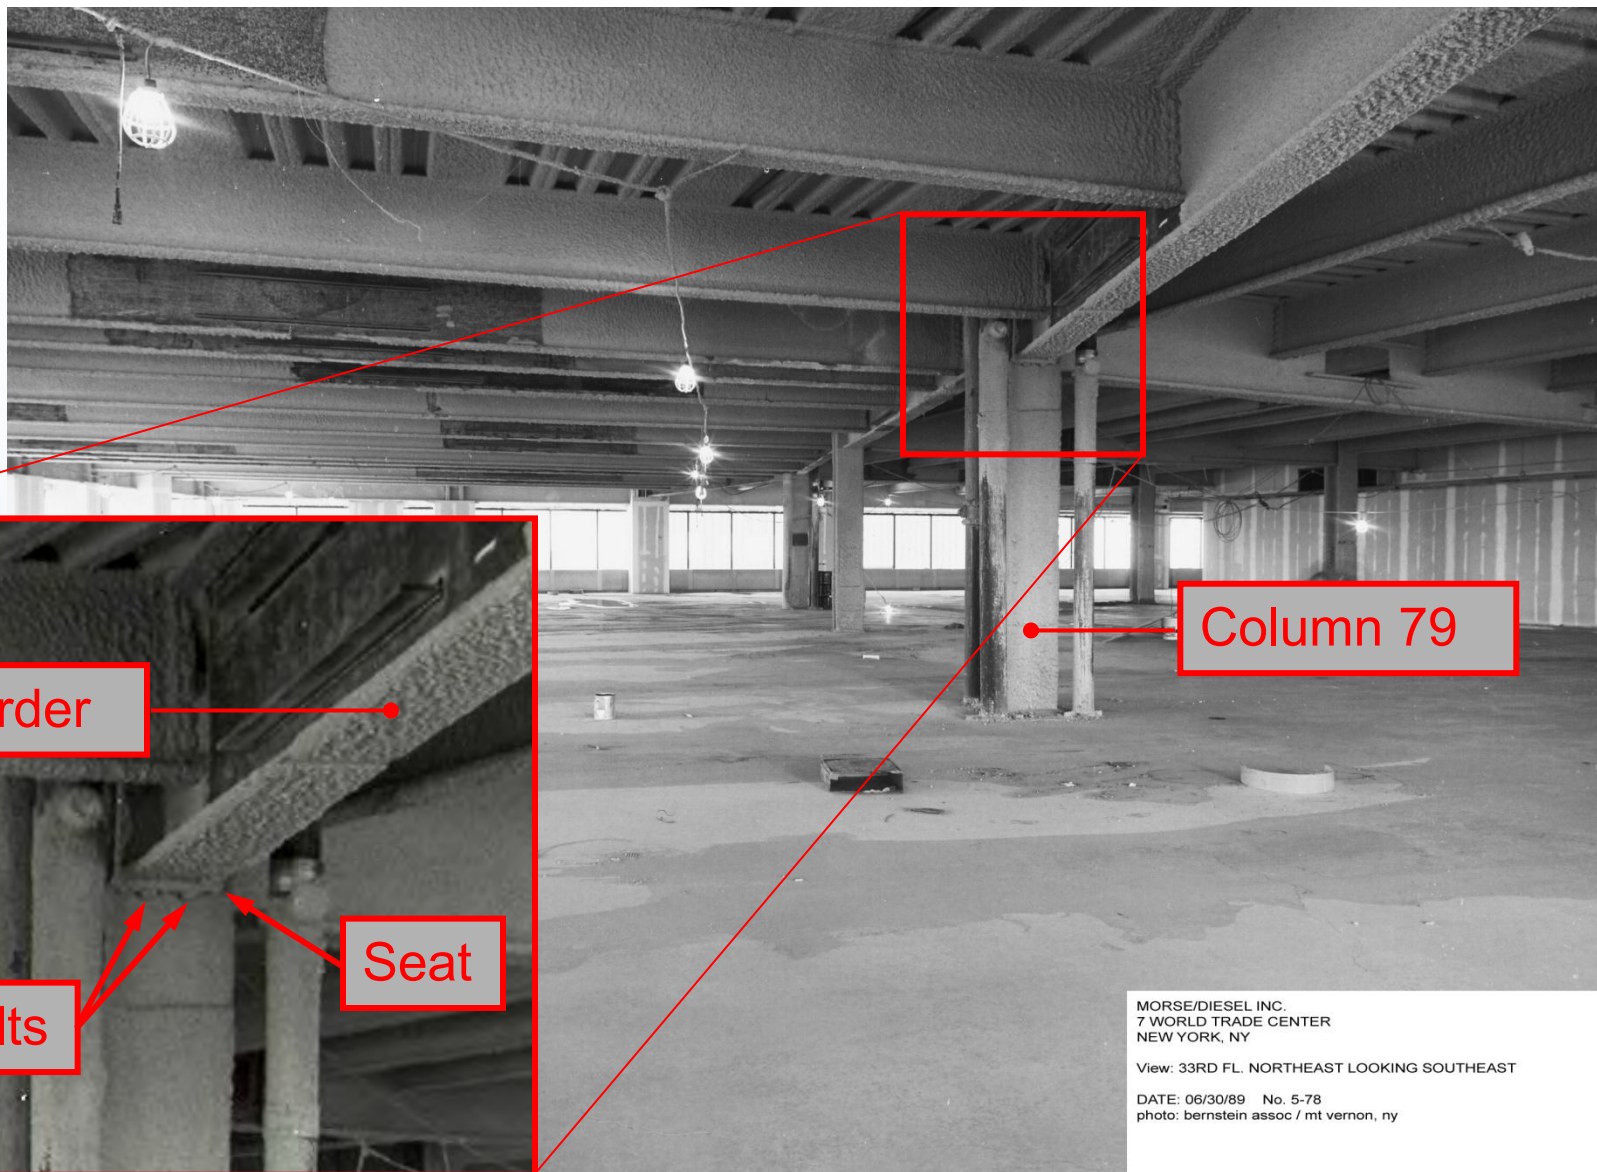
North East Floor System Near Column 79

Girder was pushed laterally by thermal expansion of floor beams, due to one-sided framing and lack of shear studs.

Forces from thermal expansion failed the connection at Column 79, then pushed the girder off the seat.

Exterior moment frame resisted forces from thermal expansion.

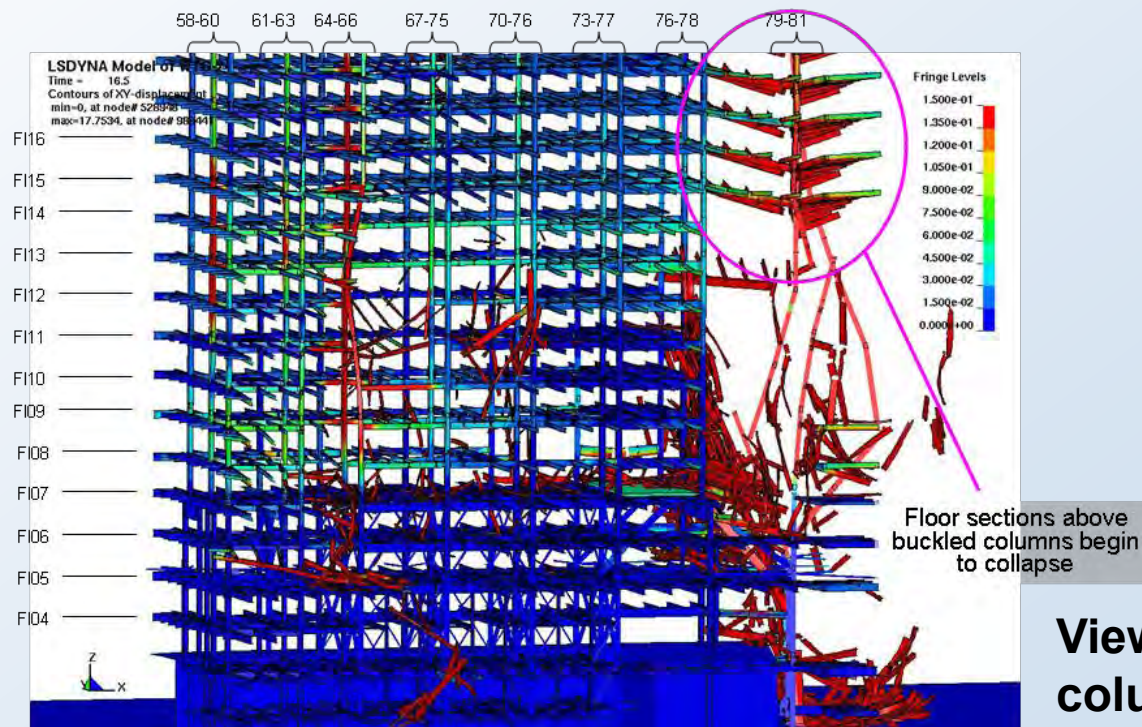
- Buckling of Column 79 triggered a vertical progression of floor system failures to the east penthouse, and subsequent cascading failure of Columns 80 and 81 on the east side of the building, that spread to include the entire east region all the way to the top of the building.

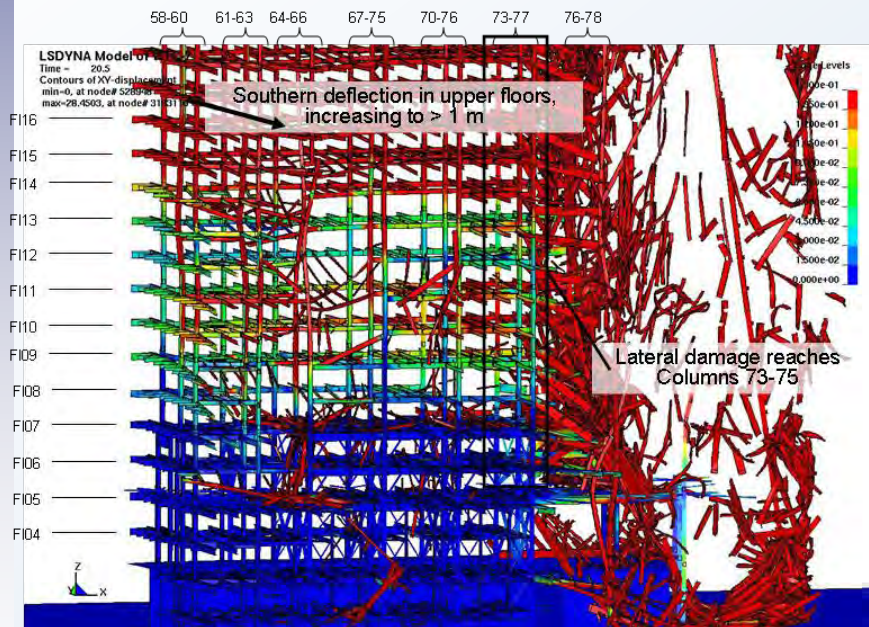
Buckling of third line of interior columns at 4.5 s following collapse initiation.

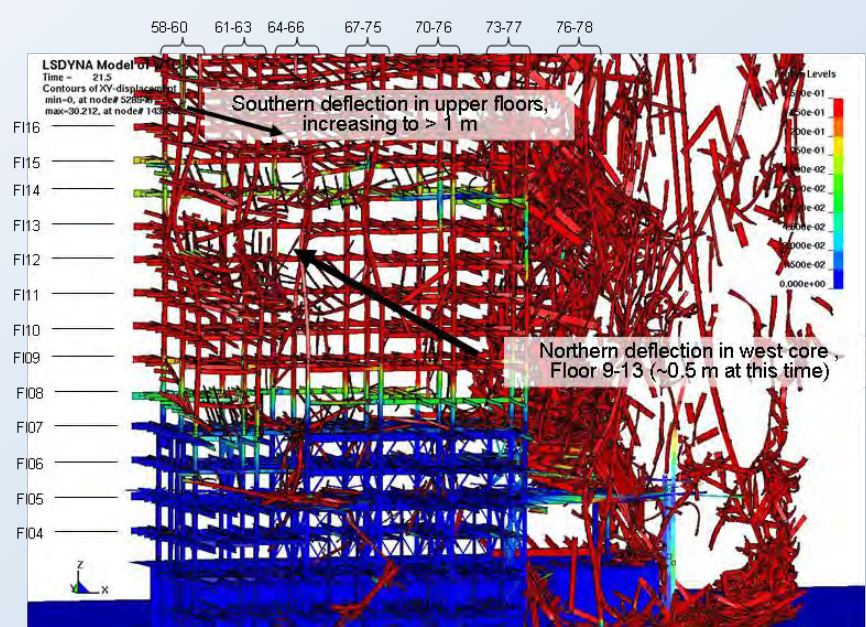
Buckling of all interior columns at 6.5 s following collapse initiation.

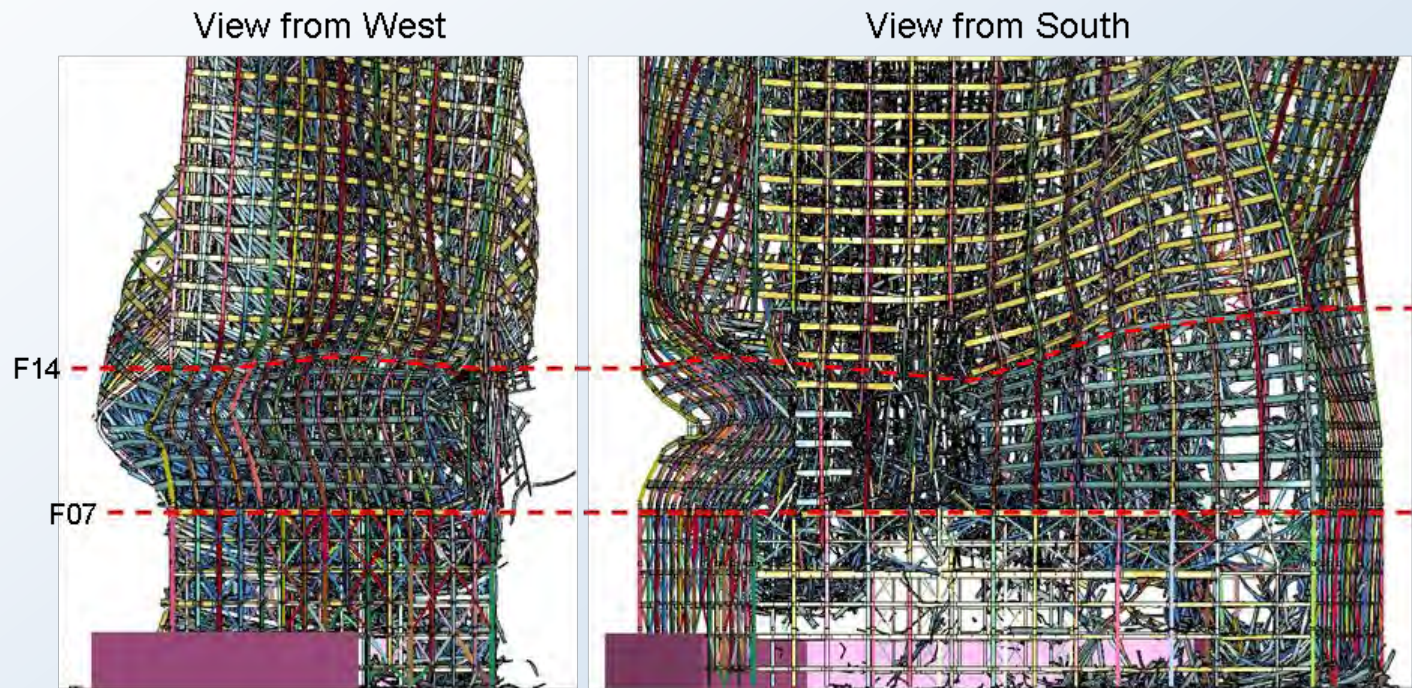
- The exterior columns buckled between Floors 7 and 14 due to load redistribution to these columns as the building core moved downward.
- The entire building above the buckled-column region then moved downward in a single unit, as observed.

Buckling of lower exterior columns.
