Technical Conference on the Federal Building and Fire Safety Investigation of the World Trade Center Disaster

Session VI - Structural Fire Response and Collapse Analysis

Observations for Structural Response Structural and Fire Protection Damage Due to Aircraft Impact

Therese McAllister

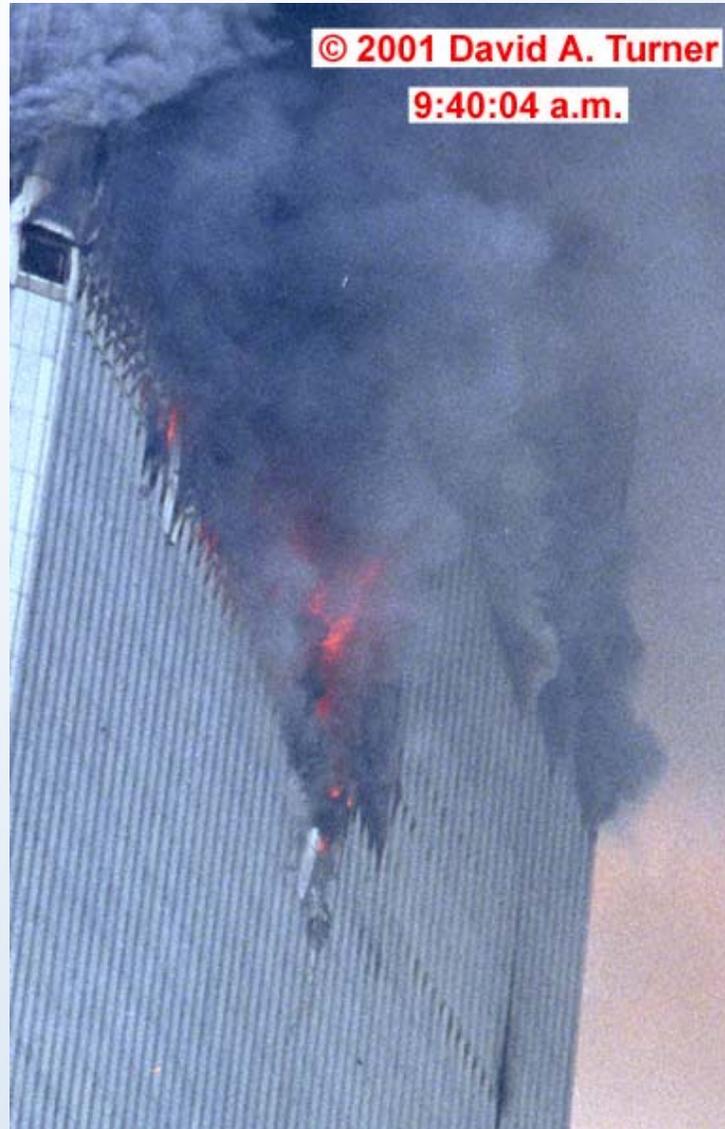
South Face of WTC 1 - 9:40 a.m. No inward bowing

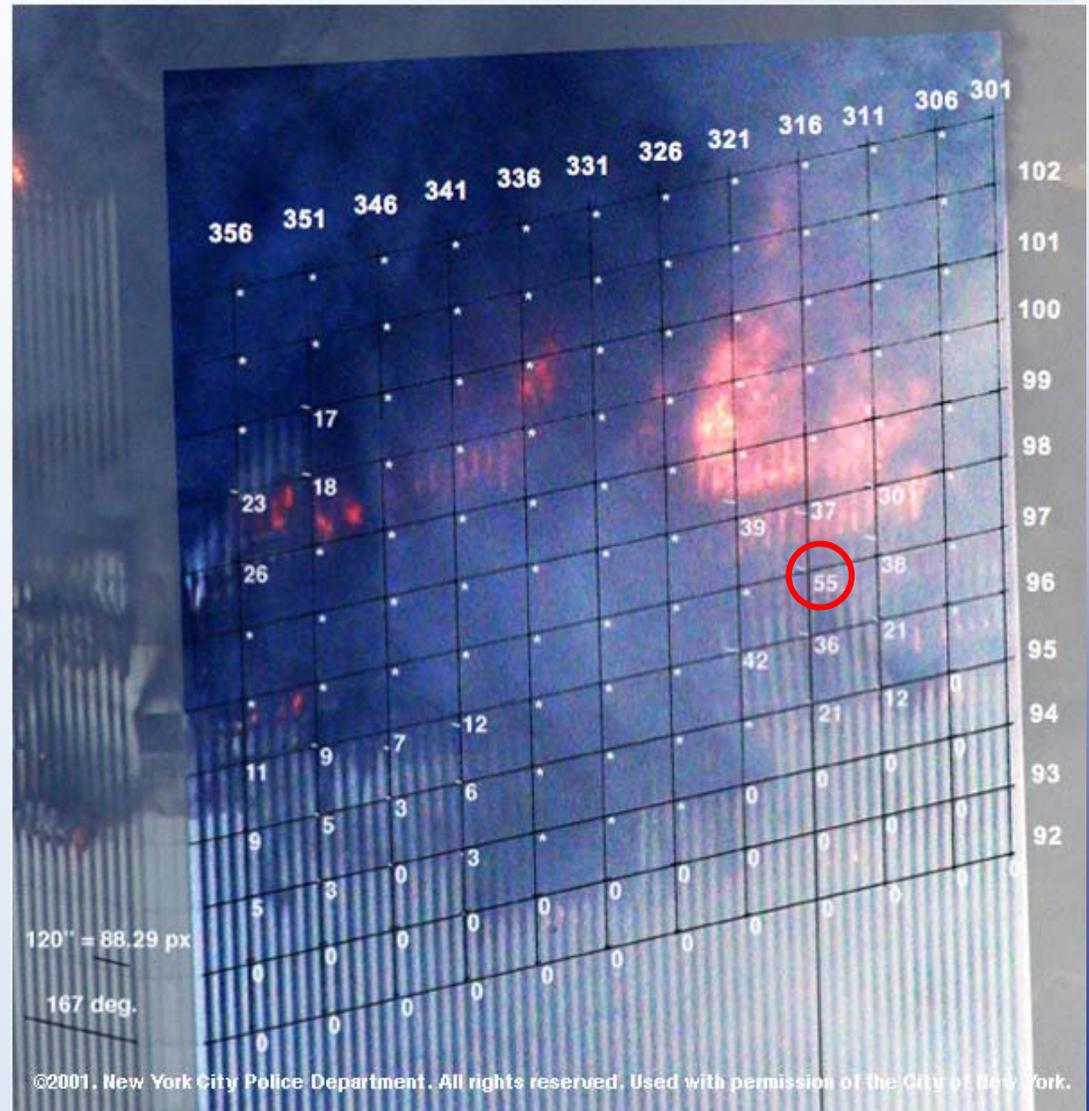
South Face of WTC1 - 10:23 a.m. Inward bowing

- **Maximum = 55 inches**
(uncertainty ~ +/- 6 inches)

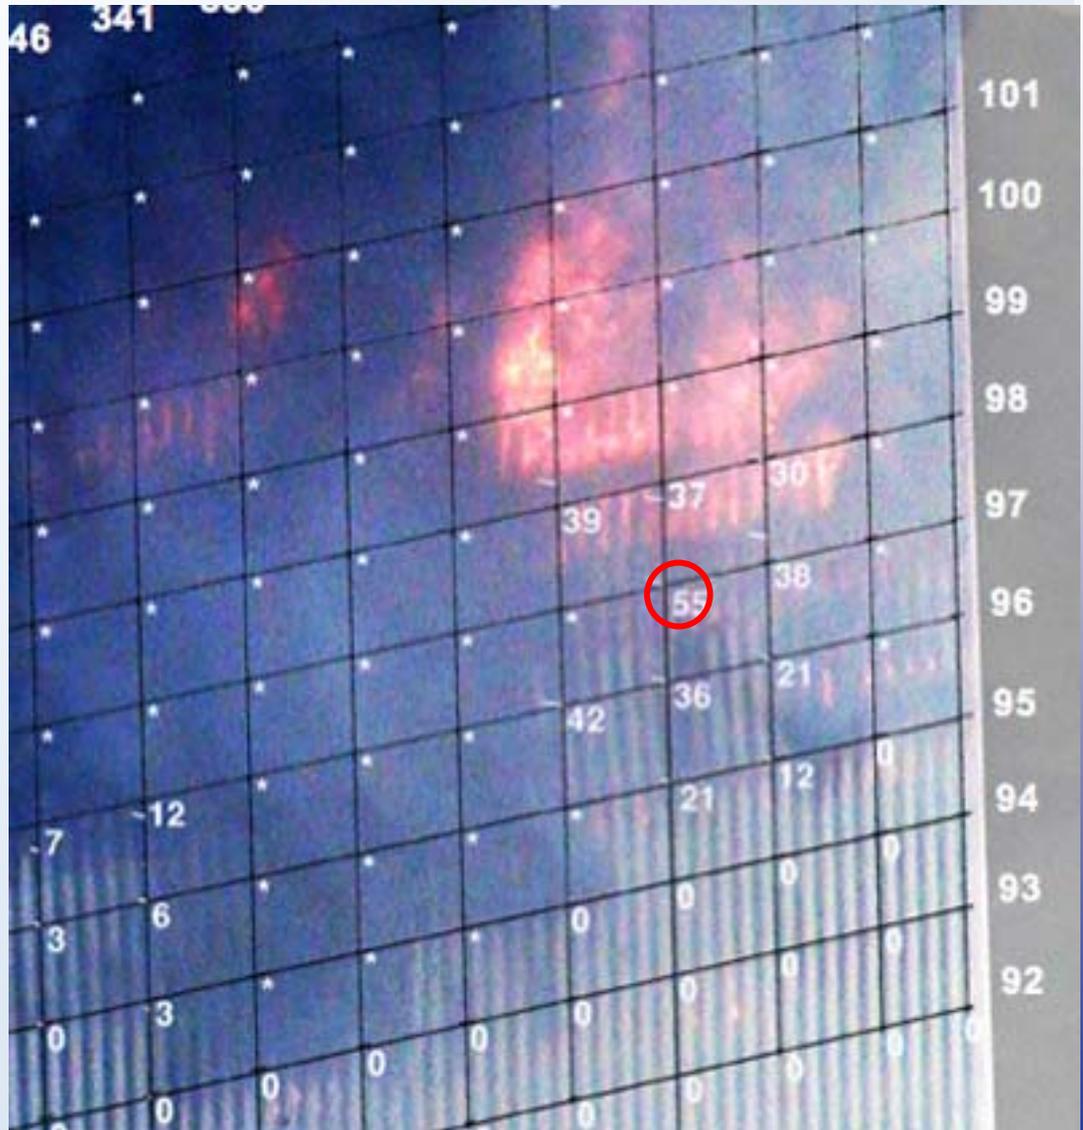
South Face of WTC1 - 10:23 a.m. Inward bowing

- **Maximum = 55 inches**
(uncertainty ~ +/- 6 inches)

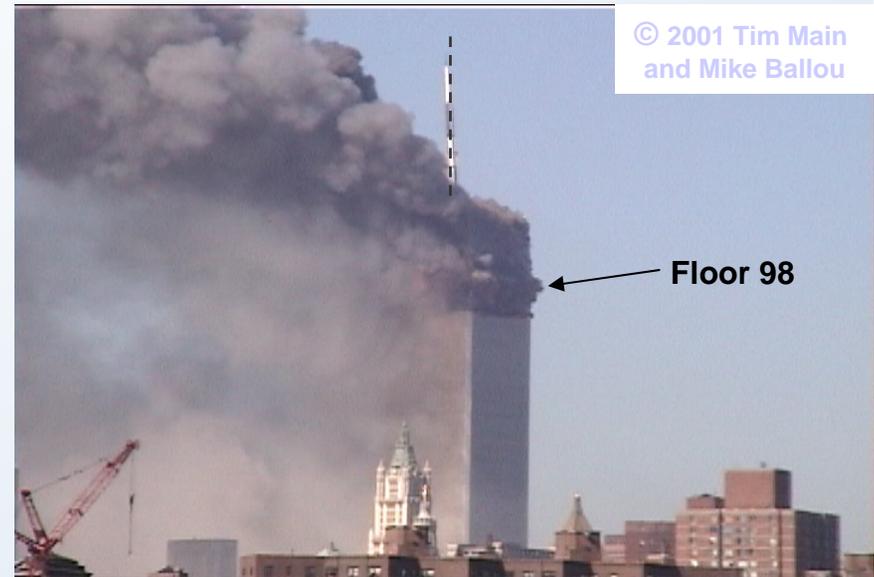
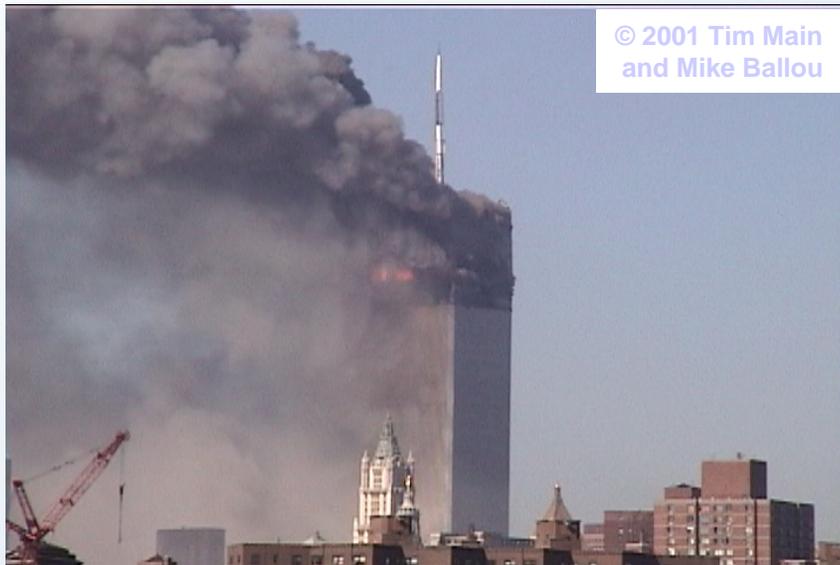
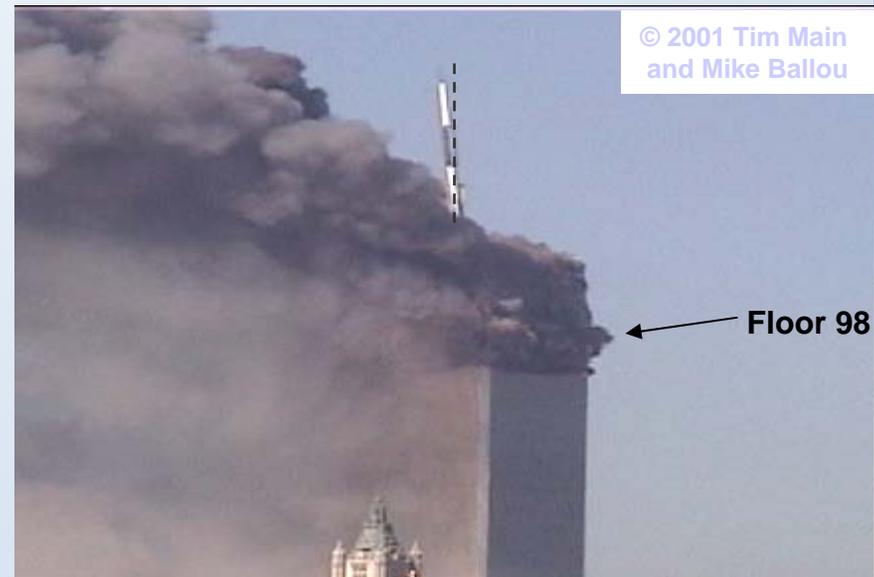
WTC 1 Collapse Initiated at 10:28 a.m.

- ❑ WTC 1 tilted to the south (view from the northeast).
- ❑ Initiation of global collapse was first observed by the tilting of the building sections above the impact region.

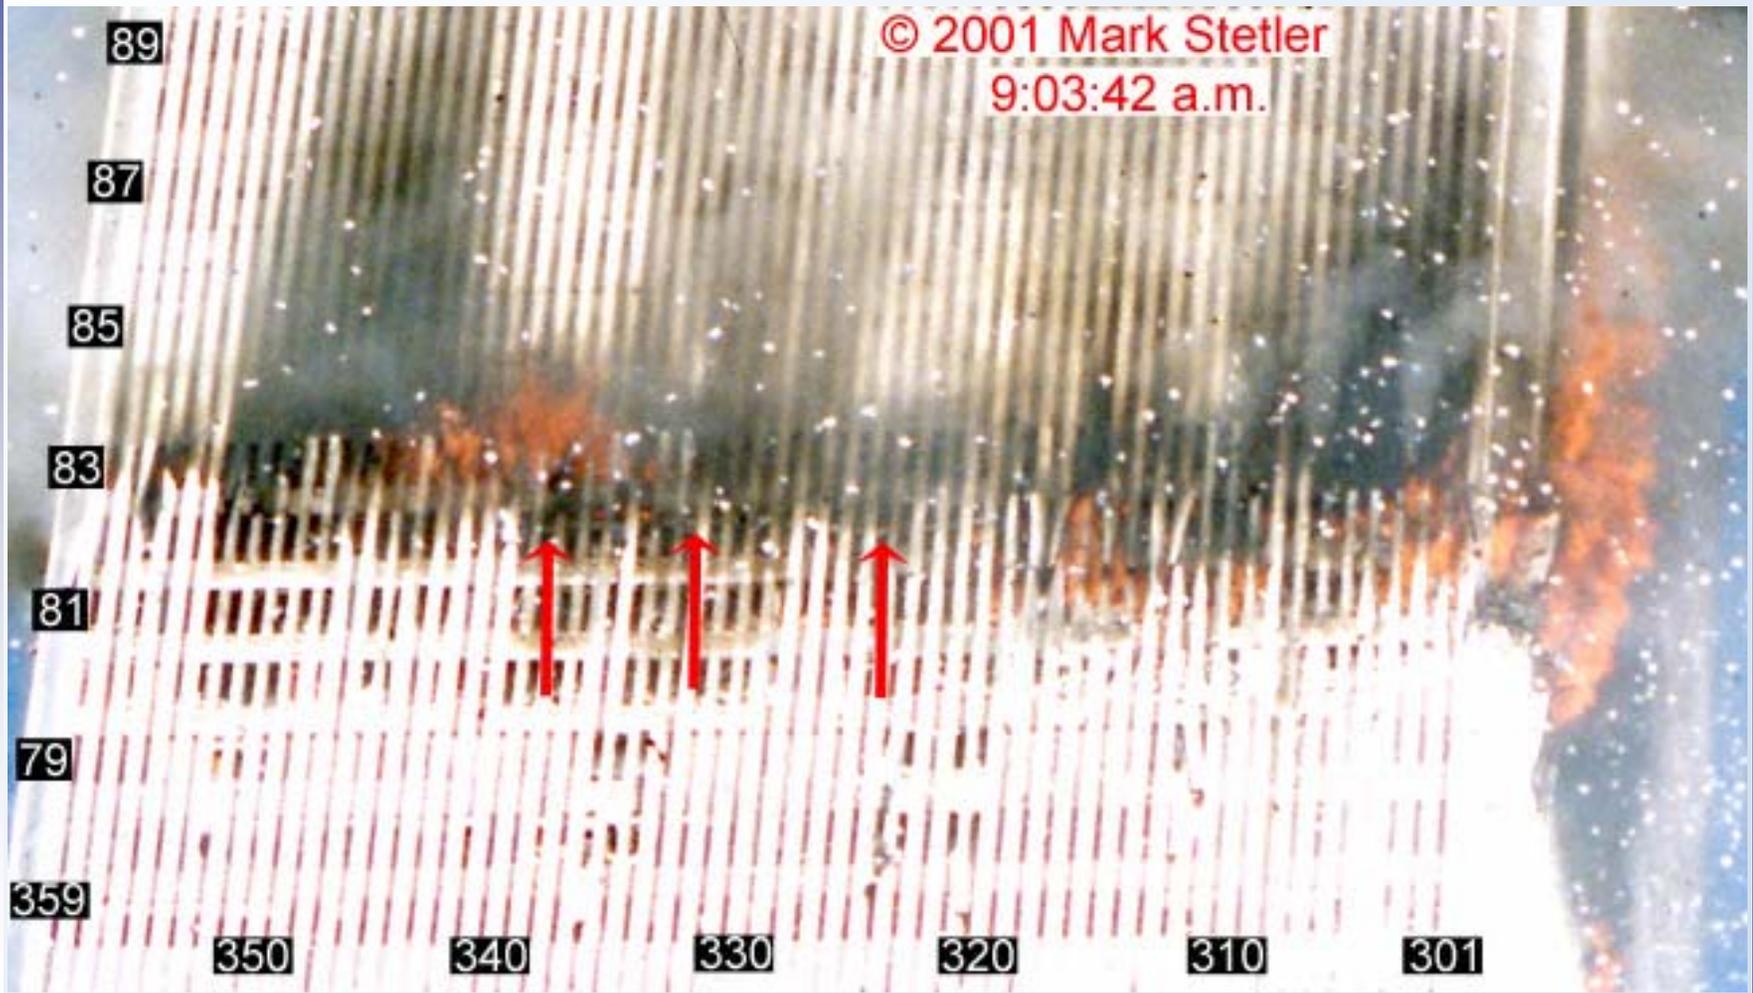
East Face of WTC 2 - 9:03 a.m. Hanging objects in east windows of Floor 82

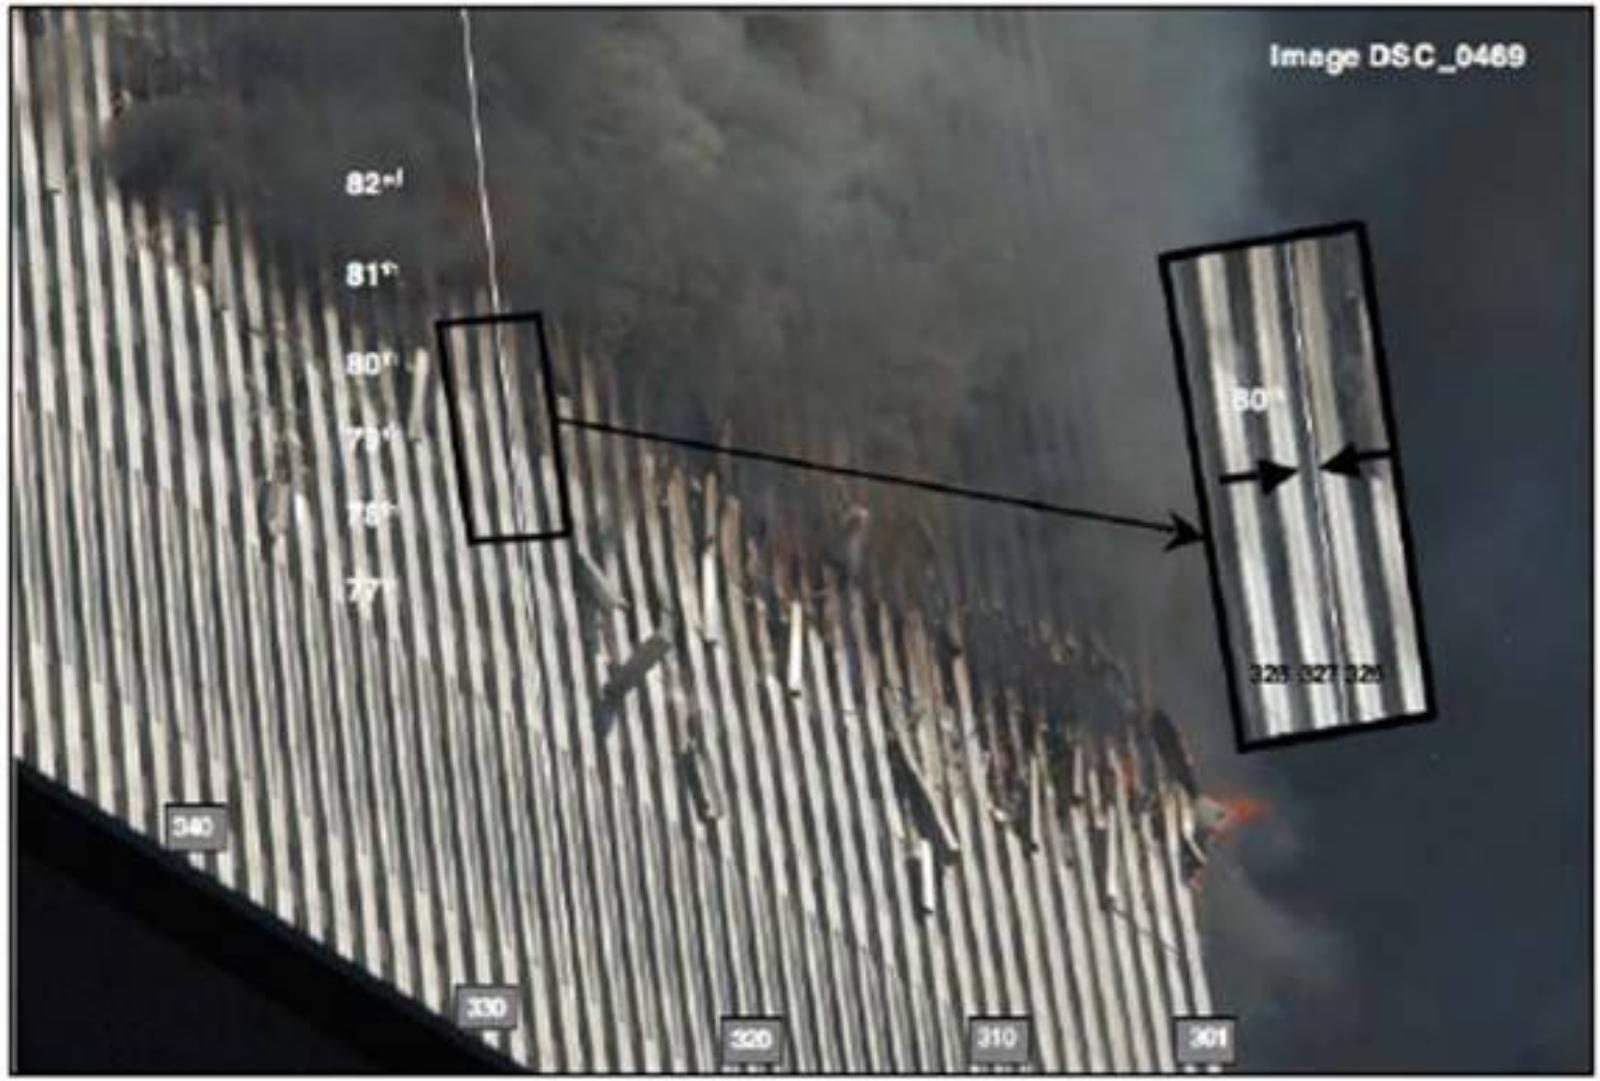
East Face of WTC 2 – 9:21 a.m. Maximum inward bowing of approx. 10 in. (18 min after impact)

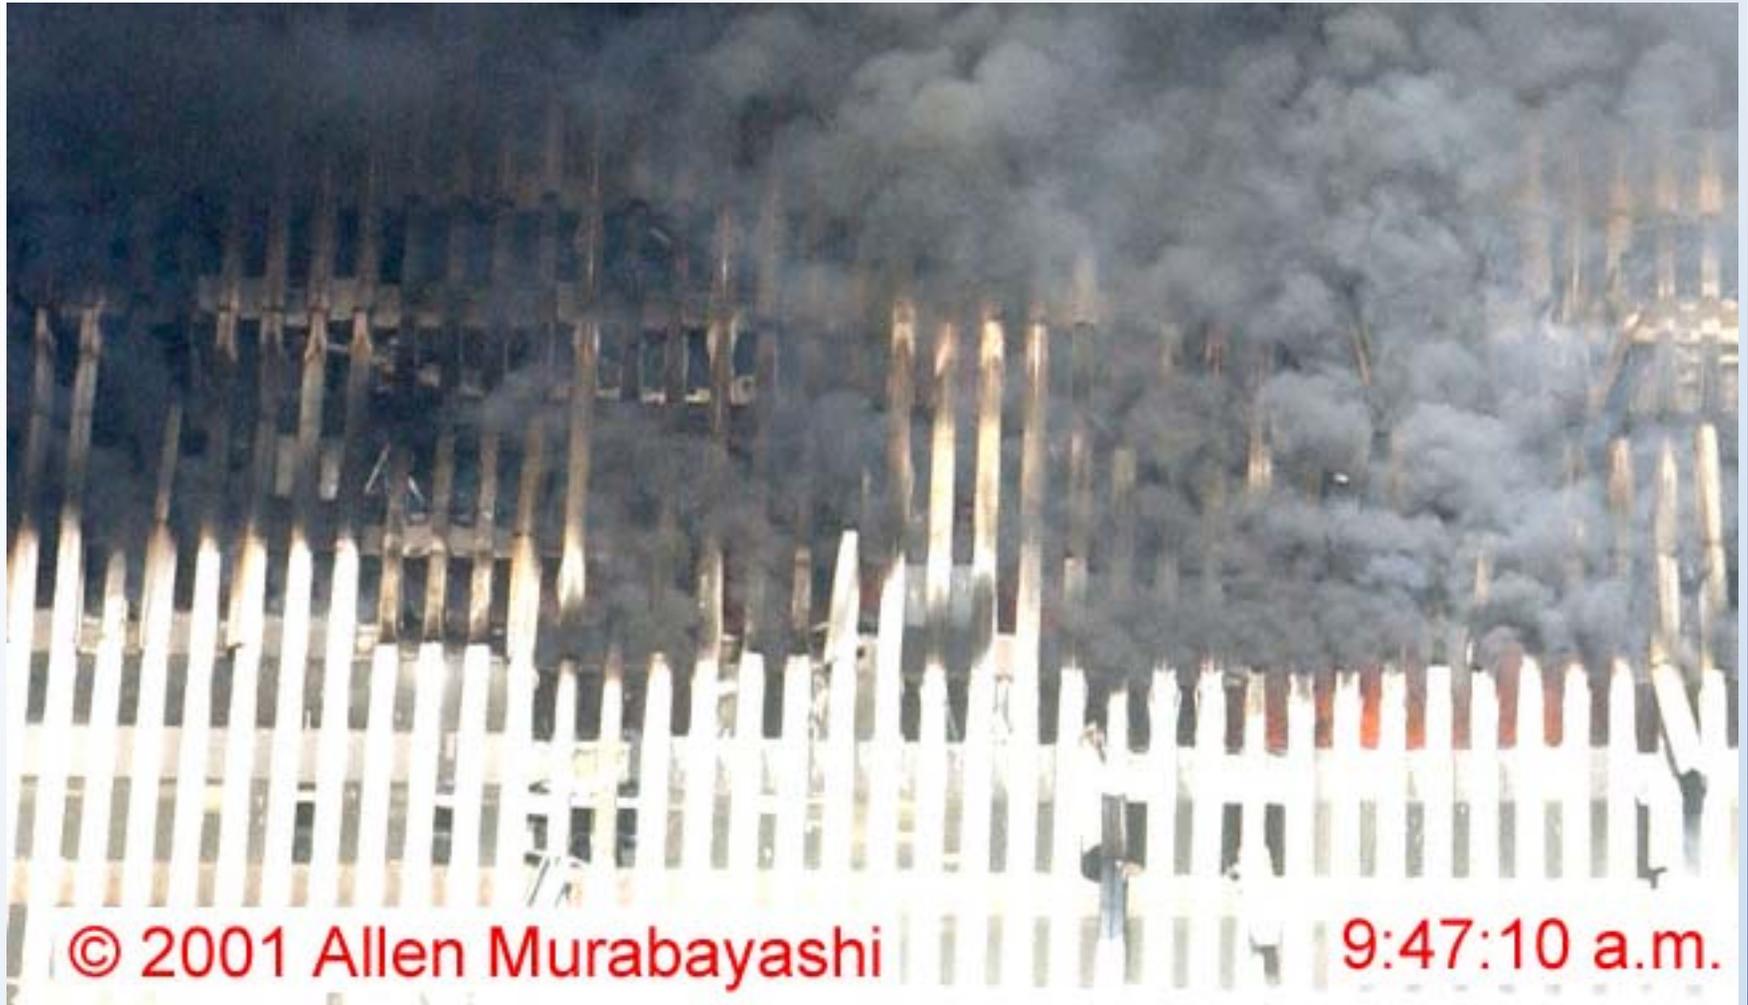
East Face of WTC 2 – 9:47 a.m. Hanging Floor 83 Slab in Windows of Floor 82

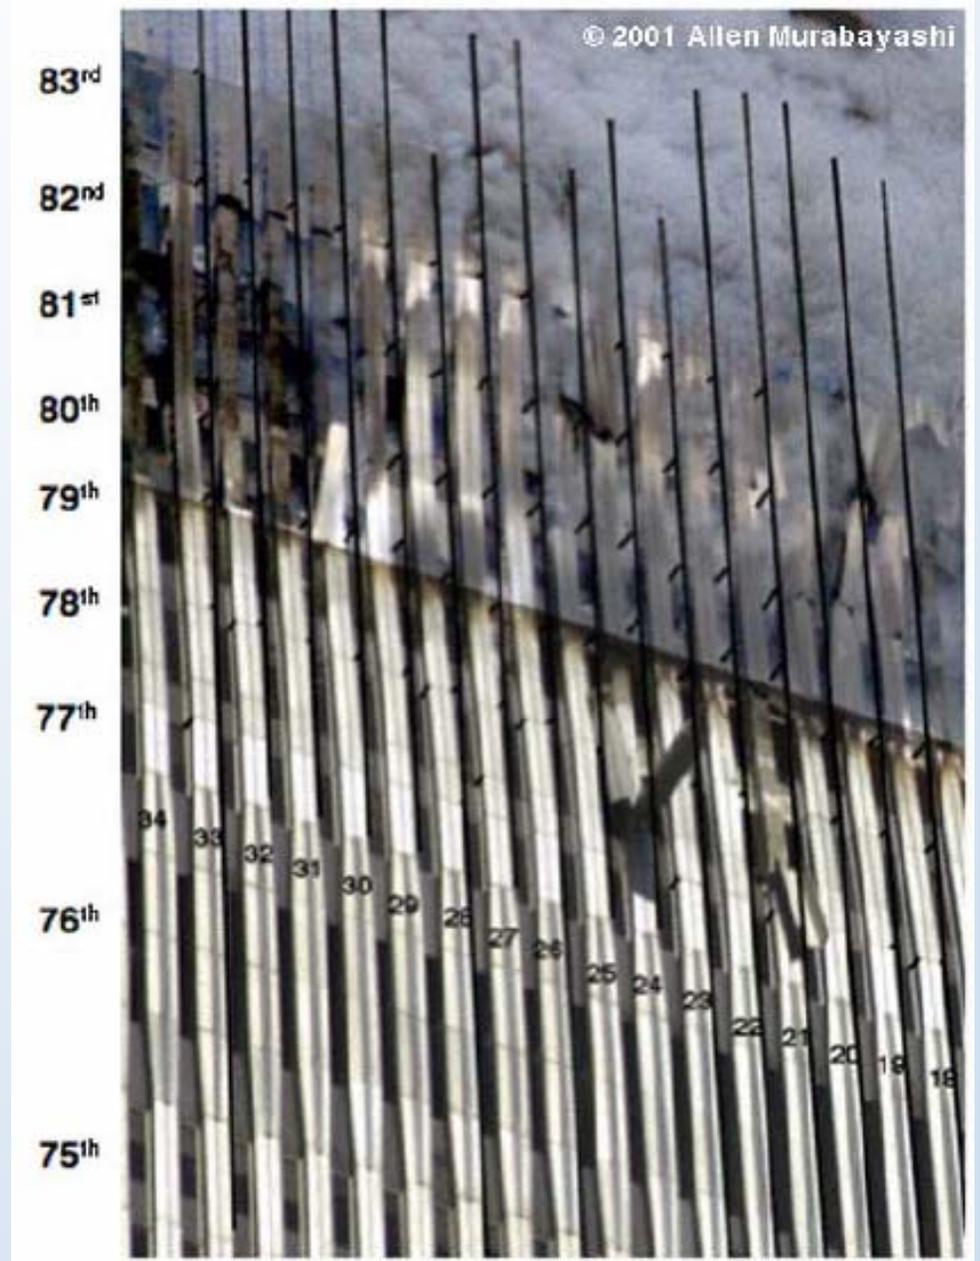
East Face of WTC 2 – 9:53 a.m.

Maximum inward
bowing of approx.
20 in.

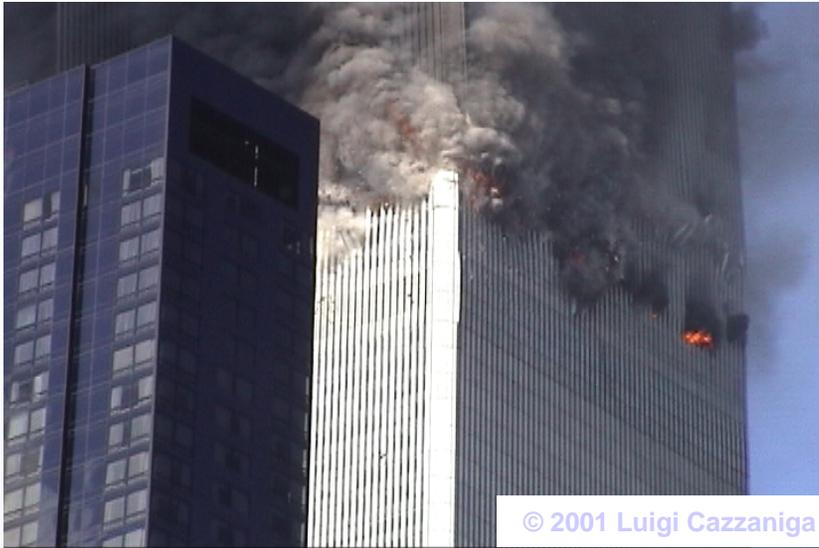
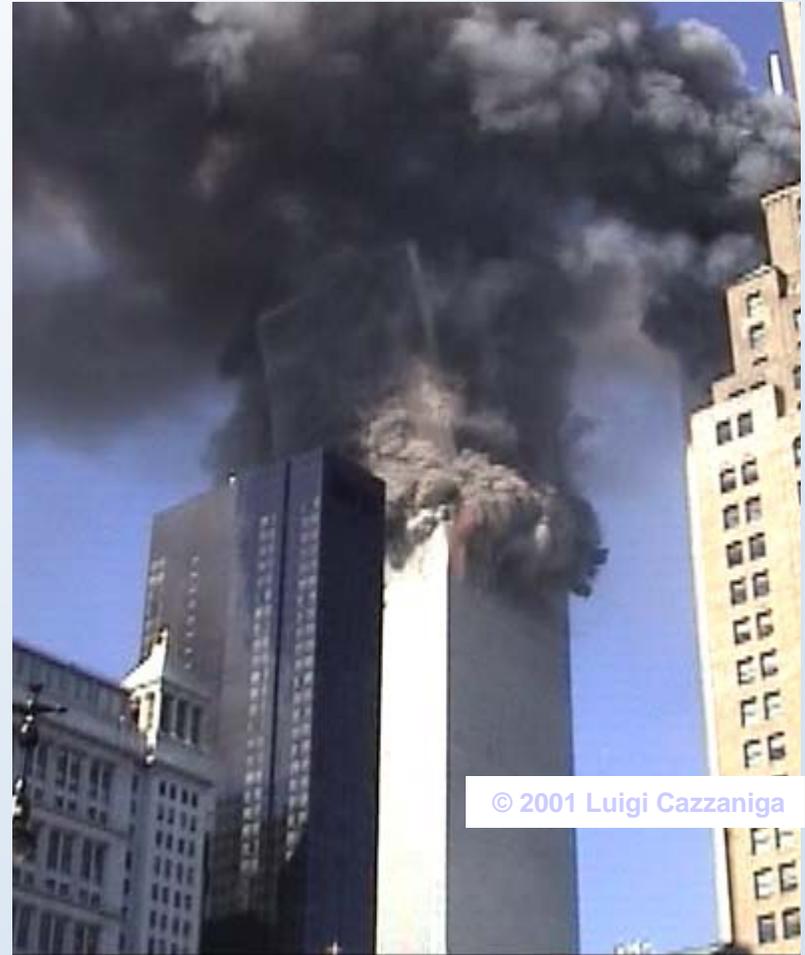
WTC 2 Collapse at 9:59 a.m.

WTC 2 tilted to the east and south in this view from the northeast.

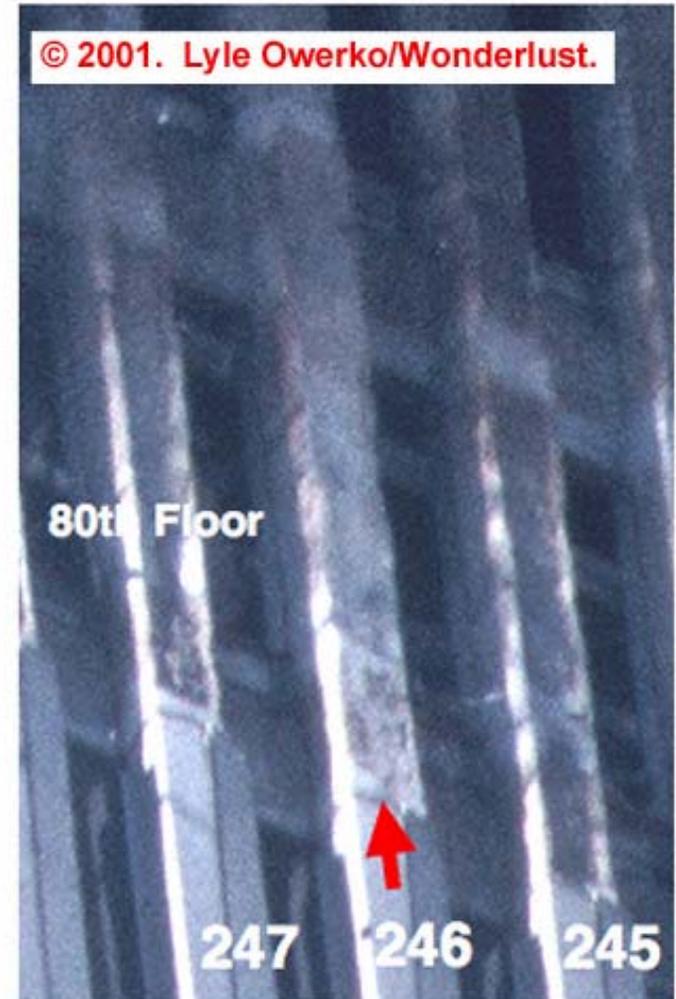
- By design, uniform thickness
- As applied, region between flange tips fill (for example, see column 246 at right)
- Missing SFRM from outer flange indicate shadowing and exposed red paint
