Building and Fire Safety: Responding to the World Trade Center Disaster

Chicago Committee on High-Rise Buildings

September 9, 2004

National Institute of Standards and Technology

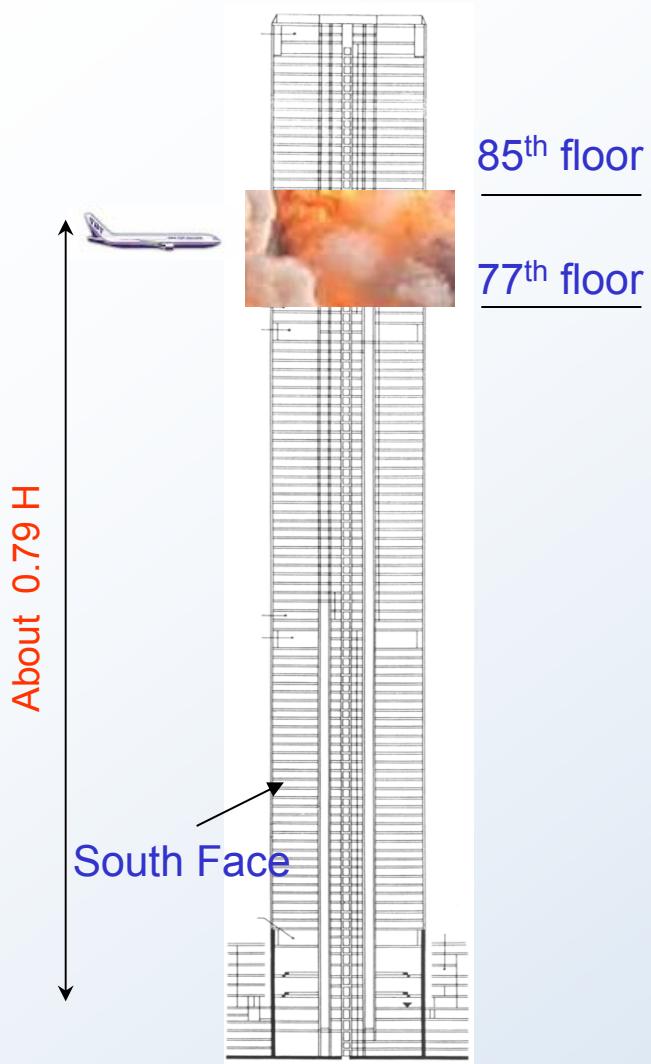
South tower: Hit at 9:02:59 AM
Collapsed after 56 minutes

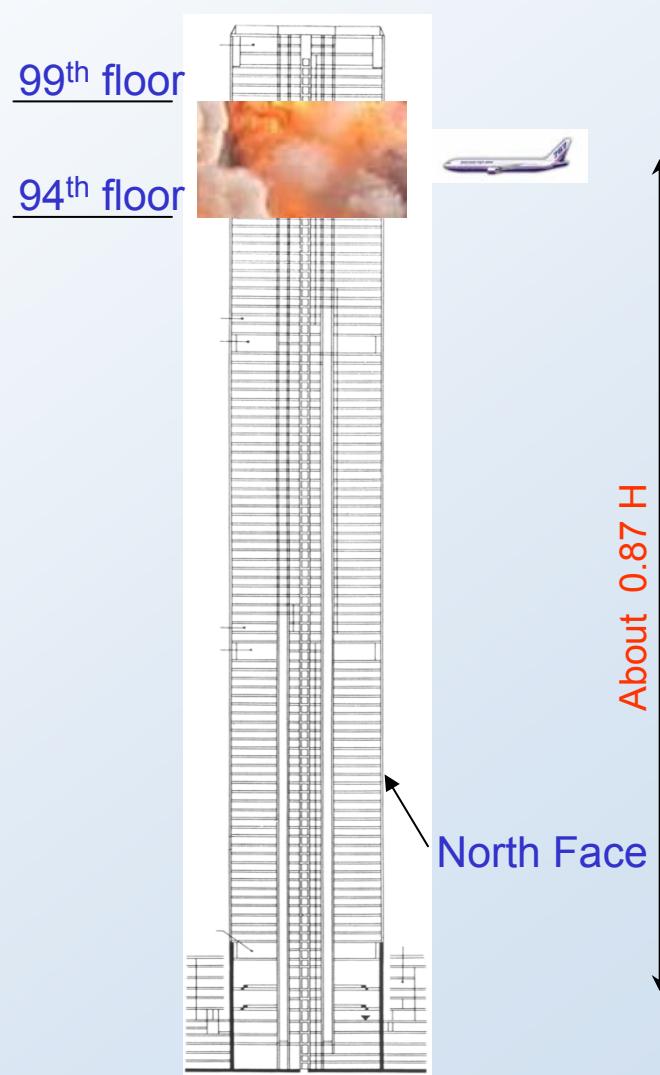
North tower: Hit at 8:46:31 AM
Collapsed after 103 minutes

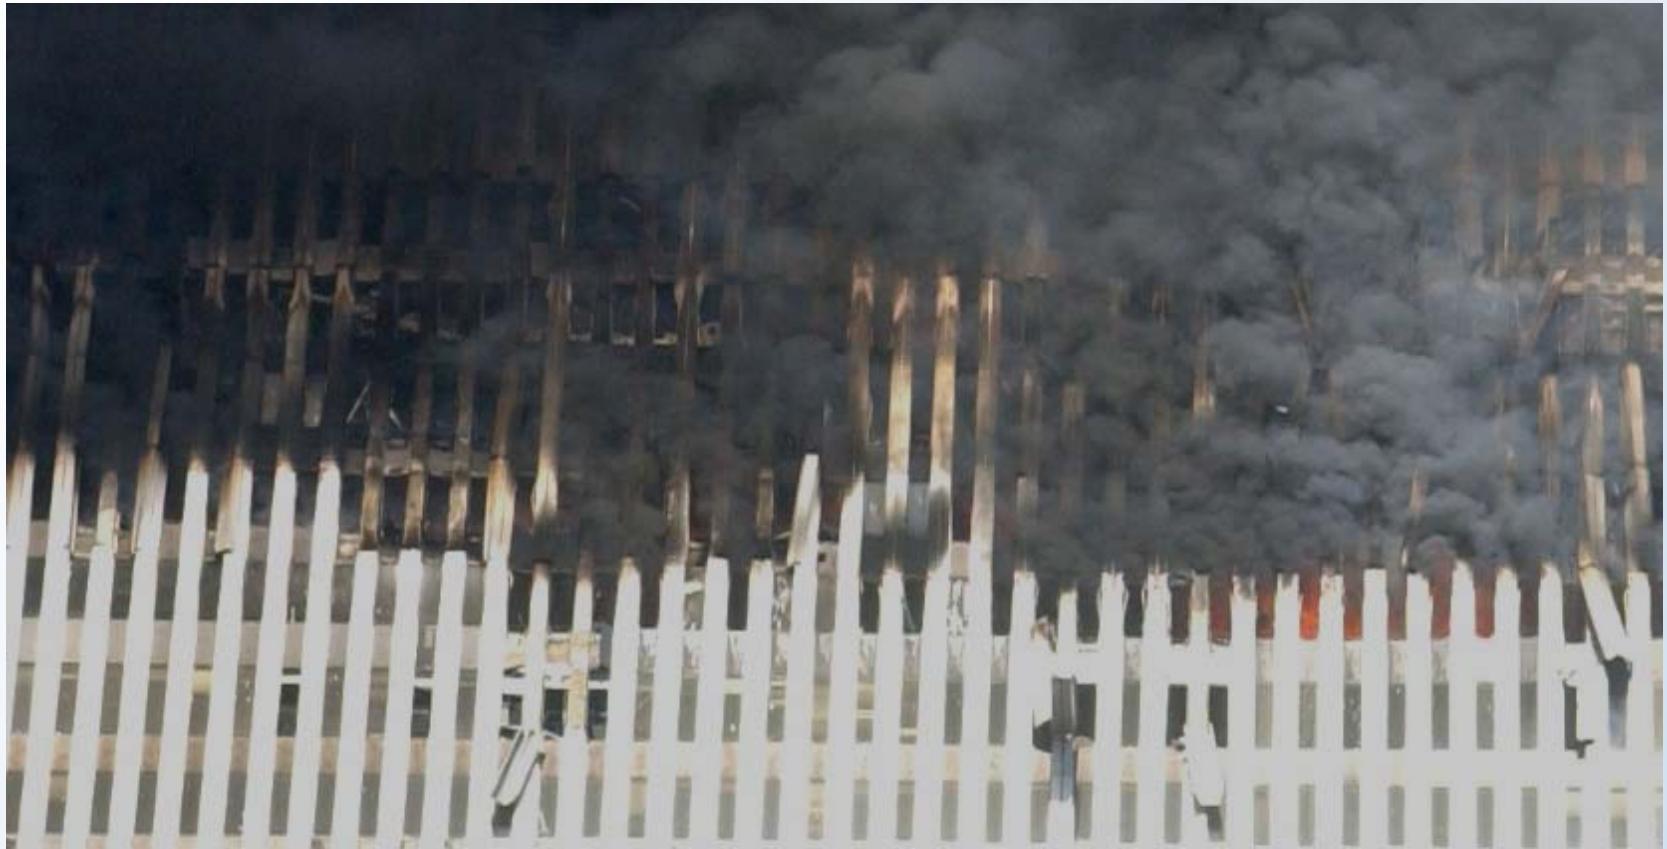
East Face of the South Tower. Image shows what appear to be a floor slab from the 83rd floor hanging across window opening over a large fraction number of the 82nd floor.

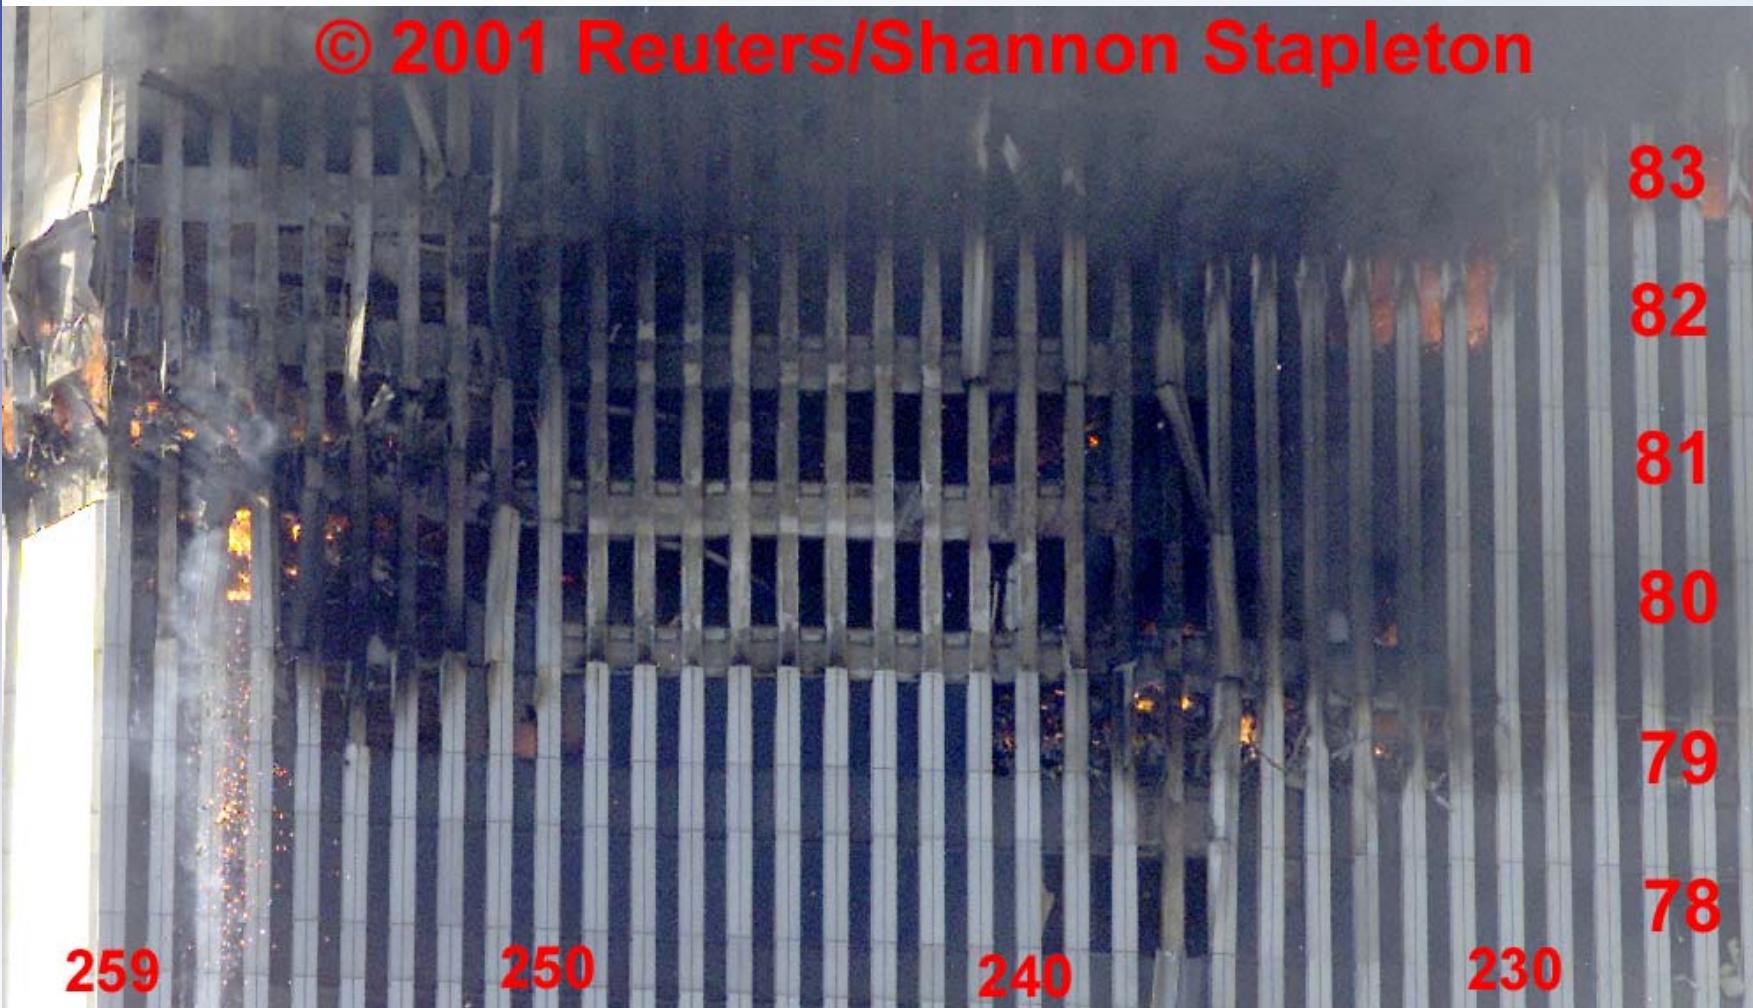
North Face of the South Tower. Image shows what appear to be portions of several floor slabs hanging across window openings on Floors 80, 81, and 82

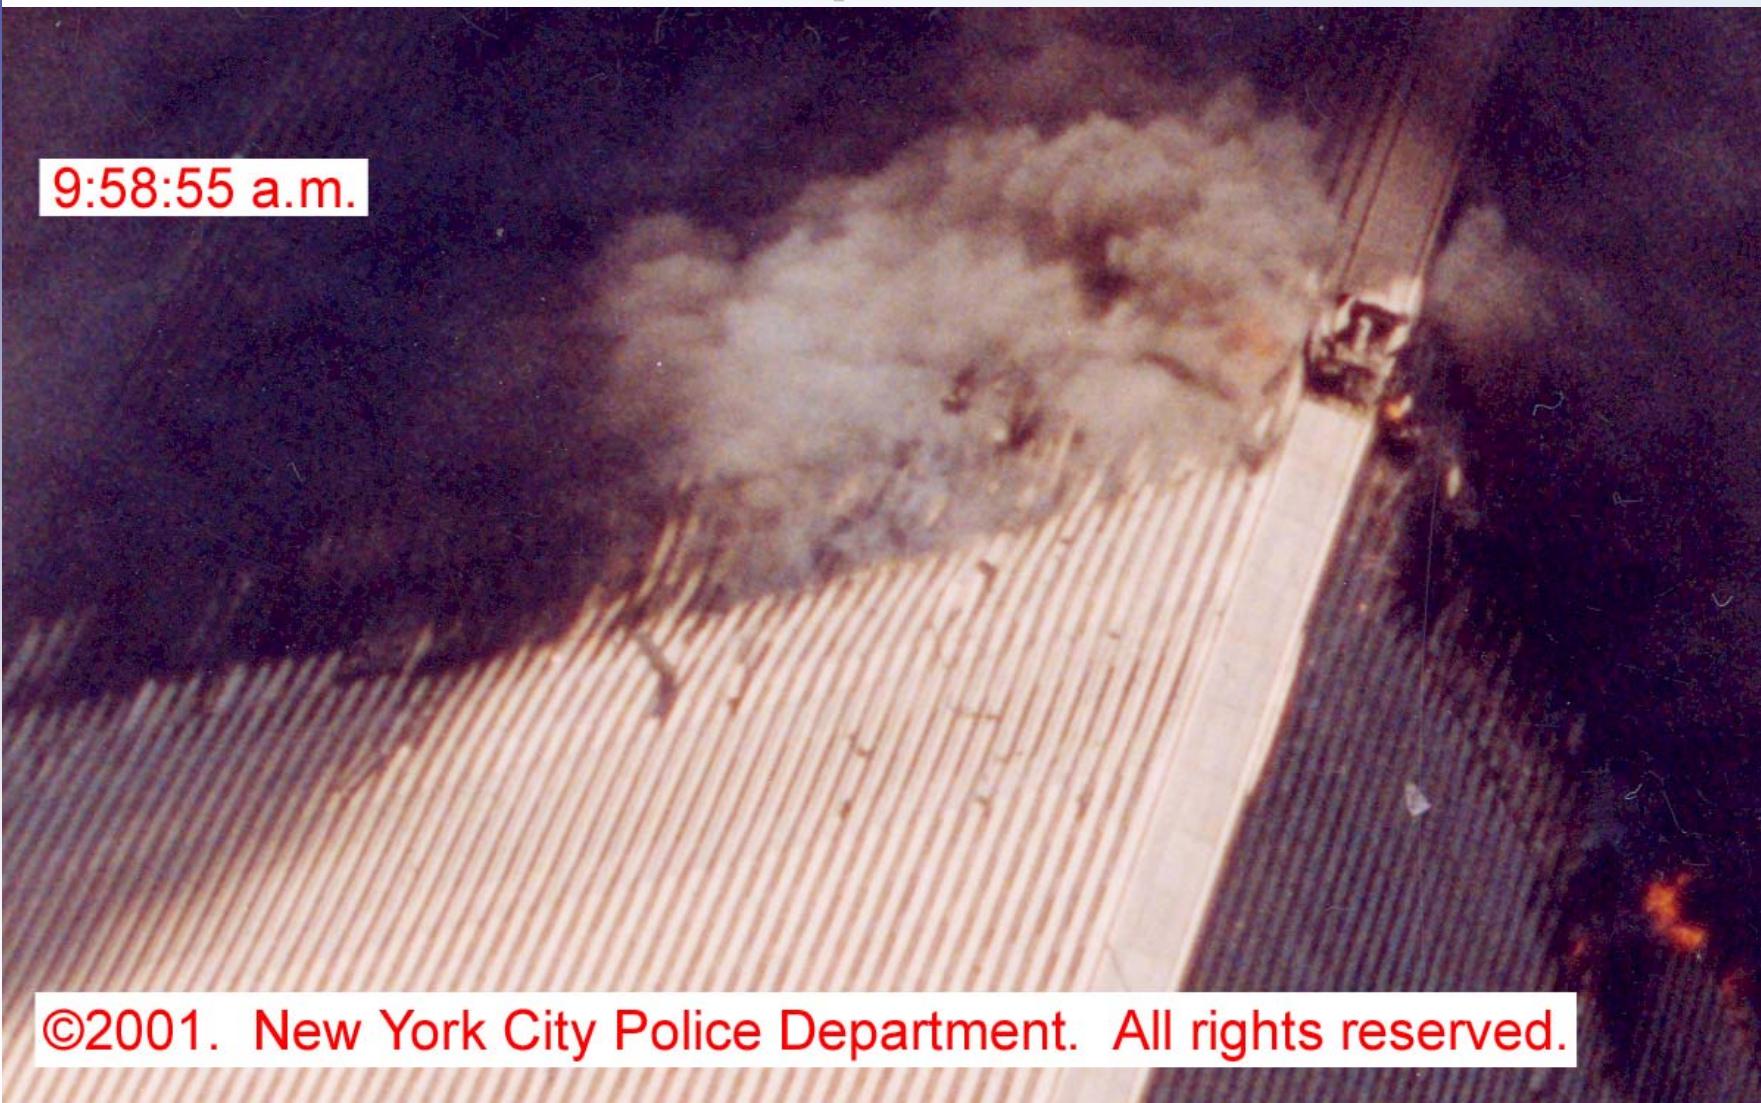
9:58:55 a.m.

Inward Bowing of Perimeter Columns Some Minutes Prior to Collapse: WTC 2 East Face

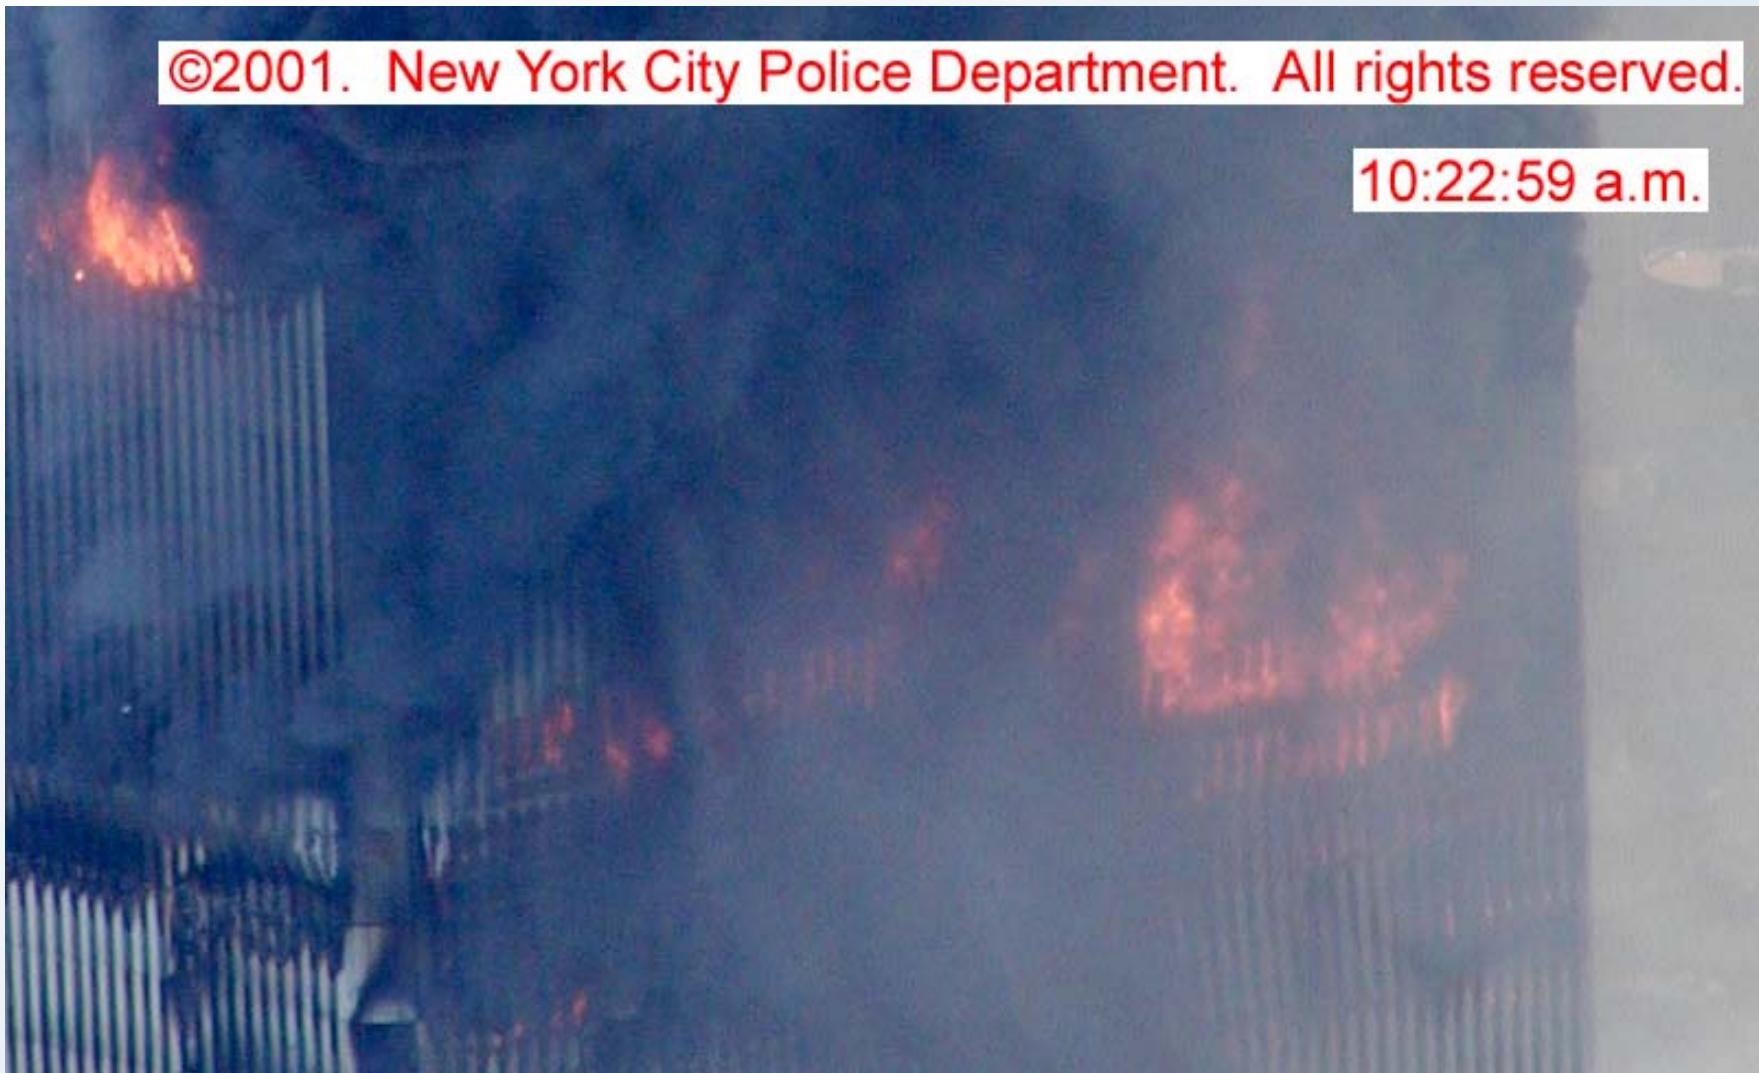
10:22:59 a.m.

Inward Bowing of Perimeter Columns Some Minutes Prior to Collapse: WTC 1 South Face

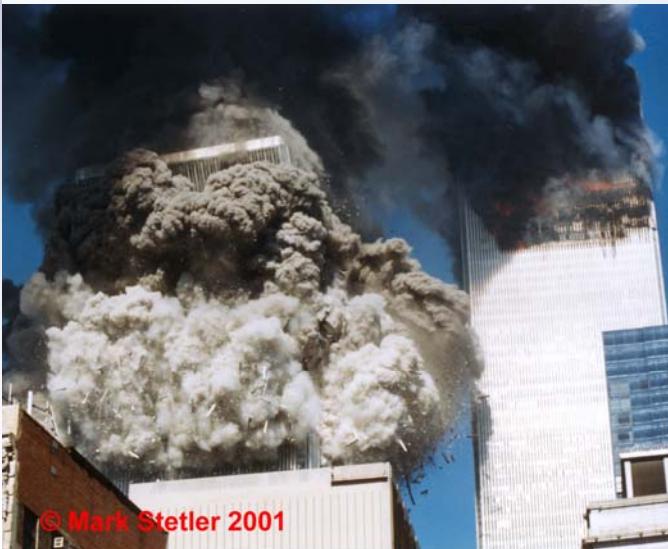
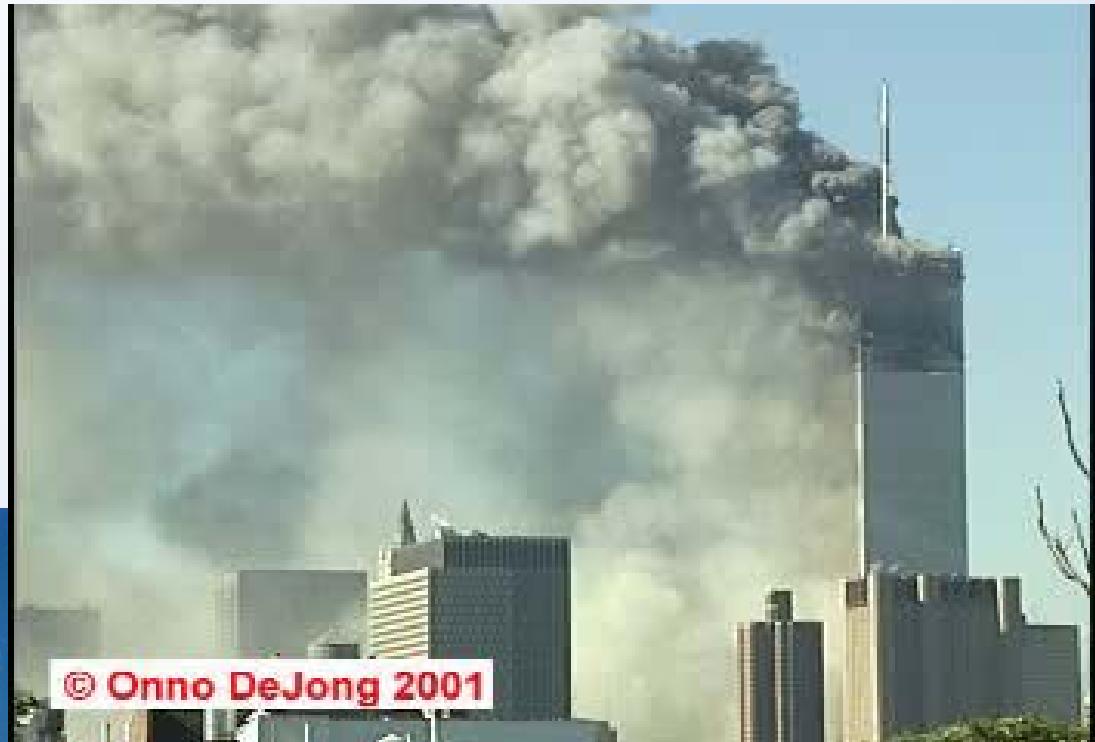
Initiation of global collapse was first observed by the tilting of building sections above the impact regions of both WTC towers.

WTC 1 tilted to the south; WTC 2 tilted to the east and south and twisted in a counterclockwise motion

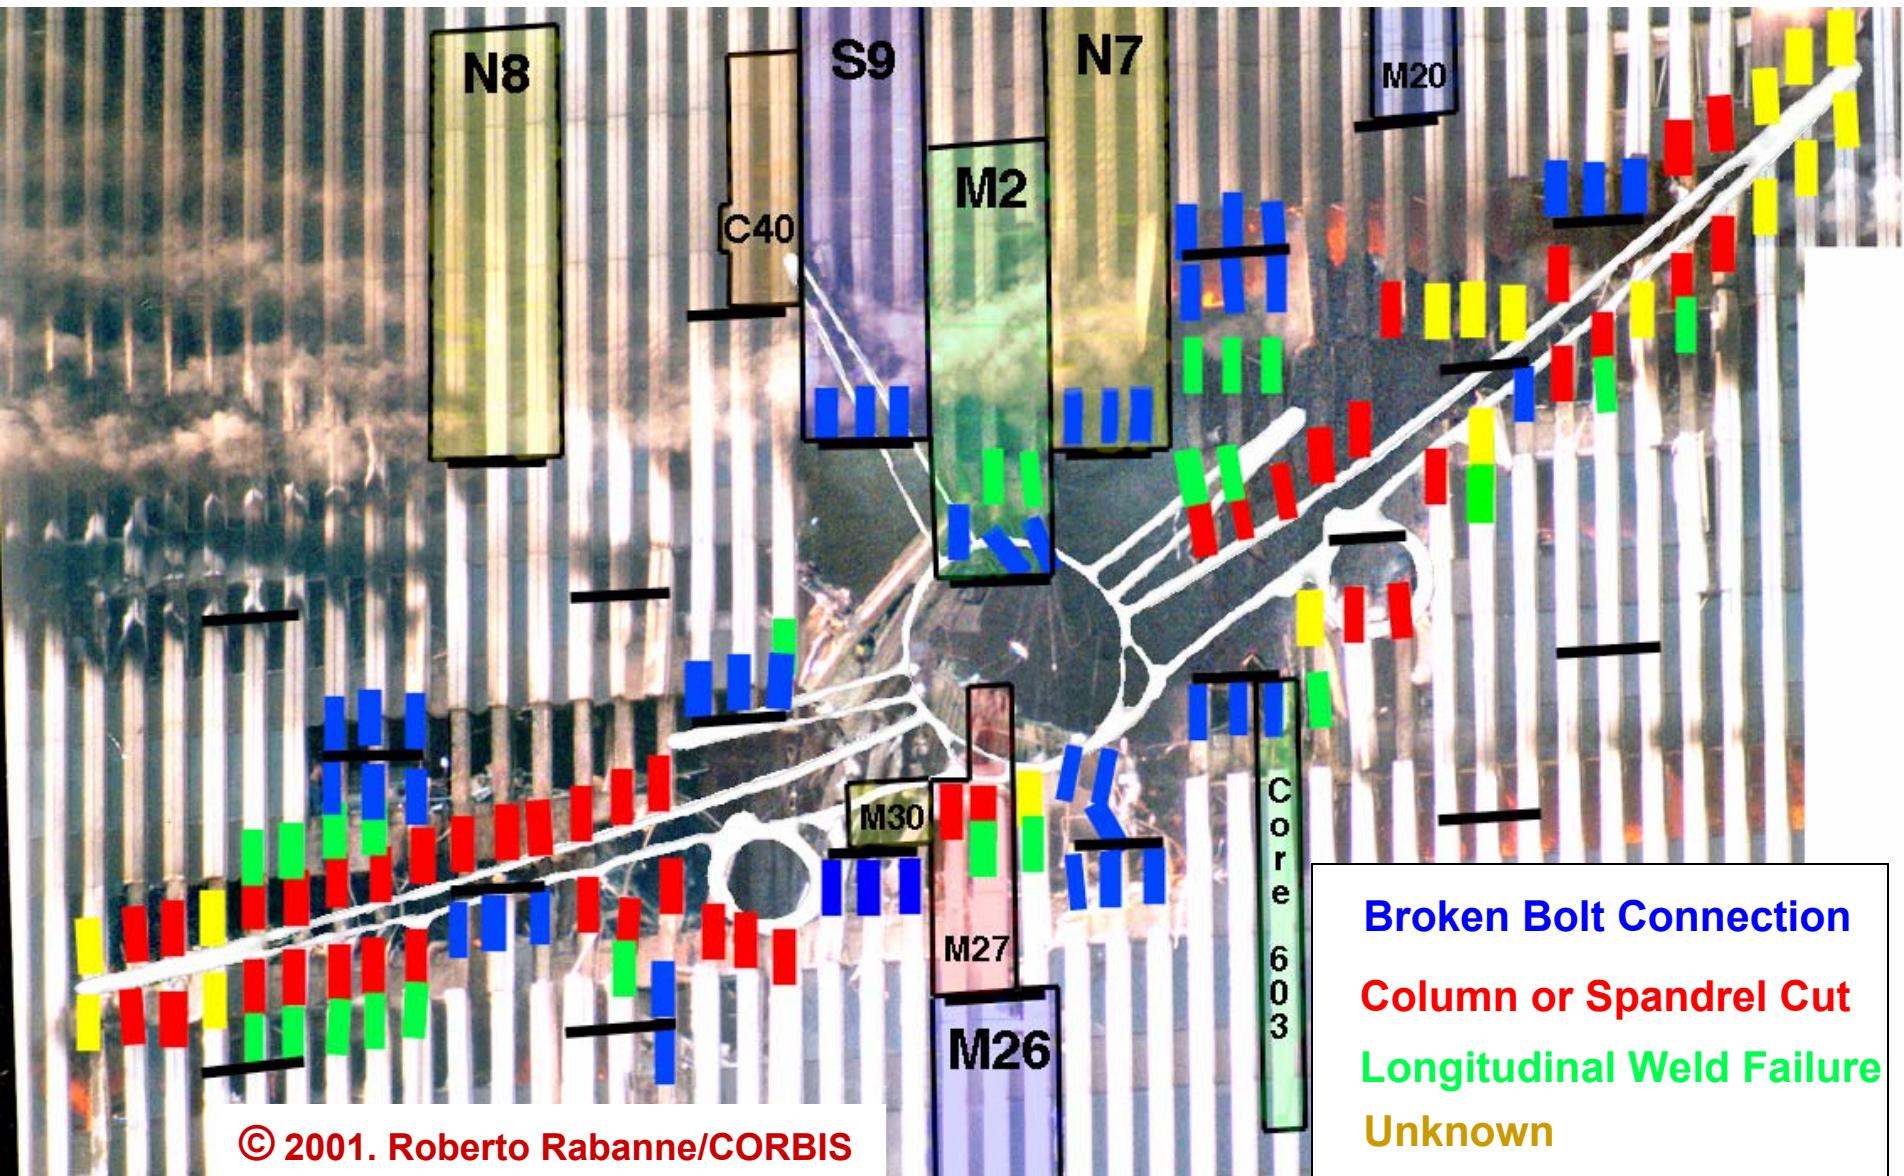
Broken Bolt Connection
Column or Spandrel Cut
Longitudinal Weld Failure
Unknown
Panel Junction

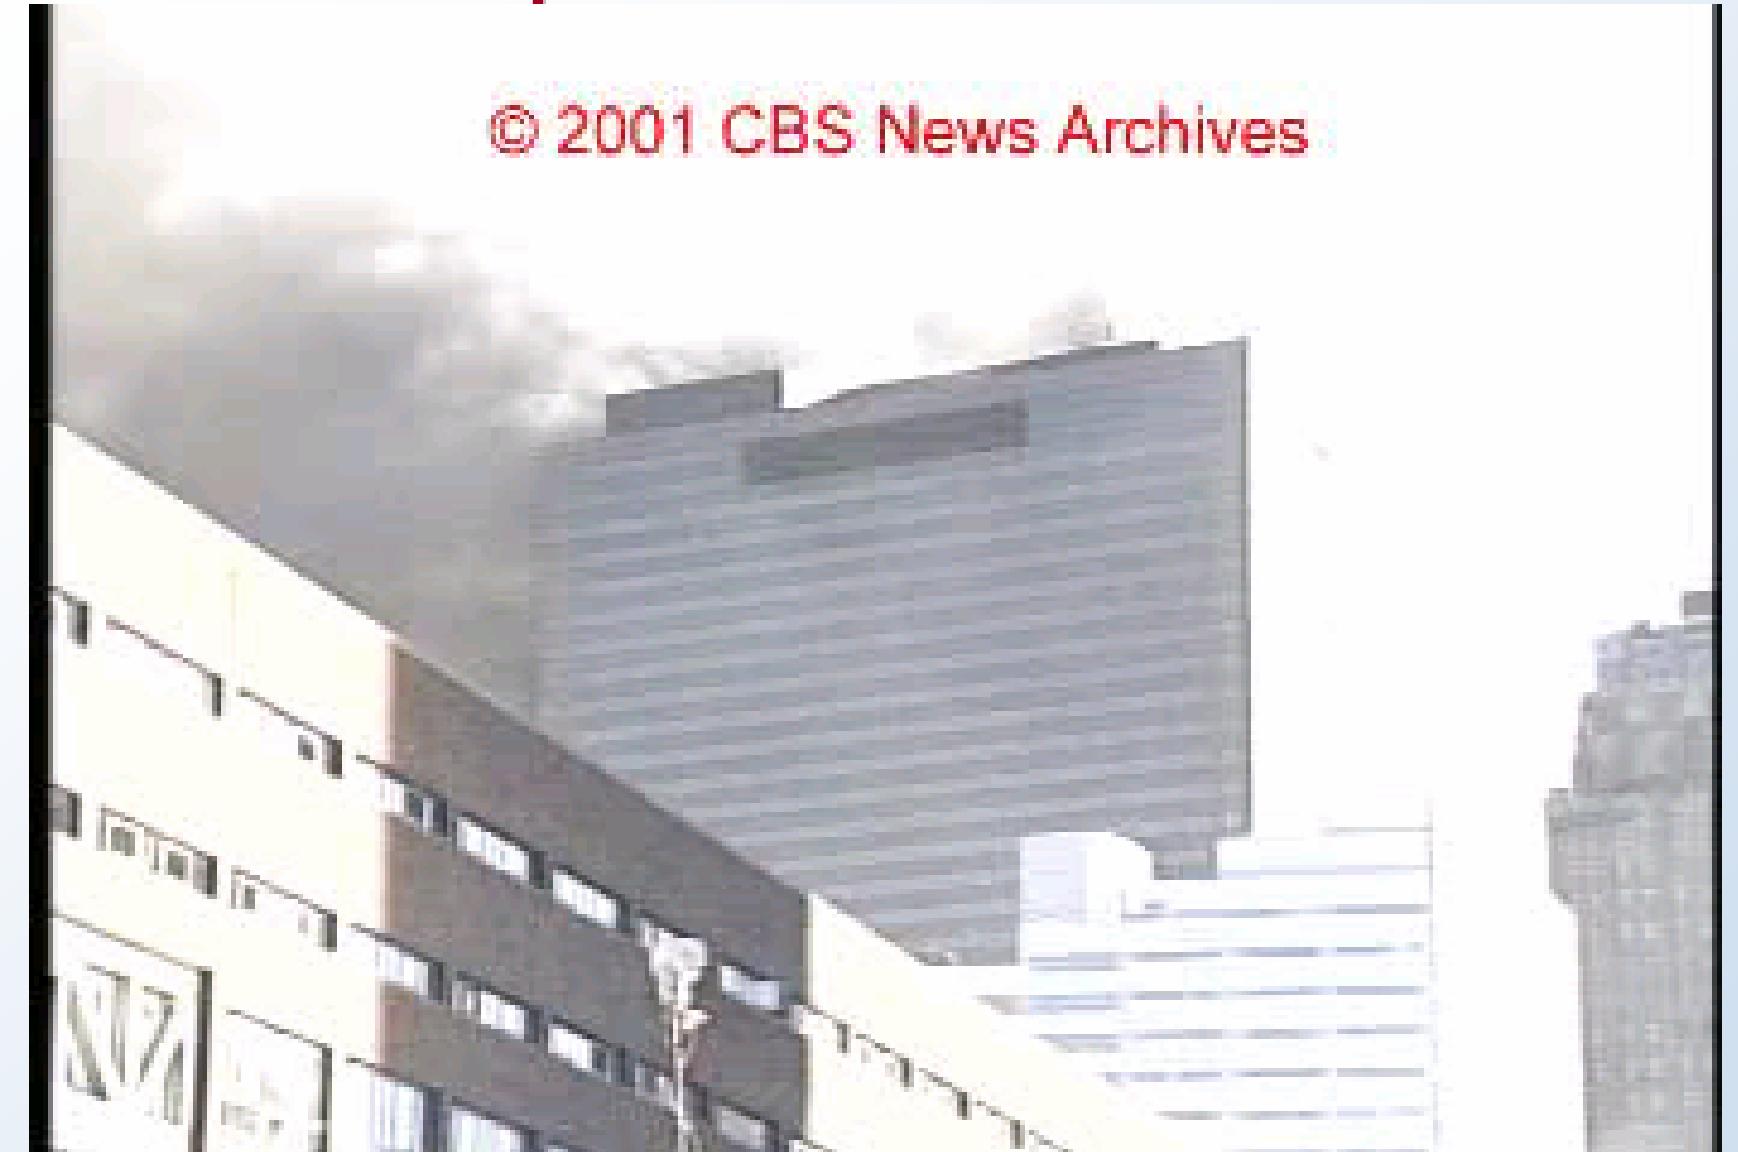
Observed Sequence of Failures in WTC 7

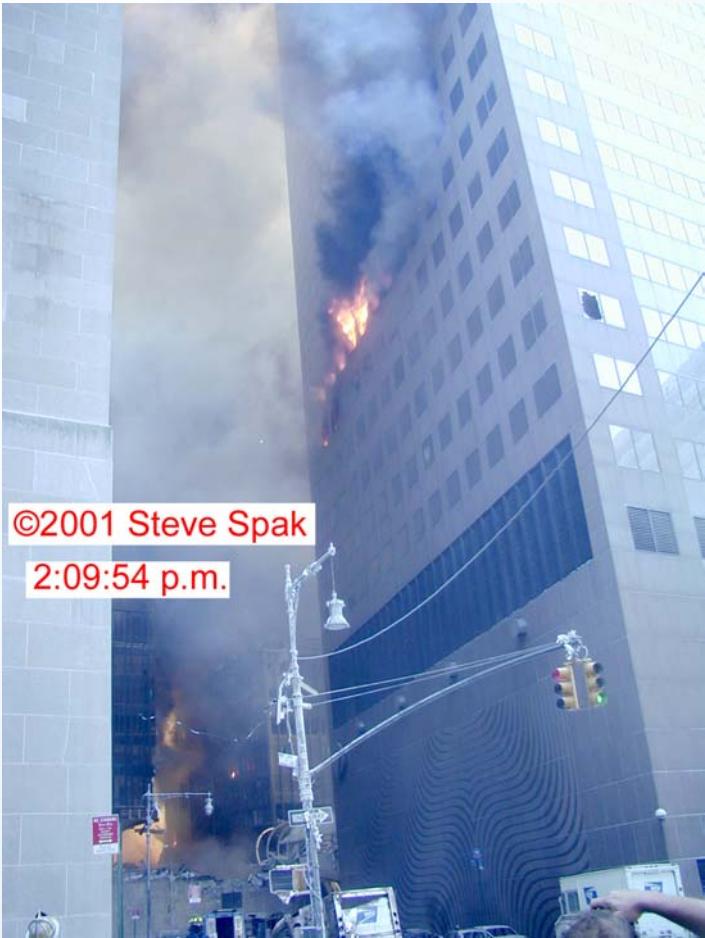
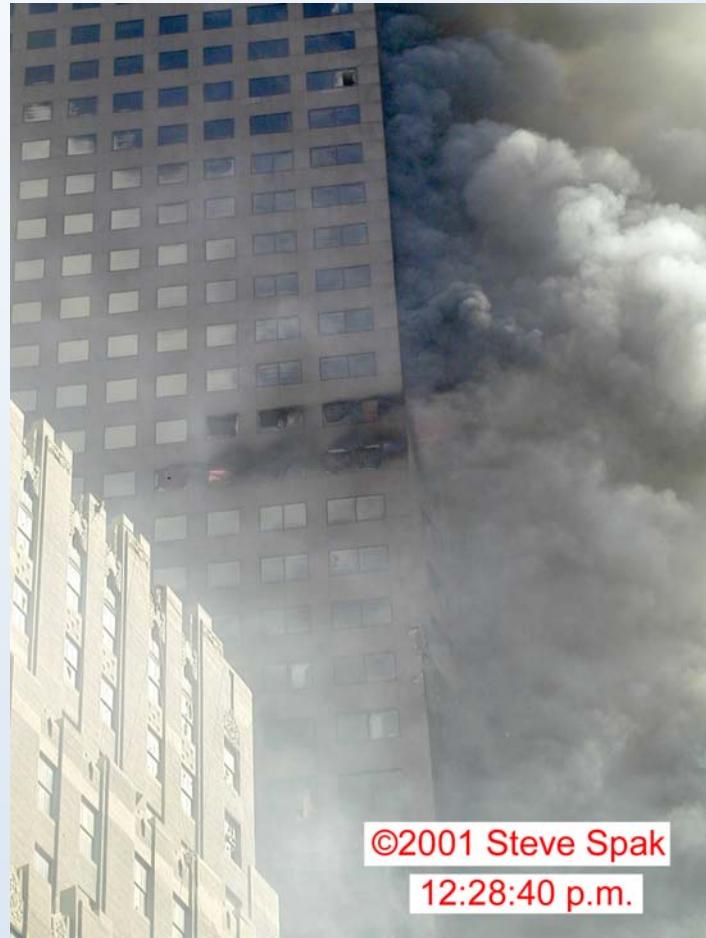
Fires in WTC 7—which began soon after WTC 1 collapsed—were observed on Floors 7, 8, 9, and 11 near the middle about half an hour before collapse; Floor 12 was burned out by this time. Fires were also seen on Floors 12, 13, 22, 29, and 30 at various times during the day.

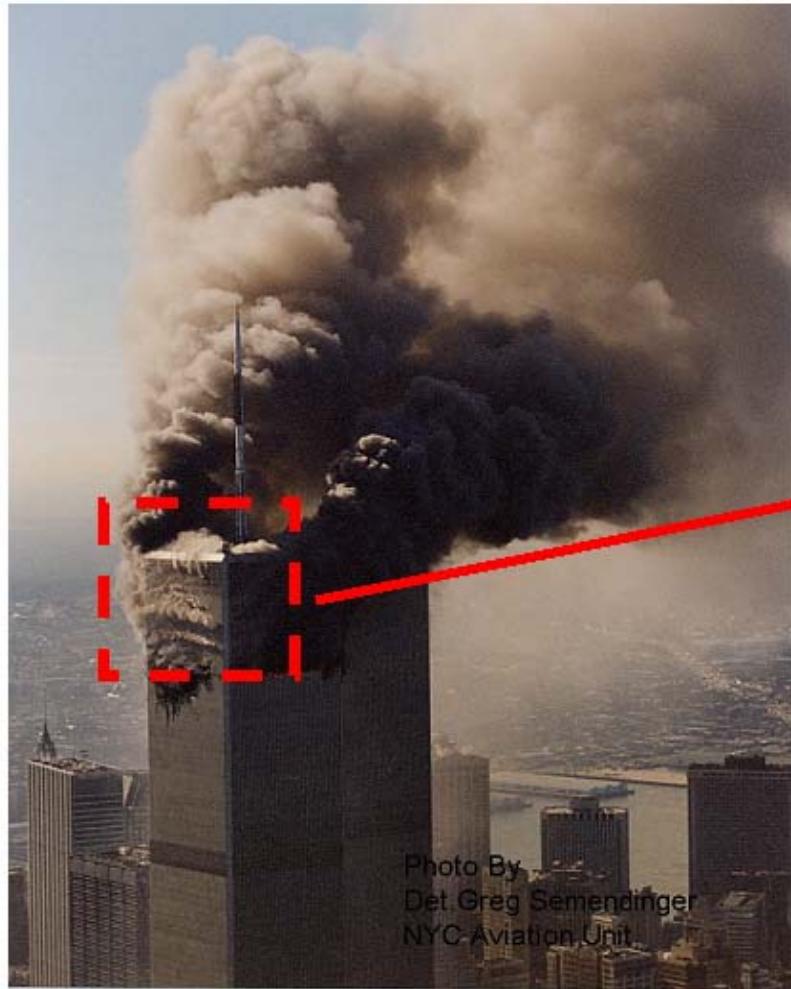
North Face – WTC 1

Smoke Exits NW Interior
Ventilation Zone Supply Inlet
