**Federal Building and Fire Safety Investigation
of the World Trade Center Disaster**

**Project 6: WTC 7 Structural Fire Response
and Collapse Analysis**

June 22, 2004

**Building and Fire Research Laboratory
National Institute of Standards and Technology
U.S. Department of Commerce**

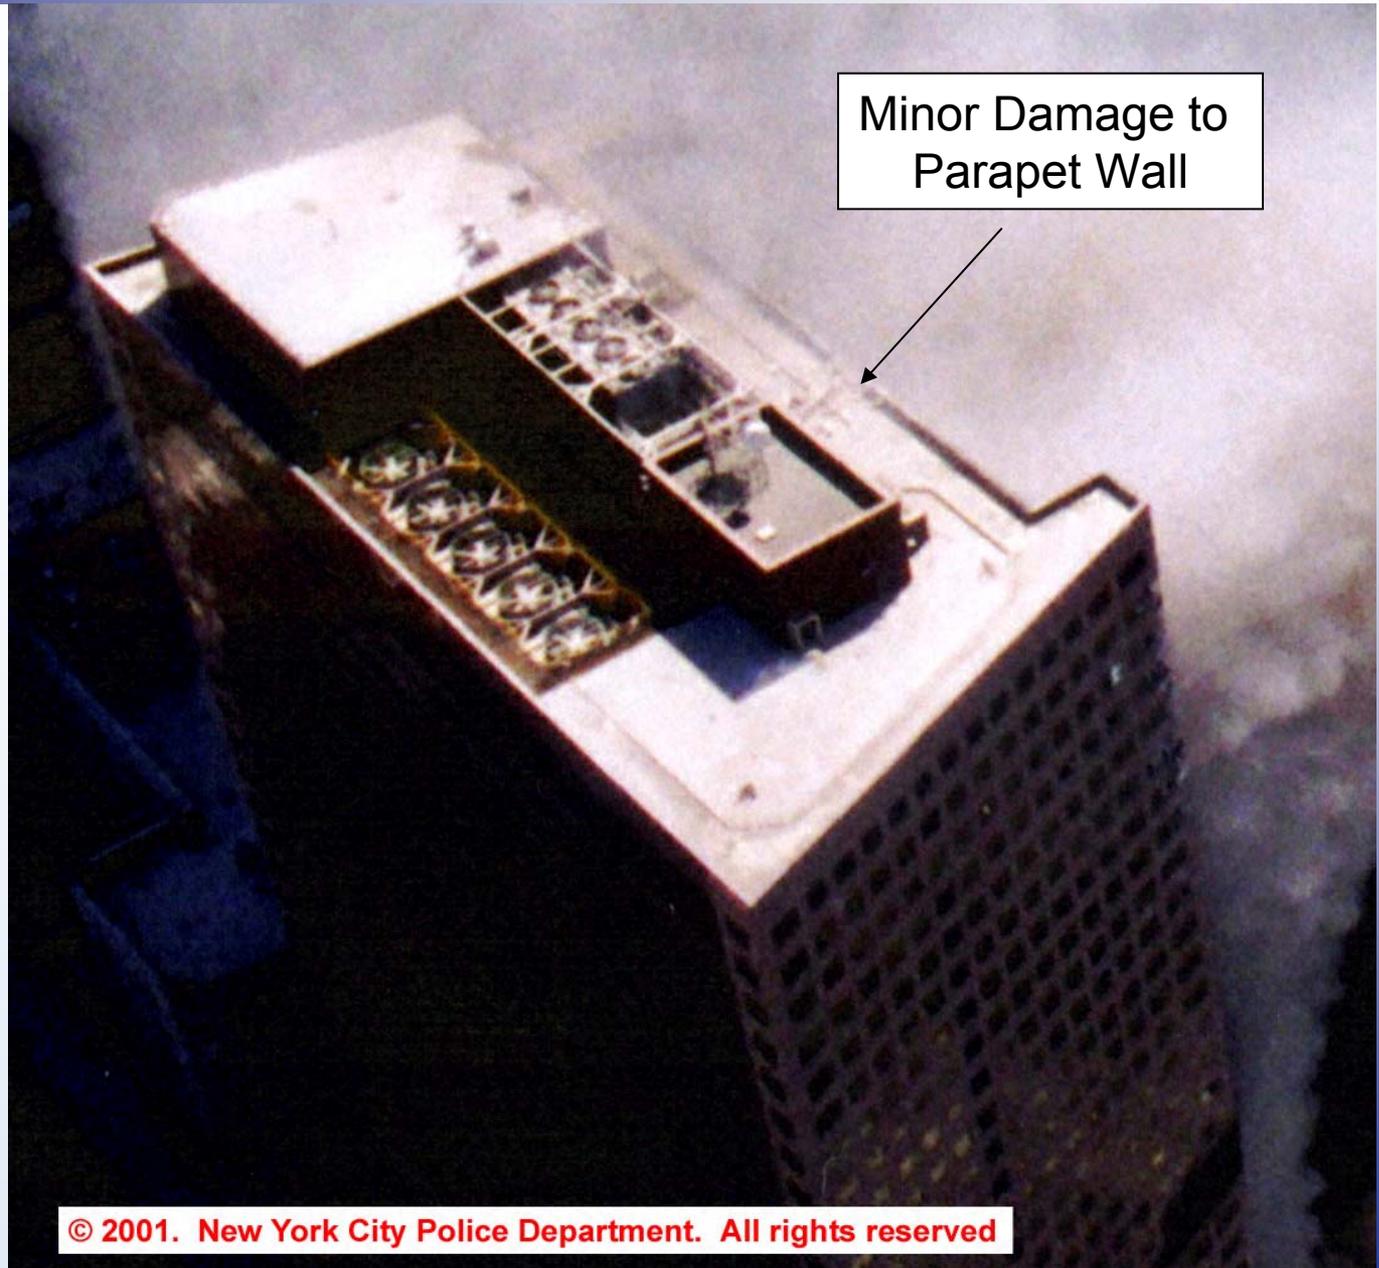
**WTC 7
Roof
After
WTC 1
Collapse**

- ❑ Heavy debris on Vesey Street and WTC 7 Promenade
- ❑ No heavy debris observed in lobby area, white dust coating
- ❑ SW Corner Damage – floors 8 to 18
- ❑ South face damage between two exterior columns - roof level down 5 to 10 floors, extent not known
- ❑ South Face Damage –
 - middle 1/4 -1/3 width south face, 10th floor to ground
 - large debris hole near center around 14th floor
 - 1/4 width south face, above 5th floor, atrium glass intact
 - 8th / 9th floor from inside, visible south wall gone with more damage to west, 2 elevator cars dislodged into elevator lobby

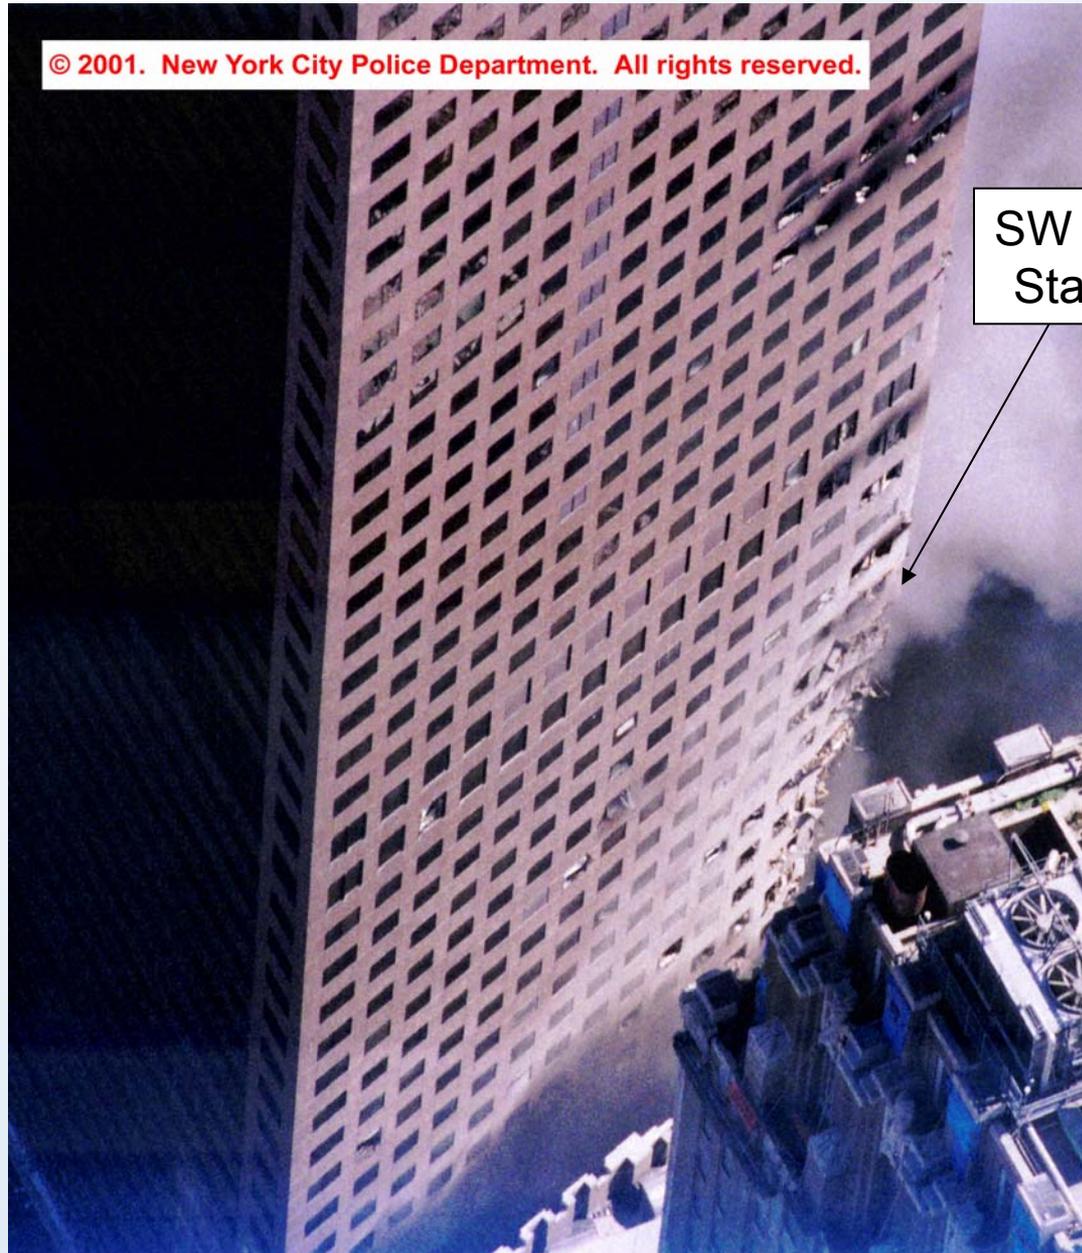
**WTC 7
SW
Corner
After
WTC 1
Collapse**

SW Corner Damage
Starting at Floor 18

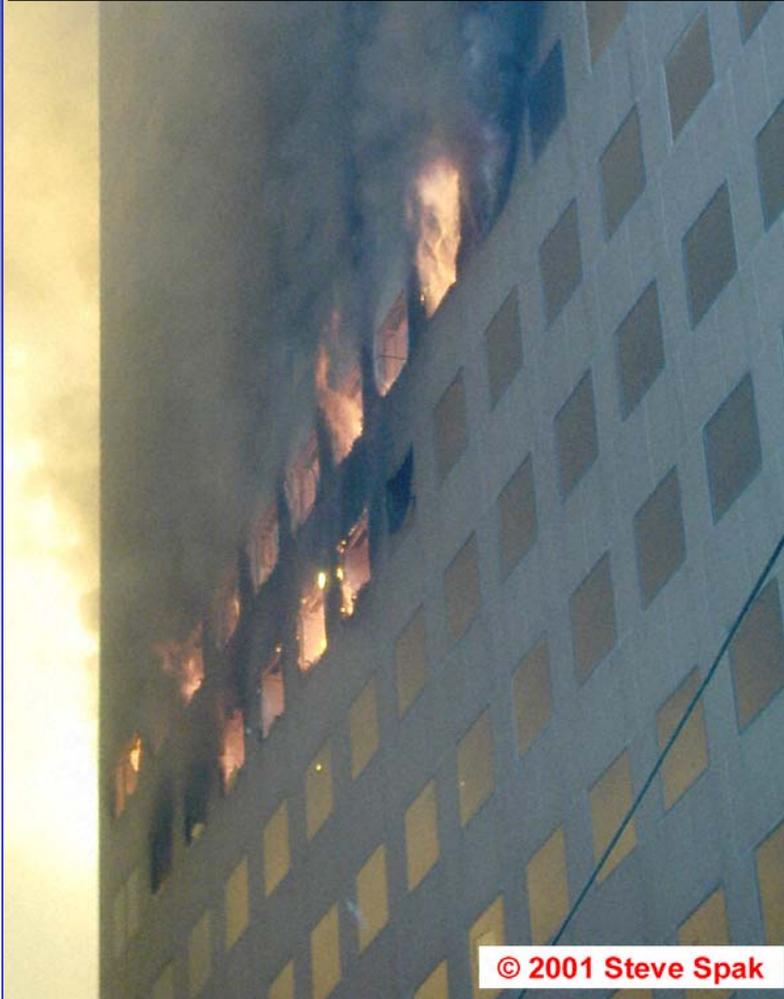
East Face Fires on Floors 11-12 near 2 PM

- ❑ Fire on floor 12;¹ area above covered with smoke
- ❑ Fire on floors 11-12¹ moved to east face and progressed to the north

¹ fires reported on floor 14, but photographs showed east face fires on floor 12

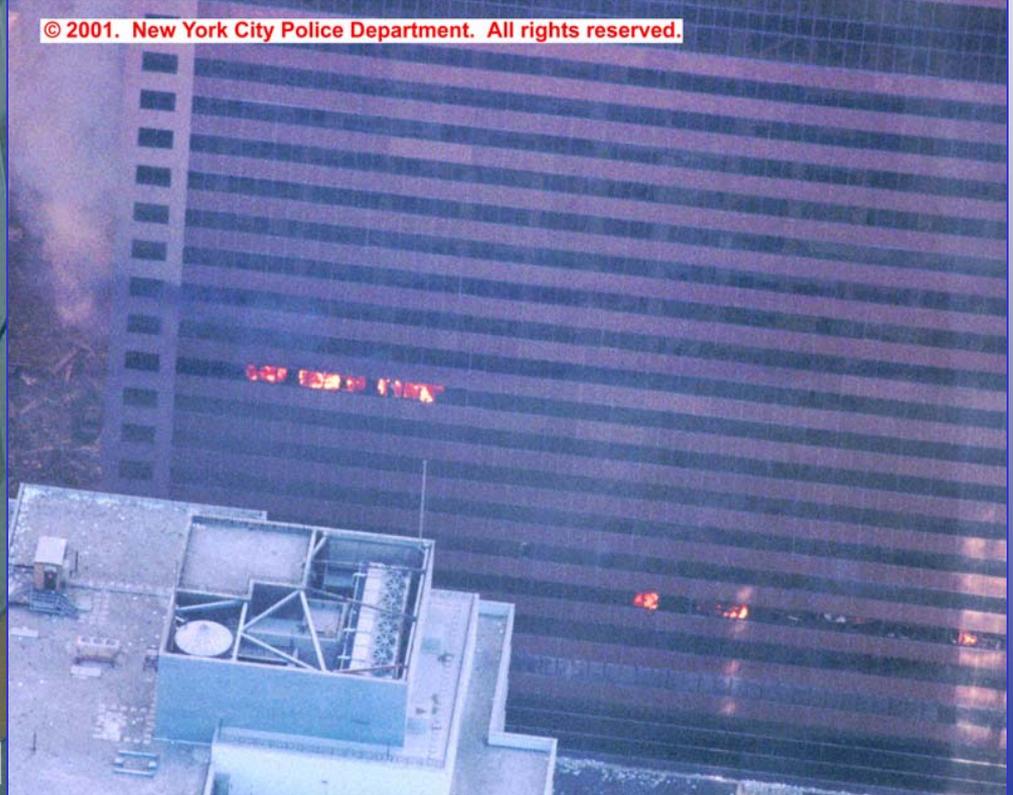
North Face Fires on Floors 7 and 12 near 3 PM

- ❑ No diesel smells reported from the exterior, stairwells, or lobby
- ❑ No signs of fire or smoke below floor 6 from stairwell and lobby areas
- ❑ Fire reported at west wall of floor 7 around 12:15 pm
- ❑ In east stairwell, smoke was observed near floors 19-20; signs of a fire observed on floor 23

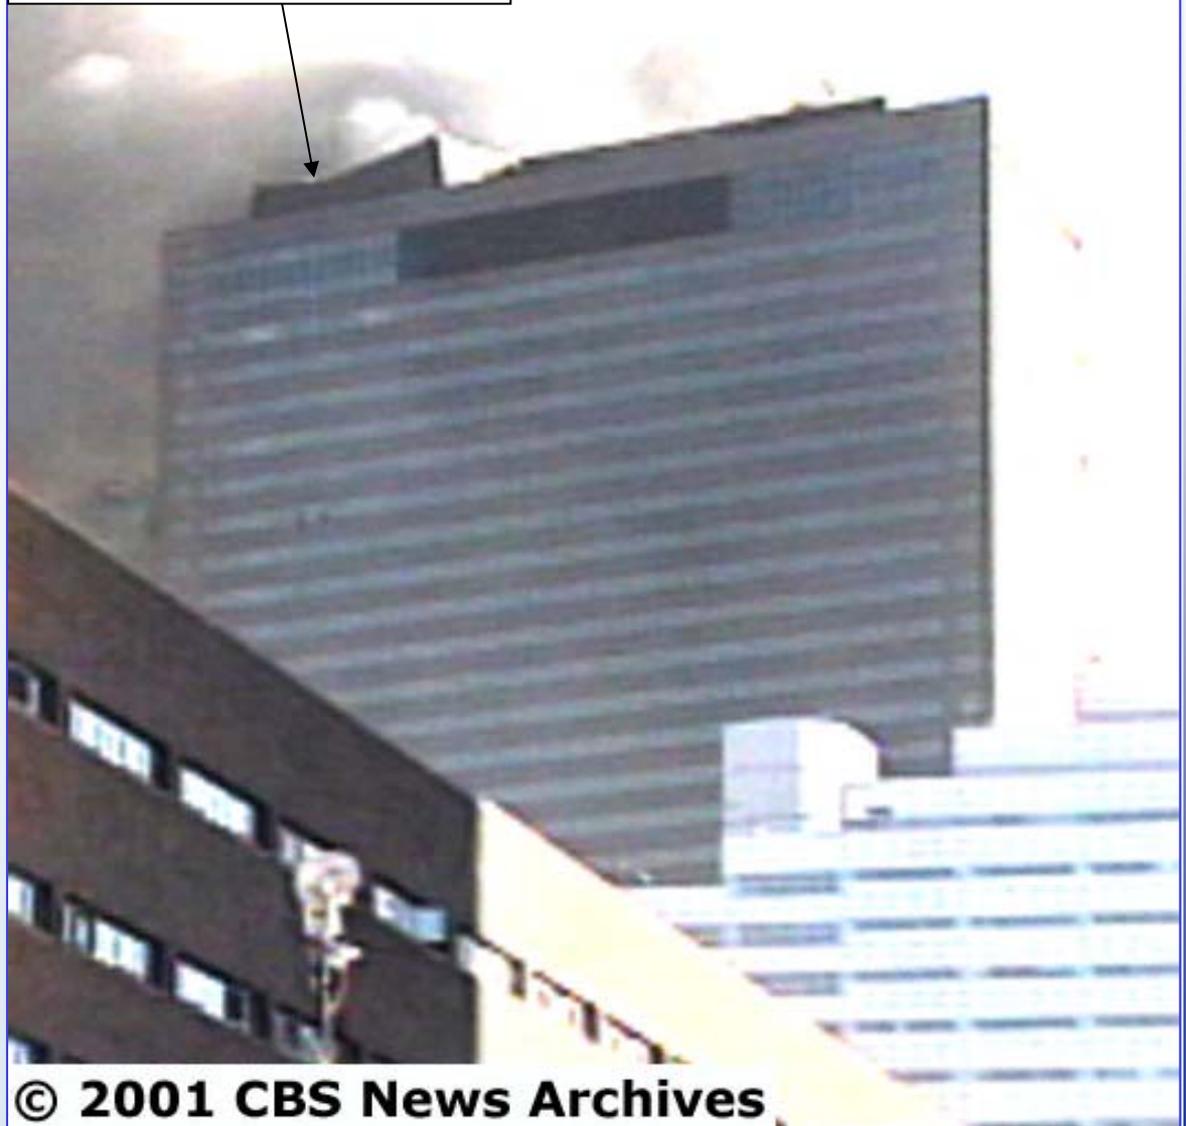
East Penthouse Kink
at Center of Roofline

- ❑ First exterior sign of failure was at the east penthouse roofline, aligned with interior columns 79, 80, and 81. Postulated initiating events include the failure of these columns.

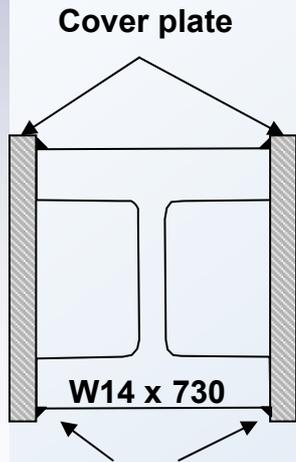
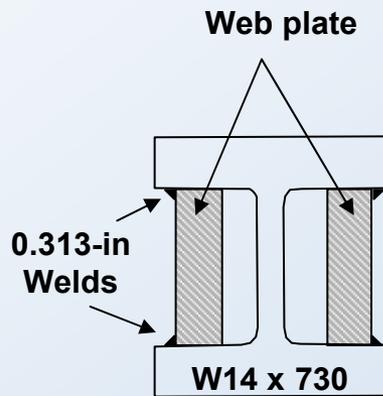
Columns 79 and 81 at Floors 5-7

Possible Modes of Column Failure:

- Squashing (Yielding) of Column
- Cover Plate Weld Failure
- Failure of Column Splice

NIST continues to evaluate the factors that could have caused column 79, 80, or 81 to fail

- Massive size of columns 79, 80, and 81 appears to require severe fires and/or damaged fireproofing to initiate thermally-related failures

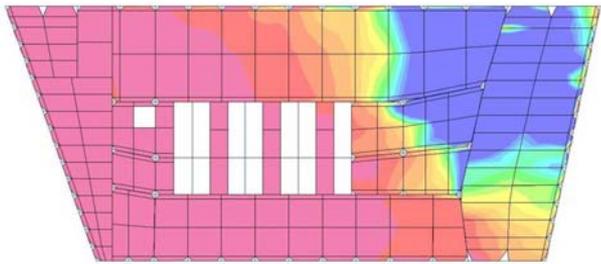
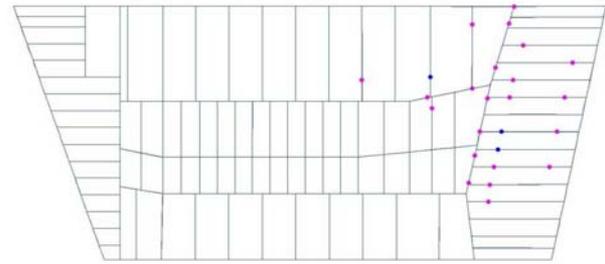
Col 79
Beam Hinges →
← Slab Force

- ❑ Columns 79, 80, and 81 supported large tributary areas for floor spans of approximately 50 ft. Failure of column 79, 80, or 81 would likely result in failure at the floor-column connections and would progress vertically up to the east penthouse.

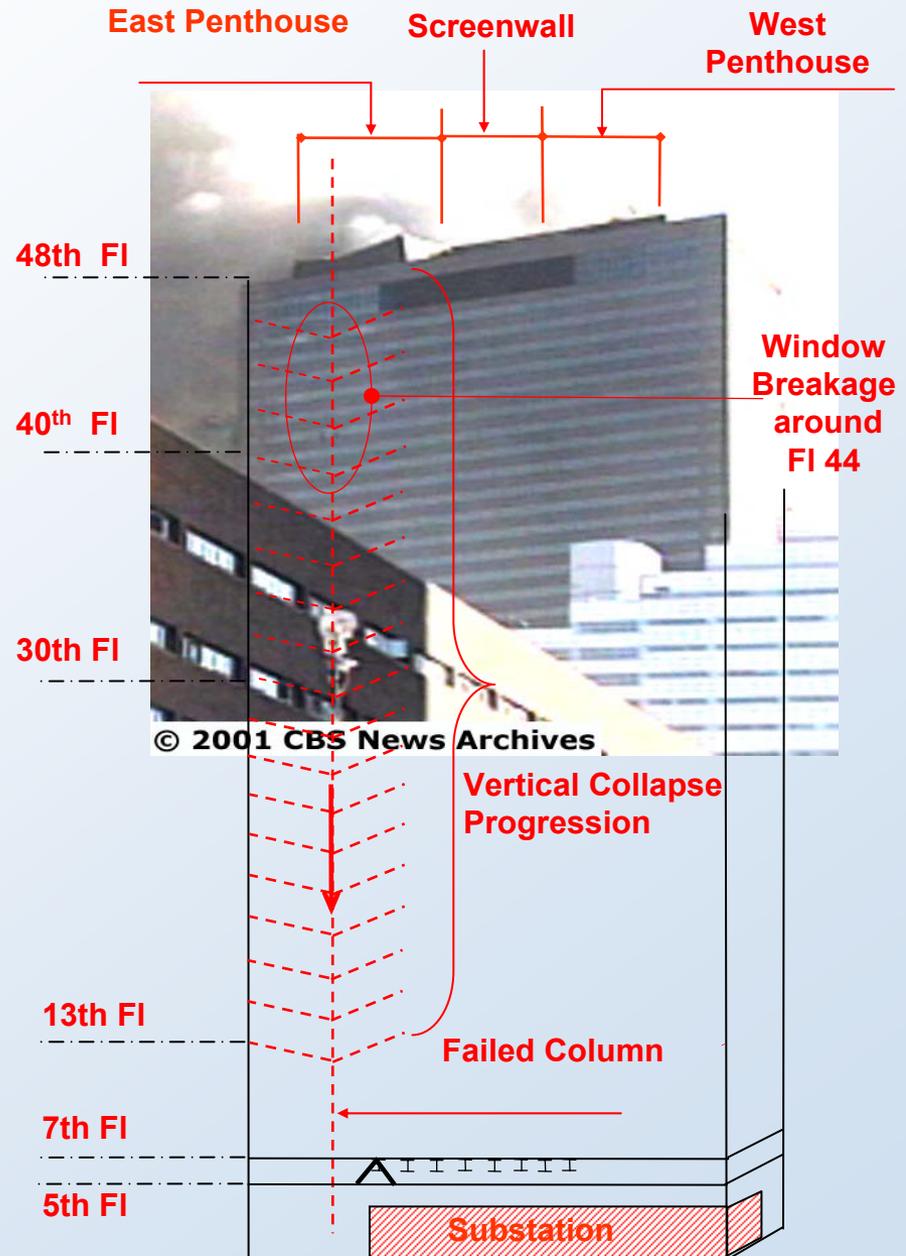
- ❑ East Penthouse Kink
- ❑ Window Breakage

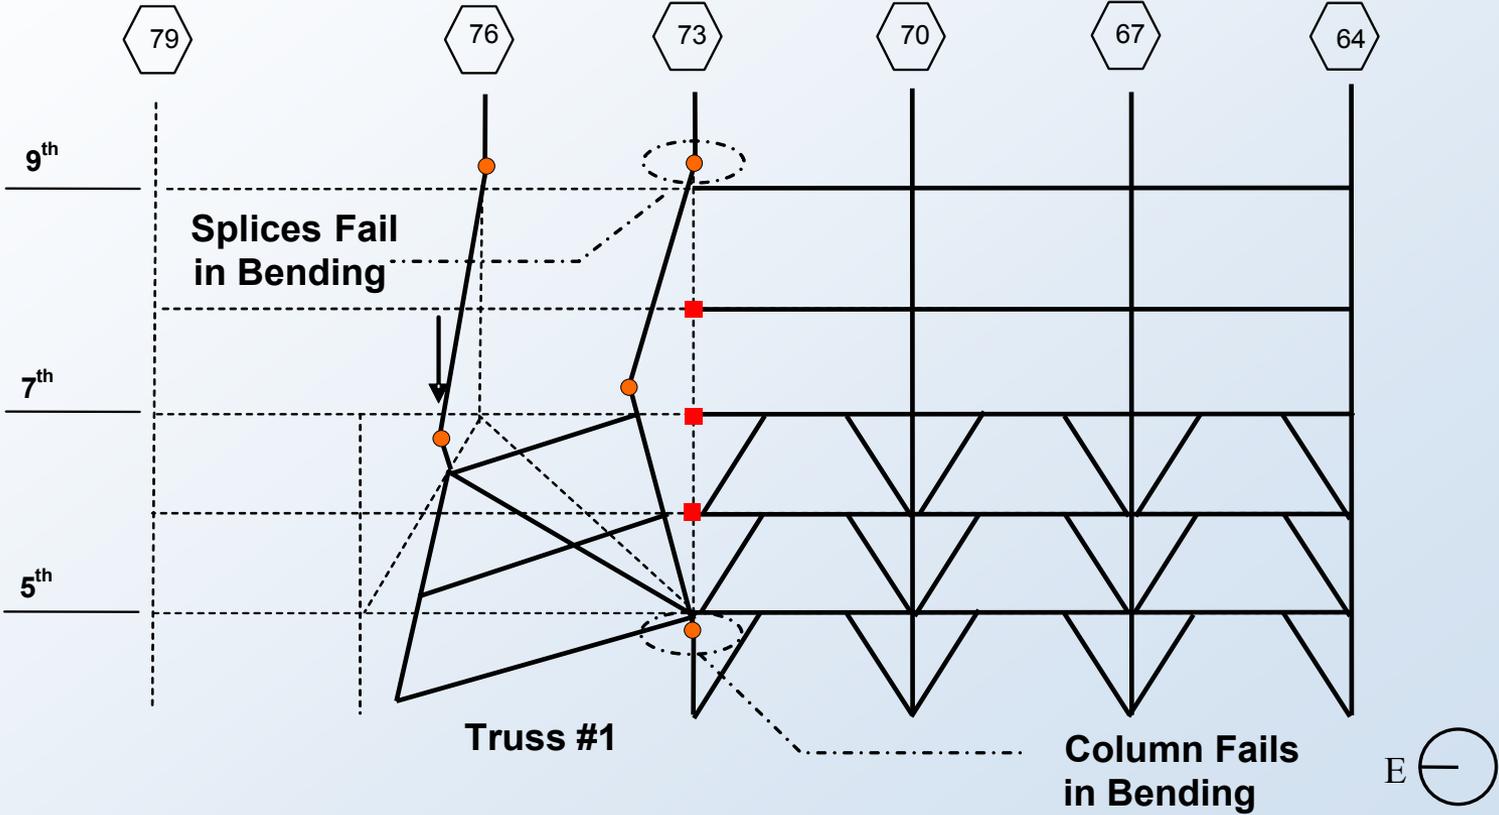
Horizontal Progression – Truss #1

- ❑ A vertical failure would pile debris on the east side of the building, damaging or severing transfer girders and trusses between floors 5 and 7.
- ❑ This secondary damage has been postulated to cause a horizontal progression of failure in the core columns at or near floors 5 and 7.

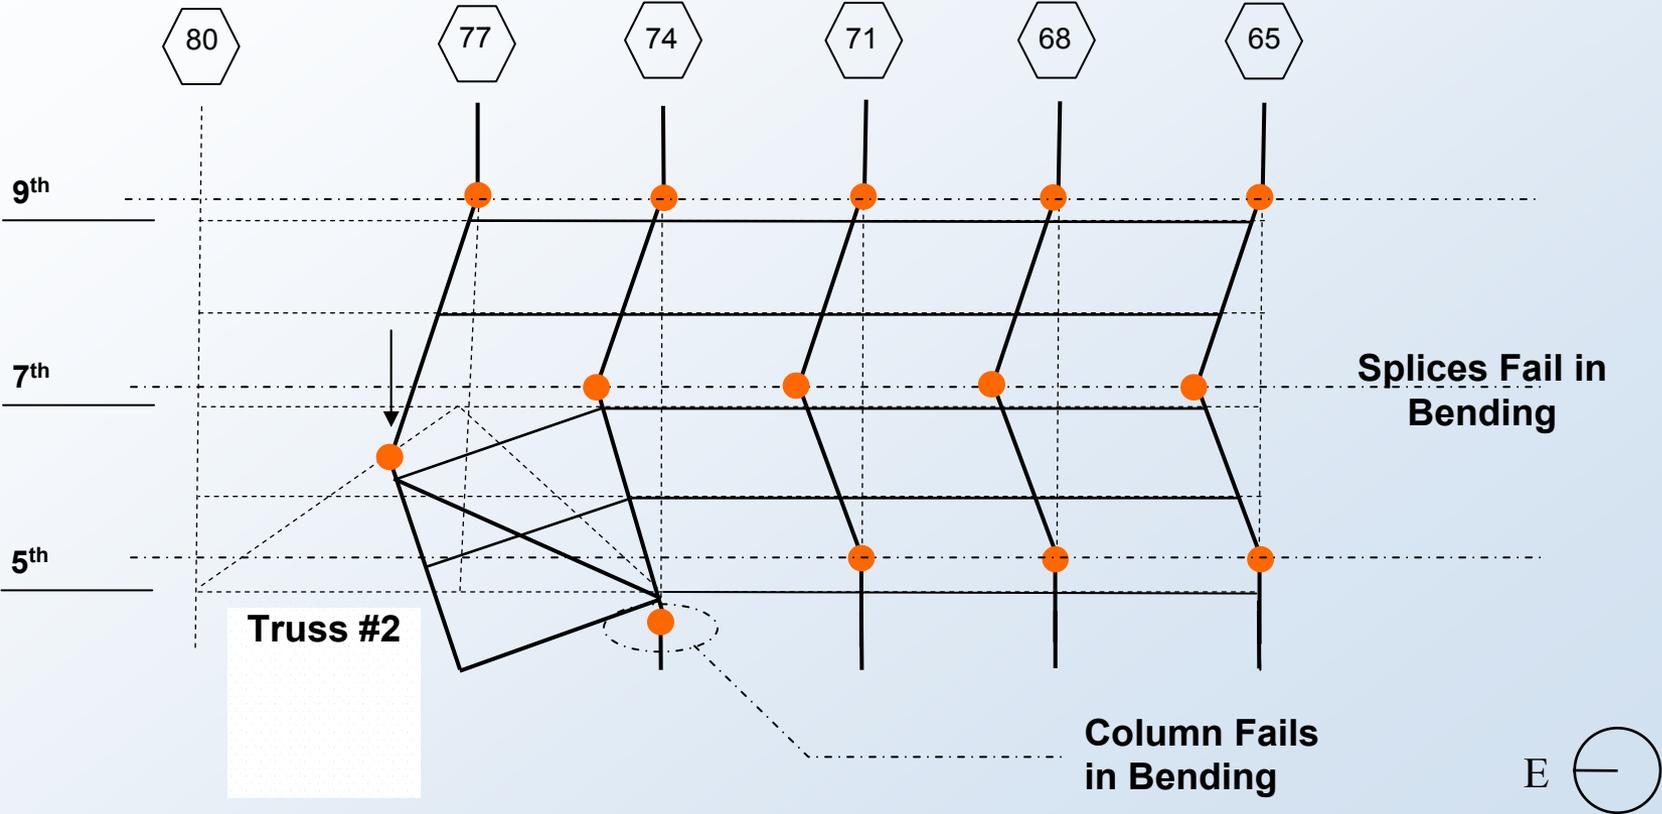
Horizontal Progression – Truss #2

- Damage to components adjacent to truss #2 from debris impact
- Damage to fireproofing from normal activities prior to event or debris damage
- Unusual fuel loads (fuel lines, high density of building contents)

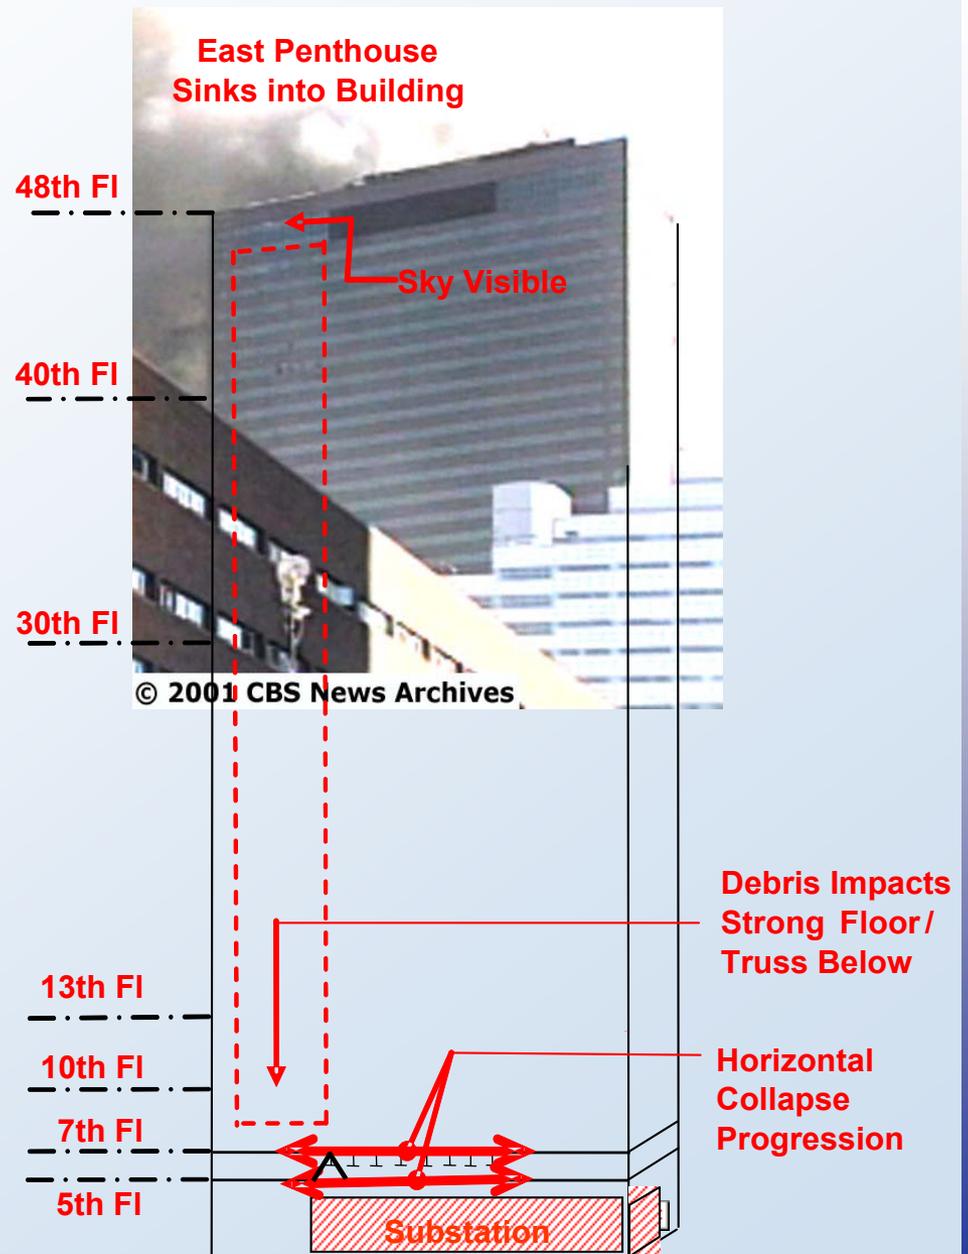
- ❑ East Penthouse Sinks
- ❑ Further Window Breakage
- ❑ No Movement for 5 sec

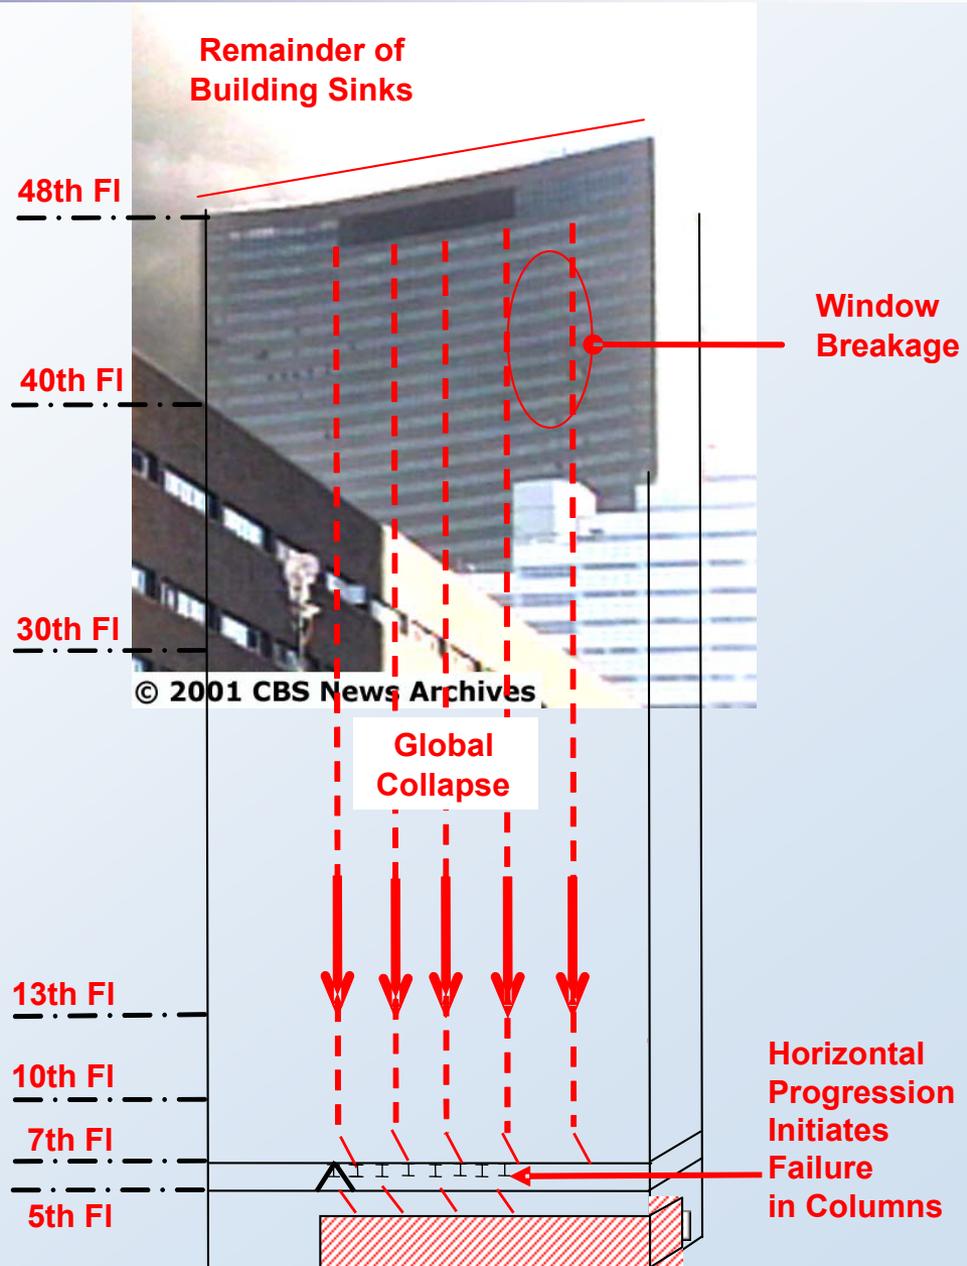
- ❑ The global collapse occurred with few external signs and is postulated to have occurred with the failure of core columns

- ❑ Center and West Penthouses Sink
- ❑ North Façade Kink at Column 76
- ❑ Window Breakage in Front of Truss #3
