NIST's Findings On The World Trade Center Fire and Collapse

**NFPA World Safety Conference & Exposition
Las Vegas, NV**

June 8, 2005

**Building and Fire Research Laboratory
National Institute of Standards and Technology**

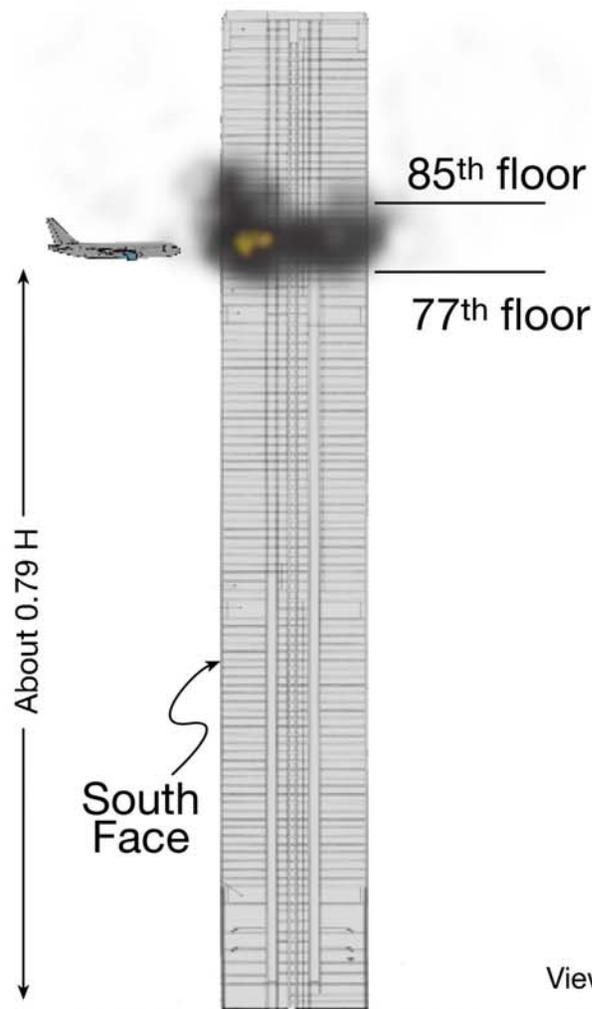
WTC 2: Hit at 9:02:59 a.m.
Collapsed after 56 minutes

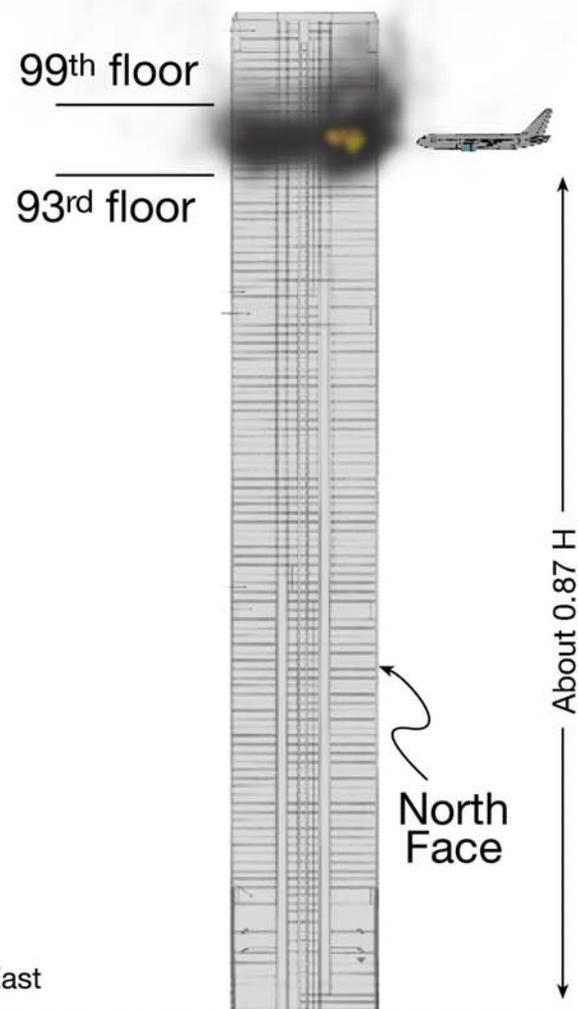
WTC 1: Hit at 8:46:30 a.m.
Collapsed after 102 minutes

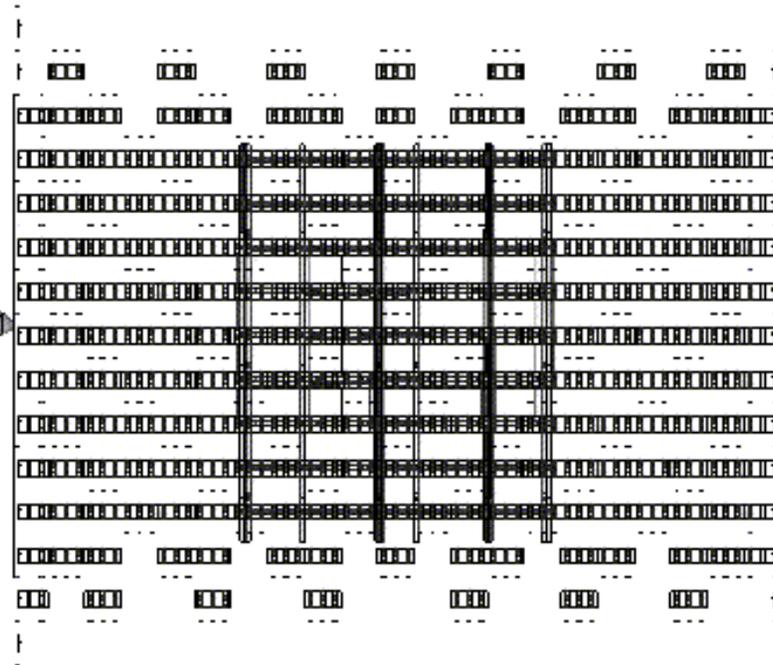
WTC 1 Damage: Composite Summary for Floors 93 to 98

Severe Floor Damage

Column Damage

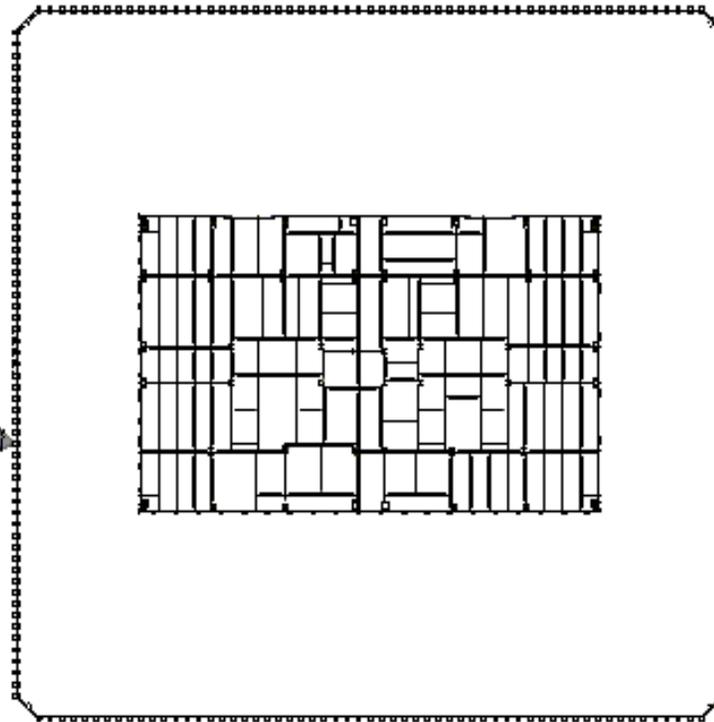
WTC 2 Damage: Composite Summary for Floors 78 to 83

Floor Damage

Column Damage

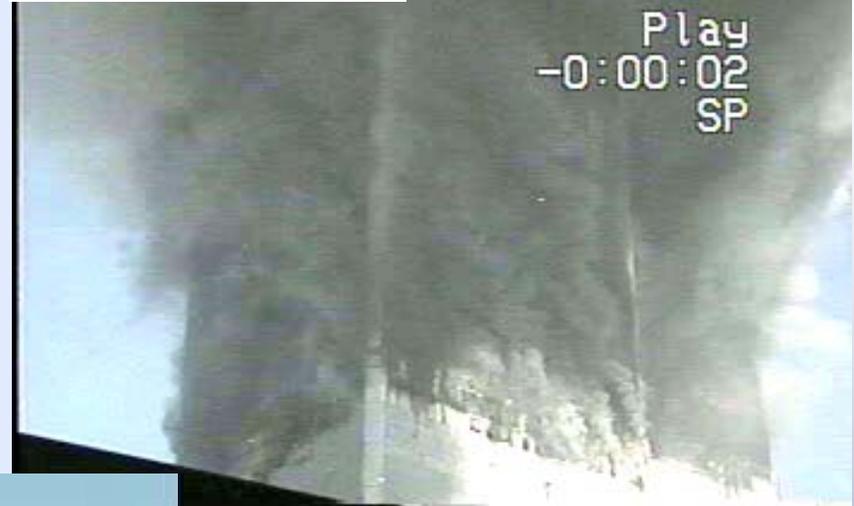
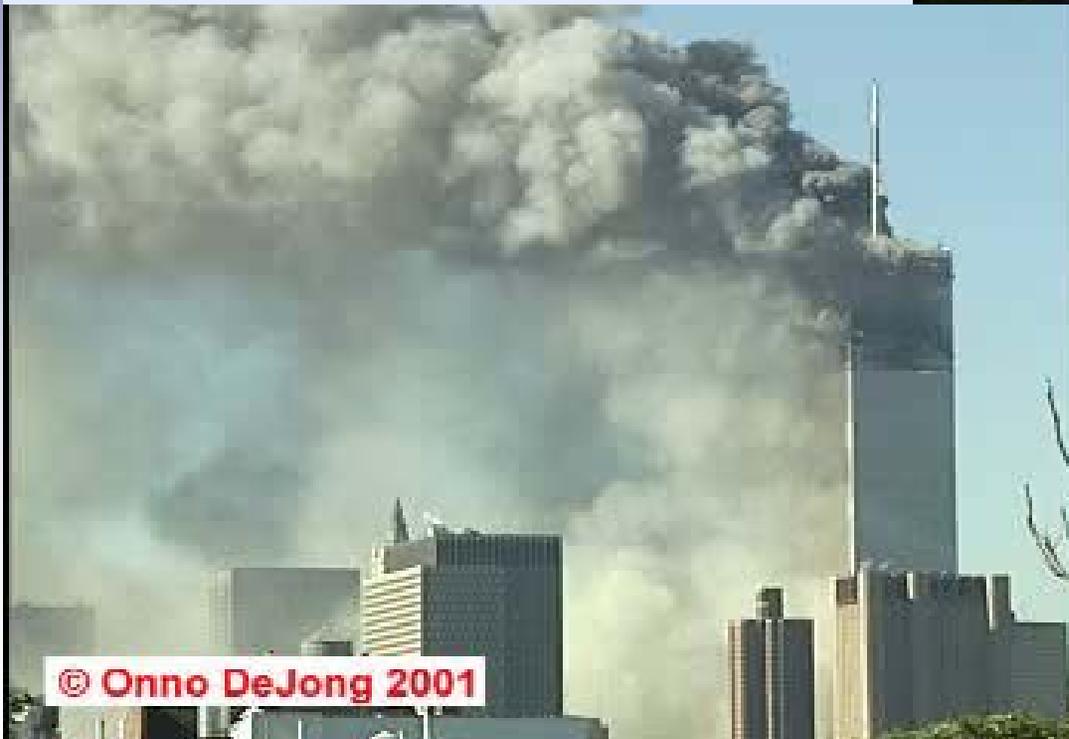
WTC 1 tilted to the south; WTC 2 tilted to the east and south and twisted in a counterclockwise motion

Initiation of global collapse was first observed by the tilting of building sections above the impact regions of both WTC towers.

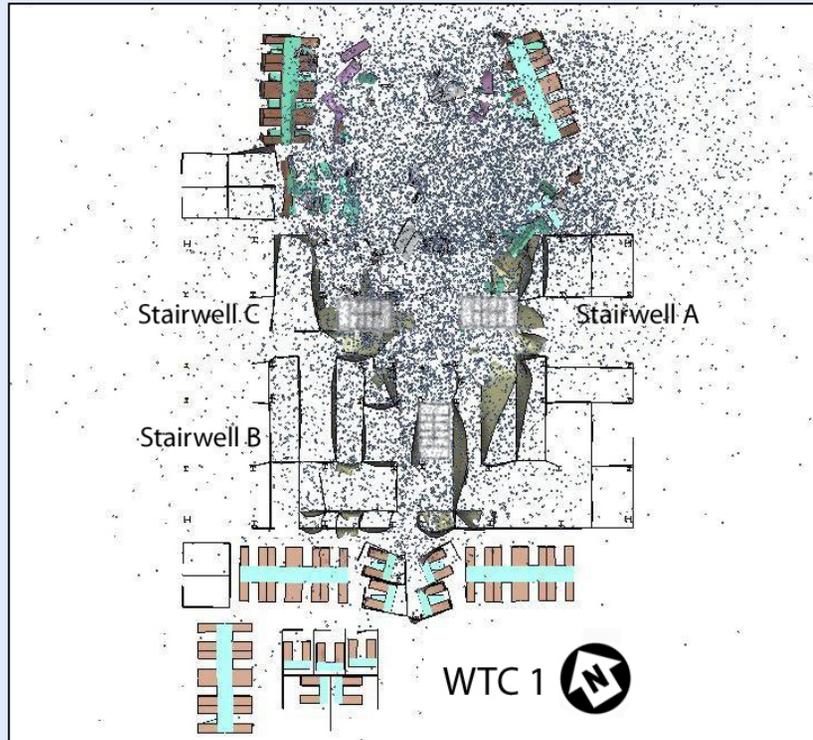
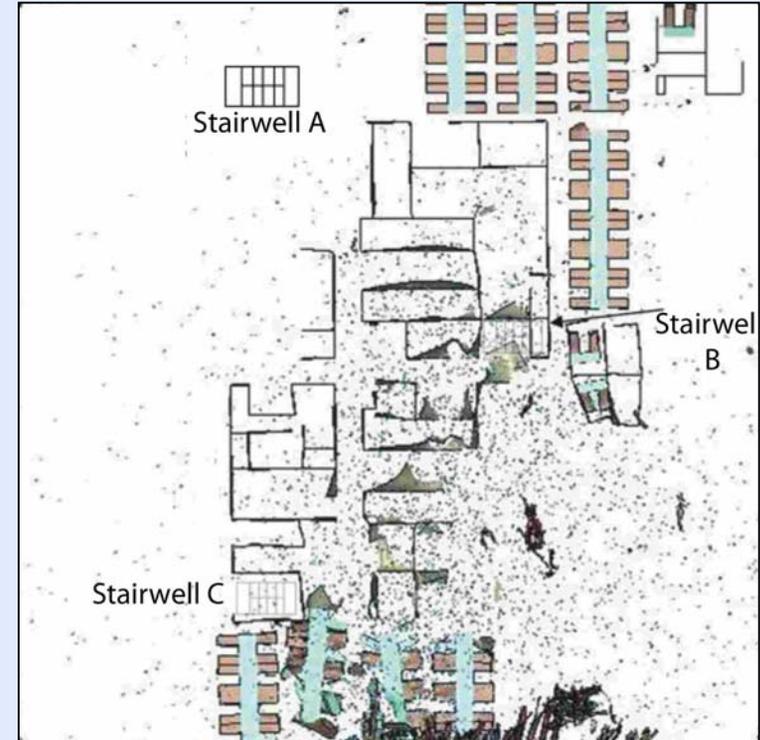
Condition of Stairwells

- The stairwells, with partition wall enclosures that provided a 2 h fire-rating but little structural integrity, were damaged in the region of the aircraft impacted floors.
- **One of the stairwells in WTC 2 (Stairwell A on the Northwest side) was passable in the region of aircraft impact for some period of time after WTC 2 was attacked.**
- All three stairwells in WTC 1 and the two other stairwells in WTC 2 were rendered impassable in the region of aircraft impact.

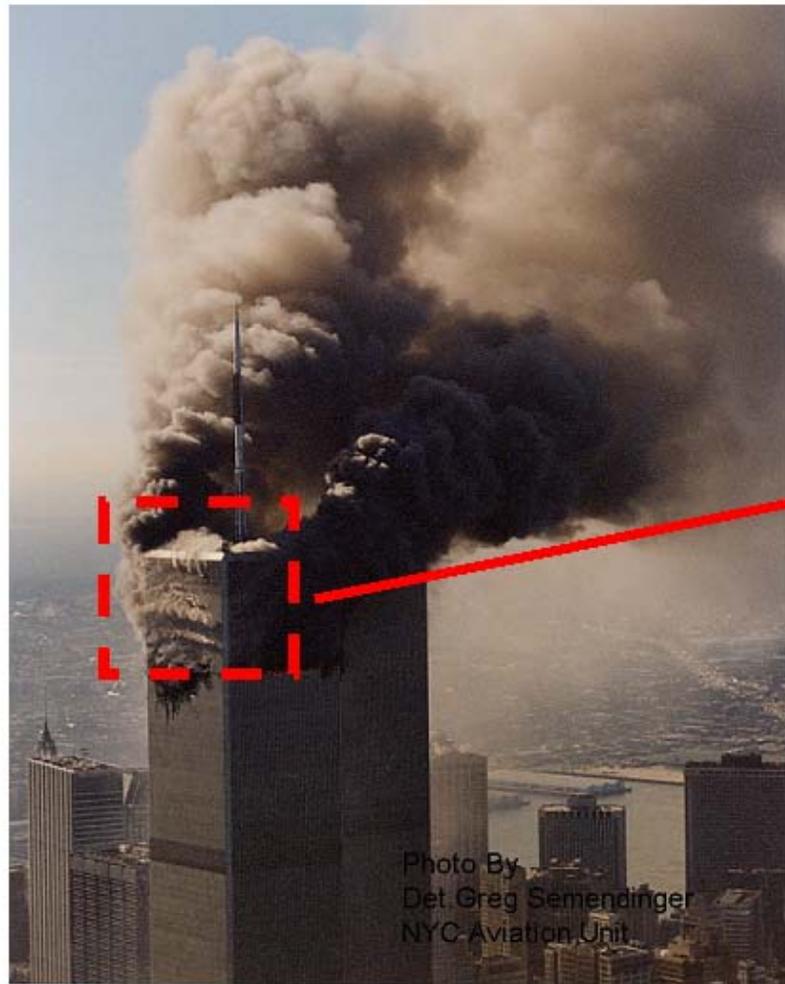
North Face – WTC 1

Smoke Exits NW Interior
Ventilation Zone Supply Inlet

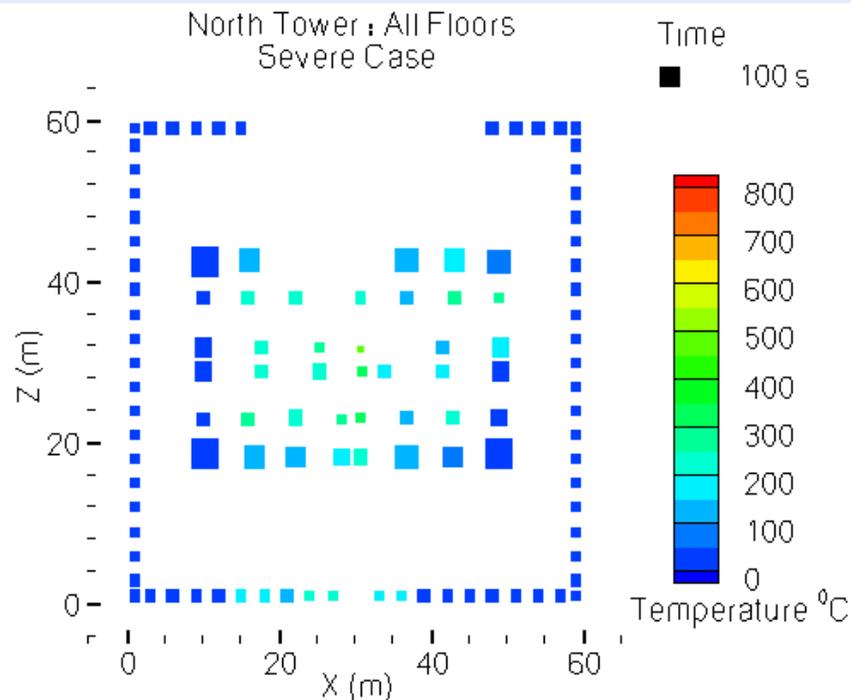
WTC 1

Shows maximum temperature reached by each column.
