NIST Response to the World Trade Center Disaster

**Federal Building and Fire Safety Investigation
of
the World Trade Center Disaster**

Part IIC – WTC 7 Collapse

April 5, 2005

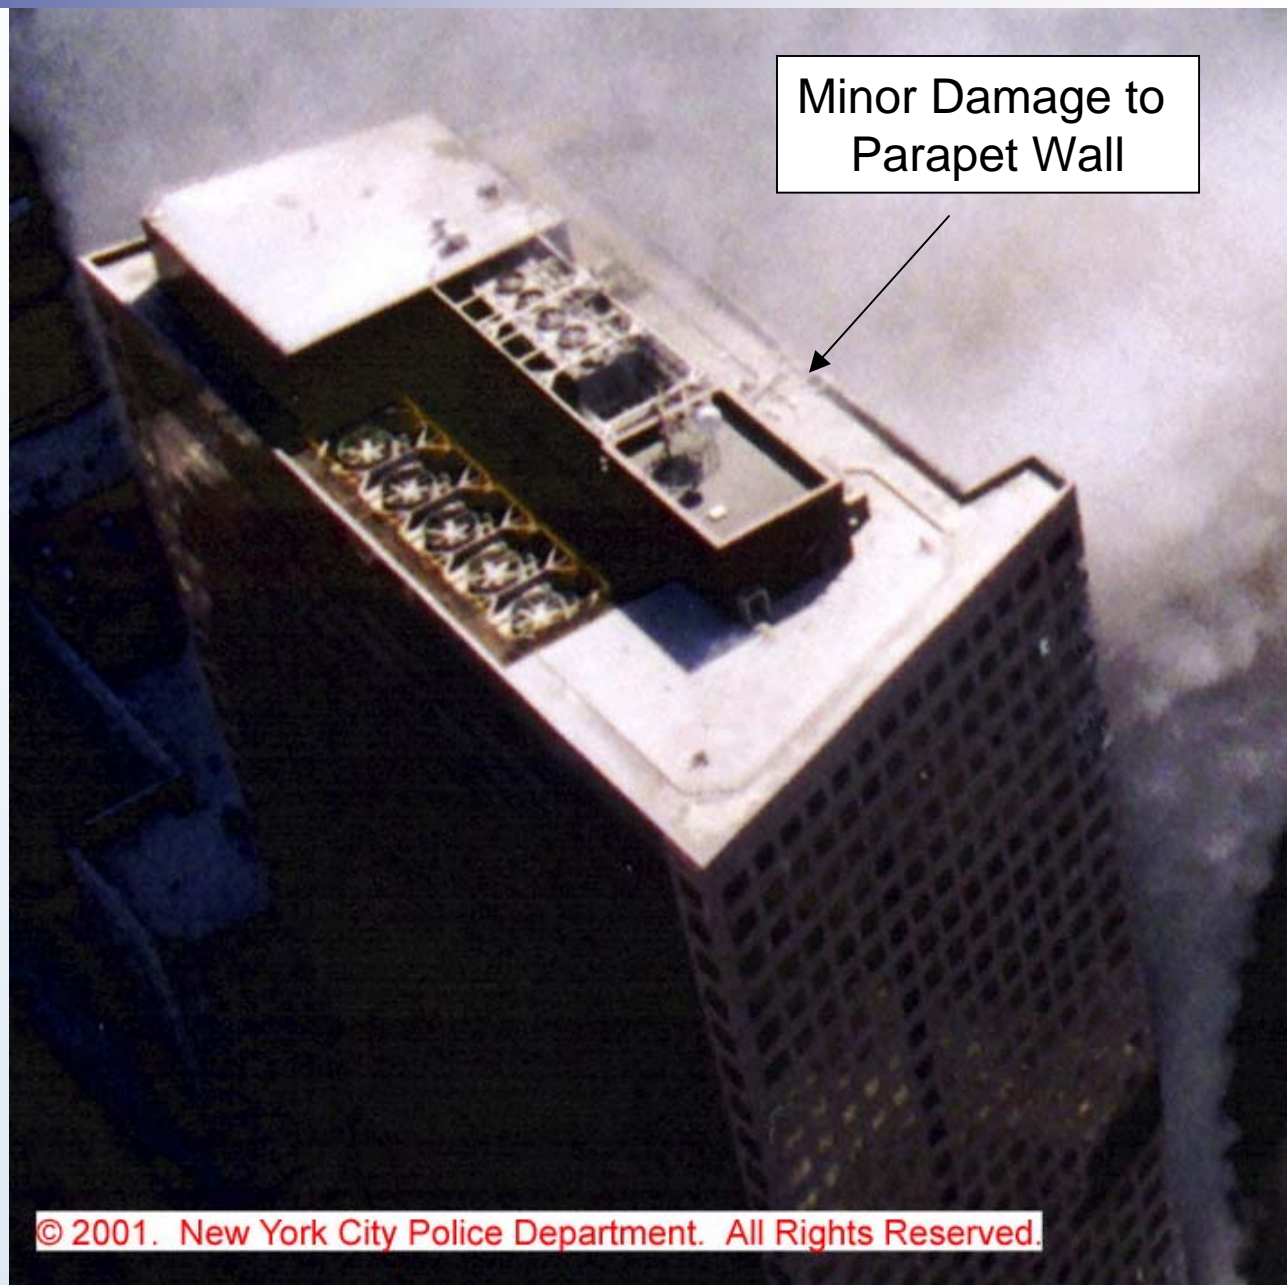
**WTC 7
Roof
After
WTC 1
Collapse**

- ❑ Heavy debris on Vesey Street and WTC 7 Promenade
- ❑ No heavy debris observed in lobby area, white dust coating
- ❑ SW Corner Damage – floors 8 to 18
- ❑ South face damage between two exterior columns - roof level down 5 to 10 floors, extent not known
- ❑ South Face Damage –
 - middle 1/4 -1/3 width south face, 10th floor to ground
 - large debris hole near center around 14th floor
 - 1/4 width south face, above 5th floor, atrium glass intact
 - 8th / 9th floor from inside, visible south wall gone with more damage to west, 2 elevator cars dislodged into elevator lobby

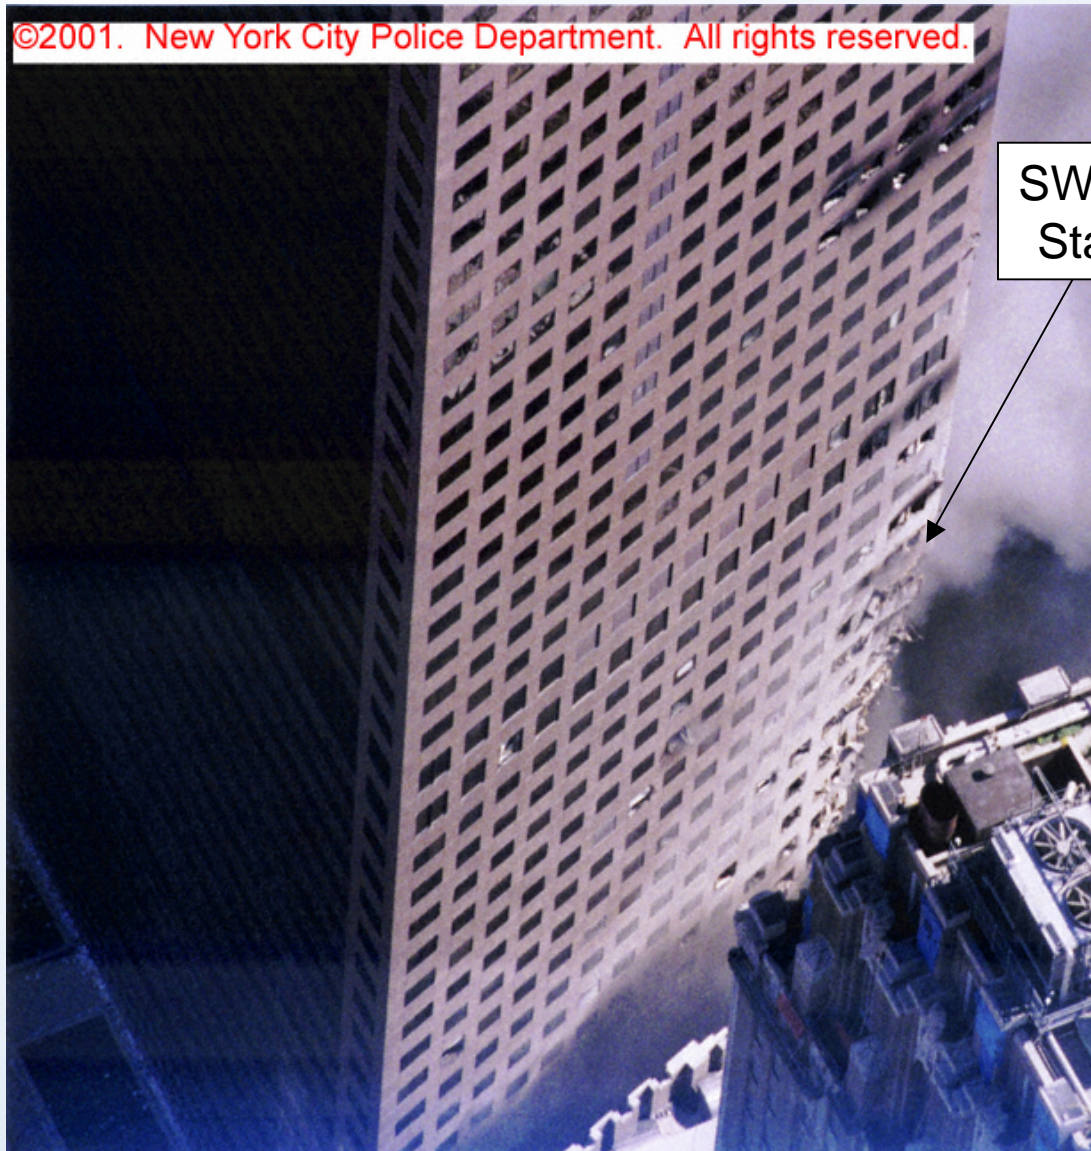
**WTC 7
SW
Corner
After
WTC 1
Collapse**

SW Corner Damage
Starting at Floor 18

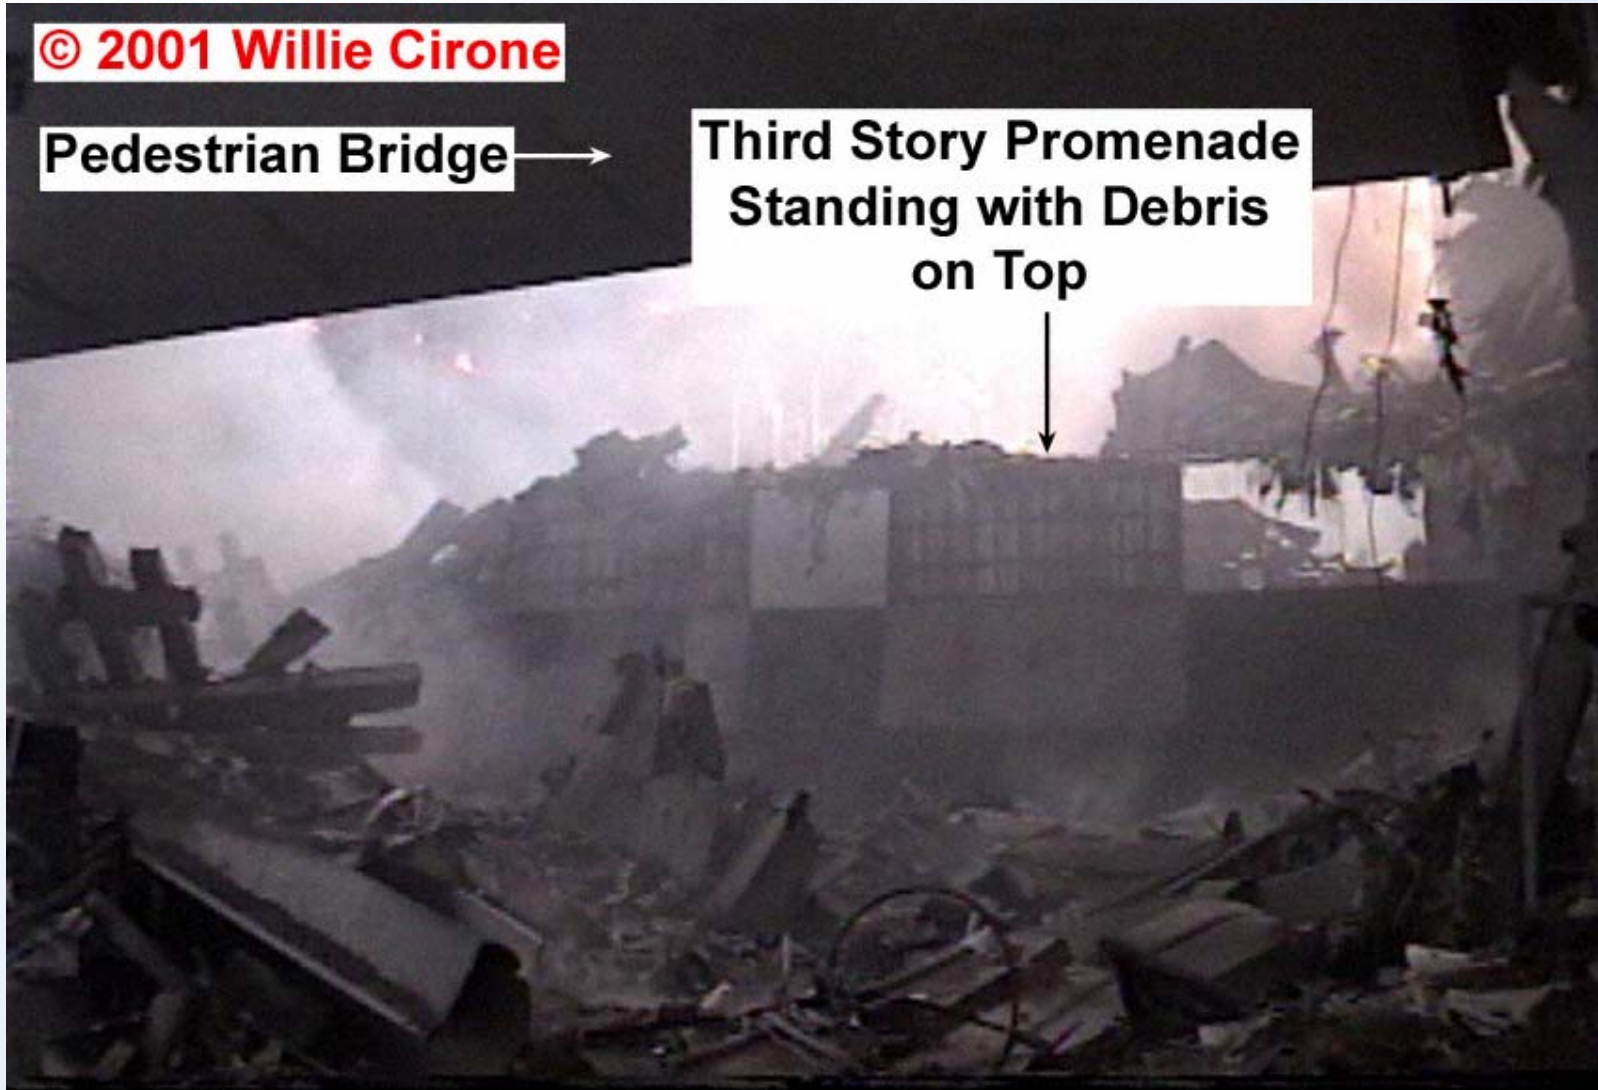
Vesey Street by Promenade After WTC 1 Collapse

Pedestrian Bridge →

Third Story Promenade
Standing with Debris
on Top ↓

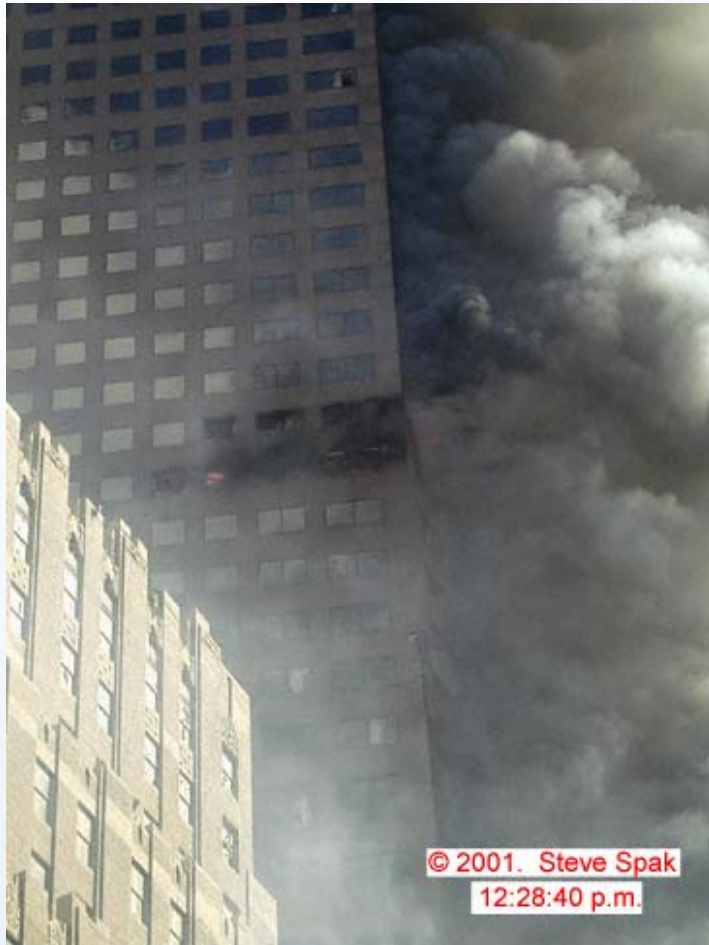
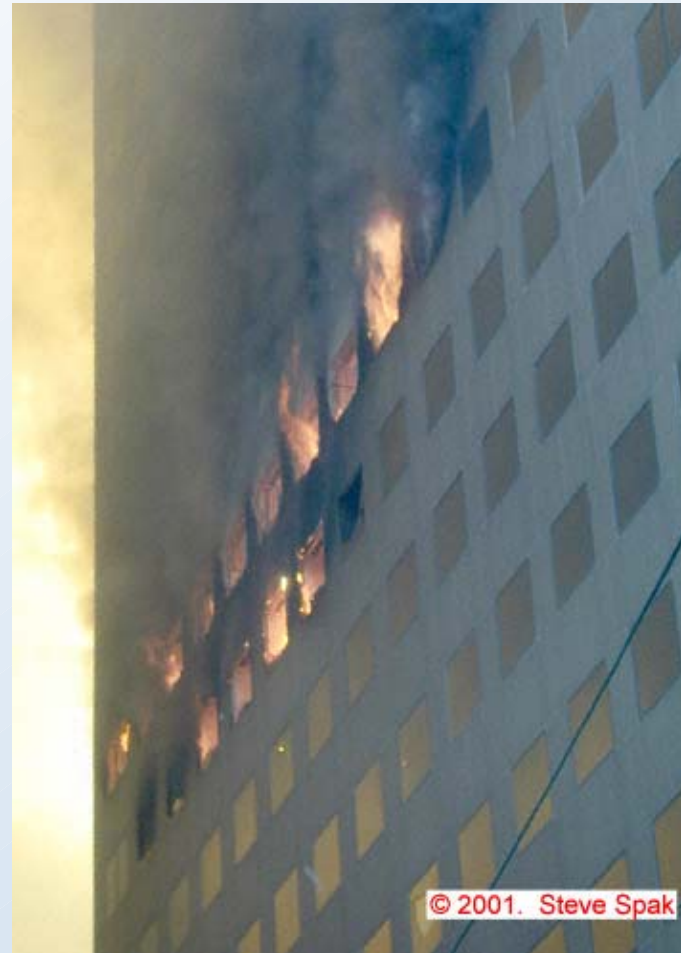
East Face Fires on Floors 11-12 near 2 PM

Fires in WTC 7—which began soon after WTC 1 collapsed—were observed on Floors 7, 8, 9, and 11 near the middle about half an hour before collapse; Floor 12 was burned out by this time. Fires were also seen on Floors 12, 13, 22, 29, and 30 at various times during the day.

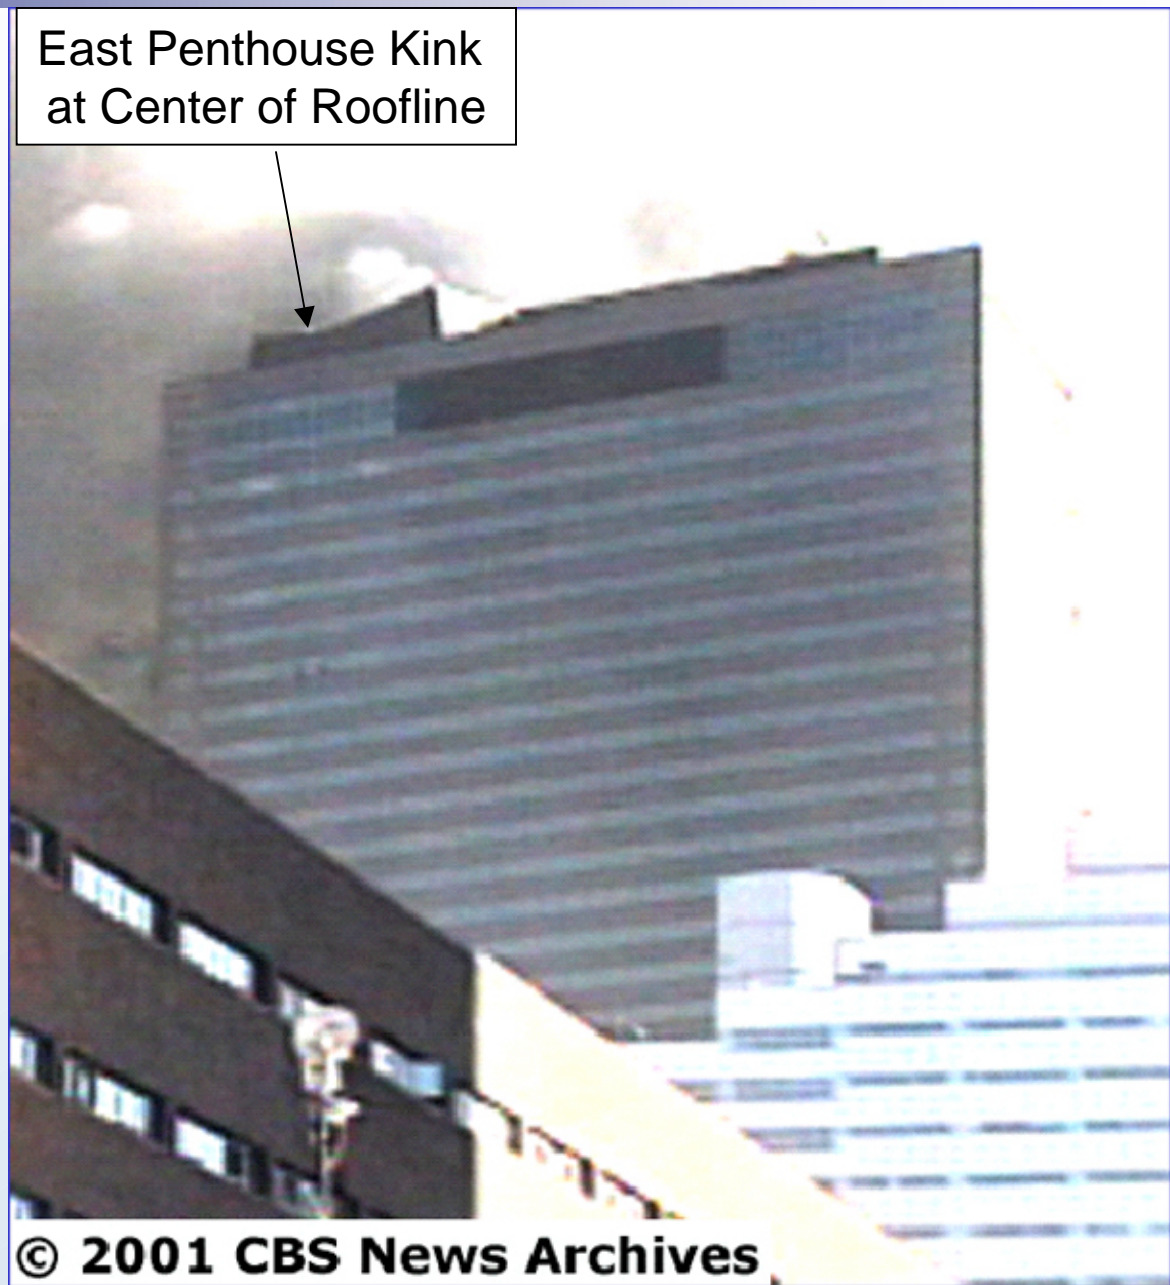
East Penthouse Kink
at Center of Roofline

- ❑ First exterior sign of failure was at the east penthouse roofline, aligned with interior columns 79, 80, and 81. Postulated initiating events include the failure of these columns.

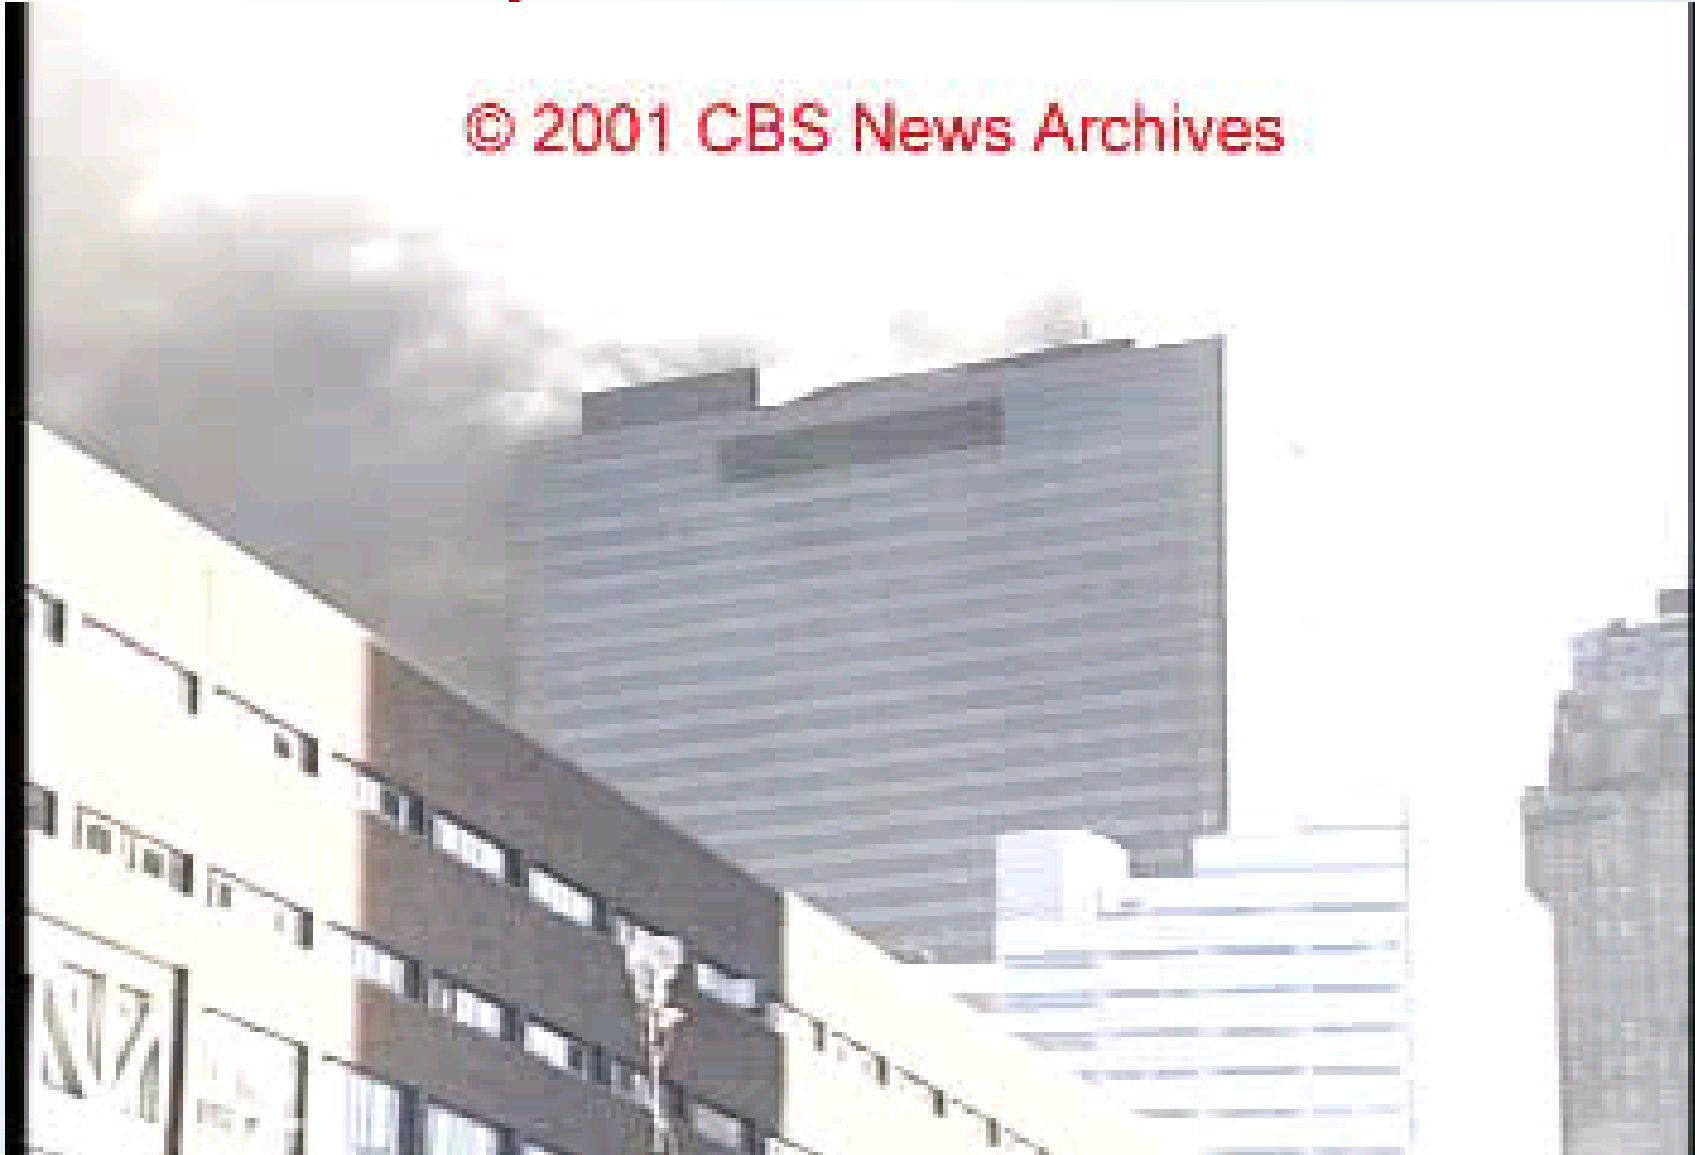
Observed Sequence of Failures in WTC 7

Time Interval (sec)	Total Time (sec)	Observation from CNN Net Dub 7 47.avi
0.0	0.0	Movement of east penthouse roofline
0.9	0.9	East penthouse kinks between columns 44 and 45 2 windows at floor 40 fail between columns 44 - 45
0.3	1.2	4 windows fail at floor 40 East penthouse submerged from view (now inside building)
0.4	1.7	3 windows break at floors 41 to 44
0.5	2.2	East penthouse completely submerged
1.8	4.0	Windows break along column 46 at floors 37 and 40
3.0	7.0	North side of west penthouse moves Movement of entire north face of WTC7 (visible above floor 21)
0.2	7.2	West end of roof starts to move
0.5	7.7	East end of roof starts to move Façade kink formed along column 46-47
0.1	7.9	West penthouse submerged Global collapse occurs as windows fail between floors 33-39 around column 55
0.3	8.2

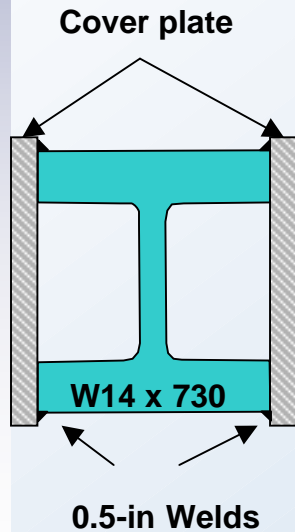
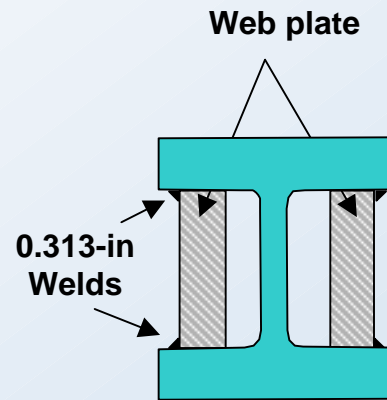
Columns 79 and 81 at Floors 5-7

NIST continues to evaluate the factors that could have caused column 79, 80, or 81 to fail

- Damage to components adjacent to truss #2 from debris impact
- Damage to fireproofing from normal activities prior to event or debris damage
- Unusual fuel loads (fuel lines, high density of building contents)

- Massive size of columns 79, 80, and 81 appears to require severe fires and/or damaged fireproofing to initiate thermally-related failures

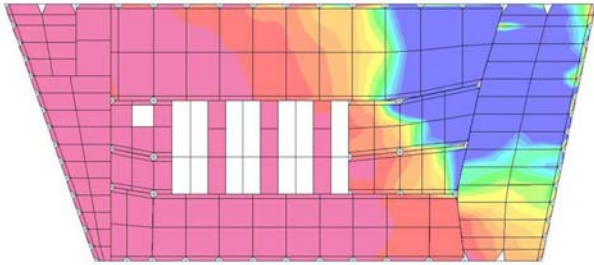
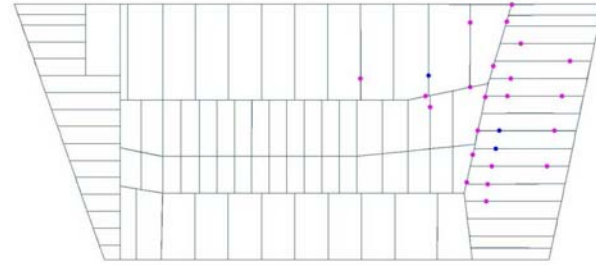
Col 79
Beam Hinges →
← Slab Force

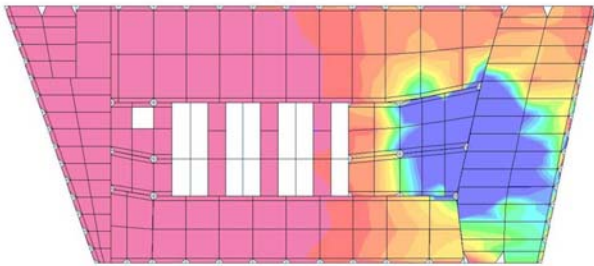
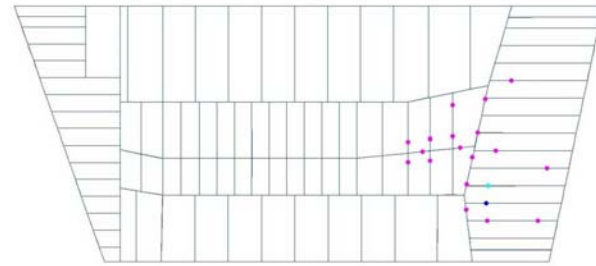
Col 80
Beam Hinges →
← Slab Force

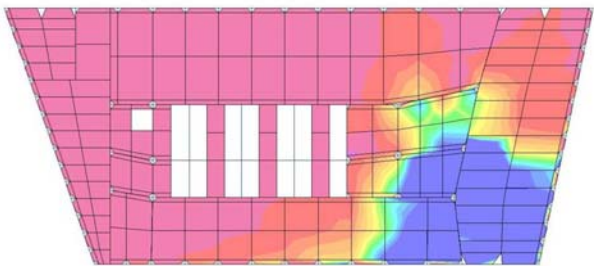
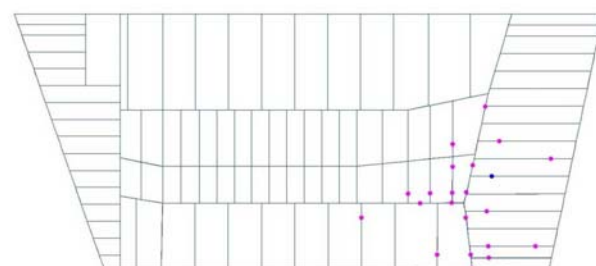
Col 81
Beam Hinges →
← Slab Force

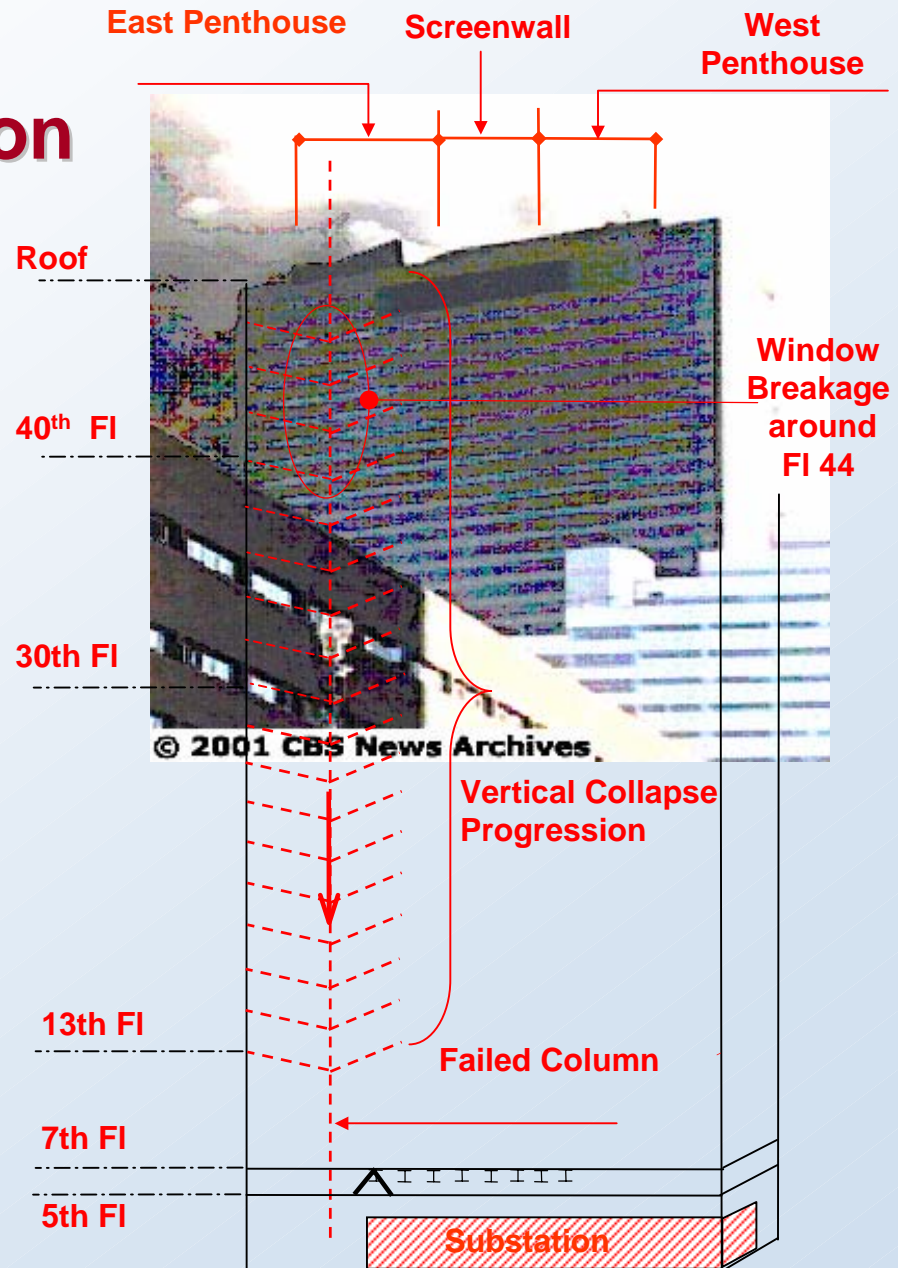
- ❑ East Penthouse Kink
- ❑ Window Breakage

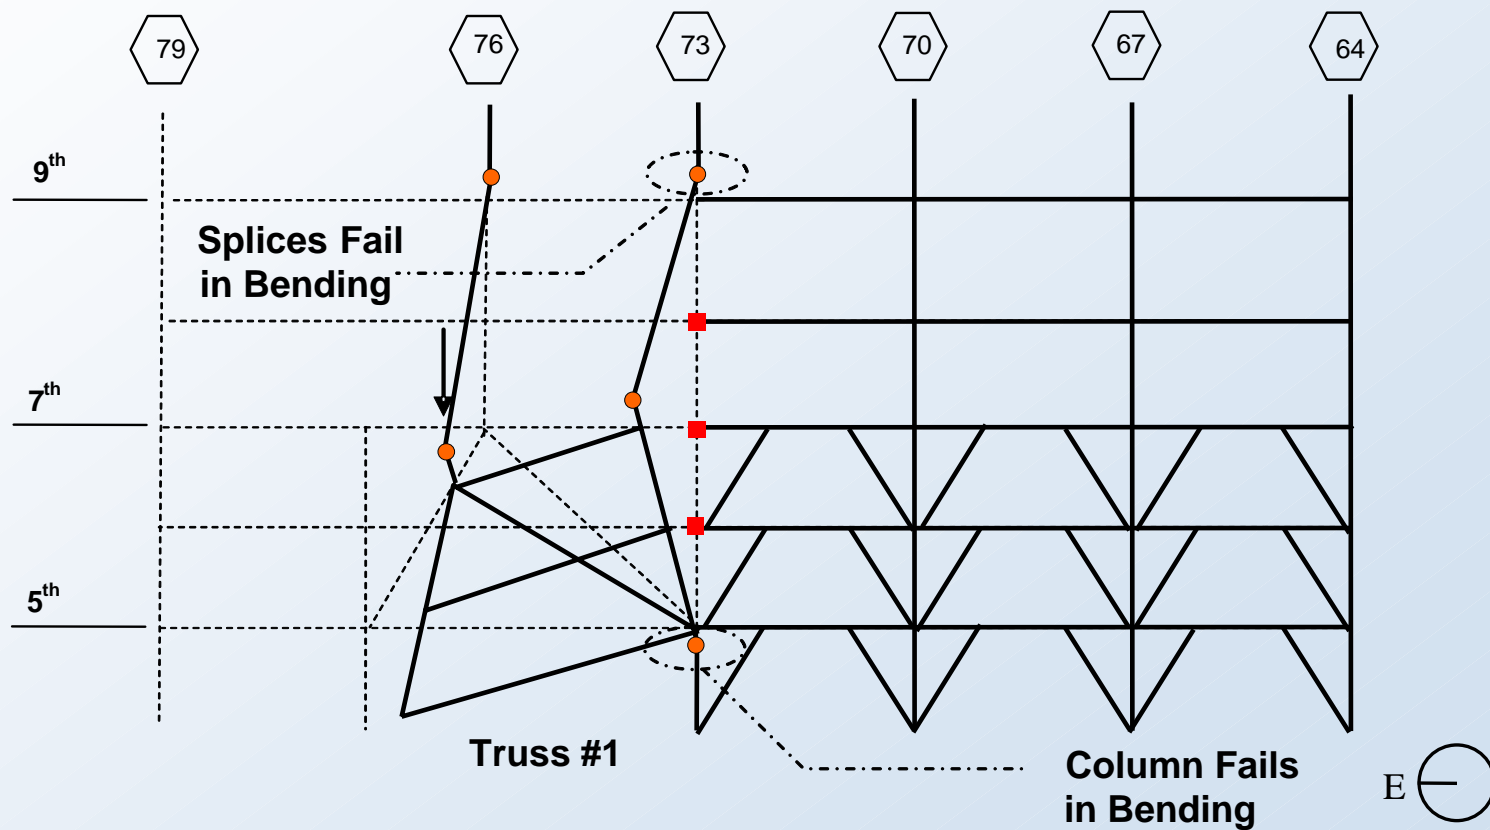
Horizontal Progression – Truss #1

- ❑ A vertical failure would pile debris on the east side of the building, damaging or severing transfer girders and trusses between floors 5 and 7.
- ❑ This secondary damage has been postulated to cause a horizontal progression of failure in the core columns at or near floors 5 and 7.

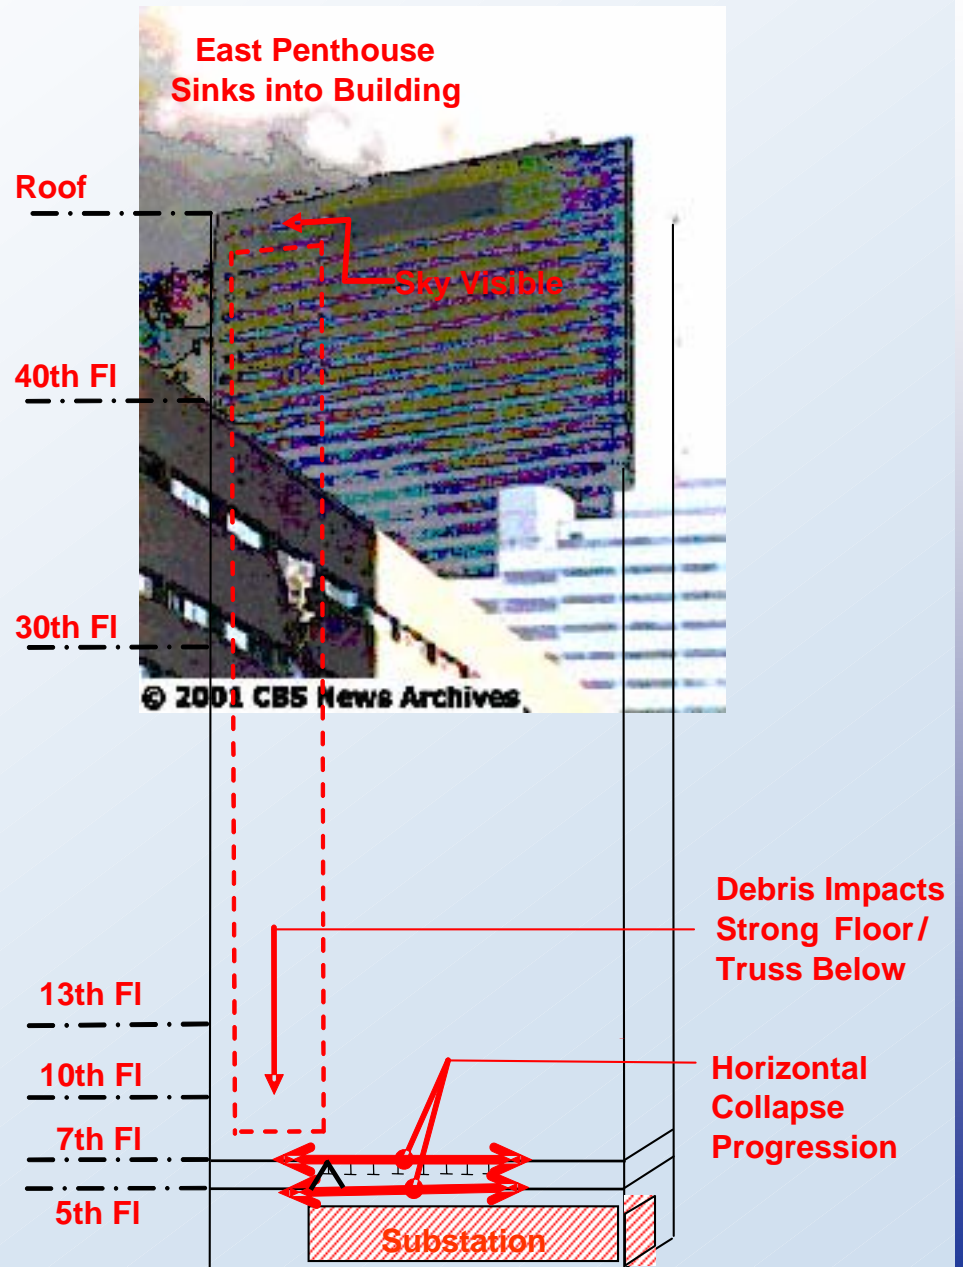
- East Penthouse Sinks
- Further Window Breakage
- No Movement for 5 sec

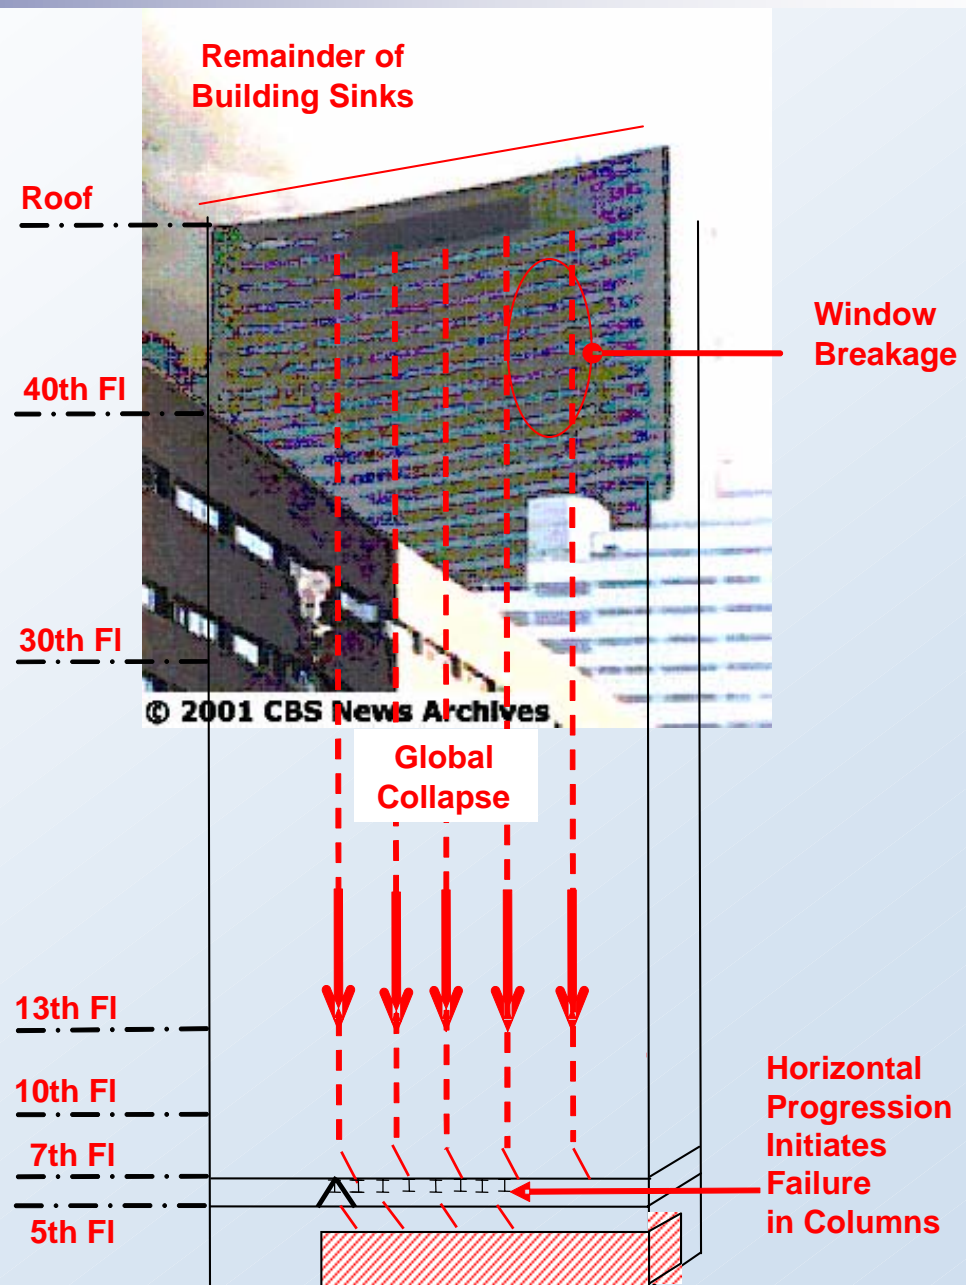
- ❑ Center and West Penthouses Sink
- ❑ North Façade Kink at Column 76
- ❑ Window Breakage in Front of Truss #3

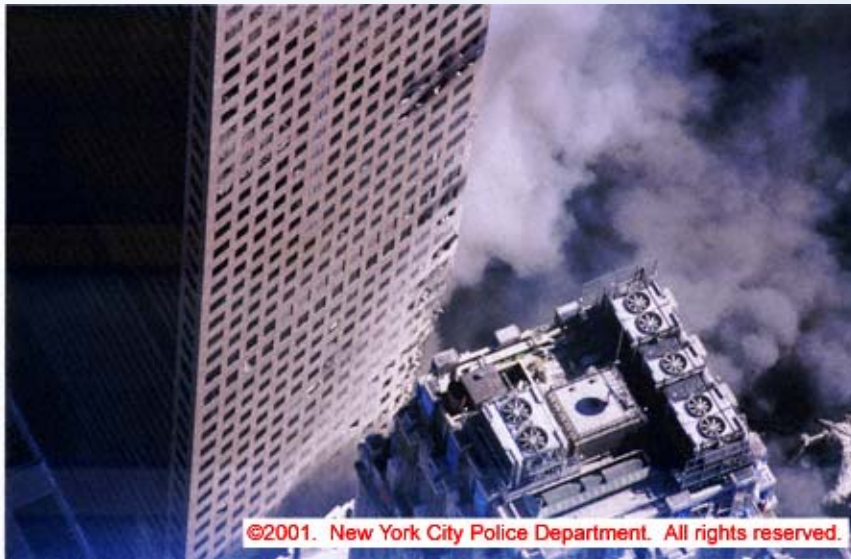
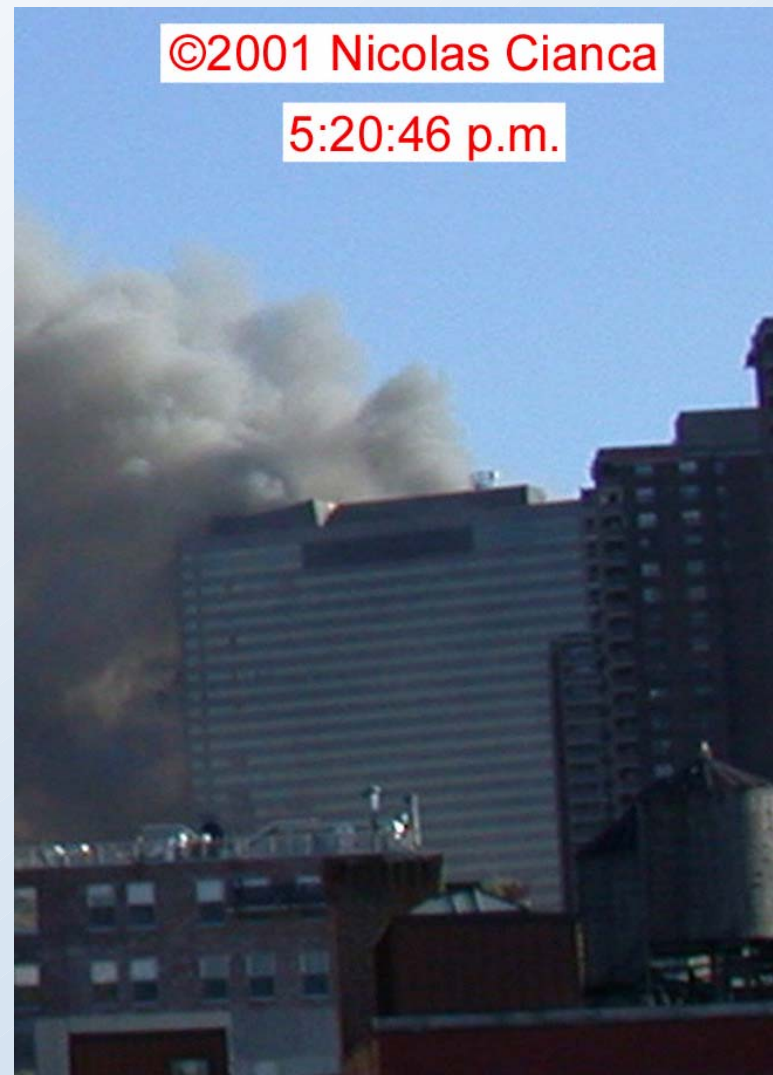
- ❑ *The first exterior sign of structural failure in WTC 7 was the sinking of the east penthouse roof structure into the building.*
- ❑ *Witnesses reported structural damage to WTC 7 on its south face and southwest corner from WTC 1 debris.*
