NIST Response to the World Trade Center Disaster

**Federal Building and Fire Safety Investigation
of
the World Trade Center Disaster**

August 21, 2008

World Trade Center 7

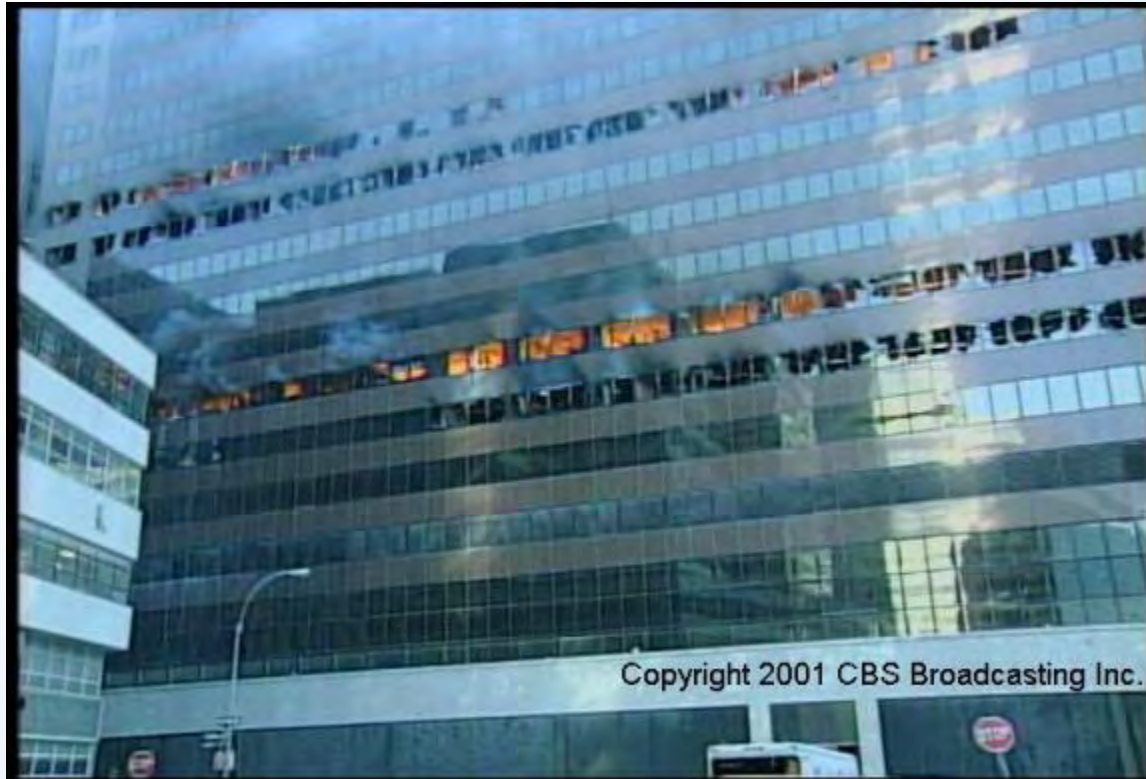
Progression of fires
on Floor 12

Fire Growth and Spread

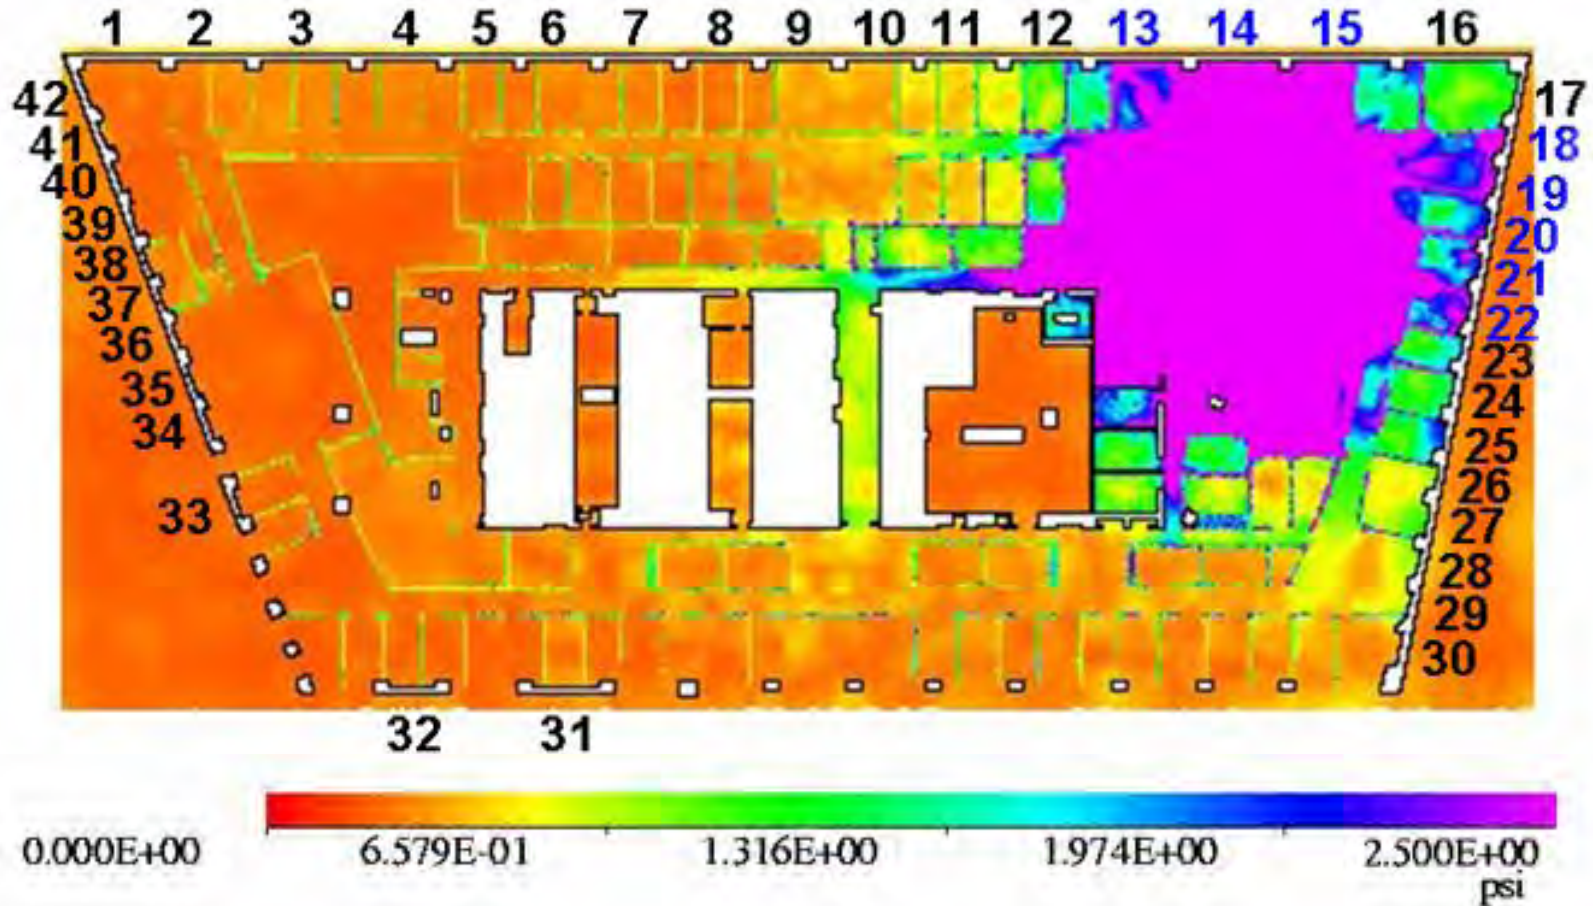
Peak over pressures for 9 lb shaped charge.

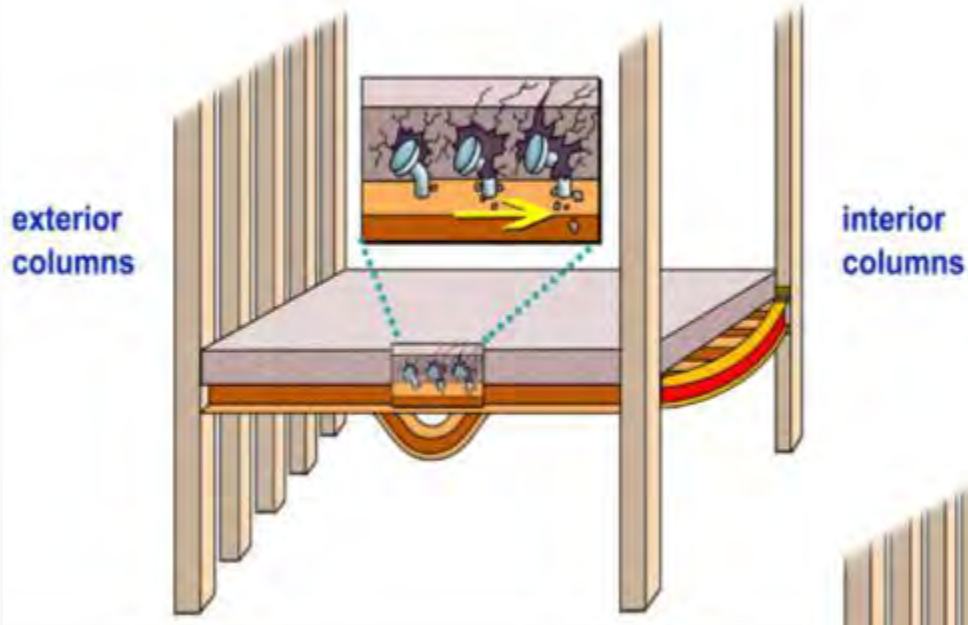
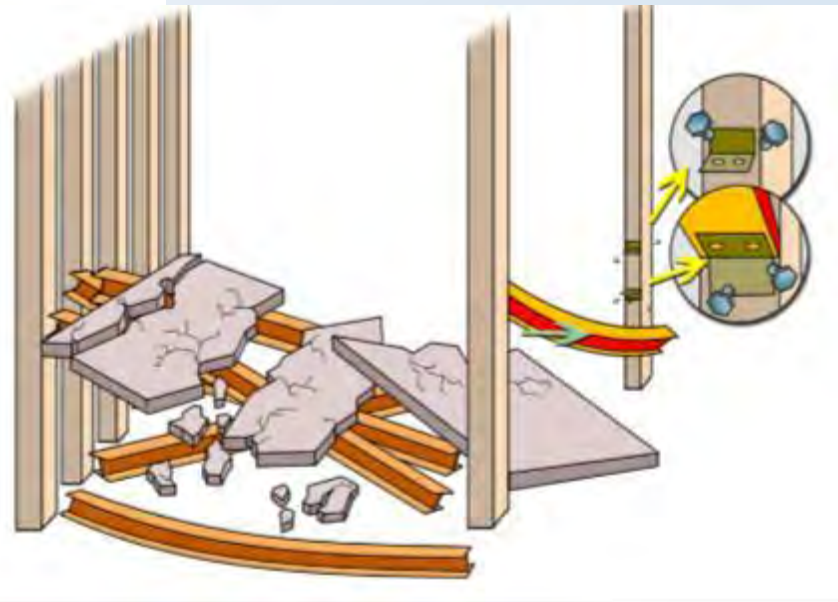
Thermal Expansion Causes Floor Failures

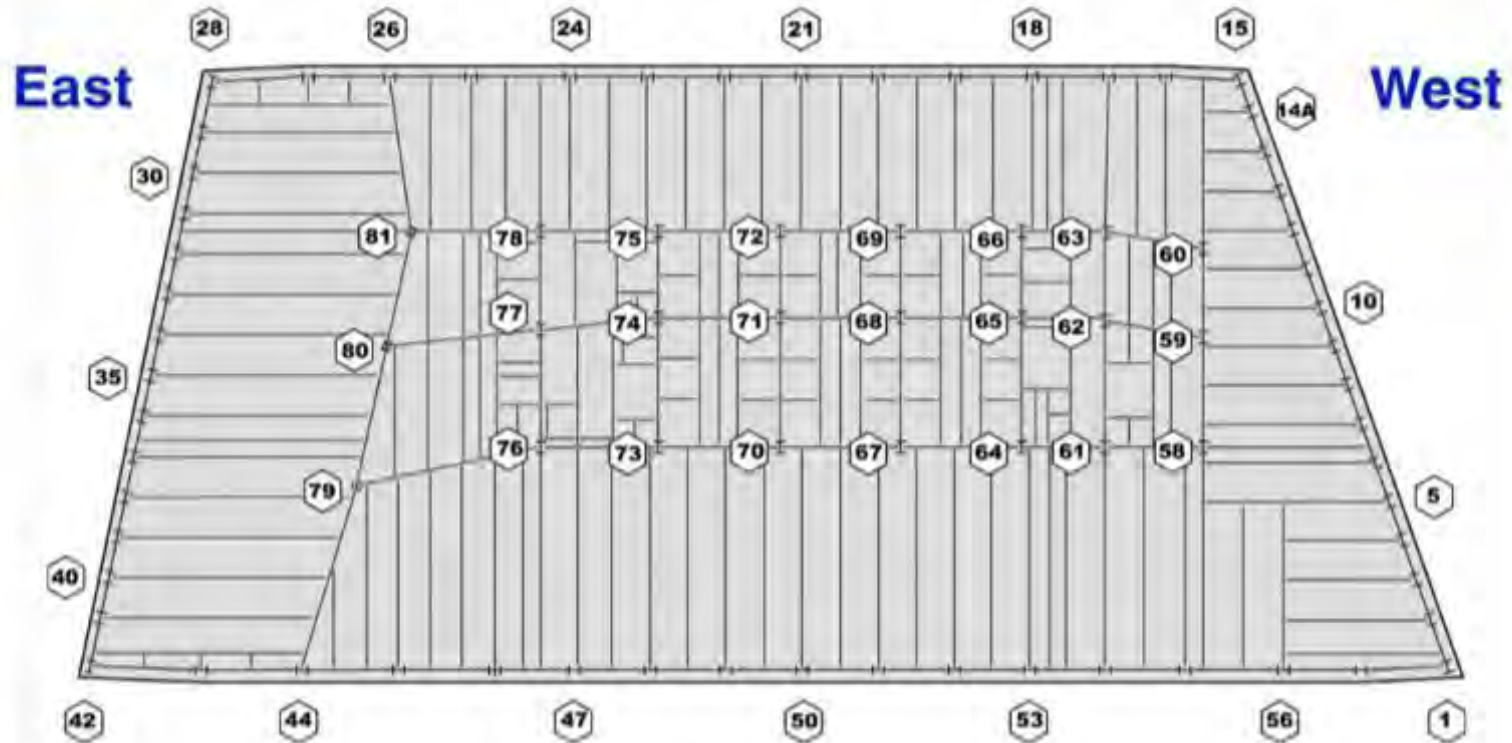
Cascading Buckling of Interior Columns

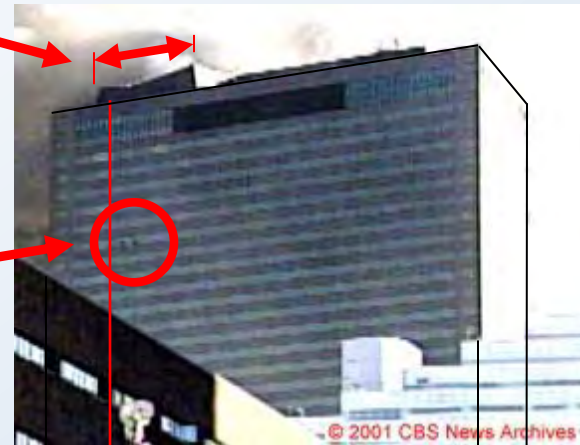
- East Penthouse Kinks

- Windows break on East Side of North Face

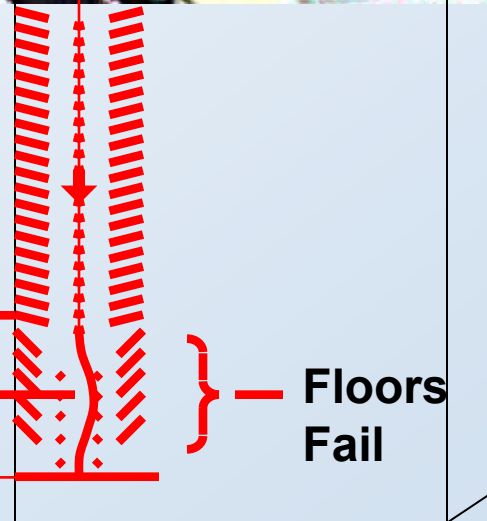
Vertical Collapse Progression

Column Buckles

Floors Fail

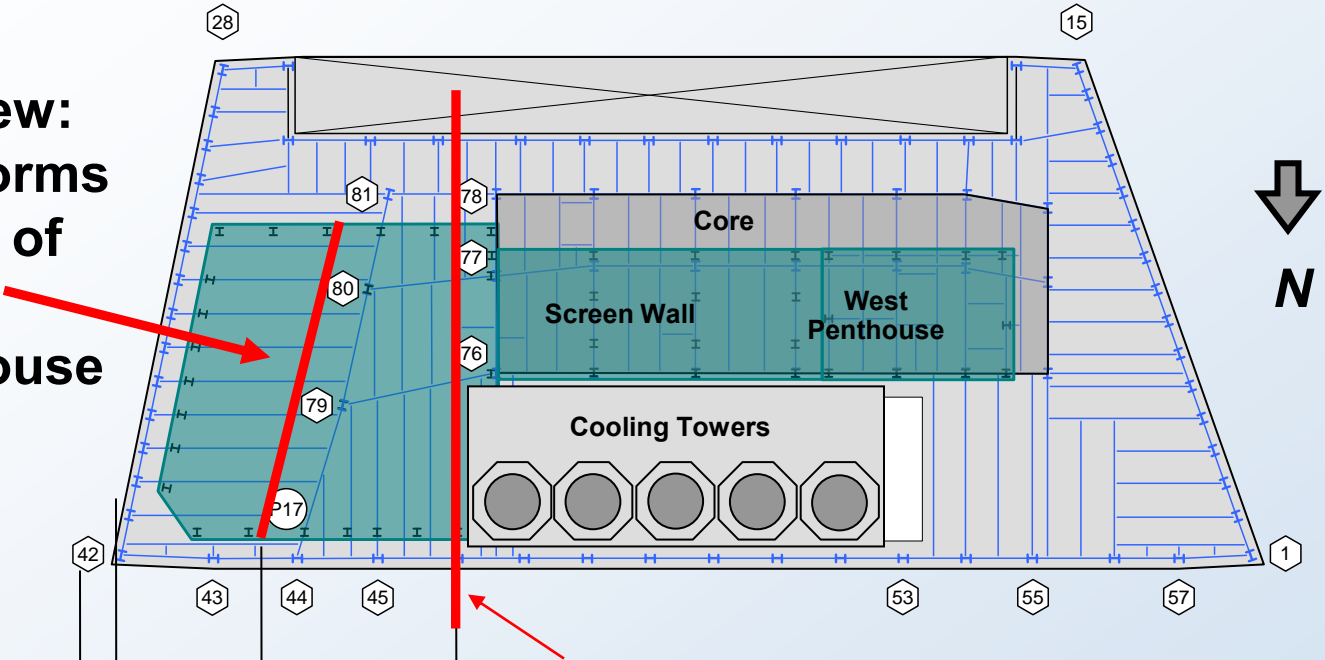
Top view:
Kink forms
in roof of
East
Penthouse

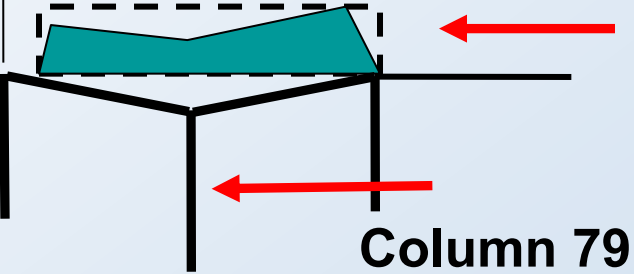
Side view:
Kink in penthouse
directly below
column 79
