NIST Response to the World Trade Center Disaster

**Federal Building and Fire Safety Investigation
of
the World Trade Center Disaster**

Part IIB – Collapse Sequence

April 5, 2005

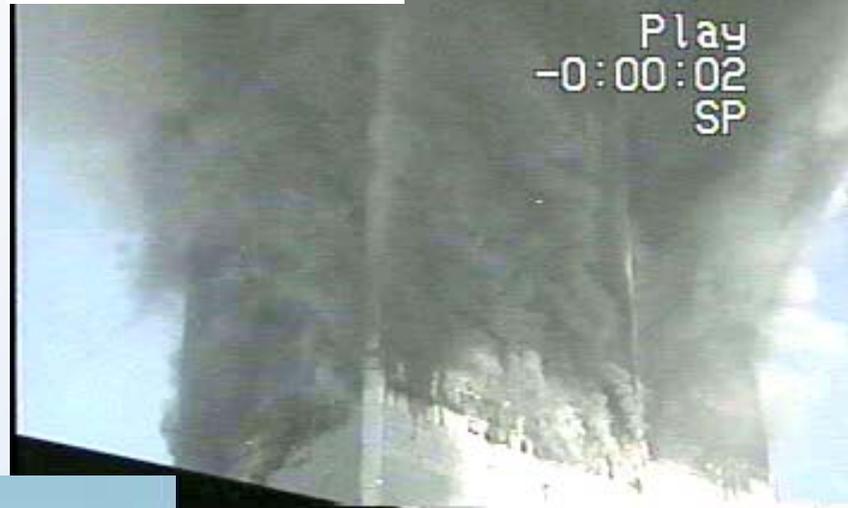
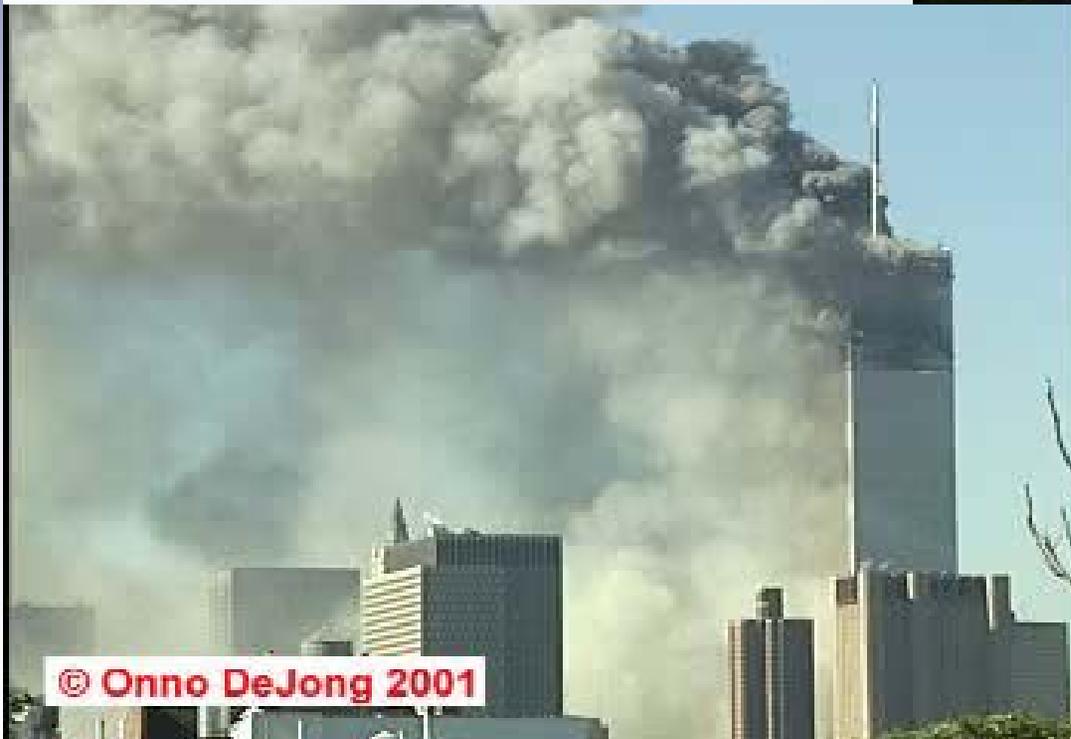
WTC 1 tilted to the south; WTC 2 tilted to the east and south.

Initiation of global collapse was first observed by the tilting of building sections above the impact regions of both WTC towers.

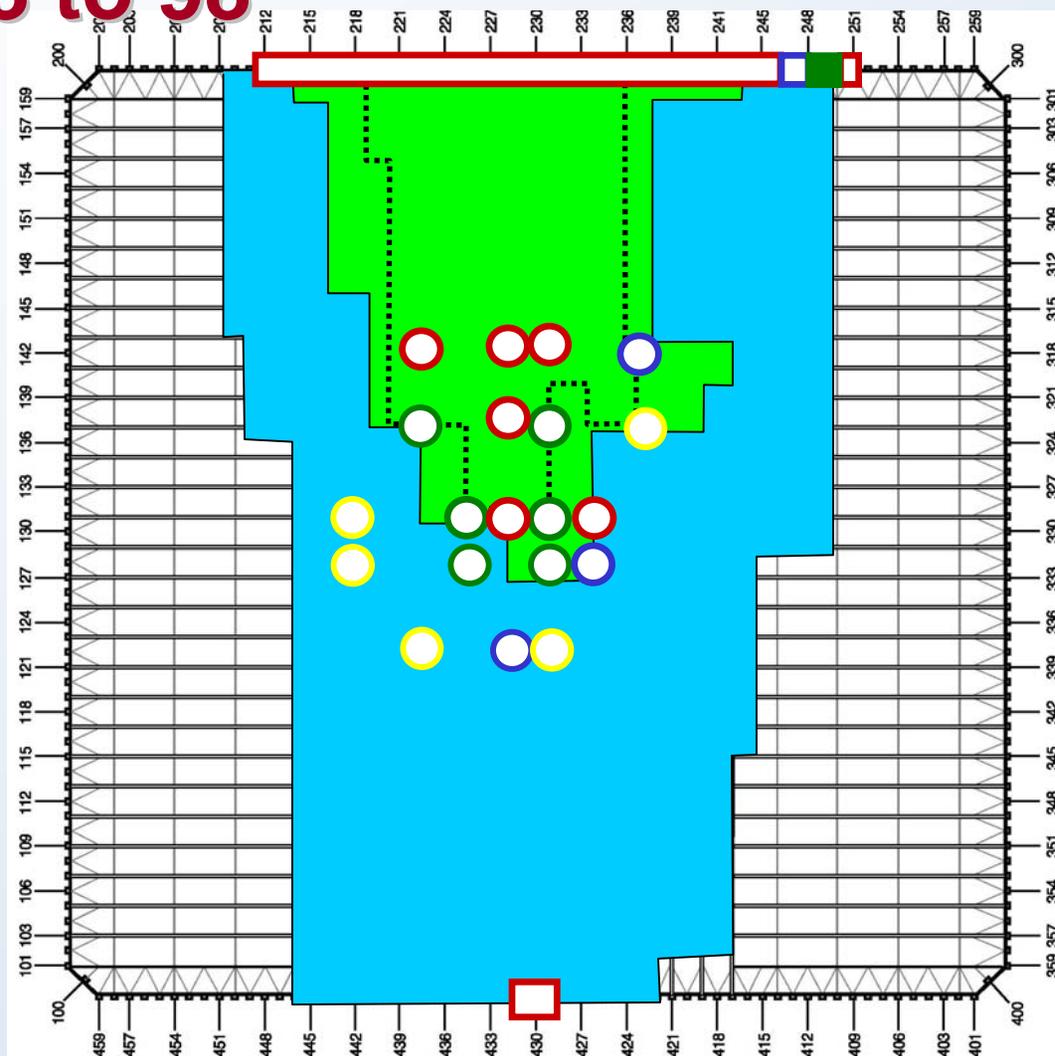
WTC 1 Damage: Composite Summary for Floors 93 to 98

- Aircraft impact severed a number of exterior columns on the North wall from floors 93 to 98, and the wall section above the impact zone moved downward.

- After breaching the building's perimeter, the aircraft continued to penetrate into the building, severing floor framing and core columns at the North side of the core. Core columns were also damaged toward the center of the core and, to a limited extent on the South side of the core. Fireproofing was damaged from the impact area to the South perimeter wall, primarily through the center of WTC 1 and at least over a third to a half of the core width.

- Aircraft impact severed a single exterior panel at the center of the South wall between floors 94 and 96.
- The impact damage to the exterior walls and to the core resulted in redistribution of severed column loads, mostly to the columns adjacent to the impact zones. The hat truss resisted the downward movement of the North wall, and rotated about the East-West axis.

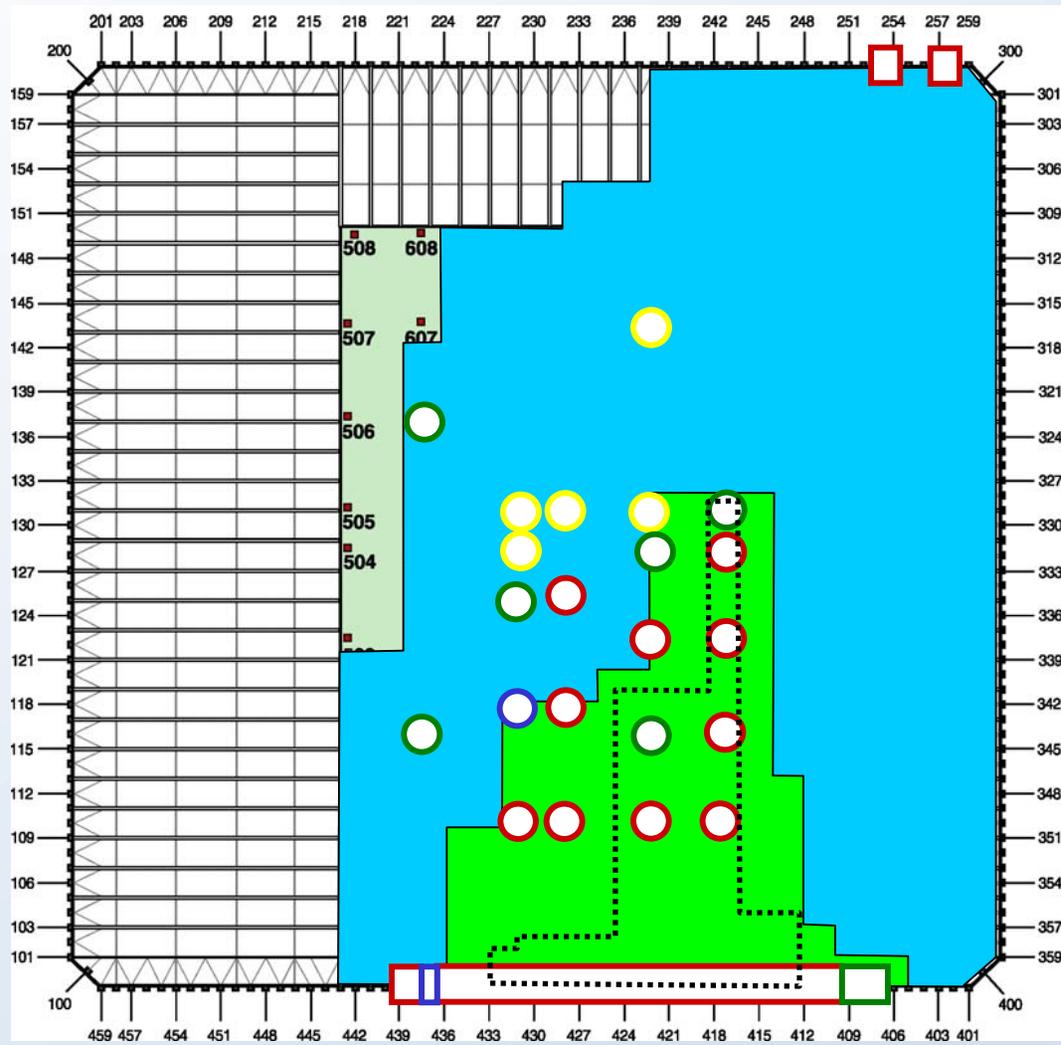
WTC 2 Damage for Severe Case

- After breaching the building's perimeter, the aircraft continued to penetrate into the building, severing floor framing and core columns at the Southeast corner of the core. Fireproofing was damaged from the impact area through the East half of the core up to the North and East perimeter walls. The floor truss seat connections over about 1/4 to 1/2 of the East side of the core were severed on floors 80 and 81 and over about 1/3 of the East perimeter wall on floor 83.

- Aircraft impact severed a few columns near the East corner of the North wall between floors 80 and 82.
- The impact damage to the exterior walls resulted in redistribution of severed column loads, mostly to the columns adjacent to the impact zones. The impact damage to the core columns resulted in redistribution of severed column loads mostly to other intact core columns and the East exterior wall. The hat truss resisted the downward movement of the South wall, and rotated about the East-West axis.

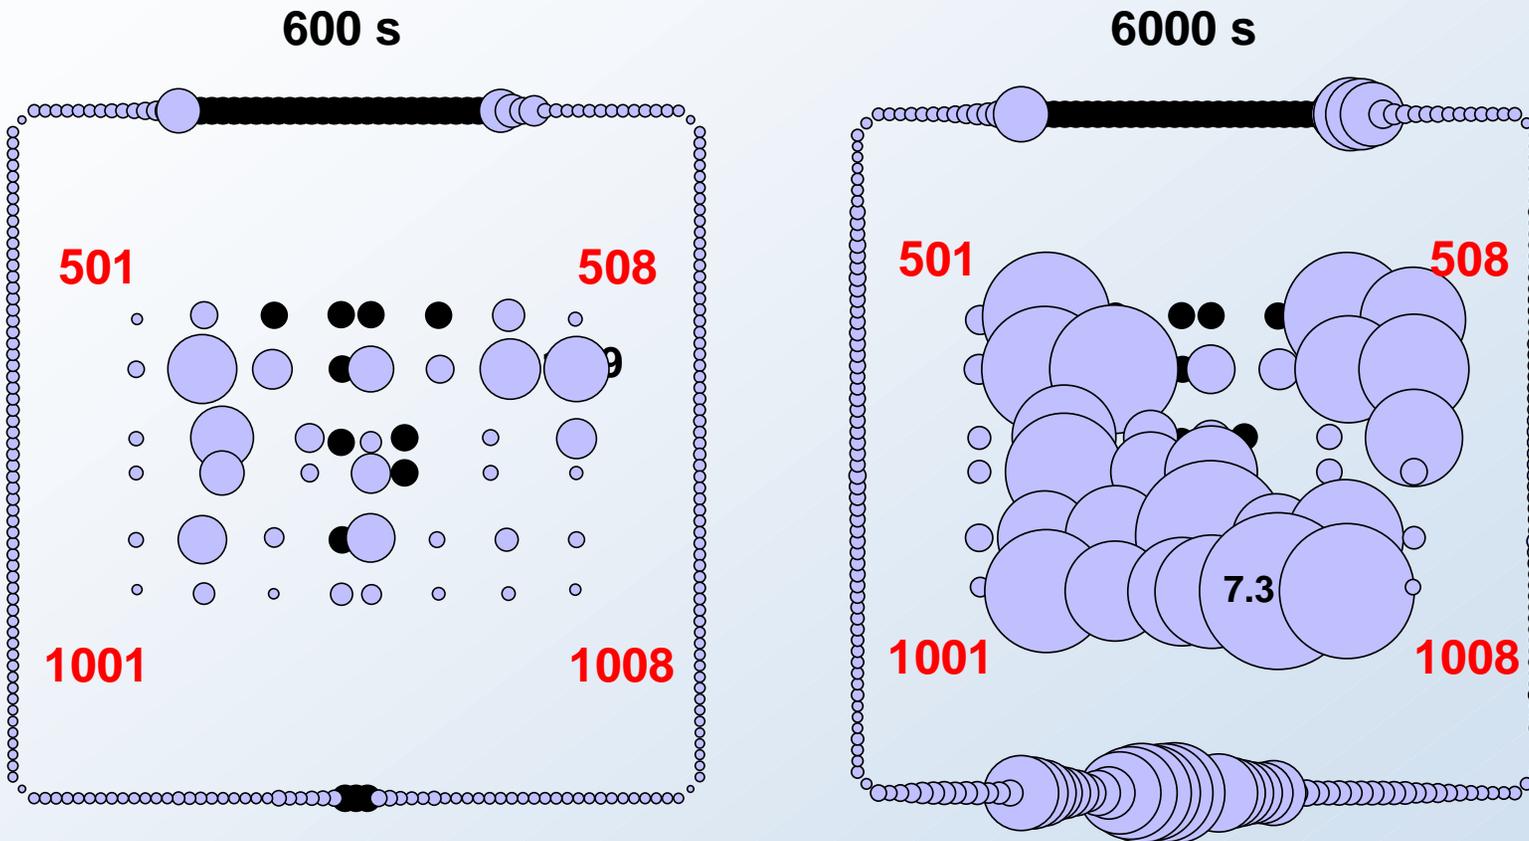
WTC 1 Severe Case: Maximum Elastic, Plastic, and Creep Strain in Columns between Floors 93 and 99

Maximum strain is given in %.

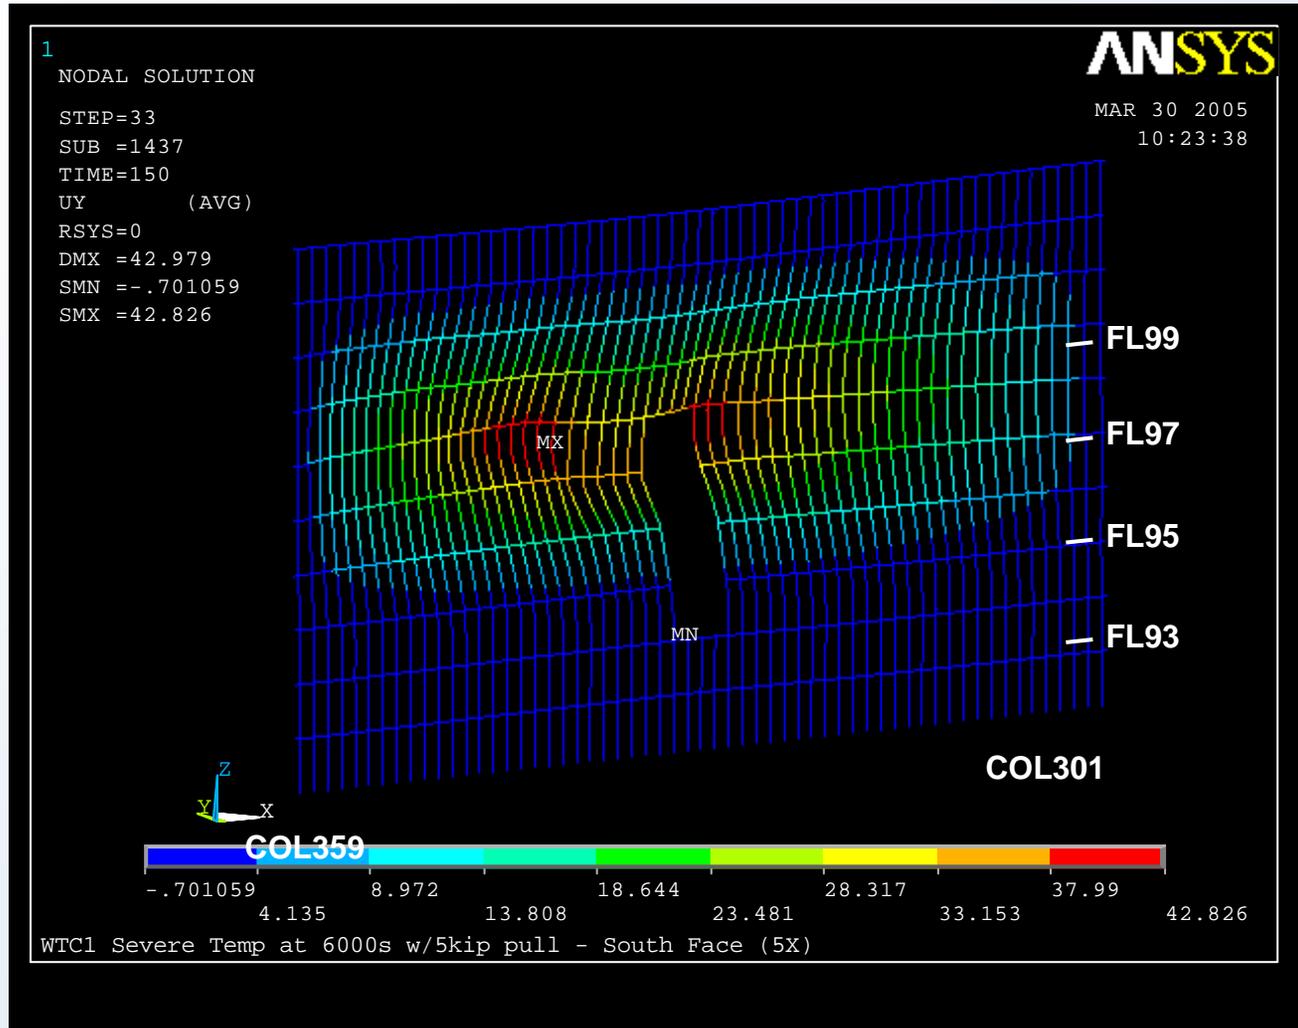
Inward Bowing of the WTC 1 South Face at 6000 s

Maximum Inward Displacement = 43 in.
Looking from the outside of the building
Inward displacement is shown as positive displacement

- Although North face had extensive impact damage, inward bowing occurred on South face and building tilted to South at collapse initiation.
 - Thermal weakening of perimeter columns with floor sagging (which induced inward pull and occurred on South side) caused inward bowing on South face and tilting in that direction.

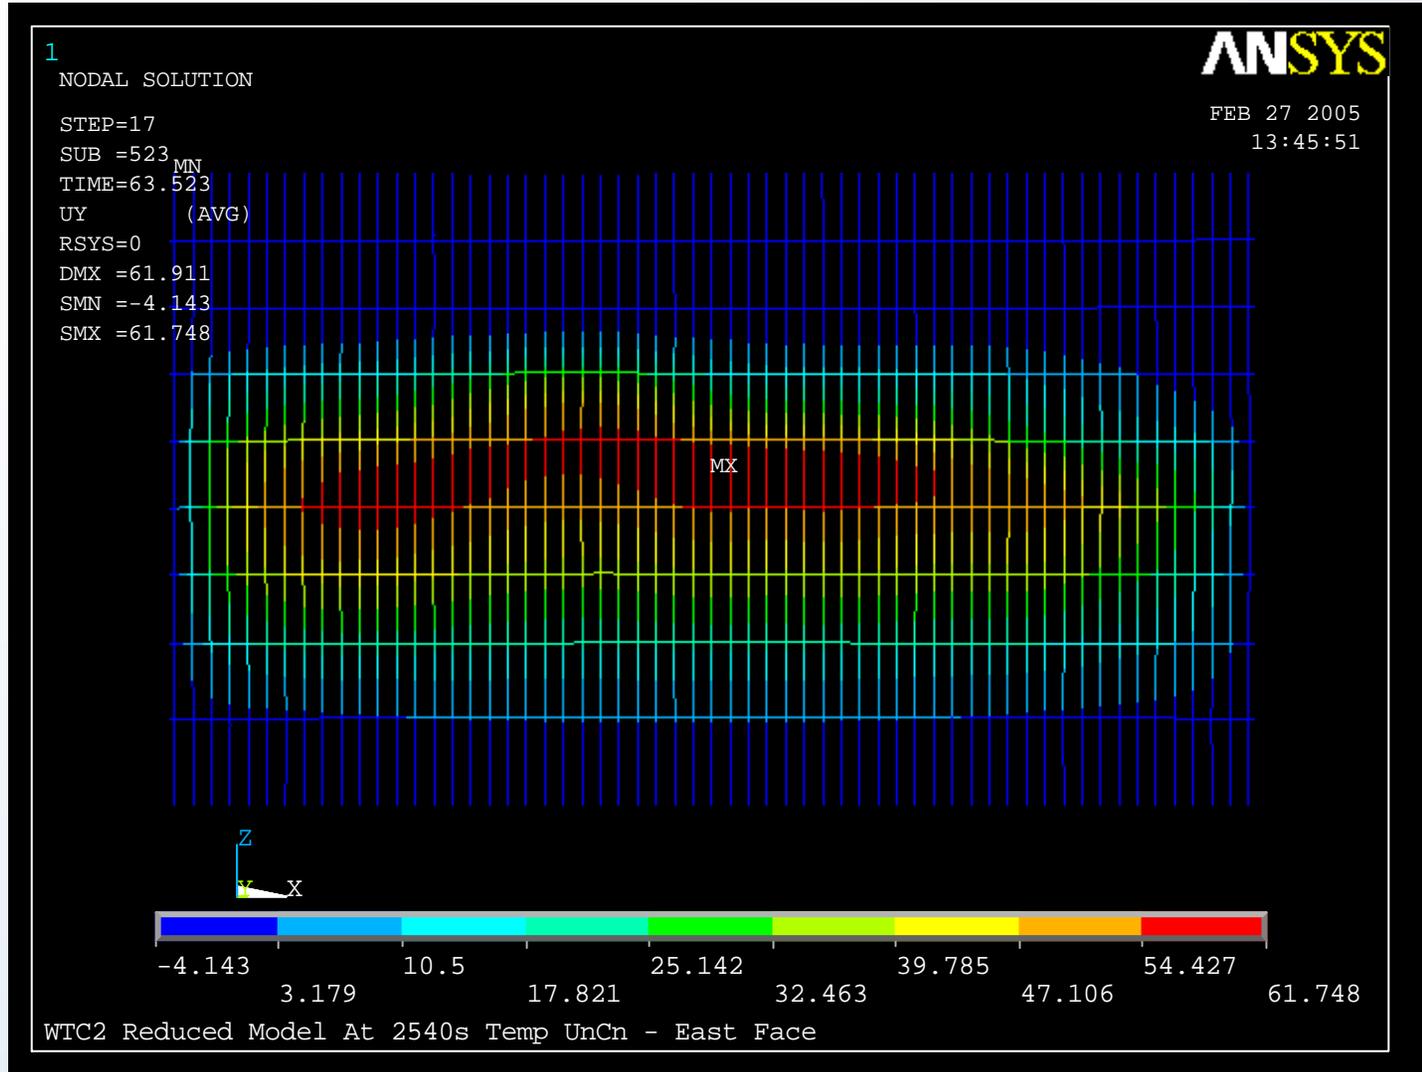
Inward Bowing of the WTC 2 East Face at 2,540 s

Maximum inward displacement = 60 in.

- Although South face had extensive impact damage, inward bowing occurred on East face and building tilted more to the East and less to the South at collapse initiation.

- Thermal weakening of perimeter columns with floor sagging caused inward bowing on East face and primary tilting in that direction (with additional Southward tilting due to the aircraft impact damage).

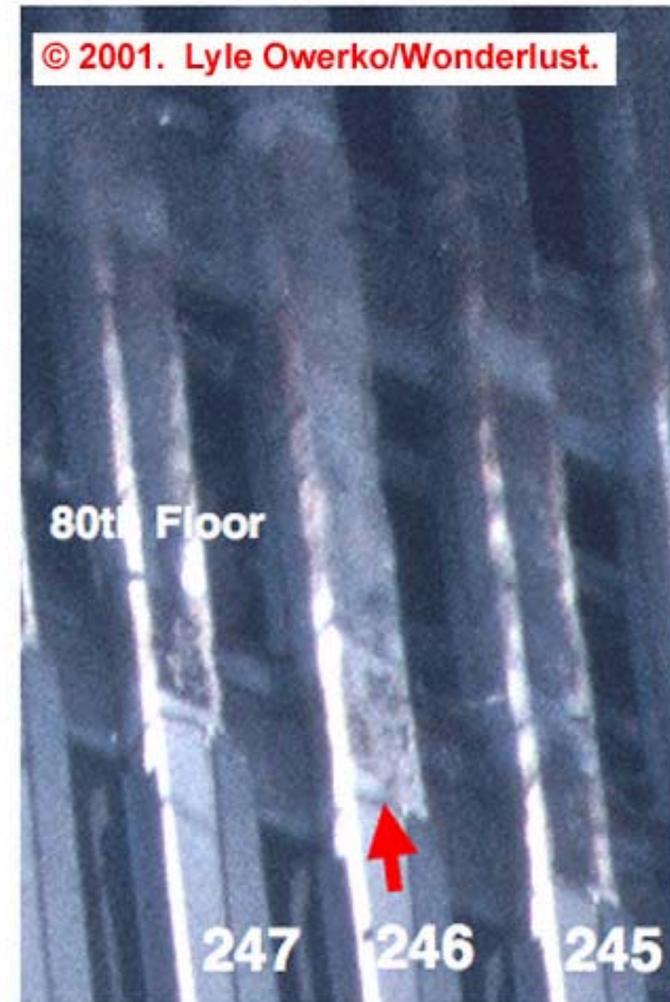
- By design, uniform thickness
- As applied, region between flange tips filled (for example, see column 246 at right)
- Missing SFRM from outer flange indicated by shadowing and exposed red paint

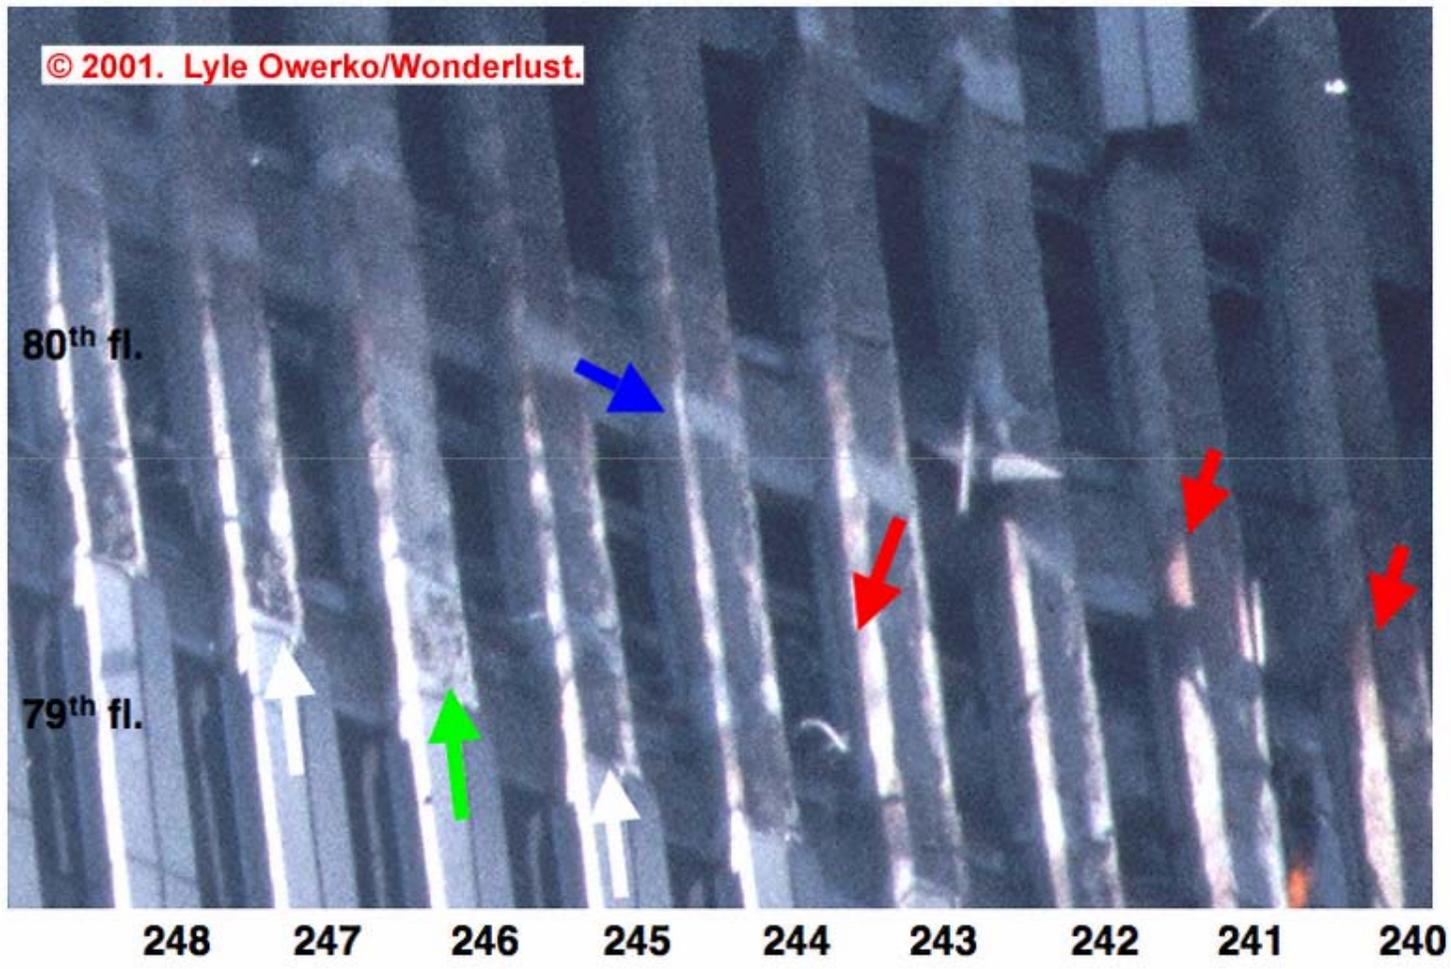
Damaged SFRM - North Face of WTC 2

Removed from flanges (red)

Intact (green)

Covered by weatherproofing coating (blue)

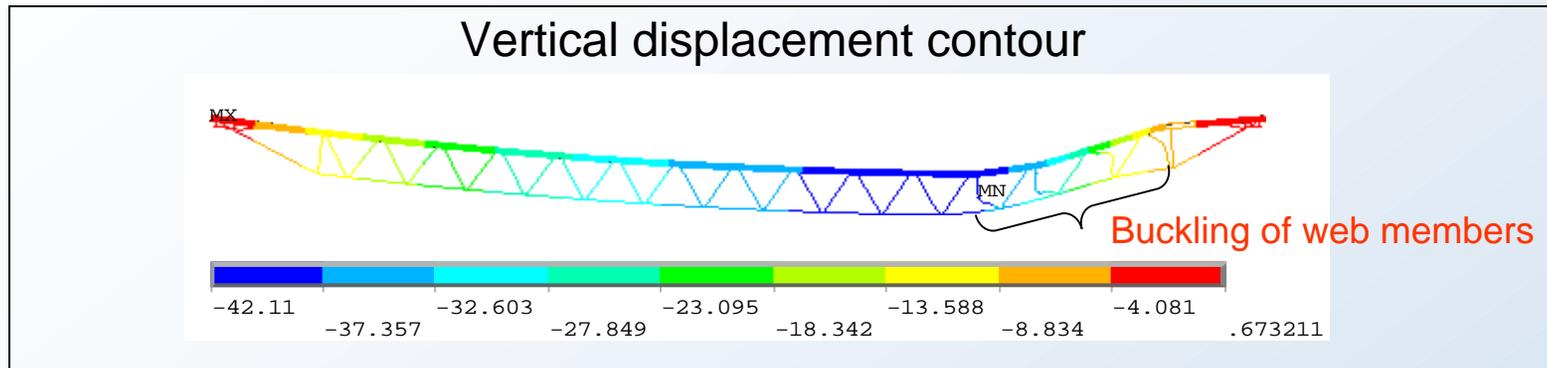
Sagging in Detailed Truss Model

- After web members buckled, the truss pulled exterior columns in.
- The tension force ranged from 9 kip to 14 kip per column in this model at the exterior column.
