NCST Investigation of the Champlain Towers South Collapse

Cross-Project Panel Theme 1: Timeline and Evidence Collection

*Judith Mitrani-Reiser, N. Emel Ganapati,
David Goodwin, Christopher Segura,
Jonathan Weigand, Kamel Saidi, and Jack Moehle*

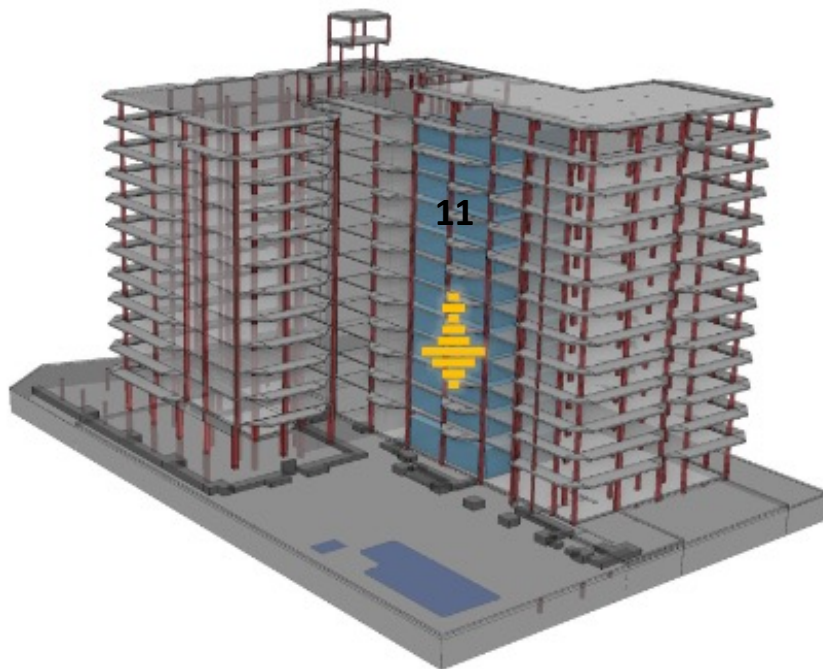
- Noises in the 11 stack units from above the 1st floor before 1 am
- Like “knocking” or a “hammer” or “table” & “chairs” being moved above
- Noises getting “louder and louder” and “more intense” closer to the time of the pool deck collapse

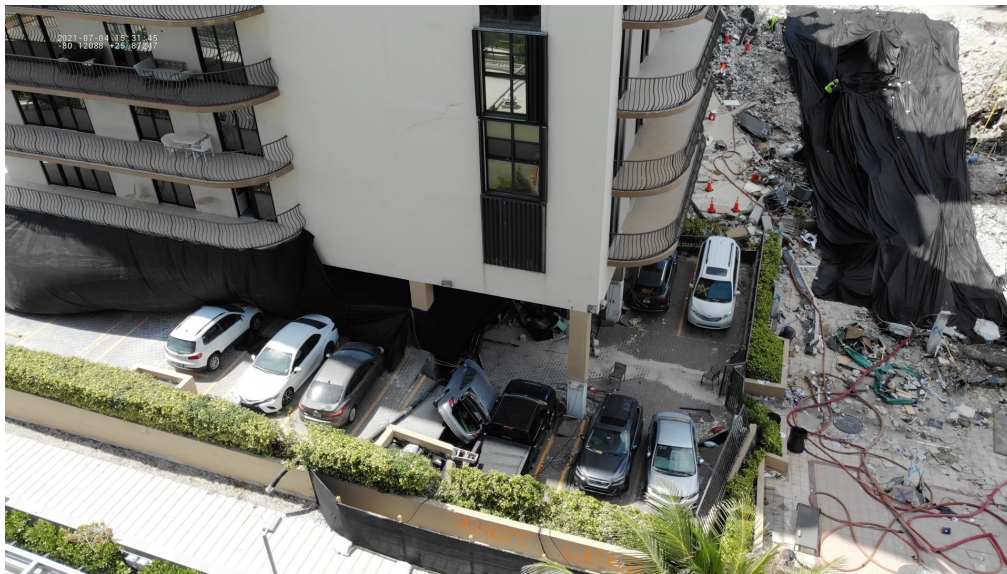
Direction of cars sinking

Car alarms "going off"

Cars sinking into the ground near the south wall from the East towards the West

Sinking does not "go all the way" to Collins Avenue

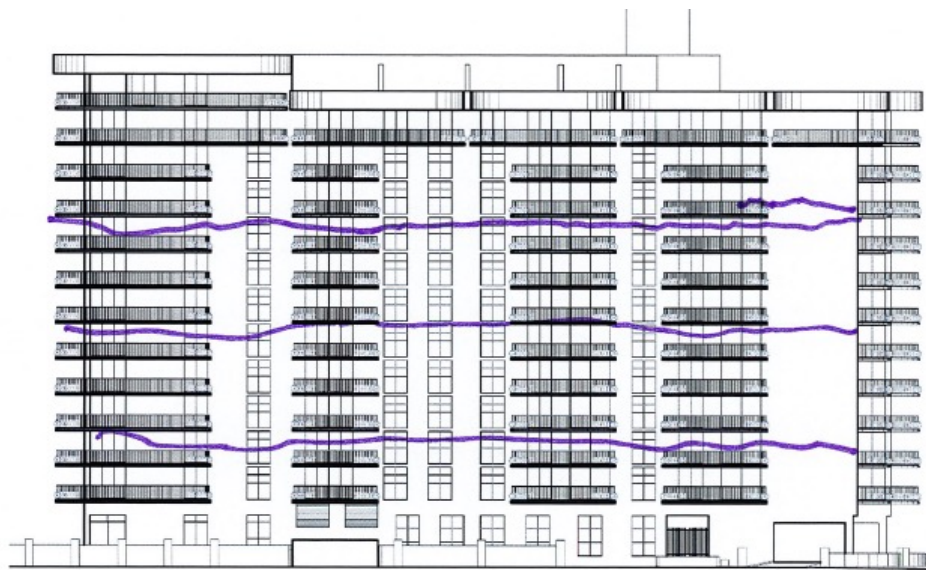
North Elevation View

- Horizontal cracks across the stucco façade
- Windows/sliding doors on the 1st floor exploding
- “A huge cloud of dust” blowing from the garage– getting “bigger and bigger” until nothing can be seen

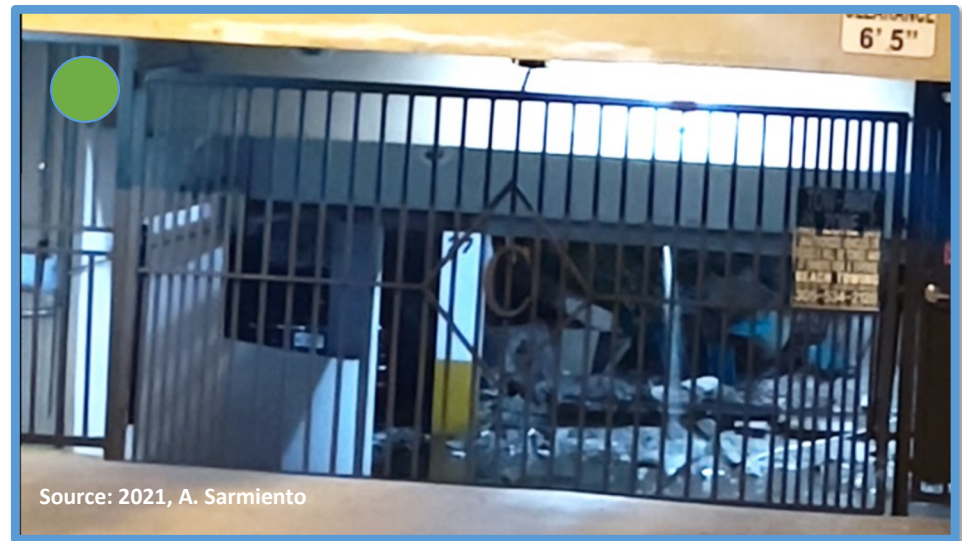
Key Point: North portion of pool deck slab collapsed into the basement (parking garage) prior to the global collapse of the eastern part of the tower

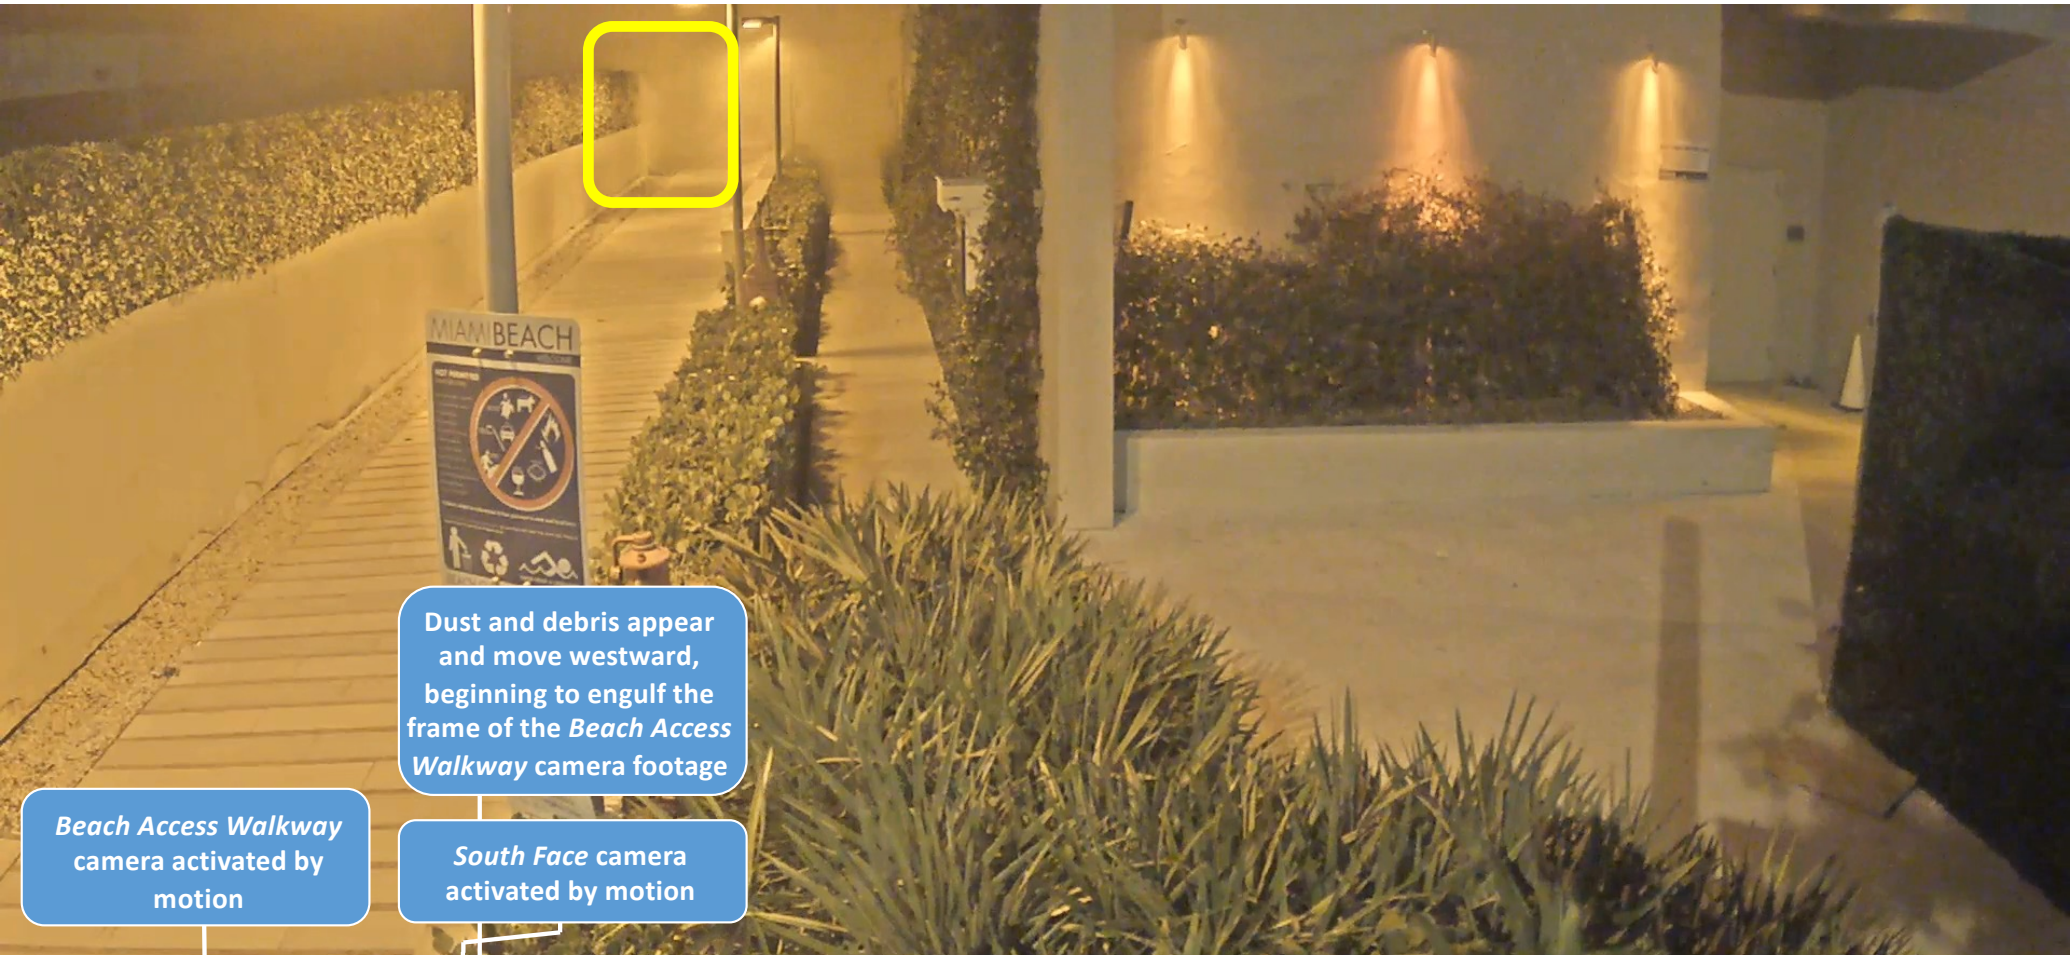
Dust and debris appear and move westward, beginning to engulf the frame of the Beach Access Walkway camera footage

Observation 1: Beach Access Walkway video captures moments just before, during, and after the tower collapses

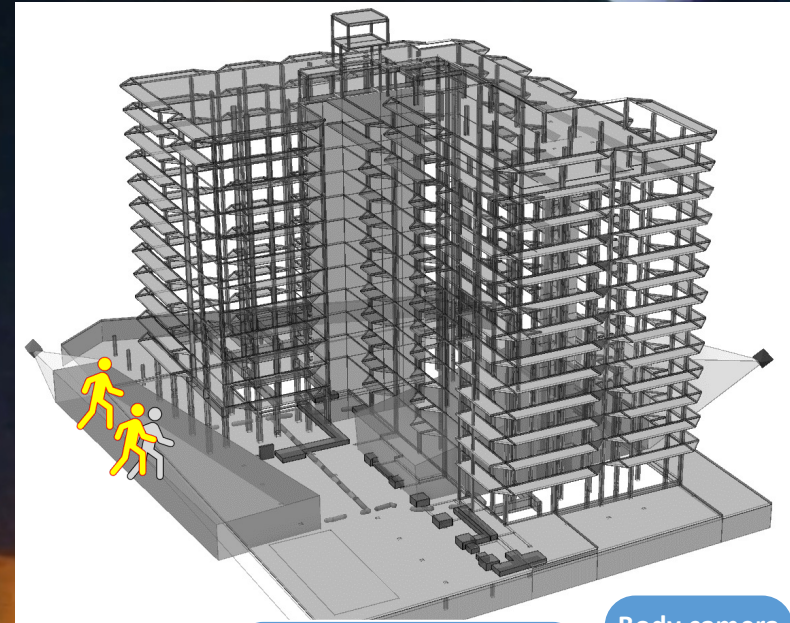
Beach Access Walkway camera shows three individuals on walkway, observing damage.

Body camera shows two individuals, observing damage.

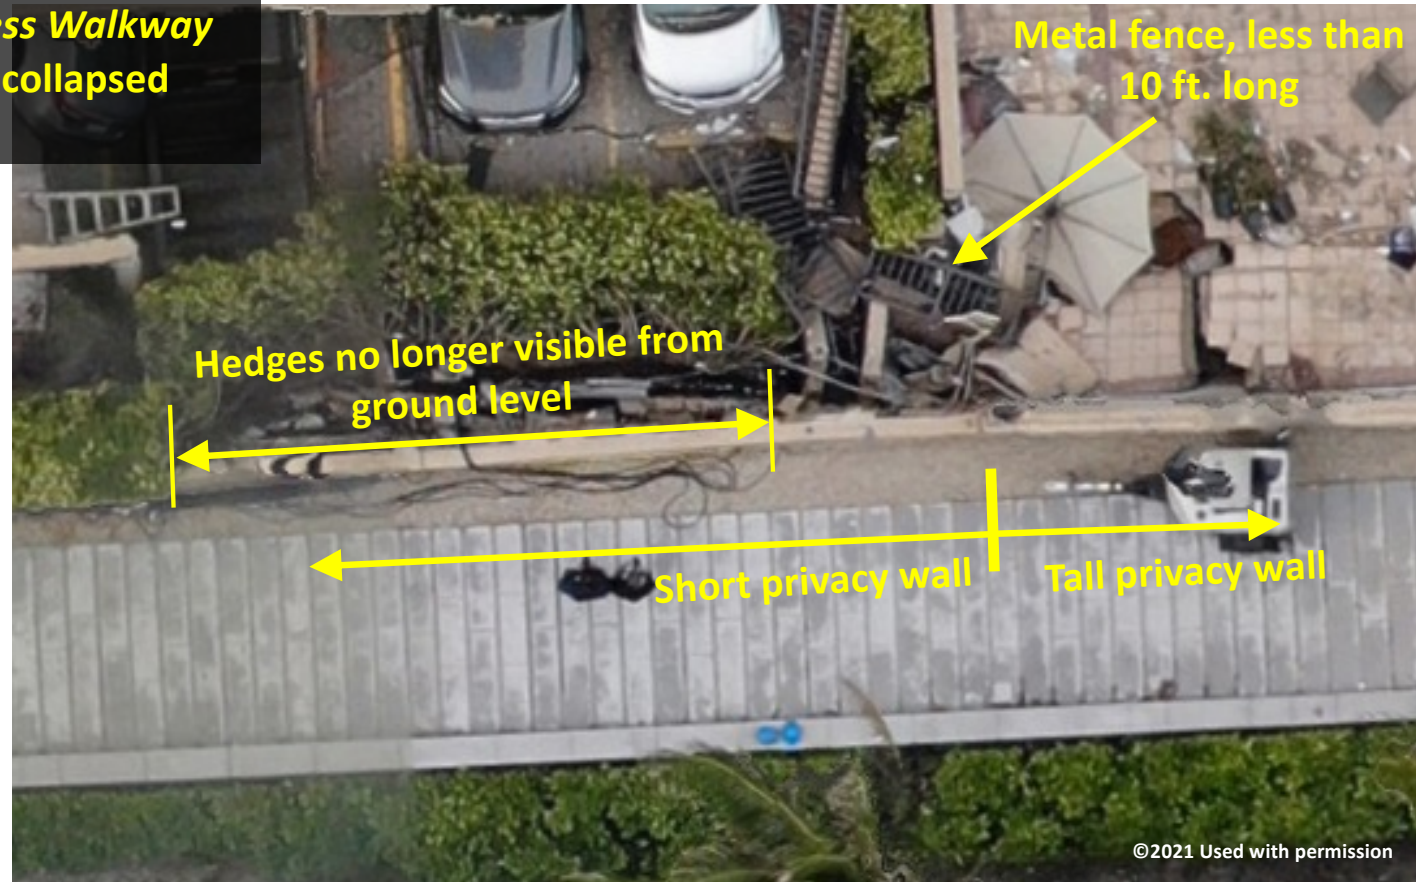
Observation 2: Portion of hedges and the metal fence are not visible in *Beach Access Walkway* footage because they had already collapsed with pool deck

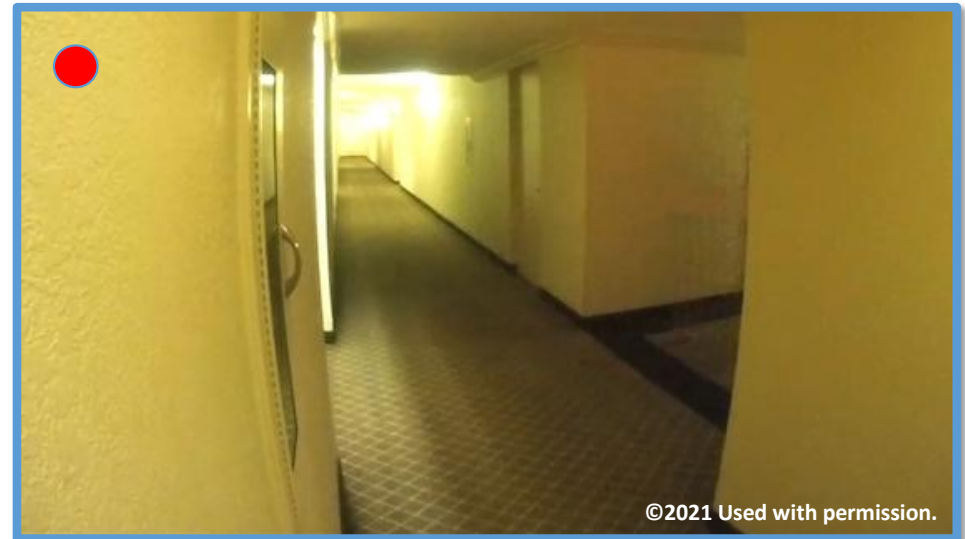
Key Point: Prior to the tower collapse, severe deflections occurred in an upper story corridor of the CTS building near Grid Location K-4. These deflections were concentrated on the south side of the corridor near Grid Line K.

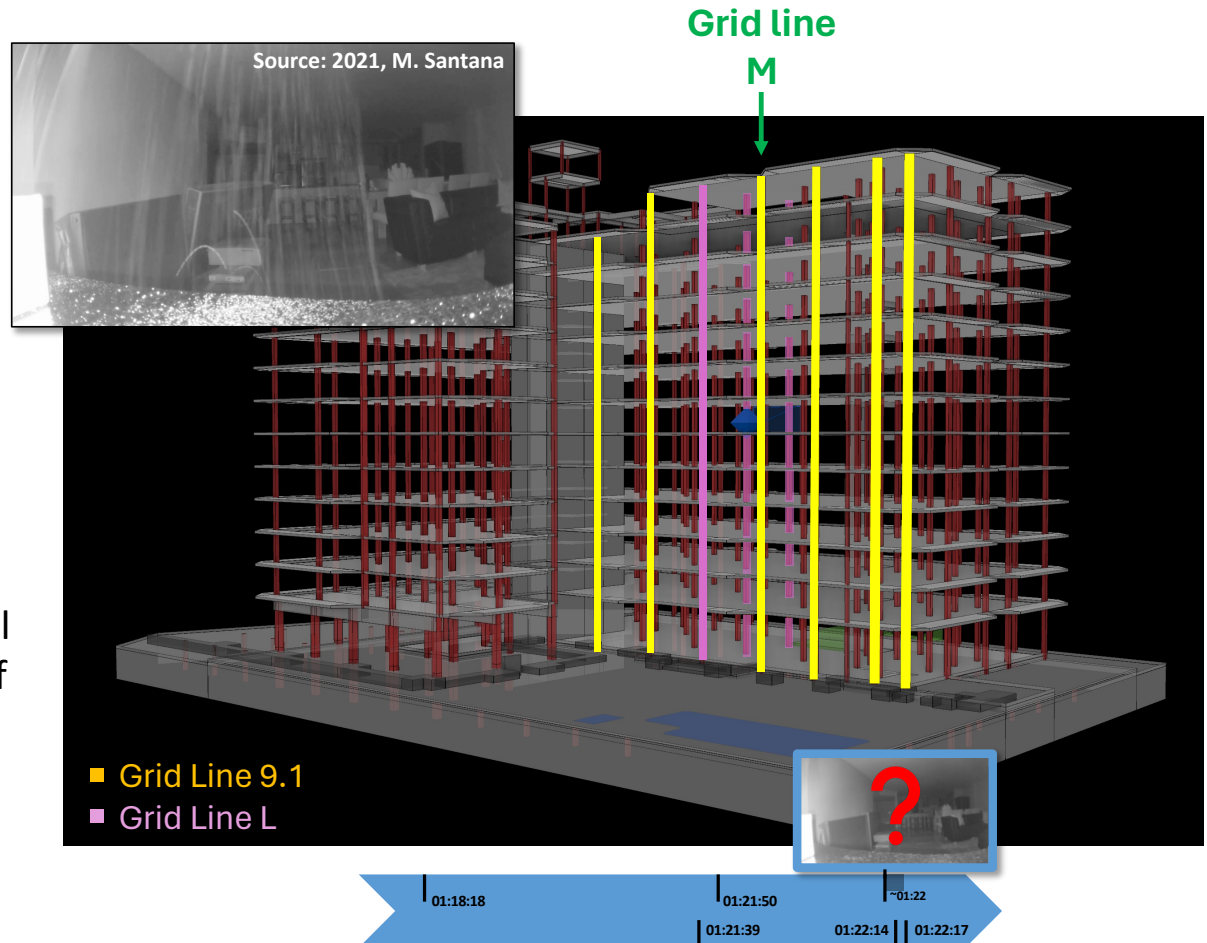
- Material seen falling in front of the camera may indicate distress from the floor above or the upper parts of the unit's walls
- Movements observed in the room are consistent with movements of Grid line 9.1
- Distortions in the kitchen partition wall may indicate greater vertical motion of Grid Line L relative to M
- No accurate timestamp yet

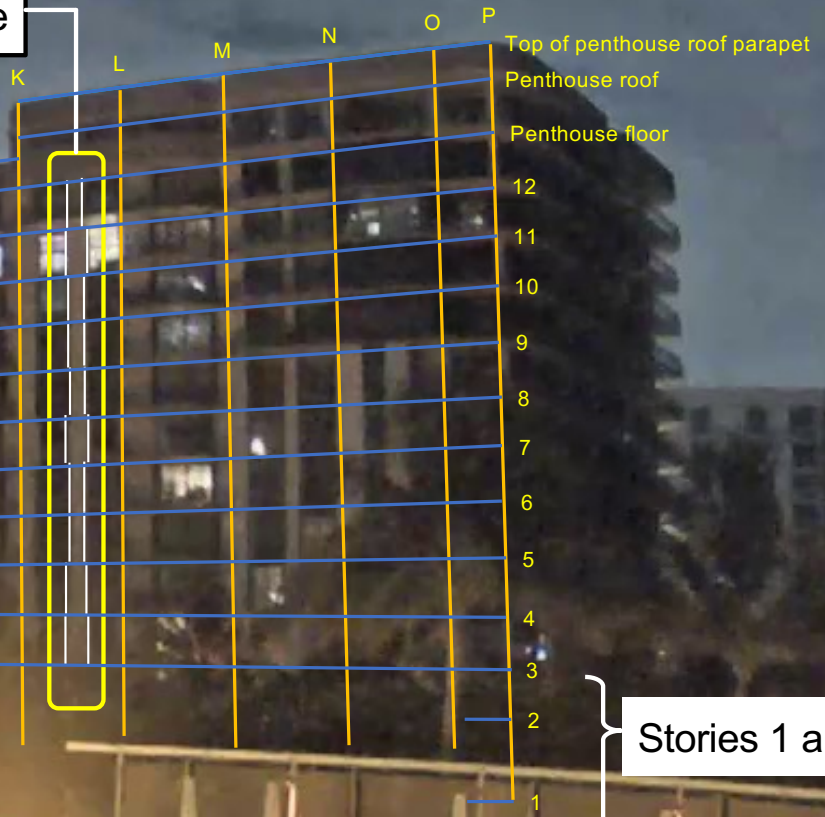
Unique façade shape

- The unique outline as seen approximately 1.5 hours before the collapse.
- The outline extends from the 3rd to the 11th floor.
- The outline is between Grid Lines K and L.

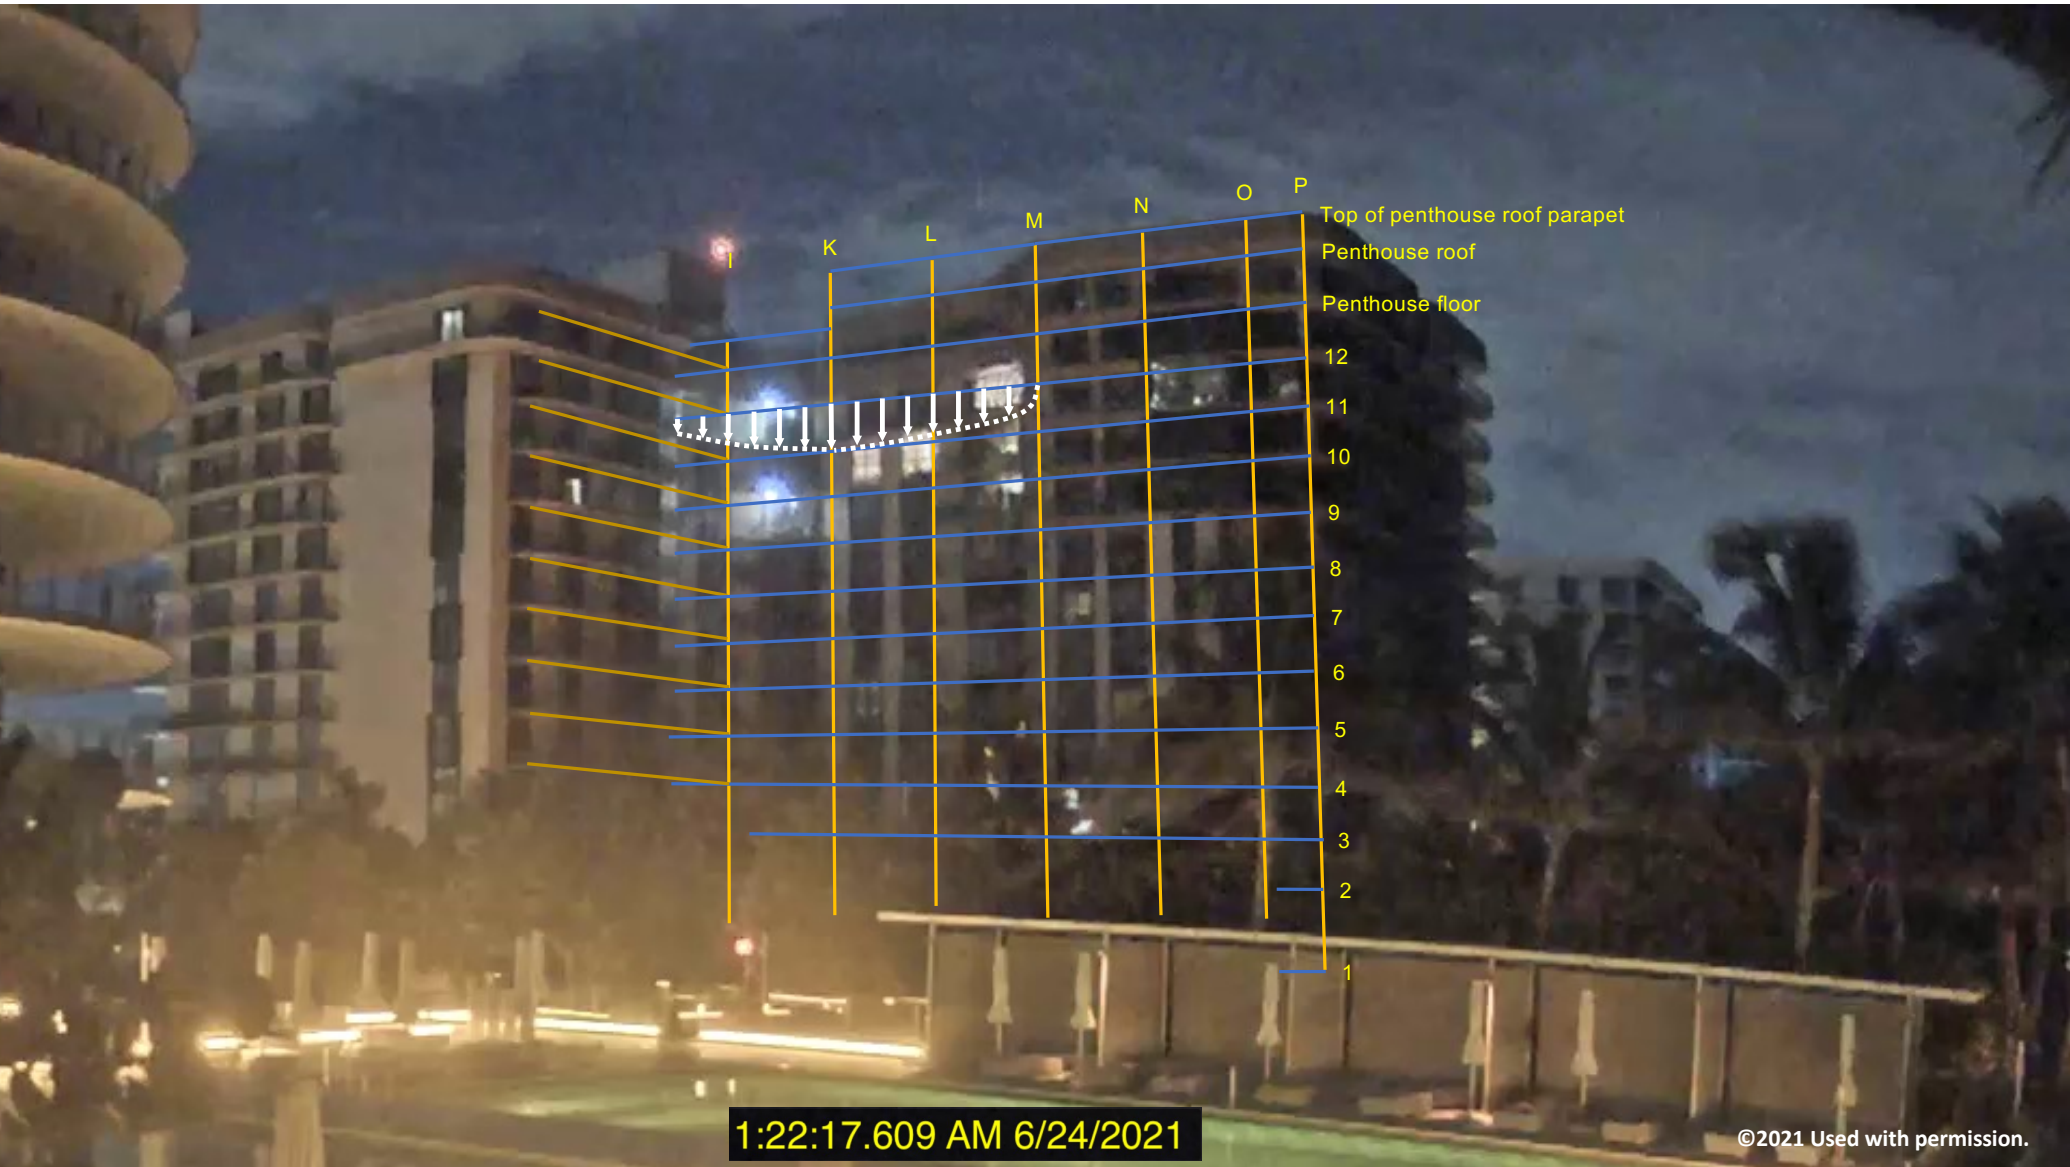
1. The unique façade shape moves uniformly downward, indicating that the failures that triggered the eastern part of the tower drop must have occurred below the 3rd floor.

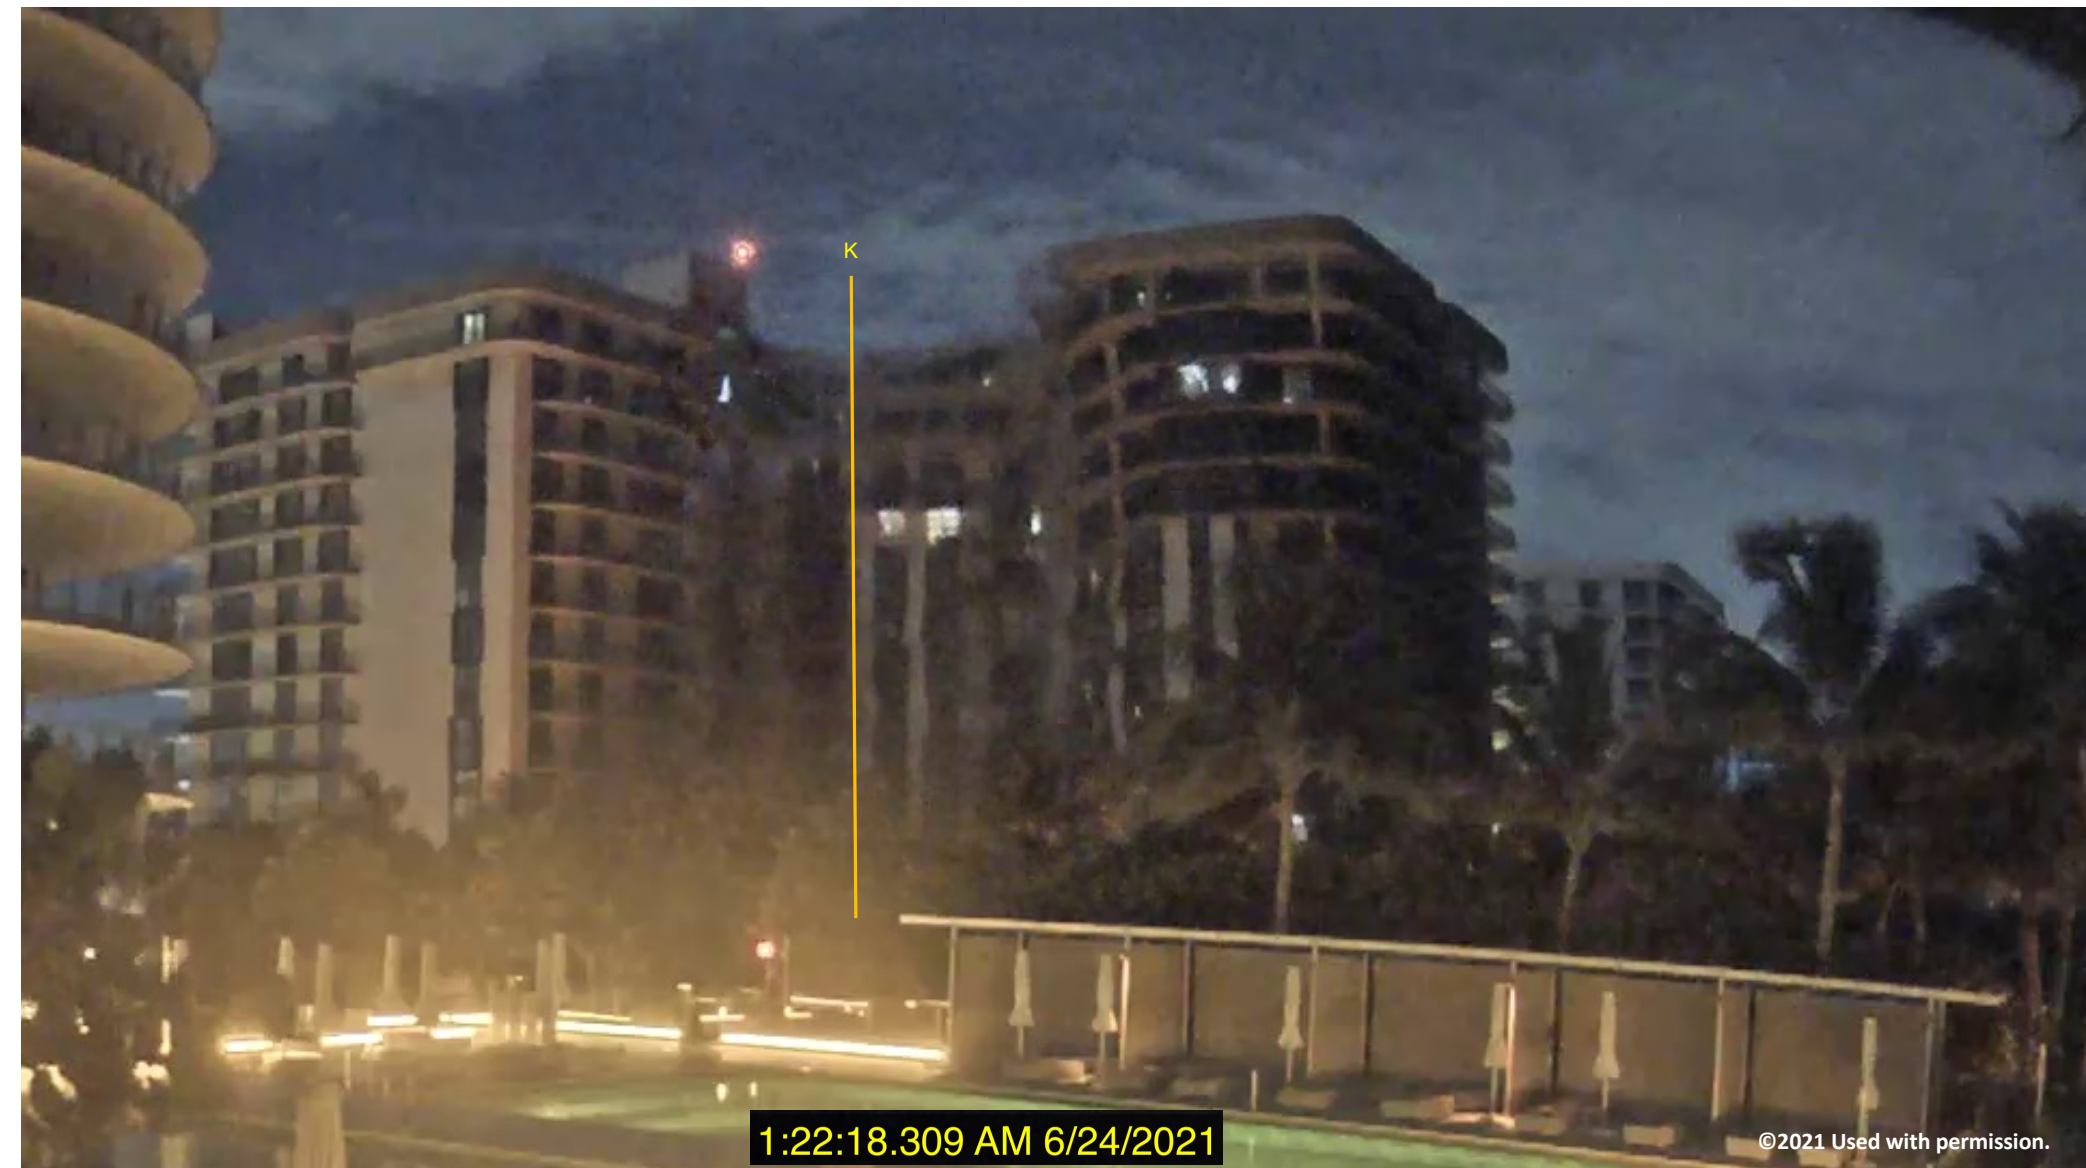
- 1. The initial failures that triggered the eastern part of the tower drop must have occurred below the 3rd floor.
- 2. In the tower collapse, the columns at K-9.1 and/or L-9.1 dropped first, followed by I-9.1 and then M-9.1.

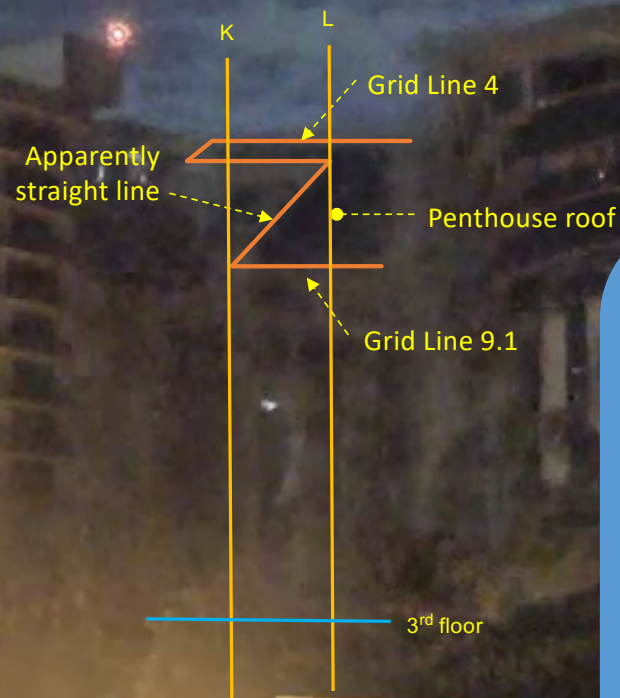
1. The initial failures that triggered the eastern part of the tower drop must have occurred below the 3rd floor.
2. In the tower collapse, the columns at K-9.1 and/or L-9.1 dropped first, followed by I-9.1 and then M-9.1.
3. As the columns on Grid Line 9.1 dropped, the collapse advanced northward.
