NCST Investigation of the Champlain Towers South Collapse

Cross-Project Panel Theme 3: Failure Hypotheses

CTS Investigation: Failure Hypotheses

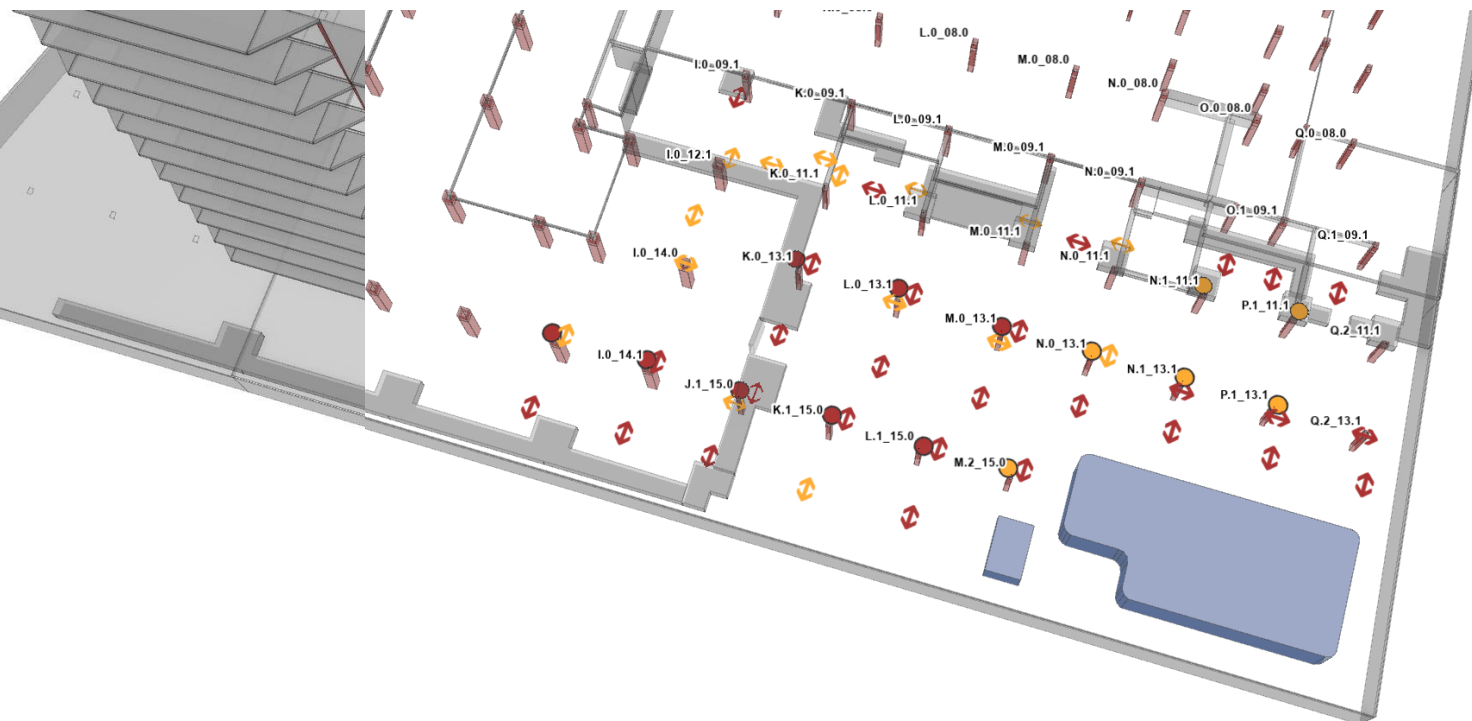
Preliminary Results of Pool Deck Code Check

- *Design deficiencies in pool deck:* High DCRs (demand/capacity ratios) in connections, in particular, along Grid Lines 13.1 and 14.1
- *Deviations in pool deck construction from design documents:* Lower top bars, wider top bar spacing, 25 % of reinforcing bars not passing over columns
- *Added super-imposed dead loads:* Heavier planters, added fill and paving

PRELIMINARY ANALYSIS RESULTS

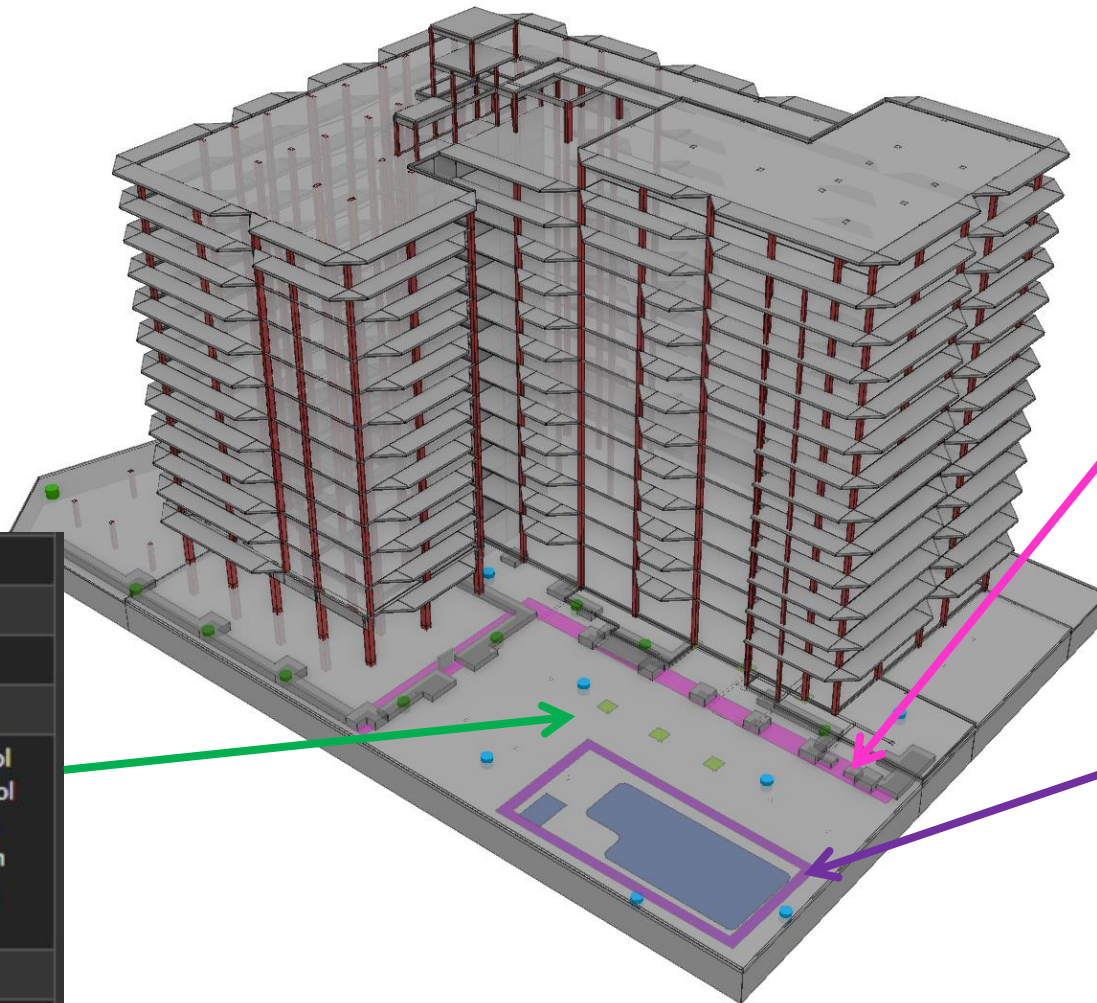
Pool Deck: Leaking Around Pool

Location	Pool Deck
Floor	1
Date	6/1/1997
Type	Leak/Water Damage
Observation	Significant resealing effort of pool deck "sealing all cracks in the pool deck and parking garage and for waterproofing". Complaints from unit 509 led to repairs in parking garage ceiling near space 25.
Repair	Replaired waterproofing

Location	Pool Deck
Floor	1
Date	2/14/2012
Type	Leak/Water Damage
Observation	Repair planters leaking into parking garage.
Repair	Seal cracks

Location	Pool Deck
Floor	1
Date	4/16/2013
Type	Concrete Damage
Observation	Removed damaged pavers and substrate surrounding the pool. "There are three separate areas in the garage where drain pipes are leaking" ; in process of getting repair proposals.
Repair	Replaced with new pavers and substrate

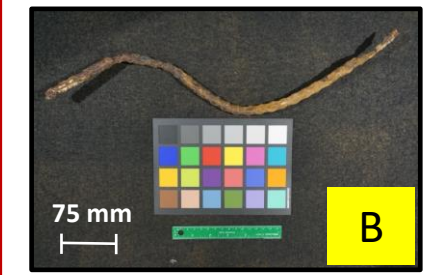
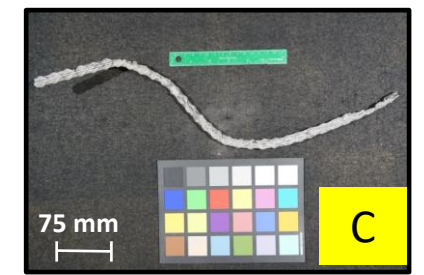
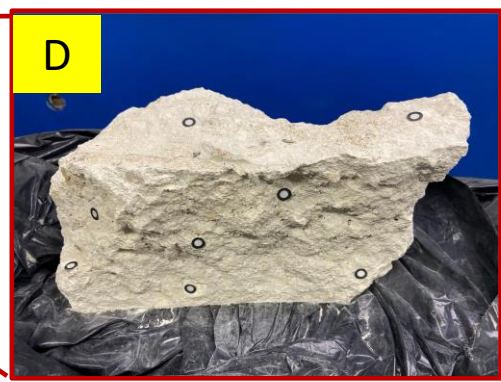
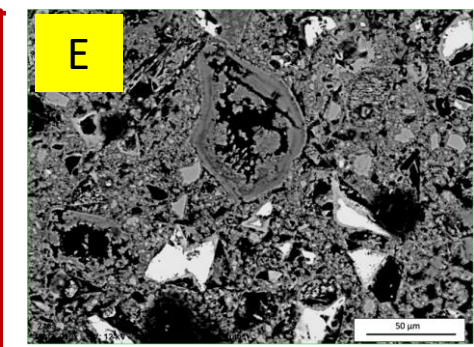
1. Reinforcing bar corrosion
 - Corroded reinforcement in slab (A)
 - Reinforcement before (B) and after (C) cleaning

2. Concrete degradation
 - Specimen extracted from slab near column (D)
 - Microstructure characterized by high porosity (black regions at E)

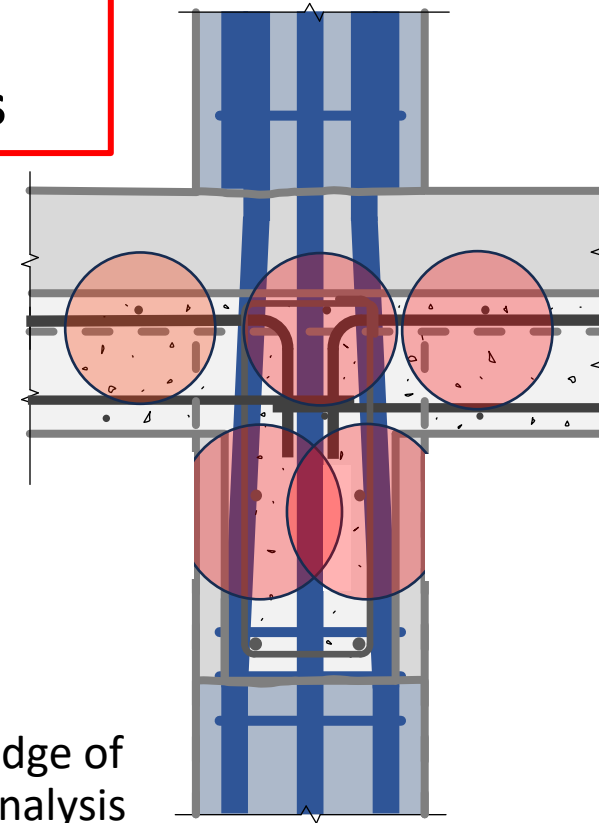
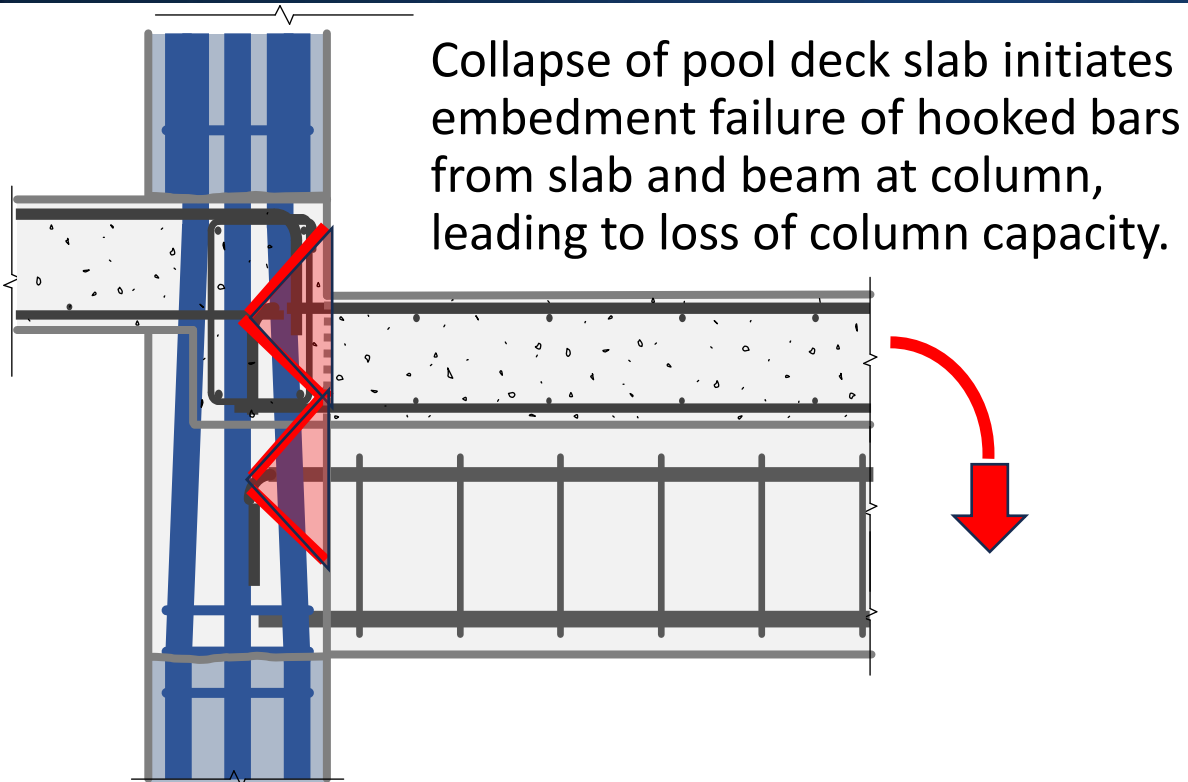
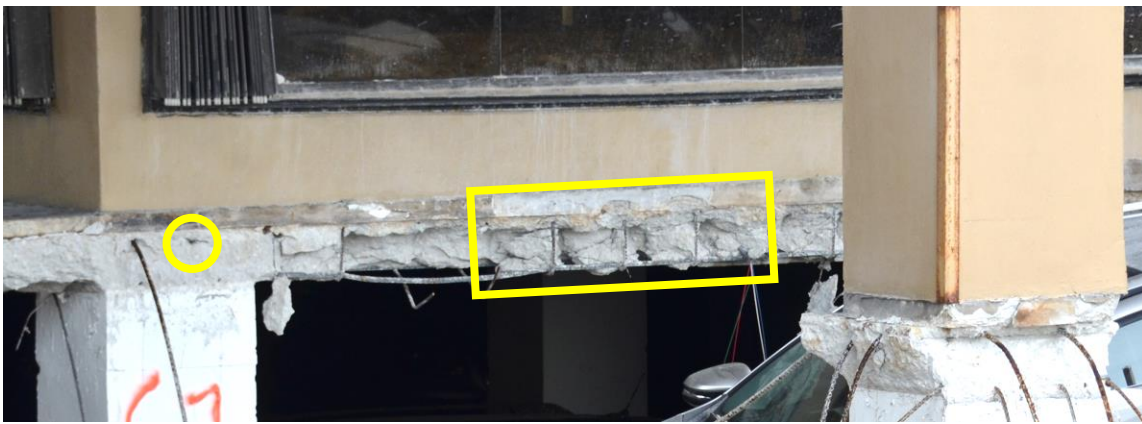
Collapse of pool deck slab initiates embedment failure of hooked bars from slab and beam at column, leading to loss of column capacity.

Image (at left) of similar condition at edge of portion that did not collapse. Image analysis of area in yellow box led to the profile (below) of concrete left after bars pulled out.

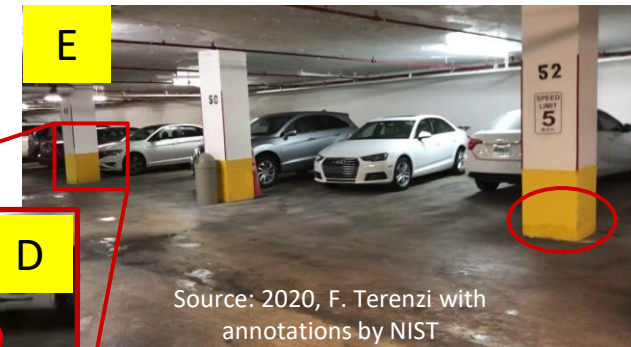
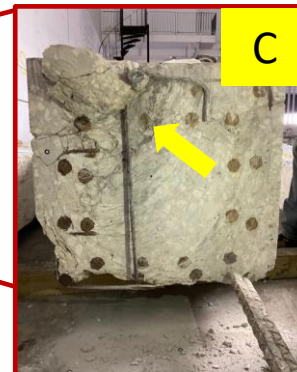
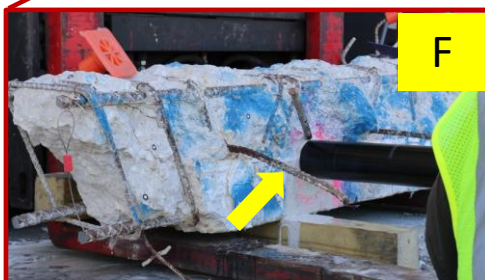
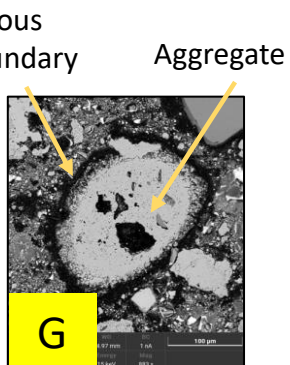
- Corrosion resulting from poorly consolidated concrete at the column bottom (A)
- Cross section of a second column showing poor consolidation at edge (B)

- Cross section of a column showing poor consolidation (C)
- Video evidence suggests that columns were repeatedly exposed to water (D & E)

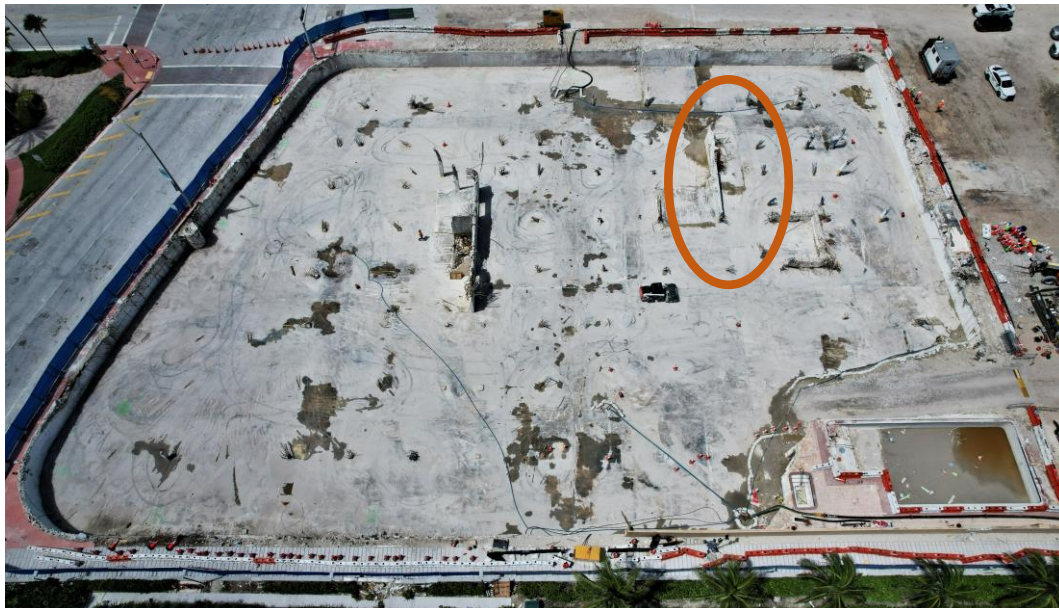
Visual Observation of Basement Slab

- Absence of gross damage
- Cracking in the Basement slab around east shear wall most likely induced during collapse sequence

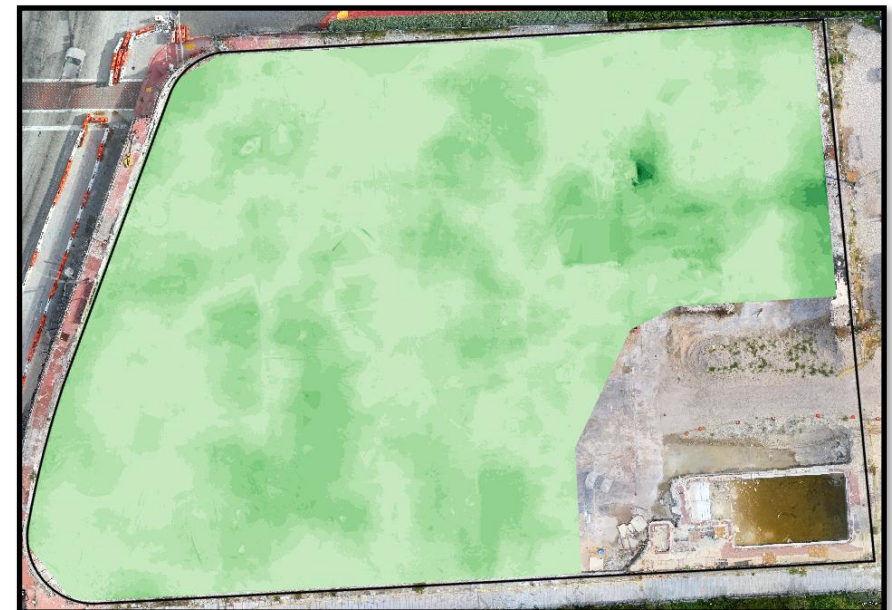
Level survey of Basement slab shows mostly level slab without sudden changes in elevation.

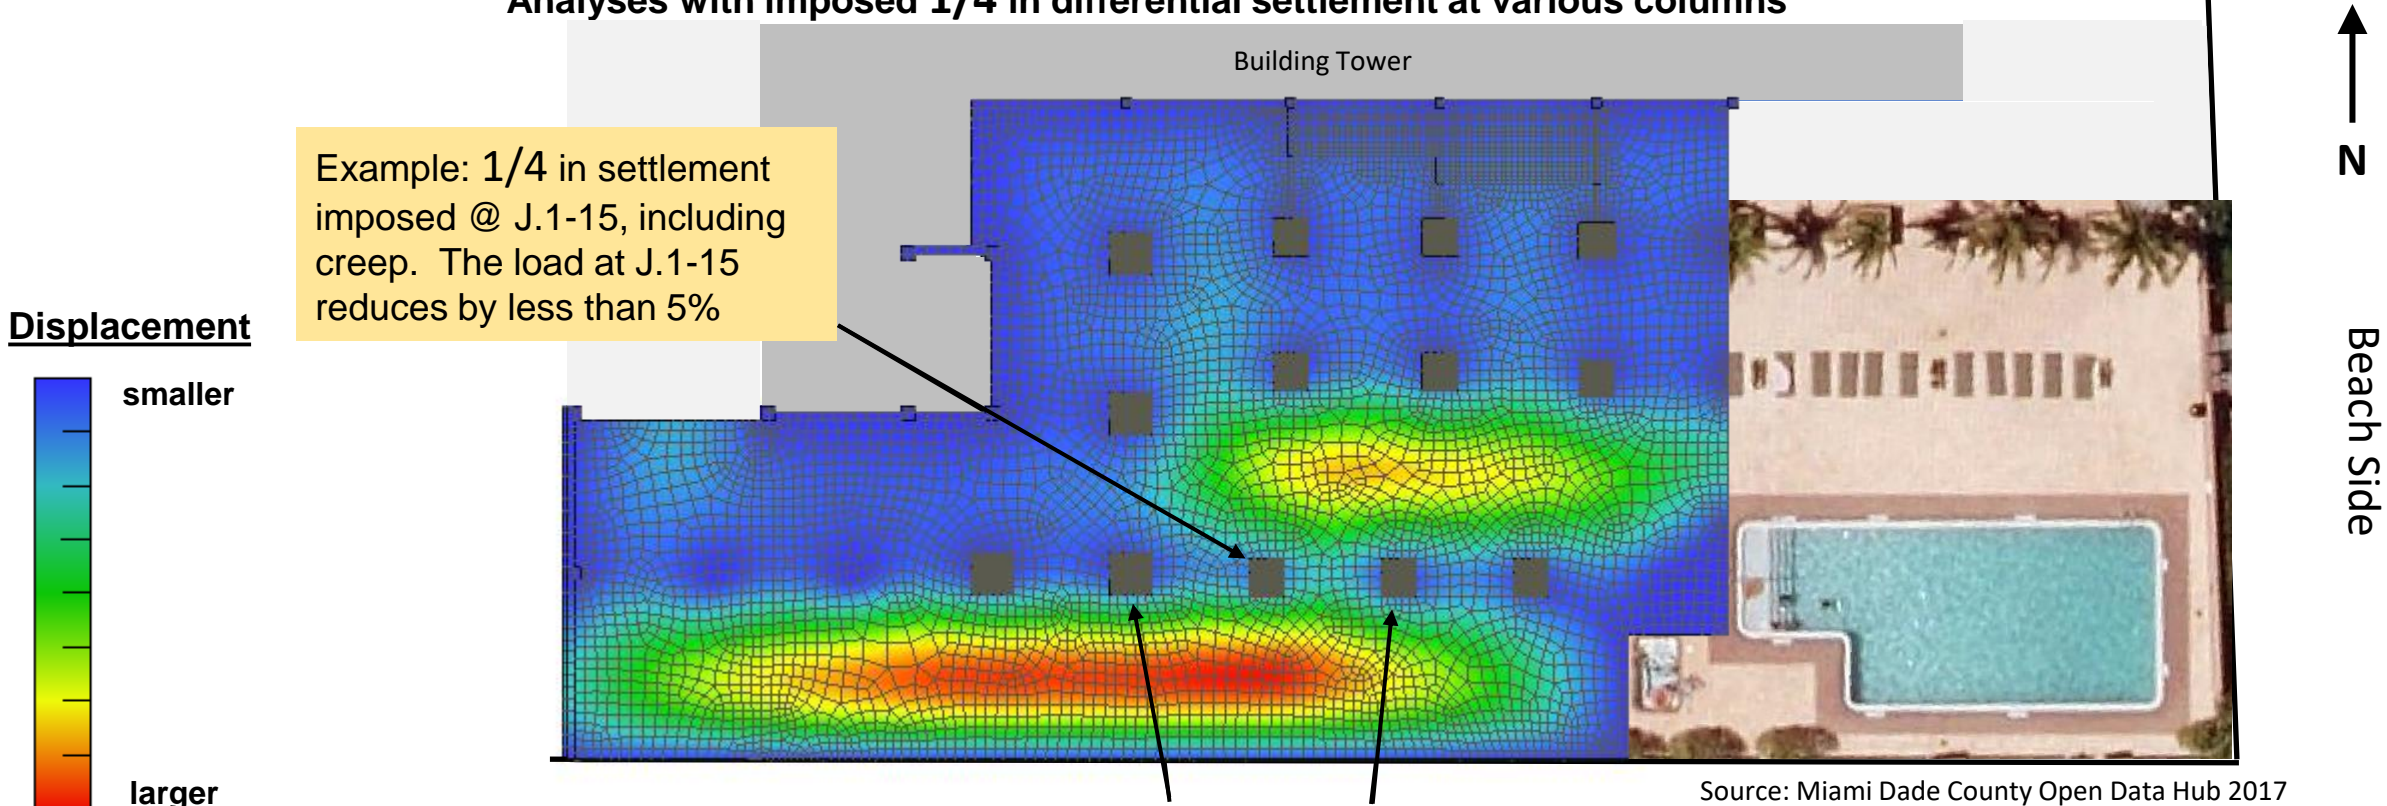
Analyses with imposed 1/4 in differential settlement at various columns

The loads at adjacent locations I-14.1 and K.1-15 increase by less than 5%.

Preliminary evaluation: 1/4 in differential settlement has minimal impact on pool deck structure

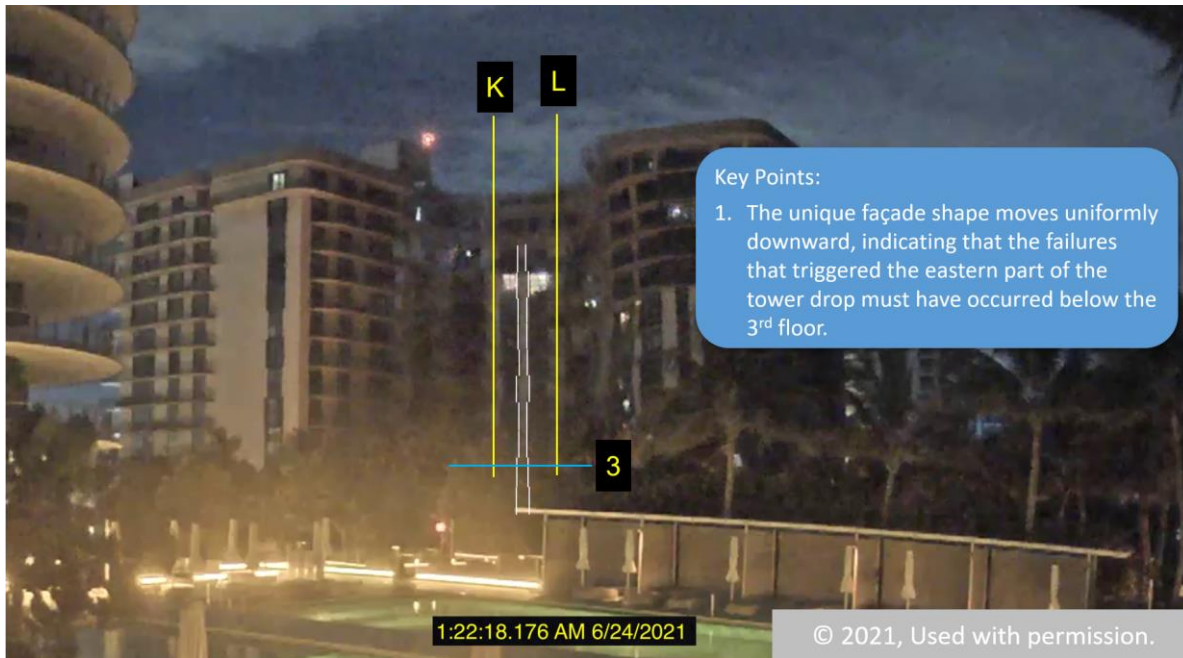
The individual stories of the tower columns at K-9.1 & L-9.1 dropped in unison above the 2nd story

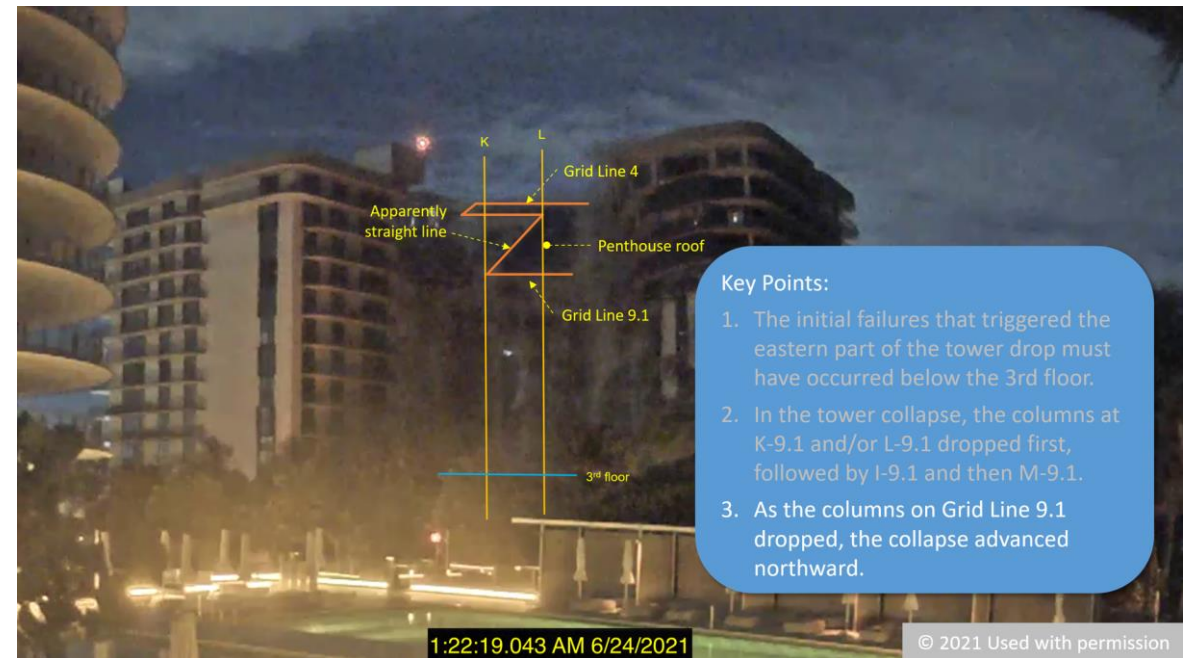
Penthouse roofline shows Grid Line 9.1 dropping in advance of Grid Line 4
