NCST Investigation of the Champlain Towers South Collapse

Concluding Remarks and Next Steps

Failure Sequence and Preliminary Data and Analyses

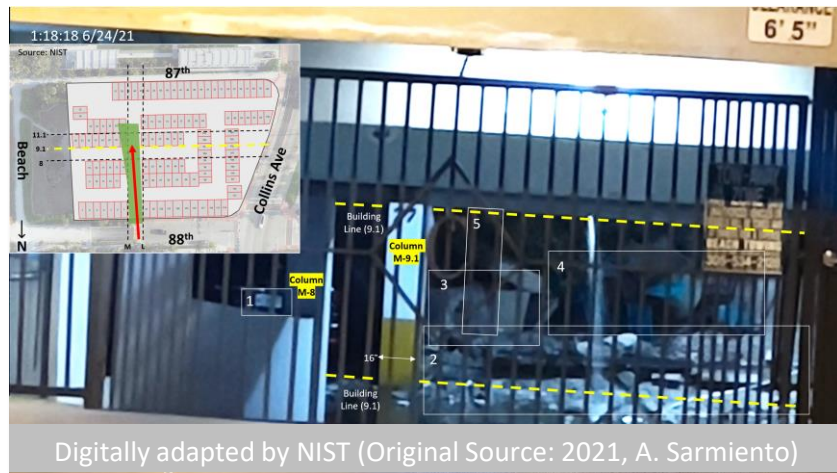
1. The pool deck collapsed between its southern extremity and its connection to the tower more than four minutes before the general collapse of the tower.

NIST's Analysis of CTS Parking Garage Ramp Video Footage

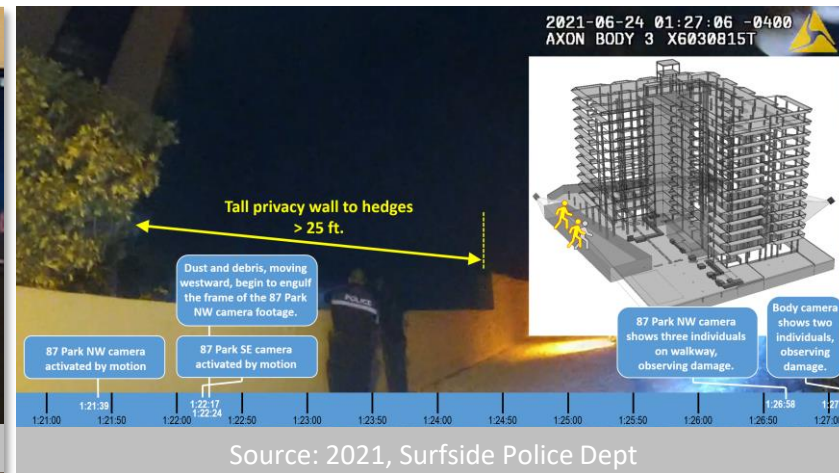
NIST's Analysis of Beach Access Walkway Video Footage

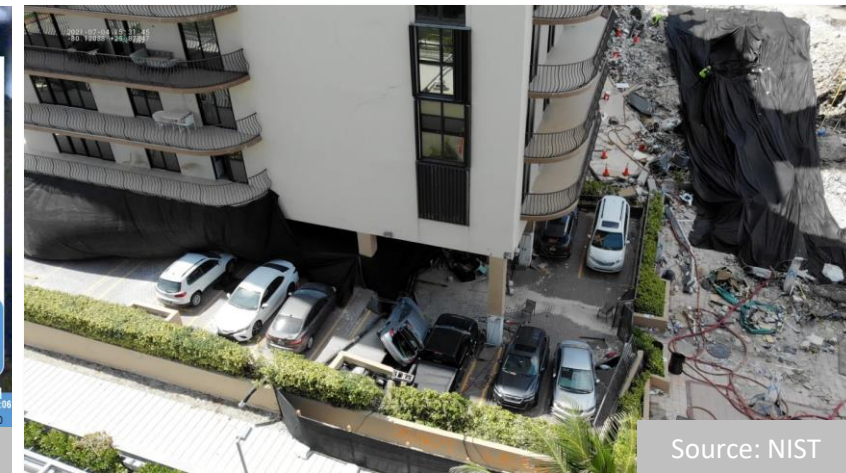
Eyewitness Accounts of Pool Deck Collapse

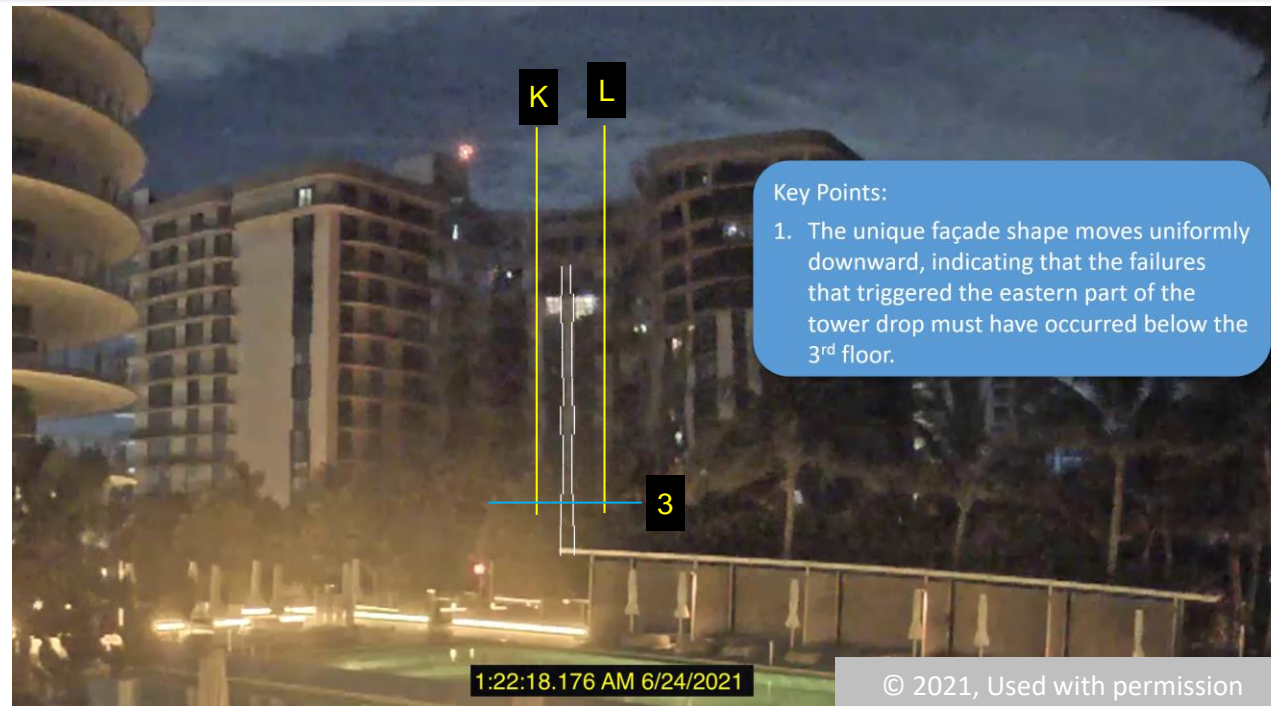
2. In the tower collapse, Grid Line 9.1 started to drop a second, or a bit more, before 1:22:17 am, the time of the first frame of the South Face Video.
- The columns on Grid Line K and/or L dropped first.
 - The initial column failures were low in the building, at or below the 3rd floor.

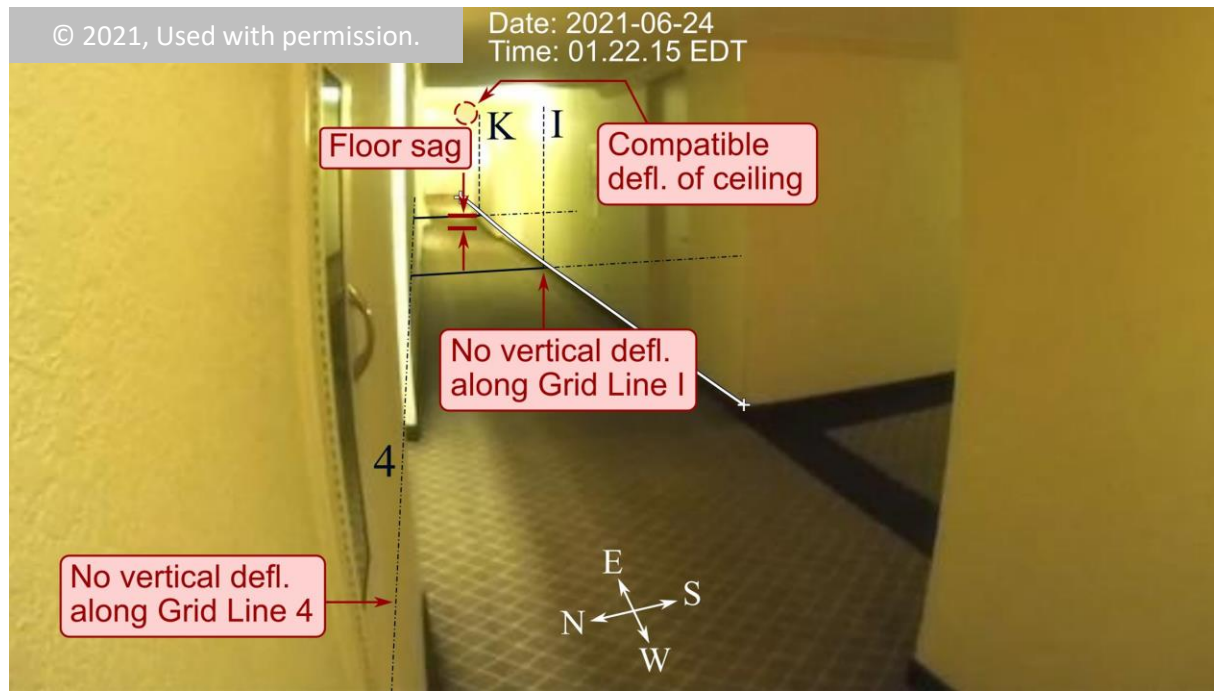
3. Videos show severe structural movements in the tower between Grid Lines K and M and Grid Lines 4 and 9.1 prior to the precipitous drop of the tower along Grid Line 9.1.

NIST's Analysis of Upper Story Corridor Video Footage

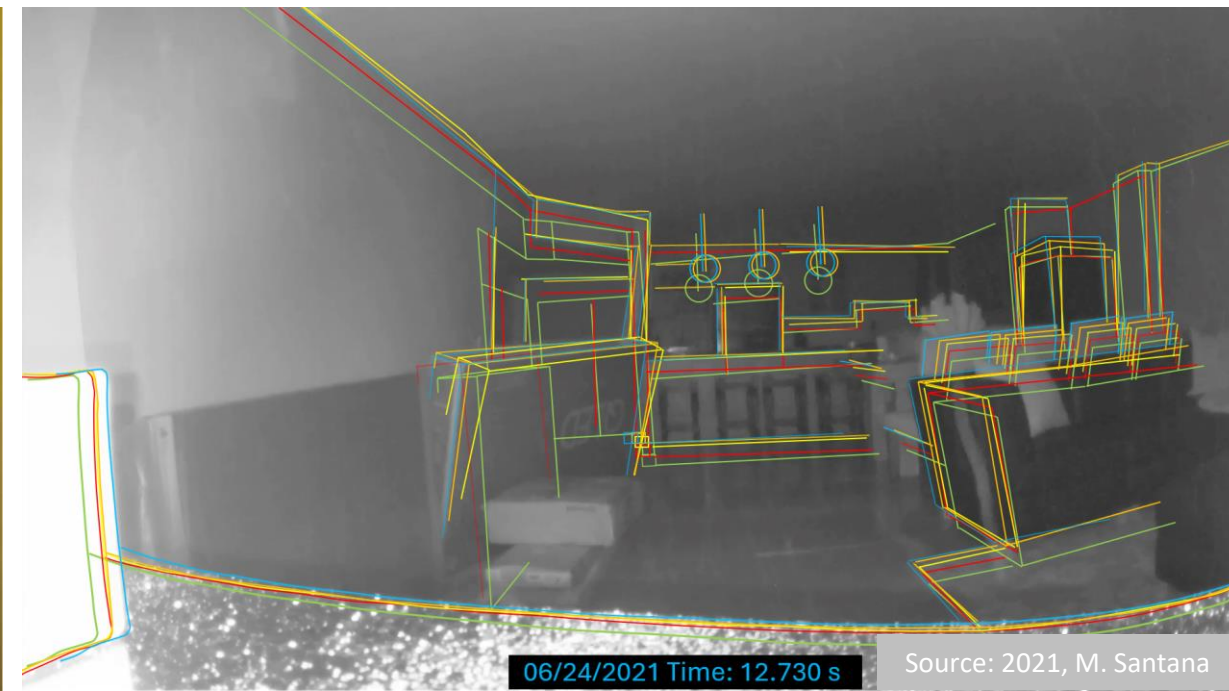
NIST's Analysis of 11 Stack Unit Video Footage

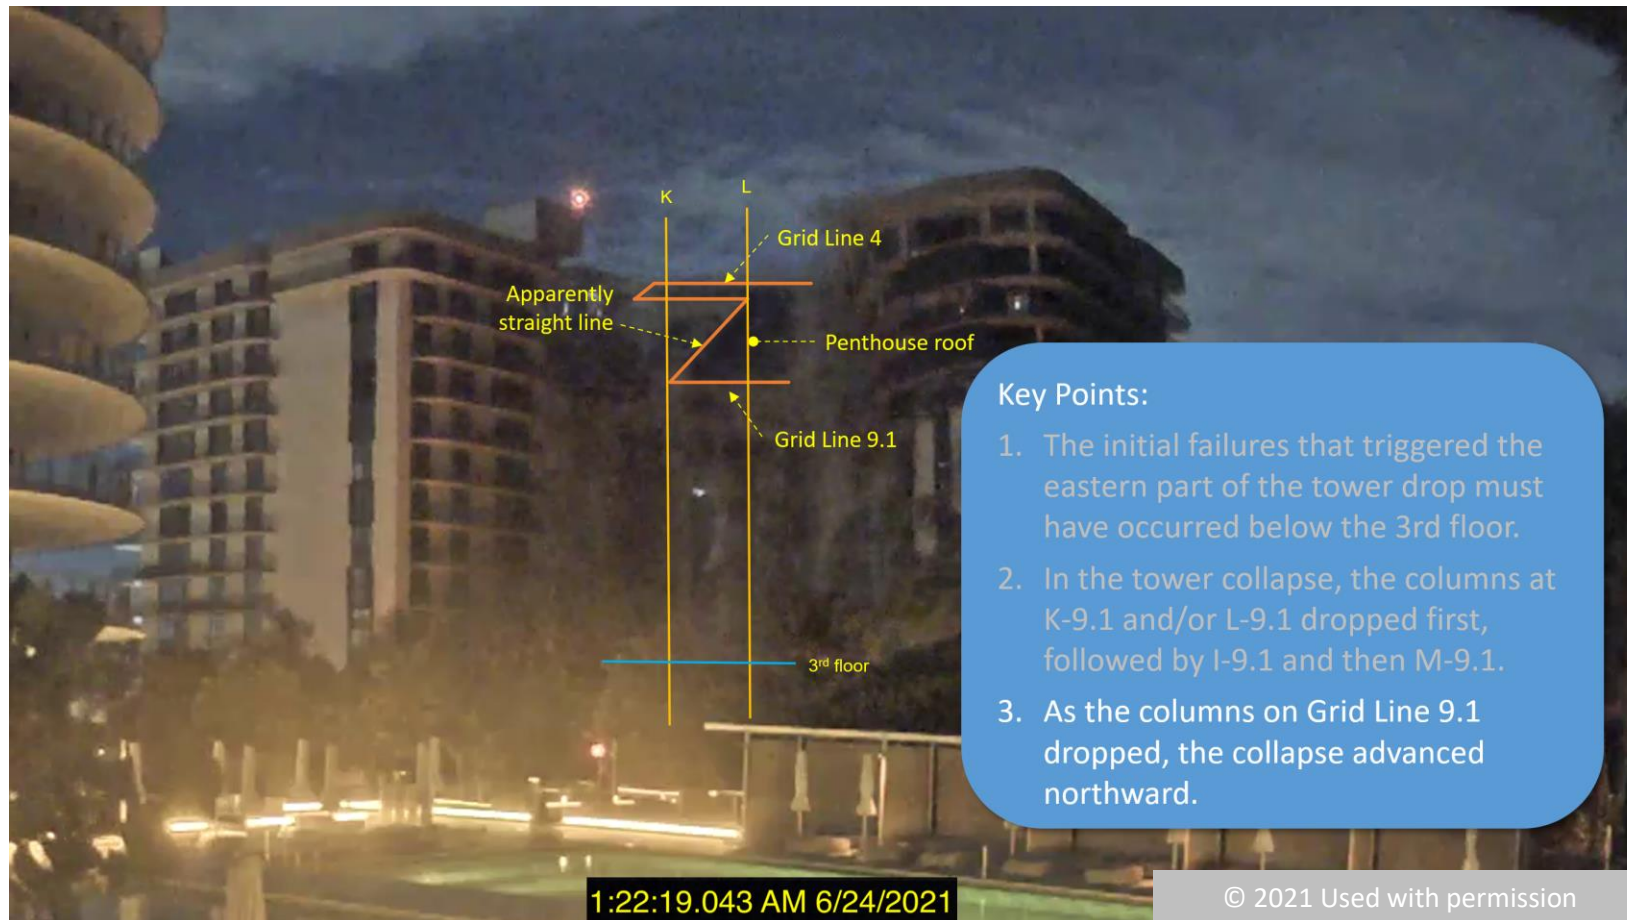
4. As the columns on Grid Line 9.1 dropped, the collapse advanced northward.

1. The initial failures that triggered the eastern part of the tower drop must have occurred below the 3rd floor.
2. In the tower collapse, the columns at K-9.1 and/or L-9.1 dropped first, followed by I-9.1 and then M-9.1.
3. As the columns on Grid Line 9.1 dropped, the collapse advanced northward.

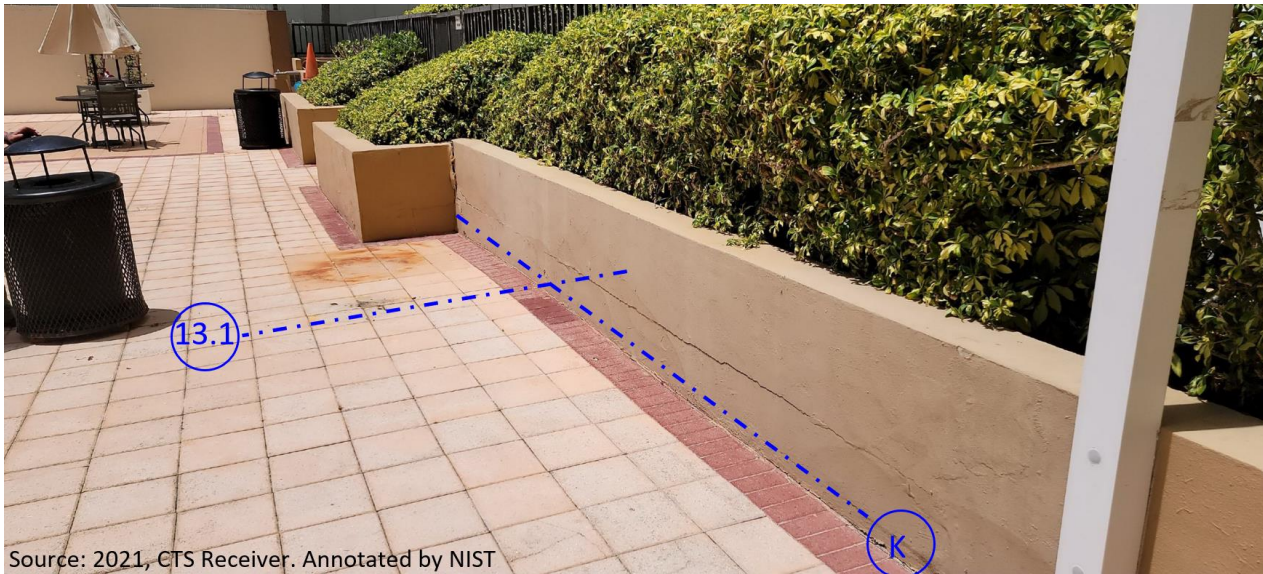
5. While there is strong evidence that the collapse initiated in the pool deck, we have not yet ruled out a failure initiation in some part of the tower that precipitated a collapse in the pool deck.
- There were indications of severe distress in the pool deck at least three weeks before the collapse.
 - There are also potential initiation points in the tower.

Damage to Pool Deck Planters Three Weeks Before the Collapse Indicated Severe Structural Distress

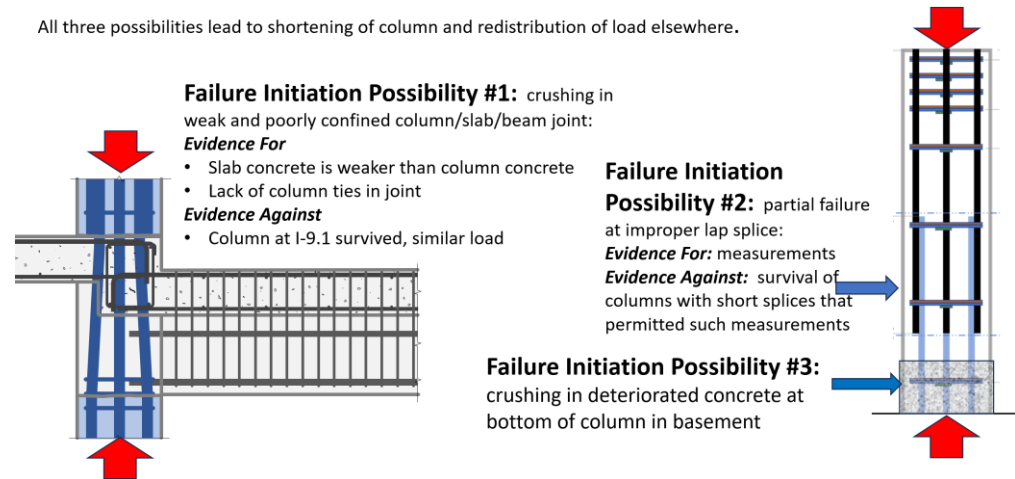
Examples of Failure Initiation Possibilities in the Tower

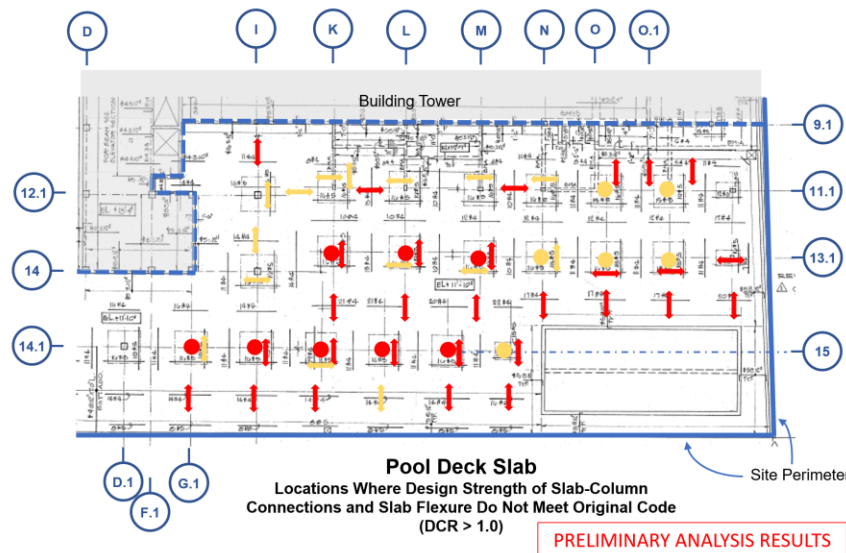
Preliminary Analysis of the Design of the CTS Pool Deck

- The instances of design understrength were far more severe in the pool deck than in the tower.
- Deviations from prescriptive code requirements for reinforcement detailing, concrete cover, and relative strengths of column vs. floor concrete.

- Pool Deck: design strength does not comply with the original codes and standards, with many areas of severe strength deficiency.
- Tower: work in progress.

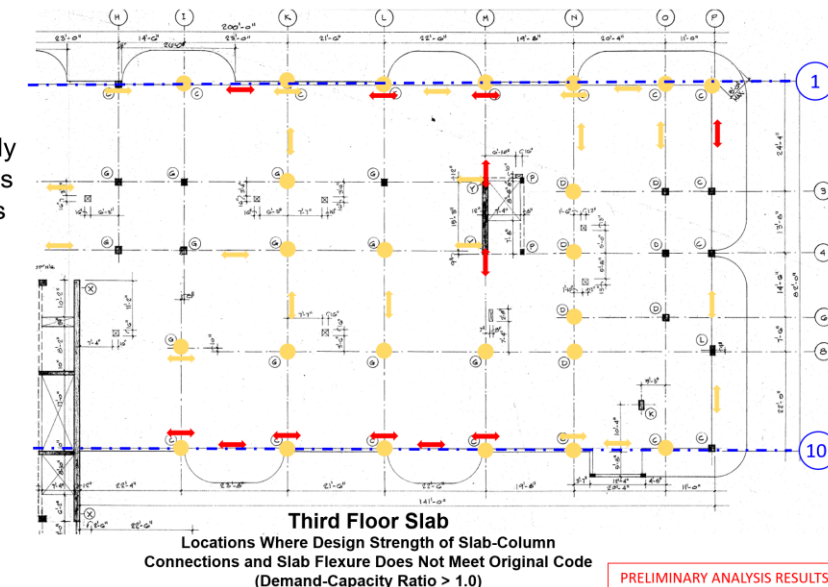
Preliminary Analysis of the Design of the CTS 3rd Floor Slab

- Design strength does not comply with the original or current codes and standards, with many areas of strength deficiency.

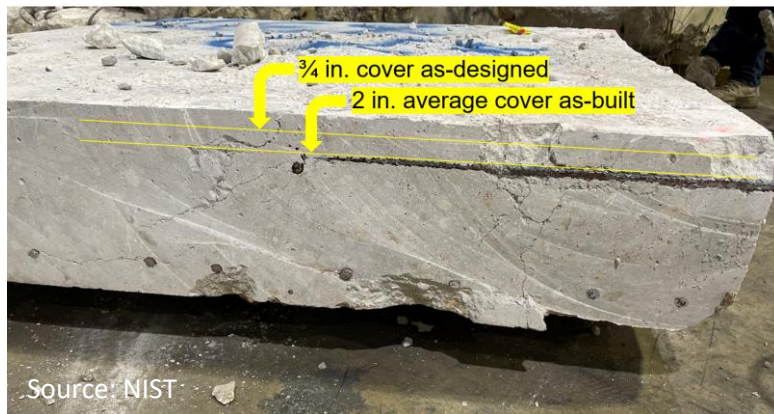
2. The placement of steel reinforcement and alignment of concrete during construction failed to meet the requirements of the structural design documents in multiple respects.

Top Reinforcement Lower Than Design Requirements

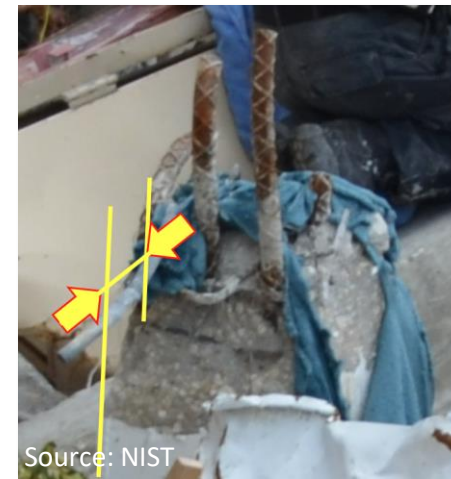
Position of Reinforcement Cage Within Columns

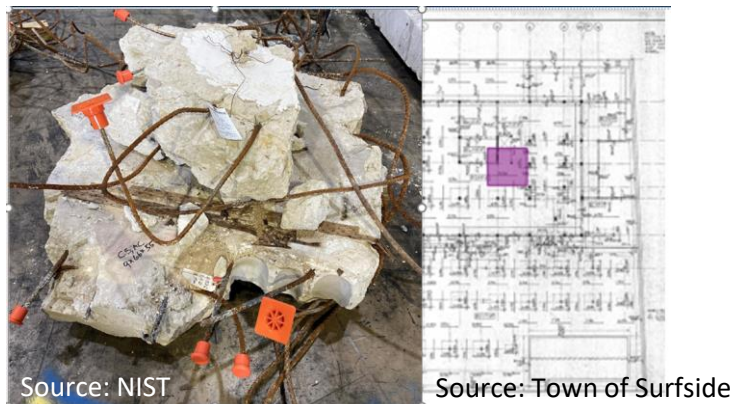
Placement of Top Bars in Column Strips

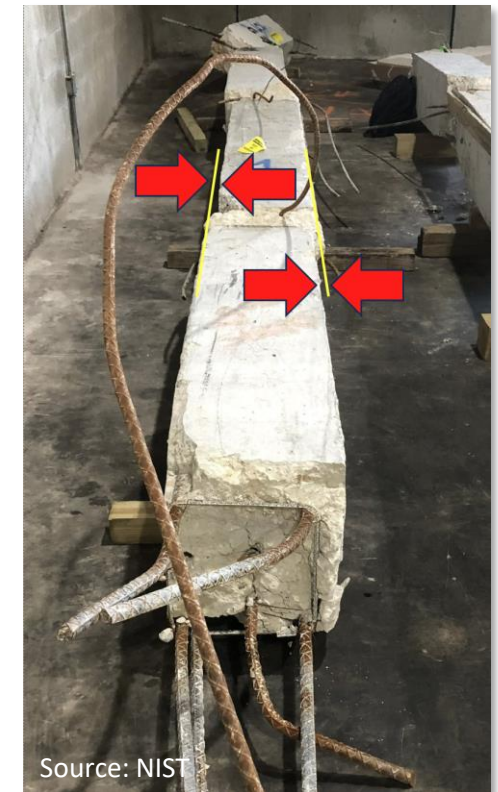
Alignment of Concrete

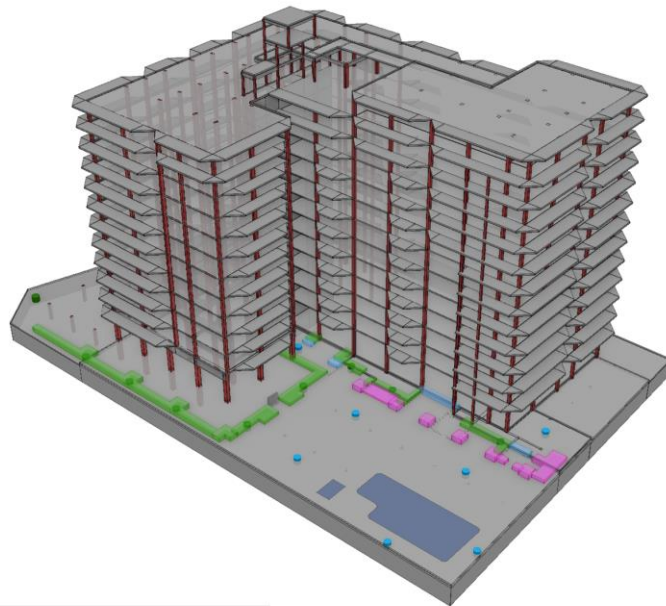
3. In the pool deck, the extent of landscaping planters was greater than shown on the original design documents, and fill and paving were added over the life of the structure, increasing the loads on the pool deck structure.

Added Planters

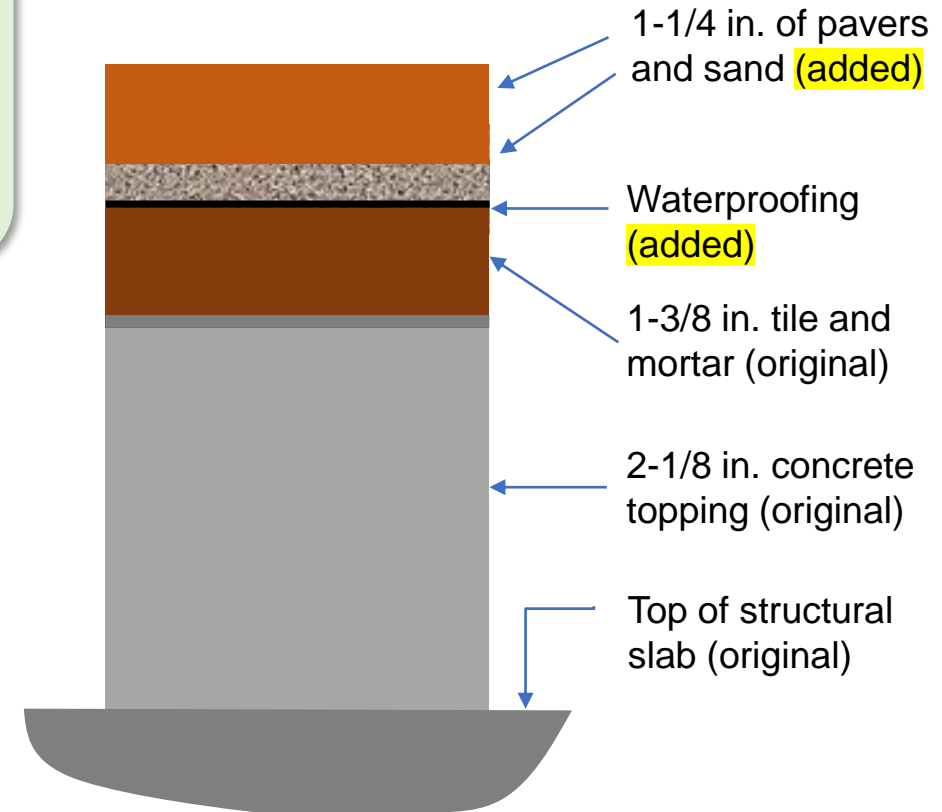
Added Waterproofing,
Sand, and Pavers

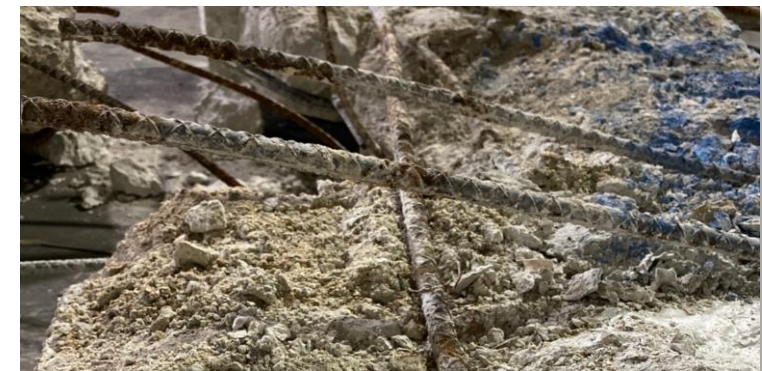
6. Some of the reinforcement in the pool deck exhibits corrosion. We continue to analyze the extent and consequences of this corrosion.

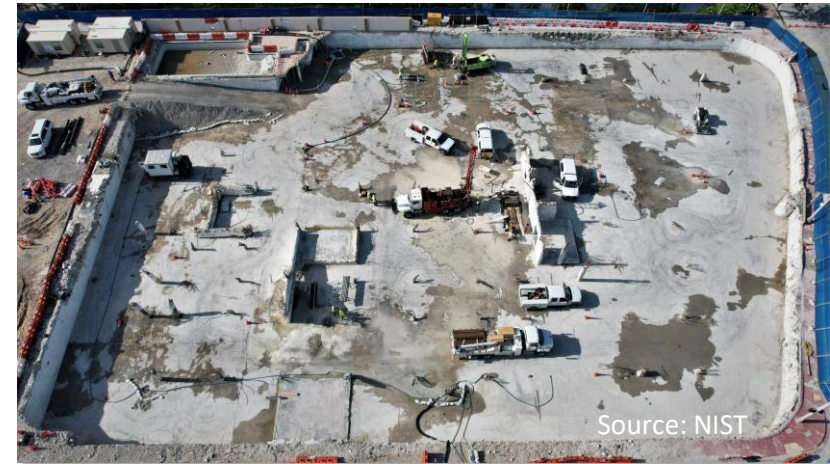
7. Geotechnical evaluations to date shows no evidence of large karstic voids that impacted the CTS foundations.

Site Investigation Included 70 Boreholes and Cone Penetrometer Tests

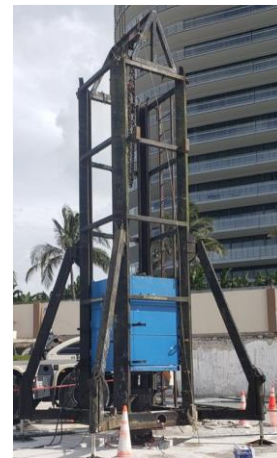
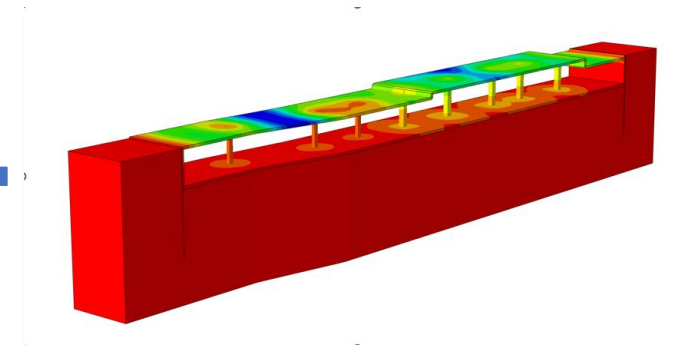
8. Geotechnical and structural evaluations to date show that estimated potential foundation settlements under structural loading were small and had minimal impact on the pool deck structure.

Analysis of Pile Differential Settlements

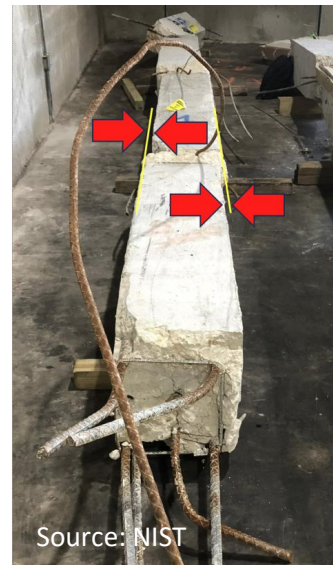
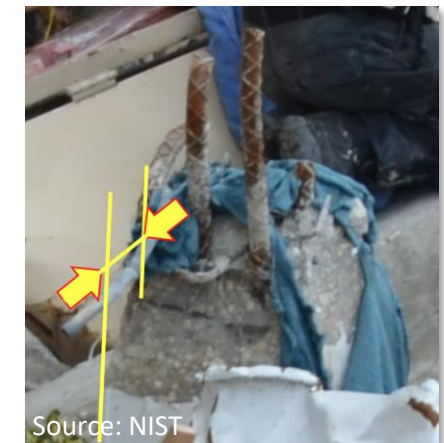
Concrete and reinforcement cage misalignment
