Summary of the Champlain Towers South NCST Investigation Progress

NCST Advisory Committee Meeting

September 9, 2025

Judith Mitrani-Reiser
Lead Investigator

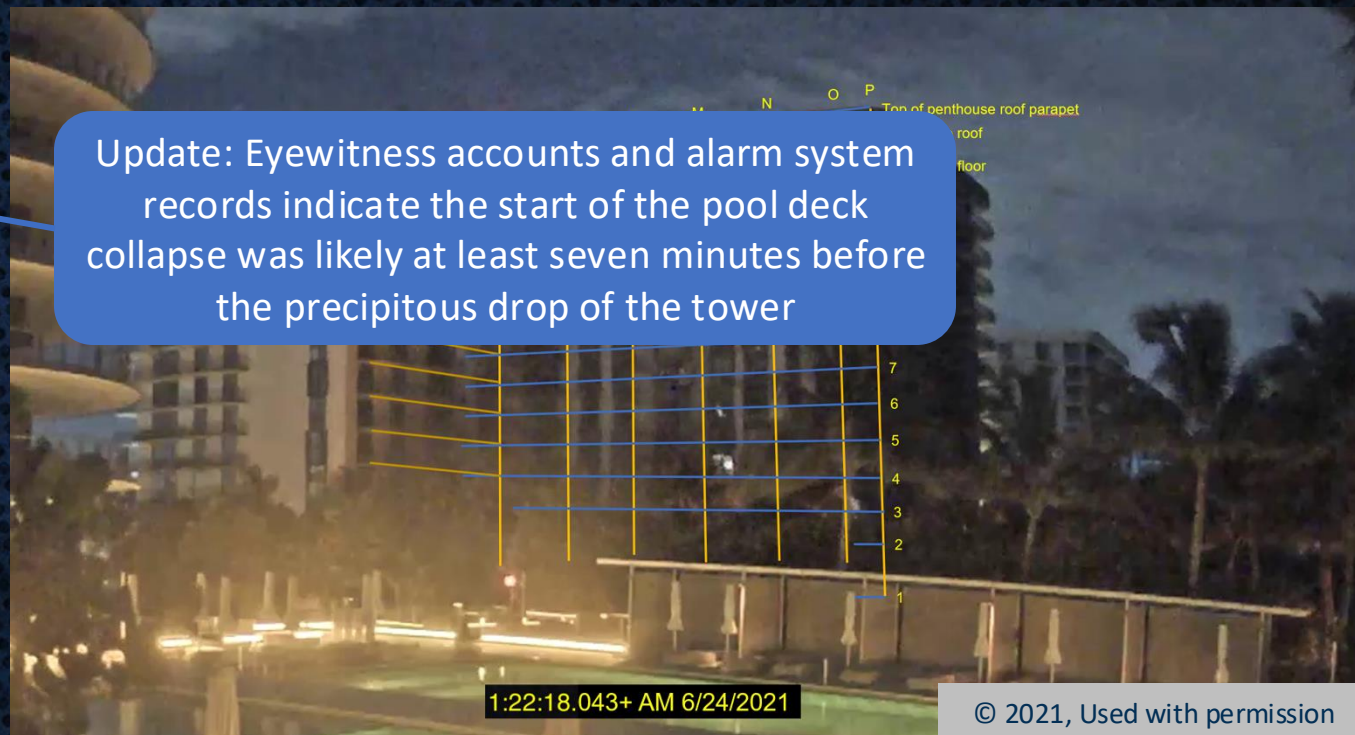
Update: Eyewitness accounts and alarm system records indicate the start of the pool deck collapse was likely at least seven minutes before the precipitous drop of the tower

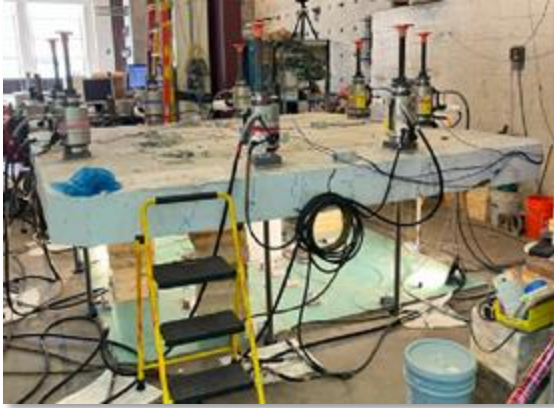
Laboratory slab-column connection tests

Design Understrength
(largest, pervasive)

Misplaced Slab Reinforcement
(pervasive)

Heavier, More Extensive Planters
(near north side of pool deck)

Added Fill and Paving
(variable)

Corrosion of Slab Reinforcement
(variable)

- Together, caused the bulk of the critically low margins of safety
- Existed from the time construction was complete – 40 years before the partial collapse

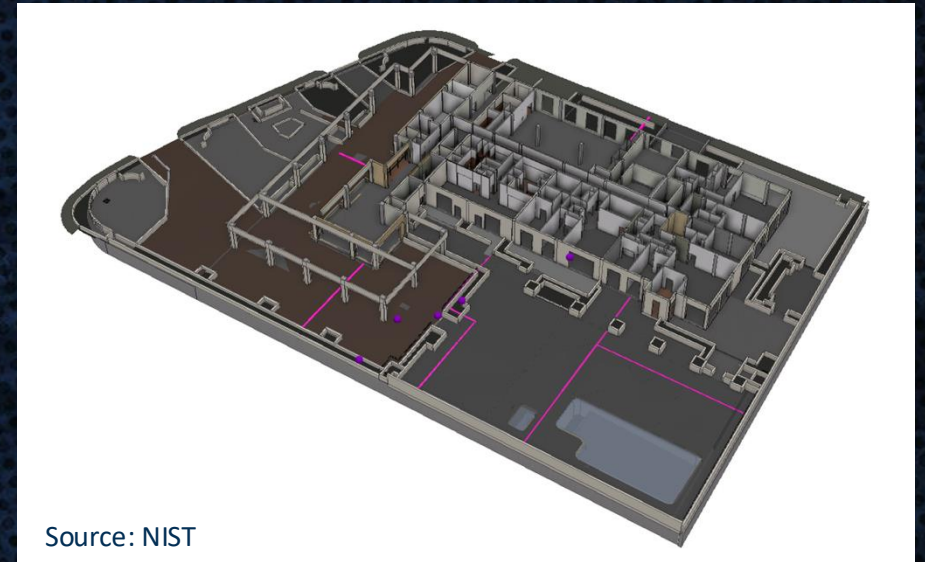
Collapse Evidence

Recent work indicates that it is **MORE LIKELY** that the failure started in a pool deck slab-column connection than we considered in June

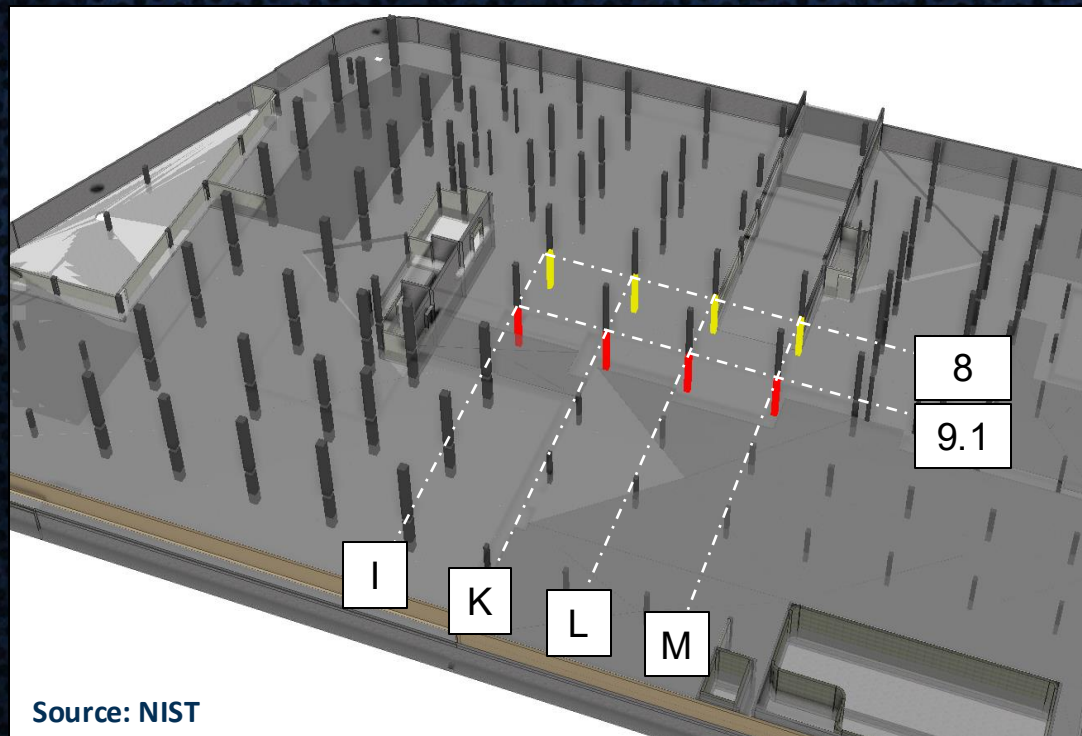
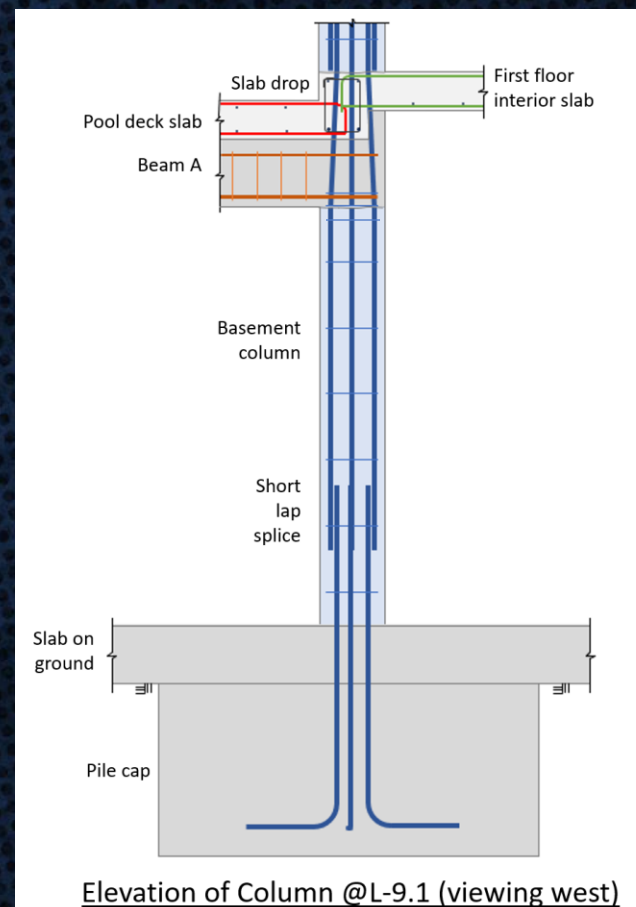
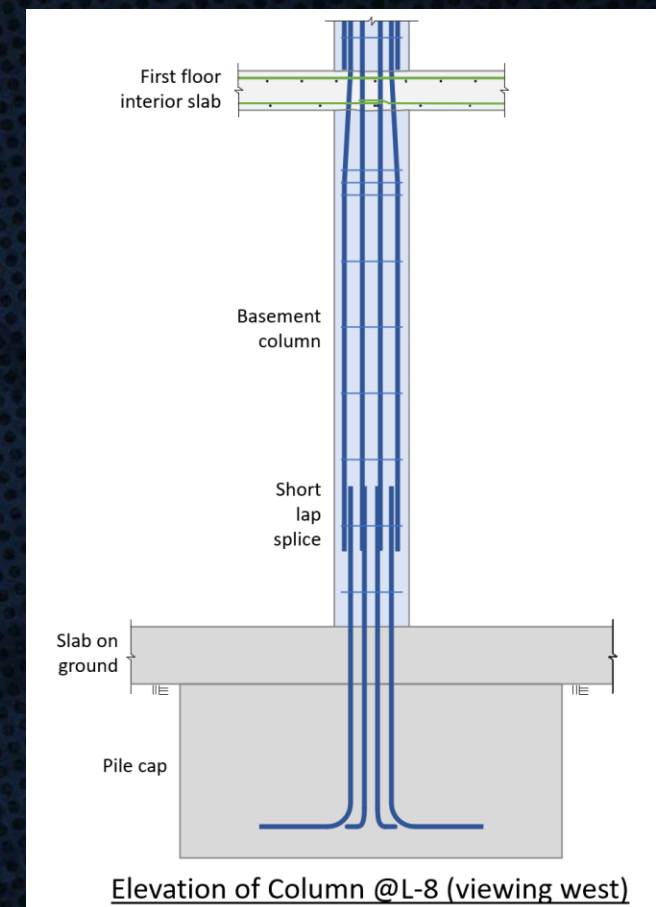
Tower Basement Columns

Columns I-8, K-8, L-8 and M-8 in yellow
Columns I-9.1, K-9.1, L-9.1 and M-9.1 in red

Reinforcement details shown are representative of details found in some specimens of the physical evidence.

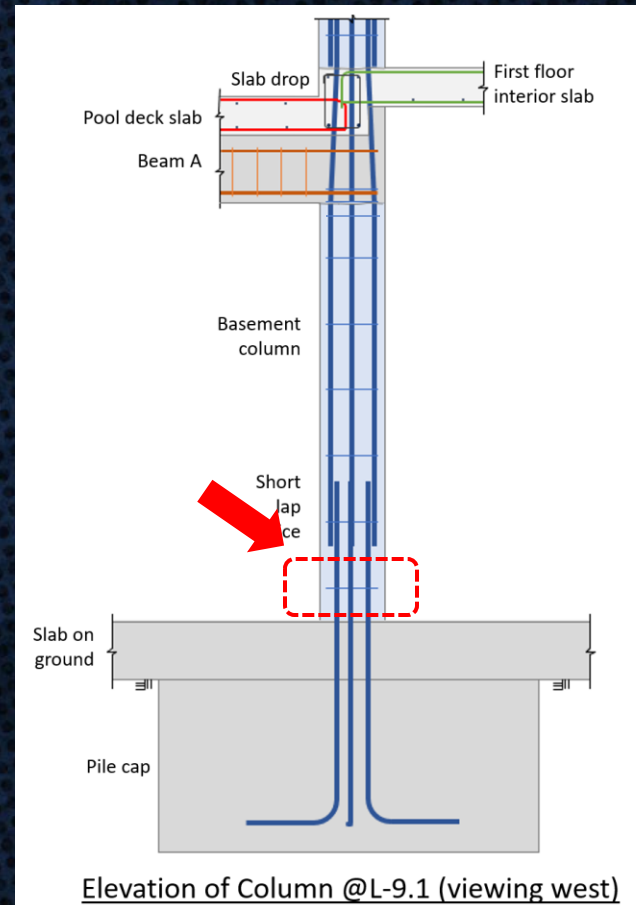
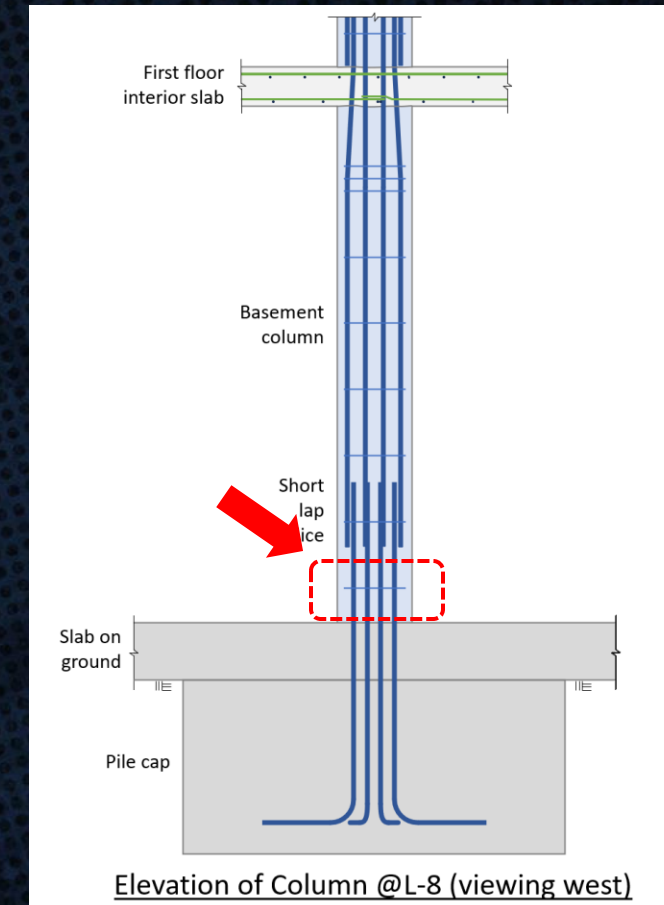
Recent work indicates failure initiation by crushing of deteriorated concrete at the base of a tower column is *less likely* than we considered in June

Material and petrographic analyses show no evidence of deterioration of the concrete at the bases of basement columns that resulted in significant loss of strength of that concrete

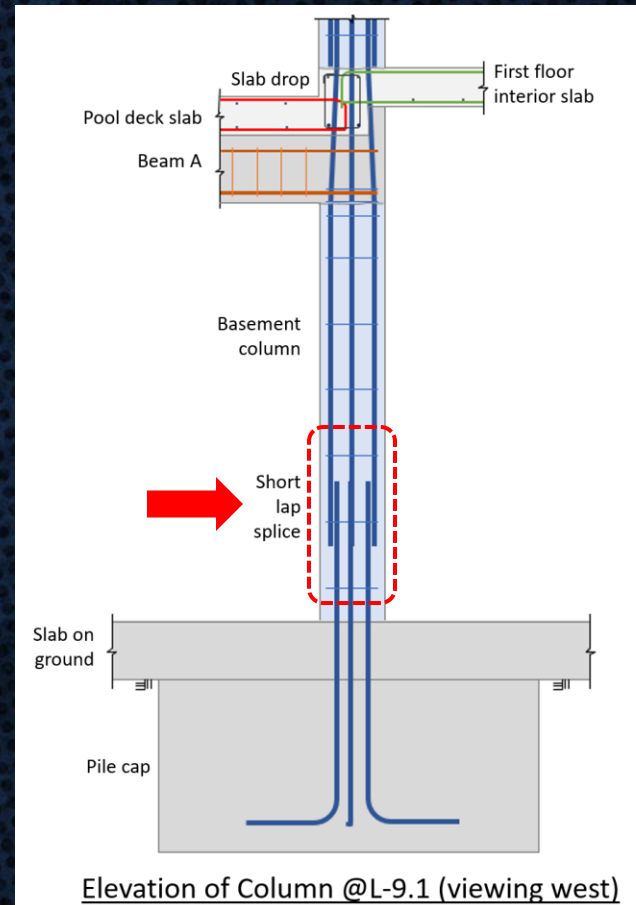
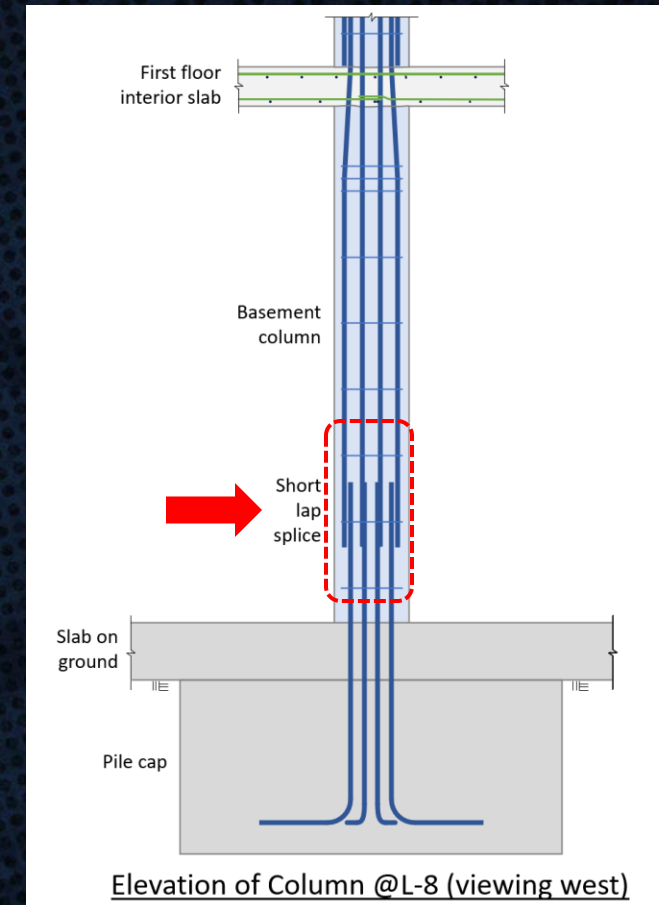
Recent work indicates failure initiation caused by a short lap splice in a tower basement column is *less likely* than we considered in June

- Structural laboratory tests of basement column replicas showed that short lap splices diminish the basement columns' strength and deformation capacity somewhat, but, absent other contributing factors, not to a level that would have failed a column under the conditions present at the time of the partial collapse
- Columns with short lap splices failed in a brittle and explosive manner in the laboratory, with immediate loss of column capacity. This failure mode is inconsistent with the scenario that the columns shortened but were able to bear sufficient load to not cause the tower to collapse

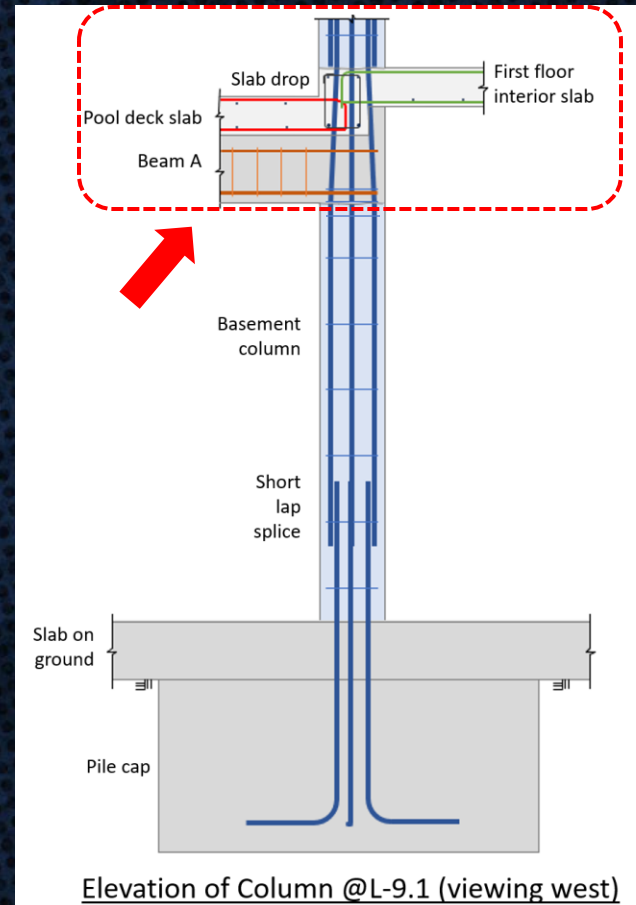
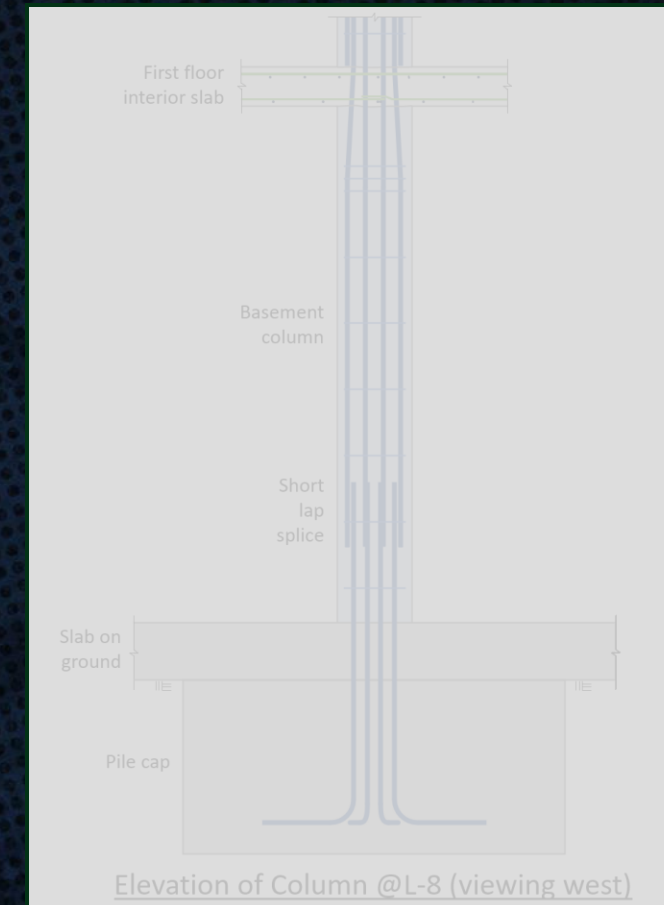
Recent work indicates failure initiation by crushing of a first-level slab-beam-column joint on Grid Line 9.1 is *less likely* than we considered in June

- During structural laboratory tests, CTS replicas (with the pool deck slab and Beam A constructed as they were prior to the failure of the pool deck) sustained column axial loads greater than the loads estimated to be present at the time of failure

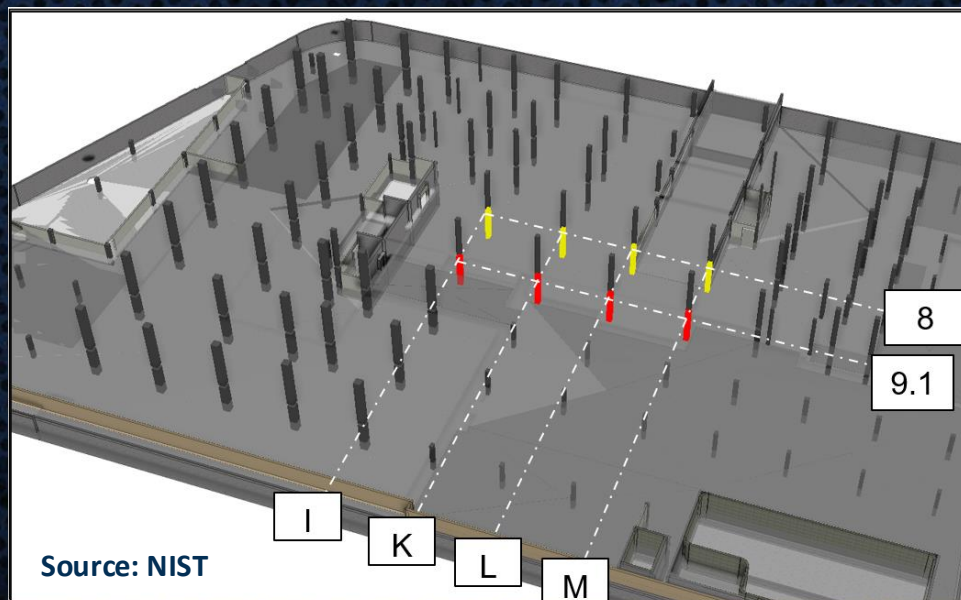
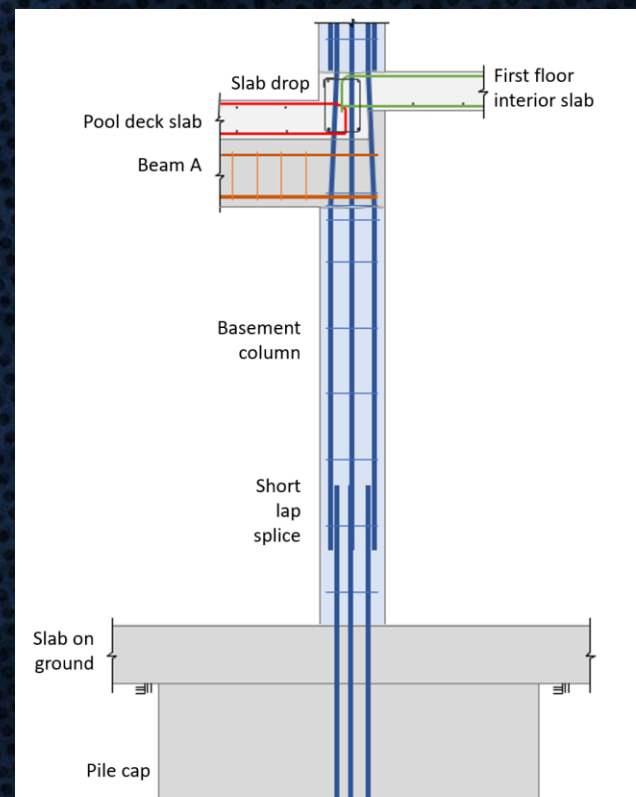
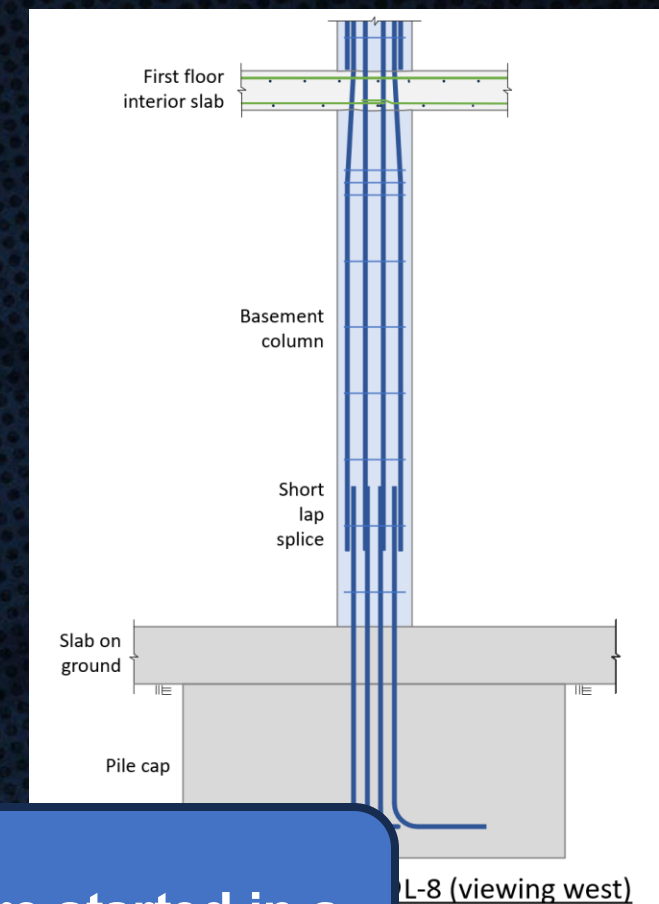
Tower Basement Columns

Columns I-8, K-8, L-8 and M-8 in yellow
Columns I-9.1, K-9.1, L-9.1 and M-9.1 in red

Recent work indicates it is **LESS LIKELY** that the failure started in a tower basement column than we considered in June

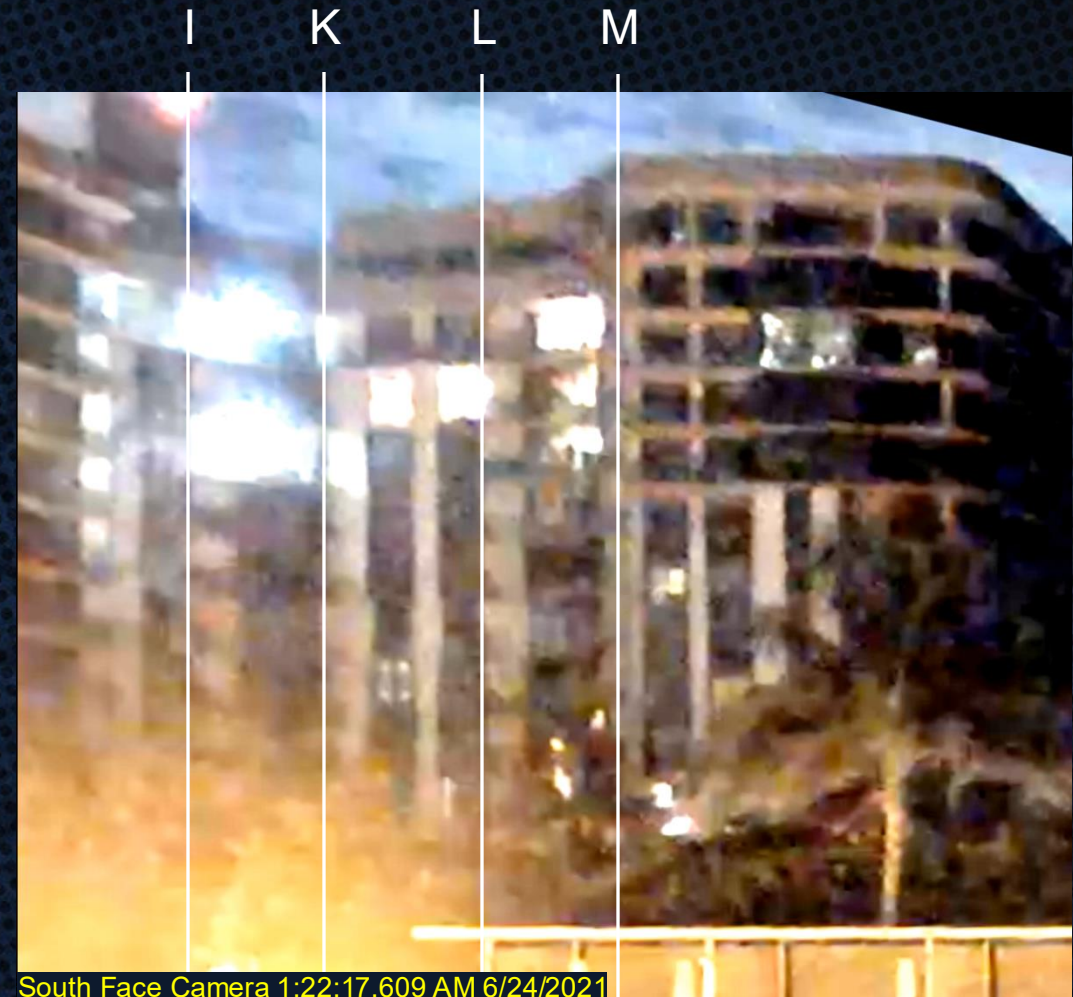
South Face Camera 1:22:17.609 AM 6/24/2021

Collapsing middle part of tower is still connected to the east part at Grid Line M, which has not yet dropped

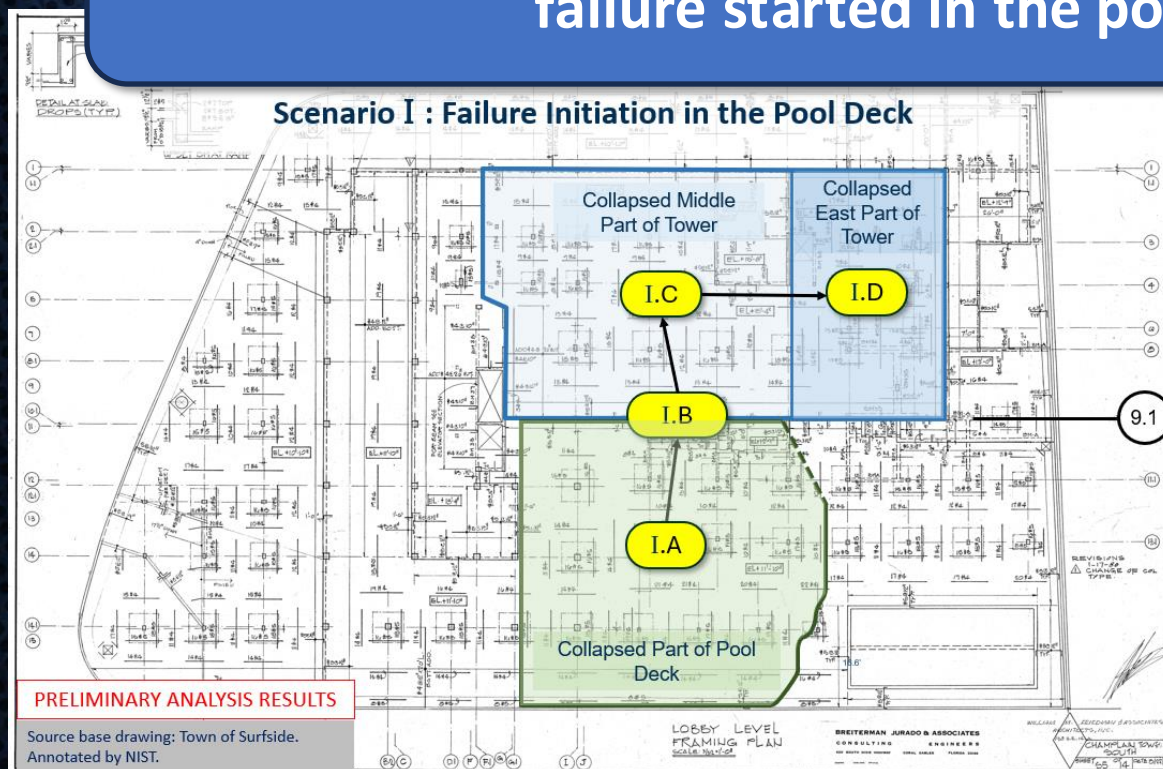
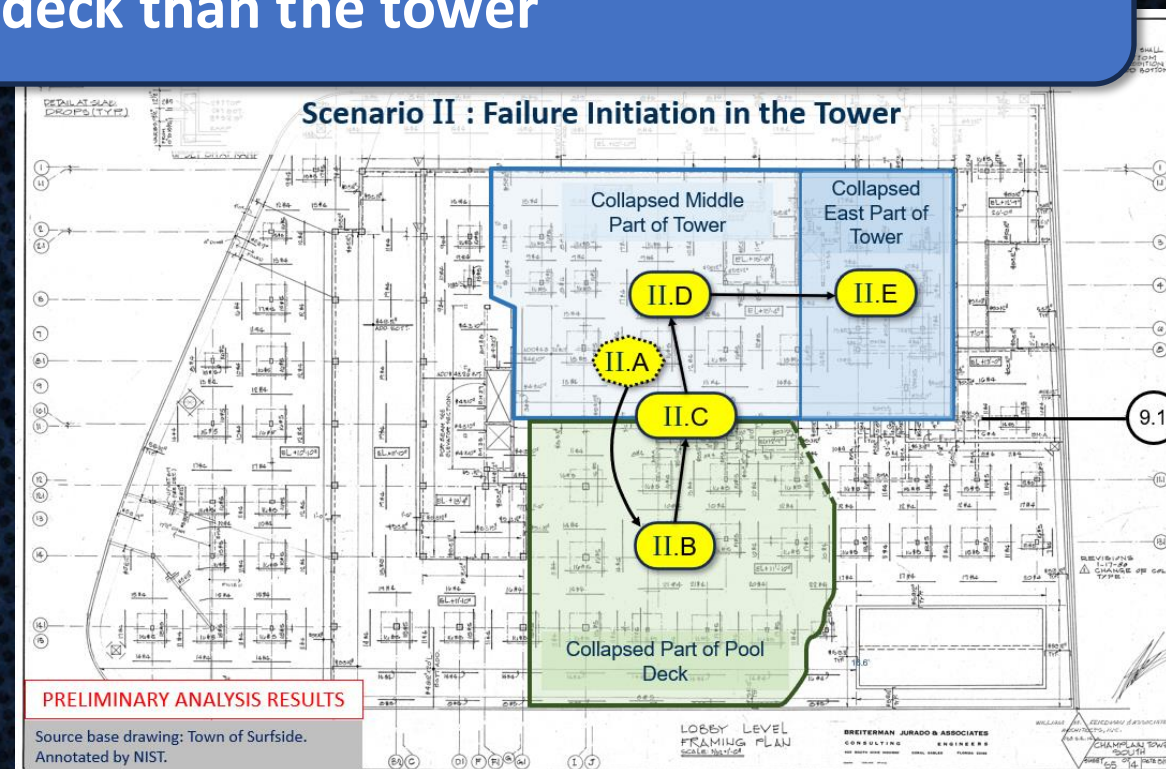
Recent work indicates that it is **MORE LIKELY** that the failure started in the pool deck than the tower

Computer vision techniques allow us to track the progression of the partial collapse through the tower
