Statistics on Failure Rates of Clock Motors

Clock and Timer Department
General Electric Company

Excerpt of a 1964 declassified General Electric memorandum discussing failure of clock motors

Subject: Surge Information - Clock and
Timer Dept. Motor Coil

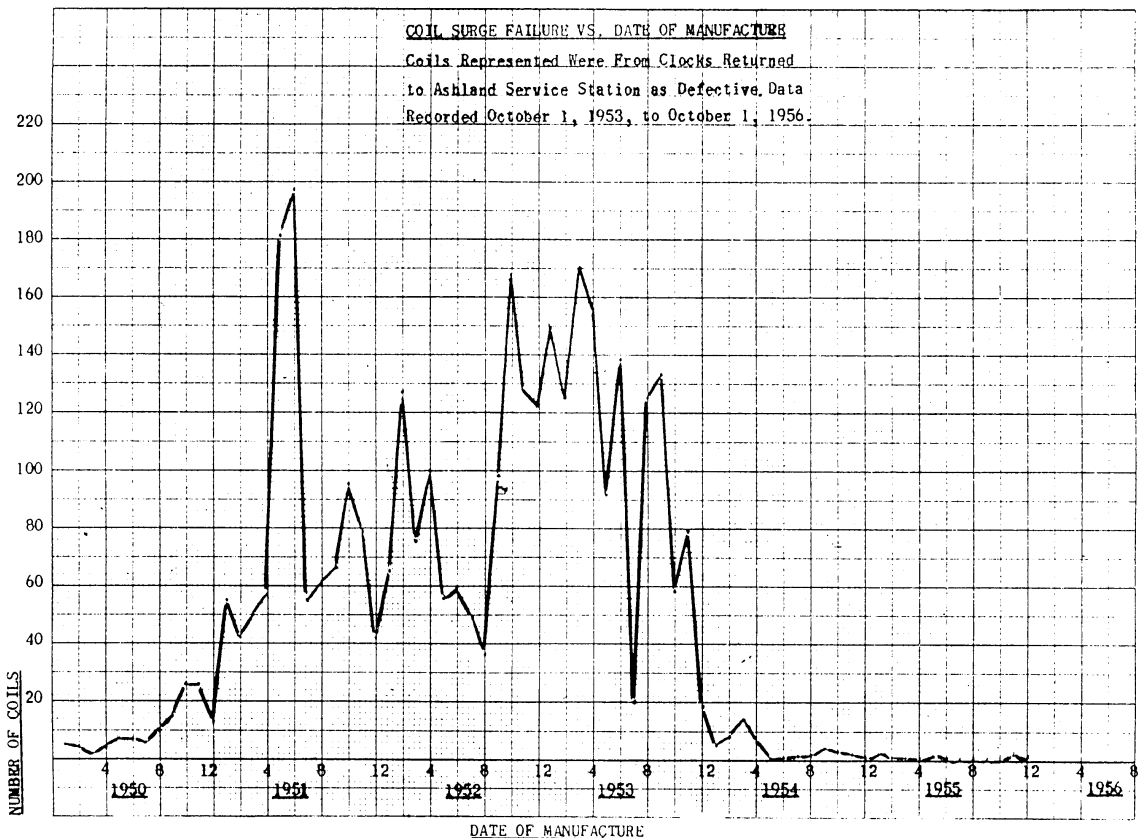
These statistics provide convincing evidence, based on a large number of reported failures, that a correlation exists between the rate of failures and the surge withstand capability of the motor windings.

A design change in this withstand level, from 2 kV to 6 kV produced a 100:1 drop in the failure rate. Interestingly, this 100:1 ratio, when plotted on a chart in which data from other sources were entered, produced a slope in good agreement with these other sources. Thus, the large number of clocks, operating 24/7/365 and unwittingly serving as sacrificial "surge counters" boosted confidence that the limited observations (in duration and in locations) being reported by other researchers were consistent.

During the summer of 1953, an increase in defective coil returns to Service Stations became apparent. An investigation showed that the majority of failures were due to surge conditions. A study was made of the coil design at that time and it was found that impulse insulation levels down to 2000V were obtained. In October of 1953, a change was made in the coil design to improve the insulation level at the points of highest potential within the coil. This had an immediate effect of increasing the surge protection of the coil from approximately 2000V to approximately 6000V minimum.

At the same time, a study was undertaken to collect all defective coil returns to the Ashland Service Station. These returns were examined to determine the causes for failure. This study continued for a period of three years during which time 5,254 coils were collected and examined. Approximately 75% of these coils returned failed due to lightning and/or other transient surge conditions. The attached chart shows the number of coils received for surge failure in the field versus their date of manufacture. The large numbers shown, particularly during 1951, can be explained by the fact that our collection of these coils was started in October of 1953. If the study which started in October had been started earlier, the portion of the curve prior to 1951 would have shown a corresponding increase in numbers. It was found in this study that it took approximately 18 months for a clock to find its way from our factory to use in the field.
