Lightning and Surge Protection of Photovoltaic Installations

Two Case Histories: Vulcano and Kythnos

François D. Martzloff
National Institute of Standards and Technology

NISTIR-89 - 4113

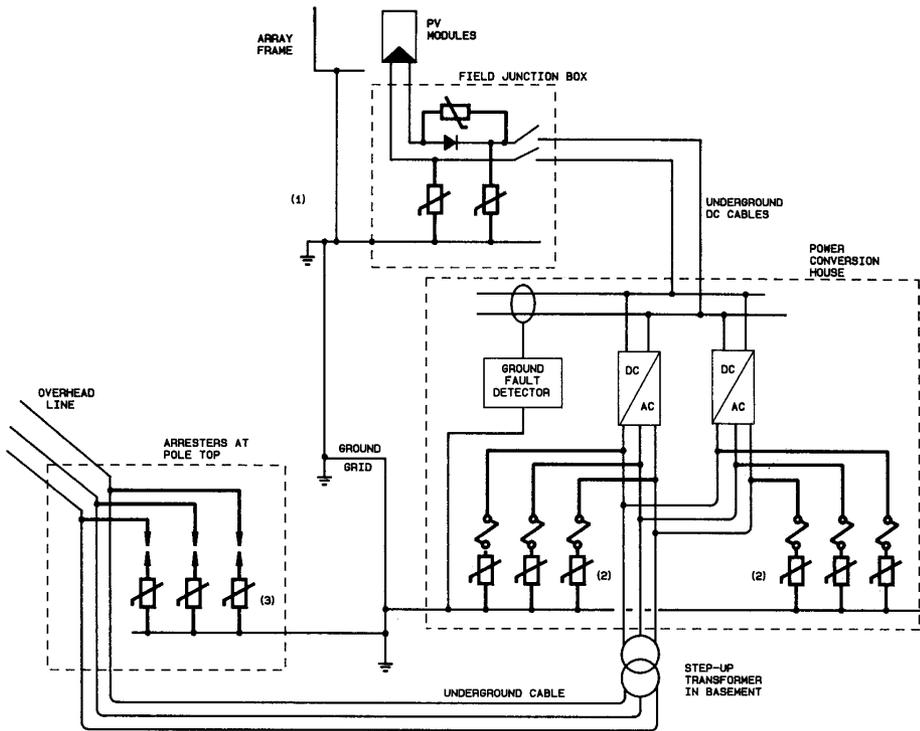
Figure 2-2. Surge protective devices at system interfaces

In the Vulcano system, the dc system is not grounded. A ground fault detection system is provided (Figure 2-2), with alarm indication on the control panel (Photograph 2-3) but no automatic trip nor remote indication of the fault condition (the system is unattended). Experience with this system is described as satisfactory after an initial period of reported difficulties associated with insulation deficiencies in the panels. (These were eventually corrected by field or factory rework on the panels.)

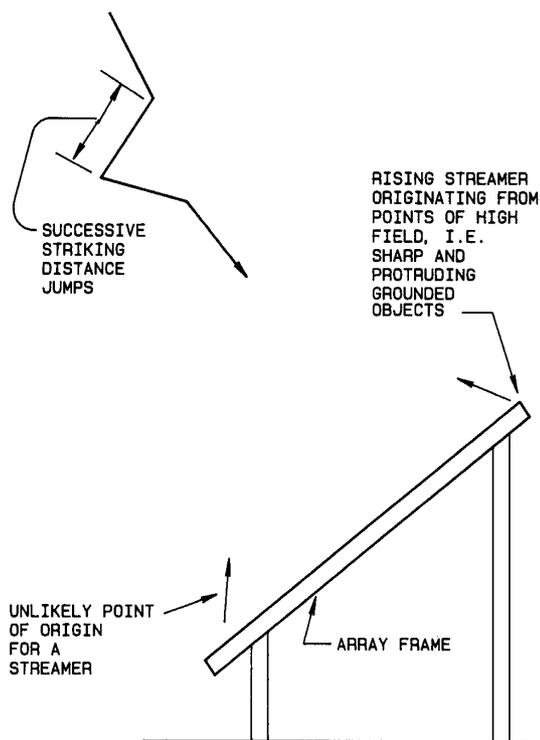
Figure 2-3. Descending stepped leader and rising streamer in a cloud-to-ground lightning strike

The damage to the module is located at the lower part of the array, as shown in Photograph 2-2. Postulating a scenario of a direct strike to the array, the point of attachment of the lightning would be the point of origin of the rising streamer that meets the descending stepped leader (Figure 2-3).

This position at the lower part of the array is rather unexpected for the point of initiation of the streamer. A more likely point for streamer initiation – and resulting termination of the strike – would be the upper edge of the array, which is 2 m above grade level (Photograph 2-15). Thus, there is some doubt on drawing a conclusion that the damage was the result of a direct strike terminating at the array.

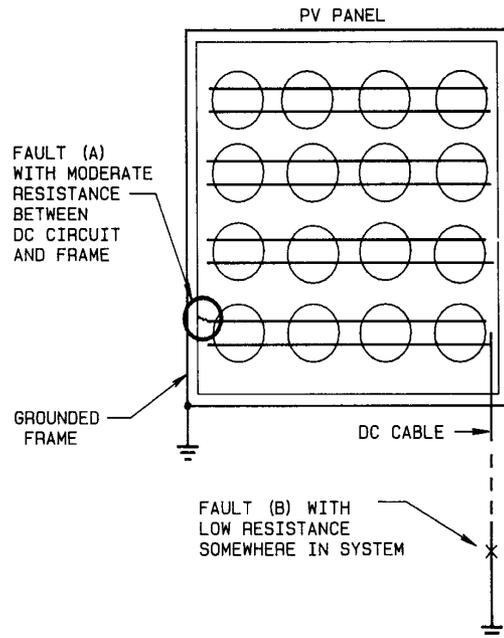
Figure 2-4. Scenario of double ground fault

In view of the reported insulation problems that occurred during the initial period of operation, one might ask whether the damage to that panel might be the result of a leakage of dc current to the frame, rather than the simple direct effect of a lightning strike. This dc leakage might be the consequence of a lightning induced overvoltage stress that created a double fault in one single event, or that created the second fault after the first had previously occurred but remained uncorrected. The scenario could unfold as follows:

In this manner, we have the elements that could create the observed effects, that is, an obvious fault with burning at (A), and a less obvious fault at (B), with a low resistance that may be eliminated during emergency maintenance work following the occurrence of the incident. The likelihood of such a double fault is admittedly low, but cannot be ruled out in view of the design of the ground fault detection system which indicates faults locally only. This scenario, still associated with lightning, would not be in contradiction with the observed low position of the damage since it does not require termination of the strike at that low point of the panel. Furthermore, the low point on the sloped array is also a place where moisture is more likely to accumulate and thus create a good candidate for a contributing cause in the scenario of two-stage insulation breakdown.

A variation on the theme of the double fault might even be that the fault was entirely caused by long-term insulation breakdown, without the “*coup de grace*” administered by the lightning incident. However, the observation of a damaged module soon after a lightning storm would point to the lightning-induced overvoltage scenario.

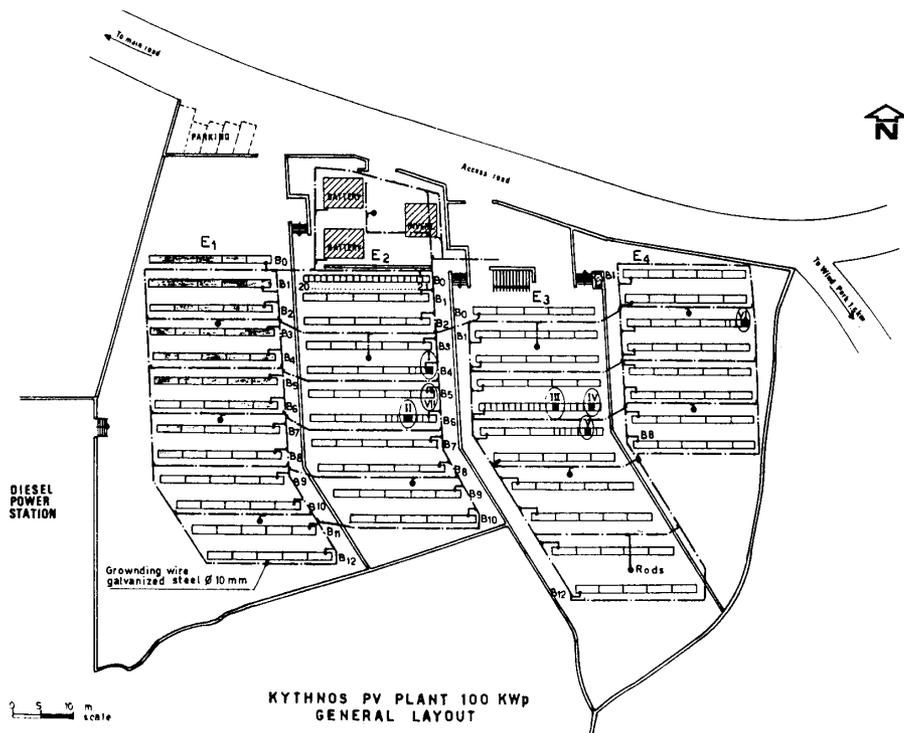
Figure 3-2. Location of ground cables, air terminals, and modules presumed damaged by lightning

Thus, five of the six damaged modules were beyond the 45° cone, and the sixth was on the fringe of the cone. Some panels in the array, not impacted by lightning, are further away from an air terminal, the greatest distance in the field being 15 meters. Another interesting statistic is the distribution of the panels with respect to being within a protected area of 8.5 meters radius (approximately 75%) or outside the protected area (25%).

MODULE - 307 0423 This module was in storage and had been at location E2 B4 1 ("I" on Figure 3-2), 10 m from the nearest air terminal. There are burn marks along both long edges,

MODULE - 303 0267 This module was in storage and had been at location E3 B5 18 ("V" on Figure 3-2), 8 m from the nearest air terminal. There are burn marks along both vertical edges, but not over the complete length (Photograph 3-20). On the right side, the burns are mostly at the upper part of the module, with damage at both corners (Photographs 3-21 and 3-22). The top right corner (Photograph 3-21) shows heavy burn marks on the frame, while the top left corner (Photograph 3-23) shows light marks on the frame. It should be noted that this module, which has the heaviest burn marks on its frame among the six modules, is the only module that was located within the "cone of protection" of an air terminal. This remark will be discussed further in the next section.

MODULE - 304 0294 This module was in storage and had been at location E3 B5 19 ("IV" on Figure 3-2), 12 m from the nearest air terminal. There are burn marks along all of the right side, and part of the left side (Photograph 3-24). Both top corners show damage (Photographs 3-25 and 3-26). The top right corner (Photograph 3-25) shows light burn marks on the frame, while the top left corner (Photograph 3-26) hardly shows any burn marks on the frame. There is extensive separation of the panel from the frame along the right side (Photograph 3-27)

MODULE - 304 0300 This module is still in the array at location E3 B4 13 ("III" on Figure 3-2), 10 m from the nearest air terminal, and was found damaged on February 5, 1987. The bypass diode in the string allows the array to remain operational. There is damage on three of the corners and some of the edges (Photographs 3-31, 3-32, and 3-33), but the heaviest damage is on the lower left corner (Photograph 3-34). The two upper corners shows surface degradation on the frame, but these do not appear to be burn marks (Photographs 3-32 and 3-33).

MODULE - 310 0592 This module is still in the array at location E4 B3 20 ("VI" on Figure 3-2), 10 m from the nearest air terminal, and was found damaged on February 25, 1988. The bypass diode in the string allows the array to remain operational. The damage is concentrated on the left edge of the module (Photographs 3-35 and 3-37). The panel is separated from the frame (Photograph 3-38). The apparent discoloration of the frame at the top left corner does not seem attributable to burns (Photograph 3-36).

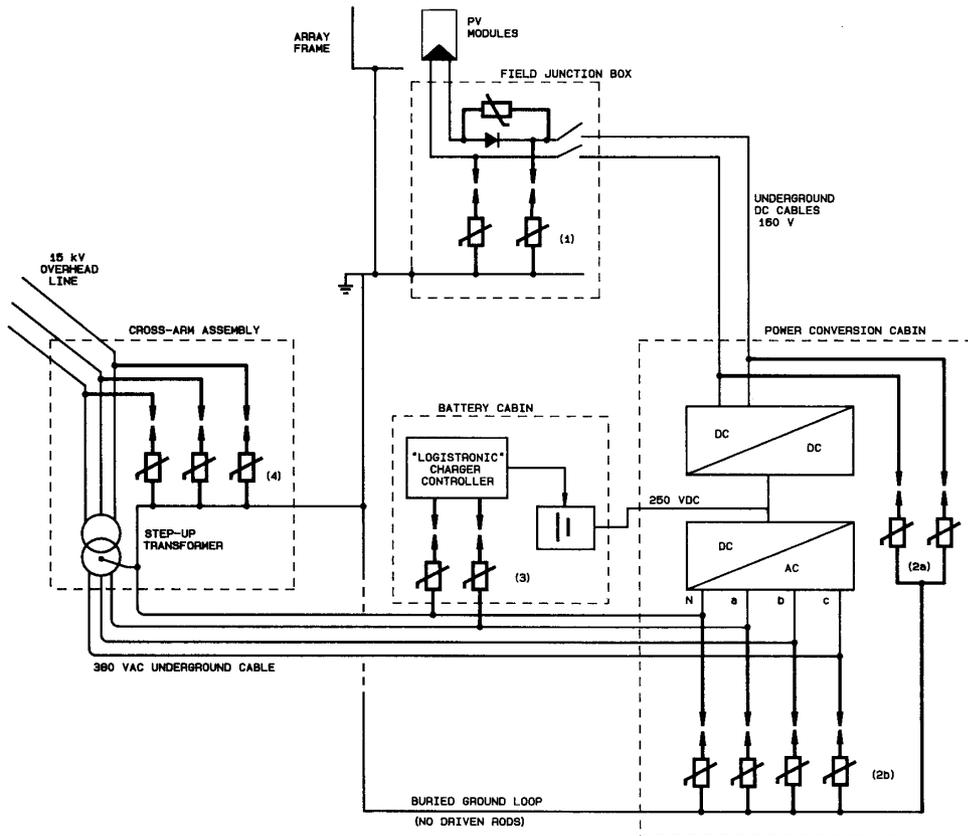
Figure 3-3. Overvoltage protection at system interfaces

This installation presents an interesting case history because it includes both lightning rods (air terminals) in the array and surge arresters in the circuits. Damage to several panels, presumably as a result of lightning over a period involving three separate occurrences, raises questions on the effectiveness of the protection against direct strikes. Damage to the surge arresters also occurred in one of the field junction boxes, but no damage occurred on the power conversion units. Some damage occurred in the control circuits of the battery charger during the initial period, when they did

not have surge arresters at their ac power input. After arresters were added to this ac input, no further damage events occurred but some upsets did still occur in the control system.

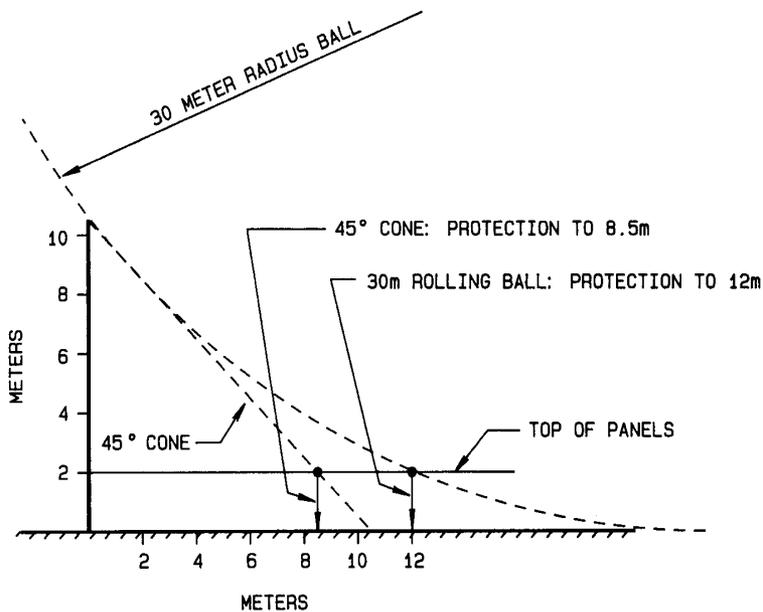
Figure 3-6. Cone-of-protection and rolling-ball criteria

The Kythnos experience involves points of (presumed) lightning termination that are at the edges of the zone of protection of several criteria, where this protection becomes more uncertain. Ironically, the most severe burn mark is found on the frame of the module that was

Indiscriminate application of the 45° cone of protection criterion to tall structures has led to contradictions. An example is occurrence of lightning strikes terminating on the side of tall buildings, within the cone of “protection”. The original concept of a cone of protection is now generally replaced by the rolling ball criterion, based on the striking distance theory. According to this striking distance theory [6], the striking distance at the tip of the descending stepped leader increases with the amount of charge in the leader. Thus, the leaders having the highest potential current level have the longest striking distance (Figure 3-4). Conversely, leaders having the lowest potential current level have the shortest striking distance. The point of termination of a lightning strike can be anywhere within the striking distance from the last point of advance of the descending stepped leader. This fact can be represented by imagining a sphere with a radius equal to the striking distance, which is determined by the charge in the lower part of the leader. Any point at ground potential penetrating that sphere is a candidate for emitting an upward streamer that will complete the path for the return stroke. Thus, points at ground potential outside of the sphere are still “protected” while the points inside the sphere are not.
