Update on a Consumer-Oriented Guide for Surge Protection

Thomas Key, Doni Nastasi, and Kermit Phipps
EPRI PEAC

Reprinted from *Proceedings, PQA'99 Conference*, May 1999

2. Lightning-Damage Case Studies

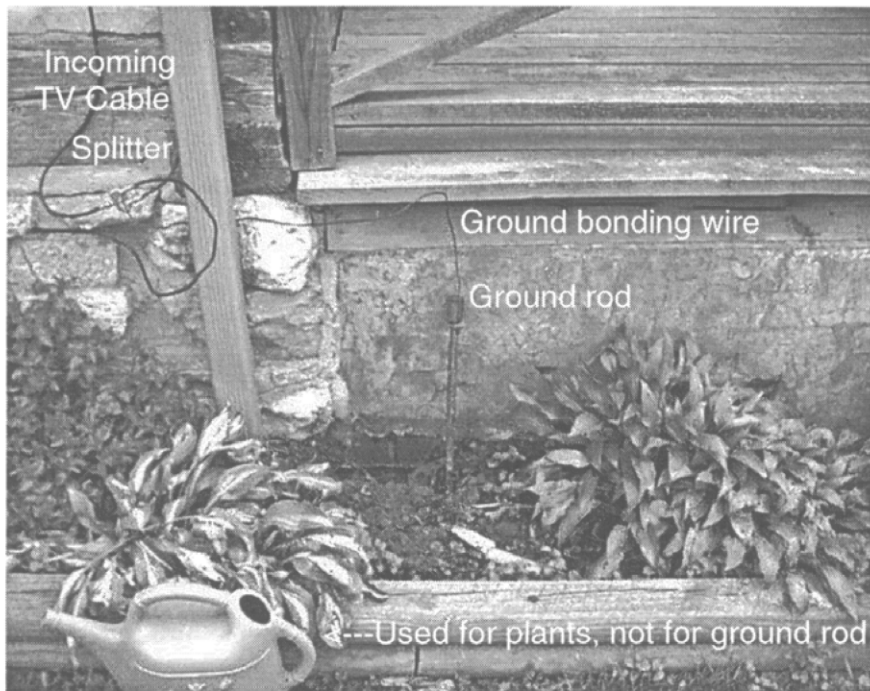
Figure 1
Cable TV service entrance and 'ground bonding'

The power service entrance is located at one end of the house, while the cable TV service entrance is located at the opposite end. A visit to the site revealed that the cable TV shield was grounded only by a questionable ground rod next to the house foundation (within the drip line, and thus in dry soil, see Figure 1). Furthermore, this grounding connection was not bonded to the grounding connection of the power service entrance, a clear violation of the National Electrical Code, according to the current edition as well as several, if not all, earlier editions [NFPA 70, 1999].

The local cable TV company was informed of this situation and took what they believed an appropriate action: the incoming cable was first routed under the house, in the crawl space, to allow bonding the shield to the power service grounding connection. From there, the cable was returned to its original point of entry into the house, at the opposite end. It would seem that under such a configuration, a lightning current surge traveling along the cable shield (instead of a proper bonding conductor), might create sufficient voltage drop along the path under the house to create problems. However, the interaction was not pursued further with the cable company. A recommendation was made to the owner of the house to install a surge reference equalizer near each of the video equipment in the house.

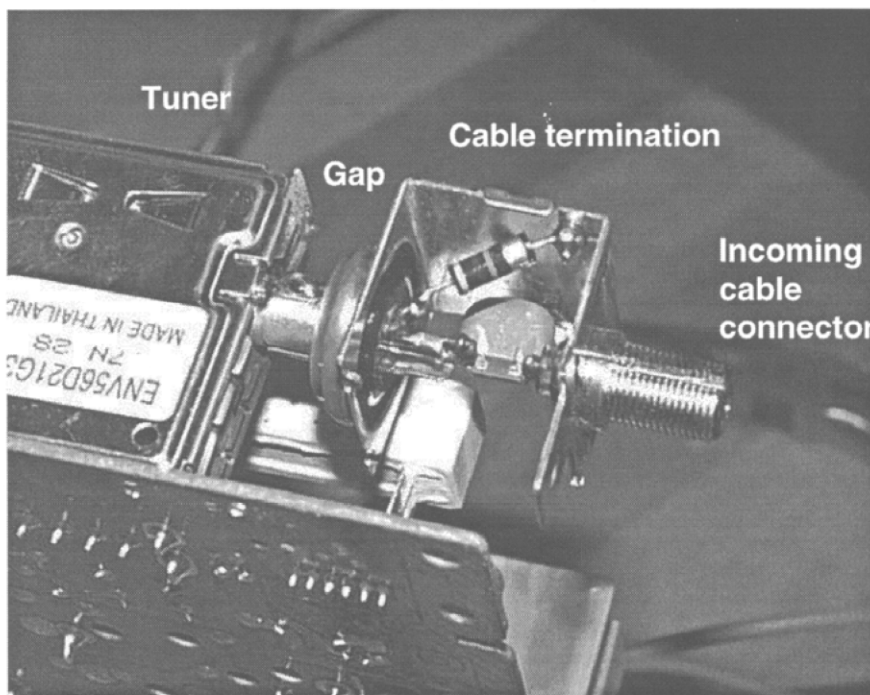
Figure 2
Cable TV input termination and UHF tuner
at rear of TV receiver

One of the failed TV receivers was made available to PEAC for examination. No evidence of damage was found on the power side of the chassis, but a clear indication of surface flashover was observed between the cable input 'ground' termination (connected to the incoming cable shield) and the shielding can of the tuner (Figure 2). After cleaning as best as possible the carbonized path of the flashover, a surge voltage was applied between the power cord of the receiver and the 'ground' of the cable input: flashover occurred for a 2 kV Ring Wave. By removing the material to a greater depth and covering it with epoxy, the gap did withstand a greater level, and failed at 2.5 kV. That flashover occurred at another part of the original insulation, thus providing valid information on the original withstand capability.

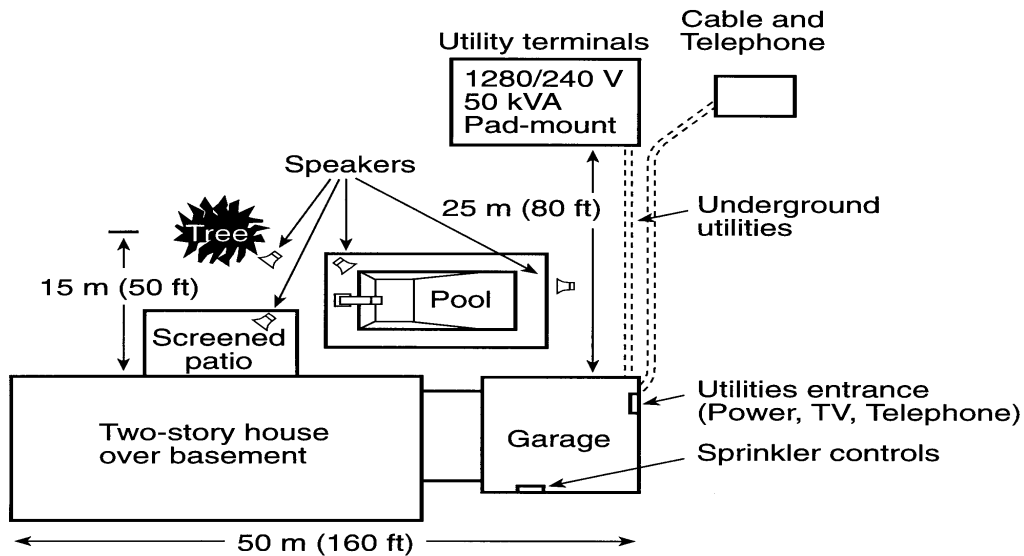
Figure 3
Schematic configuration of the Rambling Residence

The overall physical layout of the house, damaged tree, and electronic equipment are shown in Figure 3. The mature tree that was struck is much taller than the house and is the tallest of the trees in the immediate area. The bark was stripped from the tree trunk for most of its height. As shown in the figure, the trunk is only approximately 15 meters from the house and even closer to the patio, where some of the audio speakers were installed. Outdoor speakers are also located in the pool area and connecting walkways.

One of the observations during the laboratory inspection of the audio amplifiers was that the power supplies of the units were not damaged, but their output transistors that drive the speakers and the speakers themselves were damaged. Before arrangements could be made for the site visit, it was speculated that the surge energy had been coupled into the speaker wires, which are probably very long and very near to the lightning strike, rather than as a “power-line surge.” The visit to the installation verified this theory. The home entertainment equipment, including amplifiers, is centrally installed in the basement of the house. Speakers are located throughout the house, the patio, and the swimming pool area. The wire length between the outdoor speakers and the central amplifier is about 30 meters, and some of the wires run within 10 meters of the tree trunk.

Since the visit to the residence was motivated, as stated, by the curiosity of PEAC engineers rather than by a customer complaint, there was no need to offer a prescription for protection. Instead, the visiting engineers offered the general statement that for a direct strike such as the one that had occurred, providing a high level of protection confidence by a comprehensive retrofit would probably cost more than the equipment that was damaged. In contrast, the dead tree was the one irreplaceable loss that was most painful for the owners. Techniques for protecting trees exist (an extensive array of grounding cables along the limbs, [NFPA 780, 1997] and are sometimes applied to trees recognized as having great historical or esthetic value, but the cost is generally a deterrent for typical residential surroundings.
