**Gypsum Stairwell Enclosure Wall System
Tests under Uniform Static Pressure**

H.S. Lew

Building and Fire Research Laboratory

July 2009

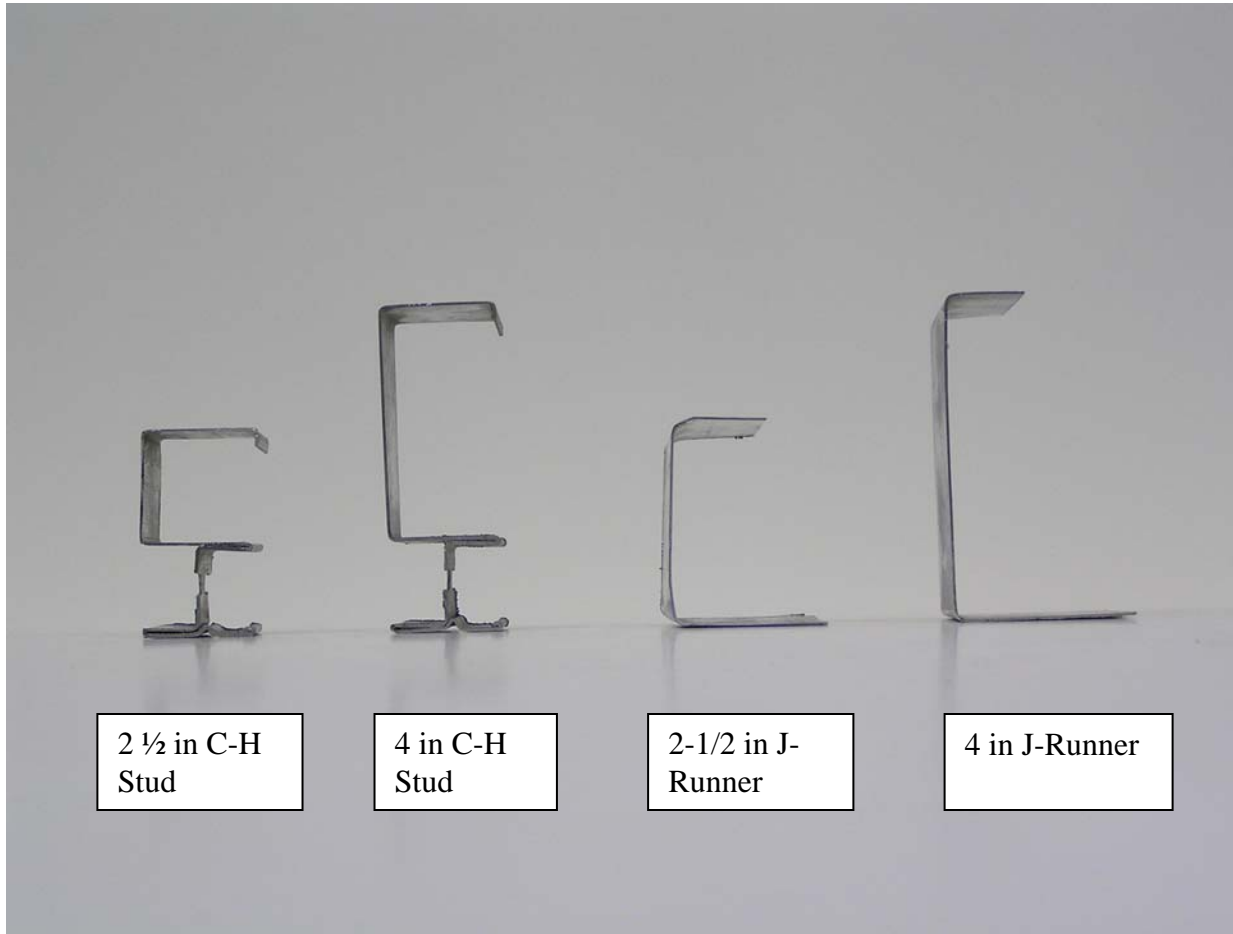
Figure 1 Cross Section of C-H Studs and J Runners

A total of three specimens were tested. The test specimens consisted of gypsum shaft wall assemblies having a two-hour fire rating. The test wall sections were 72-in wide and 100-in high. They were fabricated by NIST using materials purchased from a local building material supplier. Two types of specimens were constructed: one with 2-1/2 in steel C-H studs (20 ga.) and the other with 4 inch steel C-H studs (20 ga.). Figure 1 shows the cross section of C-H studs. The studs were spaced at 24 in on center. For both types, two layers of 1/2-in Type-X gypsum panels were applied either vertically or horizontally to the C-H studs with screws (See Table 1), and 1-in “gypsum liner panels” were inserted into the grooves of the C-H studs. Along the exterior edges of the panel, the liner panels were fastened to the C-H studs with screws at 12 in on center. The assembled gypsum panel was placed between top and bottom steel J-runners (20 ga.). The ends of the C-H studs were fastened to both flanges of the J-runners with screws. Both the top and bottom J-runners were fastened to 6-inch x 6-inch hardwood members with screws. The wood members were in turn bolted to the steel reaction beams. The top reaction beam was attached to a concrete reaction wall with 1-1/2 in diameter post-tensioning bolts, and the bottom reaction beam was anchored to the laboratory floor. Thus, the specimen acted as a one-way plate

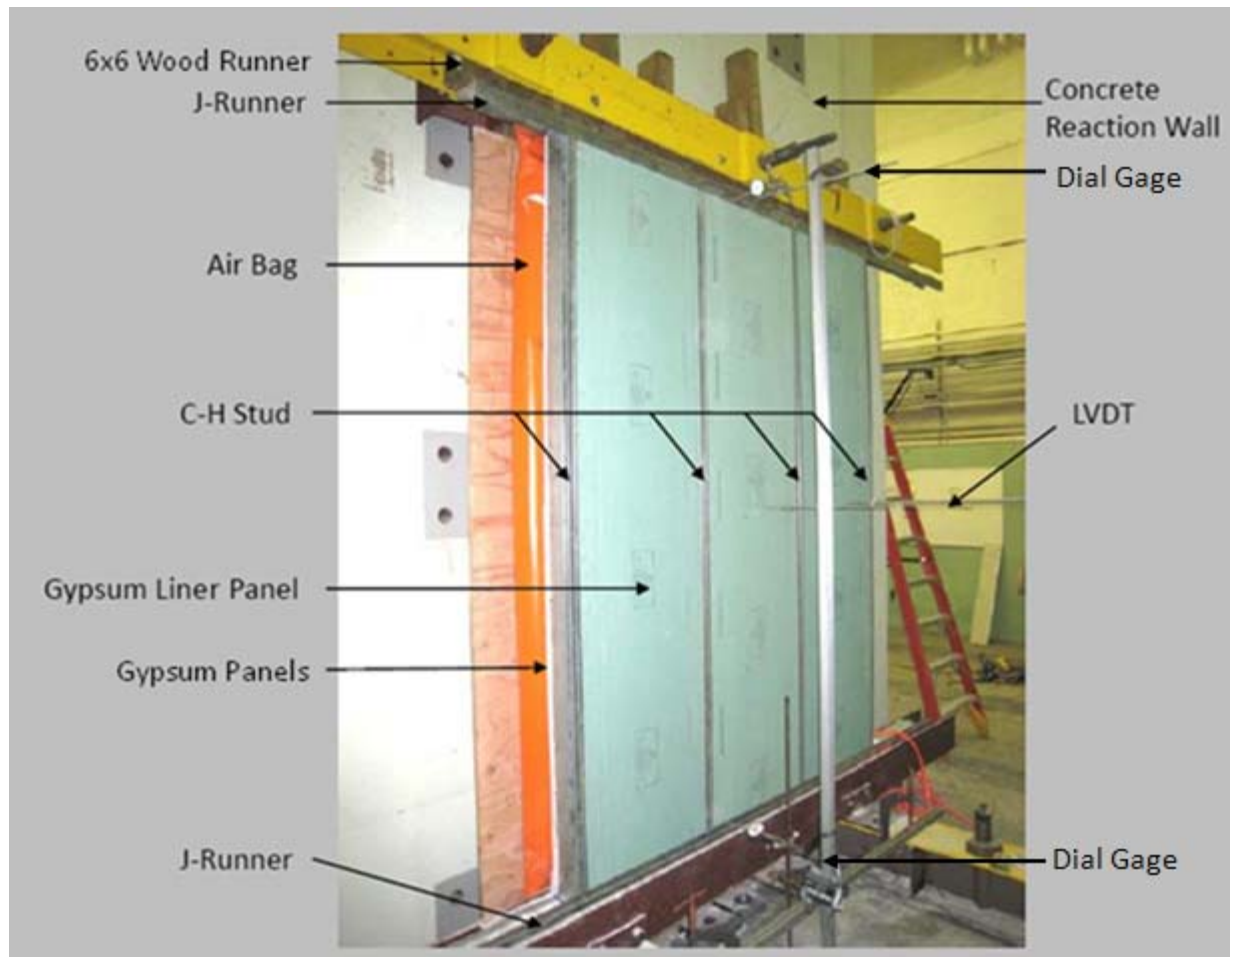
Figure 2 Test Setup

supported at the top and bottom for a span of 100 in. A specimen placed in the test fixture is shown in Figure 2.

The test section was loaded over the entire surface by an air bag. The air bag was placed between the test specimen and the concrete reaction wall. In all tests, the pressure was applied to the gypsum panel side. Thus, the gypsum panels were in compression while the liner panels were in tension.

The air pressure in the bag was increased at a rate of 0.15 psi/min until the test panel could no longer sustain the pressure increase as indicated by a large increase in deflection at the center of the panel. To monitor any horizontal movement of the J runners during test, a dial gage was positioned against the flange of the J-runners (see Figure 2). An LVDT² (linear variable differential transformer) was placed at the geometric center of the test panel to measure the displacement response of the test specimen to the applied pressure.

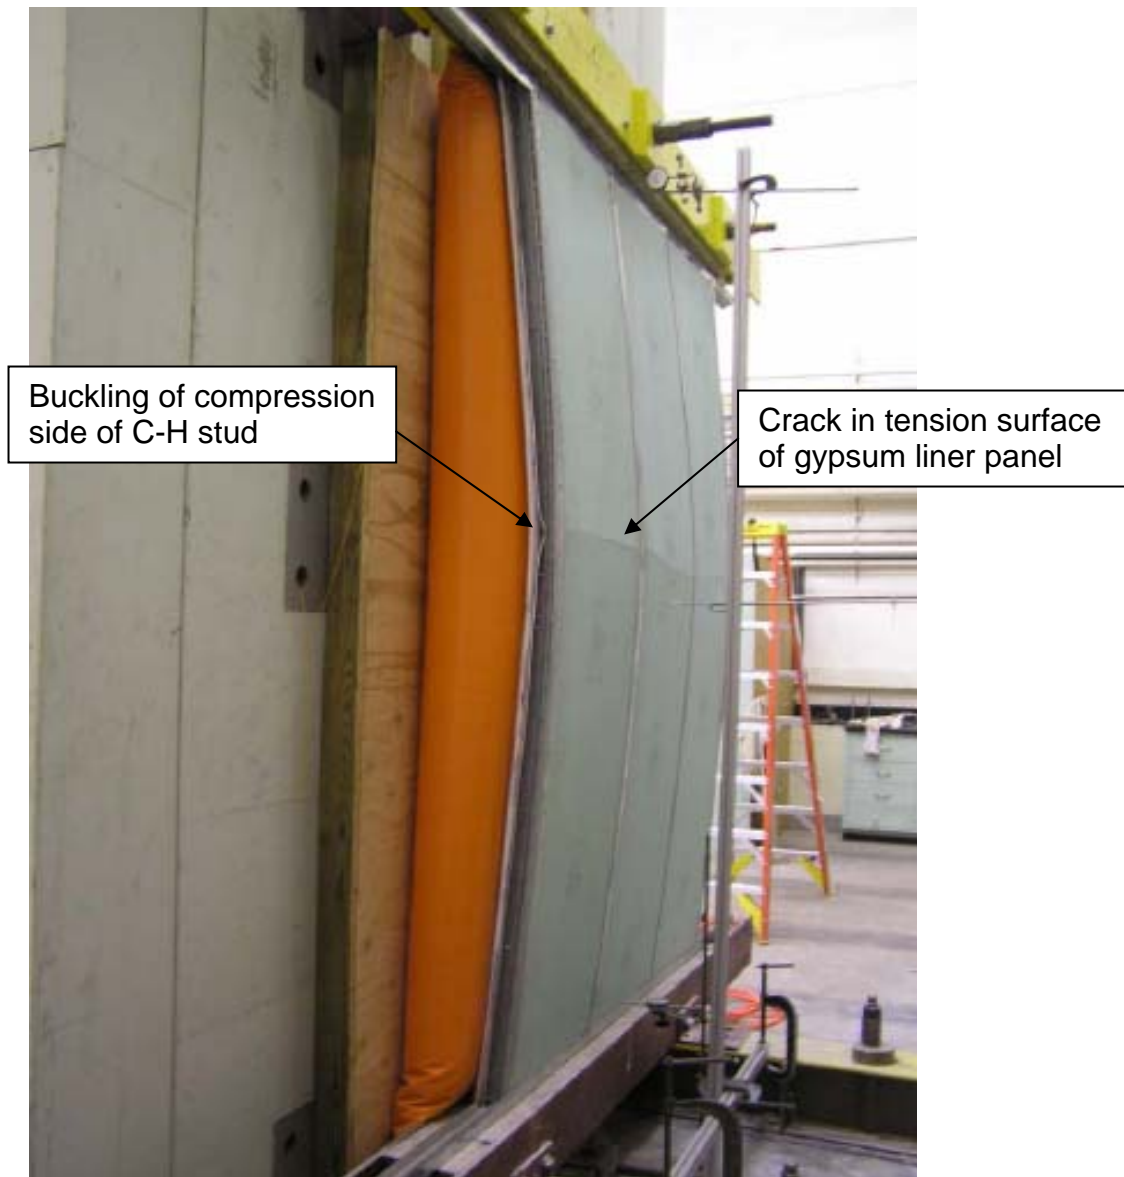
Figure 3 Post-test Photograph of Specimen 1
2-1/2 inch C-H Stud

This specimen had the gypsum panels applied in the vertical direction. When buckling of the compression side of the stud occurred, a large increase in the lateral deflection at the mid height of the panel was noted. The deflection increased rapidly as the pressure in the air bag increased. The testing was stopped at about 2.1 psi. The post-test photograph of this specimen is shown in Figure 3. It is seen that buckling of the C-H stud and cracking in the gypsum liner panels on the tension side developed at the mid height of the test panel. Removal of the gypsum panels

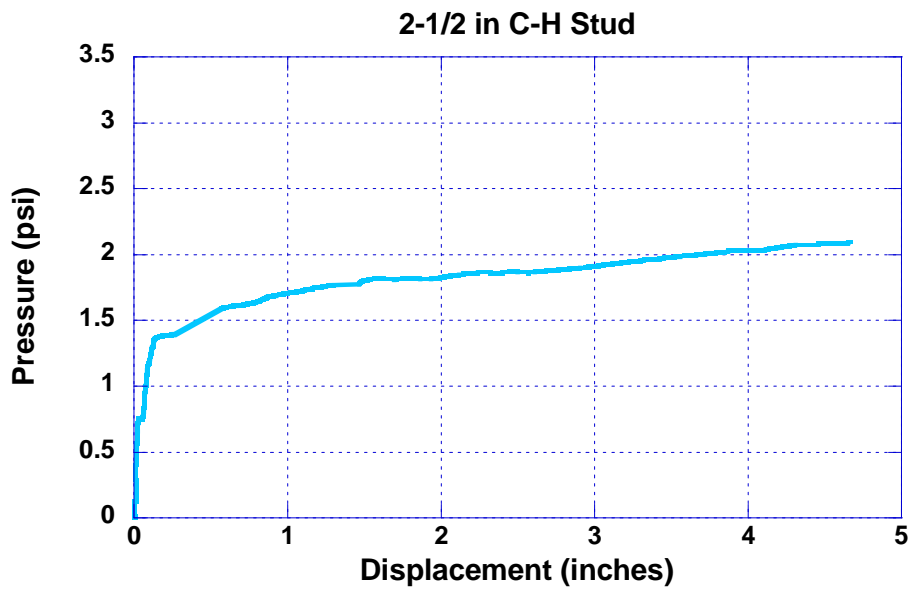
Figure 4 Air-bag pressure vs. panel center deflection plot of Specimen 1

Figure 4 shows a plot of the air-bag pressure vs. the panel center deflection for Specimen 1. It is seen that the panel behaved essentially elastically up to about 1.4 psi. Buckling of the compression flange developed at this pressure level and the deflection at the center of the panel increased rapidly.

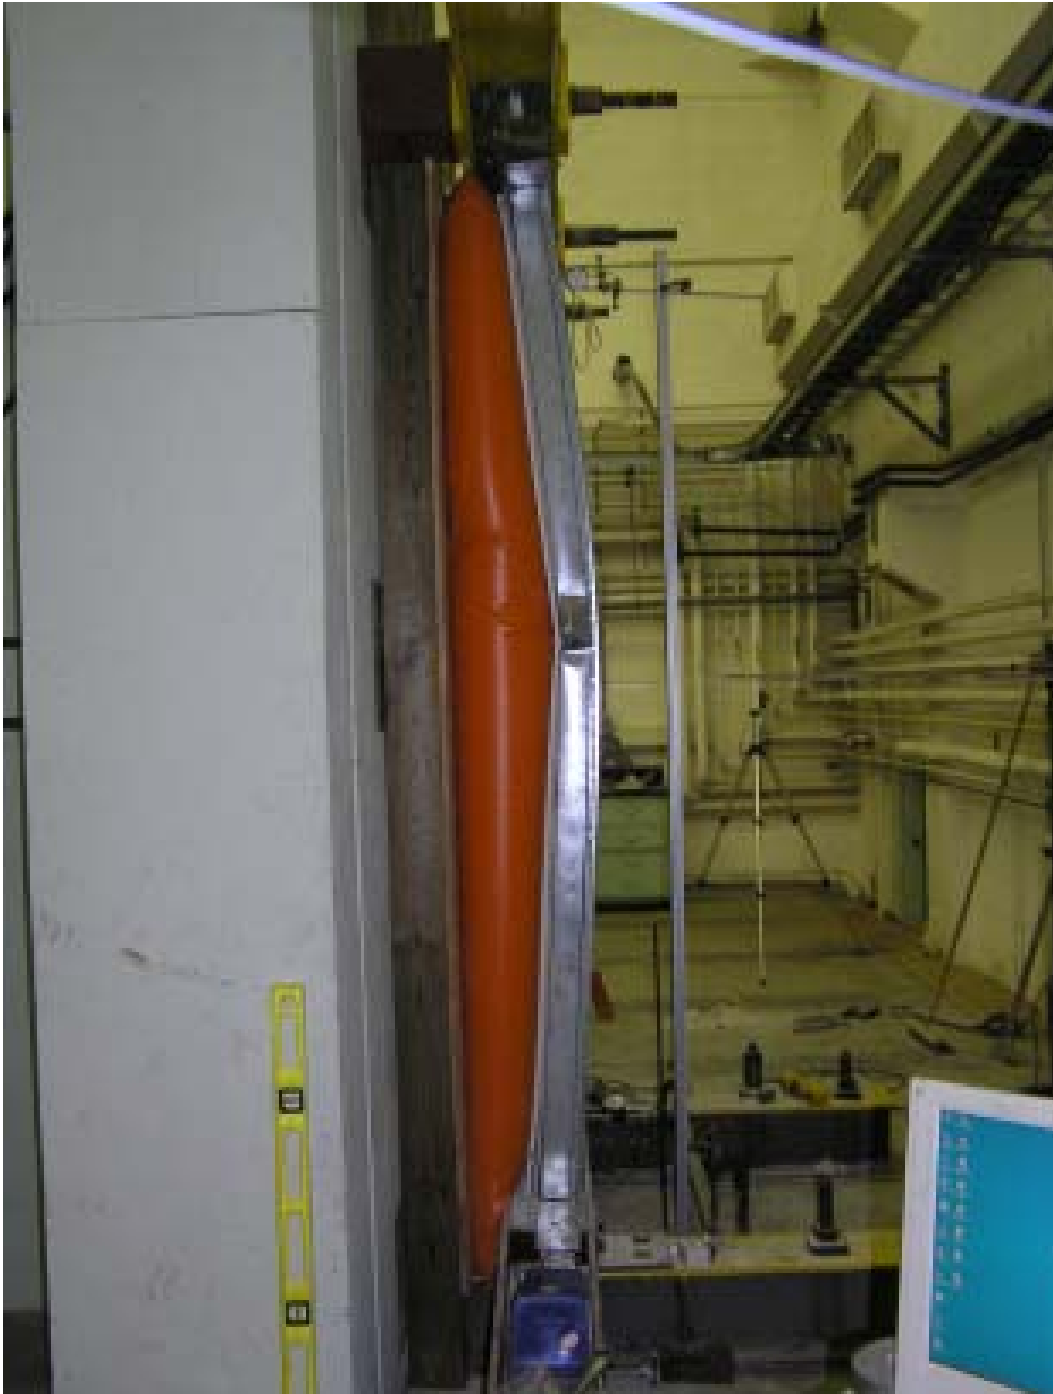
Figure 5 Post-test Photograph of Specimen 2
4 inch C-H Stud

This specimen had the gypsum panels applied in the vertical direction. The post-test photograph of this specimen is shown in Figure 5, and a close up view of the buckling of the C-H stud is shown in Figure 6. The plot of the air-bag pressure vs. the panel center deflection is shown in Figure 7. At about 2 psi, the compression flange began to buckle. Buckling of the web also appeared at about 2.4 psi, and cracks developed on the tension side of the gypsum liner panels. After reaching 3 psi the panel center deflection increased rapidly (see Figure 7). When the specimen could no longer sustain the increase in the air bag pressure, the testing was terminated.

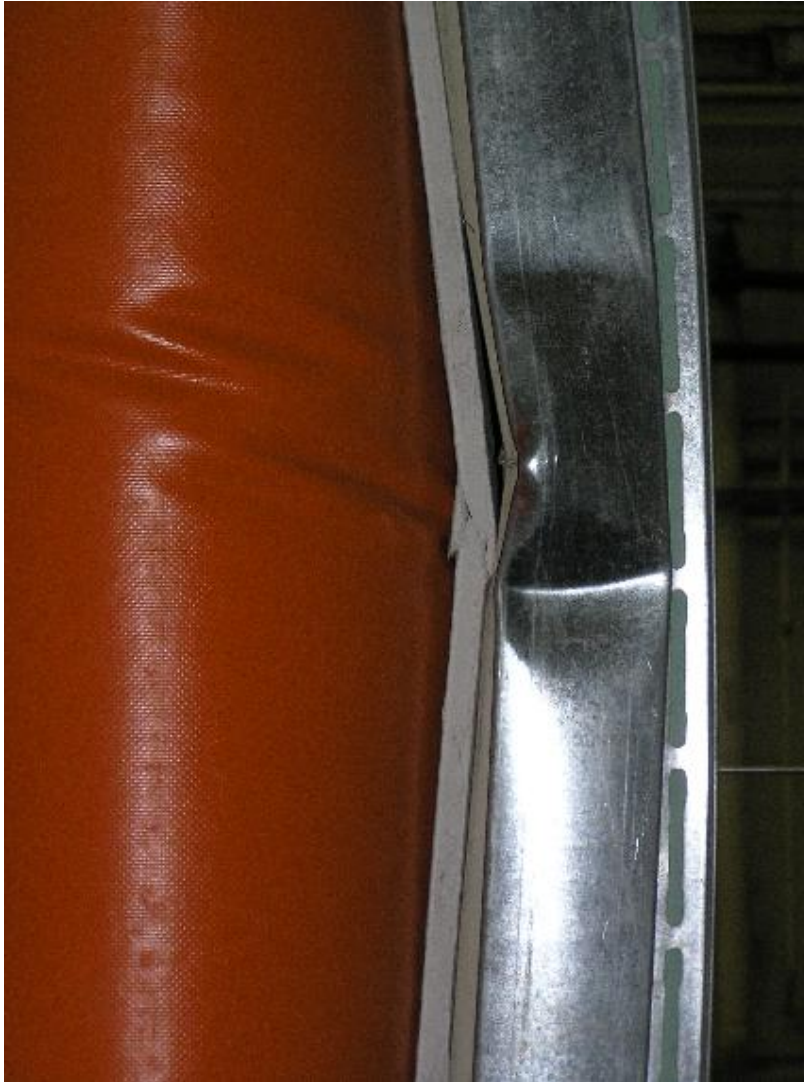
Figure 6 Close-up view of Local Buckling of
C-H Stud - Specimen 2

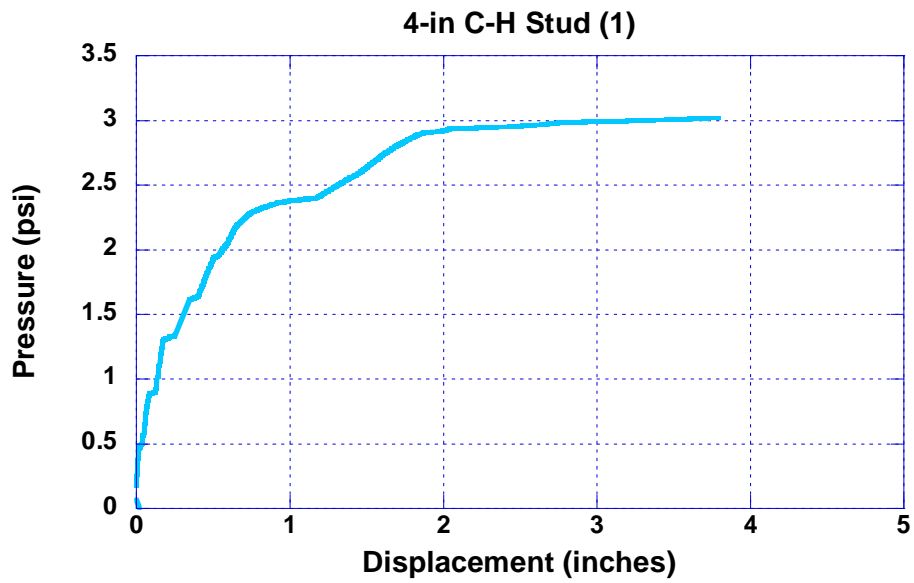
Figure 7 Air-bag pressure vs. panel center deflection plot of Specimen 2

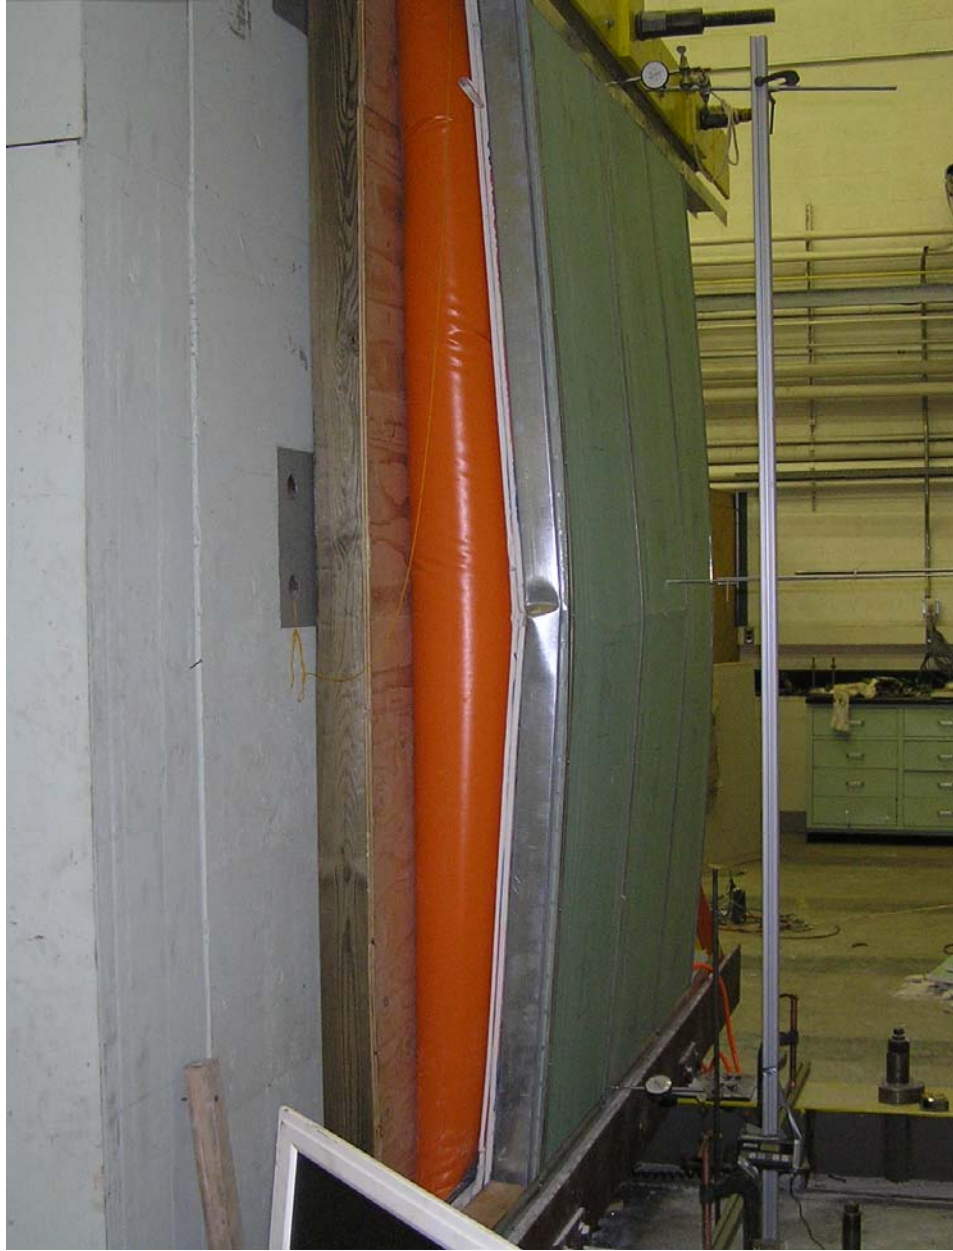
Figure 8 Post-test Photograph of Specimen 3
(4 inch C-H Stud)

This specimen was essentially the same as Specimen 2, except that the gypsum panels were applied in the horizontal direction. The post-test photograph of this specimen is shown in Figure 8, and a close up view of the local buckling of the C-H stud is shown in Figure 9. The plot of the air-bag pressure vs. the panel center deflection is shown in Figure 10. The overall behavior of Specimen 3 is similar to that of Specimen 2. At about 2 psi, the compression flange of the stud began to buckle. At about 2.5 psi the buckling of the web was noted. Similar to Specimen 2, this specimen also reached a maximum pressure of about 3 psi when the panel center deflection reached about 3 inches. Removal of gypsum liner panels revealed that all studs developed buckling (See Figure 11).

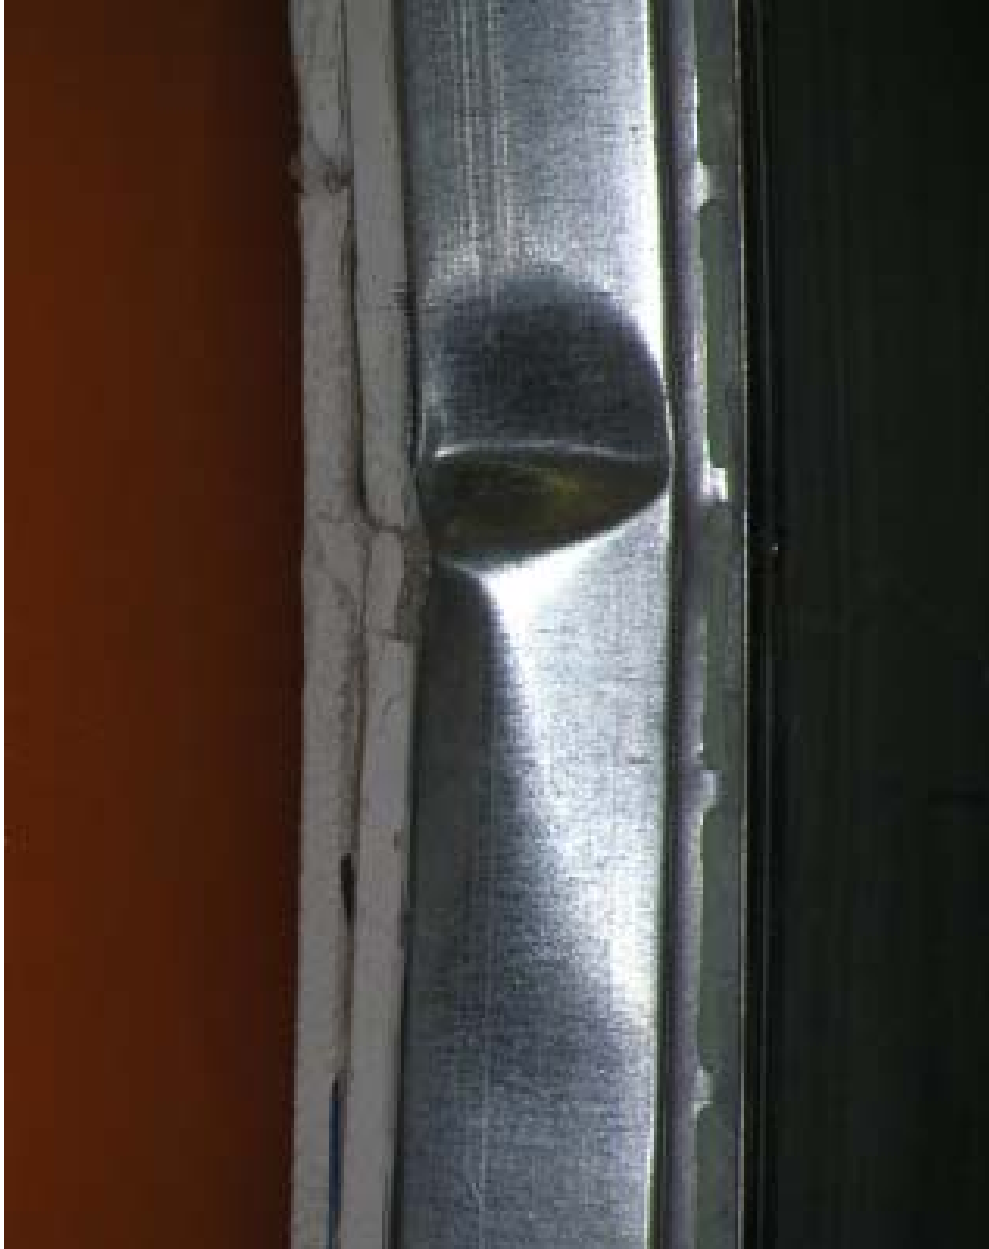
Figure 9 Close-up view of Local Buckling of
C-H Stud – Specimen 3

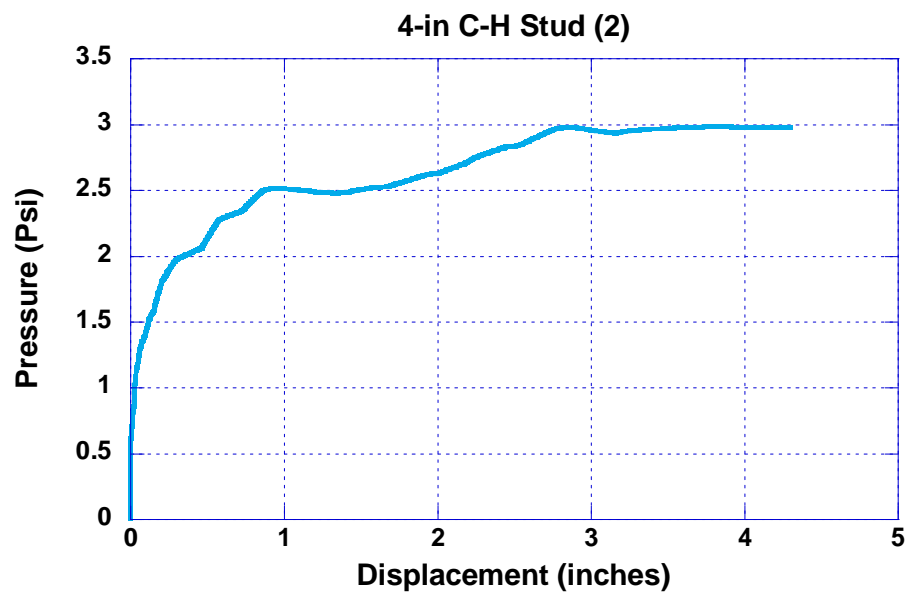
Figure 10 Air-bag pressure vs. panel center deflection plot of Specimen 3

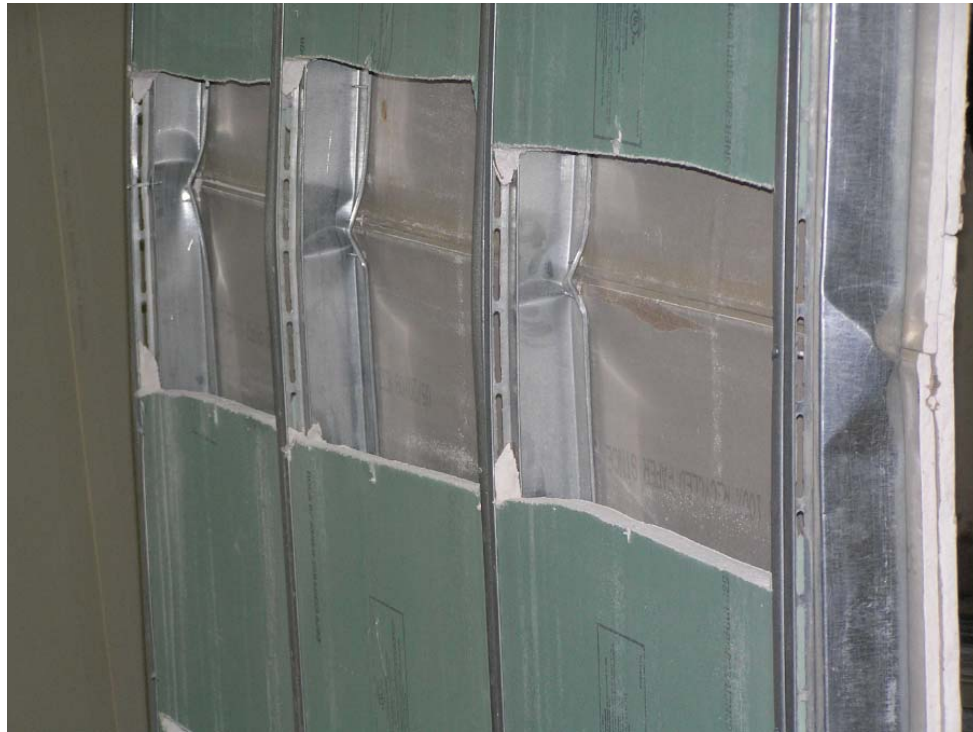
Figure 11 Development of local buckling in all four C-H studs - Specimen 3

revealed that local buckling of the compression flange developed in all four C-H studs (Similar to Figure 11).
