EXPOSING SIDING TREATMENTS, WALLS FITTED WITH EAVES, AND GLAZING ASSEMBLIES TO FIREBRAND SHOWERS

Samuel L. Manzello¹ and Sayaka Suzuki
Fire Research Division
Engineering Laboratory (EL)
National Institute of Standards and Technology (NIST)
Gaithersburg, MD 20899-8662 USA

Yoshihiko Hayashi
Department of Fire Engineering
Building Research Institute (BRI)
Tachihara 1
Tsukuba, Ibaraki JAPAN

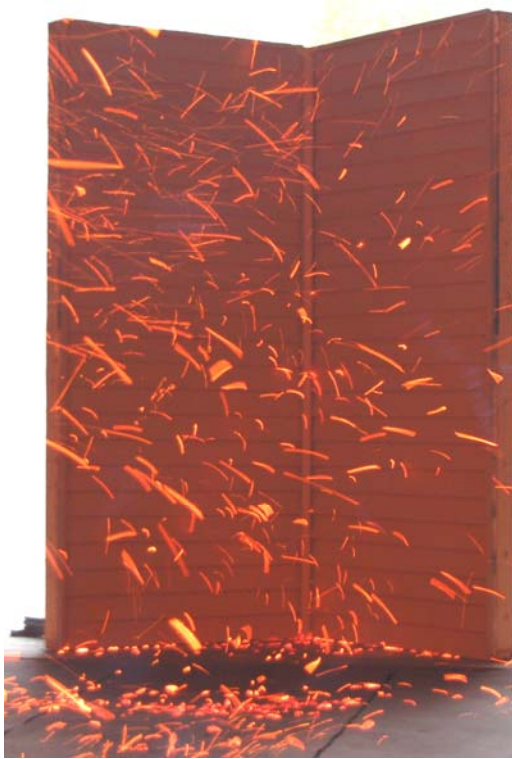
Fig. 3a

A full scale reentrant corner section (each side was 122 cm wide by 244 cm high) assembly was constructed for testing (shown in Figure 3a and detail of corner post shown in Figure 3b). To be able to control the moisture content of the sheathing (OSB) base layer, the experiments were designed in a modular fashion. Specifically, each side of the 122 cm by 244 cm full section was comprised of 12 separate OSB pieces. This allowed each section to be oven dried and simply reassembled inside the custom mounting frame. For each assembly, a moisture barrier was applied (Tyvek; a registered product of DuPont) and then the siding treatments were

Figure 3a. Picture of vinyl siding corner assembly under firebrand bombardment. **Figure 3b** is drawing of corner post.

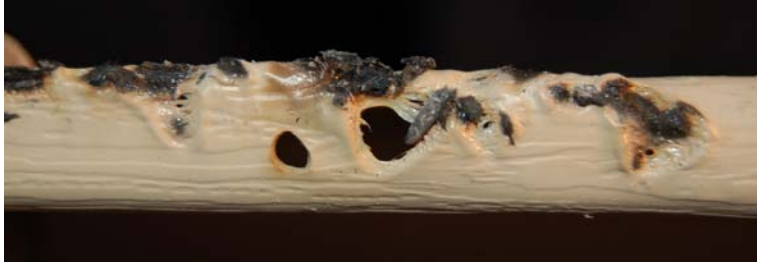
Fig. 4a

For experiments with vinyl siding conducted at 7 m/s and 9 m/s, the firebrands were observed to melt the siding to the point where holes developed through the material. A picture of this is shown in Figure 4a. While burns were observed in the moisture barrier at both wind speeds (Tyvek), ignition of the OSB sheathing was only observed for vinyl siding tests at 9 m/s and when the sheathing was dried. It is important to point out that the OSB sheathing burned completely through and ignition was observed within the framing members as well (2 x 4).

Figure 4a Image of vinyl siding (from bottom) after firebrand exposure at 7 m/s. **Figure 4b** Image of polypropylene siding after firebrand exposure at 7 m/s.

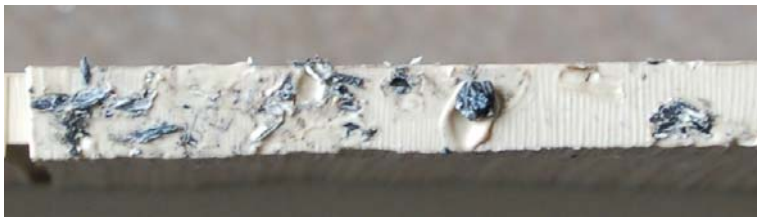
Fig. 4b

For polypropylene siding, firebrands produced melting within the material but no holes were formed within the siding itself (see Figure 4b). Firebrands were observed to penetrate the corner post and burn holes into the moisture barrier (Tyvek) but ignition was never observed in the OSB sheathing for any wind speed of moisture content considered. Nevertheless, it is important to point out that firebrands easily penetrated the corner post in both siding types.

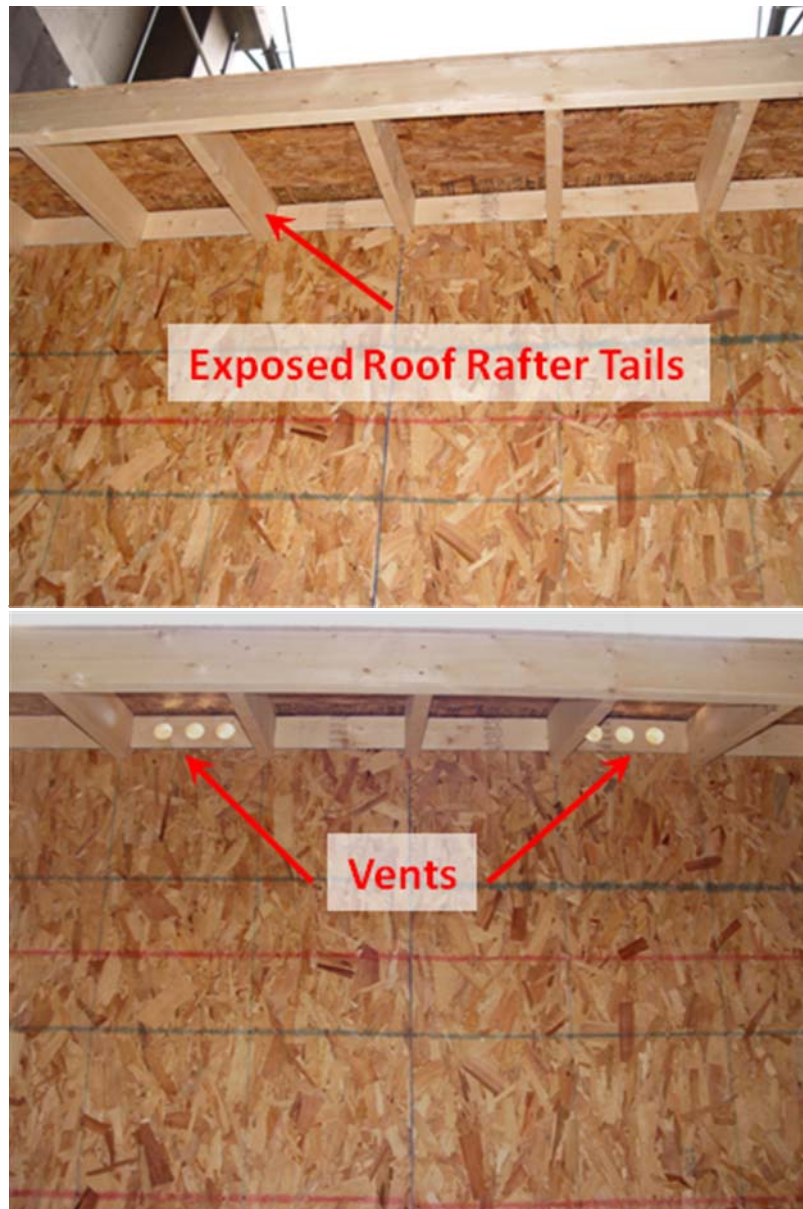
Fig. 6

Figure 6 Images of open eave construction with no vents (top) and vents (bottom).

Figure 5 displays common open eave constructions used in California. The construction found in top panel of Figure 5 was followed for testing [38]. In half of the experiments, no vent opening was used to simply observe if firebrands actually accumulated within the exposed rafters and subsequent joints (see Figure 6). In the remaining experiments, vents were installed (see bottom panel) and a mesh was placed within the vent opening (see Figure 6). For the vent openings, 50 mm holes were drilled into the blocking material and an 8 x 8 mesh (2.75 mm opening) was secured, as recommended in the new, 2010 California WUI code [35]. As in the corner tests described above, three replicate experiments were performed. Table II is a summary of the range of parameters used.

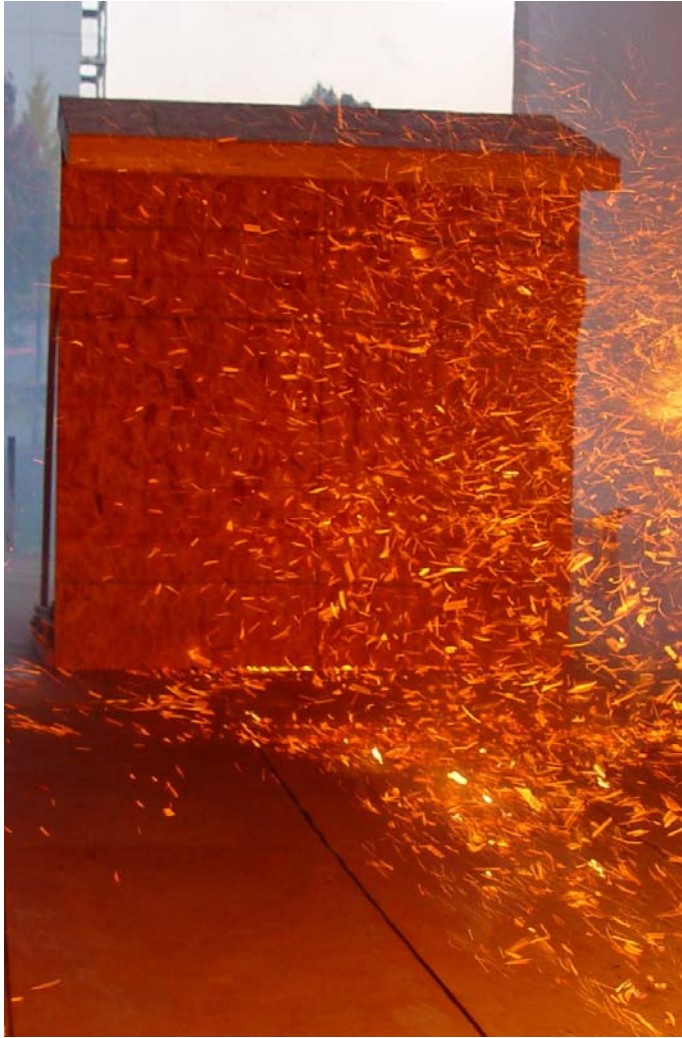
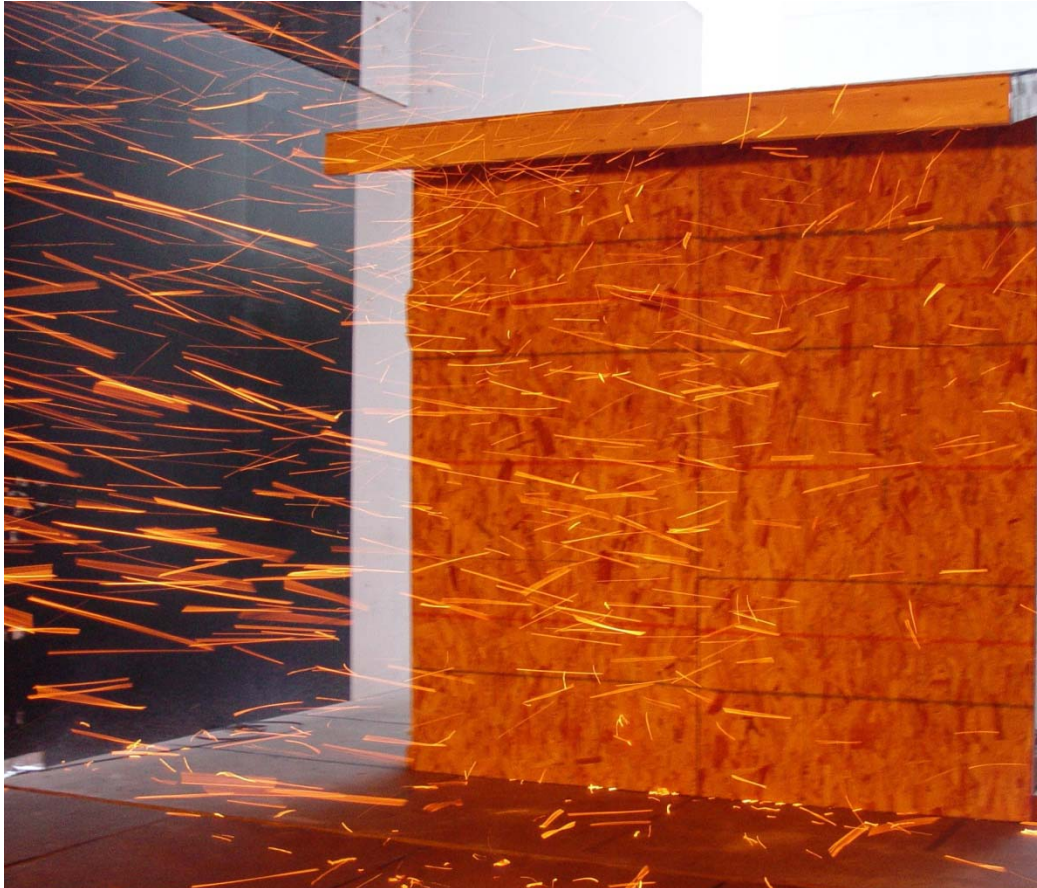
Fig. 7a

Figure 7a-b displays a typical experiment showing a wall fitted with an eave exposed to firebrand showers from the NIST Dragon inside the FRWTF. For the experiments that used no vent opening, firebrands were not observed to accumulate under the eave over the range of wind speeds considered.

Figure 7 Image of wall fitted with eave under firebrand bombardment.

the number of firebrands arriving at the vent location was 10 ± 1 (average \pm standard deviation). As the velocity was increased to 9 m/s, the total number of firebrands arriving at the vent location increased to 28 ± 2 (average \pm standard deviation). While the number of firebrands arriving at the vent locations increased as the wind speed increased, it was very small as compared to the number of firebrands that bombarded the wall/eave assembly (see Figure 7a-b).

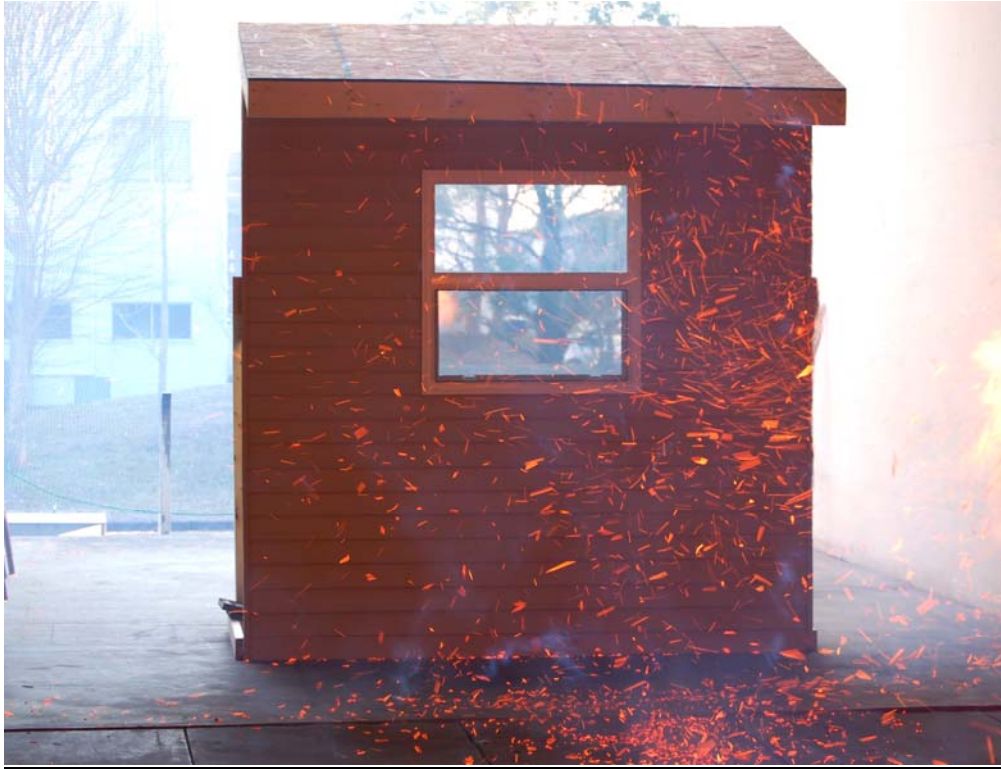
Fig. 9

The size of each of the glazing assembly was the same: 91 cm by 91cm. To mount these assemblies, a 244 cm by 244 cm wall fitted with an open eave was constructed for testing. The wall was constructed using wood framing members spaced 406 mm (16”) on center. Oriented strand board (OSB) was applied over the wood framing members and a moisture barrier was installed over the OSB. Vinyl siding was applied over the moisture barrier. An eave with a total length of 122 cm was constructed and mounted to the wall assembly. For completeness, an image of a typical experiment is shown in Figure 9.

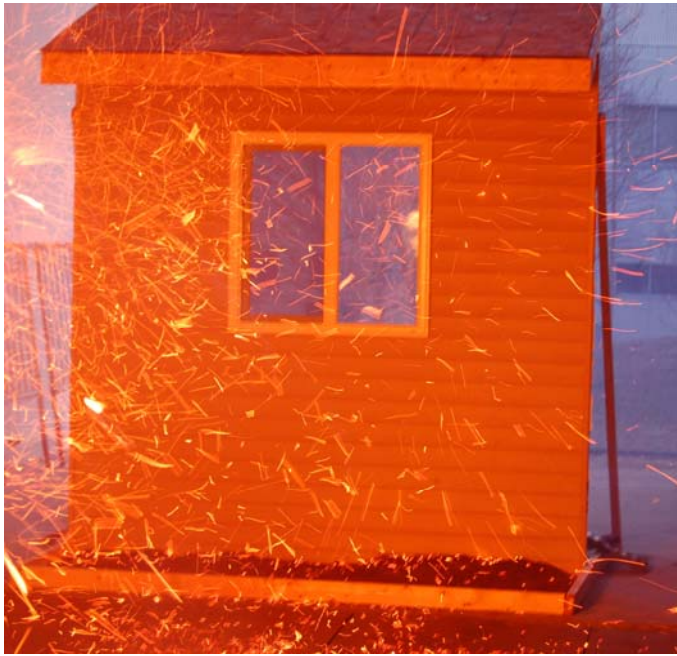
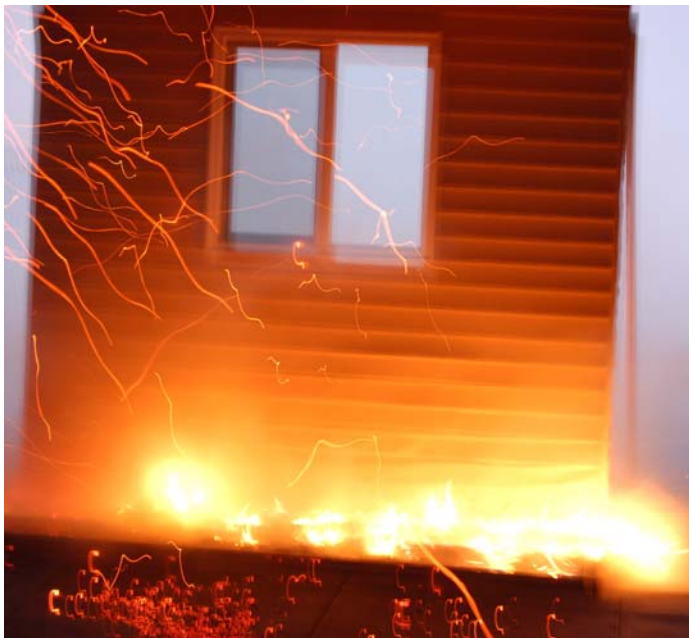
Fig. 10

Firebrands were observed to ignite the needle bed via smoldering ignition, the smoldering ignition become self-sustaining, and a transition to flaming ignition was observed (see Figure 10). The flaming ignition in the needles subsequently melted the vinyl siding and produced self-sustaining smoldering ignition at the base of the wall assembly (within the OSB; this OSB was not even dried).

Figure 10 In the top image, firebrands have caused smoldering ignition in the mulch bed. In the bottom image, smoldering ignition has transitioned to flaming ignition and the wall assembly has ignited.
