NISTIR 7837

# Measurement and Evaluation of Visibility Experiments for Powered Industrial Vehicles

December 2011

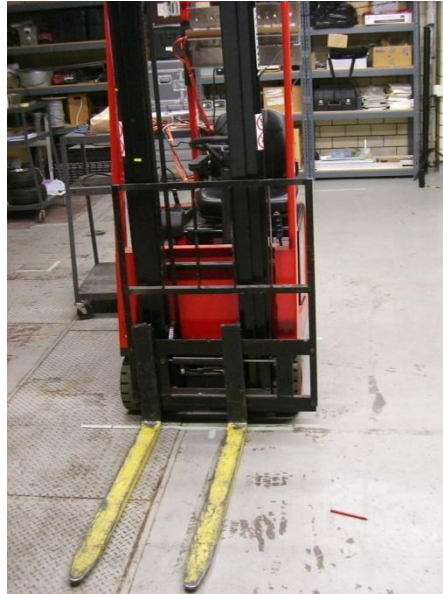
Figure 1. Forklift<sup>1</sup> used for Visibility experiments.

Forklift specifications are shown in Table 1 as directed in ISO/DIS 13564-1 Section 10.1 Truck Information. This table shows the test report's Truck information required for visibility reports.

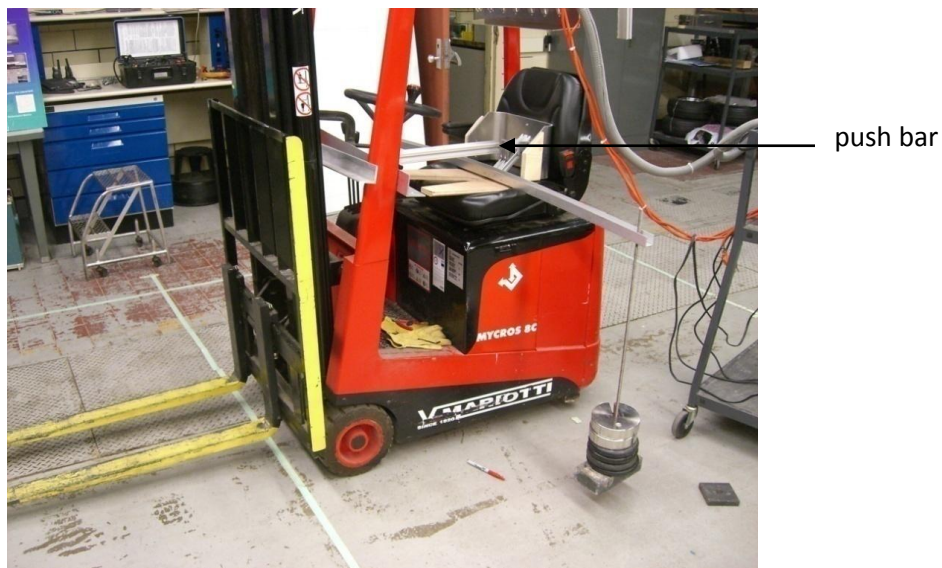
The 100 N horizontal force was applied by a researcher (see Figure 5 (a)) through a piece of extruded aluminum bar and measured using a spring scale. A second researcher measured the distance between the point of applied force and an aluminum crossbar temporarily attached to the forklift. Following the measurement, a push bar was cut and inserted between the force application point and the cross bar (see Figure 5 (b)).

A 400 N vertical force was applied by adding weights to the SIP apparatus (see Figure 5 (b)). The weights were suspended on both ends of an aluminum bar using threaded rods. The bar also included a 10-32 bolt protruding from its center and was used to apply a point load to the SIP at the standard specified location.

Figure 5. Applying (a) horizontal and (b) vertical forces. The spring scale shown in (a) indicates the applied force on the SIP device.

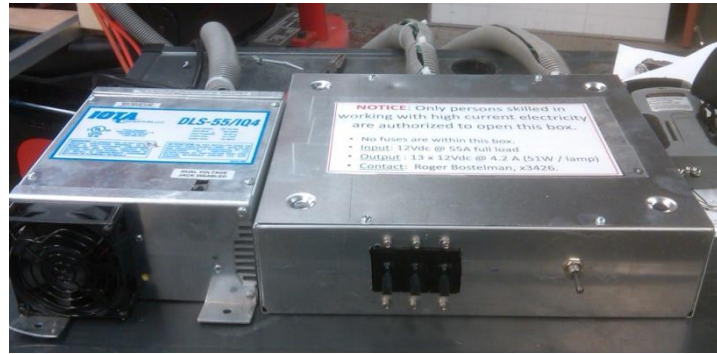
A lamp switch box was designed and built and powered by a 55 Amp power supply as shown in Figure 6 (a). The lamp switch configuration was designed as in ISO/DIS 13564-1 to turn on only the specified lamps. Four circuit breakers were used as switches to power various combinations of lights as shown in the schematic in Figure 6 (b).

Figure 6. (a) Electrical setup: (left) power supply and (right) lamps switch box; (b) Lamps wiring diagram.

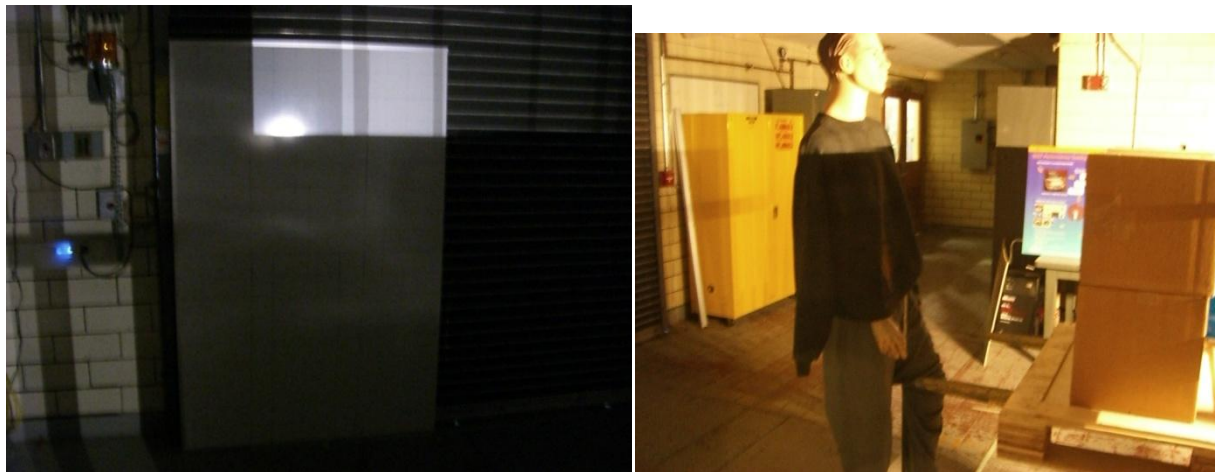
Figure 10: Photos of tests with pallet of boxes (left) using the test board and (right) using a mannequin.

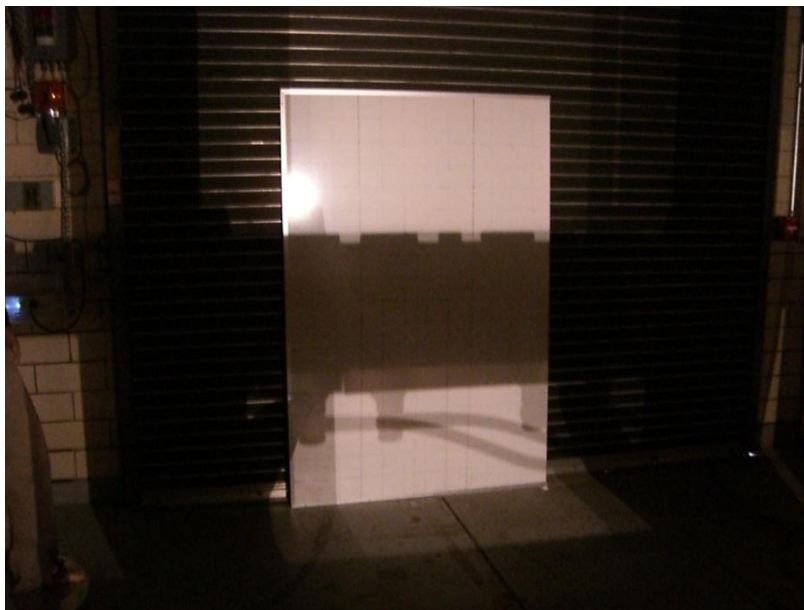
Figure 11. Shadows on the test screen when fork arms were raised to 117 cm

Table 6. Results when fork arms were raised to 117 mm above floor. See examples in Figure 11.

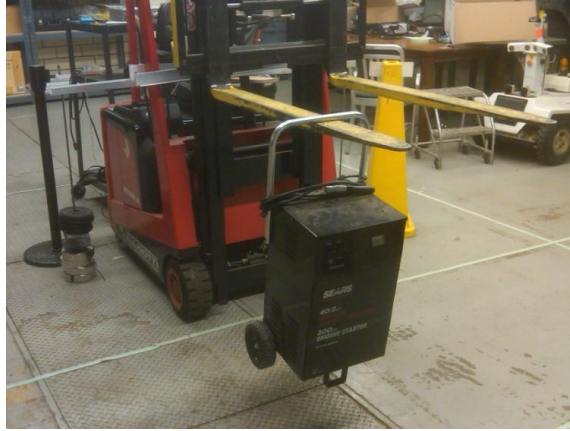
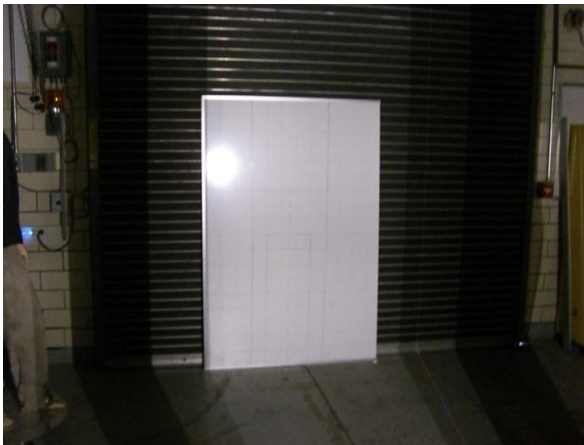
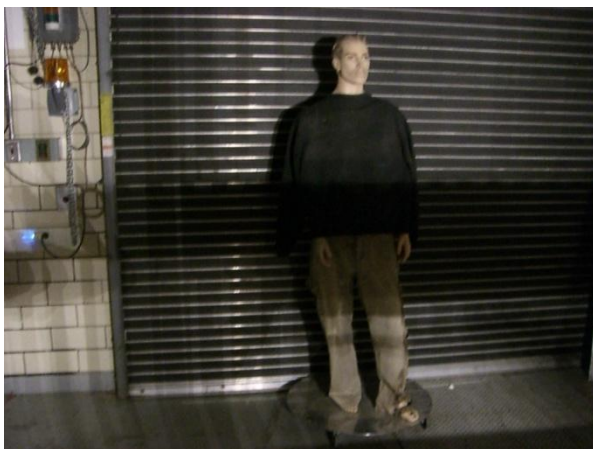
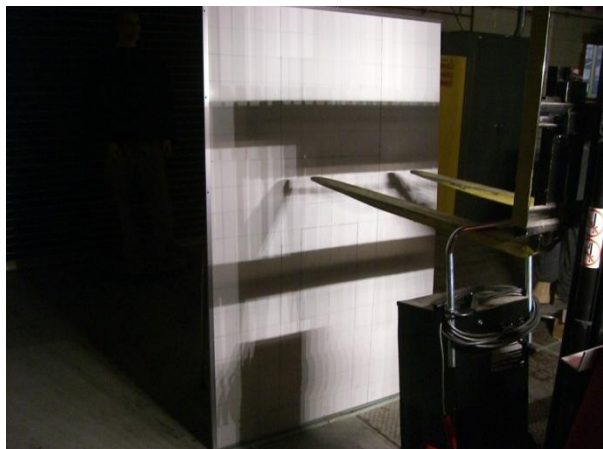
Figure 14 (a) Forklift with an underslung load used for visibility tests, (b) test body before the arms were raised, (c) test body when forklift tines were raised and resulting shadows: (d) on a mannequin and (e) on the test body at a closer path to the fork tines.

ISO/DIS 13564-1 mandates that the forklift be ‘unladen’ (unloaded) during testing. However, forklifts are used to carry and deliver loads. Tests were conducted with the forklift as if carrying a battery charger as shown in Figure 14 (a). The fork arms were raised and the fork frame structure blocked the operator’s visibility. Three test pieces were used in the test, including: test body, mannequin, ANSI/ITSDF B56.5 standard test pieces. When the fork arms were raised, the percentage of illuminated area decreased as expected due to additional forklift structure blocking lamps. When the fork arms were raised to 117 cm high, illuminated percentage of test body dropped from 100 % shown in Figure 14 (b) to 42% as shown in Figure 14 (c). Figure 14 (d) shows resulting shadows on a mannequin to interpret visibility results for pedestrians and Figure 14 (e) shows similar results as in Figure 14 (c) but on a closer test body path to the vehicle. A suggested change to the standard is that visibility tests should be tested with the forklift carrying underslung loads.

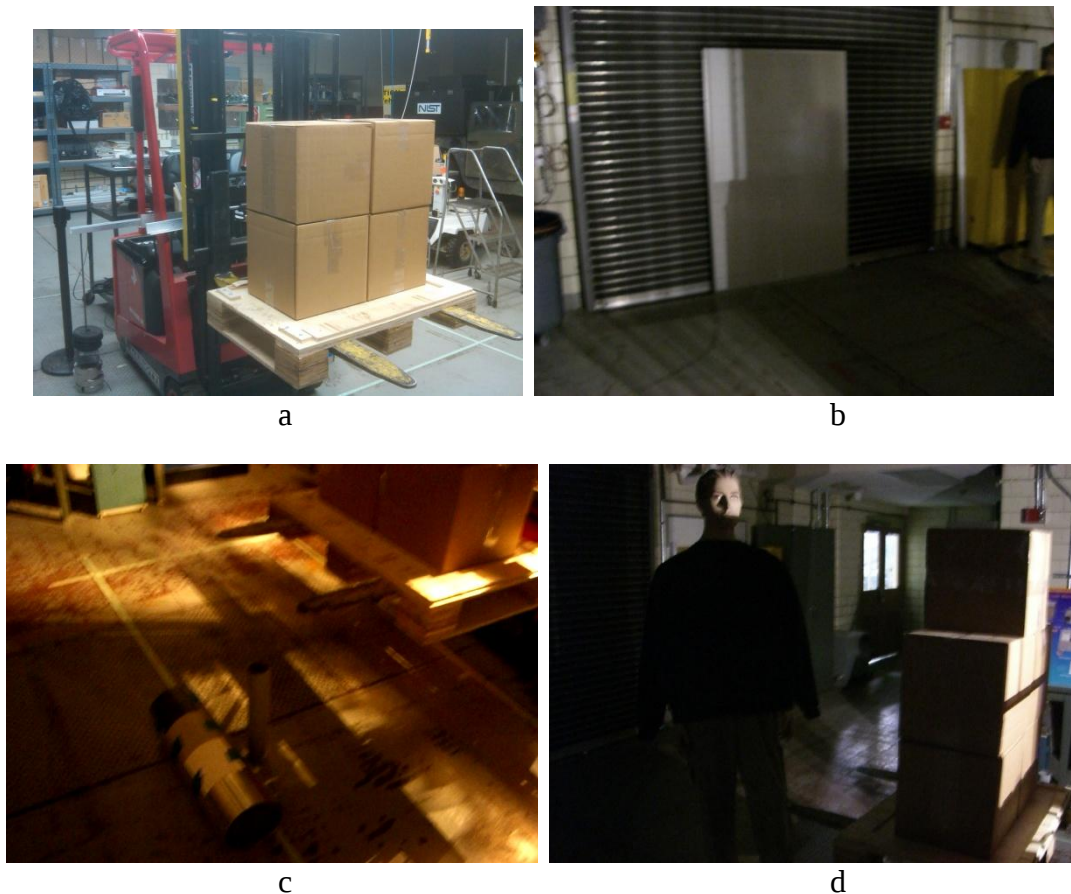
Figure 15. (a) Forklift carrying a pallet of boxes for visibility tests with resulting shadows shown on: (b) the test body, (c) ANSI/ITSDF B56.5 standard test pieces, and (d) a mannequin.

Similar to recommendation 3, recommendation 4 suggests visibility tests also be conducted while the forklift carries loads above the fork tines (see Figure 15 (a)), such as a pallet of chosen standard-size boxes. Specific load size should be specified. Illuminated area was 0 % with the test body at P1.2 as shown in Figure 15 (b). Other visibility test apparatuses were also used in NIST tests including a mannequin and ANSI/ITSDF B56.5 standard test pieces (see Figure 15 (c, d)). Illuminated area was 0 % with the mannequin and 0 % with the test pieces when they were located at the midpoint of P3.1 - P3.2.

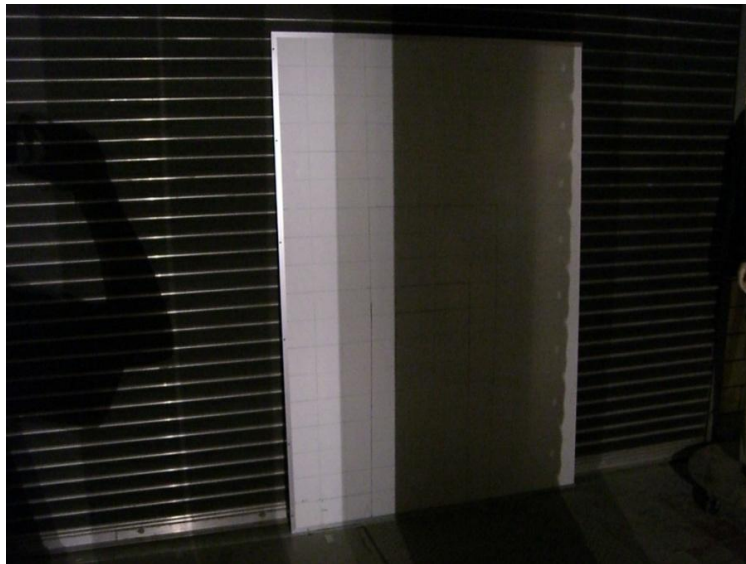
Figure 16. (a) Standard and smaller sized test screens marked on the board; (b) large screen passing the visibility test and the smaller screen failing the visibility test (i.e., fully within the shadow).

standards is to also use a smaller screen to represent small obstacles along with an appropriately safe visibility percentage. A smaller screen with 300 mm x 1000 mm was used in the test as shown in Figure 16 (a). With the midpoint of the screen at about 45 mm to the right of the midpoint of P1.2 - P1.2, the illuminated area of the original screen was 20 %, but the illuminated area of the smaller screen was 0 % where it failed the visibility test. Figure 16 (b) shows that the entire smaller screen is within the shadow thereby demonstrating 0 % visibility.

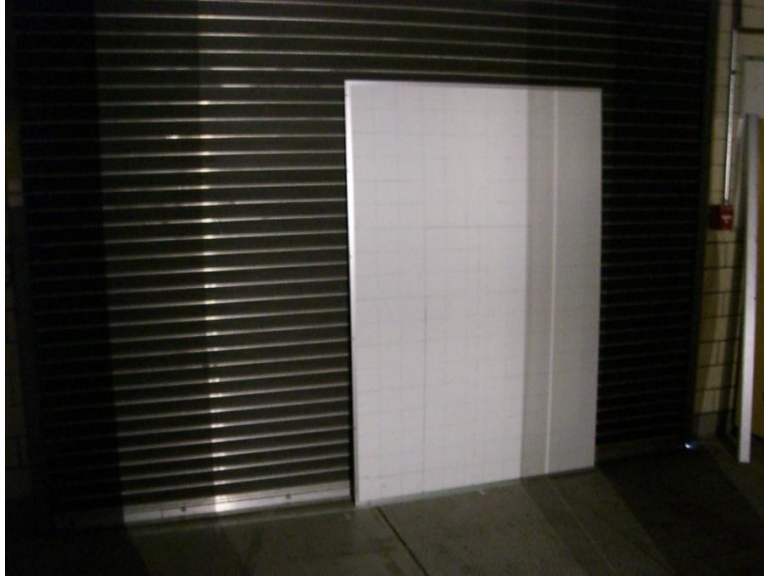
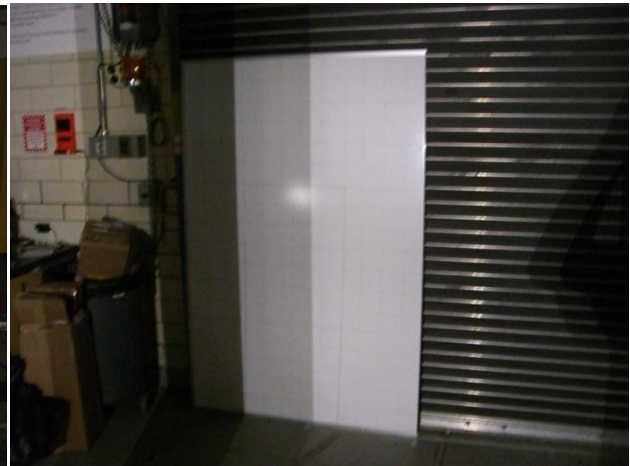
Figure 20. Examples of shadows of visibility tests, from: (a) Test 3, at location 3, (b) test 4, location 3, and (c) test 3, location is left edge of test screen at P1.1.
