Enabling the study of structure vulnerabilities to ignition from wind driven firebrand showers: A summary of experimental results

Samuel L. Manzello^{a,*}, Sayaka Suzuki^a, Yoshihiko Hayashi^b

^a National Institute of Standards and Technology (NIST), Engineering Laboratory (EL), Fire Research Division, 100 Bureau Drive, Gaithersburg, MD 20899-8662, United States

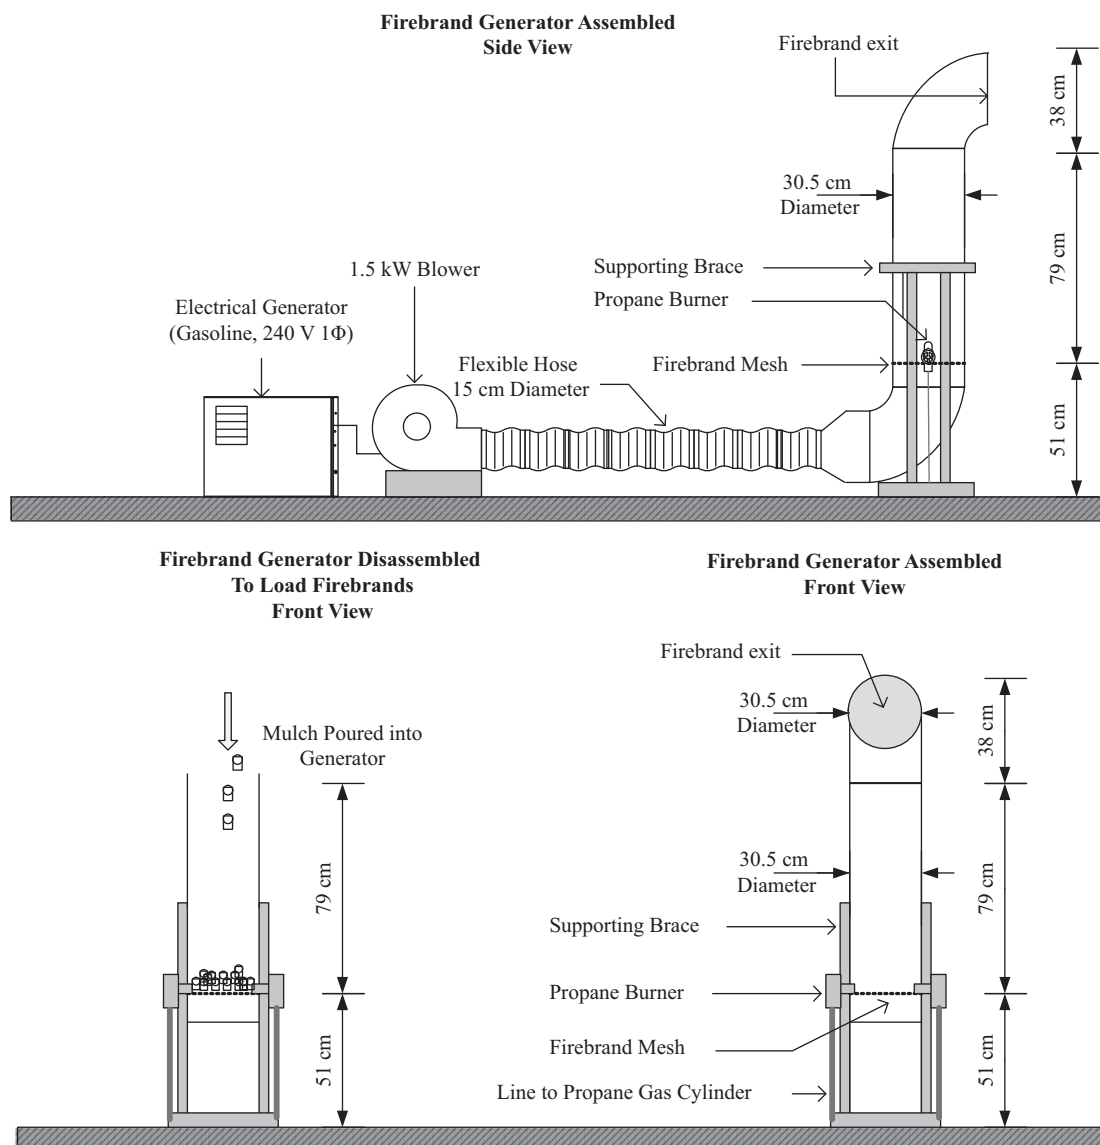
Fig. 1. Schematic of NIST Firebrand Generator (NIST Dragon).

The mulch pieces were deposited into the Firebrand Generator by removing the top portion. The mulch pieces were supported using a stainless steel mesh screen (0.35 cm spacing), which was carefully selected. Two different screens were used to filter the mulch pieces prior to loading into the firebrand generator. The first screen blocked all mulch pieces larger than 25 mm in diameter. A second screen was then used to remove all needles from the mulch pieces. The justification for this filtering methodology is provided below. The maximum mulch loading possible with the current Firebrand Generator design is 2.8 kg. The firebrand generator was driven by a 1.5 kW blower.

After the tree mulch was loaded, the top section of the Firebrand Generator was coupled to the main body of the apparatus. The blower was then switched to provide a low flow for ignition. The two propane burners were then ignited individually and simultaneously inserted into the side of the generator. This sequence of events was selected in order to generate a continuous flow of glowing firebrands for up to six minutes duration.

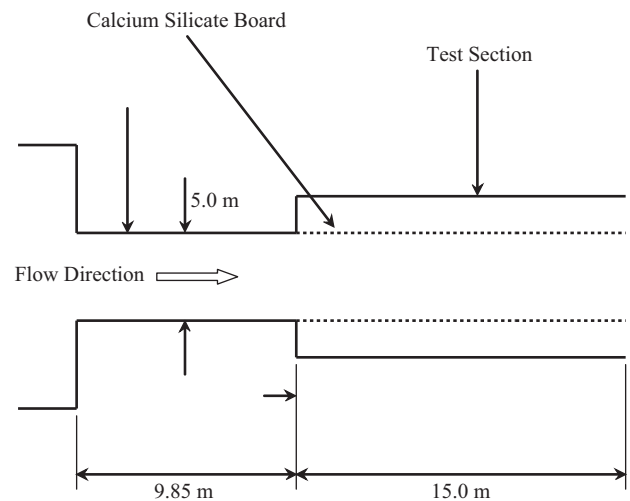
Fig. 2. Schematic of test section of Fire Research Wind Tunnel Facility (FRWTF).

The Firebrand Generator was installed inside the test section of the FRWTF at BRL. Fig. 2 displays a layout of the facility. The facility was equipped with a 4.0 m fan to produce a wind field up to a 10 m/s ($\pm 10\%$). The wind velocity distribution was verified using a hot wire anemometer array. To track the evolution of the size and mass distribution of firebrands, a series of water pans was placed downstream of the Firebrand Generator. Depending on the structure to be tested, different assemblies were placed downstream of the Firebrand Generator (mock structures, roofing assemblies, etc.).

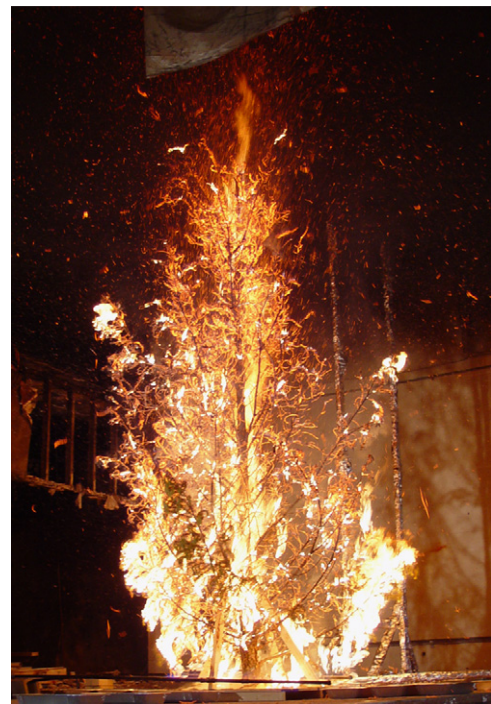
Fig. 3. Photograph of a burning Douglas-Fir tree (5.2 m) used for firebrand collection [25]. This experiment was conducted at NIST's Large Fire Laboratory (LFL).

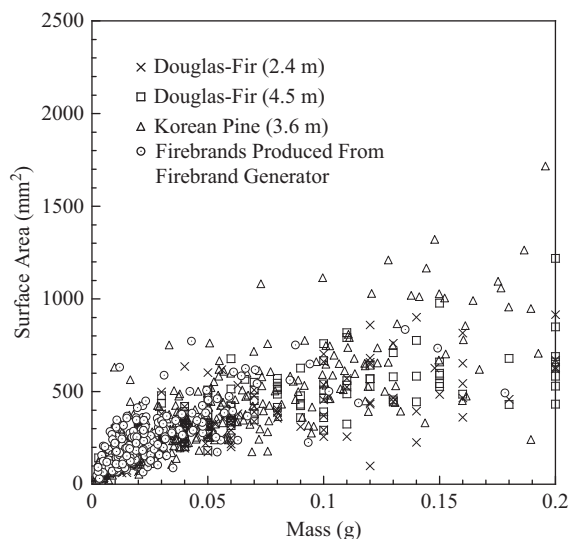
Fig. 4. Firebrands produced from burning trees compared to those produced using the Firebrand Generator. The uncertainty in determining the surface area is $\pm 10\%$.

produced. Douglas-fir was selected as the tree species for the experiments in the USA since it is abundant in the Western United States of America and it is this part of the USA where WUI fires are most prevalent. Korean Pine, another conifer species, was used for comparison to Douglas-Fir. It was observed that more than 85 % of the firebrands produced from these tree experiments were less than 0.4 g [25,26]. Therefore, the filtering procedure for tree mulch used in the Firebrand Generator was selected to produce firebrands with size/mass distributions commensurate to those measured from burning trees (see Fig. 4).

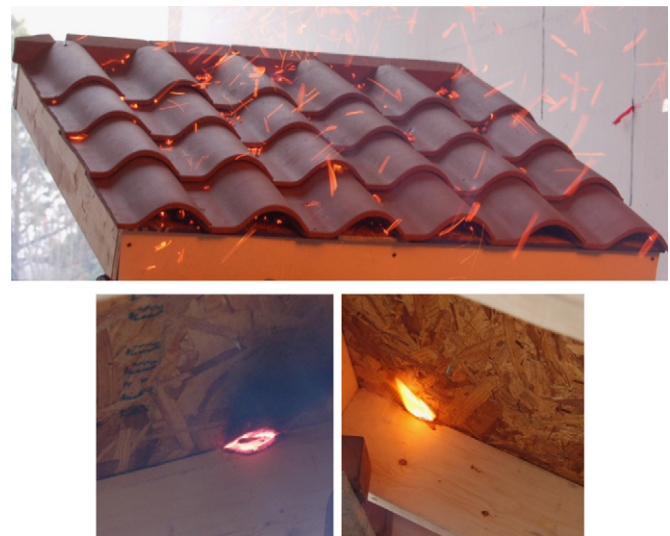
Fig. 5. Images of experiments conducted using OSB/CT without bird stops installed [22]. Intense SI was observed within the OSB base layer and eventually FI was observed. The wind tunnel speed was 7 m/s and the Firebrand Generator was located 2.0 m from the CT roofing assembly. The dimensions of the roof assembly were 122 cm by 122 cm.

When new, ceramic tile roofing assemblies are constructed by placing a base layer of oriented strand board (OSB), then tar paper (TP) is installed on top of the OSB for moisture protection, and finally ceramic tiles (CT) are applied. Aged or weathered ceramic tile roofing assemblies were simulated by not installing tar paper. For simulated aged ceramic tile roof assemblies, without the installation of bird stops, the firebrands were observed to be blown under the ceramic tiles (see Fig. 5). Bird stops, as the name suggests, are intended to mitigate the construction of nests by birds under the ceramic tiles. During the experiments, eventually, several firebrands would collect and would produce smoldering ignition (SI) within the OSB base layer. With continued application of the airflow, holes were formed within the OSB and eventually the SI would transition to flaming ignition (FI). Simulated aged ceramic tile roof assemblies, with bird stops installed, were also constructed for testing. Even though bird stops were installed, many firebrands were able to penetrate the gaps that exist between the ceramic tiles and the bird stops. These firebrands were observed to produce SI within the OSB base layer; holes were observed in some cases within the OSB base layer. The SI ignition never transitioned to FI when bird stops were applied.

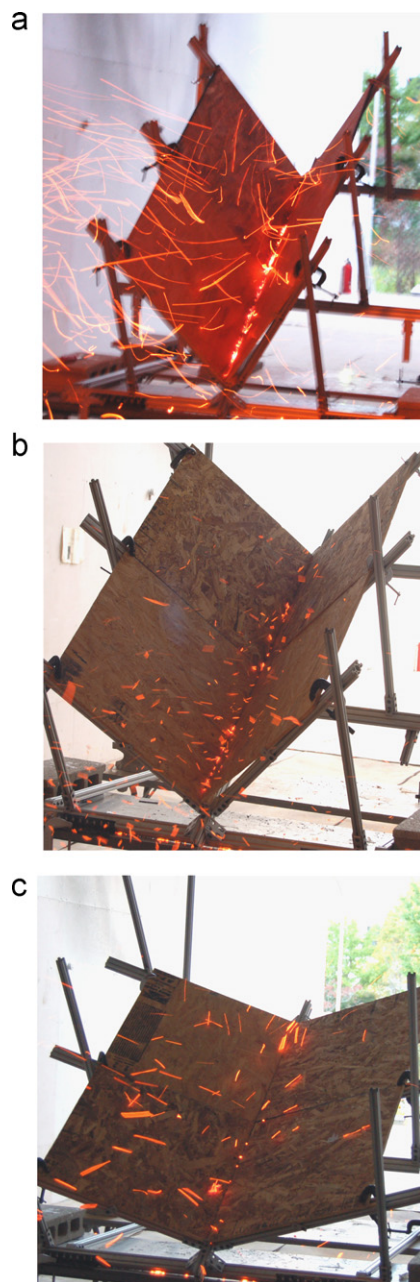
Fig. 6. Bare OSB full scale sections used for testing [21]. (a) Angle of 60°; smoldering ignition observed, (b) angle of 90°; smoldering ignition observed and (c) angle of 135°; no ignition observed. The wind tunnel speed was 7 m/s in each case and the overall dimensions of the OSB sections were 122 cm by 122 cm.

For ignition testing of roofing base layer materials (OSB), at an angle of 60°, the firebrands were observed to collect inside the channel of the OSB crevice (see Fig. 6a–c). The firebrands that collected in the crevice produced SI where they landed, eventually resulting in several holes in the OSB. The OSB continued to smolder intensely near the locations where the firebrands landed. Eventually a transition to FI was observed on the back side of the OSB. As the angle was increased to 90°, similar behavior was observed where the firebrands that collected initiated intense smoldering. Eventually, holes were formed at these locations in an identical manner to the 60°. While SI was observed, it was not possible for a transition to flaming to occur. As the angle was increased to 135°, ignition was no longer possible.

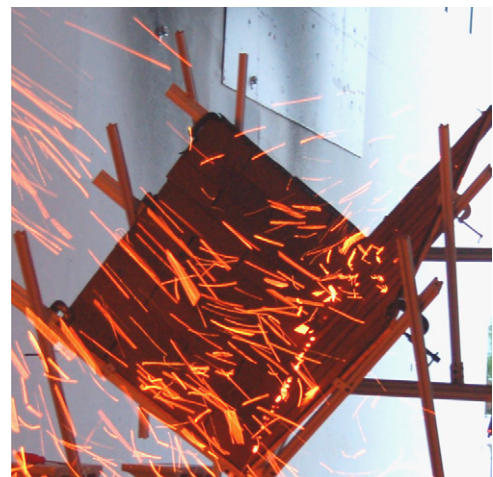
Fig. 7. Fig. 6 OSB base layer, tar paper, and asphalt shingles; angle of 90°–no ignition observed [21]. The wind tunnel speed was 7 m/s. The dimensions of the assembly were 122 cm by 122 cm.

With regard to ignition testing of roofing valleys (OSB, tar paper, and asphalt shingles), at 60° and 90°, several firebrands were observed to become trapped along the channel of two sections and along the seams of the shingles. However, no ignition events were observed. The firebrands were only capable of melting the asphalt shingles (see Fig. 7). As the angle was spread further, fewer firebrands were observed to become trapped in the seam of the two sections, in a similar manner to the base layer OSB tests. While these tests did not consider the influence of aged

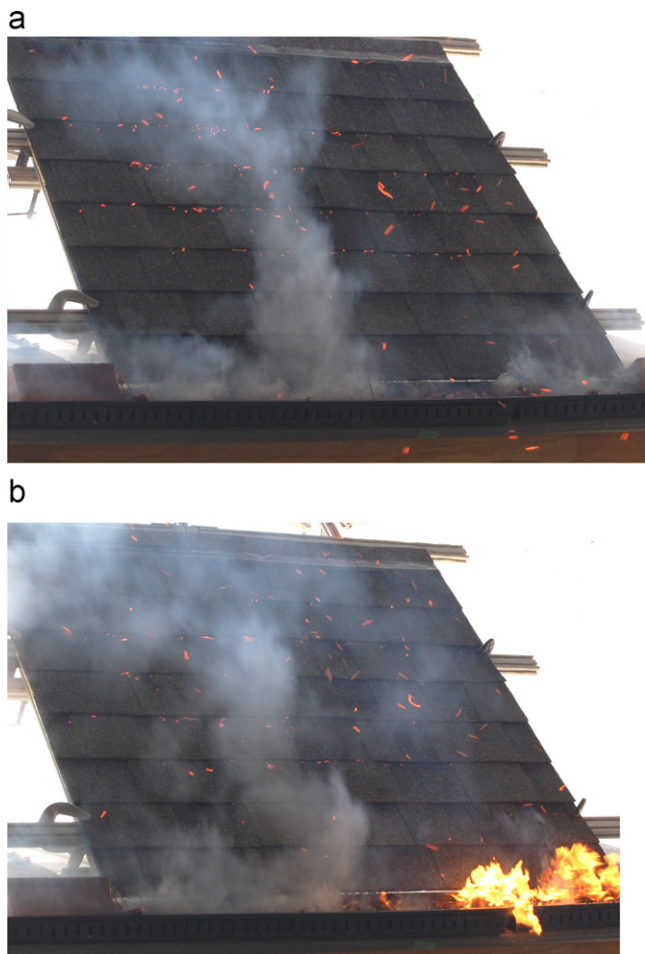
Fig. 8. Section of full scale roof assembly [21]. (a) Smoldering ignition of needles/leaves inside gutter and (b) transition to flaming ignition. The wind tunnel speed was 7 m/s and the roof assembly had dimensions of 122 cm by 122 cm.

Pine needles in the gutters of homes may be susceptible to ignition by firebrand showers. To investigate this, a flat roof section was built and a gutter was attached to the front. The gutter was constructed of polyvinyl chloride (PVC); a gutter material found in new home construction. As in the roof valley experiments described above, OSB was used as the base layer; tar paper and shingles were then applied. Dried pine needles and leaves were used and placed inside the gutter.

Fig. 8a, b displays typical results obtained from the experiments. The firebrands that were deposited inside the gutter produced SI inside the gutter. The smoldering intensified and ultimately this transitioned to FI. The asphalt shingles were observed to melt once exposed to the intense flaming that occurred inside the gutter. The flames, however, did not spread up the roof section. While the flames did not spread upwards along the roof, these images are very important since they clearly show the dangers of not cleaning gutters. The influence of pre-heated shingles as well as aged shingles was not addressed.

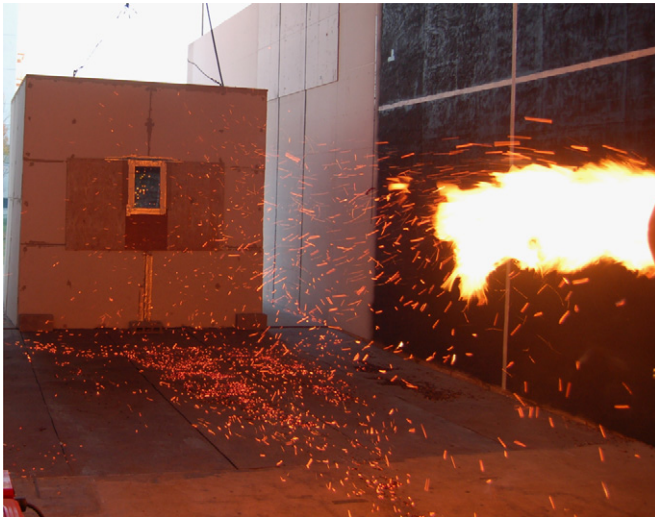
Fig. 9. Typical experiment using NIST Firebrand Generator at BRI's FRWTF [23]. The mesh installed in this experiment was 20 × 20 (1.04 mm), the wind tunnel speed was 7 m/s, and the Firebrand Generator was located 7.5 m from the structure. The dimensions of the structure were 3.06 m in height, 3.04 m in width, and 3.05 m in depth and it was constructed of calcium silicate (non-combustible) board.

were filled with shredded paper, SI followed by FI occurred in the paper for mesh sizes up to 10 × 10 (2.0 mm). The OSB layer was then observed to ignite by SI and subsequently produced a self-sustaining SI that continued to burn holes into the OSB. For the smallest mesh sizes tested (16 × 16 and 20 × 20), NI was observed in the paper and consequently NI in the crevice. A photograph of a typical experiment is shown in Fig. 9.

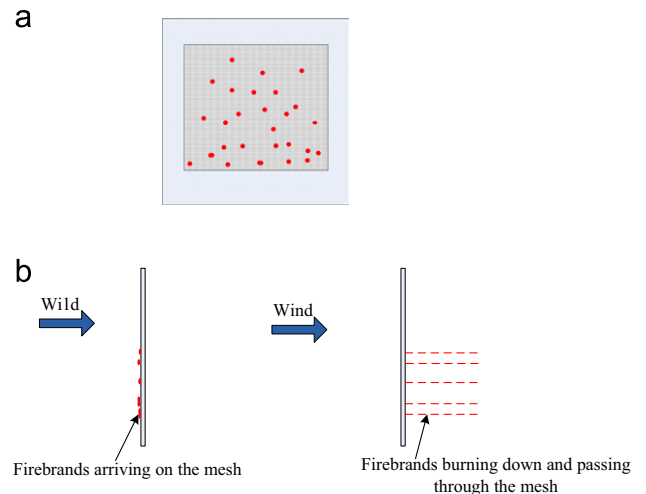
Fig. 10. Schematic of firebrand penetration through a mesh. The identical behavior was observed in both full scale and bench scale experiments. (a) Front view and (b) side view.

In summary, these experiments found that firebrands were not quenched by the presence of the mesh and would continue to burn until they were able to fit through the mesh opening, even down to a 1.04 mm opening (shown in Fig. 10). Mesh size reduction did mitigate ignition of bare wood crevices. Yet, ignition of fine fuel was still observed as mesh size was reduced suggesting that firebrand resistant vent technologies would be helpful.

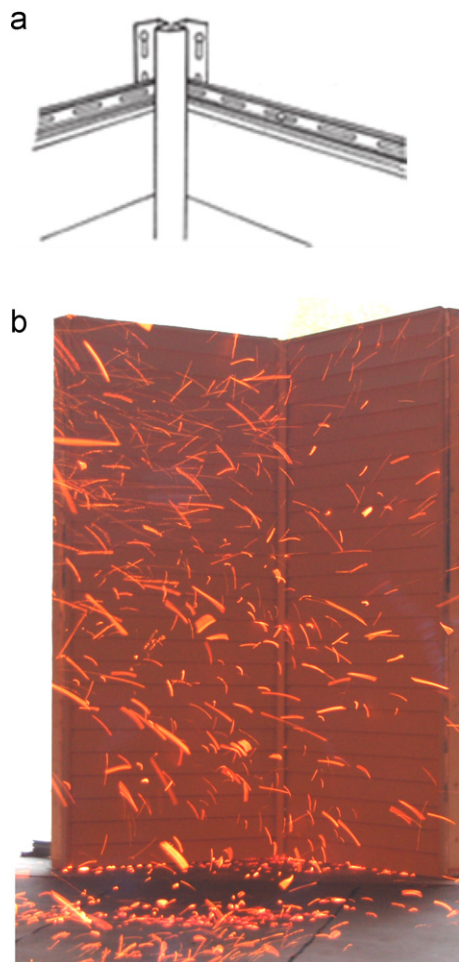
Fig. 11. (a) Drawing of a corner post and (b) picture of vinyl siding reentrant corner assembly under firebrand bombardment [33]. The dimensions of each side of this assembly were 122 cm wide by 244 cm high.

A full scale reentrant corner section (each side was 122 cm wide by 244 cm high) assembly was constructed for testing. To be able to control the moisture content of the OSB sheathing, the

experiments were designed in a modular fashion. Specifically, each side of the 122 cm by 244 cm full section was comprised of 12 separate OSB pieces. This allowed each section to be oven dried and simply reassembled inside the custom mounting frame. For each assembly, a moisture barrier was applied (Tyvek,¹ a registered product of DuPont, was used for the vinyl and polypropylene siding; felt underlayment was used for the cedar siding) and then the siding treatments were applied. The frame was constructed using wood studs with a stud spacing of 406 mm (16") on center. The American Vinyl Siding Institute and the Cedar Shake and Shingle Bureau (wall manual) were consulted for proper installation and construction was performed in accordance with their respective installation manuals [34,35].

For experiments with vinyl siding (see Fig. 11b for typical experiment) conducted at 7 m/s and 9 m/s, the firebrands were observed to melt the siding to the point where holes developed through the material. A picture of this is shown in Fig. 12. While burns were observed in the moisture barrier at both wind speeds (Tyvek), ignition of the OSB sheathing was only observed for vinyl siding tests at 9 m/s and when the sheathing was dried. It is important to point out that the OSB sheathing burned completely through and ignition was observed within the wood framing members as well (2 × 4).

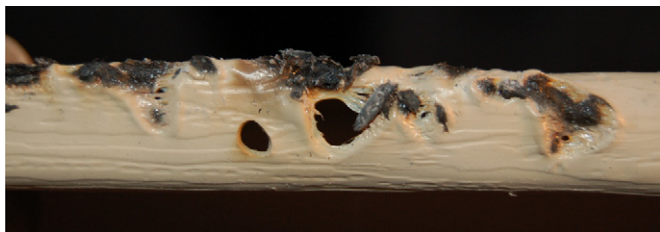
Fig. 12. Image of vinyl siding (from bottom) after firebrand exposure at 7 m/s [33].

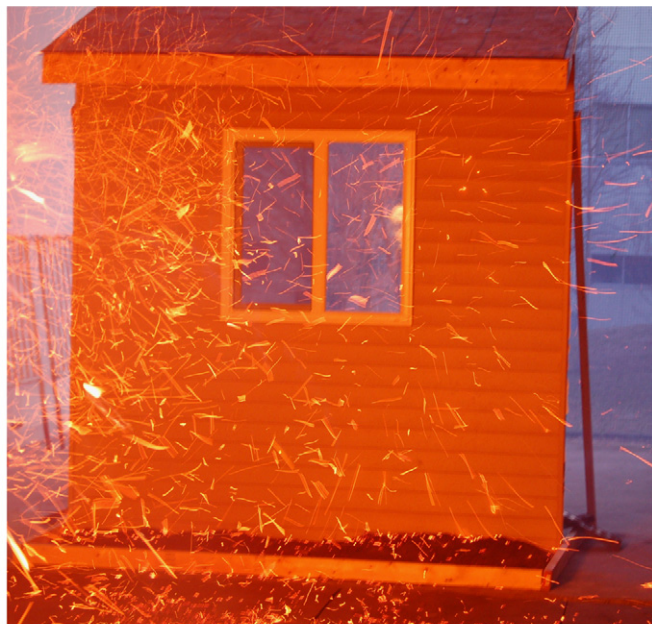
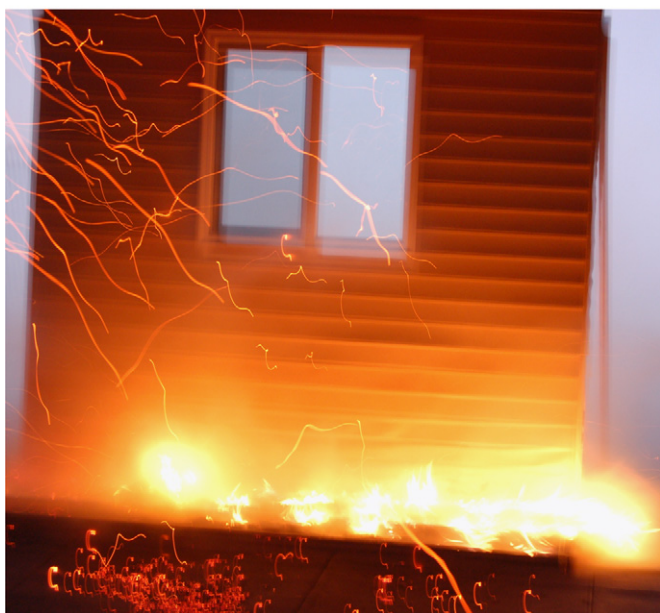
Fig. 13. In the top image, firebrands have caused smoldering ignition in the mulch bed [33]. In the bottom image, smoldering ignition has transitioned to flaming ignition and the wall assembly has ignited. The dimensions of the wall assembly were 244 cm by 244 cm.

Firebrands were observed to ignite the needle bed via SI, the smoldering ignition become self-sustaining, and a transition to FI was observed (see Fig. 13). The FI in the needles subsequently melted the vinyl siding and produced self-sustaining SI at the base of the wall assembly (within the OSB; this OSB was not even dried).

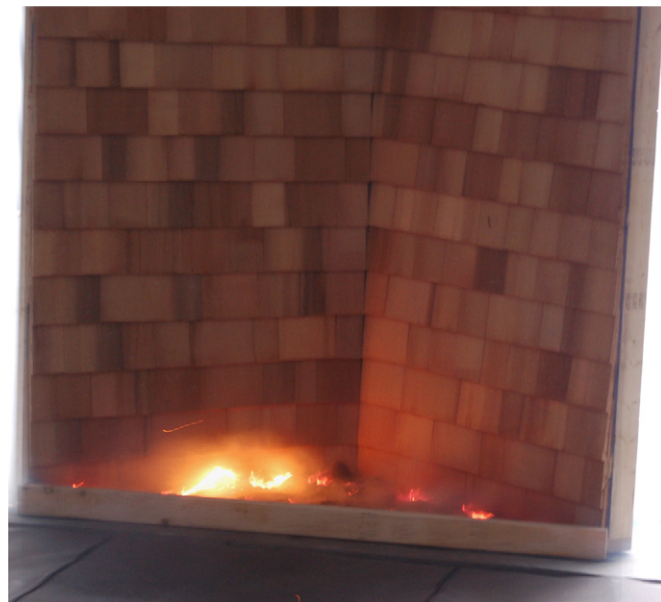
Fig. 14. Images of untreated cedar shingle siding ignited under firebrand attack at a wind tunnel speed of 7 m/s. The dimensions of each side of this assembly were 122 cm wide by 244 cm high.

When considering untreated cedar shingle siding, similar results were observed; namely ignition of wall assembly itself (see Fig. 14). The fire retarded cedar shingle siding performed very well. Even though the fine fuels exposed the wall assembly to flames, ignition of the cedar shingle siding was not observed, nor did any ignition occur in the OSB sheathing.

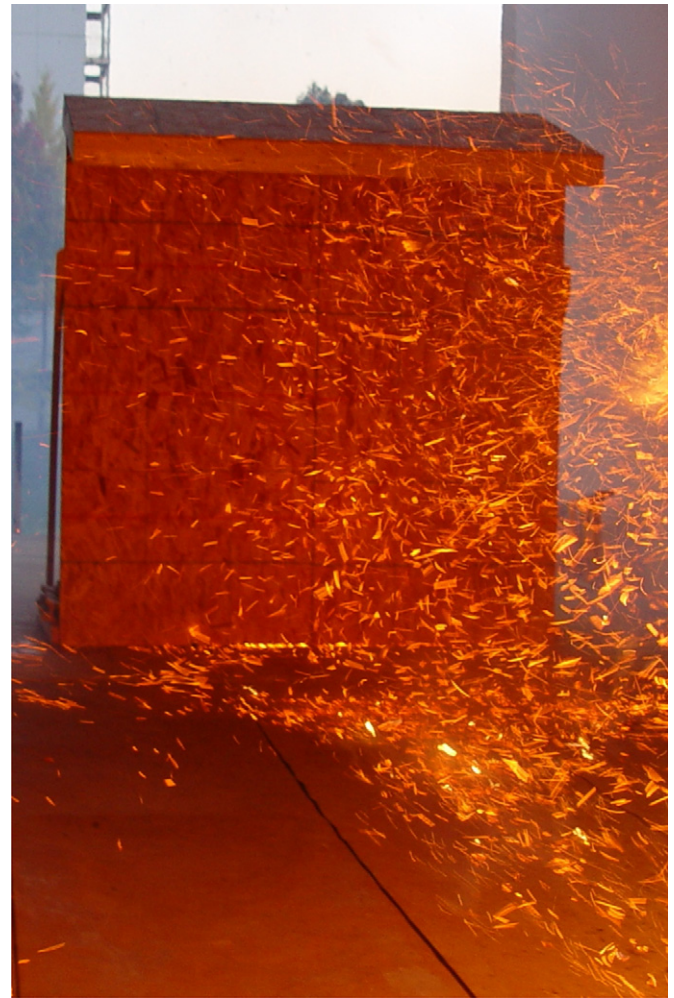
Fig. 16. Image of wall fitted with eave under firebrand bombardment [33]. The wall dimensions were 244 cm by 244 cm with a 61 cm eave overhang.

replicate experiments were performed. For the experiments that used no vent opening, firebrands were not observed to accumulate under the eave over the range of wind speeds considered (see Fig. 16 for a typical experiment).

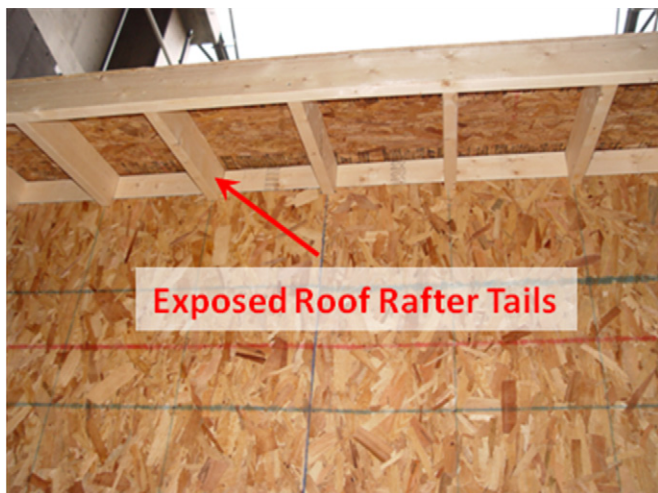
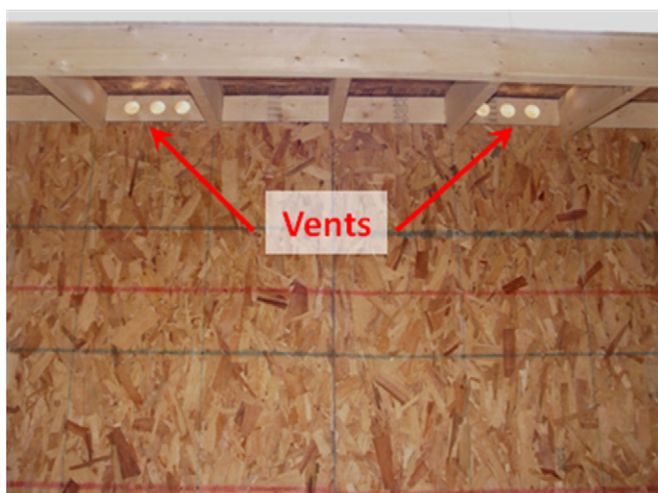
Fig. 15. Images of open eave construction with no vents (top) and vents (bottom) [33]. In both images, the wall dimensions were 244 cm by 244 cm. The eave overhang was 61 cm.

Consequently, the open eave construction, thought to be the most vulnerable configuration situation, was used for experimentation. An eave with a total length of 122 cm overhang was constructed and mounted to a 2.44 m by 2.44 m wall assembly. While the eave was 122 cm long, the actual overhang used was 61 cm. Since the purpose of these experiments was to determine if any accumulation of firebrands was observed within the eave assembly, the wall was simply fitted with OSB sheathing and it was not dried. The wall was constructed using wood framing members spaced 406 mm (16") on center. Details of these results were presented in a recent journal publication [33].

In half of the experiments, no vent opening was used to simply observe if firebrands actually accumulated within the exposed rafters and subsequent joints (see Fig. 12). In the remaining experiments, vents were installed (see bottom panel) and a mesh was placed within the vent opening (see Fig. 15). For the vent openings, 50 mm holes were drilled into the blocking material and an 8 × 8 mesh (2.75 mm opening) was secured, as recommended in the new, 2010 California WUI code [30]. Three

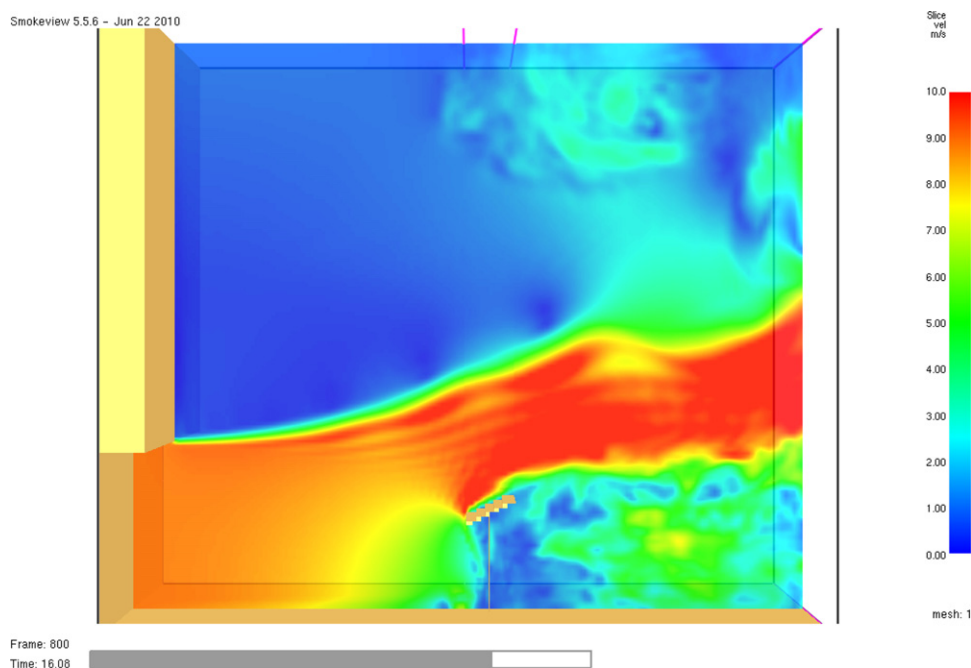
Fig. 17. FDS simulations of air flow around eave assemblies for a wind speed of 9 m/s [33]. The dimensions of the eave assembly are identical to those used in the actual experiments (see Fig. 16) and numerical grid spacing was 5 cm.

The NIST Fire Dynamics Simulator (FDS) was used to visualize the flow around the eave assembly in the FRWTF in an attempt to gain insight as to reasons why accumulation of firebrands were not observed under the eave assemblies for wind speeds of 7 m/s and 9 m/s [33]. FDS is a computational fluid dynamics model of fire-driven fluid flow and numerically solves a form of the Navier-Stokes equations appropriate for low-speed, thermally driven flow. While FDS was designed with fire in mind, it may be used, as in the case of the simulations conducted in this study, for low-speed fluid flow simulations that do not involve fire [38]. The results of the simulations are presented in Fig. 17. The dimensions of the eave assembly are identical to those used in the actual experiments and numerical grid spacing was 5 cm. As mentioned, the flow profile inside the FRWTF was mapped using a series of hot wire anemometers (21 point array). Based on these measurements, the flow profile was observed to be uniform. As a result, in these simulations, the flow profile inside FRWTF was assumed uniform and fixed at 9 m/s.

Although firebrands are not modeled, the resulting air flow profiles demonstrate why accumulation of firebrands was difficult under the eave (see Fig. 17). Specifically, the presence of the wall results in a large stagnation zone in front of the wall that becomes

more pronounced as wind speed was increased. In addition, under the eave there is an area of little or no flow velocity that would be required to drive the firebrands into the joints between the eave and wall assembly. It is important to point out that these simulations considered only airflow and do not include the seeding of firebrands into the flow. Current work at NIST is aimed at incorporating a firebrand transport model into the newly developed Wildland-Urban Interface (WUI) Fire Dynamics Simulator (WFDS).

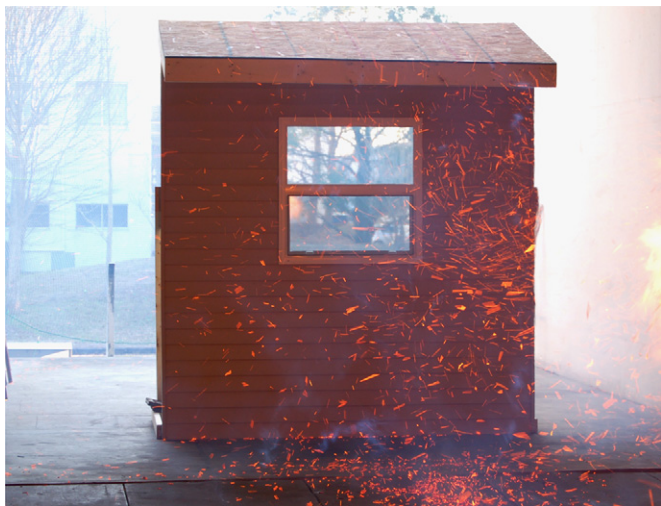
Fig. 18. Picture of wall/eave assembly fitted with a vertically sliding, double hung window exposed to firebrand showers at a wind tunnel speed of 9 m/s [33]. The dimension of wall assembly was 244 cm by 244 cm.

The sizes of each of the glazing assemblies were the same: 91 cm by 91 cm. To mount these assemblies, a 244 cm by 244 cm wall fitted with an open eave was constructed for testing. The wall was constructed using wood framing members spaced 406 mm (16") on center. OSB was applied over the wood framing members and a moisture barrier was installed over the OSB. Vinyl siding was applied over the moisture barrier. An eave with a total length of 122 cm was constructed and mounted to the wall assembly. For completeness, an image of a typical experiment is shown in Fig. 18.

For, each window assembly considered, two different wind speeds were used. Specifically, the window assemblies were exposed to firebrand showers at wind tunnel speeds of 7 m/s and 9 m/s. At 7 m/s, a majority of the firebrands produced from the NIST Dragon were observed to be carried with the flow and impinge of the wall assembly. It was observed that firebrands accumulated within the framing and this behavior was more pronounced for the vertically sliding glazing assembly; as suspected. Yet, in none of the experiments did the framing sustain sufficient damage for the window assembly to cause glass fallout and/or breakage.

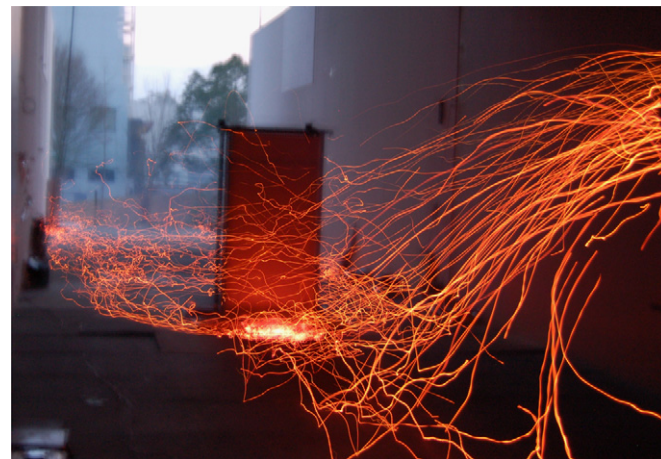
Fig. 19. Photograph taken by increasing the exposure time on the camera to visualize the firebrand streaklines or flow over the obstacles [23]. In this image, the obstacle dimensions were 2.0 m high by 1.0 m wide. The distance from the NIST Dragon to obstacle was 7.5 m.

The presence of the obstacle resulted in a stagnation plane where numerous firebrands were able to accumulate. After the firebrands were observed to accumulate, intense glowing combustion was observed and in all cases, the accumulated firebrands produced an ignition event (SI) in the wood samples. A series of photographs was also taken by increasing the exposure time on the camera to visualize the firebrand flow process over the obstacles. This image is shown in Fig. 19.

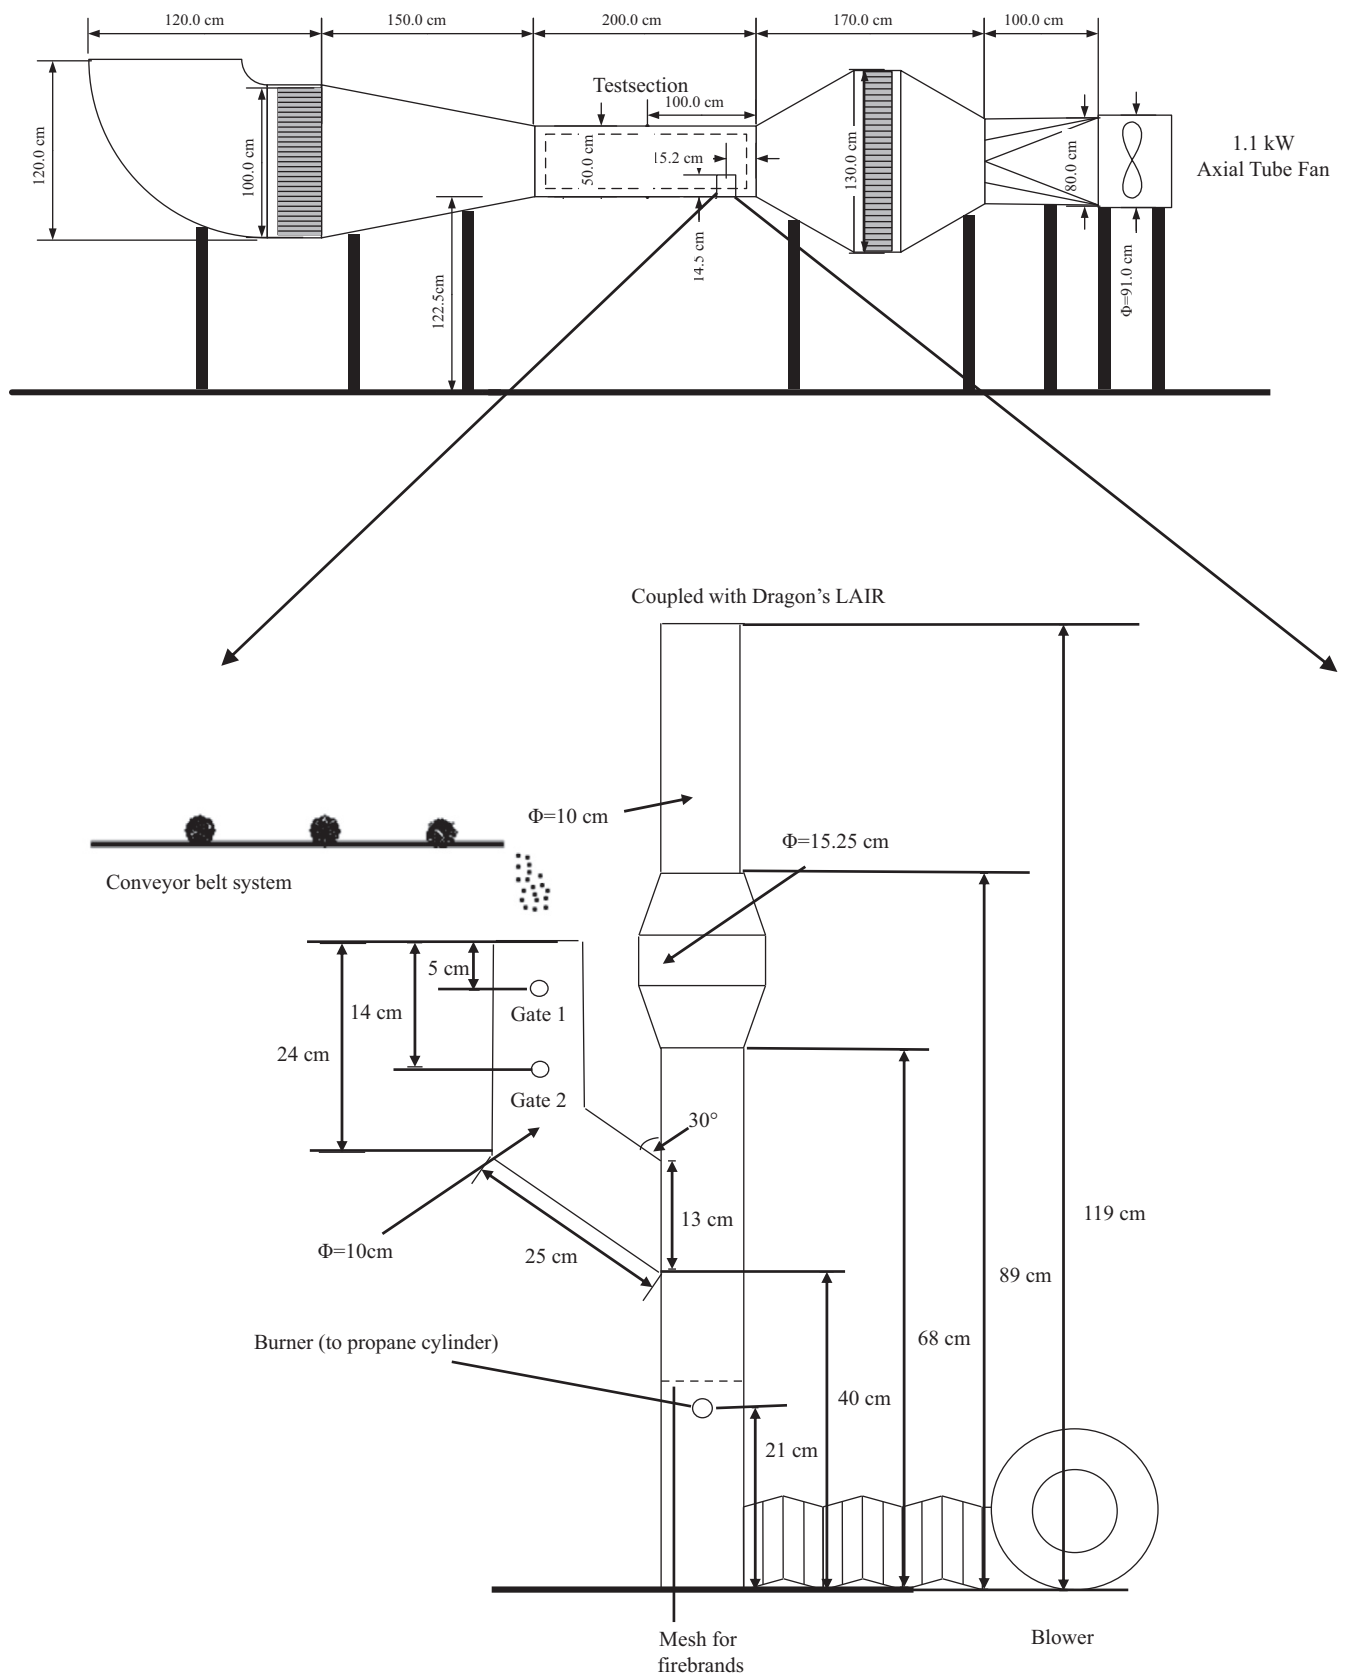
Fig. 20. Schematic of the new and improved NIST Dragon's Lofting and Ignition Research (LAIR) facility [40]. The Dragon's LAIR consisted of a reduced scale continuous feed Firebrand Generator (Baby Dragon) coupled to a reduced scale wind tunnel.

A conveyor was used to feed wood pieces continuously into the device. The conveyor belt was set at 1.0 cm/s, and groups of wood pieces were put on the conveyor belt at 12.5 cm intervals. In each experiment, the group size placed on the conveyor belt was varied to allow for different firebrand exposures to the target (described below). For all tests, Douglas-fir wood pieces machined

with dimensions of 7.9 mm (H) by 7.9 mm (W) by 12.7 mm (L) were used to produce firebrands. The reasons for using wood pieces for these experiments are provided elsewhere [23].

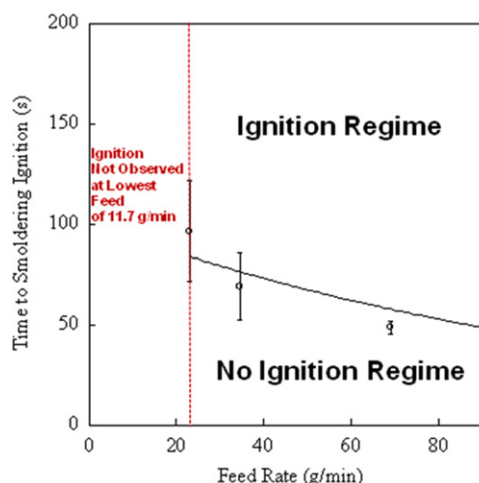
Fig. 21. Ignition regime maps (smoldering ignition) as a function of feed rate for fixed wind glowing firebrand generation rate for fixed wind tunnel speed (6 m/s) when using dried cedar crevices [40].

The number flux, at the exit of the device, was measured as a function of the feed rate. Mass flux data were calculated by multiplying the number flux and the average mass of each firebrand at different feed rates. To measure the firebrand mass, a series of water pans were placed downstream of the NIST Reduced Scale Continuous Feed Baby Dragon after firebrand production reached steady conditions. Water pans were used to quench combustion of the firebrands. If the water pans were not used, the firebrands would continue to burn and by the time collection was completed only ash would remain. These analyses

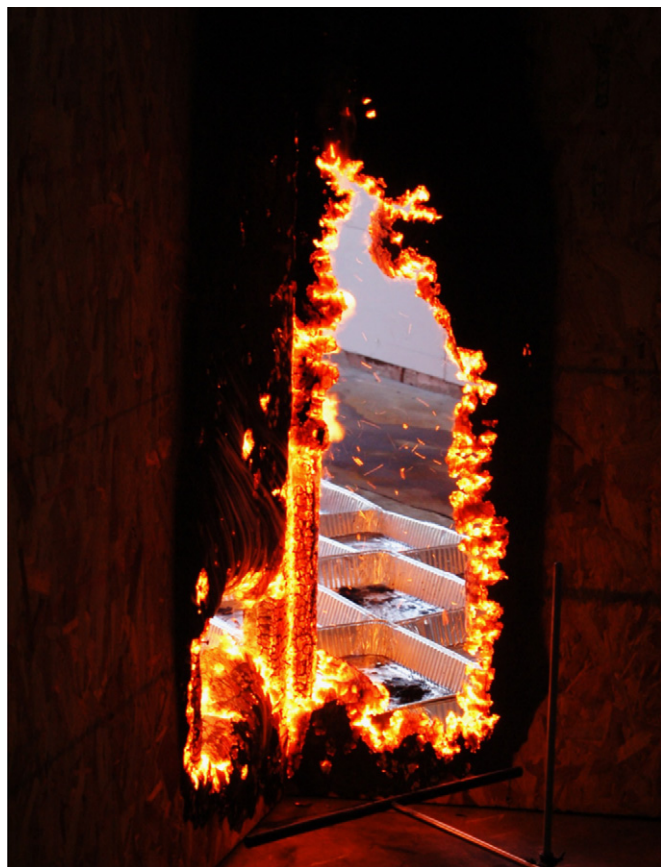
Fig. 22. Firebrand generation from a burning reentrant corner at 8 m/s applied wind [45]. Firebrands are produced on the backside of the assembly and are collected using an array of water pans downstream. The dimensions of each side of the reentrant corner were 122 cm by 244 cm.
