# **Structural Response of World Trade Center Buildings 1, 2 and 7 to Impact and Fire Damage\***

**Abstract.** The National Institute of Standards and Technology (NIST) conducted an extensive investigation of the collapse of World Trade Center towers (WTC 1 and WTC 2) and the WTC 7 building. This paper describes the component, subsystem, and global analyses performed for the reconstruction of the structural response of WTC buildings 1, 2, and 7 to impact and fire damage. To illustrate the component and subsystem analyses, the approach taken for simulating the performance of concrete slabs and shear stud connectors in composite floors subject to fire conditions are presented, as well as steel floor framing connections for beams and girders. The development of the global models from the component and subsystem analyses is briefly described, including the sets of input data used to bound the probable conditions of impact and fire damage. The final analysis results that were used to develop the probable collapse hypotheses, and a comparison of the results against observed events, are presented for each building. A review of research activities focused on improving understanding of str

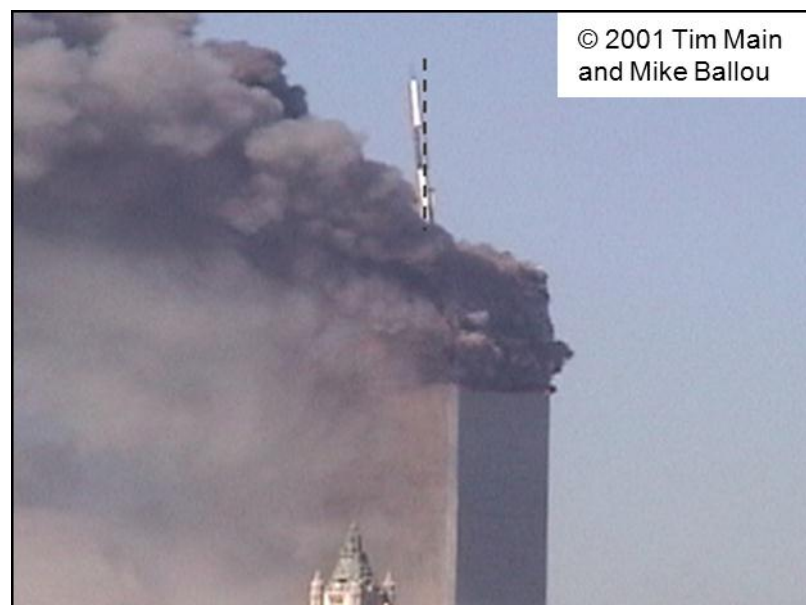
**Figure 11. Collapse initiation of WTC 1 [20].**

**Buckling of South Wall and Collapse Initiation.** The south wall bowed inward as the columns were subjected to high temperatures, pull-in forces from sagging floors, and additional loads redistributed from the core columns. Inward bowing of the south wall of approximately 1.40 m (55 in.) was observed at 10:23 a.m. EDT, as shown in Figure 10. As the inward bowing increased and columns buckled, the column loads transferred to adjacent walls by the hat truss and shear transfer through the spandrel beams and to the thermally weakened core columns via the hat truss. Consequently, buckling progressed horizontally across the south wall and rapidly along the east and west walls. The section of the building above the impact zone tilted to the south, as indicated by the tilt of the antenna on the roof shown in Figure 11, as loads could no longer be redistributed. WTC 1 collapse began at 10:28:22 a.m. EDT.

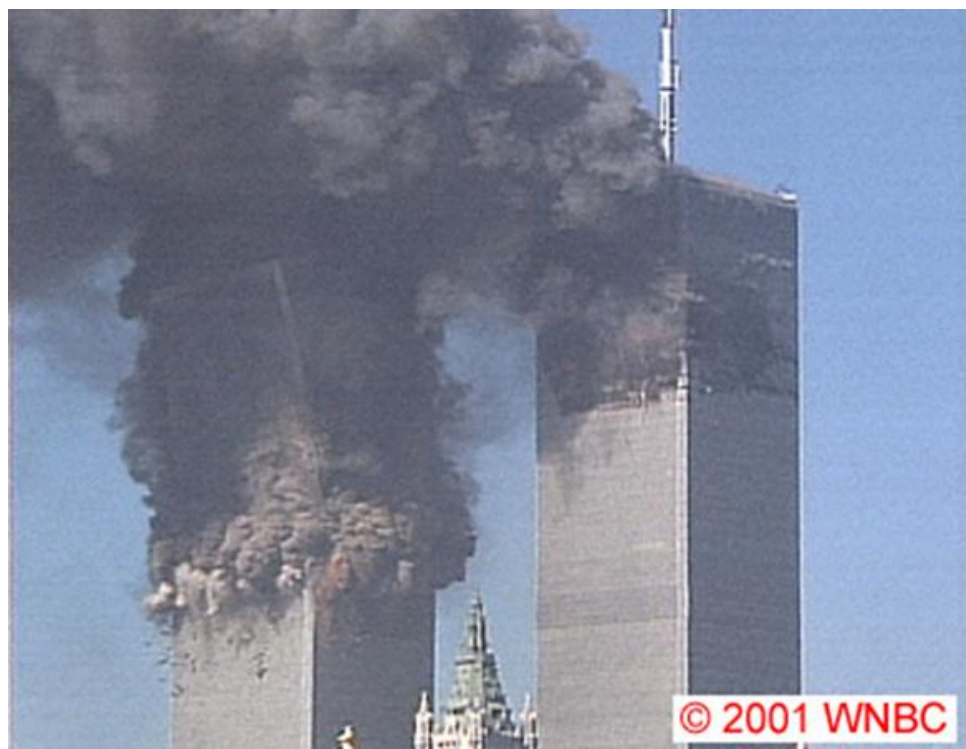
Figure 13. Collapse initiation of WTC 2 [20].

**Buckling of East Wall and Collapse Initiation.** Column buckling on the east wall started at the center and spread rapidly along both sides. As the east wall buckled, loads redistributed to the weakened core through the hat truss and to the east side of the south and north walls through the spandrel beams. The building section above the aircraft impact continued to rotate to the east as it began to fall downward, as shown in Figures 13. When the gravity loads could no longer be redistributed, WTC 2 collapse began at 9:58:59 a.m. EDT.

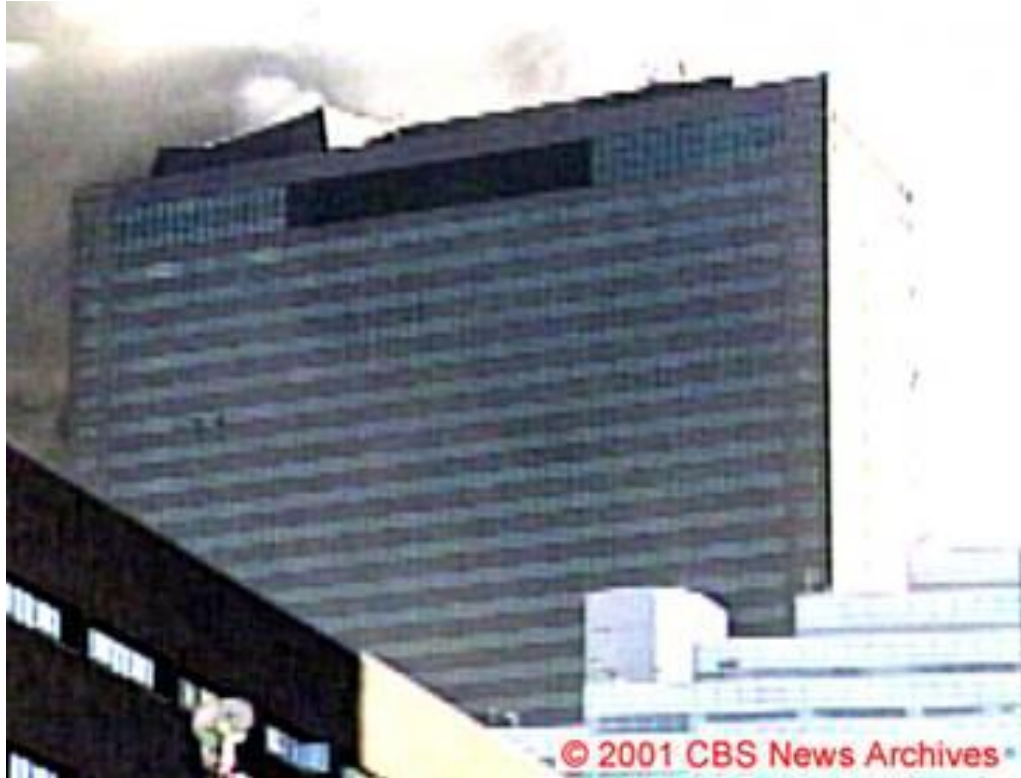
**Figure 19. North face of WTC 7 approximately 1 s after the east penthouse began to move downward [22].**
