National Construction Safety Team Investigation

The Station Nightclub Fire

Federal Advisory Committee
December 3, 2003

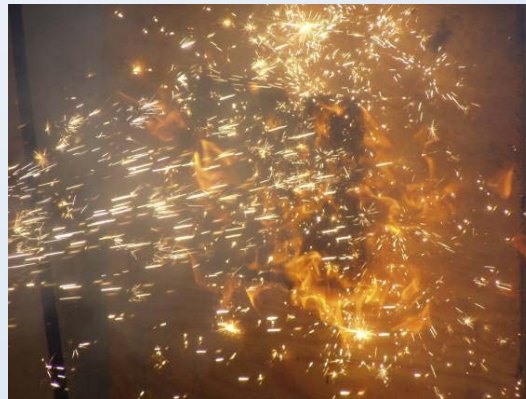
Pyrotechnic “Gerbs:”

- White color, 15 second duration, 15 foot throw
- Examine ignition properties
- Plan to measure heat flux to surface

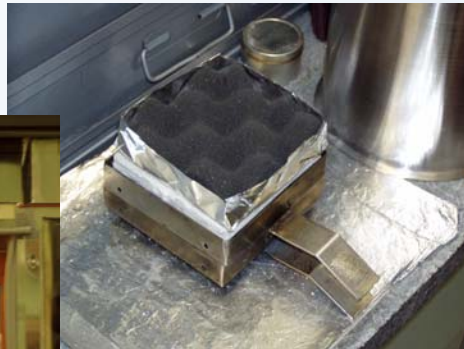
Cone Calorimeter Experiments

3 types of convoluted foam tested

2 – ether based polyurethane

1 – ester based FR PU foam

incident heat flux: 35 & 70 kW/m²

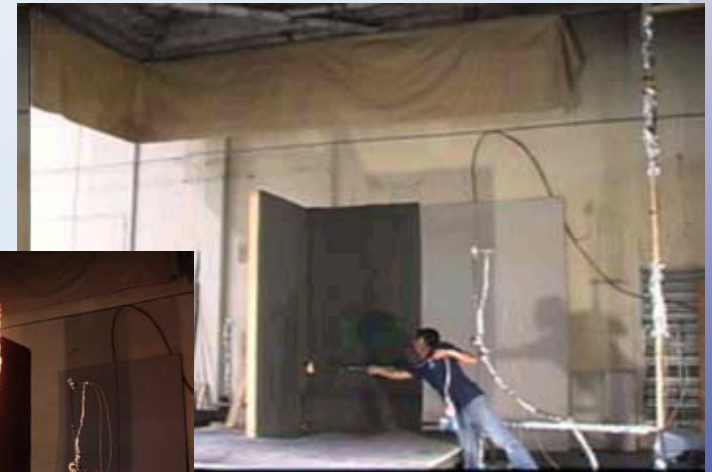
Panel Experiments

- small flame ignition
- inside and outside corner configurations
- measuring HRR, mass loss and heat flux

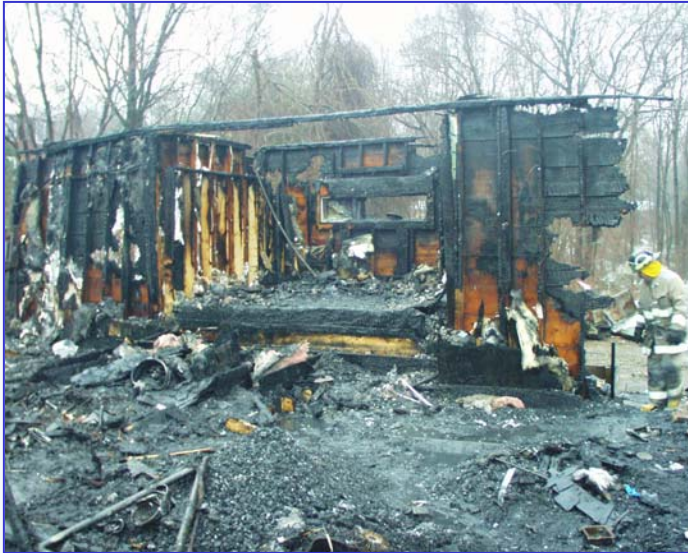
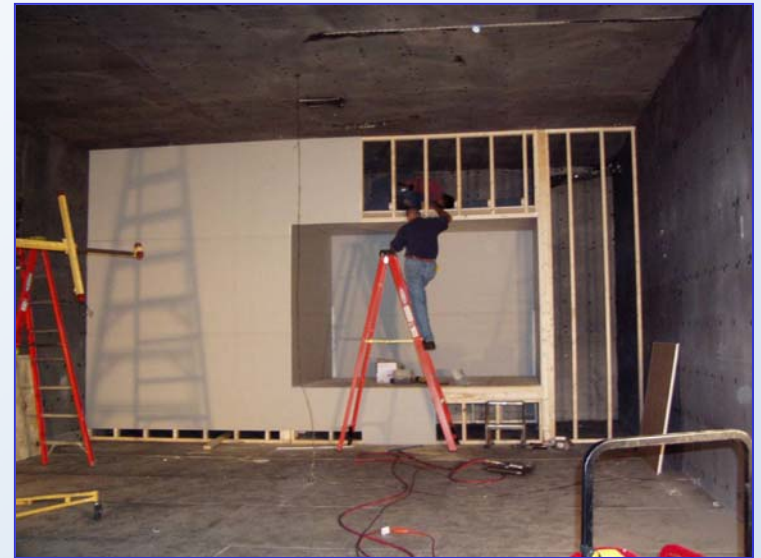
Construction

- Similar dimensions to stage area of nightclub (~ 36 ft x 24 ft x 13 ft high)
- Convoluted non-fire retarded polyurethane foam, plywood paneling
- Carpeted stage & drummer's platform, gypsum ceiling over dance floor area

Measurements: Temperature, CO, CO₂, O₂, HCN, heat flux, heat release rate

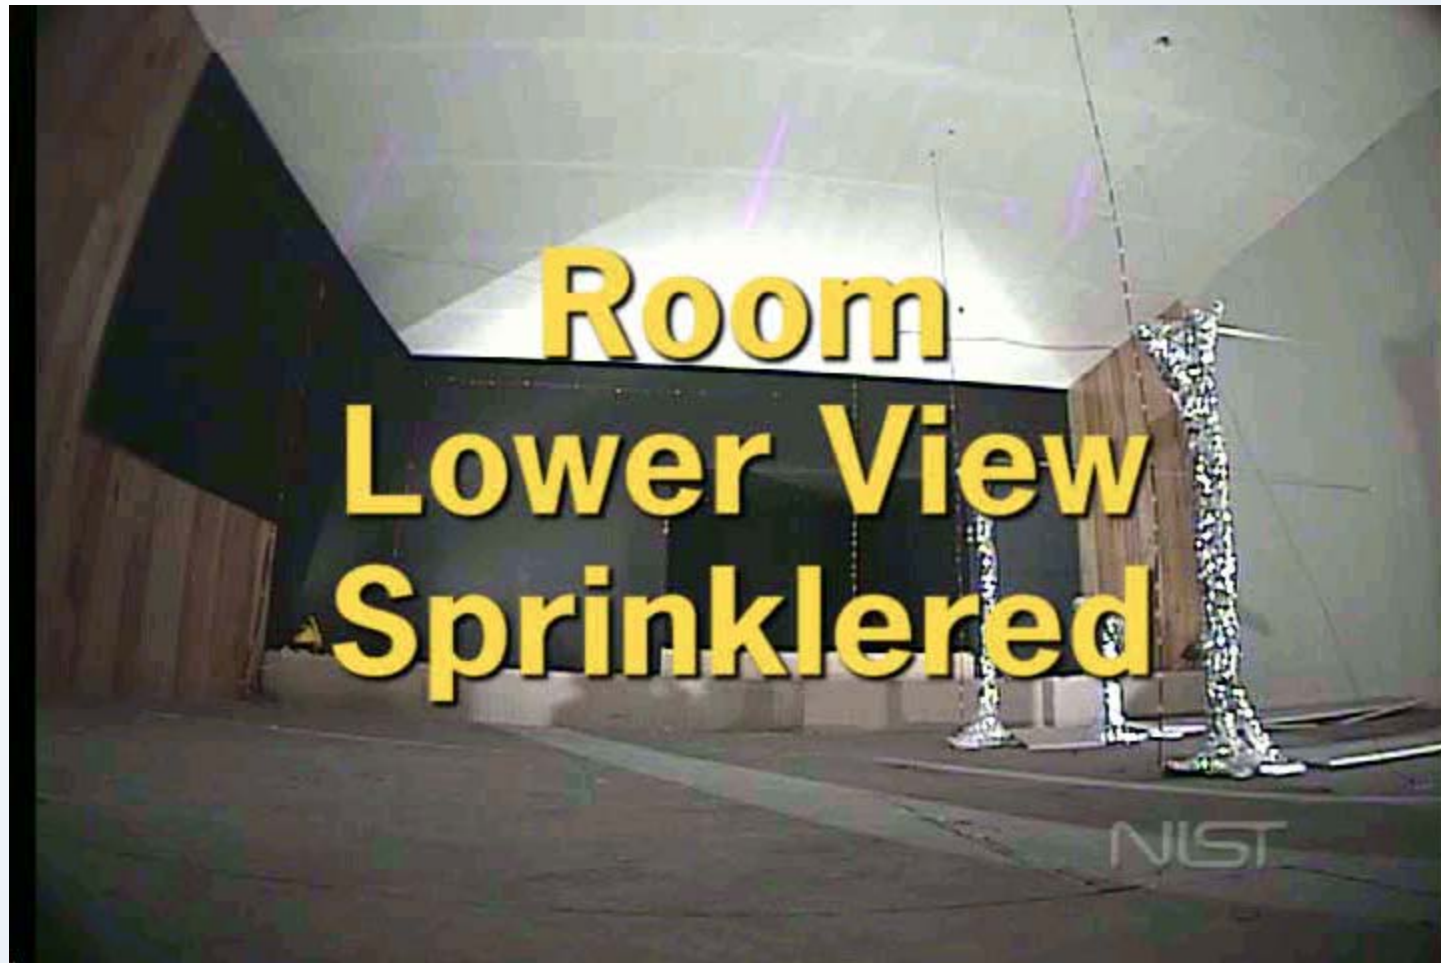
Full-scale Recreation, Stage Area Fire + sprinklers

Sprinkler system installed in test room (same geometry and materials) by commercial supplier according to current NFPA 13 standards:

- spacing – 12 ft X 12 ft (144 ft² coverage per sprinkler)
- total number of heads - 5
- design flow rate – 0.10 gpm/ft² (14.4 gpm)
- activation temperature - 165 °F

Measurements: Temperature, CO, CO₂, O₂, HCN, heat flux, heat release rate, activation time

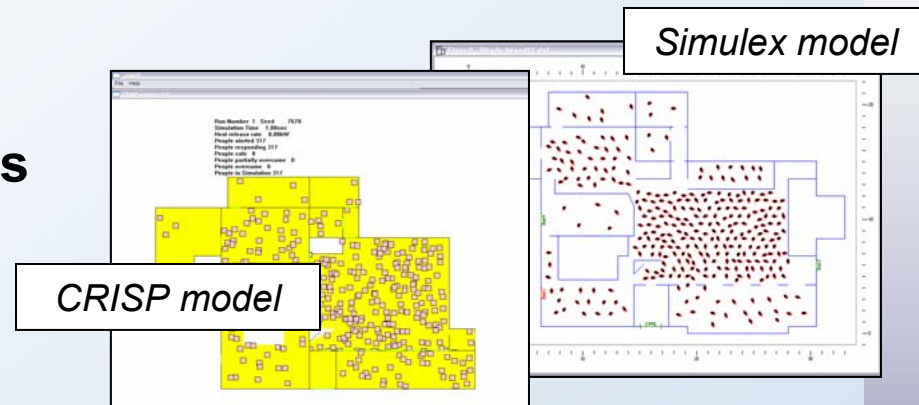
Preliminary evacuation calculations

- Simulex
- CRISP
- EVACNET4
- Hypothetical occupancy rates and evacuation scenarios examined:
404 people w/all four exits available for use in evacuation but with 90% of occupants using most familiar front exit.
- Results: 4 minutes 30 seconds for complete evacuation; no prediction of doorway pile-up
