Analysis of Structural Steel *in the NIST World Trade Center Investigation*

NIST WTC Investigation Projects

Today's presentation

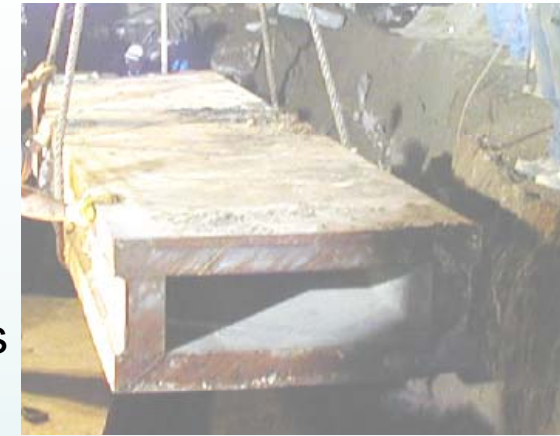
Core column assemblies

- 4 strength levels: primarily 36 ksi and 42 ksi
- Wide-flange (WF) shapes predominant in fire zone of WTC1
- Mixed shapes in WTC 2 (many box → WF transitions in floor s 80 to 86)
- Multiple steel suppliers (!)

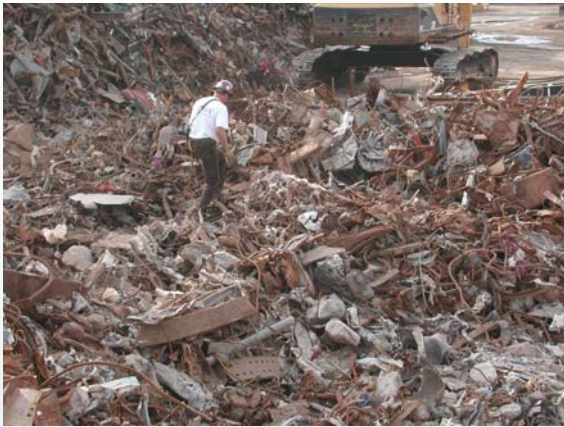
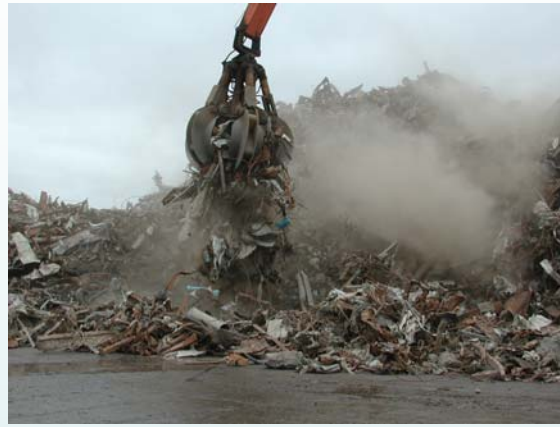
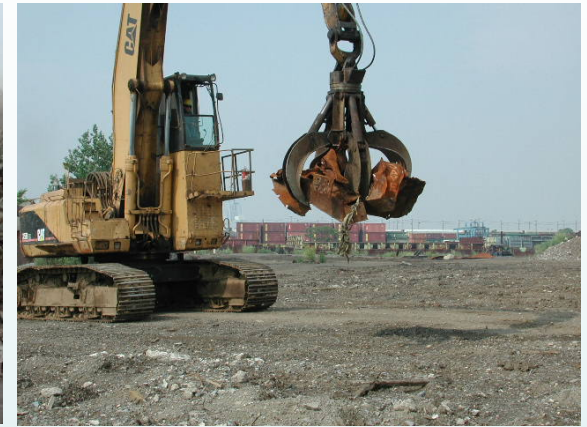
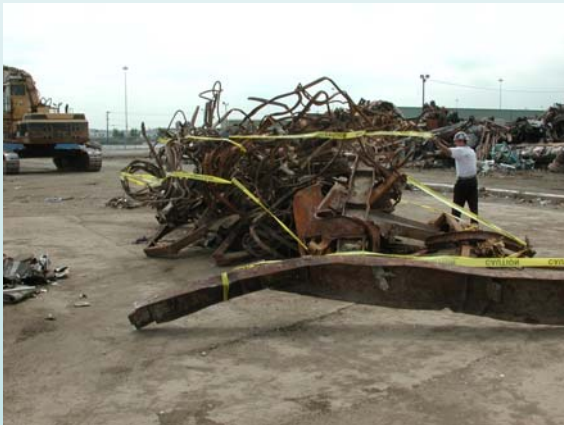
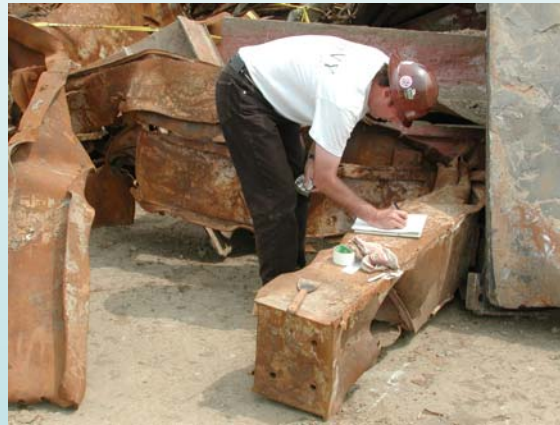
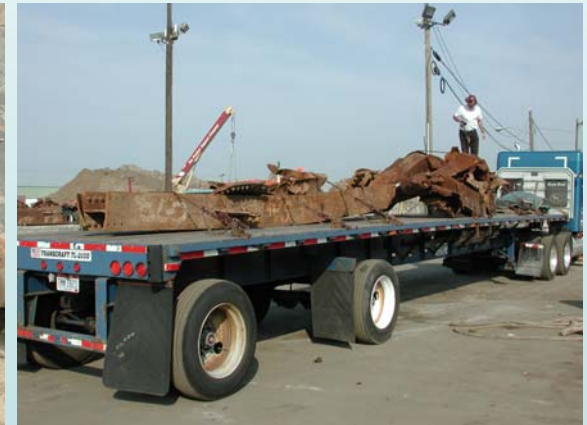
Steel Search, Collection, Logging and Shipping to NIST

~ 1.5 million tons of debris
1/4-1/3 steel
Much recycled immediately (overseas)

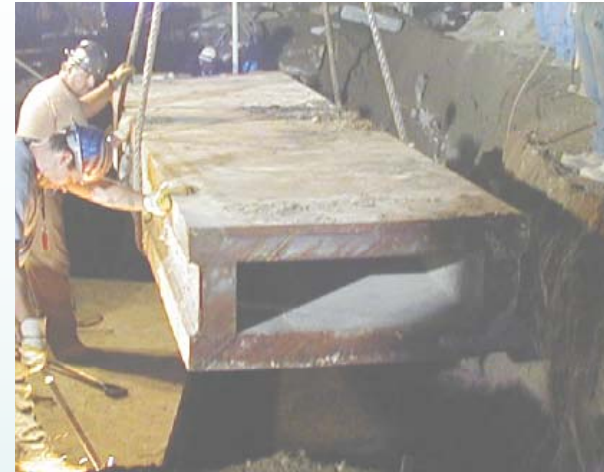
Core box column

- 5 columns
 - 2 wide flange
 - 3 built-up box columns
- 2 from impact zone

➤ *samples of 2 grades (36 and 42 ksi) of both box and wide flange columns, configurations which represent 99% of core columns in the towers.*

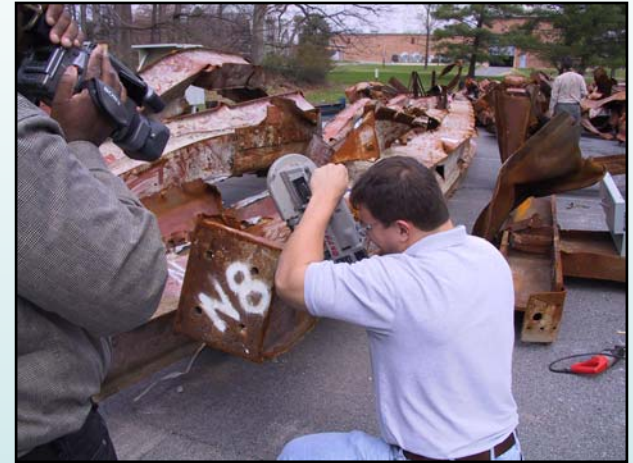
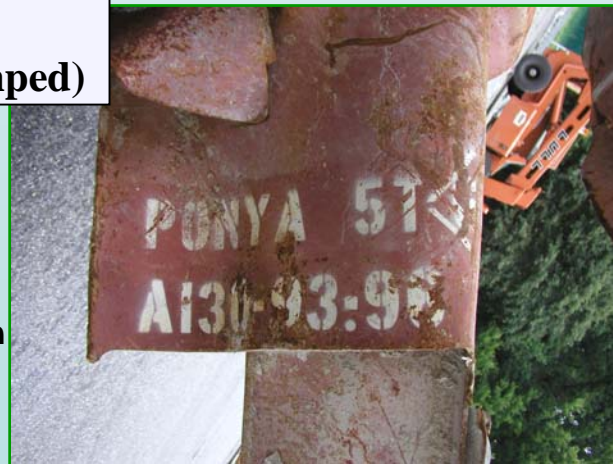
1. Generic diagram
2. Sample identification code
3. Removal method that causes minimal disturbance to the surrounding material

Documentation extremely important!

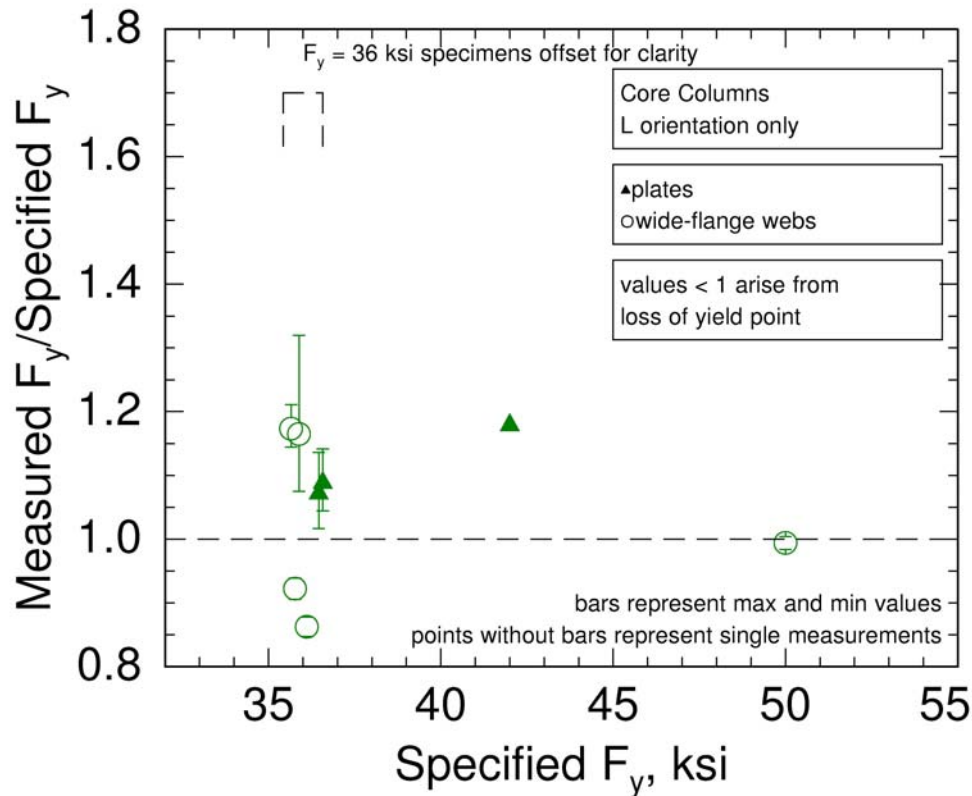
Core column properties

- 4 wide-flange (WF) columns (36 ksi, 42 ksi)
- 3 box columns (36 ksi, 42 ksi)
- 1 beam (50 ksi)
- Specimens with measured/specified <1 exhibit evidence of prior deformation
- Chemistry: 36 ksi plates and shapes are consistent with the requirements of A 36

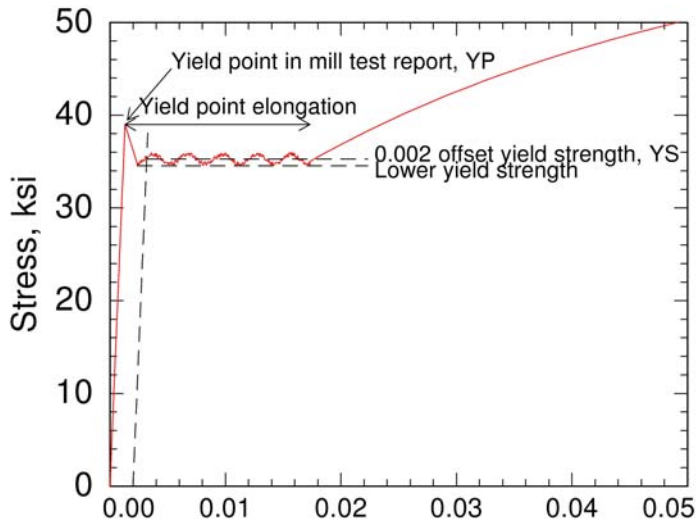
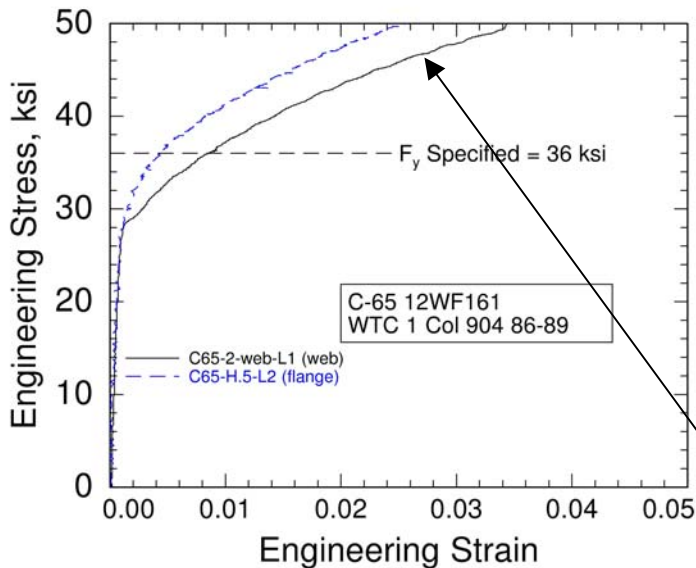
Core columns: damaged specimens

- Low-strength steels are qualified on yield point
- YP/YS can be > 1.1
- Mechanical damage can remove YP
- Most recovered core columns are heavily deformed

Work hardening brings strength up to expected value by $e=0.03$

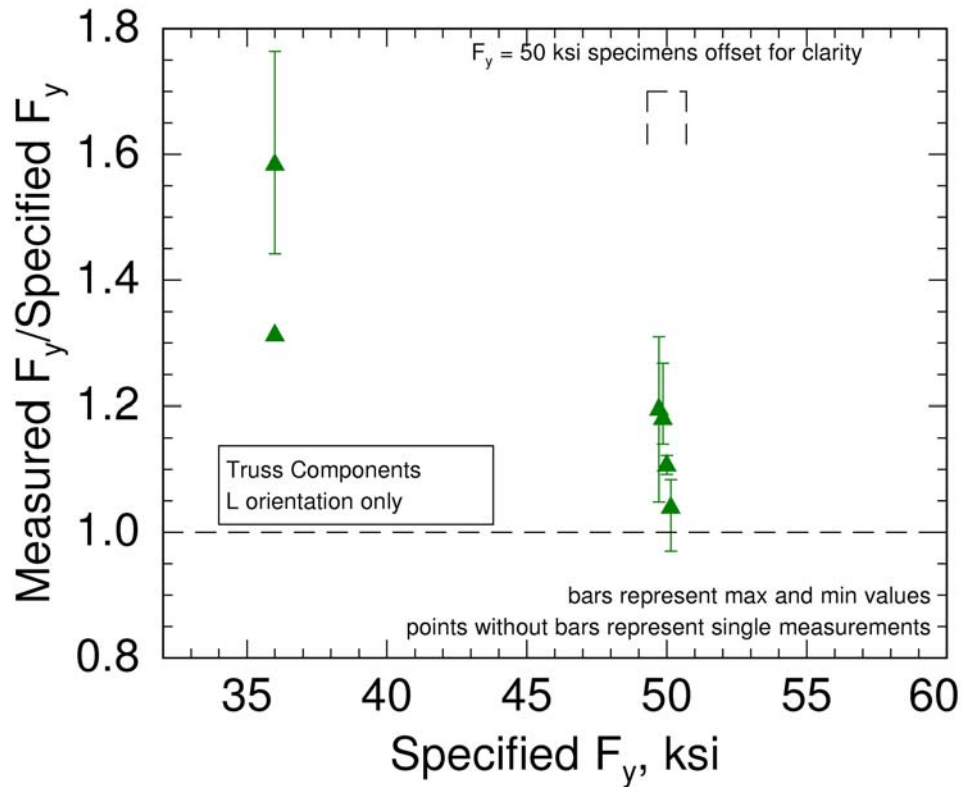
Truss component properties

- A 36 $F_y = 36$ ksi
 - Lower chord and web of 60' trusses
- A 242 $F_y = 50$ ksi
 - Both chords and web of 36' trusses
 - Both chords of bridging trusses
 - Upper chord of 60' trusses
- Chemistry requirements of A 36-66 and A242-66 are similar

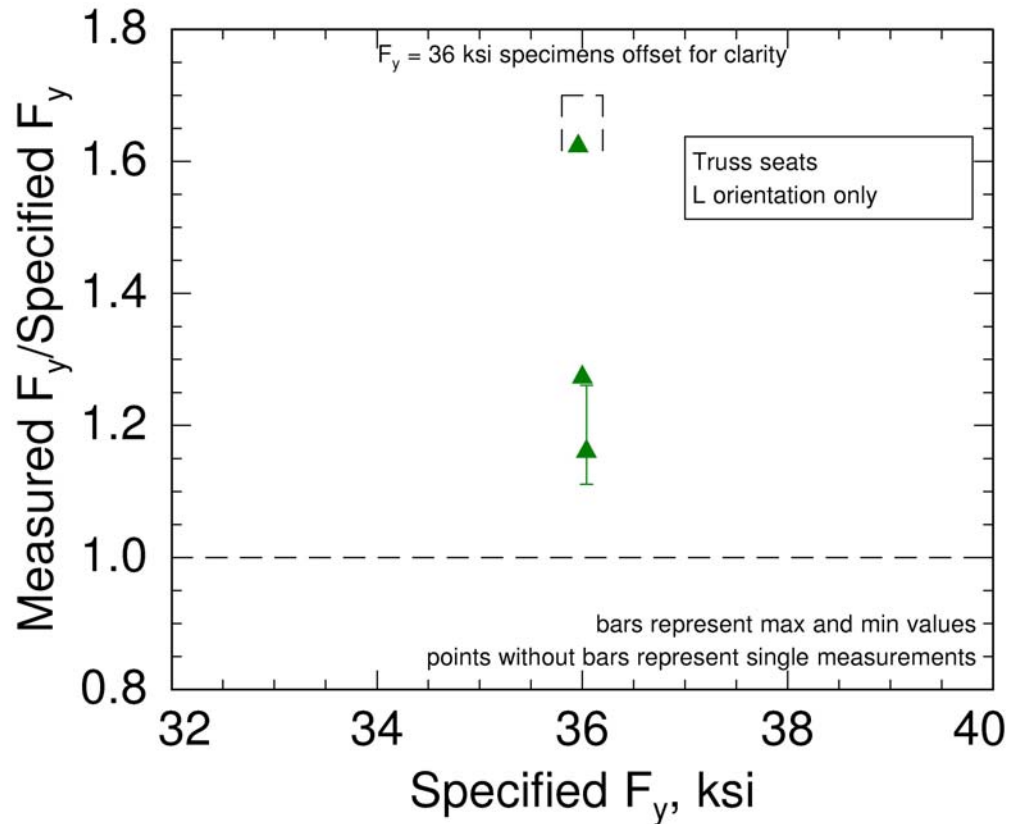
Truss seat properties

- All truss seats specified with $F_y=36$ ksi
- Chemistry of all seats consistent with A36

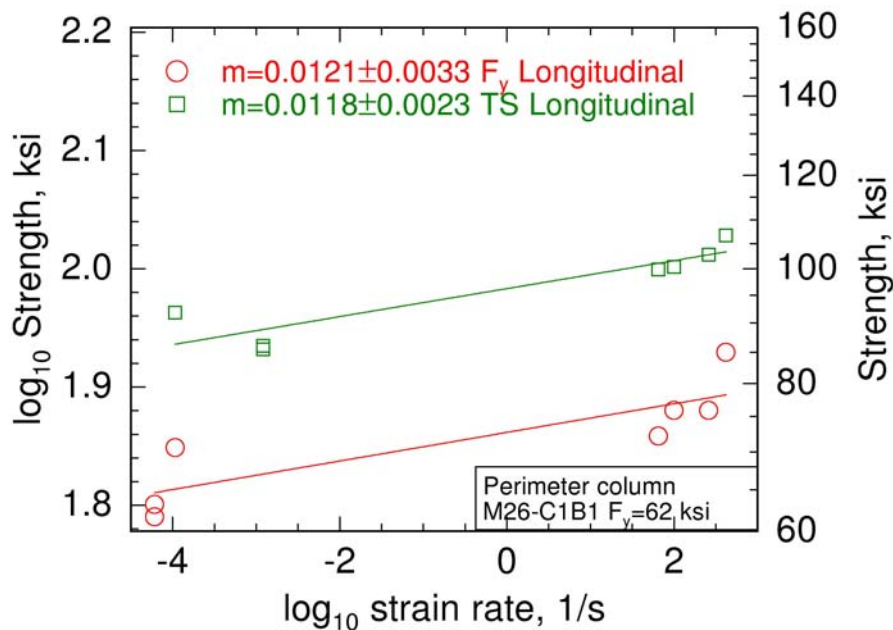
Properties: strain rate sensitivity

$$\sigma_1 = \sigma_0 \dot{\epsilon}_1^m$$

$m = 0.02$ results in 5 % stress increase per decade of strain rate

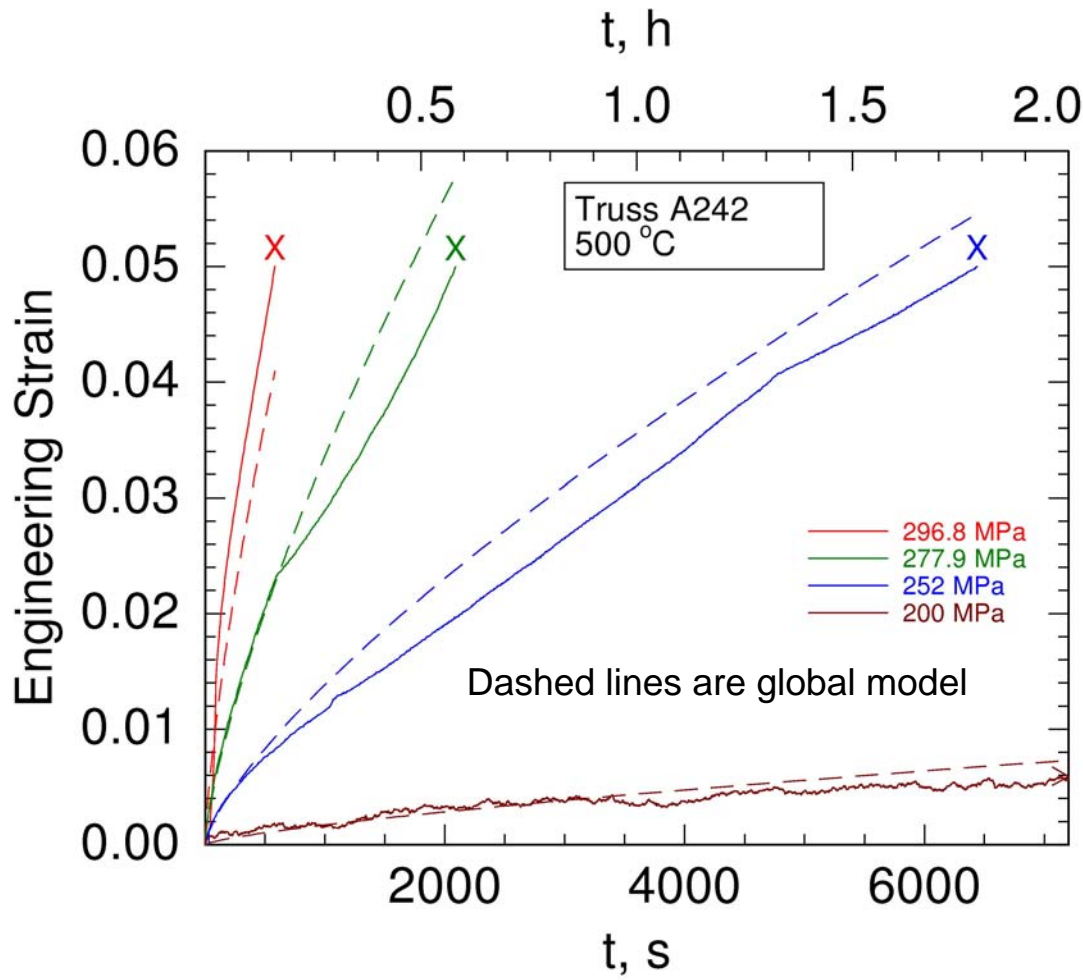
Properties: Creep

- Characterize floor truss steels
- $0 \text{ h} < t < 2 \text{ h}$
- Model all other steels using literature values for AS A149 (like A 36)
- Scale applied stress by ratio of RT tensile strengths (best method)

$$\varepsilon_c = At^b \sigma^C$$

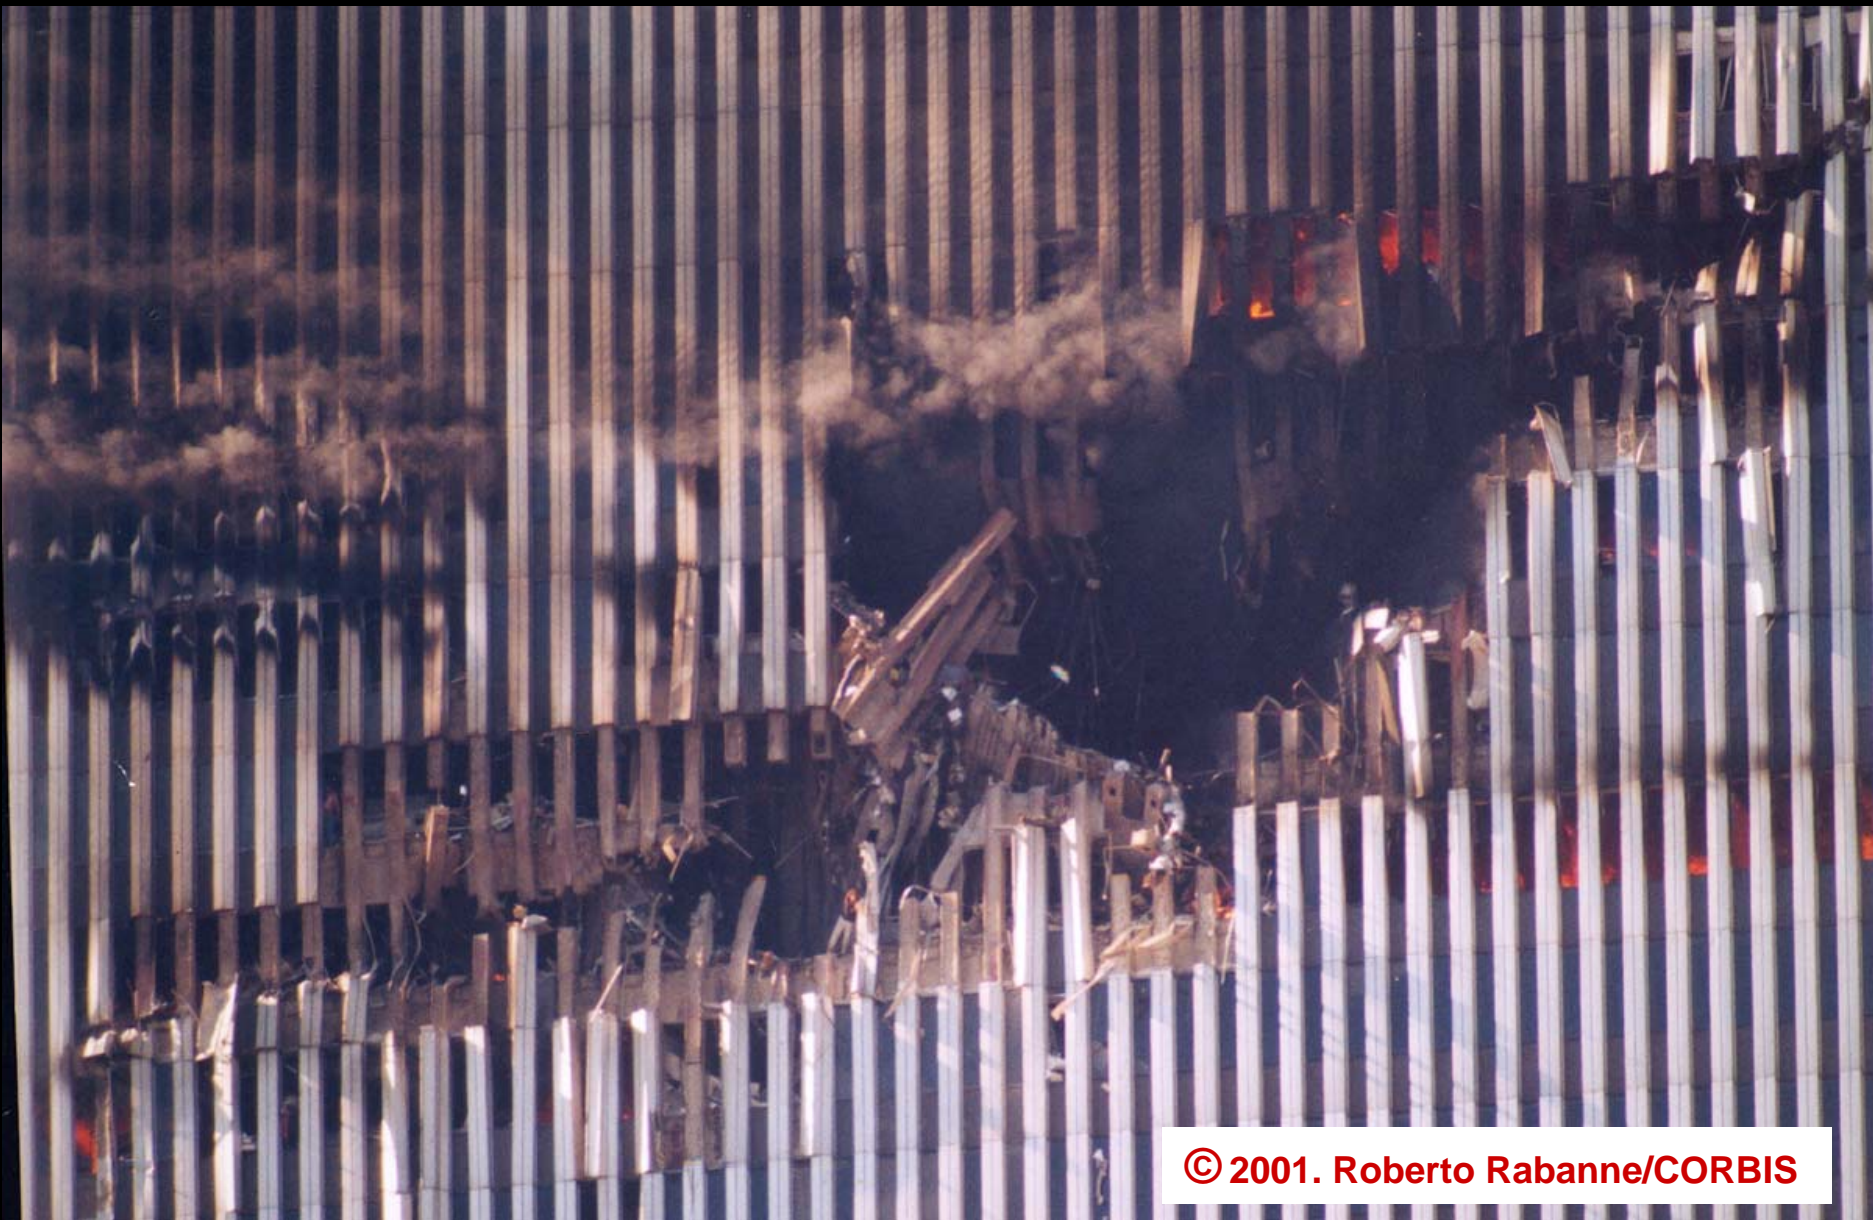
Original Image – North Tower, North Face

Exterior Steel Damage Due to Aircraft Impact

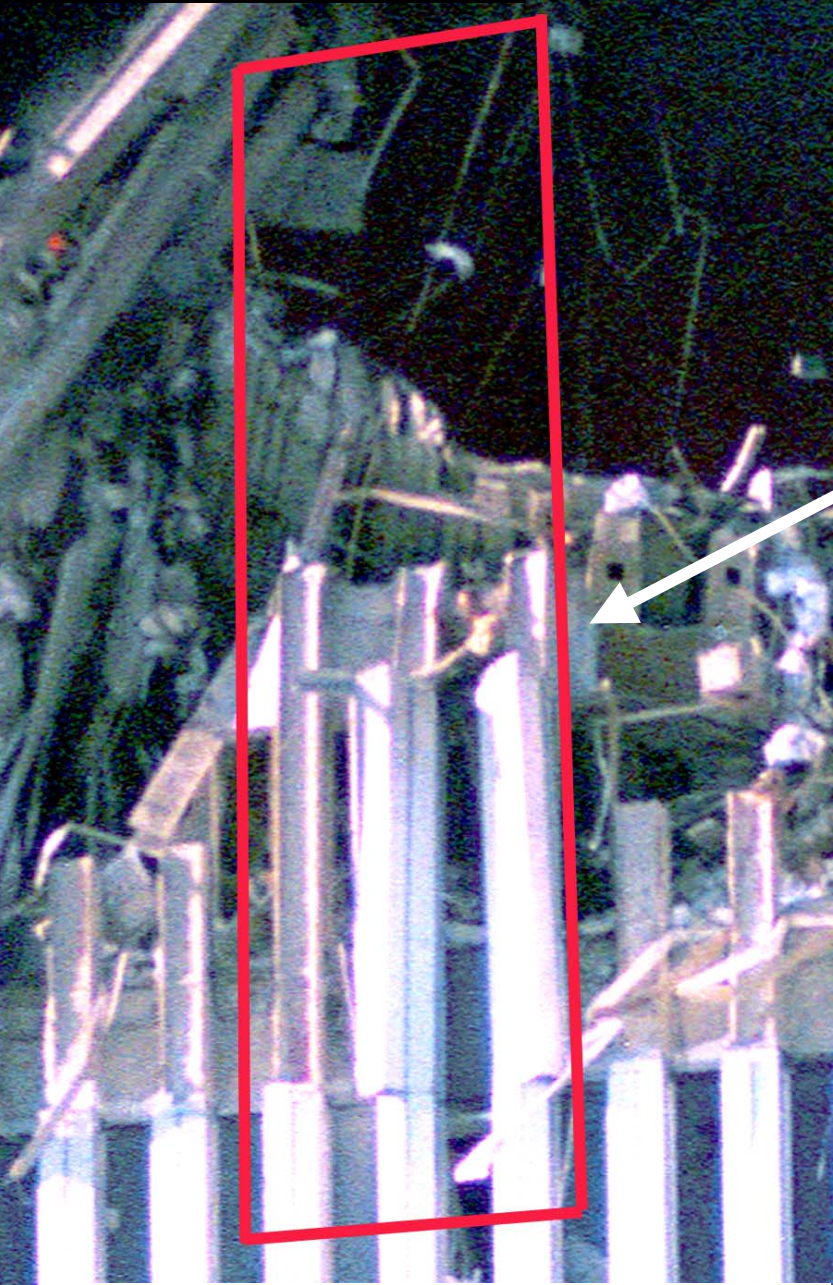
WTC 1, North Face

Original locations of inventory panels as identified by Metallurgy Division

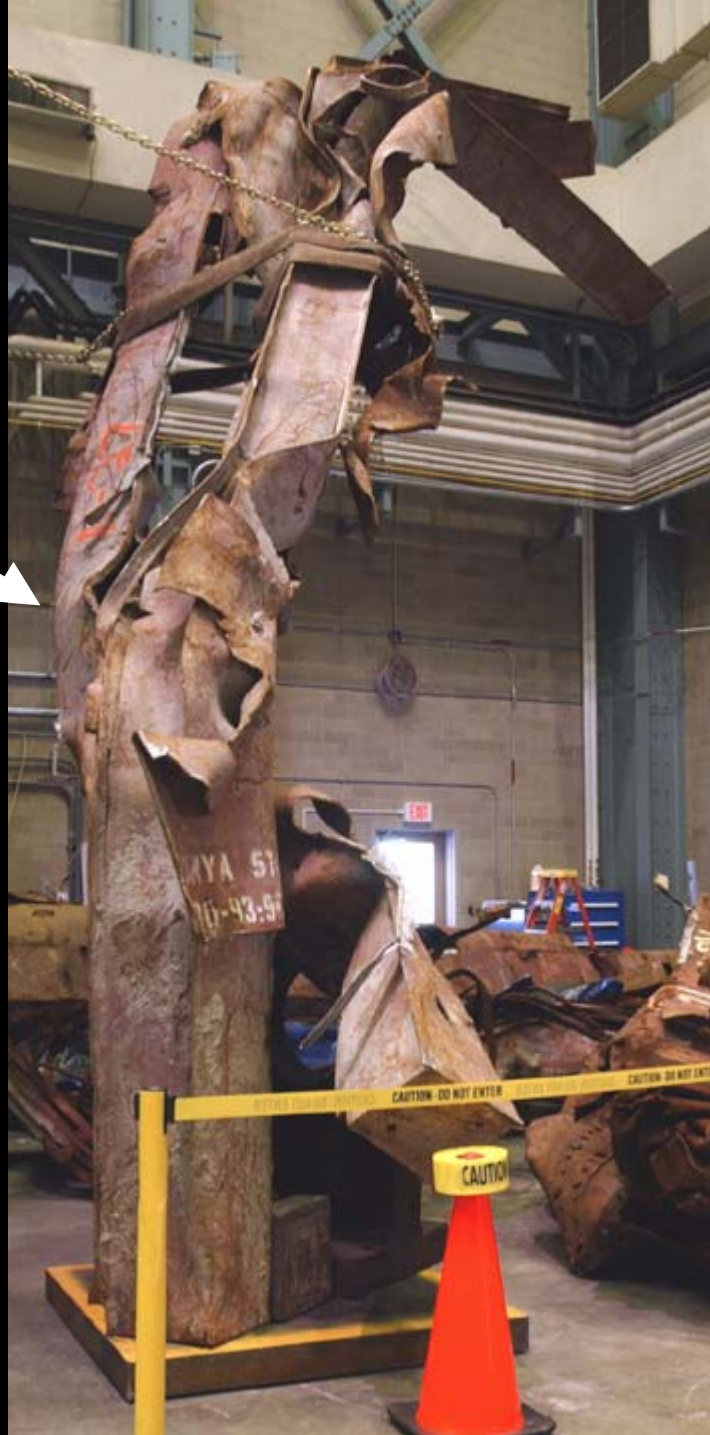
M-27

Direct comparison with state of recovered steel

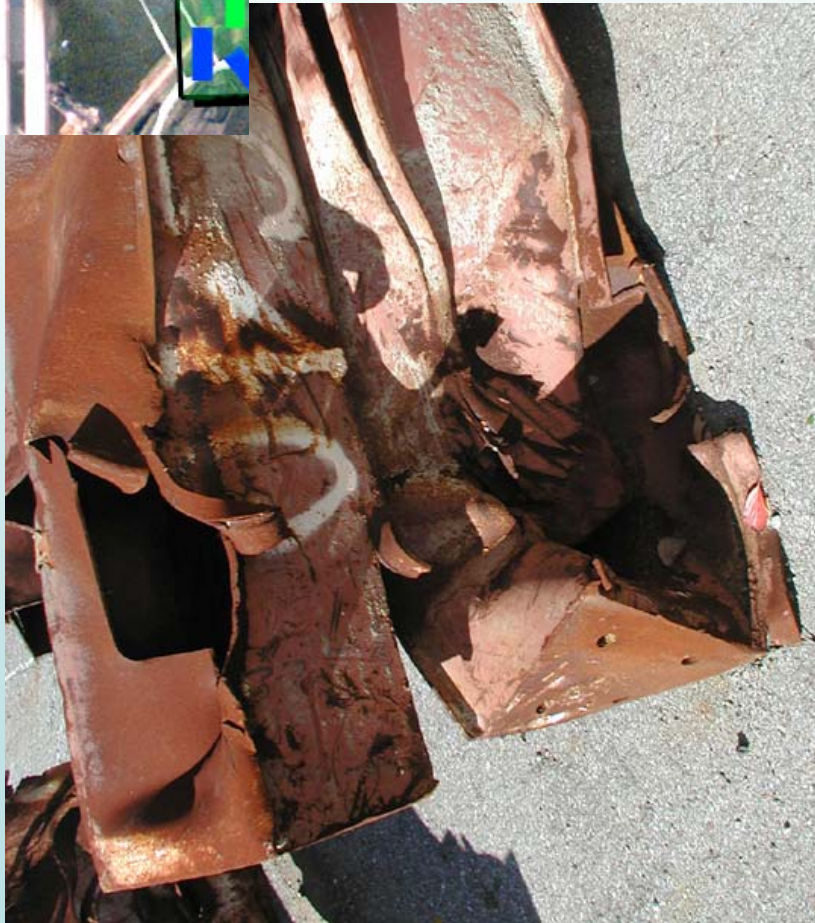
C40 hit by tip of tail?

Closer examination shows collision damage unlikely – damage occurred during fall

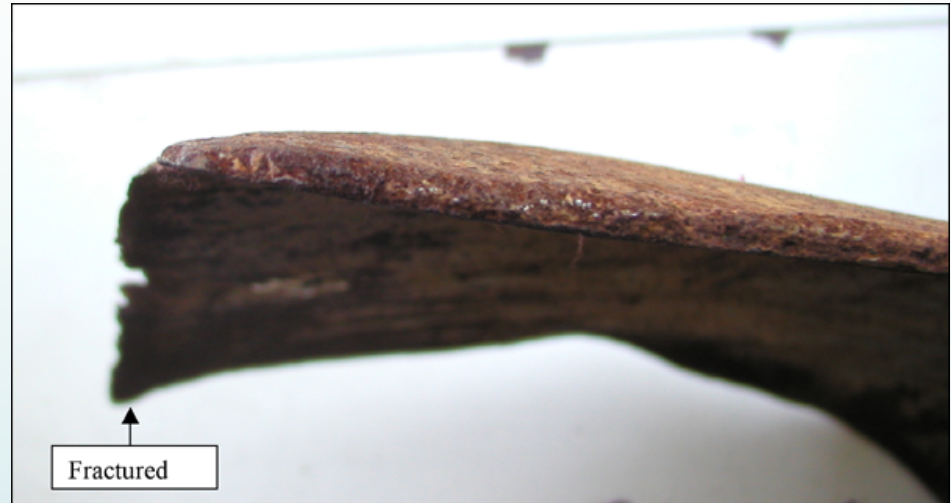
High Rate Failure Mode Observation

- Measured fracture surface profile on outer web from M2 that broke in the impact
- Considerable thinning within an inch of the fracture surface
- Indicates large energy absorption during failure
- No need to have a transition from a low energy to high energy absorption failure mode in the FEA model of the aircraft impact with the building.

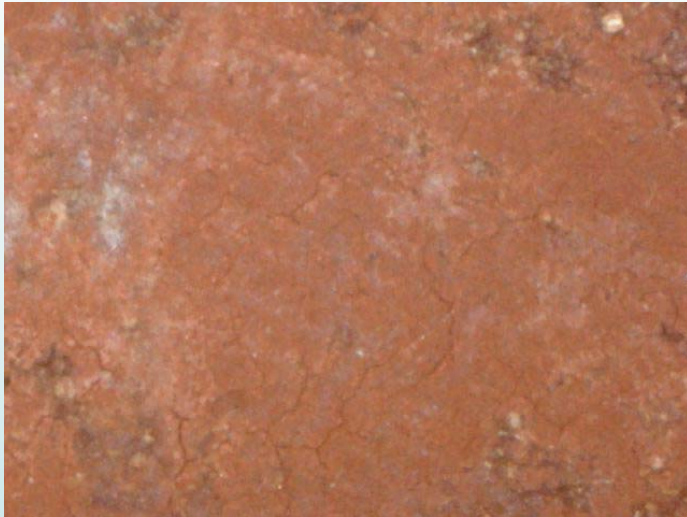
As applied

- Suspending liquid - high vapor pressure
- Bake cycle to dry out - 200 degrees F
- Left faint, closed drying cracks
- Almost no organics left to “burn”

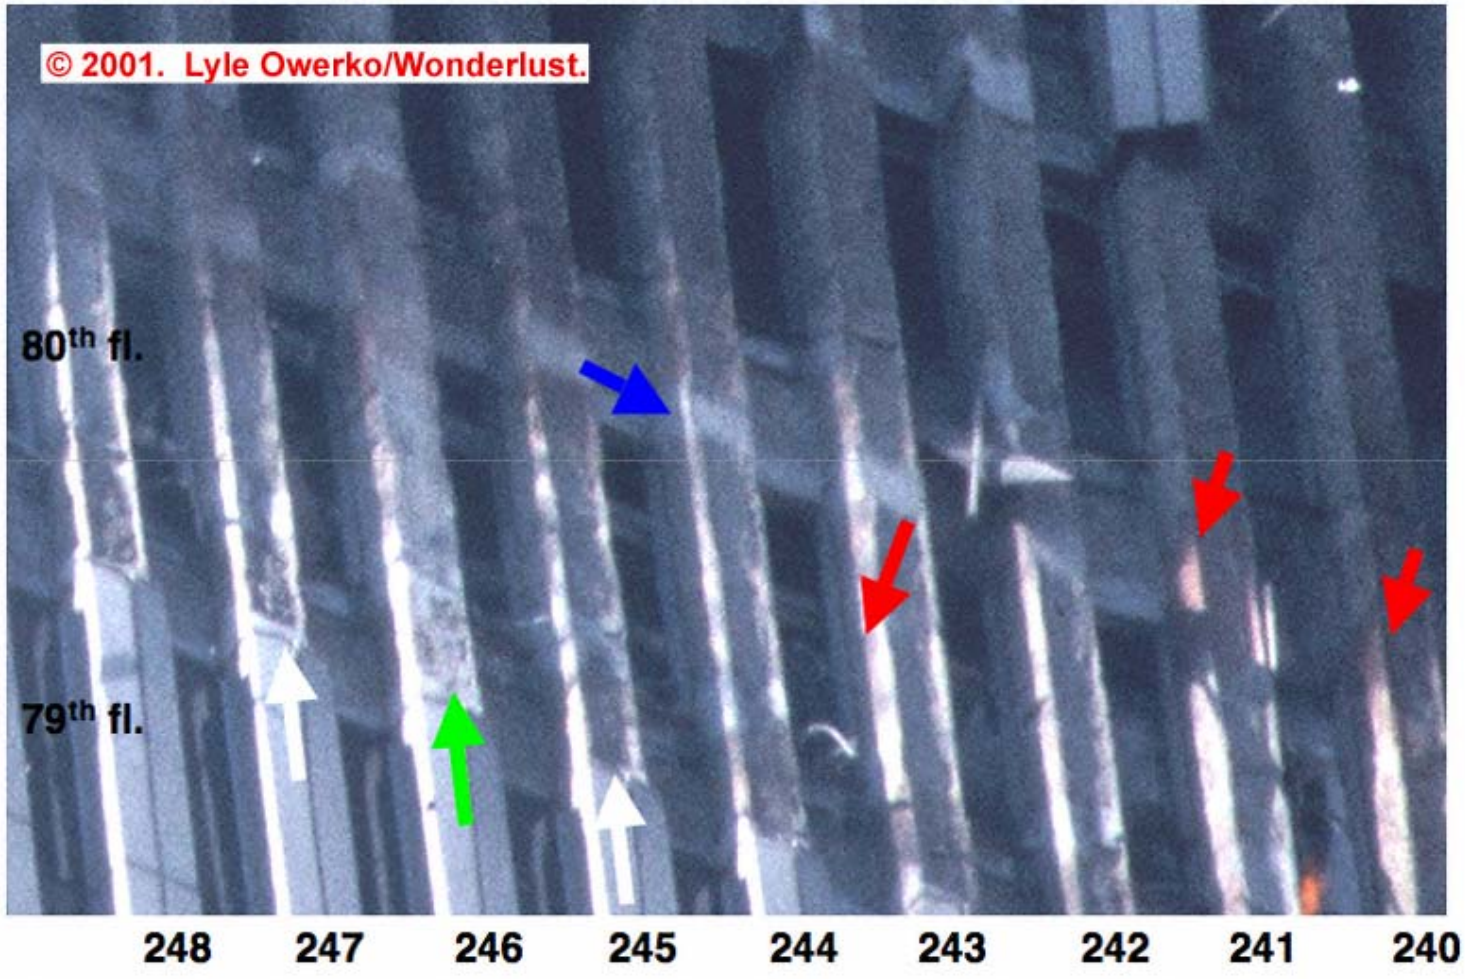
Internal Impact North Face of WTC 2

Removed from flanges (red)

Intact (green)

Removed from outer web (white)

Covered by weatherproofing coating (blue)

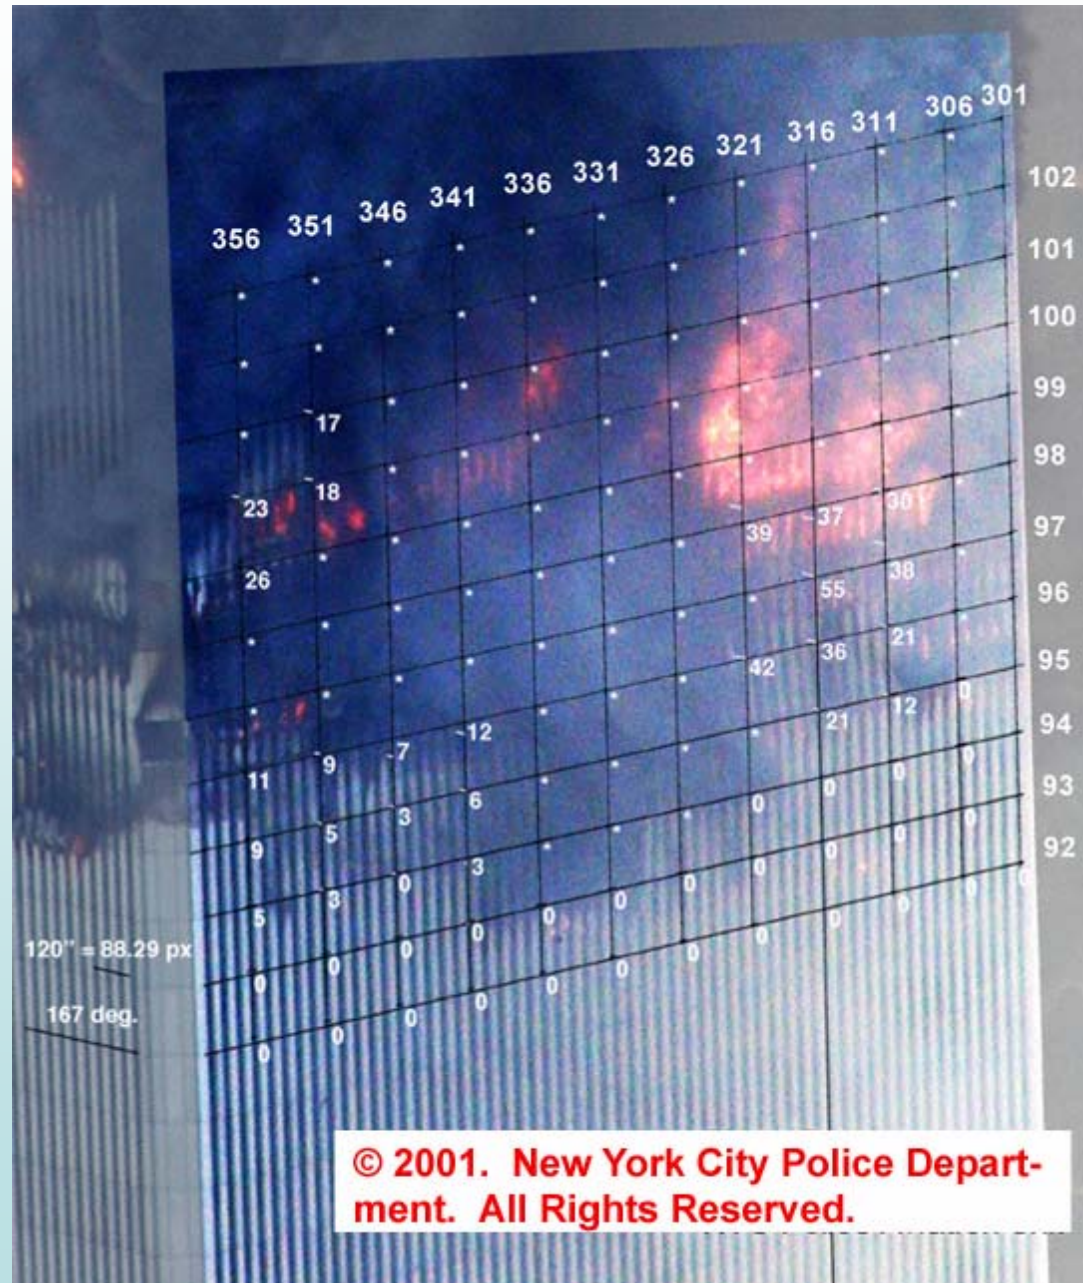
Bowing of Perimeter columns: South Face of WTC1

Time: 10:22 AM

(6 minutes before collapse)

- Measurements of inward bowing (inches)
- **Maximum = 55 inches**
(uncertainty $\sim \pm 6$ inches)
- deflection may be larger beneath smoke in center of building face
- No column deflection observed 38 minutes earlier
