Refueling Infrastructure-Status of Biofuels and Investigations

**NIST Workshop on Alternative
Fuels and Materials:
Biocorrosion**

Kristi Moriarty

July 22, 2013

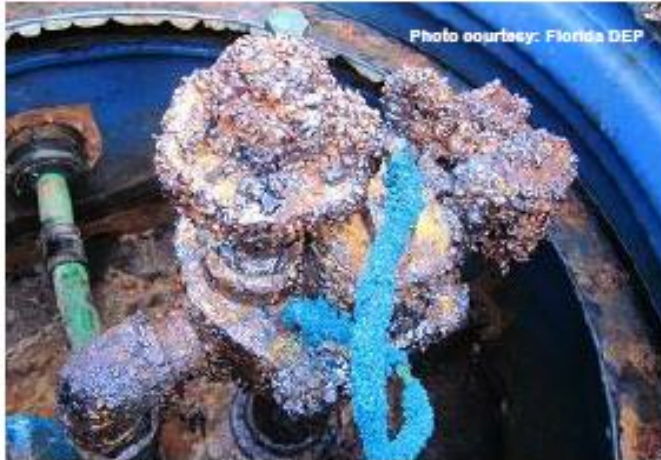
E10 STP, unknown grade (Florida) – Feb. 2011

STP Corrosion – EPA OUST Photos

- **8 sump water samples were provided**
 - 6 samples exhibited low ethanol and acetate concentrations
 - 1 sample exhibited high acetate and low ethanol (STP exhibited corrosion)

- 1 sample had high ethanol and low acetate (STP exhibited little corrosion)
- **A concentration of ethanol in vapors of 10,000 mg/L generally correlated to corrosion on the STP**

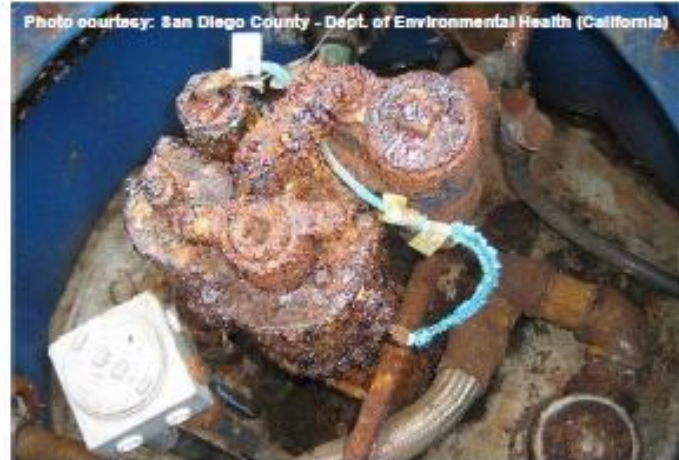
91 octane STP (California) – August 2010

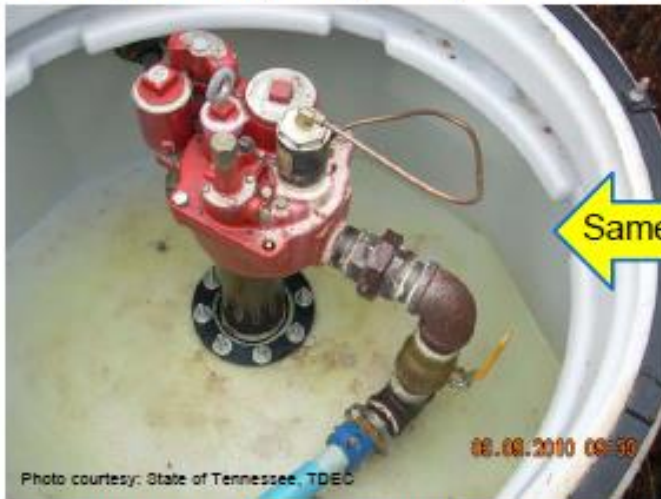
Premium/E10 STP (Tennessee) – March 2010

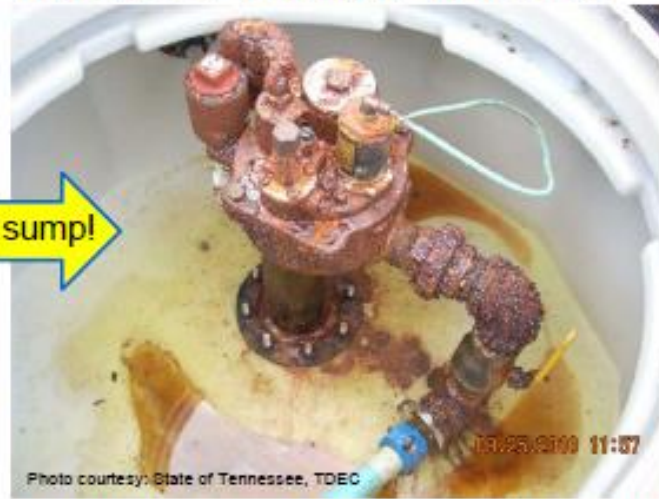
Premium/E10 STP (Tennessee) – August 2010

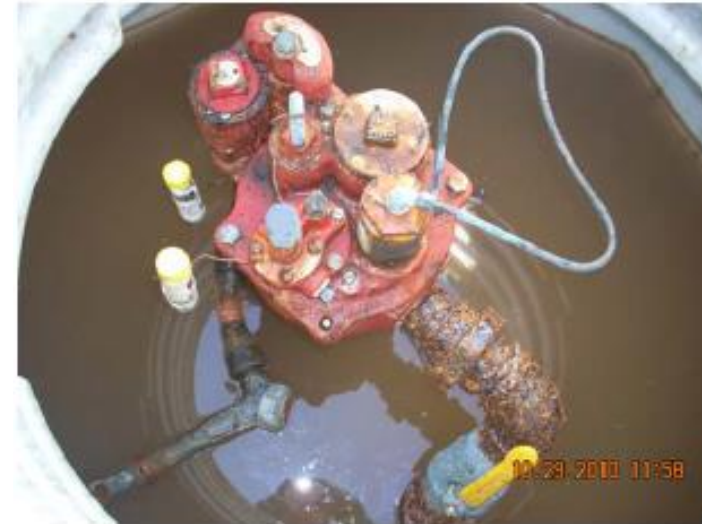
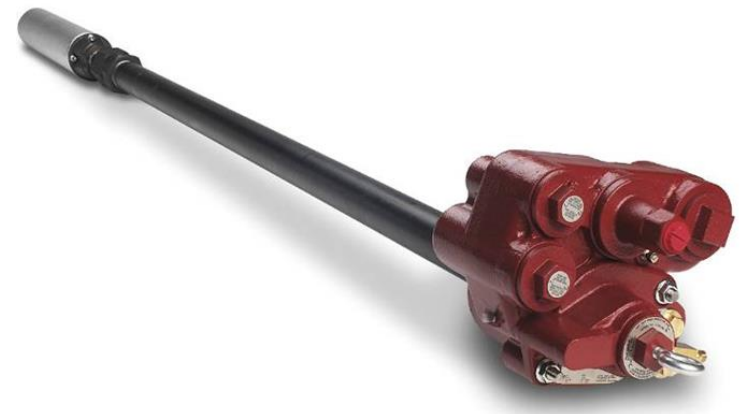
- 20 inspectors from 9 states provided photos
 - 70 vapor samples were collected from 15 sumps in TN; 13 sumps in FL; 2 sumps in CA; collected in 2010 and 2011

- 33 regular gasoline
 - 29 premium gasoline
 - 7 E85
 - 1 diesel
 - 13 sump vapor samples exhibited a concentration of ethanol greater than 10,000 mg/l
 - Of this; 60% occurred in premium

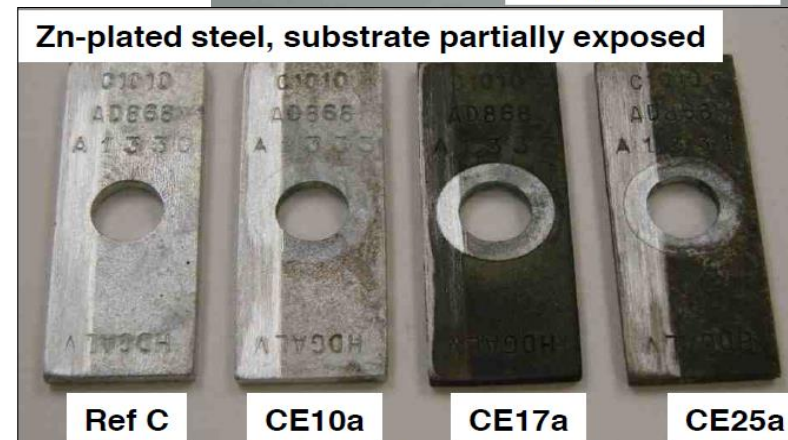
- Coupons exhibited slight discoloration but no measurable corrosion

- No measurable or accelerated corrosion resulted for either the completed plated or the partially-plated specimen
- Aggressive ethanol content resulted in modest corrosion and film formation on Cu-based alloys; highest corrosion rate ($\sim 30 \mu\text{m}/\text{y}$) for brass in CE10a, but original machining marks are still visible on surface
- Zn surfaces experienced discoloration due to film formation also modest weight change

- Brass, bronze, zinc, and lead were most affected by the test fluids
- No apparent trends with ethanol concentration
- Corrosion rates are considered modest and not likely to impact overall component performance
