# Corrosion of Copper and Steel Alloys in the Presence of *Acetobacter* sp. in a Simulated UST Sump Environment

Jeffrey Sowards & Elisabeth Mansfield

Applied Chemicals and Materials Division, NIST – Boulder, CO

# Problem: Rapid UST Corrosion

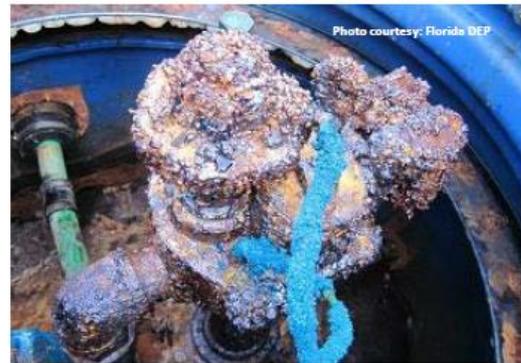
E10 STP, unknown grade (Florida) – Feb. 2011

Underground Storage Tank (UST) sump components are susceptible to rapid corrosion at stations dispensing gasoline-ethanol blends and ultra-low-sulfur diesel fuel. Components include copper tubing, brass valves, and steel submersible turbine pumps (STP) and piping.

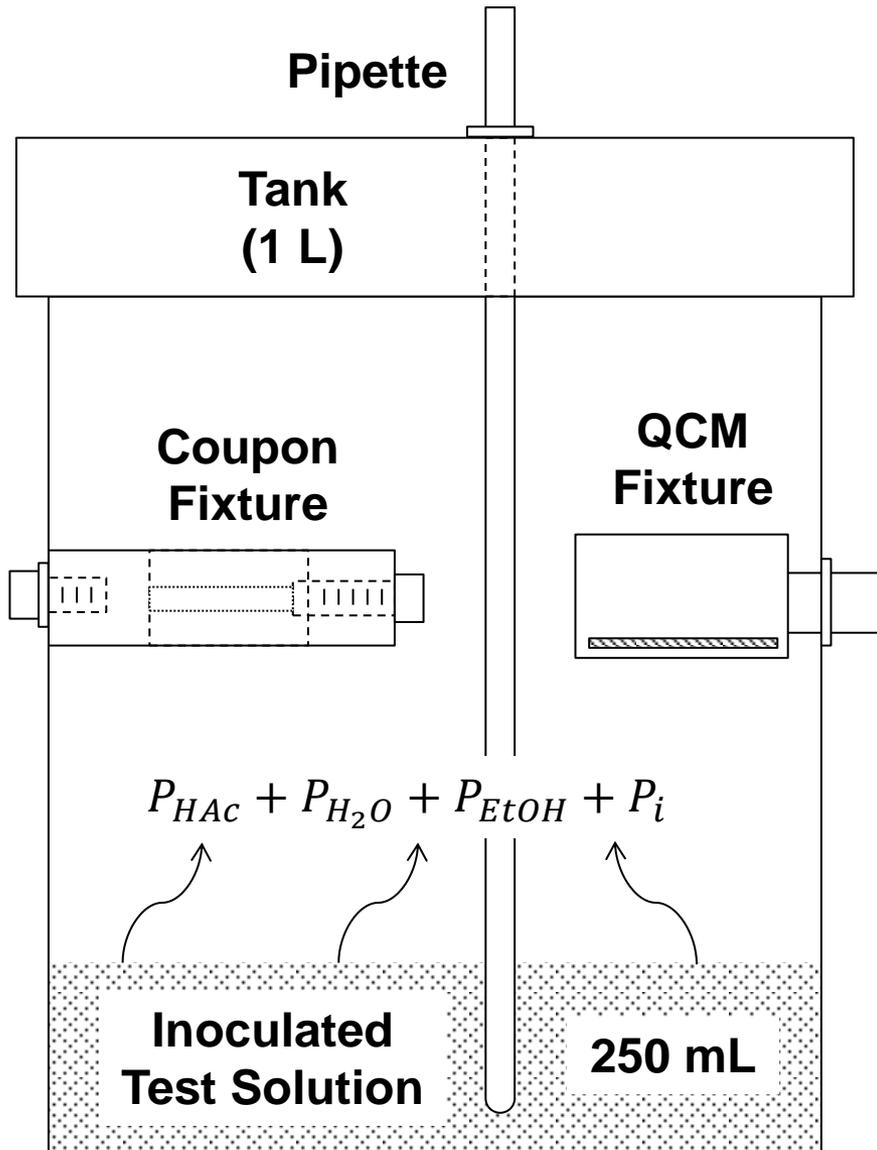
# Headspace Corrosion Test Setup

- Inoculate 250 mL of Test Media with *Acetobacter sp.*
- Expose metal coupons to the vapor phase only
- Expose Fe and Cu quartz crystal microbalances (QCM) and monitor frequency shift ( $\propto$  mass change)

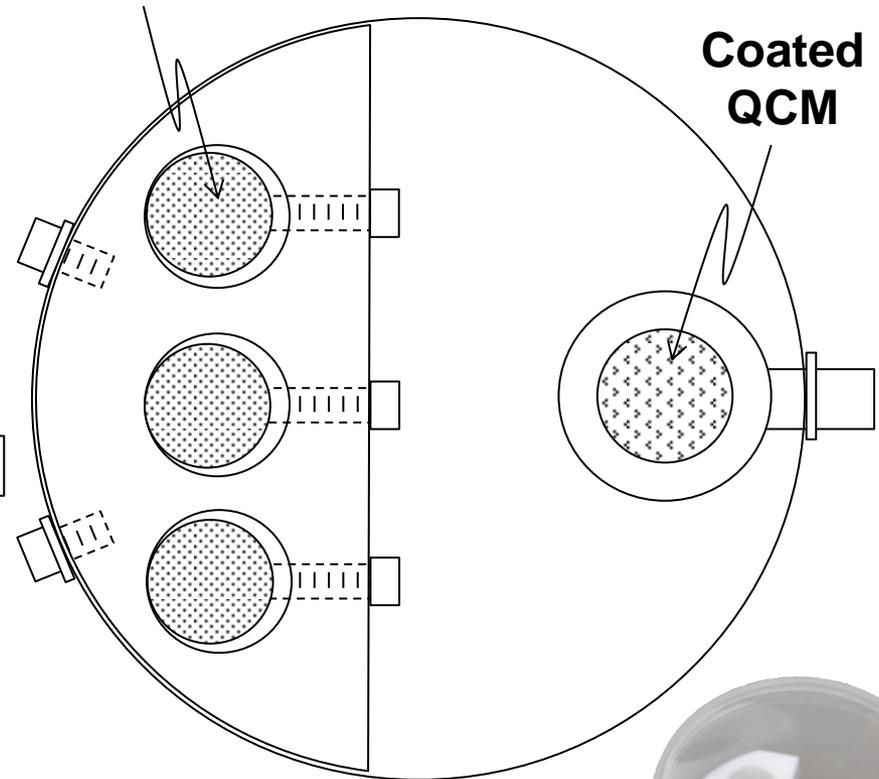
**Test Coupon**

*diameter = 19 mm*  
*thickness = 2.8 mm*

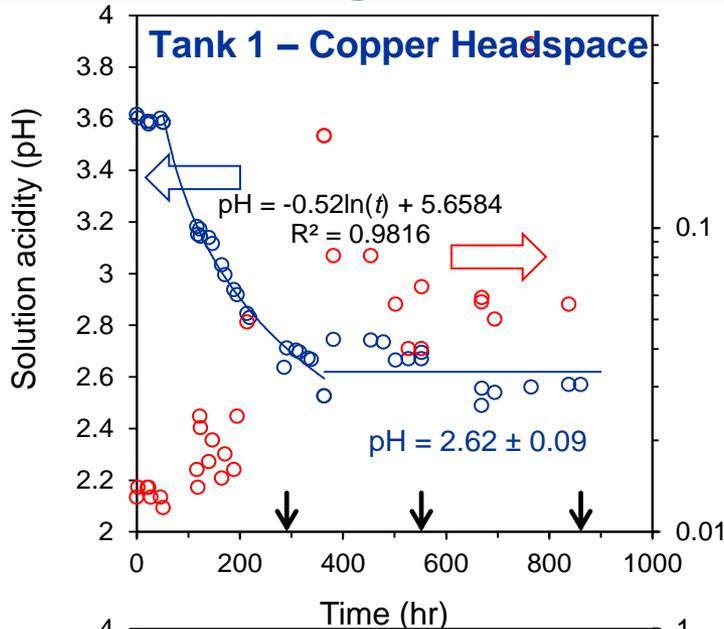
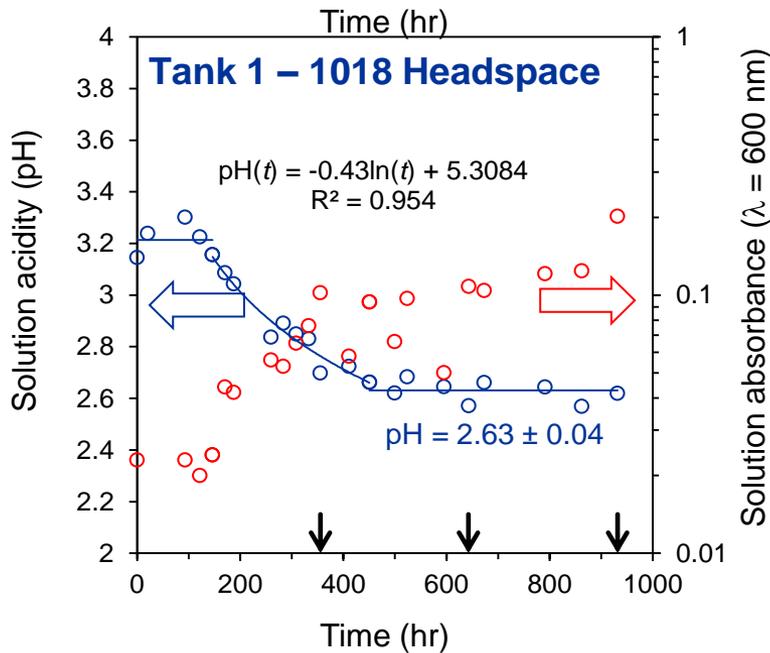
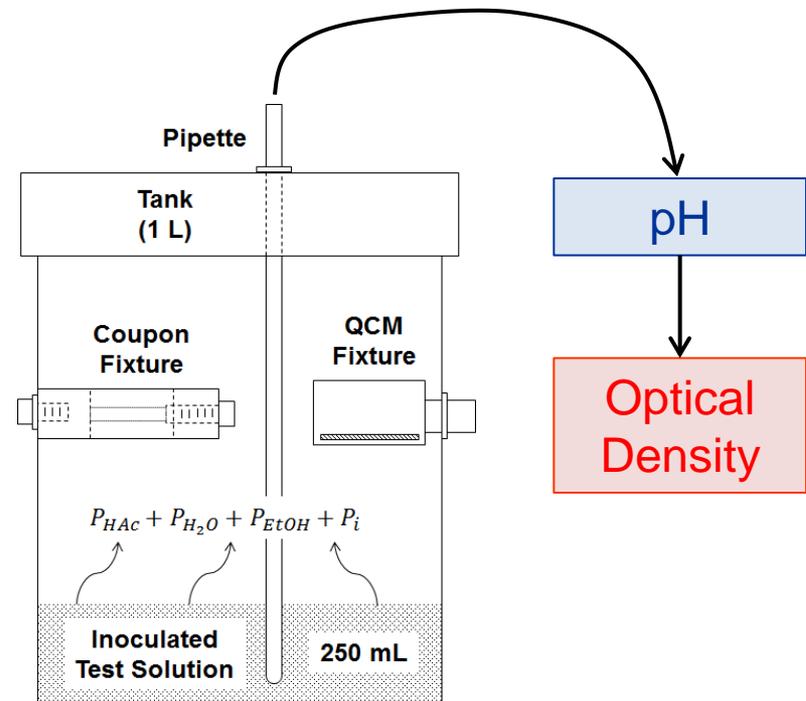
# Measuring Bacteria Kinetics

Liquid samples were collected from the tank bottoms daily and acidity and *Acetobacter* cell density were measured.

- The initial pH was slightly higher in the copper tests; however, both series of tests decayed to similar pH levels in the solution.
- The tanks produced repeatable bacteria behavior in copper and steel corrosion tests.

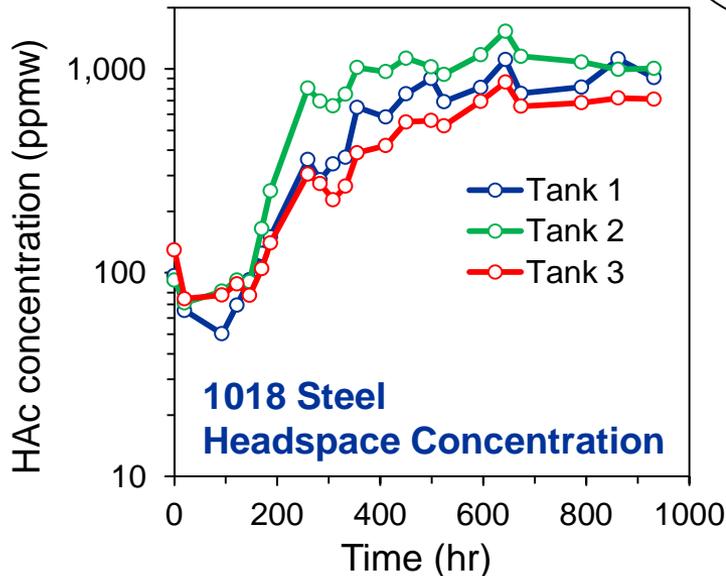
# Headspace Acetic Acid Concentration

- A solution with pH = 2.6 has an acetic acid concentration of 1.4 M and approximately 1000 ppmw in the space above the solution.

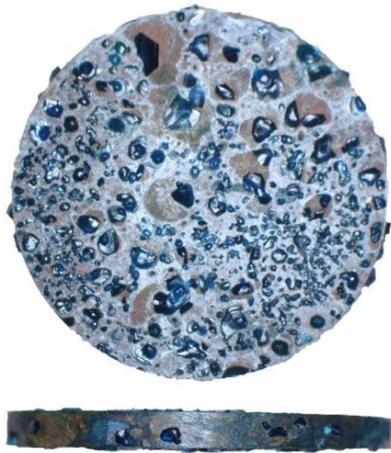
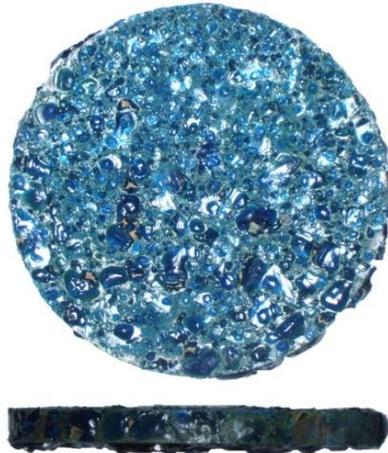
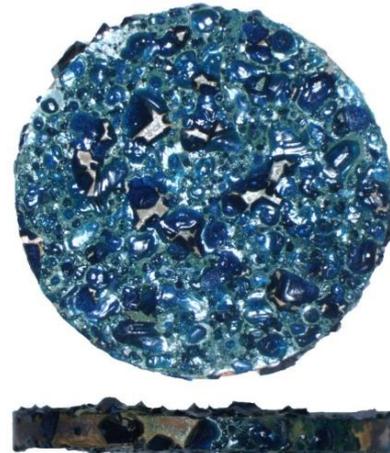
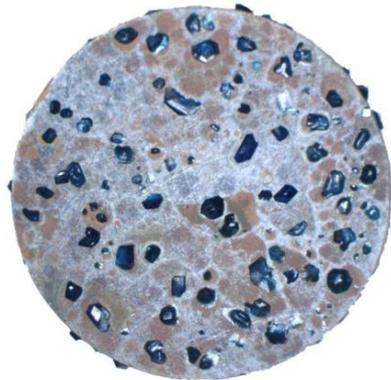
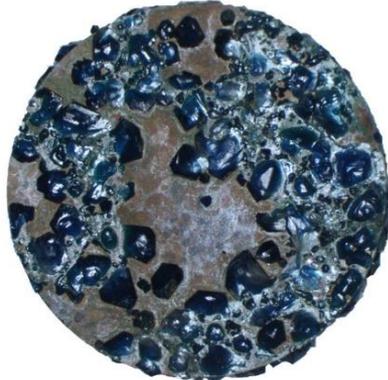
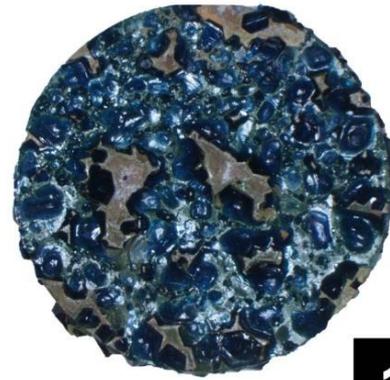
# Copper Corrosion After Headspace Exposure

292 hr

550 hr

863 hr

X-Ray Diffraction (XRD) was used to identify corrosion products:

- Copper acetate dihydrate
- Copper hydroxide acetate
- Cuprite

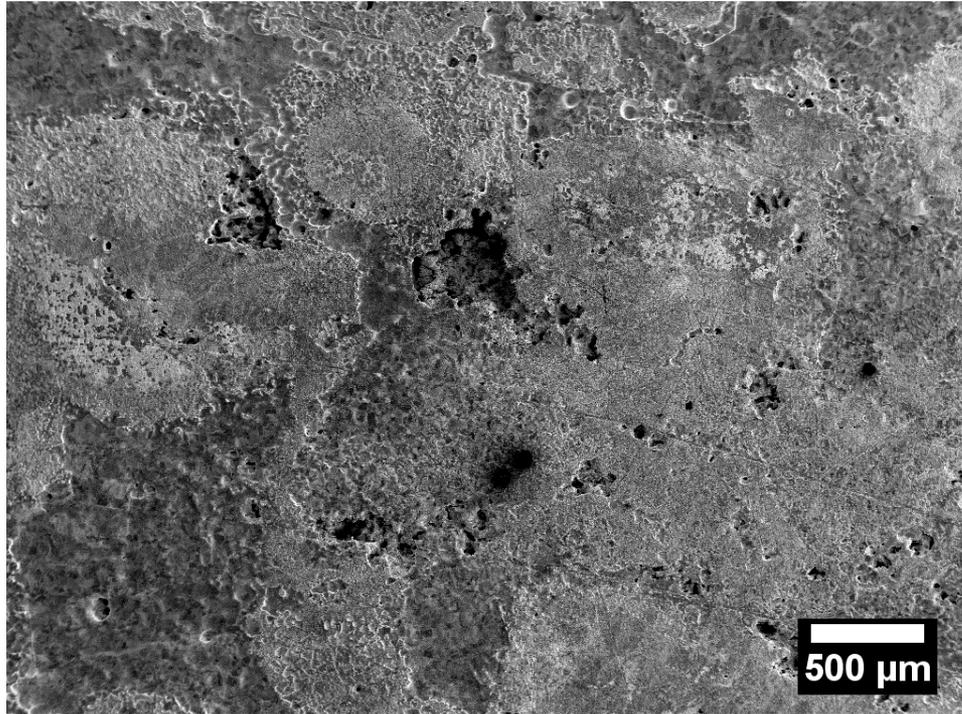
# Headspace Corrosion Morphology

Removal of copper acetate revealed that general corrosion and pitting corrosion occurred under the crystals.

Small pits coalesced into larger pits with a wide, shallow appearance.

Pit Depth: Pit Width  $\approx$  1:2

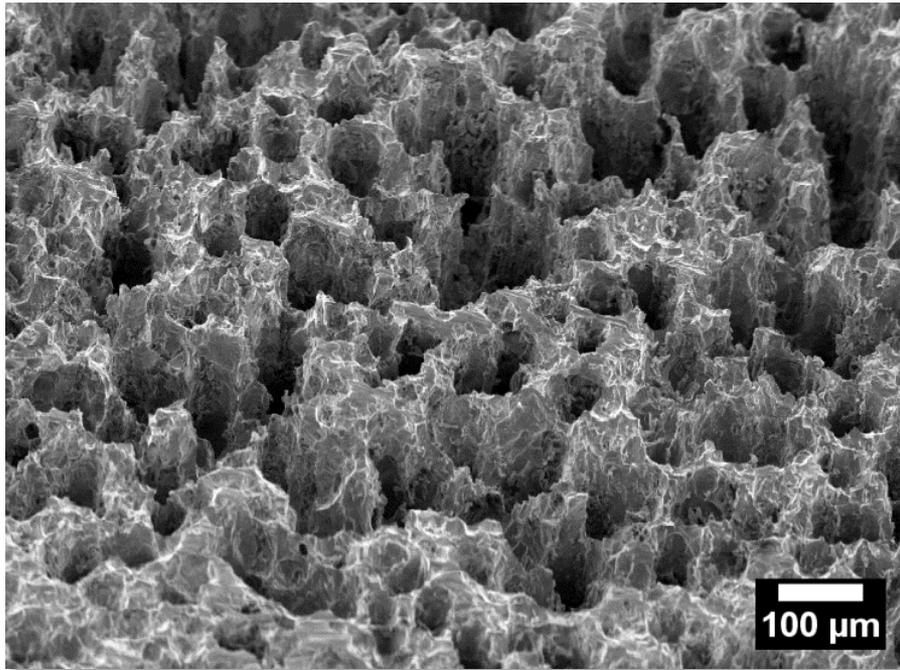
# Headspace Corrosion Morphology

Removal of iron oxidation products revealed general pitting corrosion underneath.

Pit density varied spatially about the radial direction of the coupons.

Pit initiation appear to be associated with non-metallic inclusions (e.g. MnS); therefore, alloy sulfur content may play an important role in pitting.

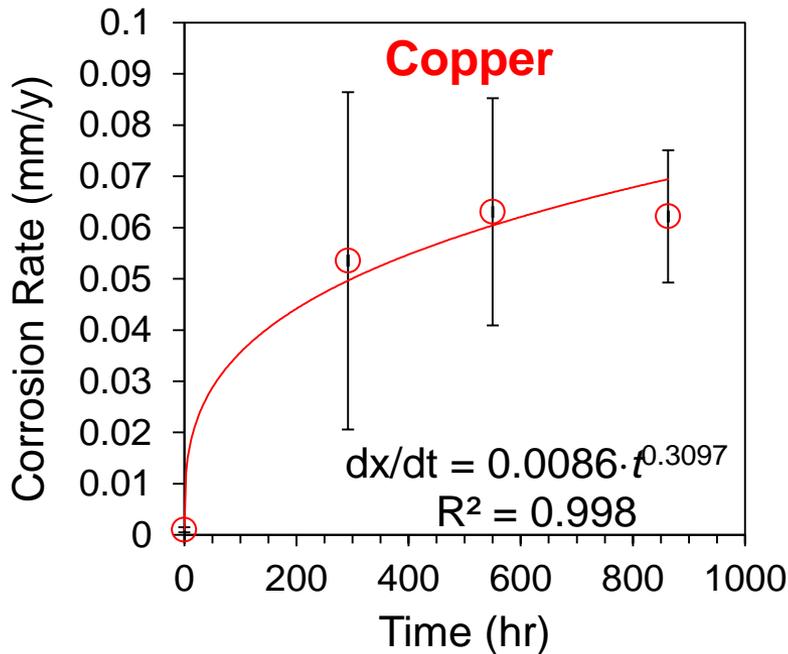
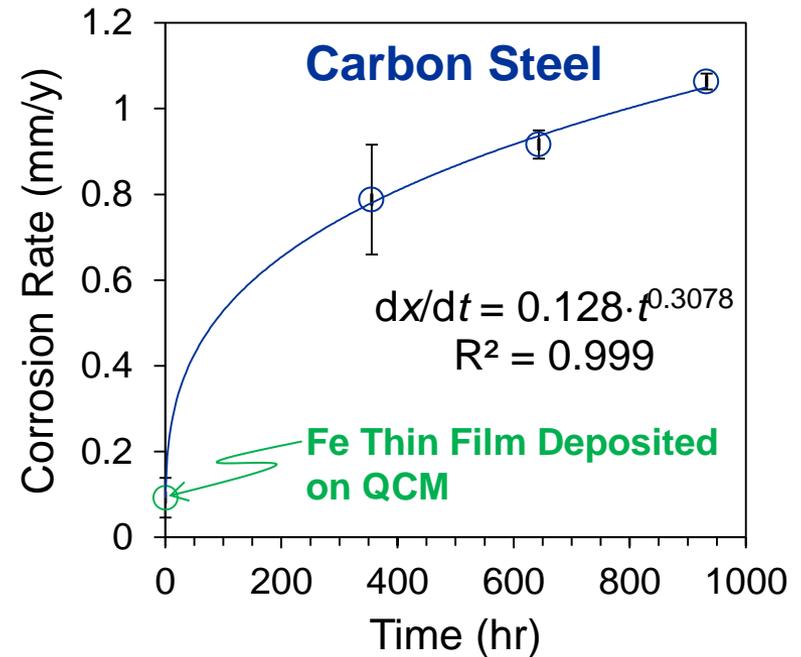
# Headspace Corrosion Rate & Model

Atmospheric  
Corrosion  
Empirical Model<sup>1</sup>

$$\frac{\Delta x}{\Delta t} = A_0 \cdot t^n$$

$\Delta x/\Delta t$  = corrosion rate (mm/y)  
 $A_0$  = initial corrosion rate (mm/y)  
 $t$  = exposure time (hr)

Lower  $n \propto$  greater  
protectiveness of surface film

Material	$A_0$ (mm/y)	$n$	$R^2$
Copper	$8.6 \times 10^{-3}$	0.3097	0.998
Steel	$128 \times 10^{-3}$	0.3078	0.999

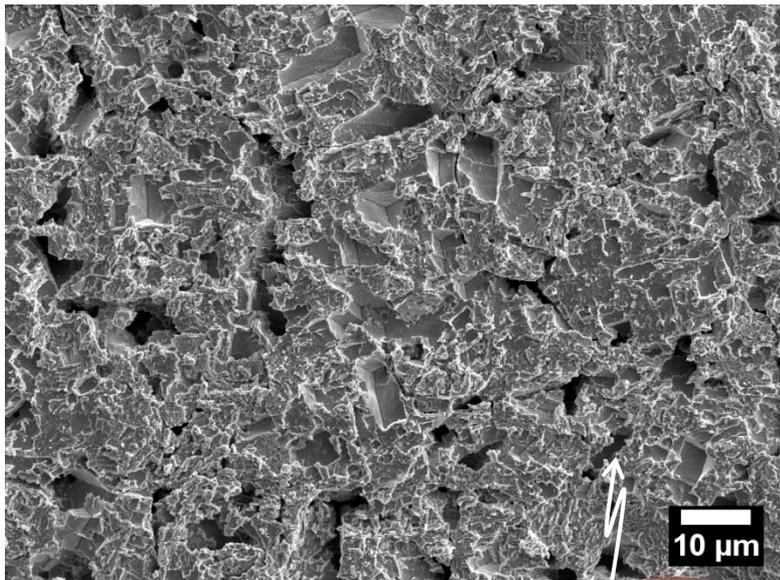
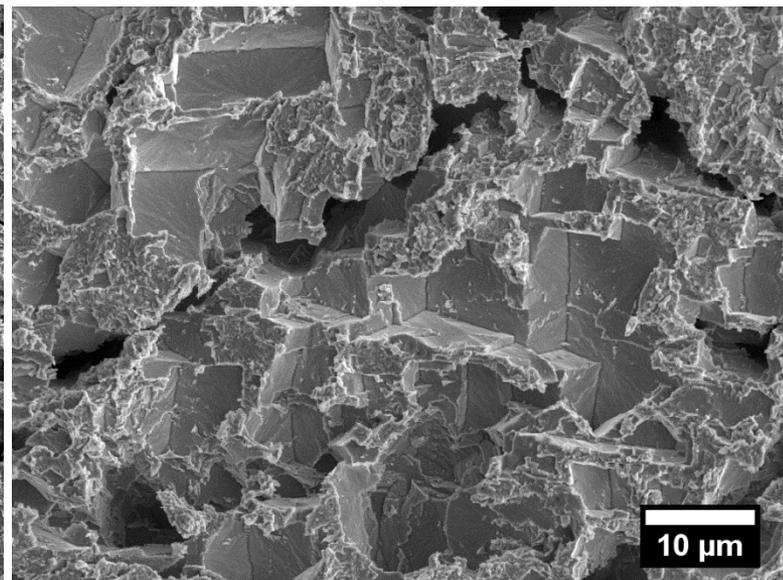
Intergranular  
Attack

Corrosion rate after 36 days  
exposure was:

**0.051 mm/y ± 0.010 mm/y**

Deep intergranular attack was  
observed indicating that stress-  
corrosion cracking may lead to  
greatly accelerated perforation  
of copper tubing.

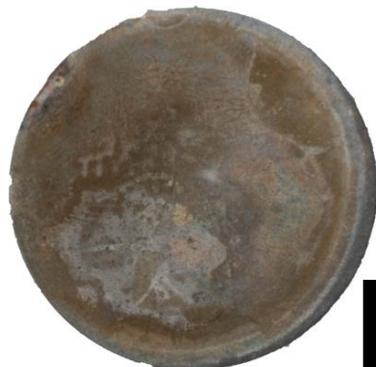
# Steel Corrosion Damage

Corrosion rate after 39 days exposure was:  
**0.061 mm/y  $\pm$  0.003 mm/y**

This is comparable to the copper headspace and immersion coupons. Such a low rate may be related to bacterial attachment, which could protect the steel by a passivation mechanism. However, the surface was covered with pits within ferrite grains, although some attack at interphase boundaries was noted.

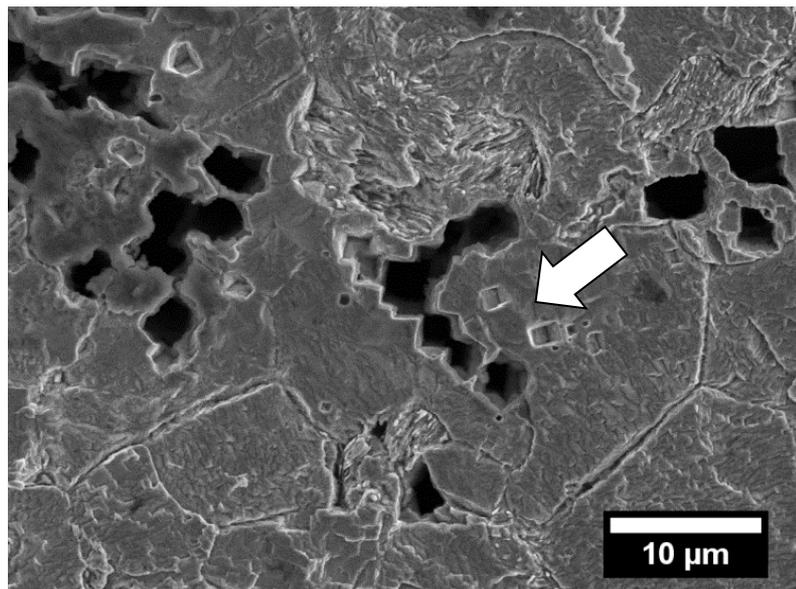
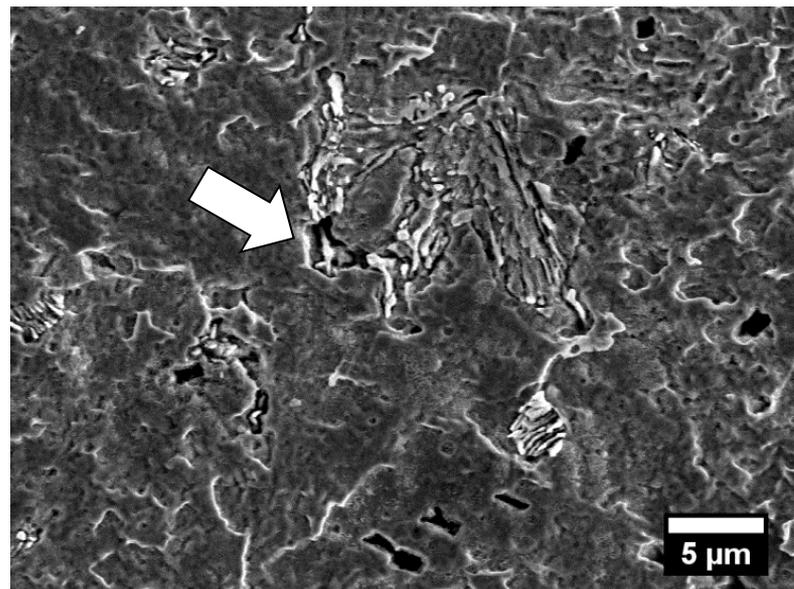
Dislocation Etch Pits

Pearlite Boundary Attack

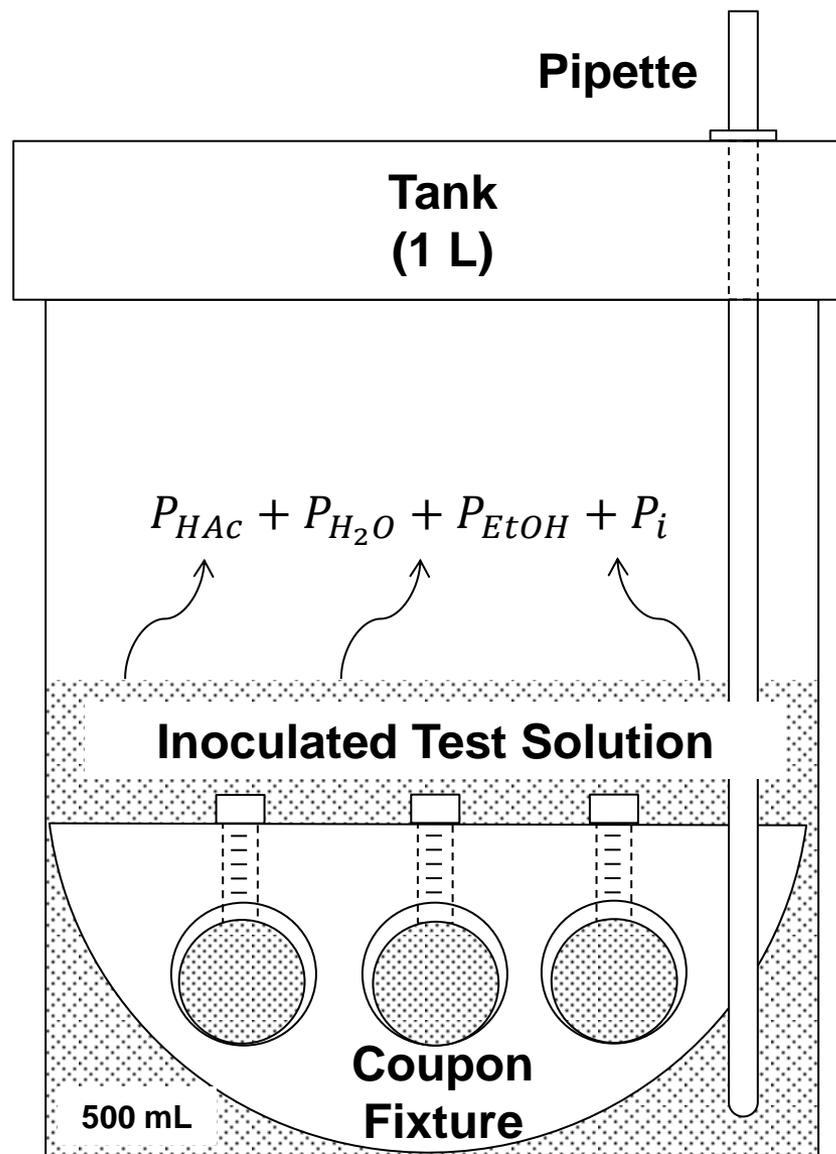
# Immersion Corrosion Test Setup

- Inoculate 500 mL of Test Media with *Acetobacter sp.*
- Fully immerse alloy coupons in the liquid phase Test Media

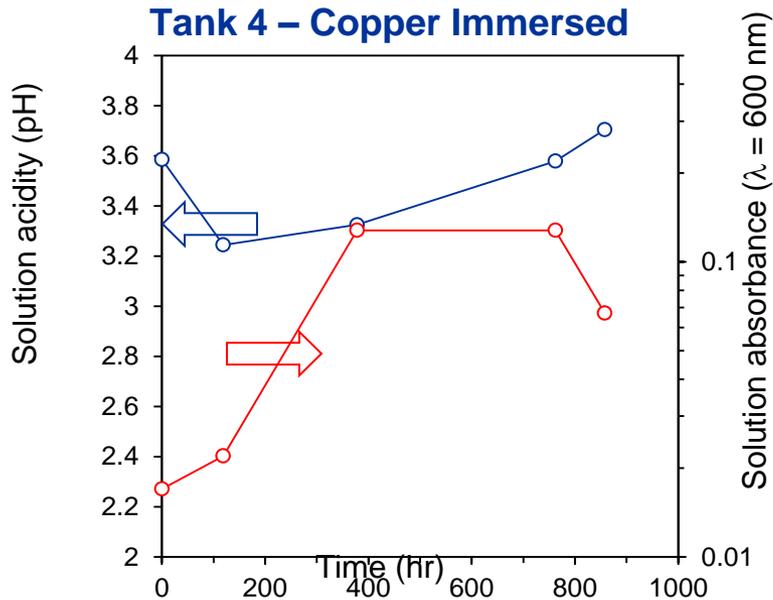
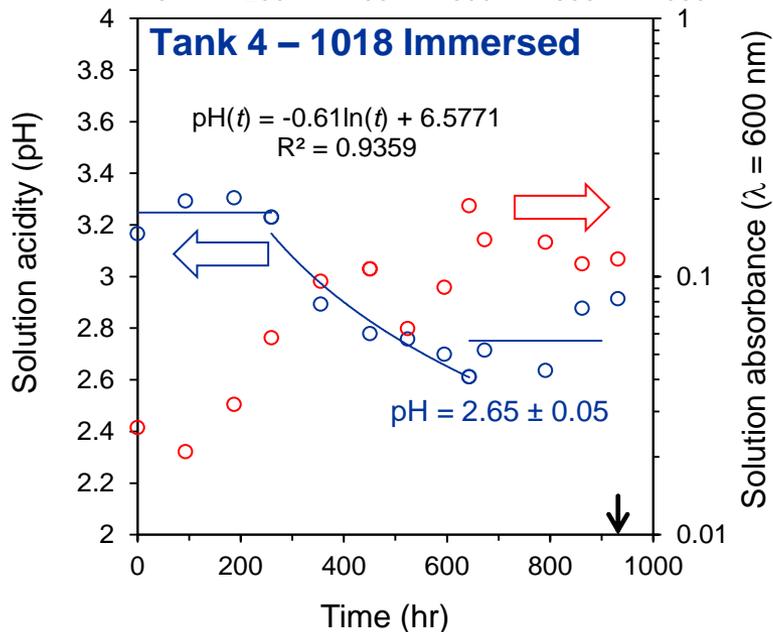
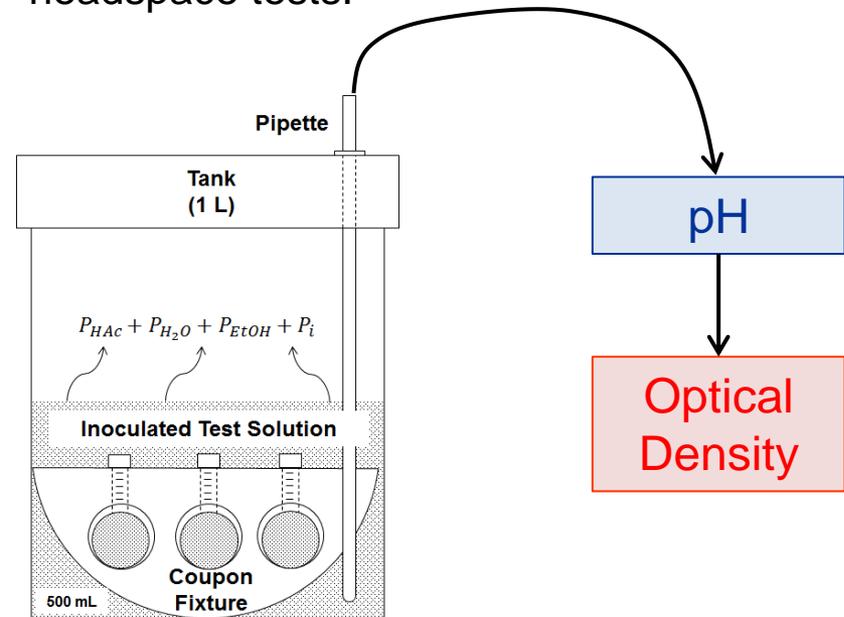
# Measuring Bacteria Kinetics

Liquid samples were collected from the tank bottoms and acidity and *Acetobacter* cell density were measured.

- When copper coupons were immersed in the test solution, the pH increased over time and bacteria tended to clump in an unusual morphology. Copper has some antimicrobial properties.
- When steel coupons were immersed, the bacteria kinetics were similar to the headspace tests.

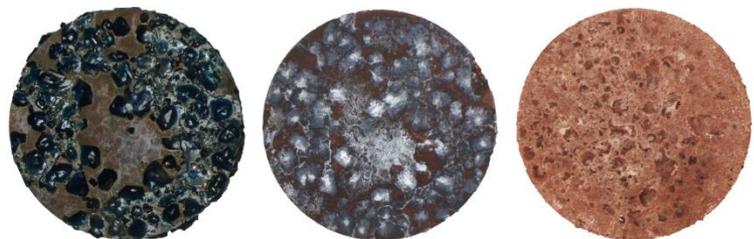
As-tested condition removed from Tank 2      Sonicated for 3 minutes in Deionized Water      Brushed for 4 minutes in HCl/H<sub>2</sub>O Solution

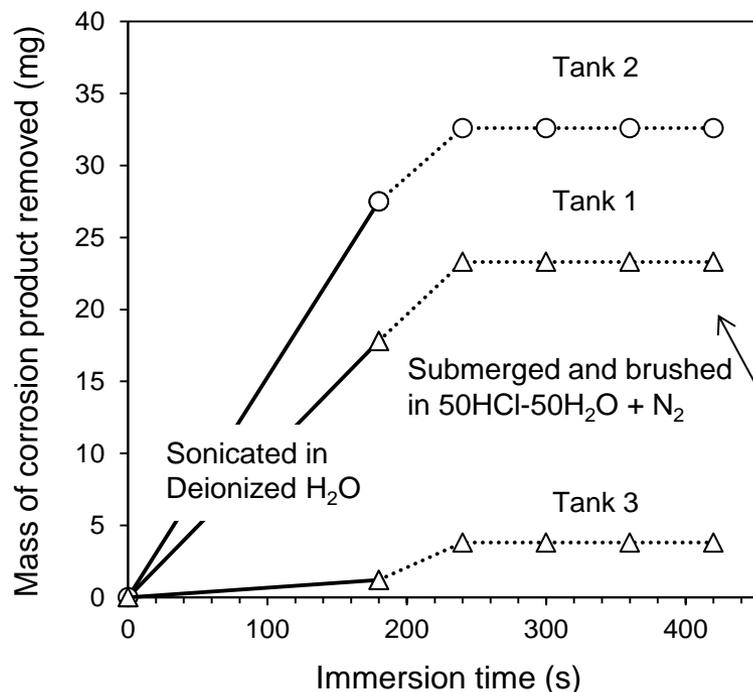
Removal of corrosion product reveals extensive pitting corrosion underneath the corrosion product.

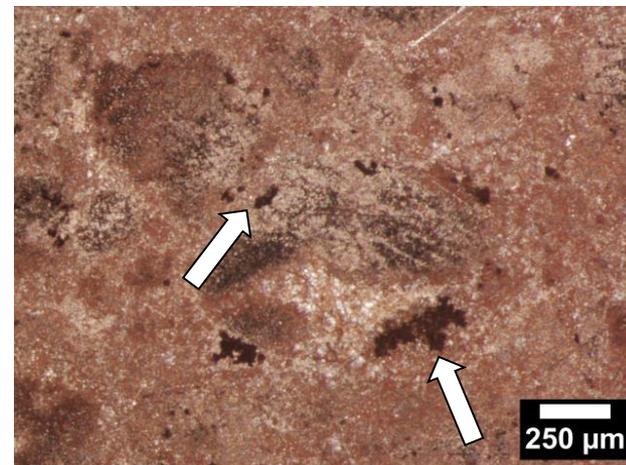
The cleaning process removes the corrosion product but does not corrode the underlying metal.

- Blue crystals are removed with sonication
- Silver-colored corrosion product is more tenacious, and is removed mechanically and chemically by brushing in HCl/H<sub>2</sub>O Solution

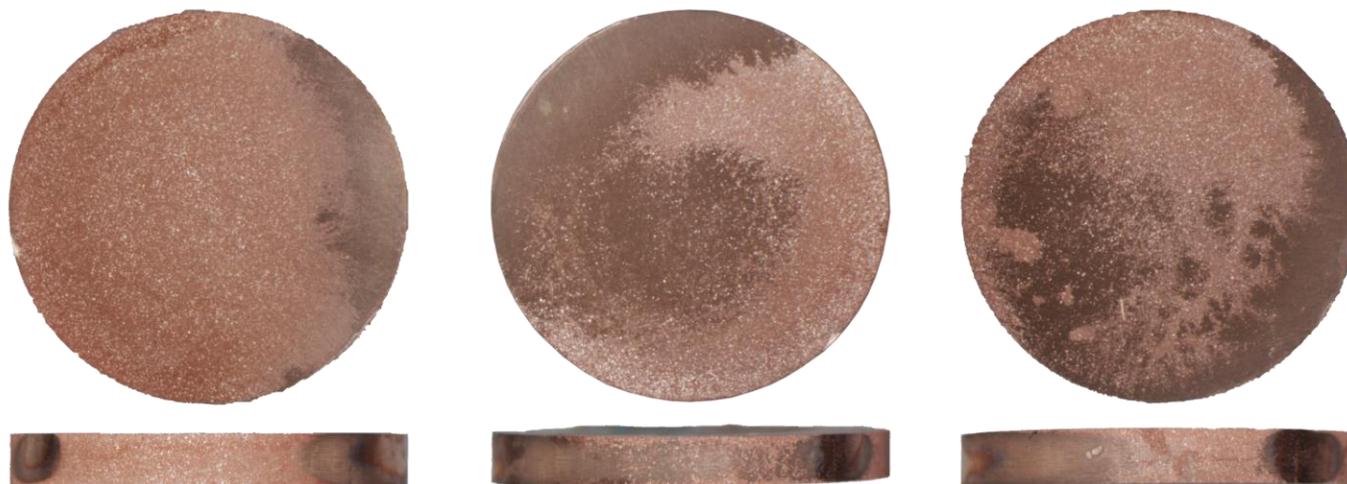
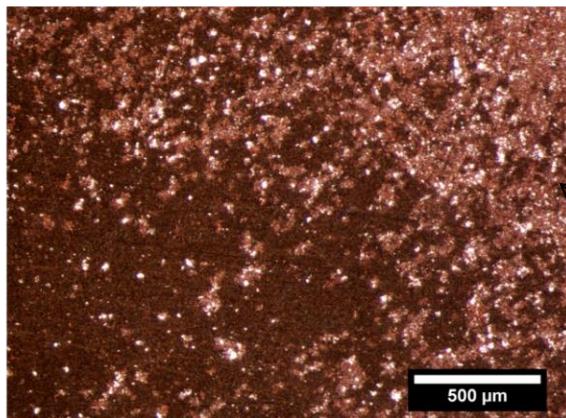
TANK 4

Surface Pitting

Corrosion was not as extensive on the immersion coupons as compared to the headspace coupons. Pit morphology exhibited a shallow and coalesced appearance. The test solution notably turned a blue color during testing, indicating the presence of dissolved copper acetate.

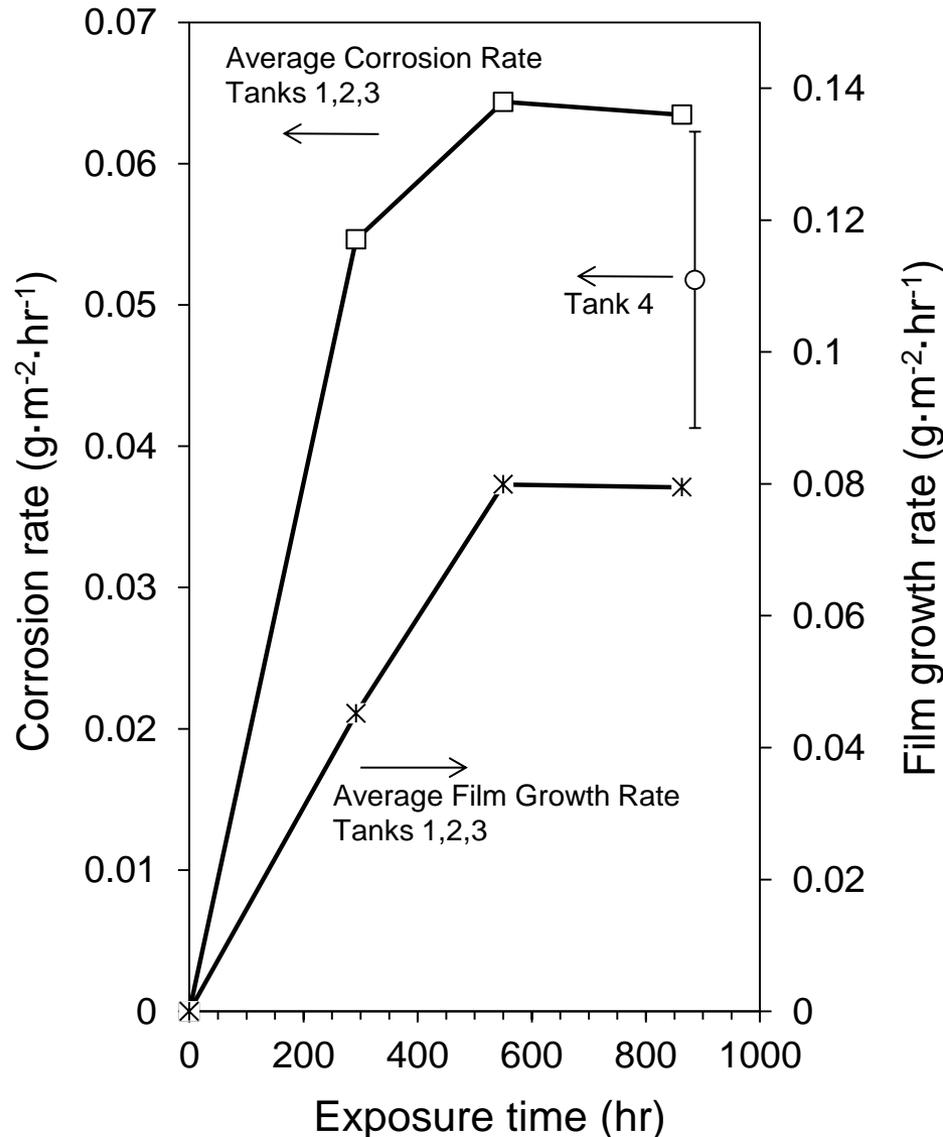
# Copper Corrosion Rate

Corrosion rate and film growth rate in the headspace (Tanks 1, 2, 3) exhibit a plateau above a certain exposure period. This suggests that the copper corrosion rate increased until coupon surface was covered with the bluish corrosion product (i.e., a *steady-state* condition was achieved).

- Film growth rate is slightly higher than corrosion rate since mass is added to the system when acetate is captured at the copper surface.
- Immersed coupons (Tank 4) exhibited slightly lower corrosion rates compared to the headspace coupons.
- A typical corrosion rate of copper in water is about ~0.0025 mm/y (~0.1 mpy)
- An “acceptable” corrosion rate of copper in an open-loop system is typically less than 0.025 mm/y (<1.0 mpy)
- Corrosion rate of copper here is ~0.08 mm/y (~3.3 mpy)

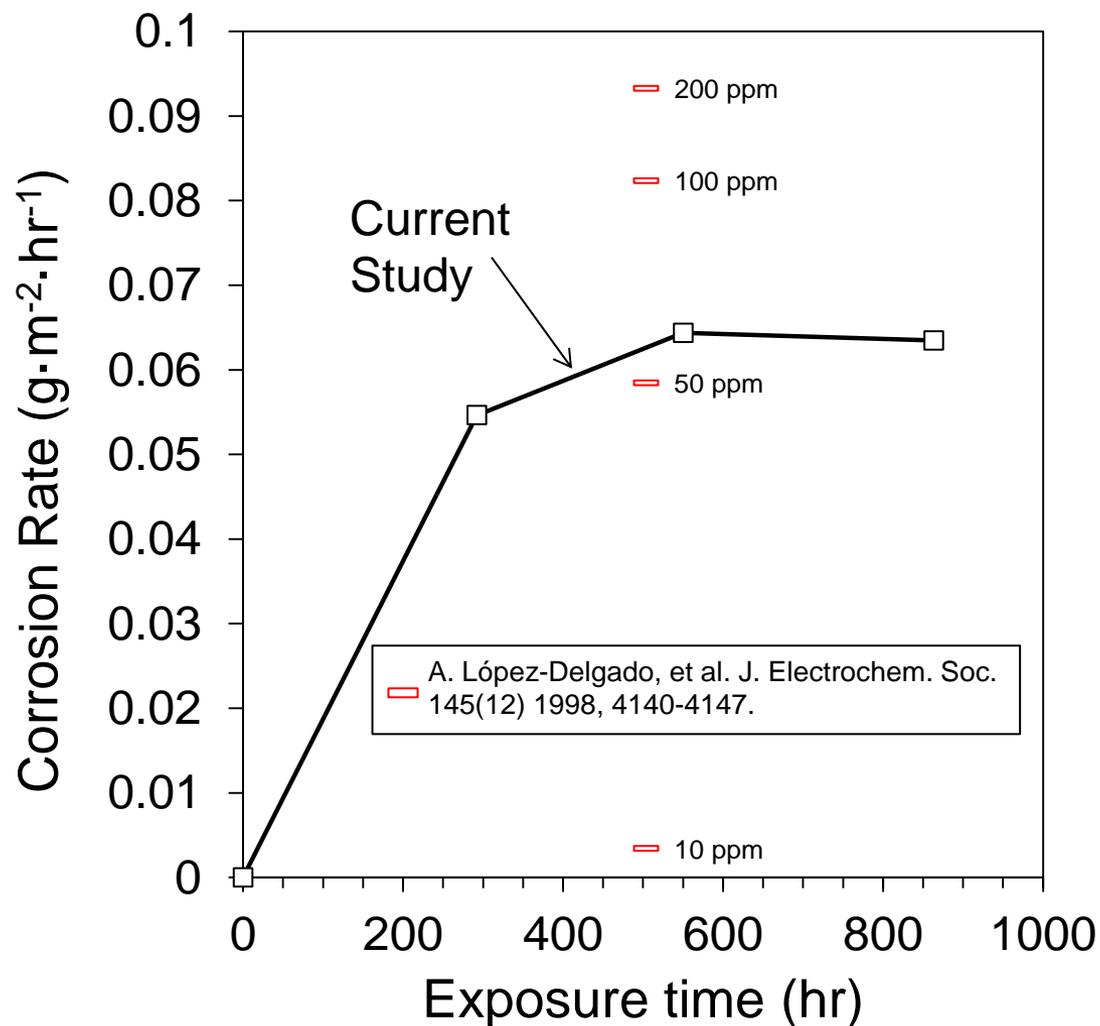
**A comparison with abiotic acetic acid corrosion of copper is made here. Estimates based on this comparison suggest bacteria could produce acetic acid vapor concentrations in the range of 50 to 100 ppmw although calculated values suggest we may have significantly higher levels.**

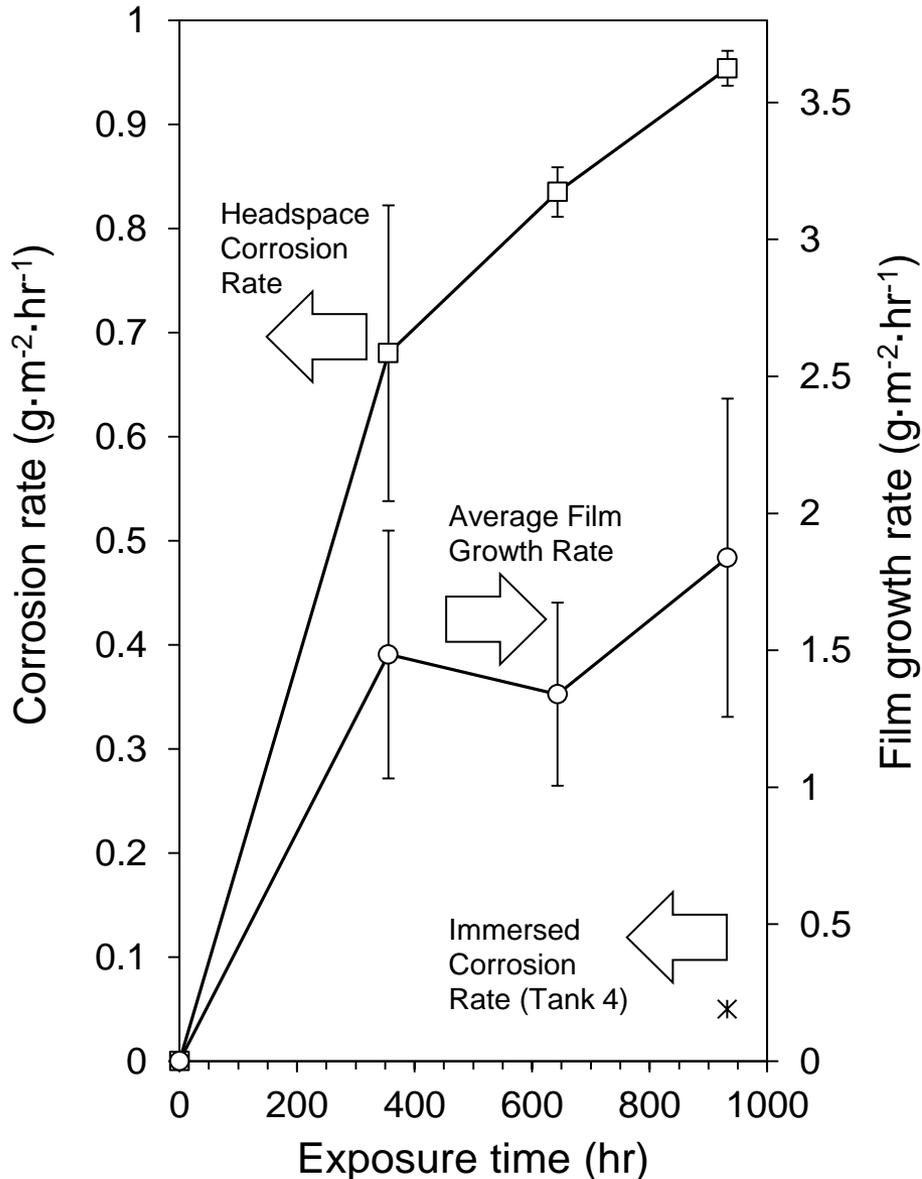
# Steel Corrosion Rate

Corrosion rate likely has some dependence of the film growth as seen in the copper corrosion.

- Corrosion rate of 1018 steel coupons exposed to headspace was an order of magnitude greater than copper in the headspace and continuously increased with exposure time. (> 1 mm/y !!!)
- Film-growth rate on headspace coupons is higher since mass is added to the system when iron oxidation products are captured by the steel surface.
- Immersed coupons exhibited significantly lower corrosion rates than in the headspace. Microbial attachment (formation of a biofilm) may play a role in this behavior.

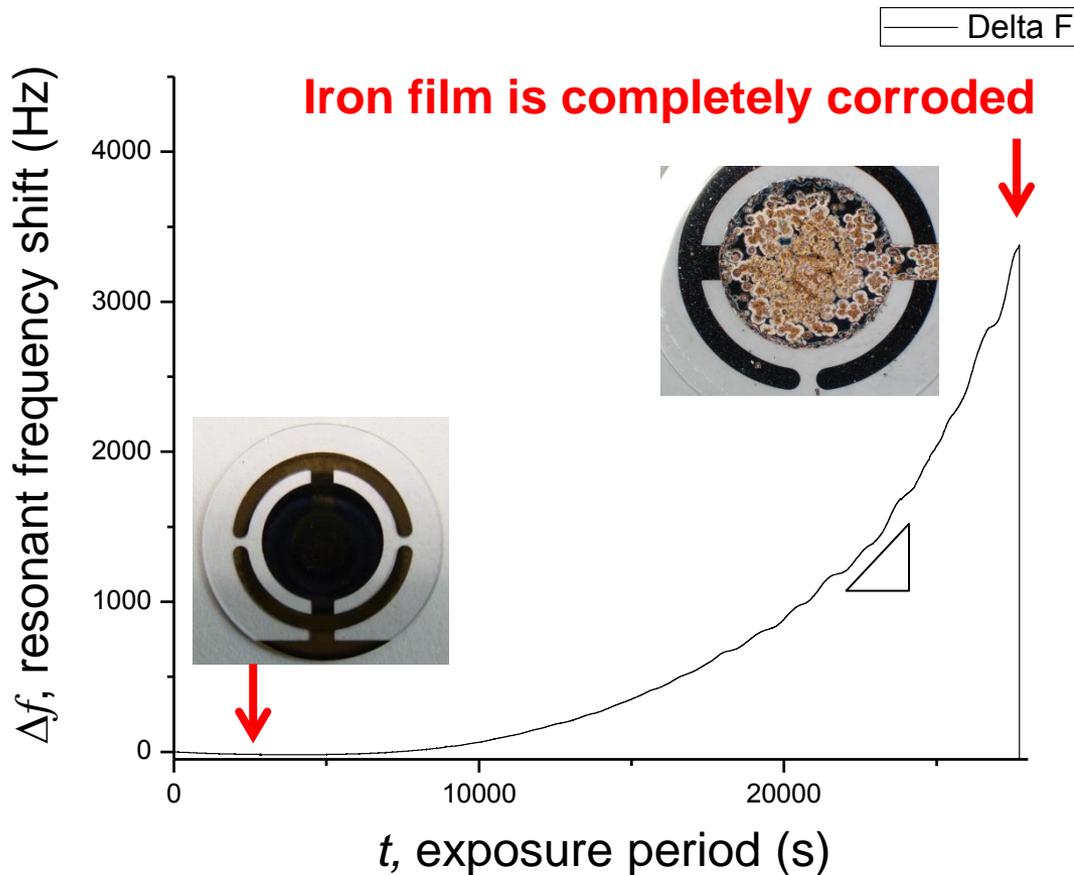
# Corrosion of Fe Thin Film Sensor

We deposit thin Fe films onto quartz crystals. The crystals are excited with an oscillating voltage so that they vibrate at their resonant frequency. The mass of the crystal can be measured real-time by monitoring the shift in the resonant frequency.

Mass change occurs due to oxidation of the thin iron layer as evident by the frequency shift.

Sensor technology could be used as an early warning system for the onset of corrosion or to study corrosion in the field.

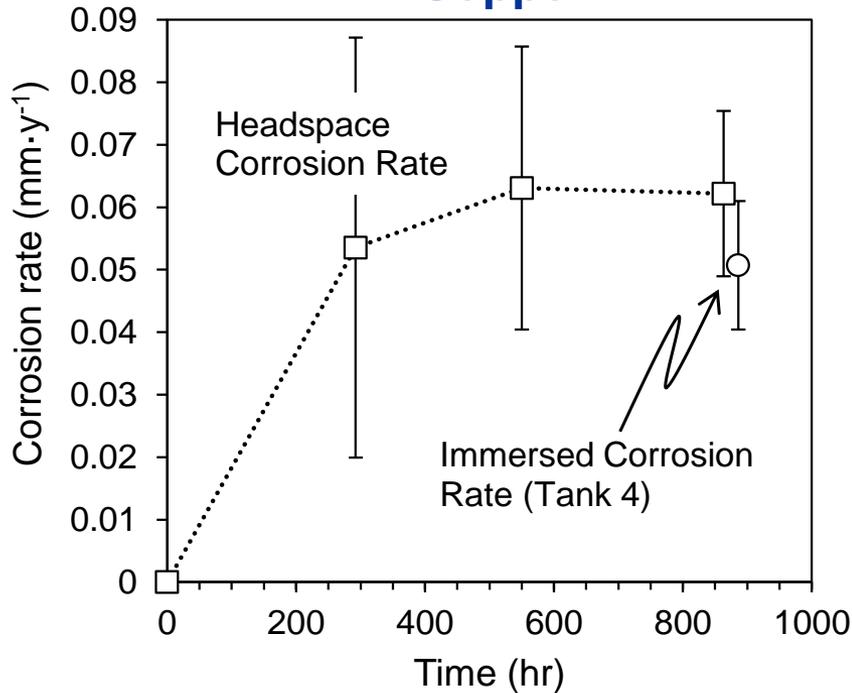
## Copper

- Copper corrosion rate was up to ~0.08 mm/y in the headspace. It would take 15 years to corrode through copper tubing with 1.2 mm wall thickness.
- Deep grain-boundary attack was observed on the cold-worked copper immersed in solution!
- Stress-corrosion cracking is a likely concern, which would likely reduce the tubing life and lead to leakage of fuel into the environment and into the sump.

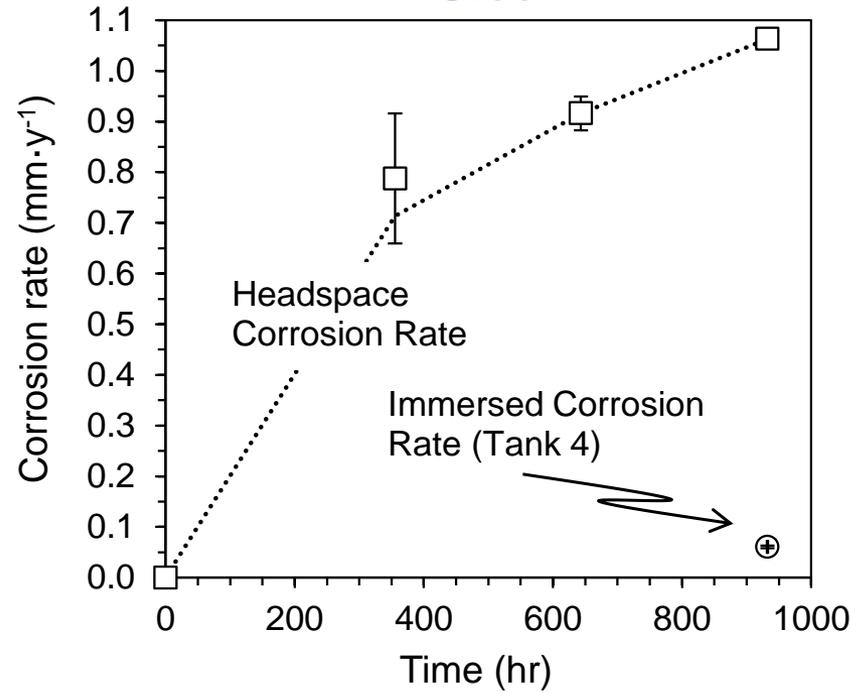
## Steel

- Steel corrosion rate was above 1.0 mm/y in the headspace! This is an order of magnitude higher than that of the copper.
- Corrosion rate was lowest when the steel was immersed into the bacteria solution (~0.06 mm/y). This may be related to biofilm attachment on the steel corrosion coupons.
