Champlain Towers South Investigation and California Wildfires Update

CTS Investigation

CTS Investigation: Collapse Sequence

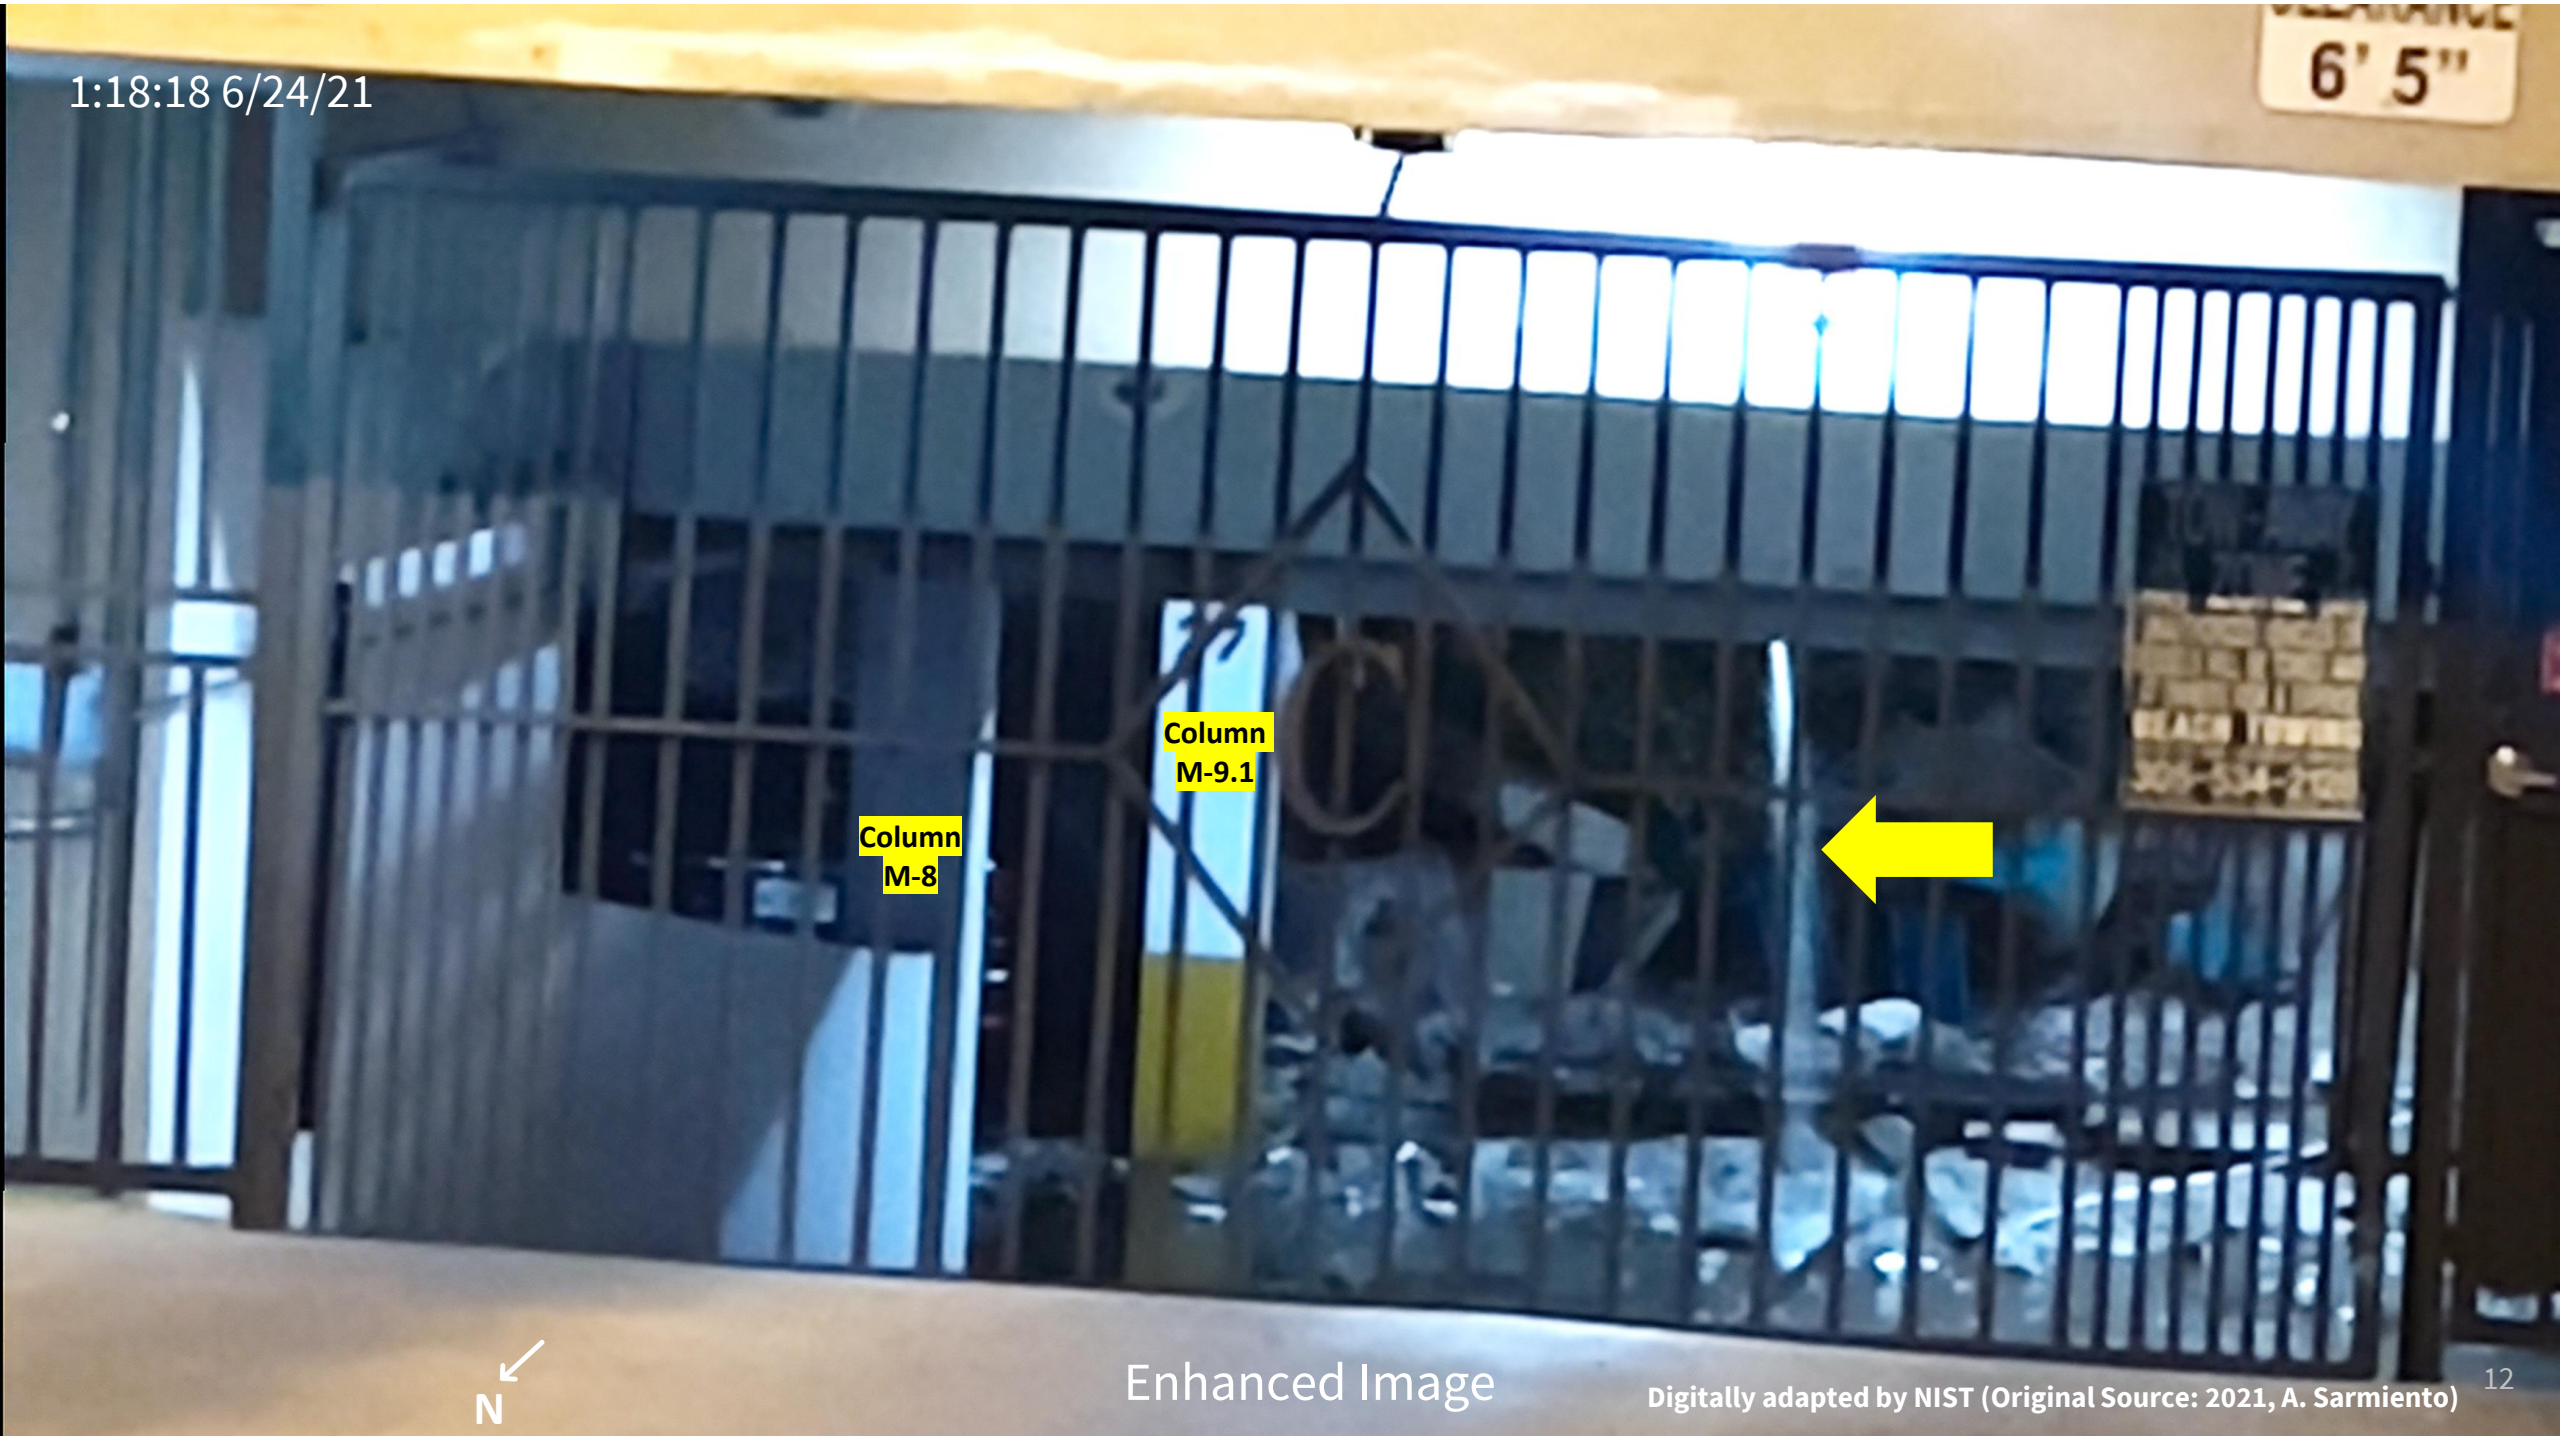
01:18:18

1:18:18 6/24/21

Column
M-9.1

Column
M-8

Enhanced Image

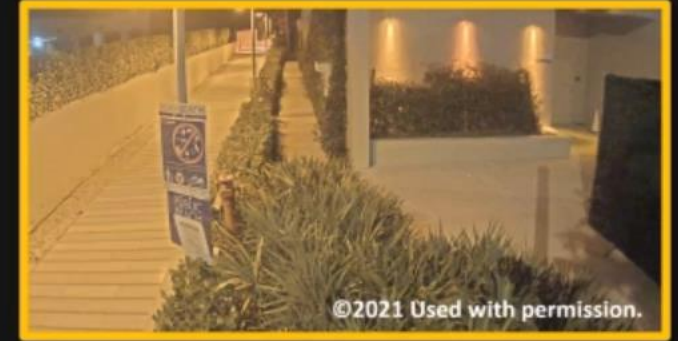
01:21:50

Beach Access Walkway

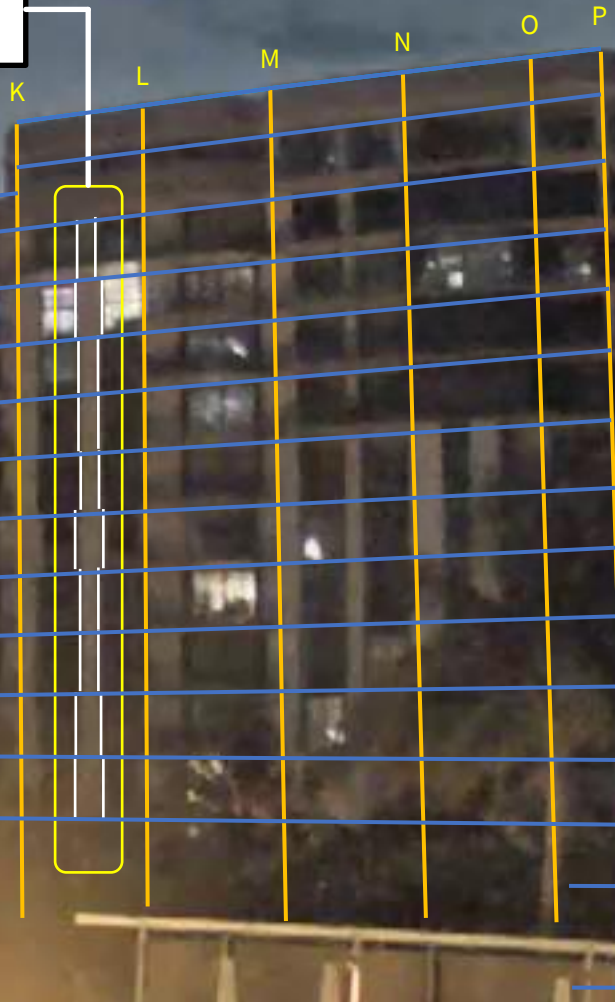
Unique façade shape

Top of penthouse roof parapet
Penthouse roof
Penthouse floor

Stories 1 and 2 blocked from view

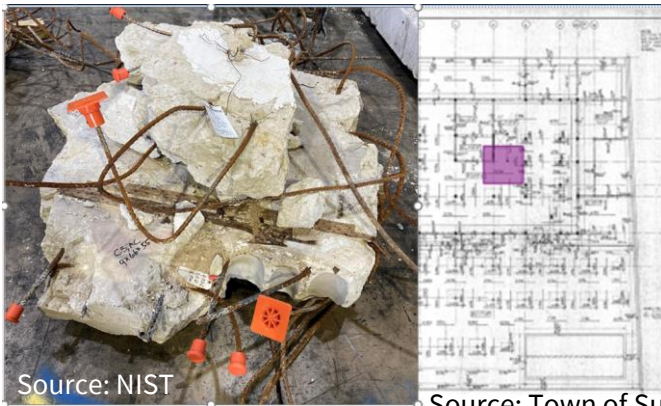
2 Placement of Top Bars in Column Strips

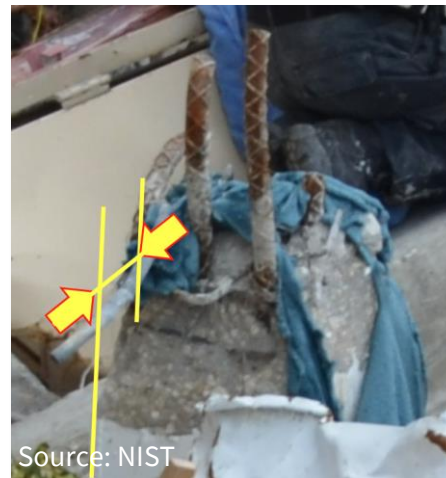
3 Position of Reinforcement Cage within Columns

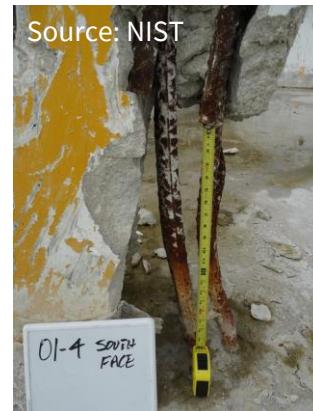
5 Short, high lap splices in columns

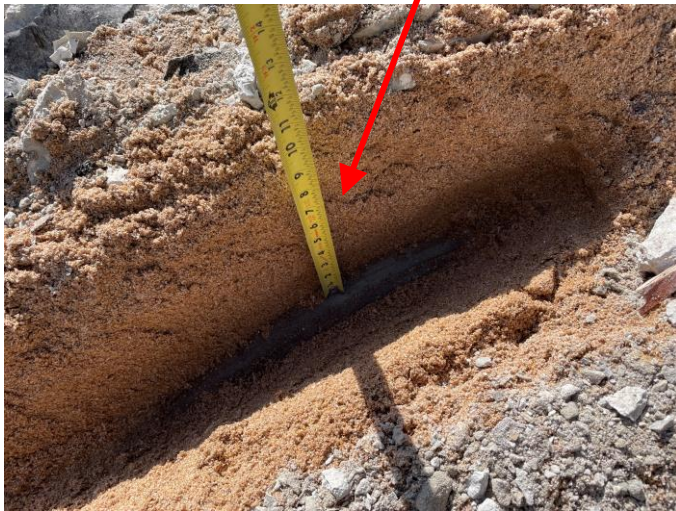
9 in. **added** sand setting bed

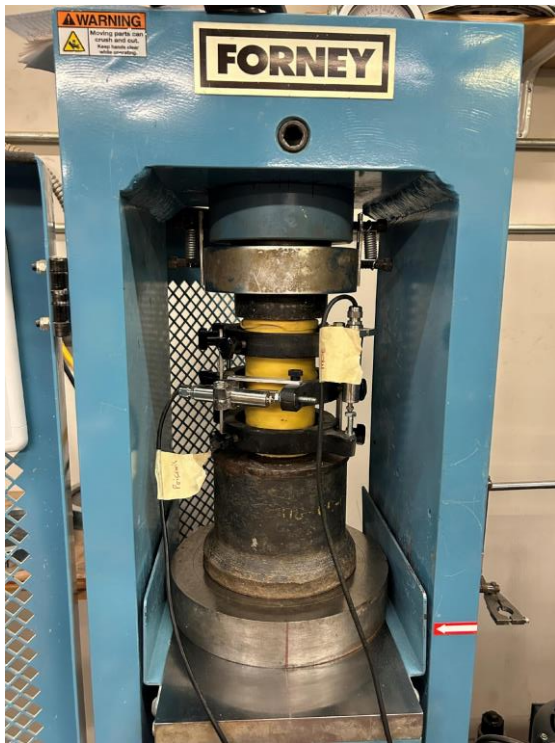
**594 Tests Completed for
Mechanical Properties of
Concrete**

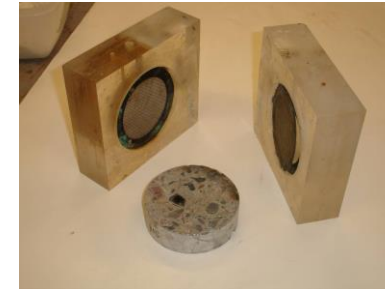
**Approx. 300 Petrographic, Chemical, and
Durability Related Property Tests of
Structural Concrete**

Test for resistance to chloride ion penetration.
