Characterization of Edge Fracture in Various Types of Advanced High Strength Steel

James Dykeman, Skye Malcolm

Based on SAE 2011 Paper# 2011-01-1058

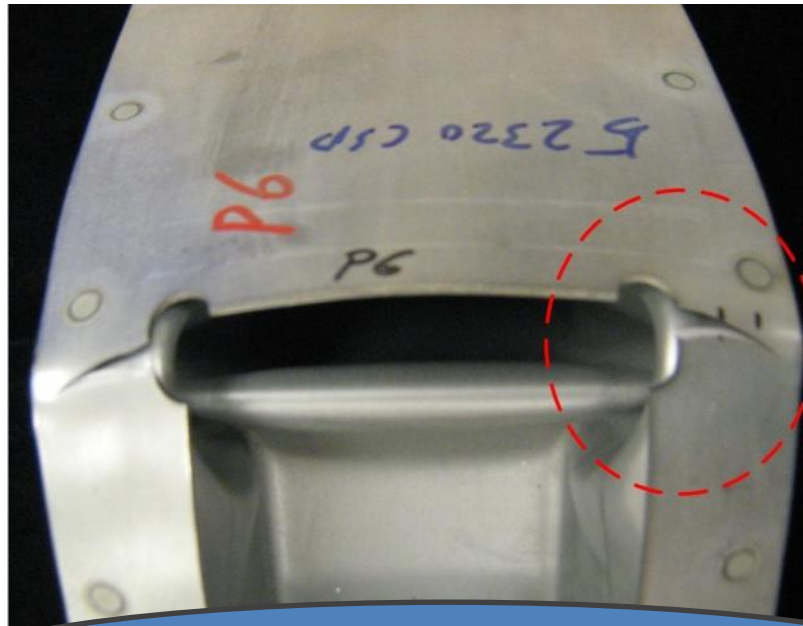
- Technical Challenge - Fracture Issues in Crash Deformation
 - Previous mild steels failed by "necking or plastic instability".
 - New AHSS is more prone to fracture, particularly at edges.
 - Edge cracks on AHSS can be problematic in early vehicle development.

**These type of fractures
difficult to predict.**

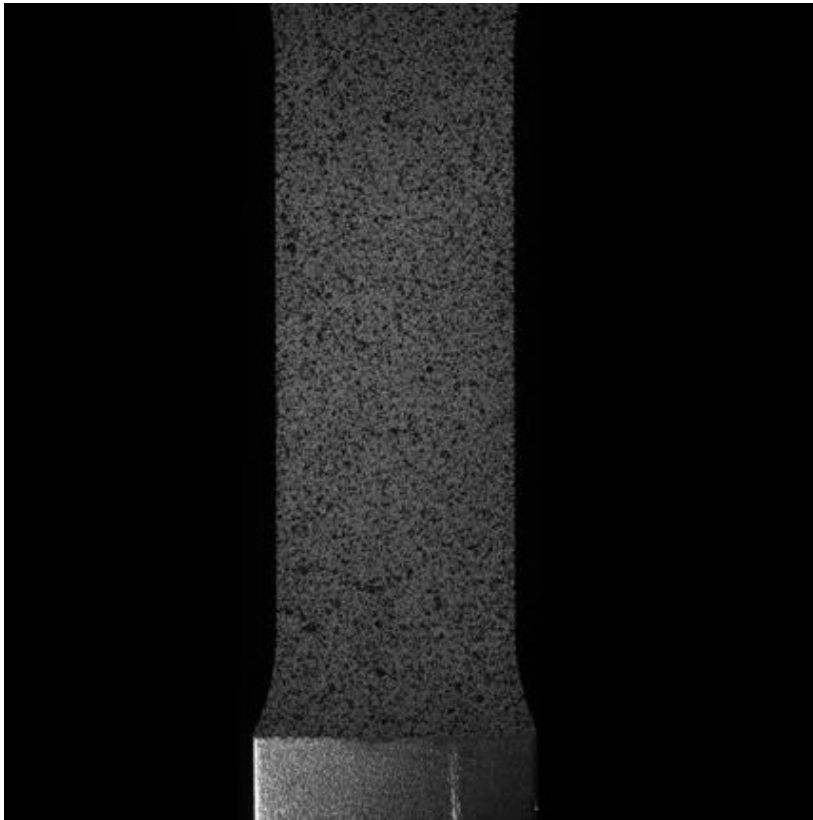
- Strain Measurement Method
 - Example tensile test with DIC speckle pattern.

↑ Software measures displacement of speckle pattern to calculate strain.

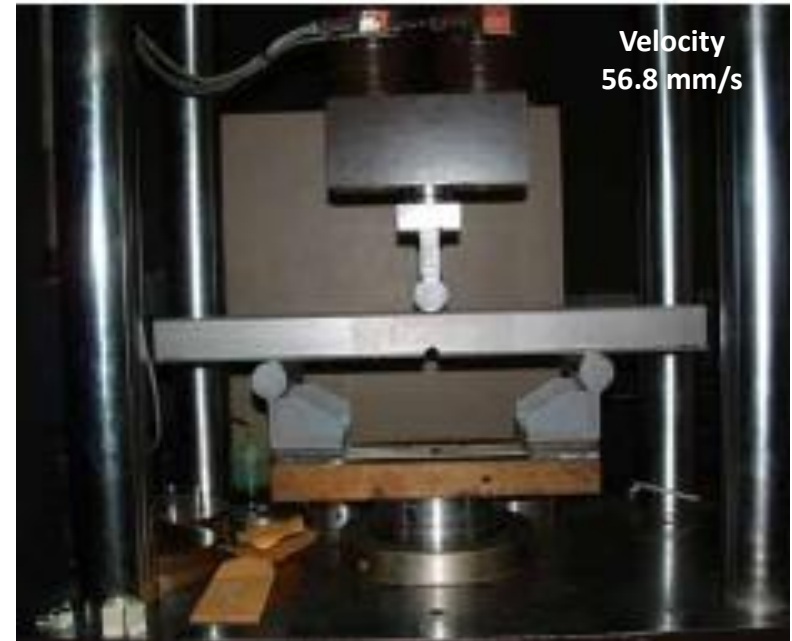
■ Hat Section with Side Notch

■ Test Set-up:

Materials, 1.4t:

JAC 780T

JSC 980Y Low Carbon

Edge:

Punched
Water Jet

- Hat Sections with side notches were tested in bend crush mode.
- Two Materials and two edge conditions were included.
- DIC was used for strain measurement.

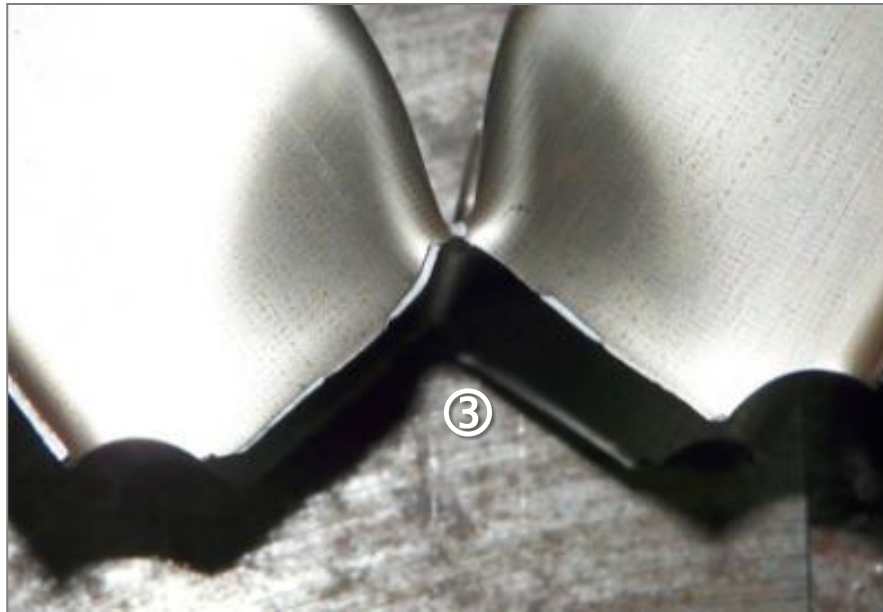
- Hat Section with Side Notch
 - Failure Sequence of Hat Section during deformation

1. Components experience buckling on top of hat section.
2. Fracture at the notch subsequently occurs.
3. Cracking progresses up through the sidewall of section.

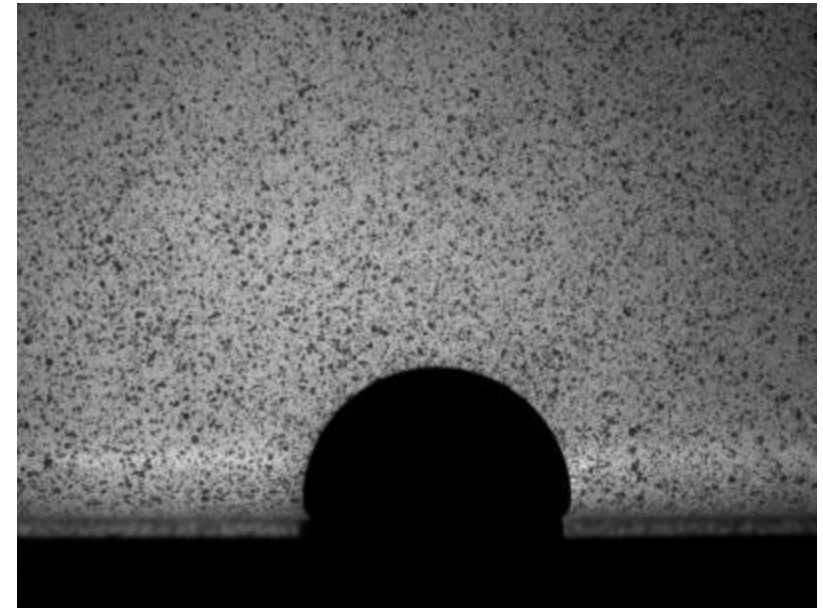
JAC 780T, 1.4t

Fracture Strain - Water Jet	Fracture Strain - Punch
0.38	0.20

Punching had a significant effect on 780T fracture behavior.

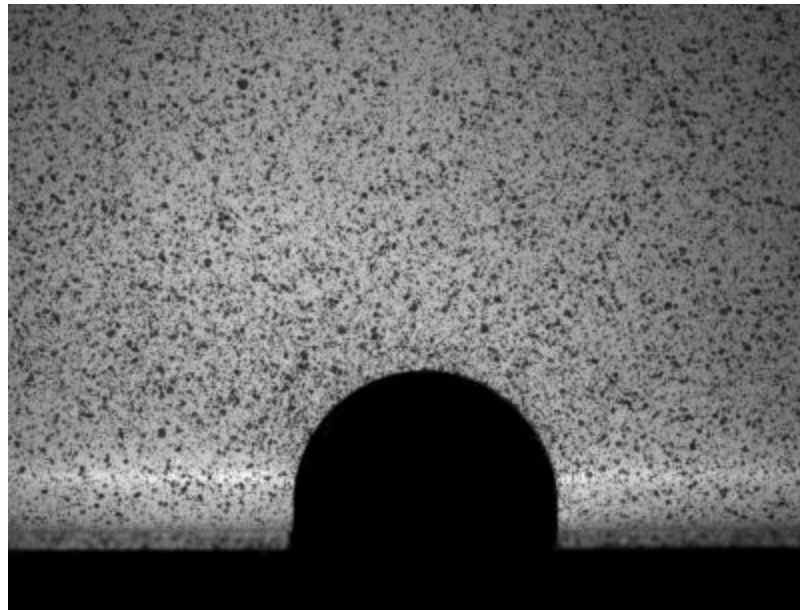
Fracture Strain - Water Jet	Fracture Strain - Punch
.35	.33

Punching had less effect on JSC 980Y fracture behavior

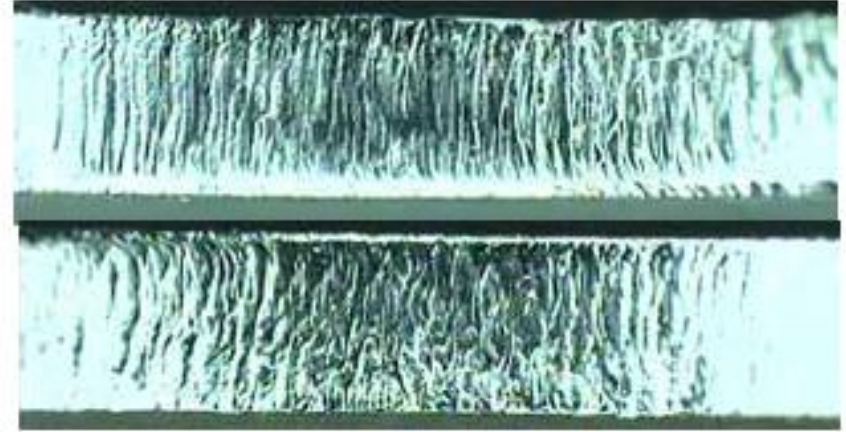
LASER - used for hot stamp production

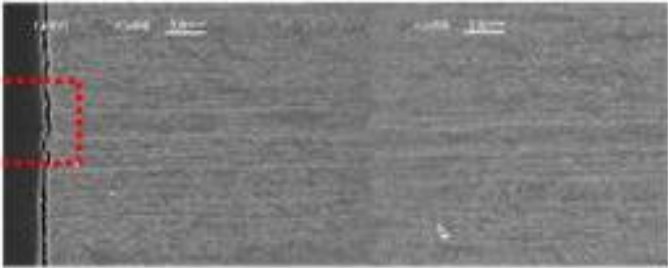
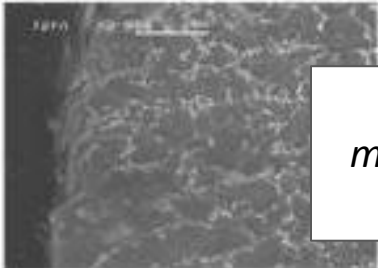
<div>WATER JET <i>minimal damage</i> <i>< 5um</i></div>
Laser 590R

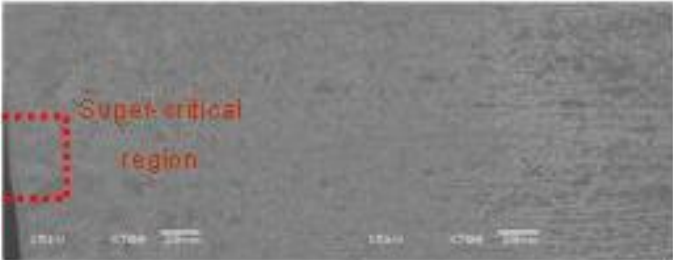
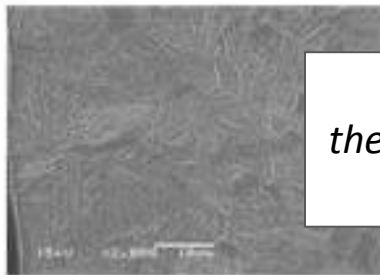
<div>Super-critical region</div>

<div>LASER <i>thermal hardening</i> <i>~ 200 um</i></div>
Punch 590R

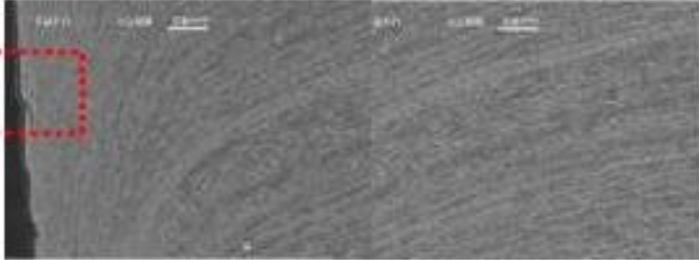
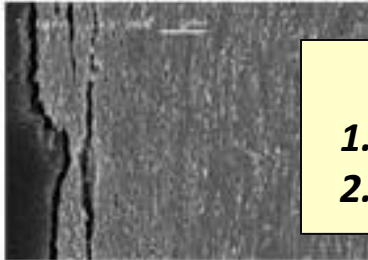
<div>PUNCH <i>1. work hardening</i> <i>2. micro cracks</i></div>
