CLIMATE SPECIFIC ACCELERATED AGEING TESTS

And outdoor failures observed

Karl A. Berger (AIT)

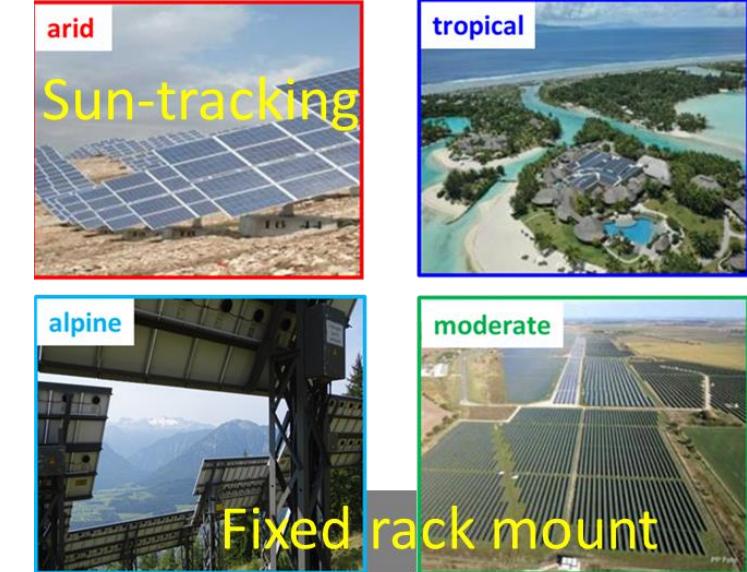
FAILURE STATISTICS FIELDDED PV-MODULES >2000, (303)

RELATIVE PERCENTAGE OF REPORTED FAILURES PER COMPONENT AND CLIMATE ZONE AS DERIVED FROM THE INFINITY STUDY, M. Halwachs et al., Renewable Energy, vol.139, pp. 1040-1060, 2019.

Component	Köppen Geiger main climate zone				
	A tropical	B arid	C temperate	D continental	E alpine / polar
Glass	33%	22%	22%	19%	-
Cells/Busbars	46%	29%	38%	62%	15%
Interconnectors	4%	5%	3%	-	15%
Encapsulant	8%	11%	12%	-	8%
Backsheet	-	9%	1%	5%	54%
Junction Box	4%	15%	13%	-	8%
Other	4%	8%	7%	14%	-

- Many common failures in A – D but clearly visible differences
- E (Alpine) clearly differs from the others (with having no broken frames or glass in our sample)
- >300 observed failures in systems built after 2000 is still a (too) small sample
- Update with more data would be nice ...

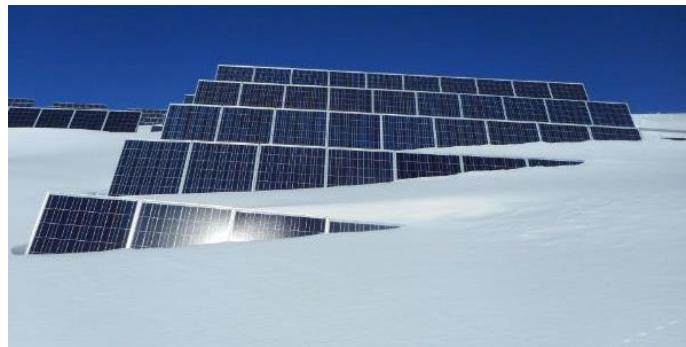
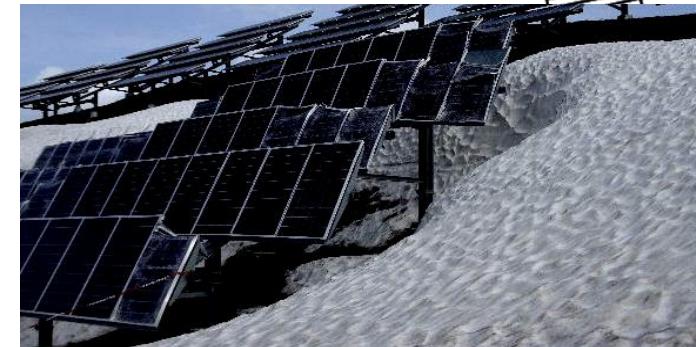
MW system +2000 m a.s.l. buried under several meters of snow in early Spring 2019.
Pics from mid May & June 2019. Module top bent backwards – System failure?

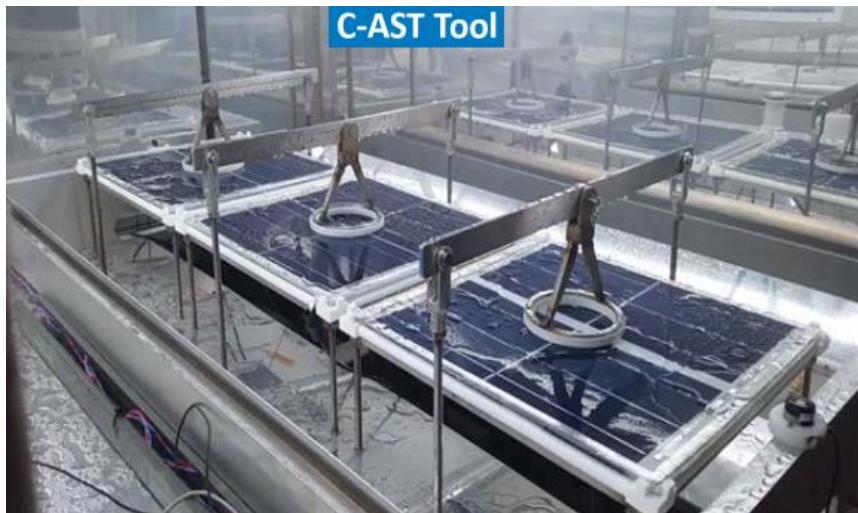
Combined-accelerated stress testing
<https://www.nrel.gov/docs/fy19osti/73984.pdf>
