Federal Building and Fire Safety Investigation of the World Trade Center Disaster

Project #3: Analysis of Structural Steel

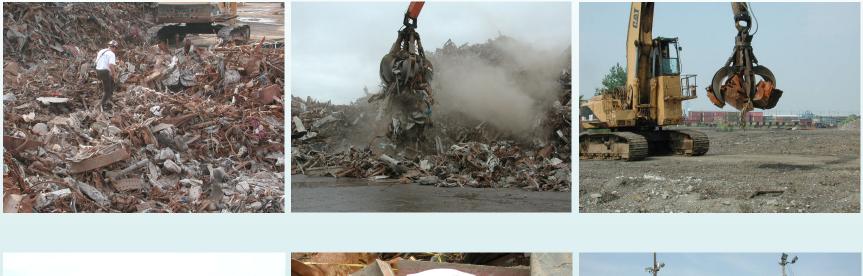
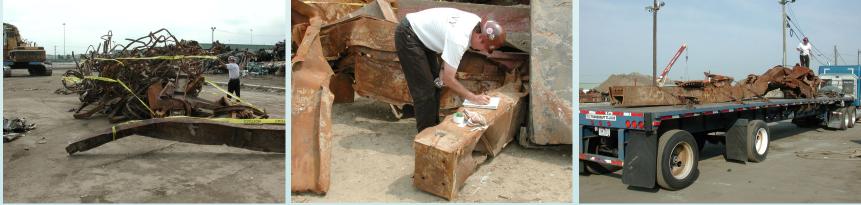
Steel Search, Collection, Logging and Shipping to NIST

~ 1.5 million tons of debris 1/4-1/3 steel

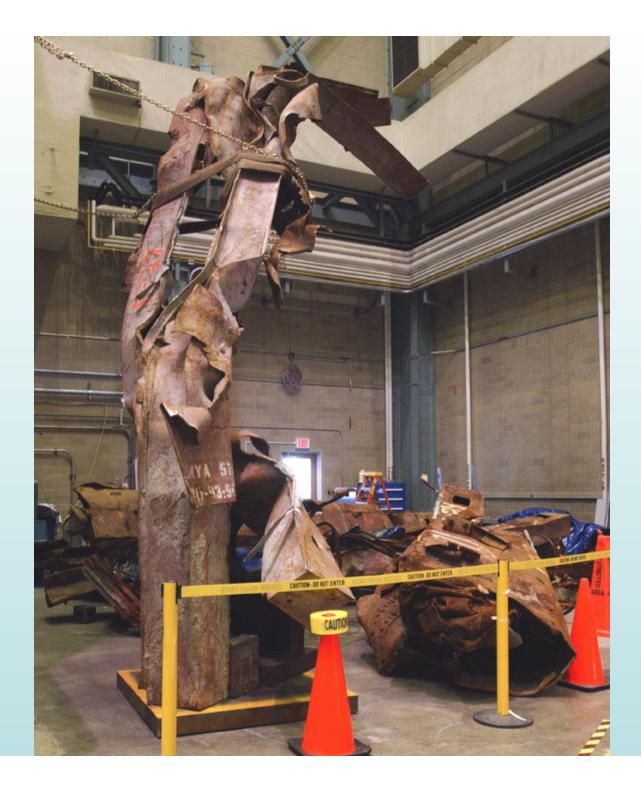
Task 2 Document Failure Mechanisms and Damage

- Analysis in progress
- Examination of local damage and failure mechanisms
- Requires deciphering of post-collapse damage from pre-collapse
 - image analysis, comparison of pre-collapse images with salvaged steel
- Wiss, Janney, Elstner contractors
 - Experts in structural failure analysis
 - Will provide observations and statistics of repeated patterns of pos impact failures/fractures of bolts, welds, truss seats, spandrel splices, and column splices, & fire damage described as function of location (in or away from impact zone or fires)
 - Identify any structural elements that might have been especially sensitive to the fire
- These observations will help us estimate energy absorbed during impact, and performance in fire.

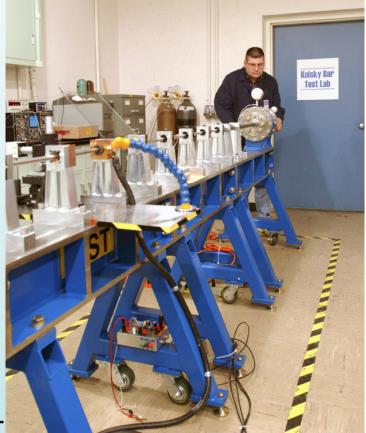
Kolsky Bar setup

Conventional tensile vs Kolsky Bar (compression)

- Yield strength and workhardening behavior
- Strain rates from 500 per second to 5000 per second (500,000% elongation per second)
- Specialized Kolsky Bar equipment at NIST
